1 EXISTING DAM PLAN
SCALE: 1"=40'

POTENTIAL DEFICIENCY MATRIX

S1.0
DATE: NOV. 13, 2018
DRAWN BY: S.R.M.
DESIGNED BY: T.R.T.
CHECKED BY: -
JOB NO.: 9624.000
SHEET: 1 OF 3

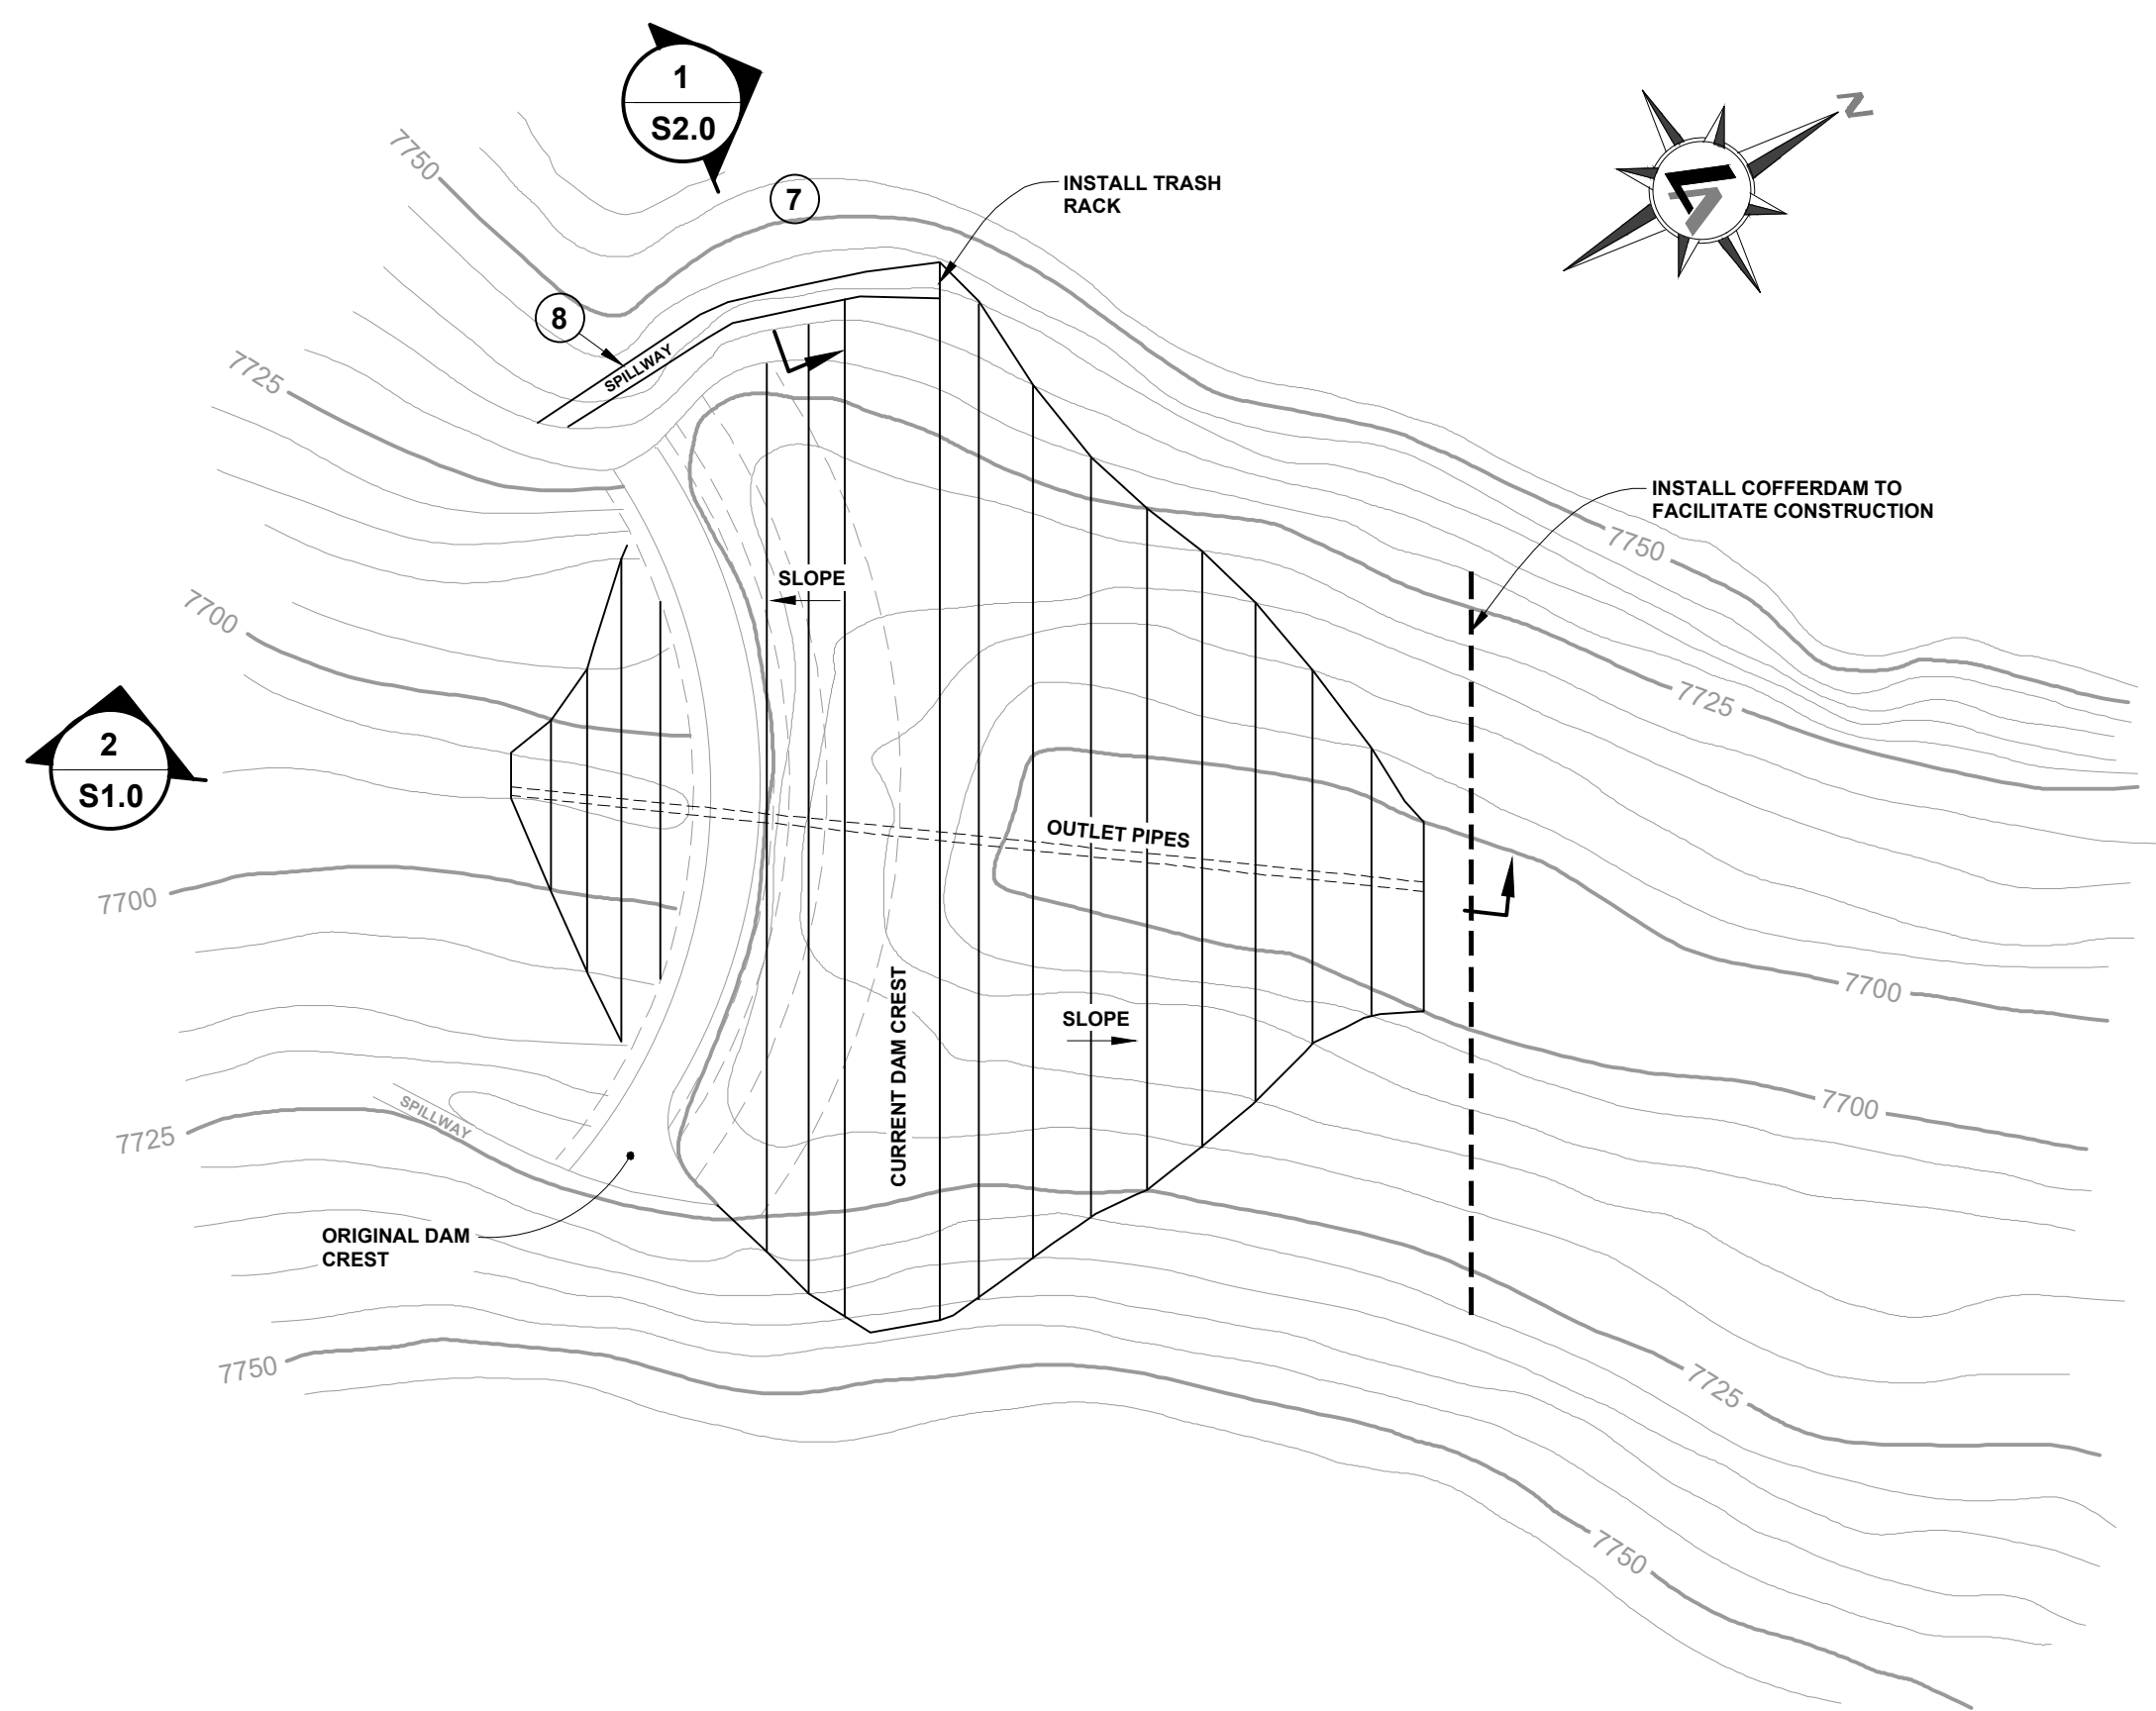
MARK	DEFICIENCY	PREFERRED UPGRADE
1	EMBANKMENT UNSTABLE DURING A SEISMIC EVENT	INSTALL (N) 3:1 SLOPE AND STABILITY BERM - SEE 3/S1.0 & NOTE 1
2	INADEQUATE COMPACTION LEADING TO SETTLEMENT DURING A SEISMIC EVENT	DENSIFY ORIGINAL DAM EMBANKMENT - SEE 3/S1.0
3	OVERTOPPING OF CREST DURING A SEISMIC EVENT	INCREASE CREST HEIGHT - SEE 3/S1.0
4	LEAKAGE AND CORROSION IN OUTLET PIPES	REPLACE OUTLET PIPES - SEE 3/S1.0
5	DETERIORATED OUTLET STRUCTURE	REPLACE - SEE 3/S1.0
6	POTENTIAL LIQUIFACTION DURING A SEISMIC EVENT	COMPACTION GROUT
7	UNSTABLE SLOPE ABOVE SPILLWAY	SEE 2/S2.0
8	DETERIORATION IN SPILLWAY WALLS; SPILLWAY FILLS w/ SNOW	SEE 2/S2.0
9	INADEQUATE MANUAL CONTROLS	REPLACE

NOTES: 1. AS AN ALTERNATIVE TO CONSTRUCTING A NEW EMBANKMENT SLOPE, THE EXISTING EMBANKMENT COULD BE DENSIFIED BY COMPACTION GROUTING OR VIBRO COMPACTION.
