FACILITY CONDITION ASSESSMENT REPORT FOR:

OFFICE OF THE MILITARY NATIONAL GUARD

BATTLE BORN YOUTH CHALLENGE ACADEMY SITE 100 UNIVERSITY AVE CARLIN, NV 89822-

Survey Date: 5/9/2022

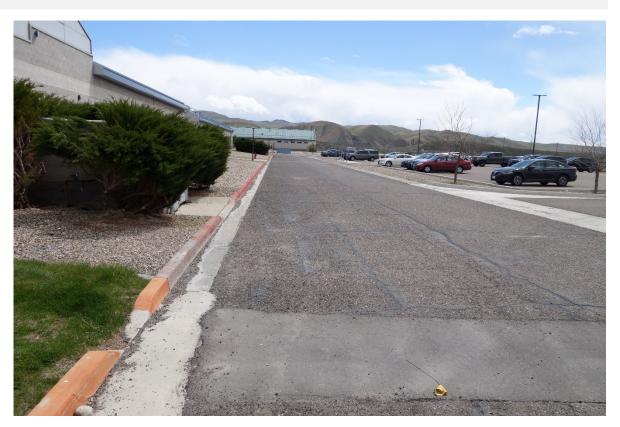
9796 BATTLE BORN YOUTH CHALLENGE ACADEMY SITE

It is important to maintain the asphalt concrete paving on the site. This project would provide for minor crack filling and slurry sealing of the paving site wide including access roads and parking areas. Striping is included in this estimate. This project should be scheduled on a 4 - 5-year cyclical basis to maintain the integrity of the paving and prevent premature failure. 121,000 square feet of asphalt area was used to generate this estimate.

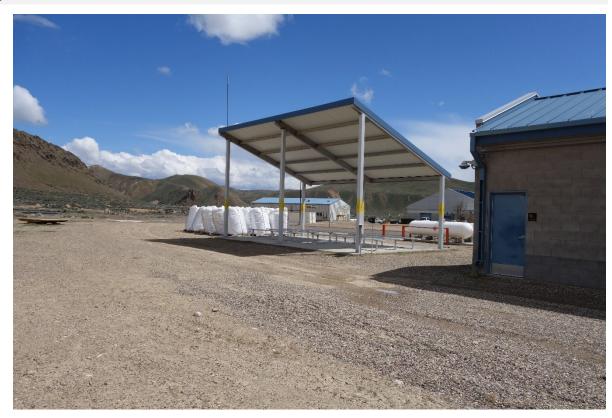
9796 BATTLE BORN YOUTH CHALLENGE ACADEMY SITE

There are 10 steel shade ramadas in different locations throughout the site which are either 600 sf. or 1,366 sf. for a total of 6,766 sf. The exterior finishes are in good condition. It is important to maintain the finish, weather resistance and appearance of the structures. This project would provide for painting of the structures, and it is recommended that this project be scheduled on a cyclical basis to maintain the integrity of the structures.

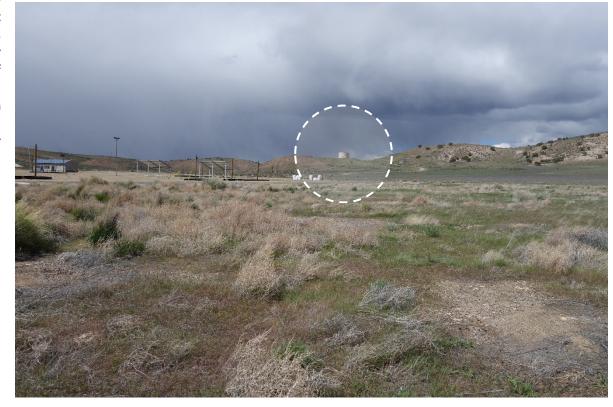
4266 WATER TANK

The interior and exterior finishes on the water storage tank are original and show signs of corrosion and deterioration. This project recommends a complete recondition of the 246,000-gallon tank's interior and exterior and complete sanitization of tank interior at the conclusion of the project.

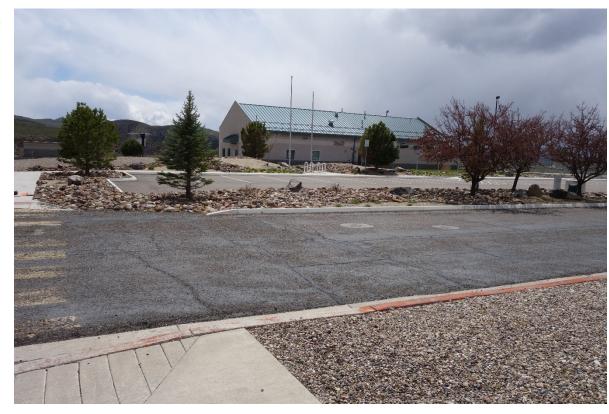
PROJECT ID: 3161-EXT-1

The exterior finishes were in good condition. It is important to maintain the weather resistance finish, and appearance of the building. This project would provide funding to protect the exterior of the building. Included in the cost are cleaning and sealing the masonry and caulking of the flashing, fixtures and all other penetrations. It is recommended that the building be sealed and caulked in the next 8 - 9 years and that this project be scheduled on a cyclical basis to maintain the integrity of the structure.

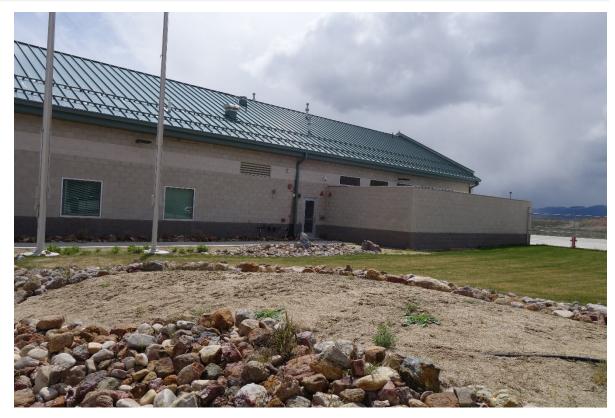
PROJECT ID: 3161-INT-1

The interior finishes are in good condition. It is recommended that the interior walls and ceilings be painted at least once in the next 7 - 9 years. Prior topainting, all surfaces should be repaired and prepped. An epoxy-based paint should be utilized in wet areas for durability.

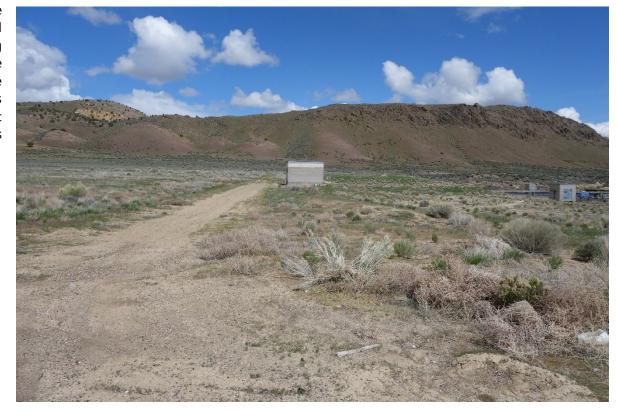
3037 STORAGE SHED

The exterior finishes were in good condition. It is important to maintain the finish, weather resistance and appearance of the building. This project would provide funding to protect the exterior of the building. Included in the cost are cleaning and sealing the masonry and caulking of the flashing, fixtures and all other penetrations. It is recommended that the building be sealed and caulked in the next 6 - 8 years and that this project be scheduled on a cyclical basis to maintain the integrity of the structure.

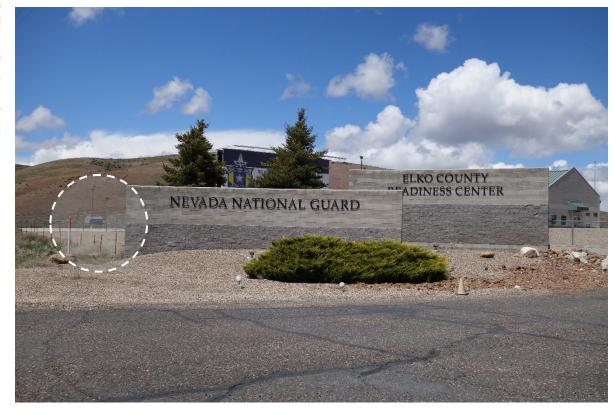
3036 DOMESTIC WATER PUMP HOUSE

It is important to maintain the finish, weather resistance and appearance of the building. This project would provide funding to protect the exterior of the building. Included in the cost are cleaning and sealing the masonry and caulking of the flashing, fixtures and all other penetrations. It is recommended that the building be sealed and caulked in the next 4 - 5 years and that this project be scheduled on a cyclical basis to maintain the integrity of the structure.

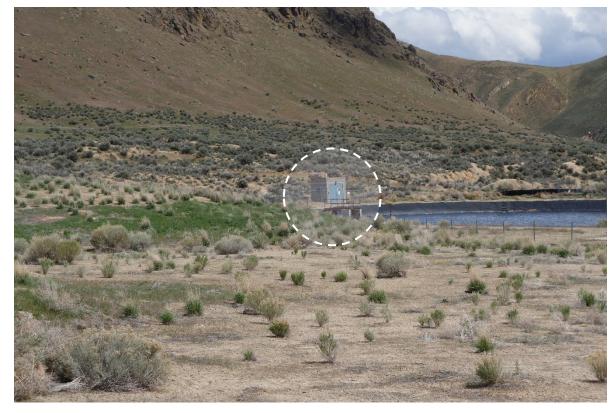
3034 CHEMICAL STORAGE BUILDING

The exterior finishes were in fair condition. It is important to maintain the finish, weather resistance and appearance of the building. This project would provide funding to protect the exterior of the building. Included in the cost are cleaning and sealing the masonry and caulking of the flashing, fixtures and all other penetrations. It is recommended that the building be sealed and caulked in the next 4 - 5 years and that this project be scheduled on a cyclical basis to maintain the integrity of the structure.

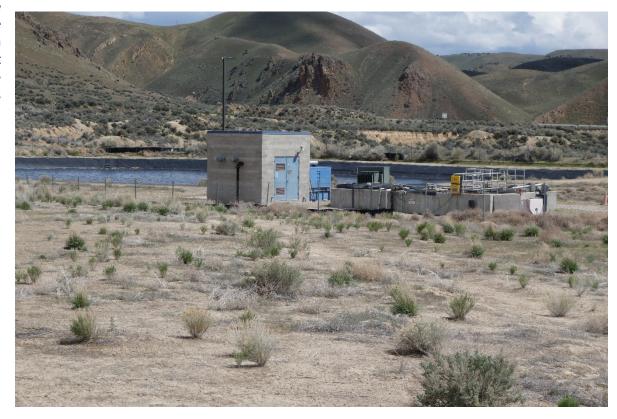
3033 SANITARY SEWER BUILDING

The exterior finishes were in fair condition. It is important to maintain the finish, weather resistance and appearance of the building. This project would provide funding to protect the exterior of the building. Included in the cost are cleaning and sealing the masonry and caulking of the flashing, fixtures and all other penetrations. It is recommended that the building be sealed and caulked in the next 4 - 5 years and that this project be scheduled on a cyclical basis to maintain the integrity of the structure.

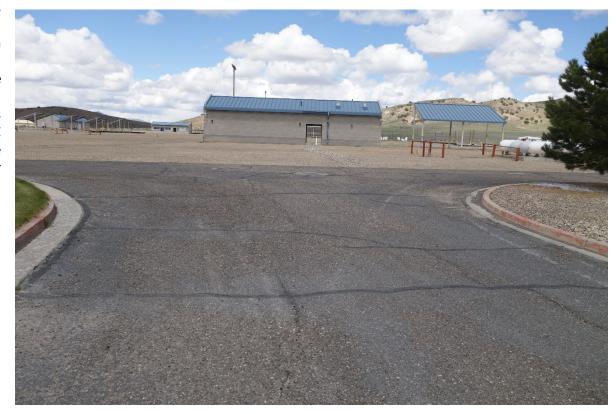
PROJECT ID: 2967-EXT-3

The exterior finishes were in fair condition. It is important to maintain the finish, weather resistance and appearance of the building. This project would provide funding to protect the exterior of the building. Included in the cost are cleaning and sealing the masonry and caulking of the control joints, windows, flashing, fixtures and all other penetrations. It is recommended that the building be sealed and caulked in the next 2-3 years and that this project be scheduled on a cyclical basis to maintain the integrity of the structure.

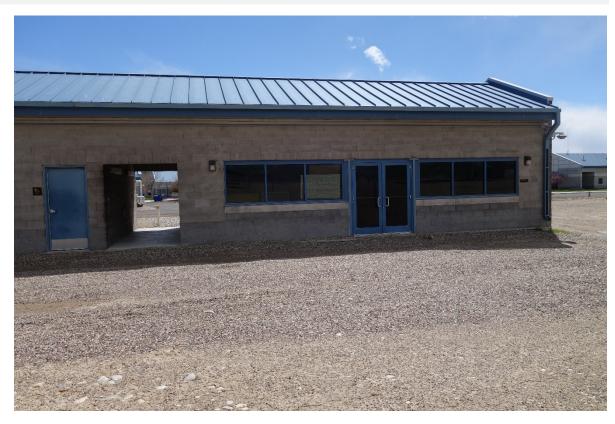
PROJECT ID: 2967-HVA-1

The HVAC system is original to the building and should be planned for replacement. It is not energy efficient and has reached the end of its expected and useful life. The R-22 refrigerant in the cooling system is no longer EPA compliant and its production was phased out completely January 1, 2020. This project would provide for installation of a new HVAC system and cleaning of the existing duct work and grilles. This project includes removal and disposal of the existing HVAC system and all required connections to utilities.

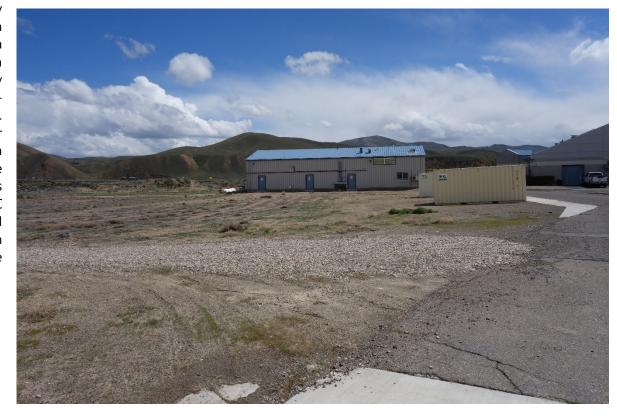
PROJECT ID: 2964-EXT-2

The exterior finishes are in fair condition. It is important to maintain the finish, weather resistance and appearance of the building. This project would provide funding to protect the exterior of the building. Included in the cost is the caulking and sealing of the windows, flashing, fixtures and all other penetrations. It is recommended that the building be caulked and sealed in the next 4 - 5 years and that this project be scheduled on a cyclical basis to maintain the integrity of the structure.

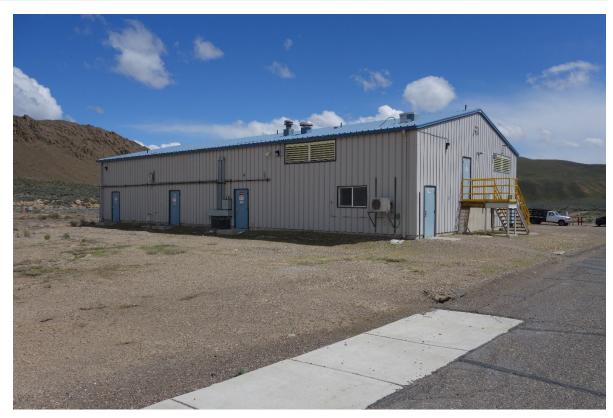
PROJECT ID: 2964-INT-2

The interior finishes are in fair condition. It is recommended that the interior walls and ceilings be painted at least once in the next 4 to 5 years. Prior to painting, all surfaces should be repaired and prepped. An epoxy-based paint should be utilized in wet areas for durability.

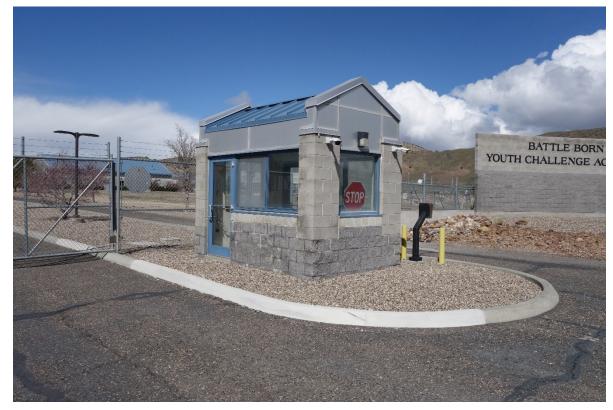
2963 BLDG #14-SECURITY KIOSK

The Security Kiosk is a concrete masonry unit and wood framed structure with a standing seam metal roofing system on a concrete slab-ongrade foundation. It is currently not in use.

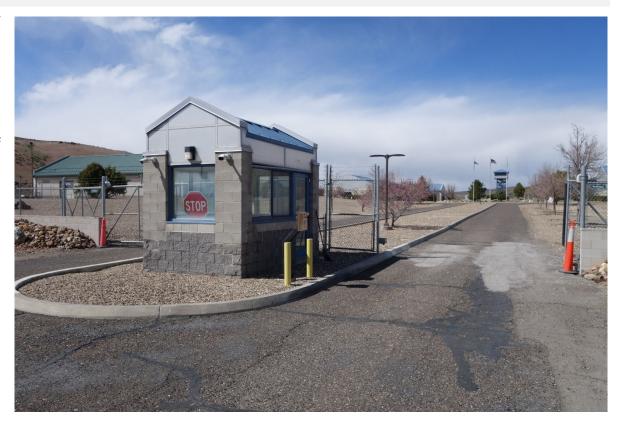
The exterior finishes were in fair condition. It is important to maintain the finish, weather resistance and appearance of the building. This project would provide funding to protect the exterior of the building. Included in the cost are cleaning and sealing the masonry and caulking of the control joints, metal panels, windows, flashing, fixtures and all other penetrations. It is recommended that the building be sealed and caulked in the next 4 - 5 years and that this project be scheduled on a cyclical basis to maintain the integrity of the structure.

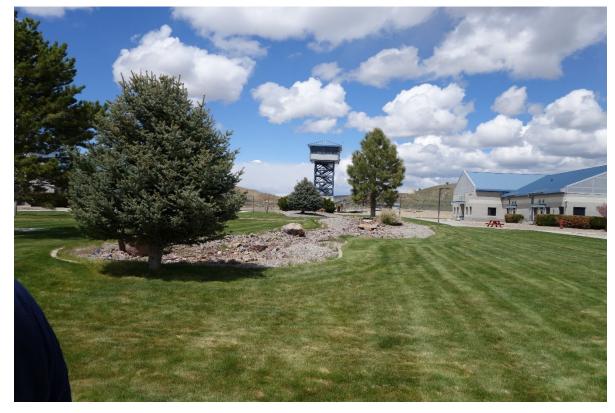
2962 BLDG #13-TOWER

The Tower is a large steel framed structure with a standing seam metal roofing system on a concrete foundation. It is located on the north side of the quad and was used for observation purposes. It is no longer in use.

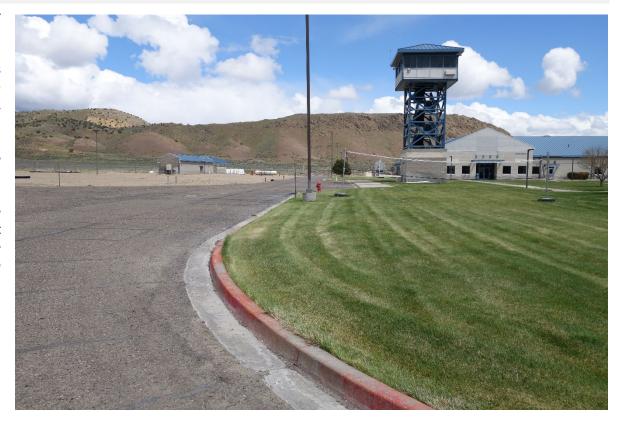
The exterior finishes were in fair condition. It is important to maintain the finish, weather resistance and appearance of the building. This project would provide funding to protect the exterior of the building. Included in the cost are cleaning and painting of the steel posts, beams and columns, sealing and caulking of the metal panels, windows, flashing, fixtures and all other penetrations. It is recommended that the building be painted, sealed and caulked in the next 4 - 5 years and that this project be scheduled on a cyclical basis to maintain the integrity of the structure.

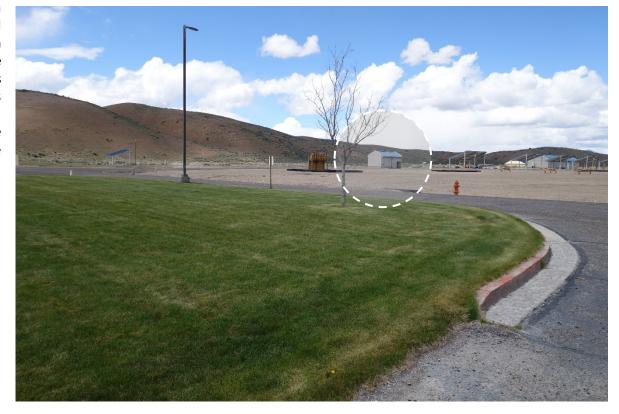
2960 BLDG #10-TOILET ROOMS

The Toilet Rooms building is a concrete masonry unit, steel and wood framed structure with a standing seam metal roofing system on a concrete slab-on-grade foundation. It has Men's and Women's restroom facilities and is mostly ADA compliant. There are wall mounted heating units to supply the restrooms. There is no cooling. The building is in good condition.

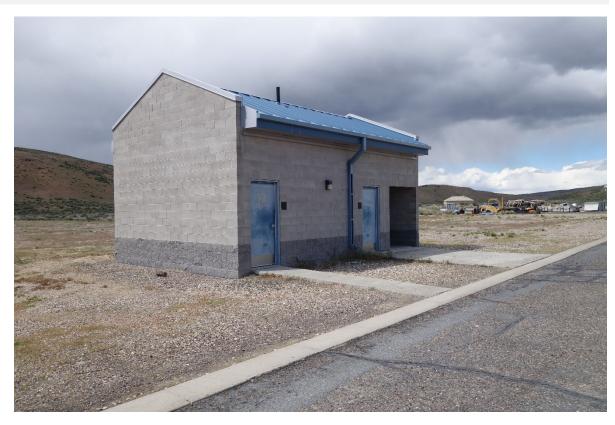
The exterior finishes were in fair condition. It is important to maintain the finish, weather resistance and appearance of the building. This project would provide funding to protect the exterior of the building. Included in the cost are cleaning and sealing the masonry and caulking of the control joints, windows, flashing, fixtures and all other penetrations. It is recommended that the building be sealed and caulked in the next 2-3 years and that this project be scheduled on a cyclical basis to maintain the integrity of the structure.

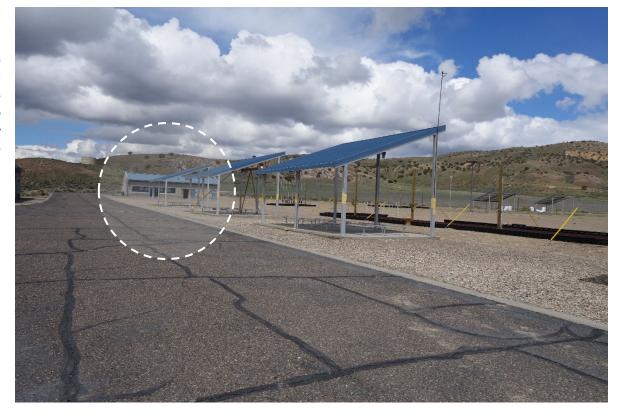
PROJECT ID: 2959-EXT-2

The exterior finishes were in fair condition. It is important to maintain the finish, weather resistance and appearance of the building. This project would provide funding to protect the exterior of the building. Included in the cost are cleaning and sealing the masonry and caulking of the control joints, windows, flashing, fixtures and all other penetrations. It is recommended that the building be sealed and caulked in the next 4 - 5 years and that this project be scheduled on a cyclical basis to maintain the integrity of the structure.

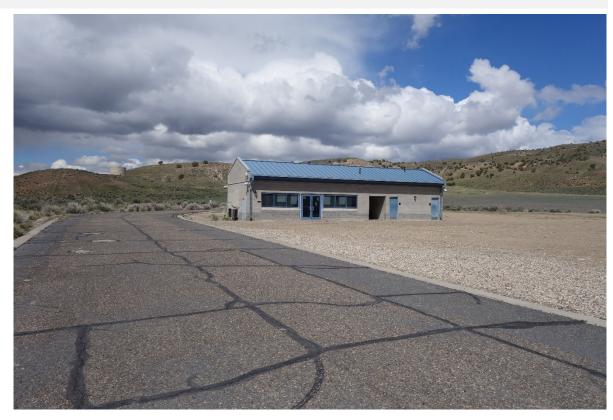
PROJECT ID: 2959-HVA-1

The HVAC system is original to the building and should be planned for replacement. It is not energy efficient and has reached the end of its expected and useful life. The R-22 refrigerant in the cooling system is no longer EPA compliant and its production was phased out completely January 1, 2020. This project would provide for installation of a new HVAC system and cleaning of the existing duct work and grilles. This project includes removal and disposal of the existing HVAC system and all required connections to utilities.

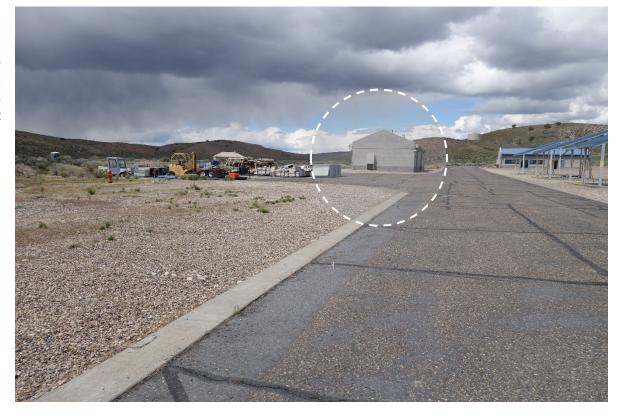
PROJECT ID: 2958-EXT-2

The exterior finishes were in fair condition. It is important to maintain the finish, weather resistance and appearance of the building. This project would provide funding to protect the exterior of the building. Included in the cost are cleaning and sealing the masonry and caulking of the control joints, windows, flashing, fixtures and all other penetrations. It is recommended that the building be sealed and caulked in the next 4 - 5 years and that this project be scheduled on a cyclical basis to maintain the integrity of the structure.

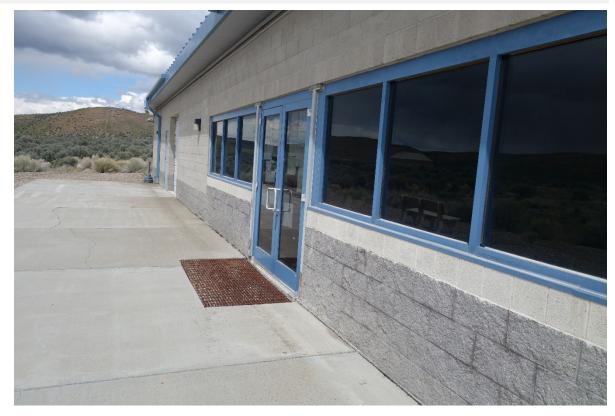
PROJECT ID: 2958-HVA-1

The HVAC system is original to the building and should be planned for replacement. It is not energy efficient and has reached the end of its expected and useful life. The R-22 refrigerant in the cooling system is no longer EPA compliant and its production was phased out completely January 1, 2020. This project would provide for installation of a new HVAC system and cleaning of the existing duct work and grilles. This project includes removal and disposal of the existing HVAC system and all required connections to utilities.

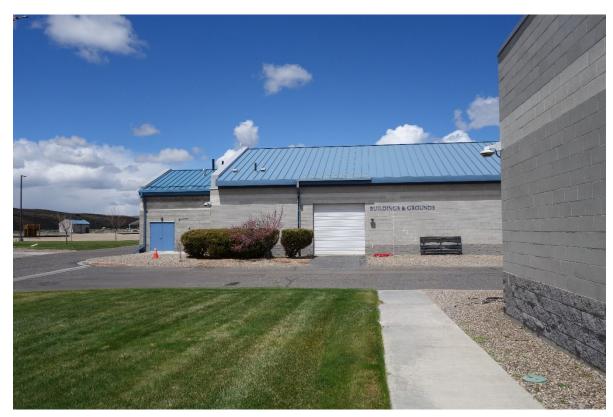
PROJECT ID: 2957-ELE-1

Arc flash and electrical breaker coordination studies have not been performed or it has been more than 5 years since the last coordination study. Safety requirements for maintenance personnel and the latest electrical code require coordination studies to be verified and performed every 5 years, along with arc flash labeling on all electrical panels. This project will perform the required coordination study, evaluation, adjustments and labeling for the building's electrical distribution system.

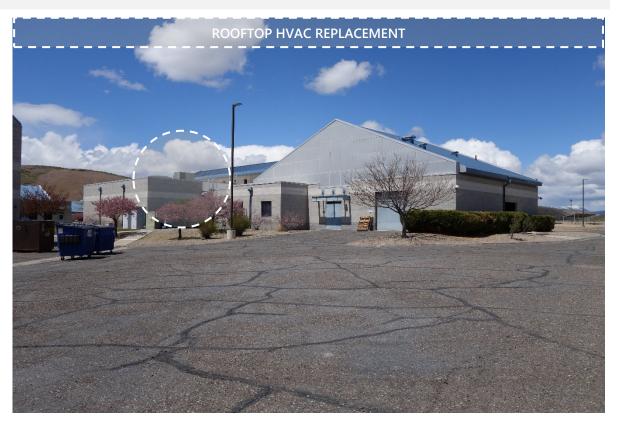
PROJECT ID: 2955-EXT-3

The exterior finishes were in fair condition. It is important to maintain the finish, weather resistance and appearance of the building. This project would provide funding to protect the exterior of the building. Included in the cost are painting the steel architectural elements, cleaning and sealing the masonry and caulking of the control joints, metal panels, windows, flashing, fixtures and all other penetrations. It is recommended that the building be sealed and caulked in the next 4 - 6 years and that this project be scheduled on a cyclical basis to maintain the integrity of the structure.
