STATE OF NEVADA
STATE PUBLIC WORKS DIVISION

FACILITY CONDITION ASSESSMENT REPORT FOR:

OFFICE OF THE MILITARY
NATIONAL GUARD

SITE #: 9796 BATTLE BORN YOUTH CHALLENGE ACADEMY SITE
100 UNIVERSITY AVE
CARLIN, NV 89822-

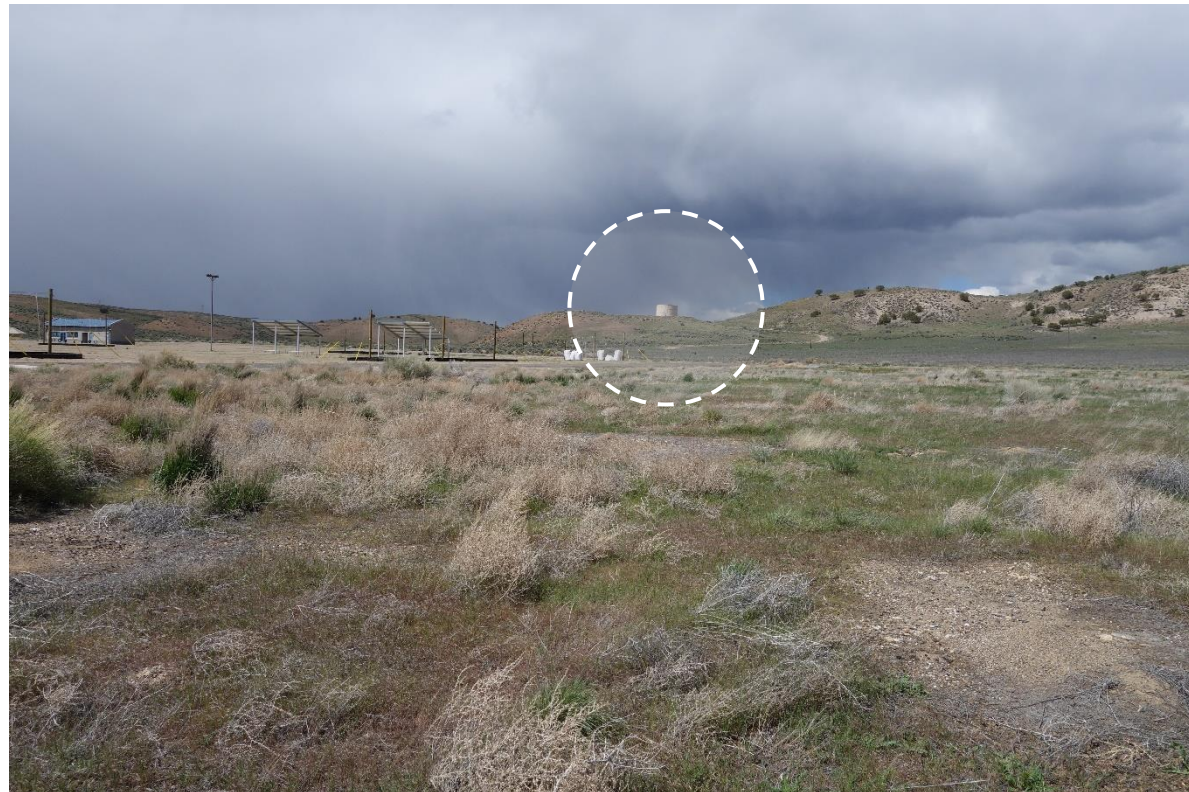
4266 WATER TANK

The interior and exterior finishes on the water storage tank are original and show signs of corrosion and deterioration. This project recommends a complete recondition of the 246,000-gallon tank's interior and exterior and complete sanitization of tank interior at the conclusion of the project.

This project is in design under CIP 21-M47, and the estimate is based off that project.

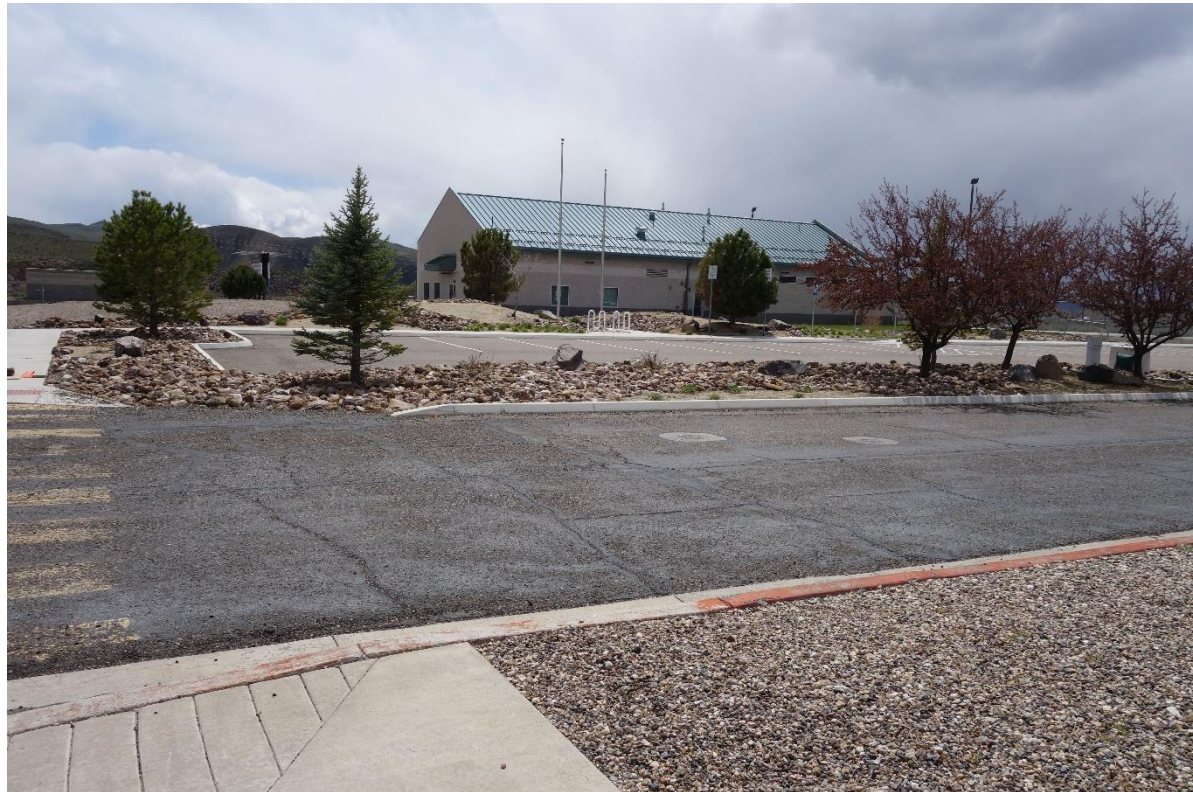
3161 CARLIN READINESS CENTER

The exterior finishes were in good condition. It is important to maintain the finish, weather resistance and appearance of the building. This project would provide funding to protect the exterior of the building. Included in the cost are cleaning and sealing the masonry and caulking of the flashing, fixtures and all other penetrations. It is recommended that the building be sealed and caulked in the next 8 - 9 years and that this project be scheduled on a cyclical basis to maintain the integrity of the structure.

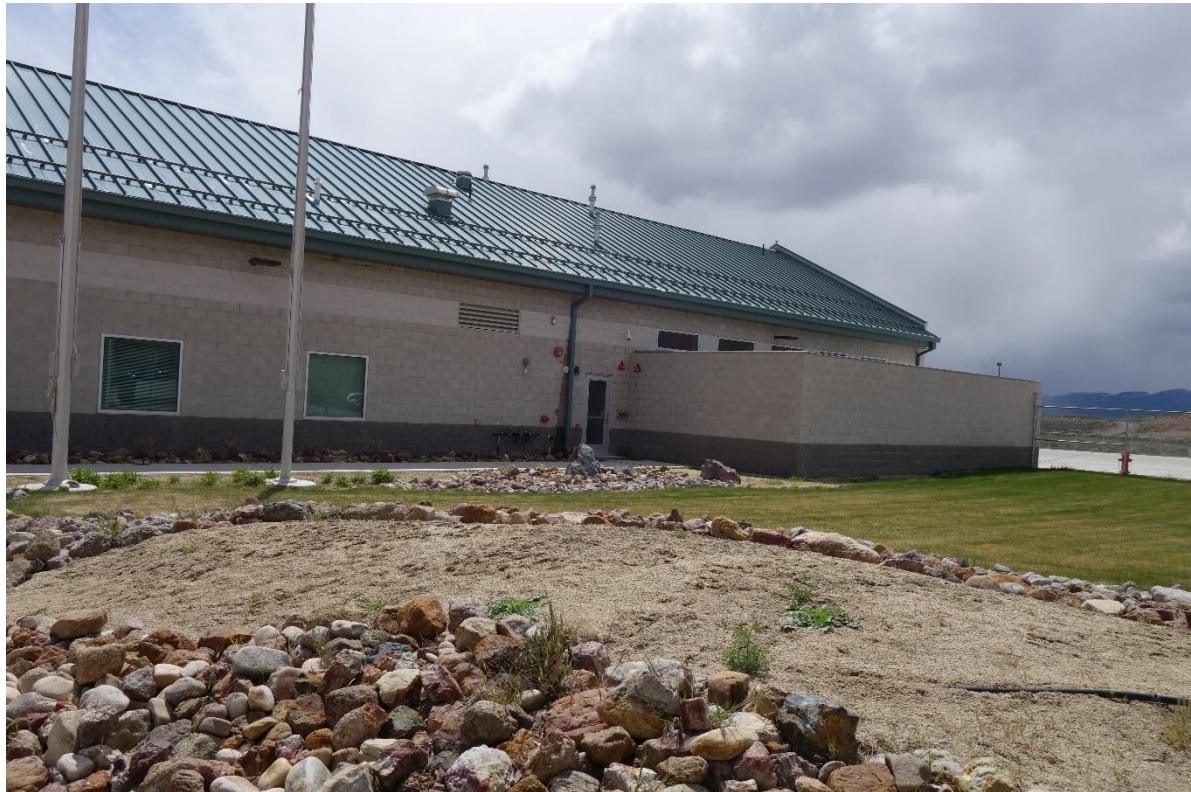
3161 CARLIN READINESS CENTER

The interior finishes are in good condition. It is recommended that the interior walls and ceilings be painted at least once in the next 7 - 9 years. Prior to painting, all surfaces should be repaired and prepped. An epoxy-based paint should be utilized in wet areas for durability.

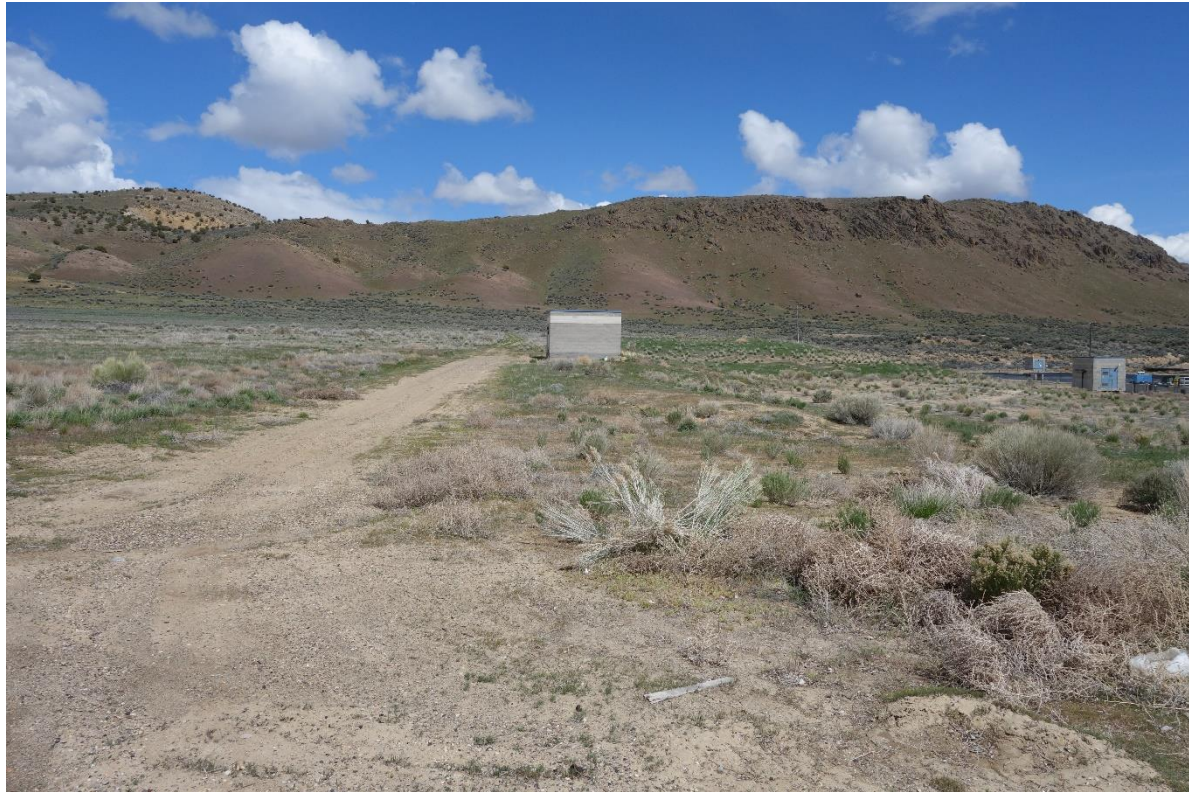
3037 STORAGE SHED

The exterior finishes were in good condition. It is important to maintain the finish, weather resistance and appearance of the building. This project would provide funding to protect the exterior of the building. Included in the cost are cleaning and sealing the masonry and caulking of the flashing, fixtures and all other penetrations. It is recommended that the building be sealed and caulked in the next 6 - 8 years and that this project be scheduled on a cyclical basis to maintain the integrity of the structure.

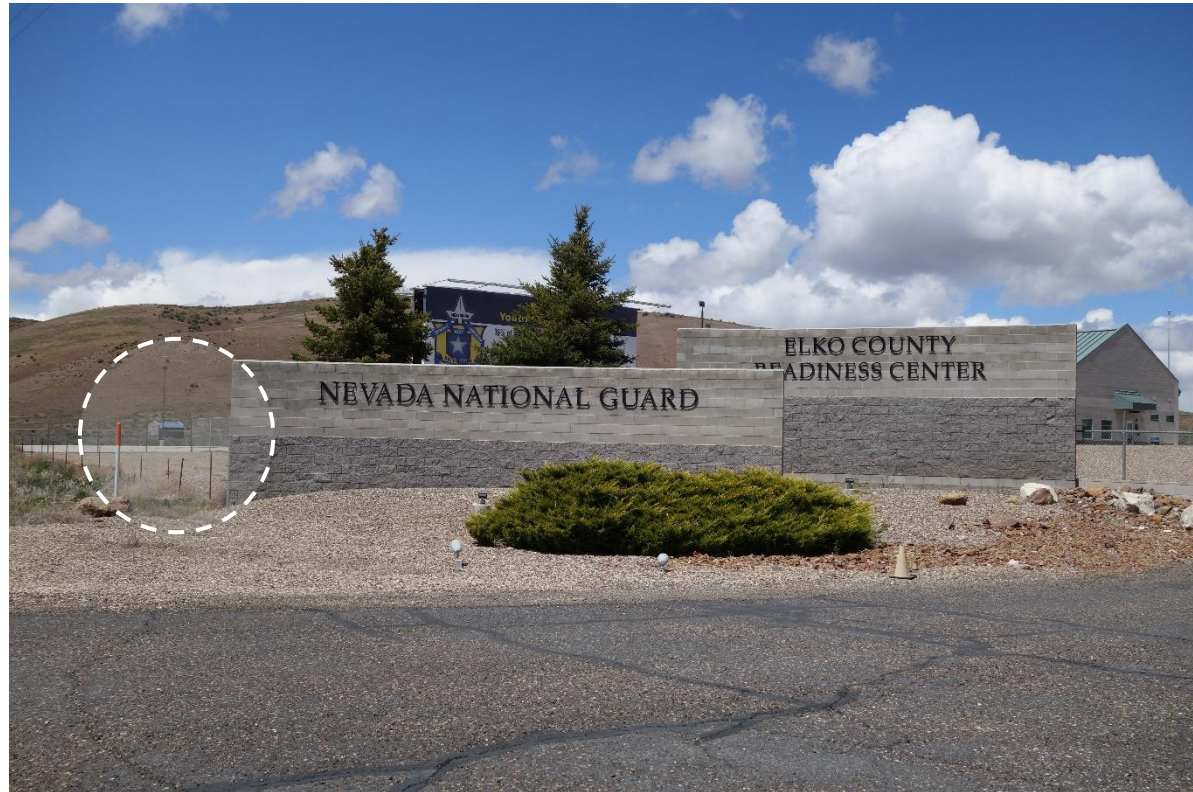
3036 DOMESTIC WATER PUMP HOUSE

It is important to maintain the finish, weather resistance and appearance of the building. This project would provide funding to protect the exterior of the building. Included in the cost are cleaning and sealing the masonry and caulking of the flashing, fixtures and all other penetrations. It is recommended that the building be sealed and caulked in the next 4 - 5 years and that this project be scheduled on a cyclical basis to maintain the integrity of the structure.

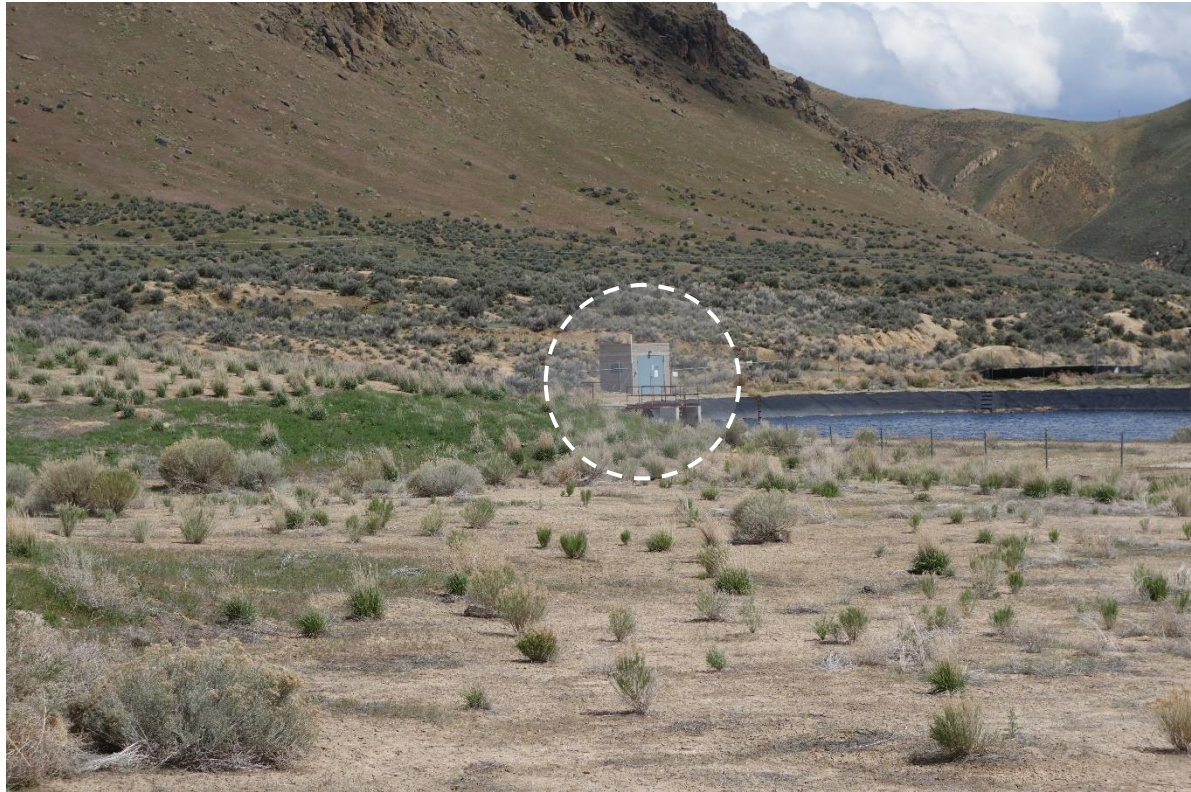
3034 CHEMICAL STORAGE BUILDING

The exterior finishes were in fair condition. It is important to maintain the finish, weather resistance and appearance of the building. This project would provide funding to protect the exterior of the building. Included in the cost are cleaning and sealing the masonry and caulking of the flashing, fixtures and all other penetrations. It is recommended that the building be sealed and caulked in the next 4 - 5 years and that this project be scheduled on a cyclical basis to maintain the integrity of the structure.

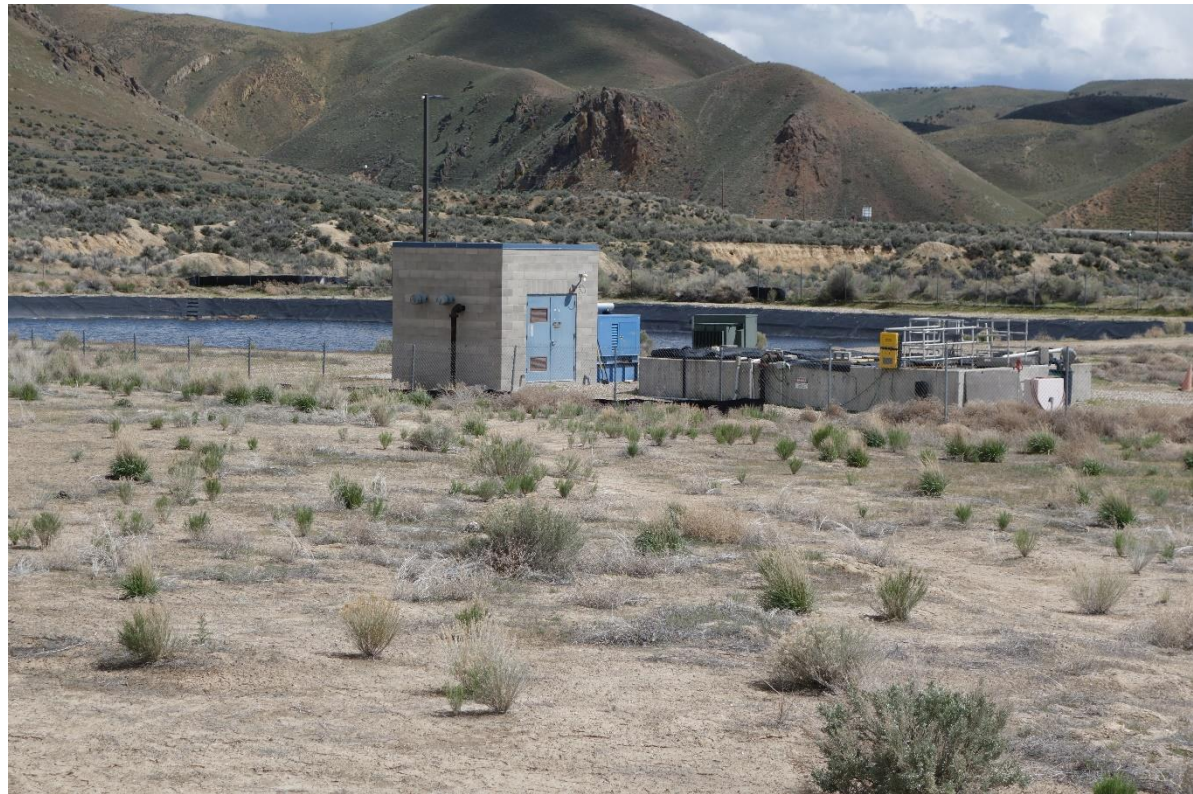
3033 SANITARY SEWER BUILDING

The exterior finishes were in fair condition. It is important to maintain the finish, weather resistance and appearance of the building. This project would provide funding to protect the exterior of the building. Included in the cost are cleaning and sealing the masonry and caulking of the flashing, fixtures and all other penetrations. It is recommended that the building be sealed and caulked in the next 4 - 5 years and that this project be scheduled on a cyclical basis to maintain the integrity of the structure.

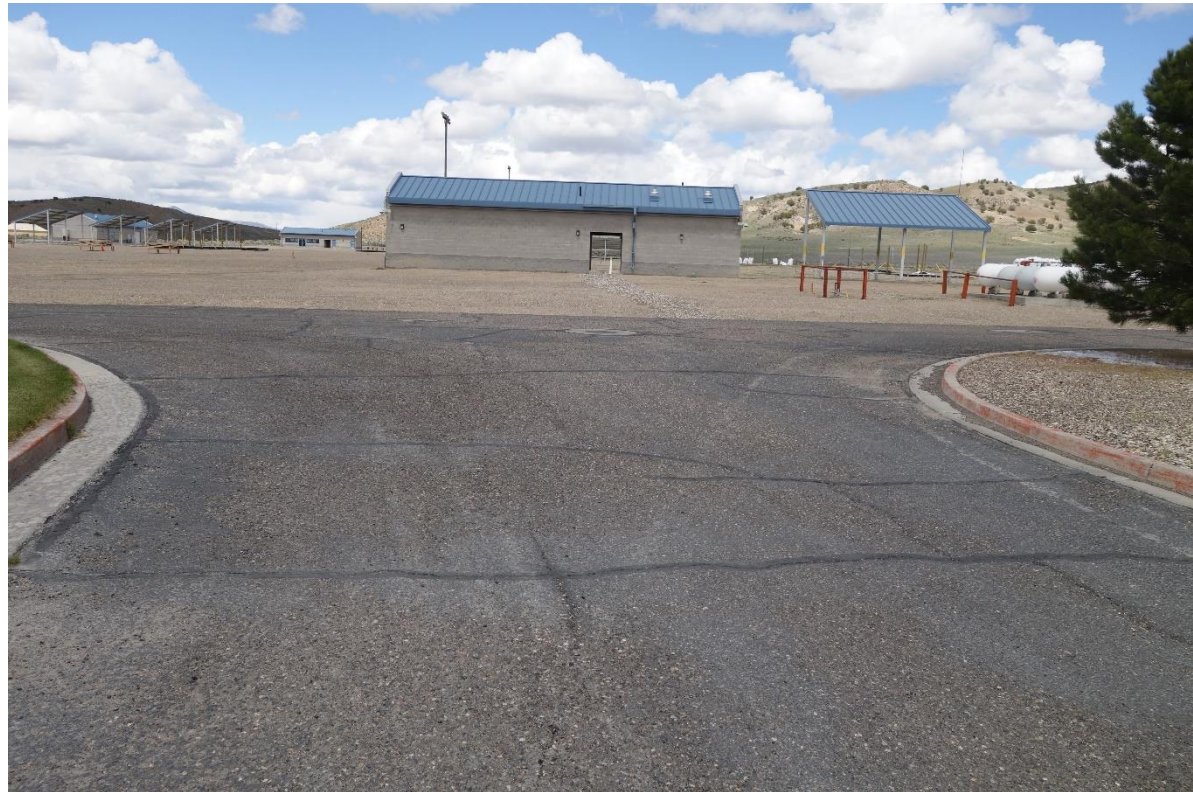
2967 BLDG #9-CLASSROOM/TOILET #2

The exterior finishes were in fair condition. It is important to maintain the finish, weather resistance and appearance of the building. This project would provide funding to protect the exterior of the building. Included in the cost are cleaning and sealing the masonry and caulking of the control joints, windows, flashing, fixtures and all other penetrations. It is recommended that the building be sealed and caulked in the next 2-3 years and that this project be scheduled on a cyclical basis to maintain the integrity of the structure.

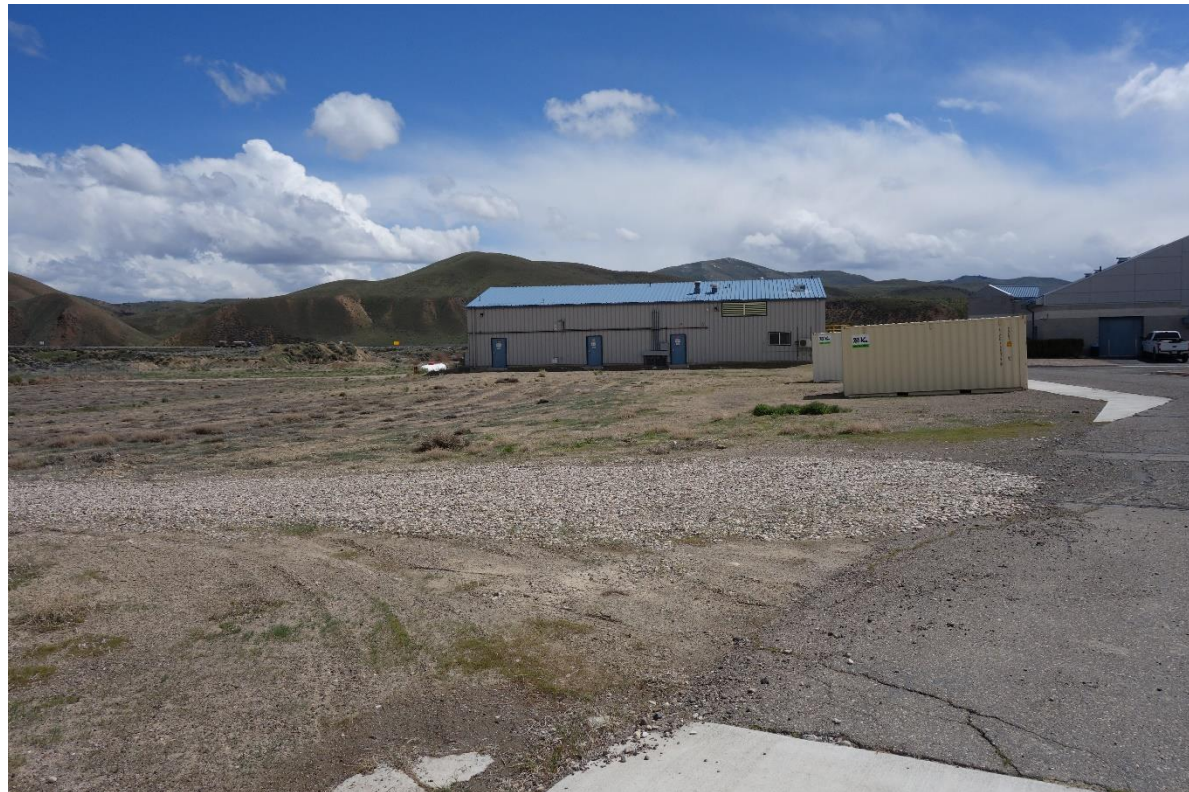
2964 MAINTENANCE BUILDING

The exterior finishes are in fair condition. It is important to maintain the finish, weather resistance and appearance of the building. This project would provide funding to protect the exterior of the building. Included in the cost is the caulking and sealing of the windows, flashing, fixtures and all other penetrations. It is recommended that the building be caulked and sealed in the next 4 - 5 years and that this project be scheduled on a cyclical basis to maintain the integrity of the structure.

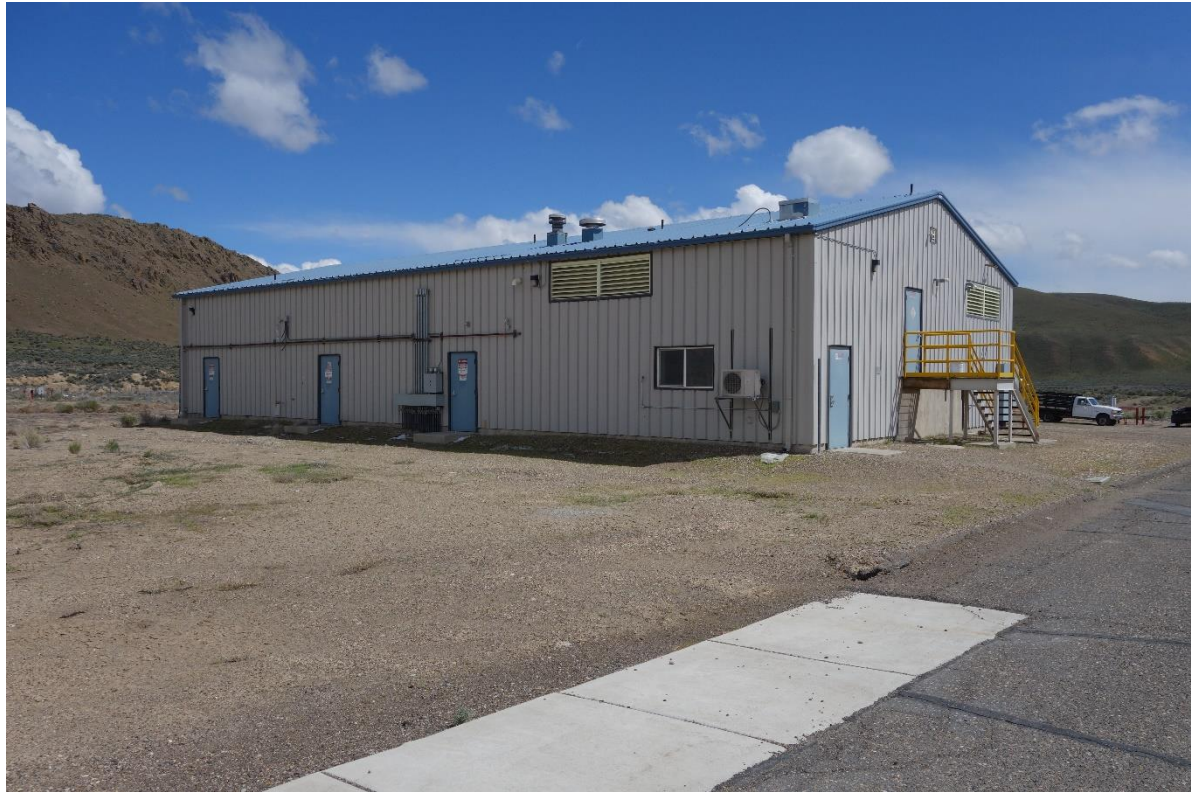
2964 MAINTENANCE BUILDING

The interior finishes are in fair condition. It is recommended that the interior walls and ceilings be painted at least once in the next 4 to 5 years. Prior to painting, all surfaces should be repaired and prepped. An epoxy-based paint should be utilized in wet areas for durability.

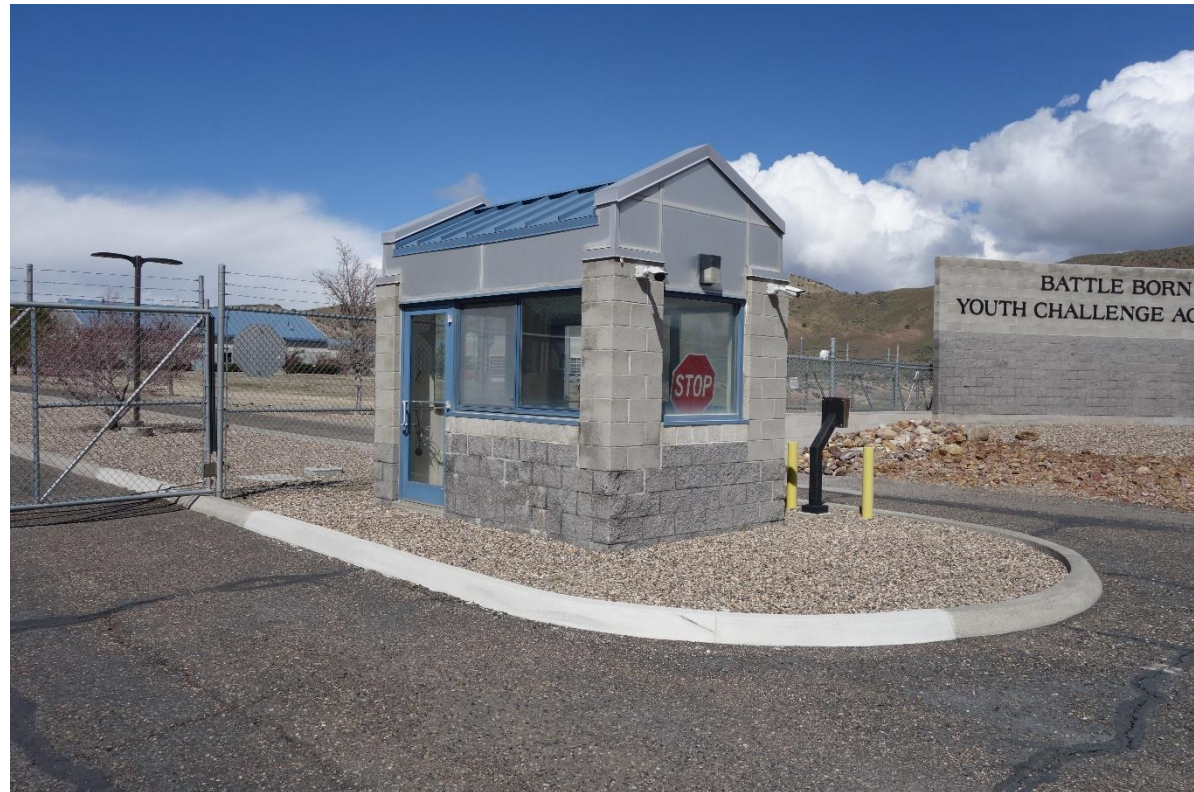
2963 BLDG #14-SECURITY KIOSK

The exterior finishes were in fair condition. It is important to maintain the finish, weather resistance and appearance of the building. This project would provide funding to protect the exterior of the building. Included in the cost are cleaning and sealing the masonry and caulking of the control joints, metal panels, windows, flashing, fixtures and all other penetrations. It is recommended that the building be sealed and caulked in the next 4 - 5 years and that this project be scheduled on a cyclical basis to maintain the integrity of the structure.

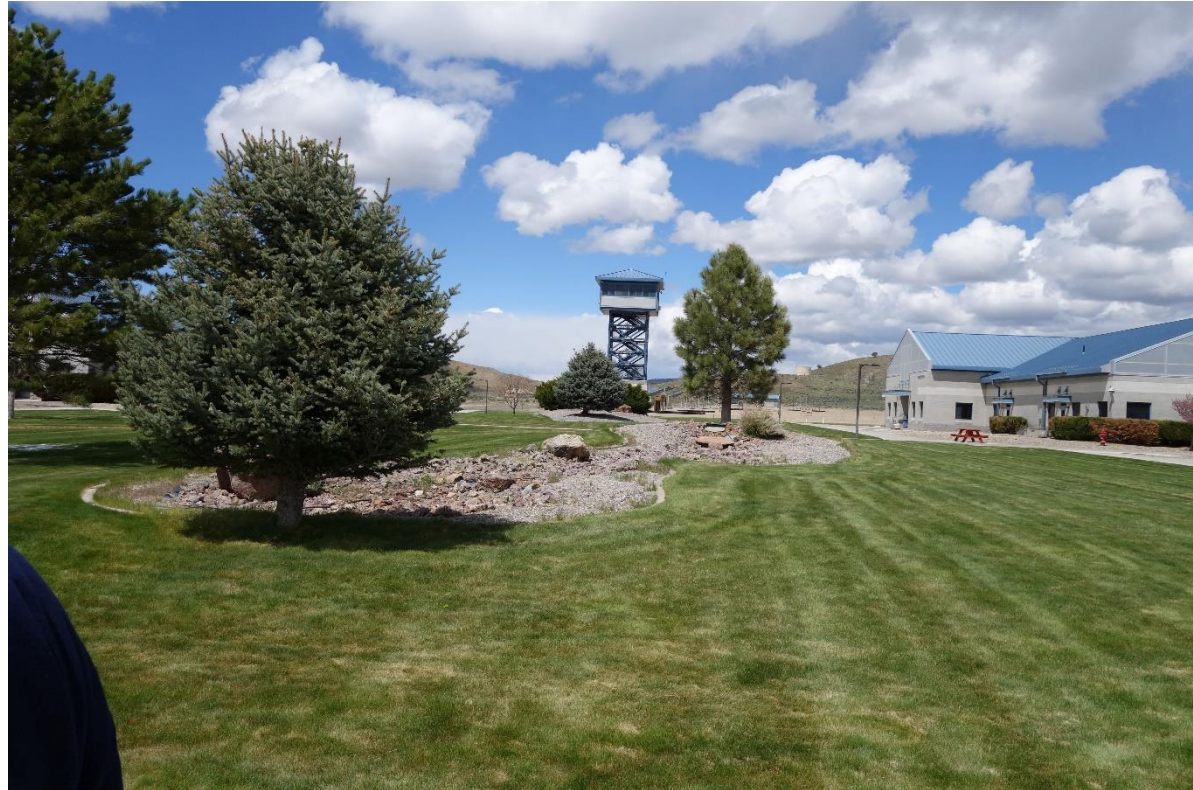
2962 BLDG #13-TOWER

The exterior finishes were in fair condition. It is important to maintain the finish, weather resistance and appearance of the building. This project would provide funding to protect the exterior of the building. Included in the cost are cleaning and painting of the steel posts, beams and columns, sealing and caulking of the metal panels, windows, flashing, fixtures and all other penetrations. It is recommended that the building be painted, sealed and caulked in the next 4 - 5 years and that this project be scheduled on a cyclical basis to maintain the integrity of the structure.

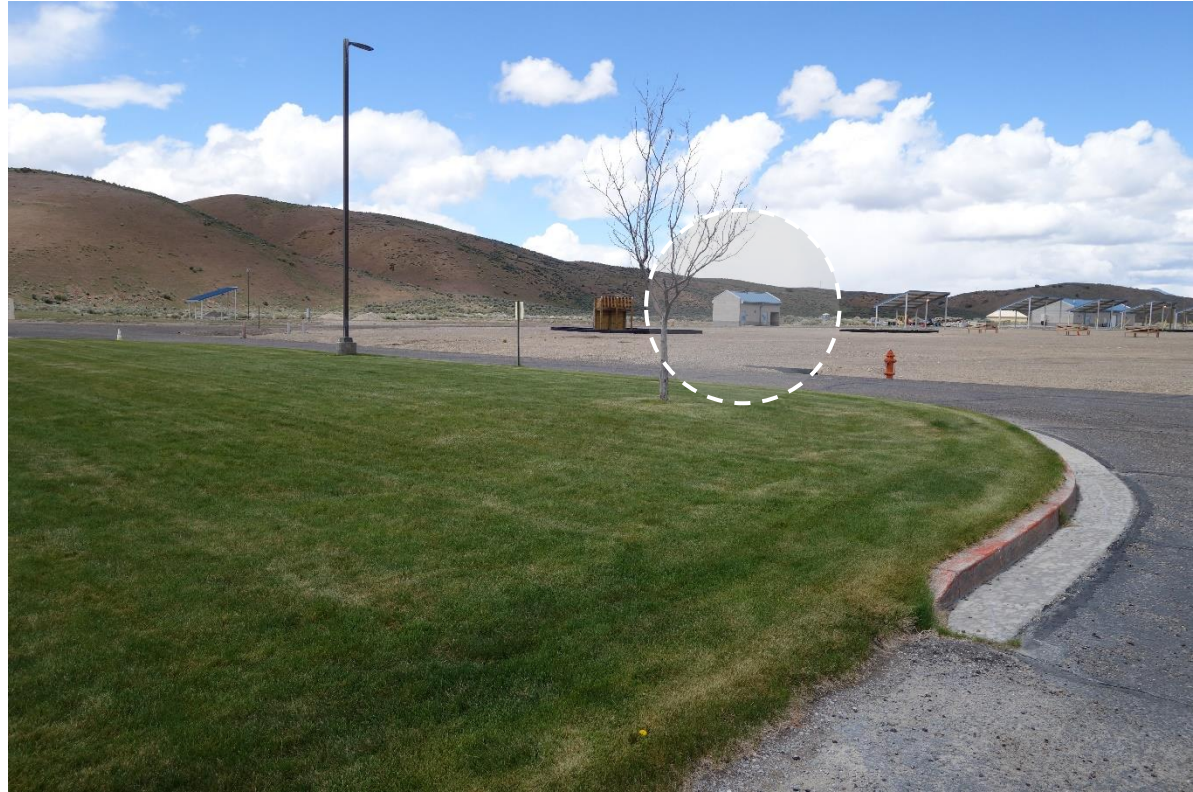
2960 BLDG #10-TOILET ROOMS

The exterior finishes were in fair condition. It is important to maintain the finish, weather resistance and appearance of the building. This project would provide funding to protect the exterior of the building. Included in the cost are cleaning and sealing the masonry and caulking of the control joints, windows, flashing, fixtures and all other penetrations. It is recommended that the building be sealed and caulked in the next 2-3 years and that this project be scheduled on a cyclical basis to maintain the integrity of the structure.

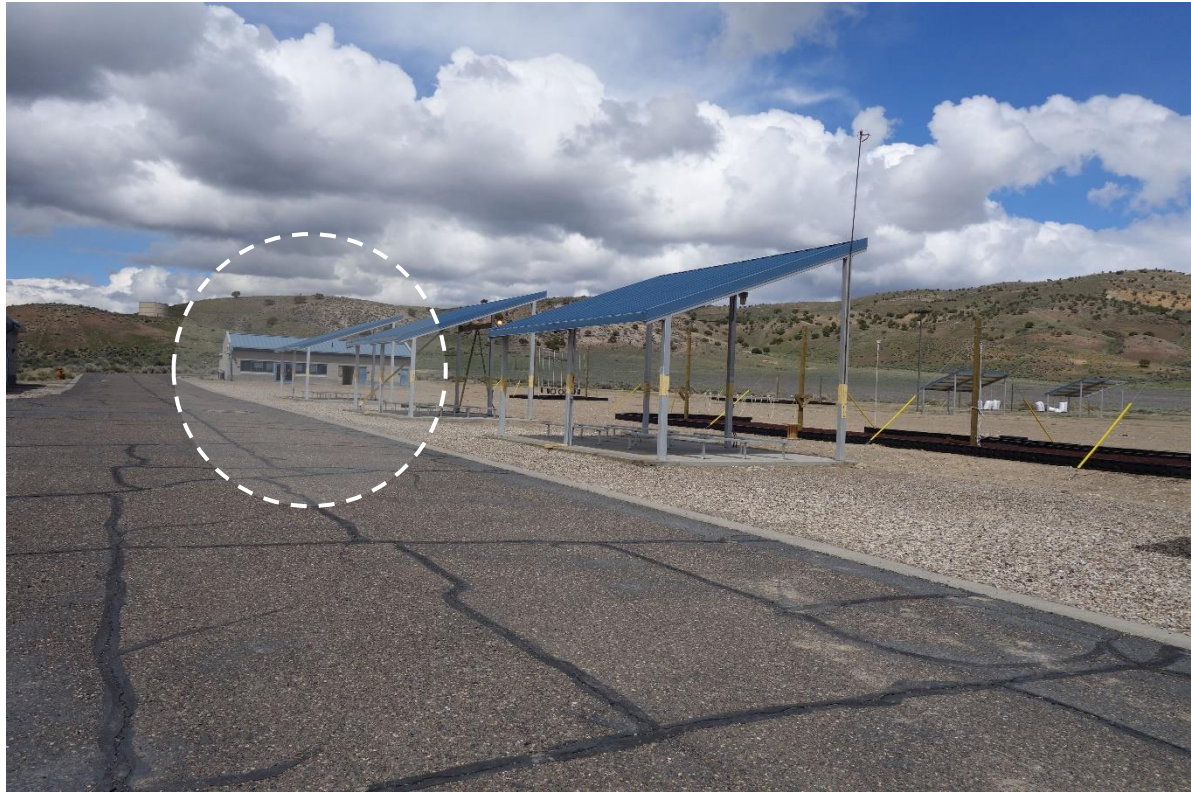
2959 BLDG #9-CLASSROOM/TOILET #1

The exterior finishes were in fair condition. It is important to maintain the finish, weather resistance and appearance of the building. This project would provide funding to protect the exterior of the building. Included in the cost are cleaning and sealing the masonry and caulking of the control joints, windows, flashing, fixtures and all other penetrations. It is recommended that the building be sealed and caulked in the next 4 - 5 years and that this project be scheduled on a cyclical basis to maintain the integrity of the structure.

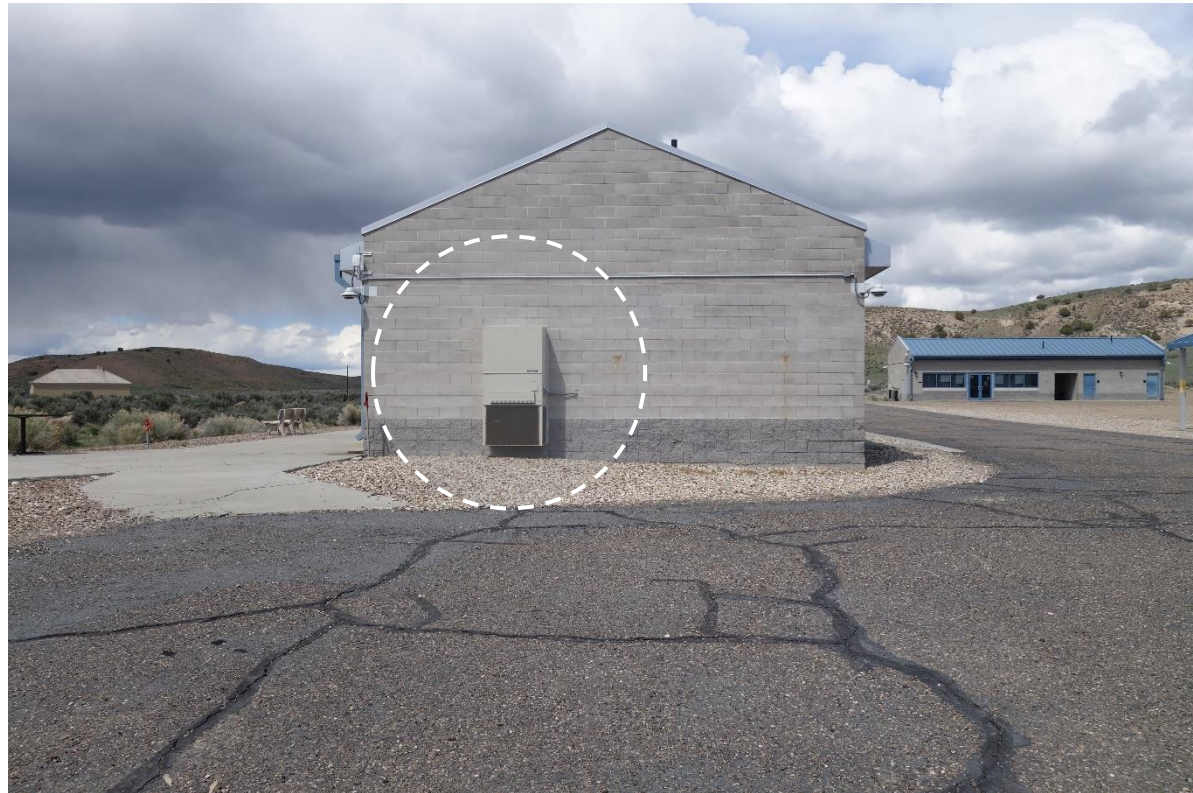
The HVAC system is original to the building and should be planned for replacement. It is not energy efficient and has reached the end of its expected and useful life. The R-22 refrigerant in the cooling system is no longer EPA compliant and its production was phased out completely January 1, 2020. This project would provide for installation of a new HVAC system and cleaning of the existing duct work and grilles. This project includes removal and disposal of the existing HVAC system and all required connections to utilities.

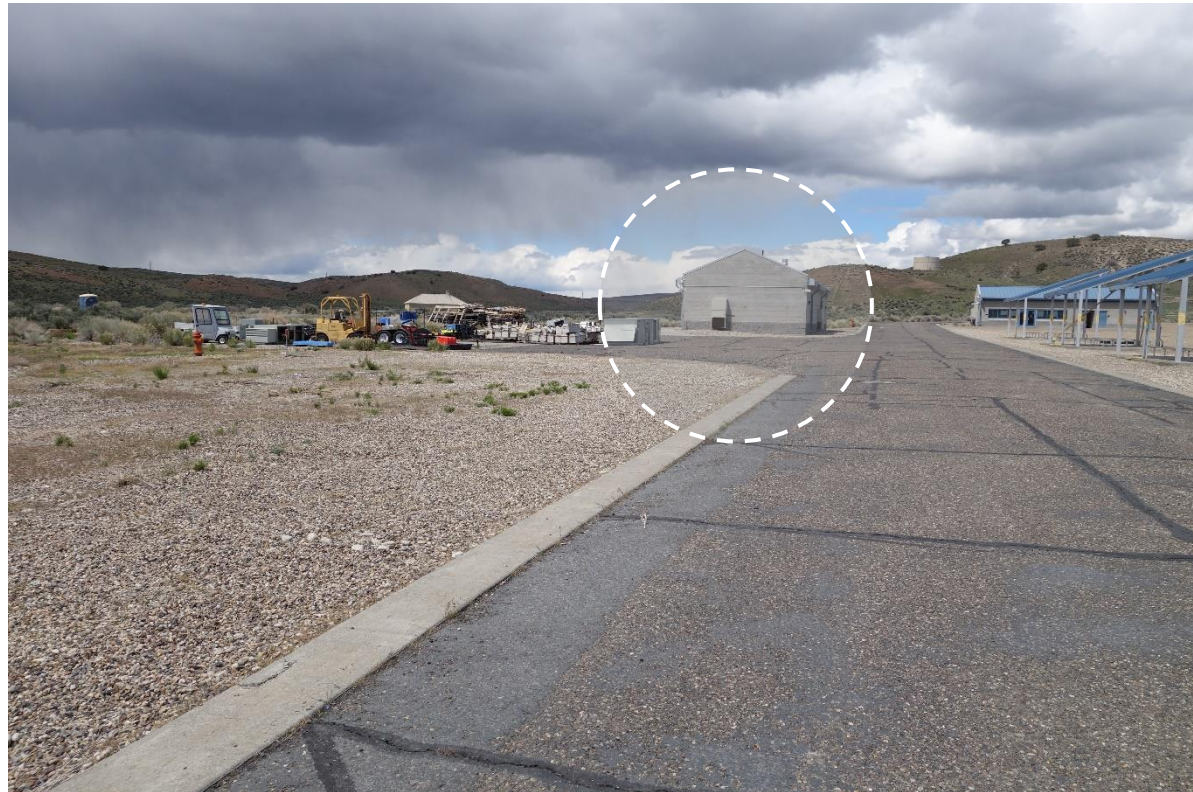
2958 BLDG #8-CABANA/STORAGE

The exterior finishes were in fair condition. It is important to maintain the finish, weather resistance and appearance of the building. This project would provide funding to protect the exterior of the building. Included in the cost are cleaning and sealing the masonry and caulking of the control joints, windows, flashing, fixtures and all other penetrations. It is recommended that the building be sealed and caulked in the next 4 - 5 years and that this project be scheduled on a cyclical basis to maintain the integrity of the structure.

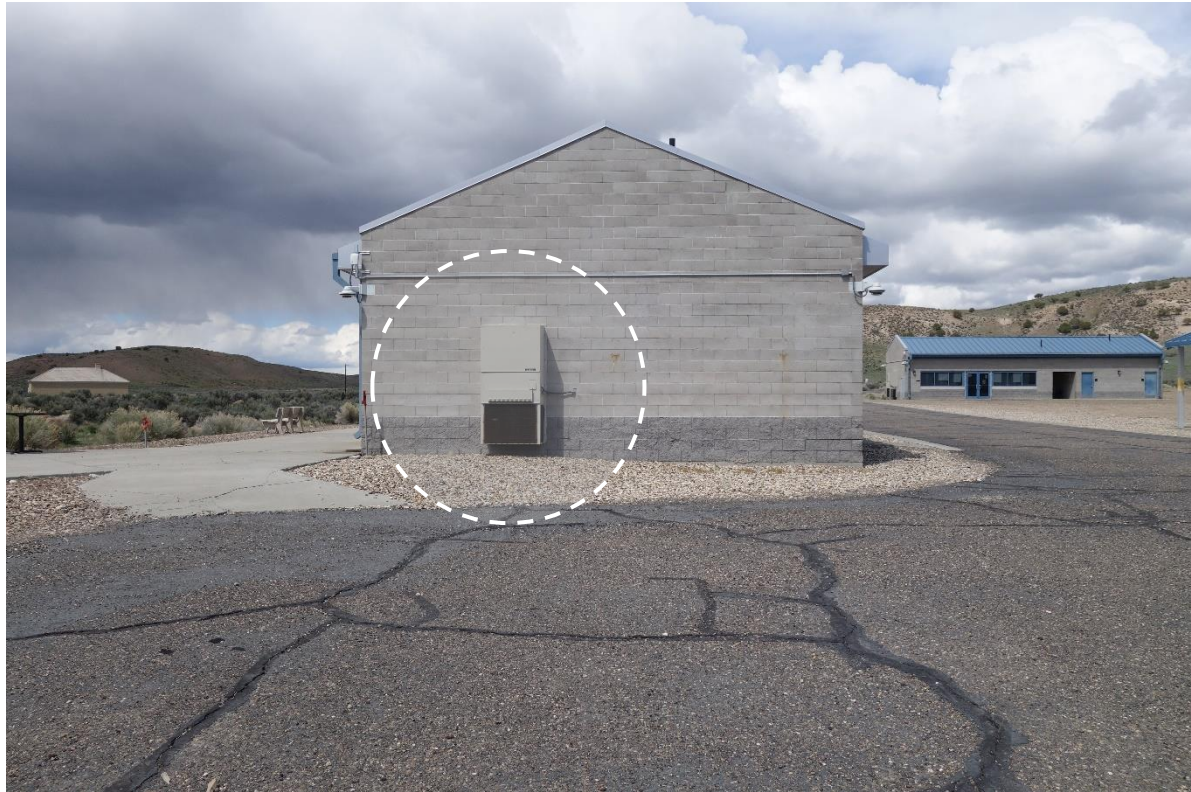
The HVAC system is original to the building and should be planned for replacement. It is not energy efficient and has reached the end of its expected and useful life. The R-22 refrigerant in the cooling system is no longer EPA compliant and its production was phased out completely January 1, 2020. This project would provide for installation of a new HVAC system and cleaning of the existing duct work and grilles. This project includes removal and disposal of the existing HVAC system and all required connections to utilities.

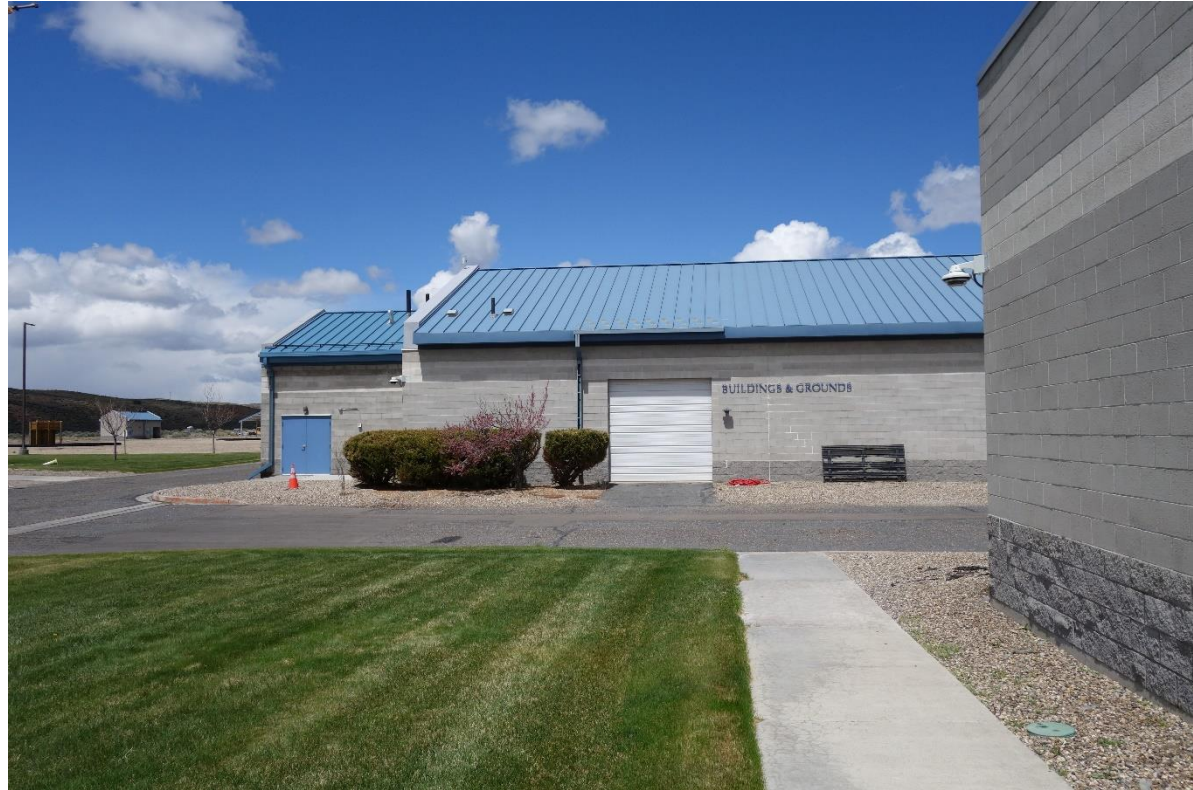
2957 BLDG #7-BUILDINGS AND GROUNDS

Arc flash and electrical breaker coordination studies have not been performed or it has been more than 5 years since the last coordination study. Safety requirements for maintenance personnel and the latest electrical code require coordination studies to be verified and performed every 5 years, along with arc flash labeling on all electrical panels. This project will perform the required coordination study, evaluation, adjustments and labeling for the building's electrical distribution system.

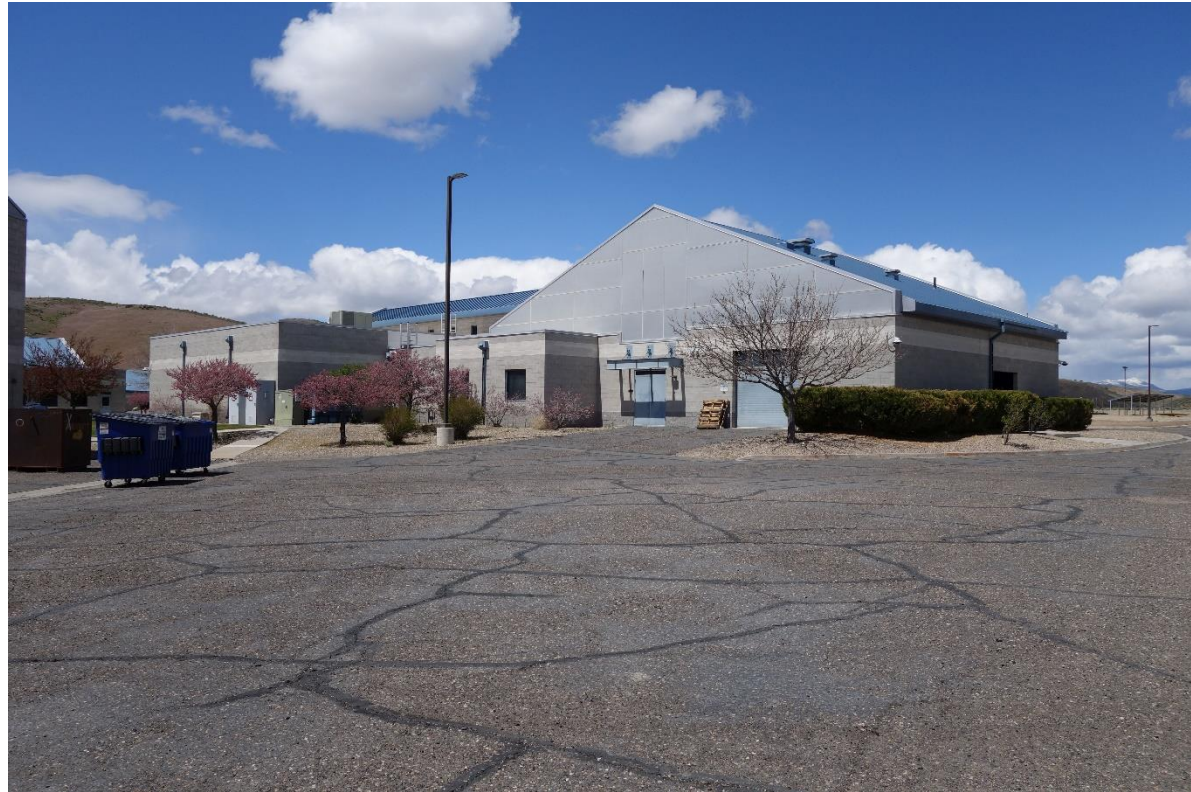
2955 BLDG #5-BOYS DORMITORY

Arc flash and electrical breaker coordination studies have not been performed or it has been more than 5 years since the last coordination study. Safety requirements for maintenance personnel and the latest electrical code require coordination studies to be verified and performed every 5 years, along with arc flash labeling on all electrical panels. This project will perform the required coordination study, evaluation, adjustments and labeling for the building's electrical distribution system.

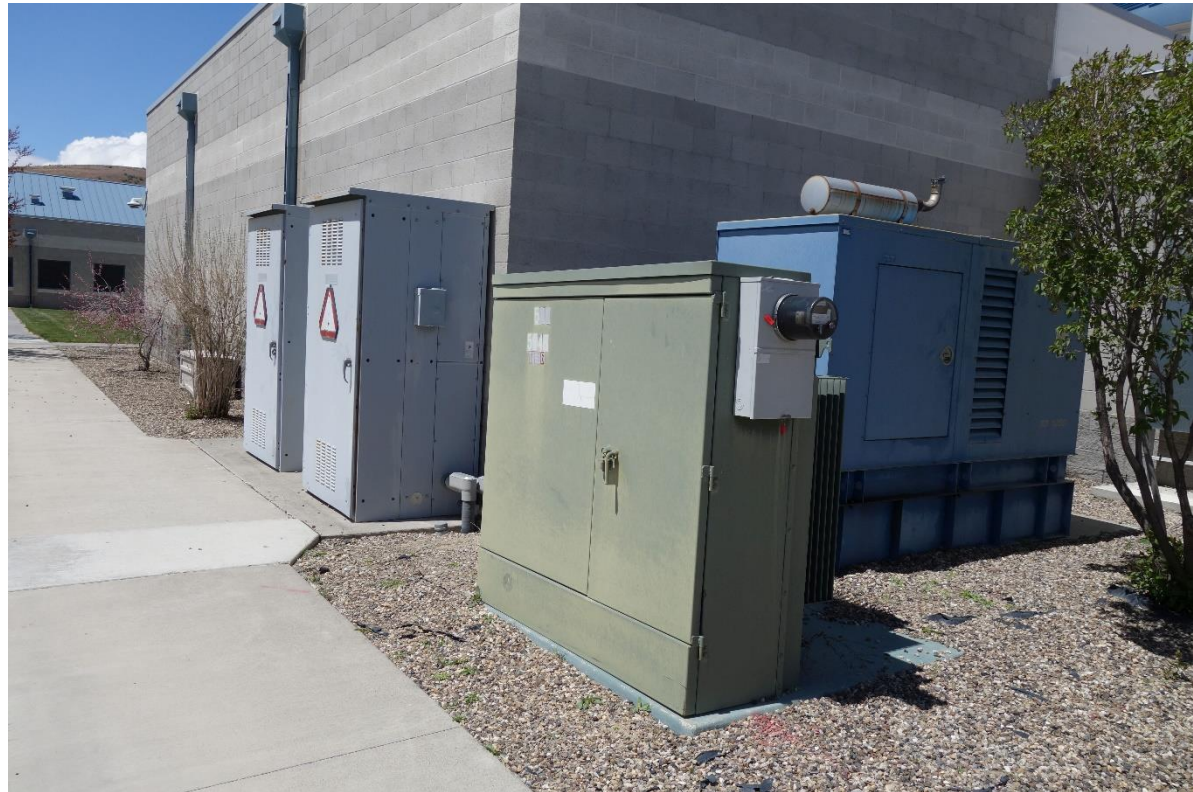
2955 BLDG #5-BOYS DORMITORY

The water source heat pumps (WSHE's) and one rooftop unit (RTU) are original to the building and have reached the end of their useful life. This project recommends the replacement of the WSHP's including cleaning the existing duct work and grilles and test & balance. This project includes removal and disposal of the existing HVAC system and all required connections to utilities.

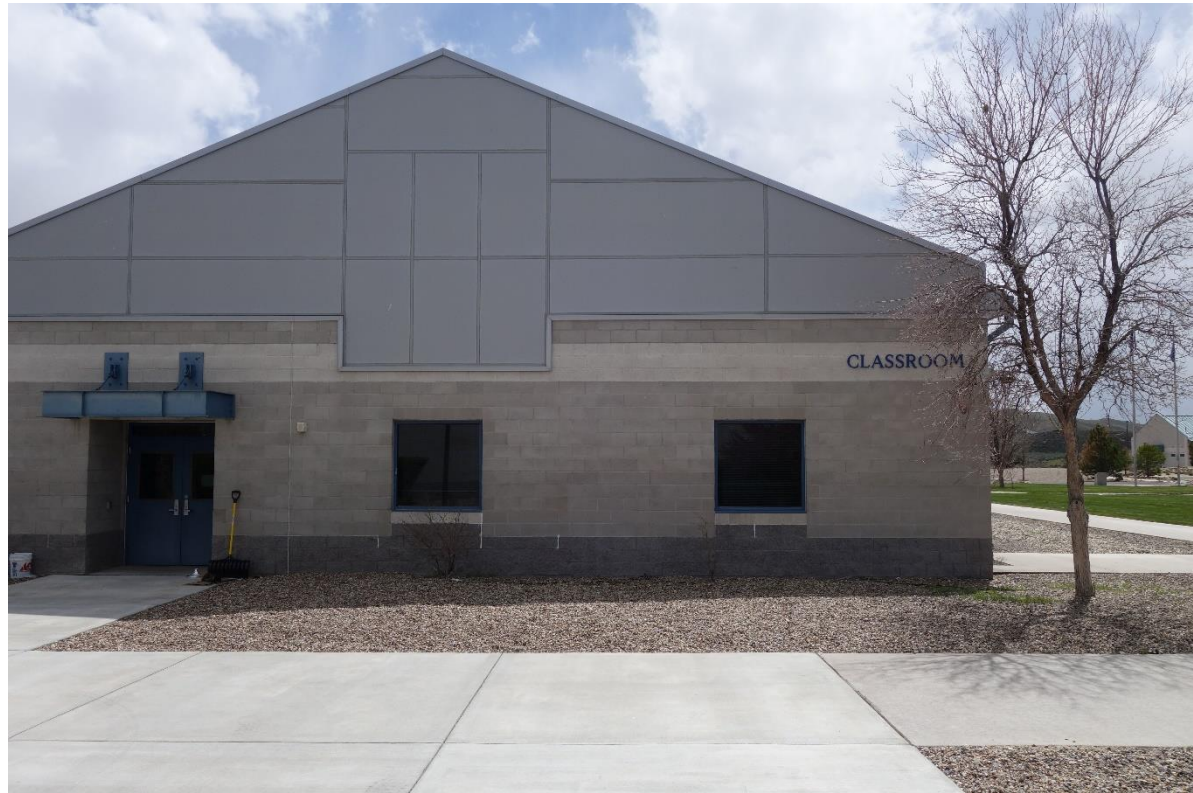
2953 BLDG #3-CLASSROOM

Arc flash and electrical breaker coordination studies have not been performed or it has been more than 5 years since the last coordination study. Safety requirements for maintenance personnel and the latest electrical code require coordination studies to be verified and performed every 5 years, along with arc flash labeling on all electrical panels. This project will perform the required coordination study, evaluation, adjustments and labeling for the building's electrical distribution system.
