STATE OF NEVADA STATE PUBLIC WORKS DIVISION

FACILITY CONDITION ASSESSMENT REPORT FOR:

OFFICE OF THE GOVERNOR
ENTERPRISE INFORMATION TECHNOLOGY SERVICES

SITE #: 9855 DATA CENTER SITE
575 E. THIRD STREET
CARSON CITY, NV 89701-

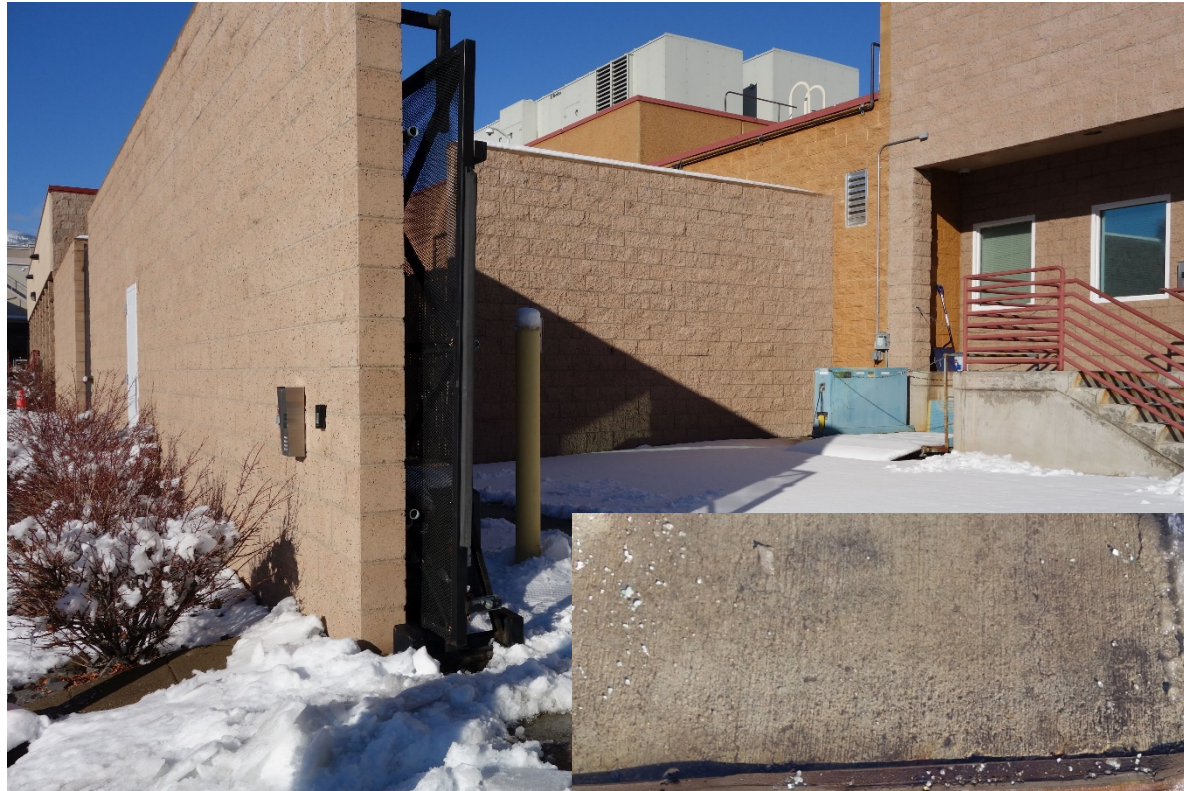
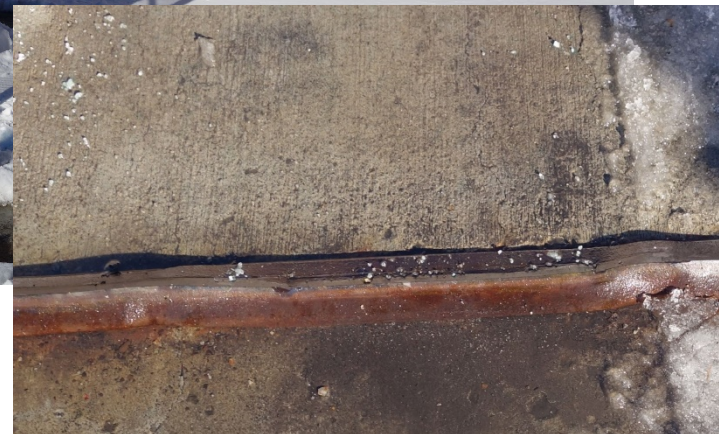
SECURITY GATE REPLACEMENT

The security gate is failing and in need of replacement or repairs. The gate guide rails are damaged, and some portions are completely broken. This project would fund the removal & replacement of the concrete footing as needed and installation of new gate rails, repair or replace the gate, gate operator and access controls.
