DEPARTMENT OF ADMINISTRATION
STATE PUBLIC WORKS DIVISION
FACILITY CONDITION ASSESSMENT

PROPERTY PORTFOLIO REVIEW PROJECT ADDENDUM

9908 - SUMMIT VIEW YOUTH CORRECTIONAL CENTER SITE 5730 RANGE RD LAS VEGAS, NV 89115-1927 CLARK COUNTY

SURVEY DATE: 03/08/2023

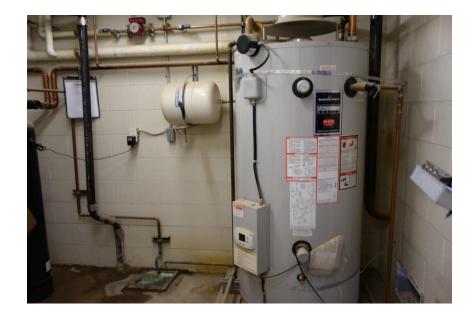
HOUSING UNIT #2 - EVEREST

There is a 100 gallon gas-fired water heater in the building. The average life span of a water heater is eight to ten years. With the passage of time and constant use, this unit is showing signs of wear and should be scheduled for replacement in the next 2 - 3 years. It is recommended that a new gas-fired water heater be installed with new seismic restraints. Removal and disposal of the existing equipment is included in this estimate.

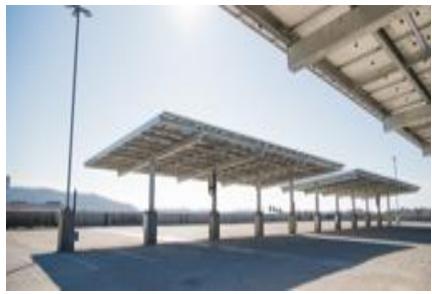
SOLAR CARPORT #15

Survey and document rooftop photovoltaic arrays on parking structures, including panels, mounting hardware, wiring, and monitoring/control systems. Deliverables include updated inventory, condition ratings, and prioritized recommendations for maintenance or further evaluation.

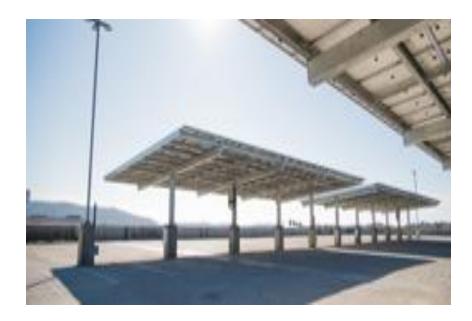
Survey and document rooftop photovoltaic arrays on parking structures, including panels, mounting hardware, wiring, and monitoring/control systems. Deliverables include updated inventory, condition ratings, and prioritized recommendations for maintenance or further evaluation.

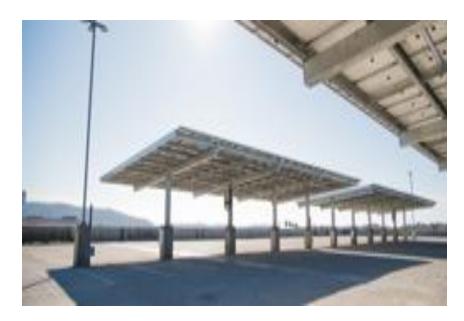
Survey and document rooftop photovoltaic arrays on parking structures, including panels, mounting hardware, wiring, and monitoring/control systems. Deliverables include updated inventory, condition ratings, and prioritized recommendations for maintenance or further evaluation.

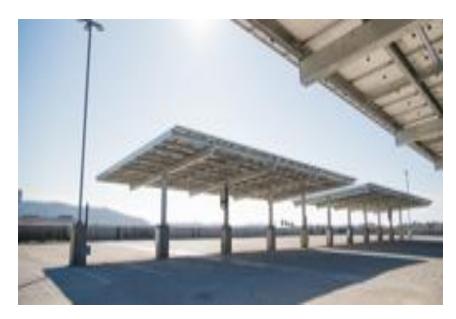
Survey and document rooftop photovoltaic arrays on parking structures, including panels, mounting hardware, wiring, and monitoring/control systems. Deliverables include updated inventory, condition ratings, and prioritized recommendations for maintenance or further evaluation.

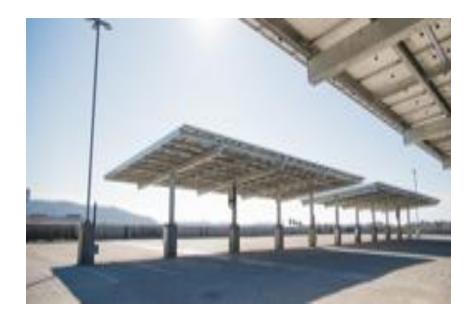
Survey and document rooftop photovoltaic arrays on parking structures, including panels, mounting hardware, wiring, and monitoring/control systems. Deliverables include updated inventory, condition ratings, and prioritized recommendations for maintenance or further evaluation.

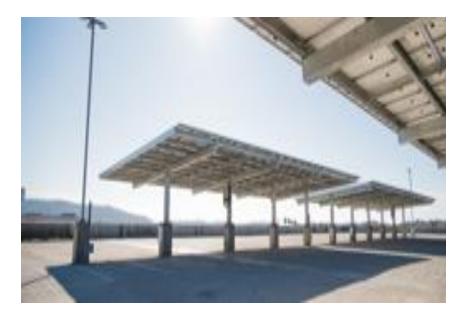
Survey and document rooftop photovoltaic arrays on parking structures, including panels, mounting hardware, wiring, and monitoring/control systems. Deliverables include updated inventory, condition ratings, and prioritized recommendations for maintenance or further evaluation.

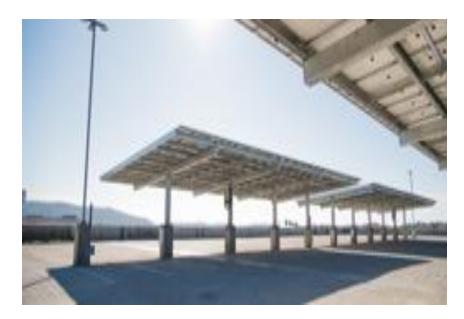
Survey and document rooftop photovoltaic arrays on parking structures, including panels, mounting hardware, wiring, and monitoring/control systems. Deliverables include updated inventory, condition ratings, and prioritized recommendations for maintenance or further evaluation.

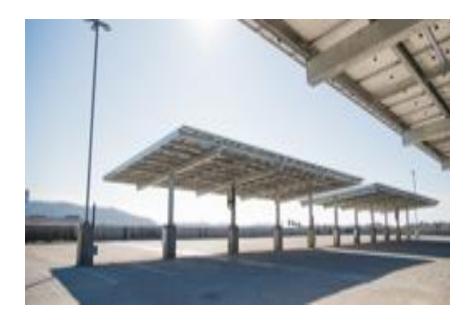
Survey and document rooftop photovoltaic arrays on parking structures, including panels, mounting hardware, wiring, and monitoring/control systems. Deliverables include updated inventory, condition ratings, and prioritized recommendations for maintenance or further evaluation.

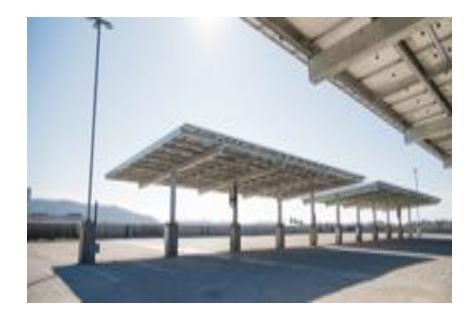
Survey and document rooftop photovoltaic arrays on parking structures, including panels, mounting hardware, wiring, and monitoring/control systems. Deliverables include updated inventory, condition ratings, and prioritized recommendations for maintenance or further evaluation.

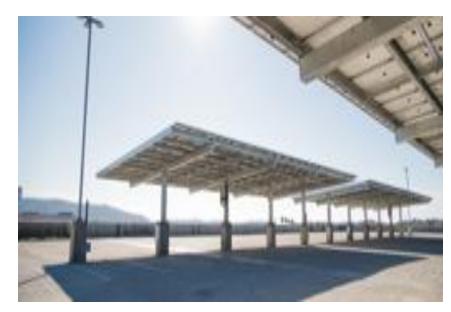
Survey and document rooftop photovoltaic arrays on parking structures, including panels, mounting hardware, wiring, and monitoring/control systems. Deliverables include updated inventory, condition ratings, and prioritized recommendations for maintenance or further evaluation.

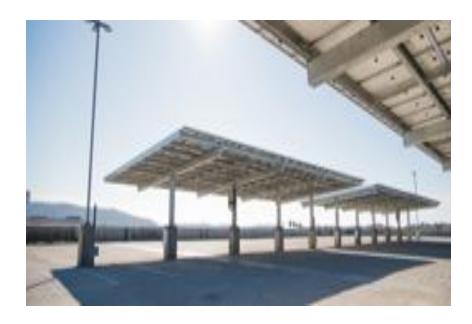
SOLAR CARPORT #2

Survey and document rooftop photovoltaic arrays on parking structures, including panels, mounting hardware, wiring, and monitoring/control systems. Deliverables include updated inventory, condition ratings, and prioritized recommendations for maintenance or further evaluation.

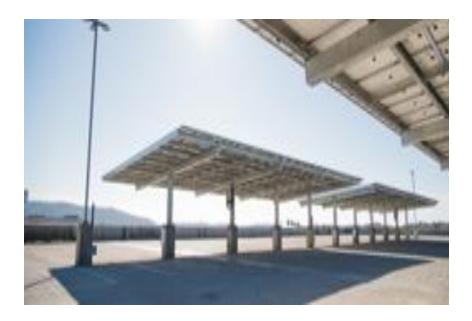
SOLAR CARPORT #1

Survey and document rooftop photovoltaic arrays on parking structures, including panels, mounting hardware, wiring, and monitoring/control systems. Deliverables include updated inventory, condition ratings, and prioritized recommendations for maintenance or further evaluation.
