# **OLD LAS VEGAS MORMON FORT STATE HISTORIC PARK**

**Site Number: 9913**  
**STATE OF NEVADA PUBLIC WORKS DIVISION**  
**FACILITY CONDITION ANALYSIS**

Report distributed in October 2021

Survey Date: 12/12/2017

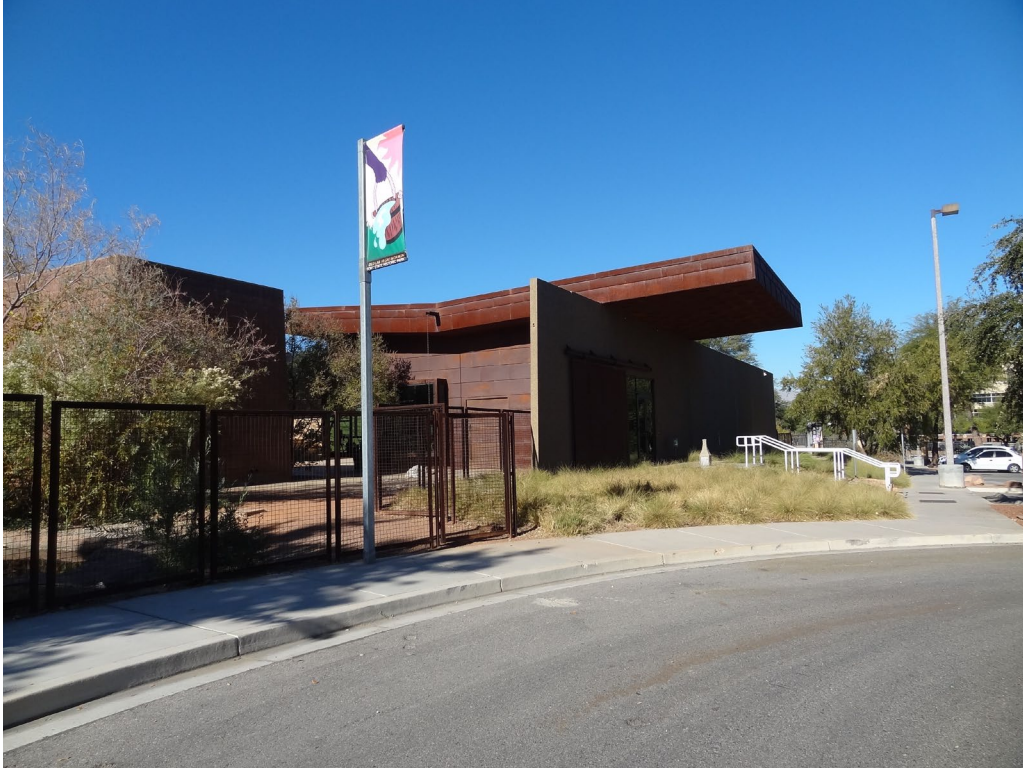
Old Las Vegas Mormon Fort State Historical Park - Site #9913  
Description: Crack Fill & Slurry Seal Needed.

#### **SLURRY / CRACK SEAL ASPHALT PAVING**

It is important to maintain the asphalt concrete paving on the site. This project would provide for minor crack filling and fog sealing of the paved parking lot. Striping is included in this estimate. This project should be scheduled on a 5 year cyclical basis to maintain the integrity of the paving and prevent premature failure. 25,000 square feet of asphalt area was used to generate this estimate.
