STATE OF NEVADA
STATE PUBLIC WORKS DIVISION

FACILITY CONDITION ASSESSMENT REPORT FOR:

OFFICE OF THE MILITARY
NATIONAL GUARD

PLUMB LANE READINESS CENTER SITE - USA
685 E PLUMB LN
RENO, NV 89502-3505

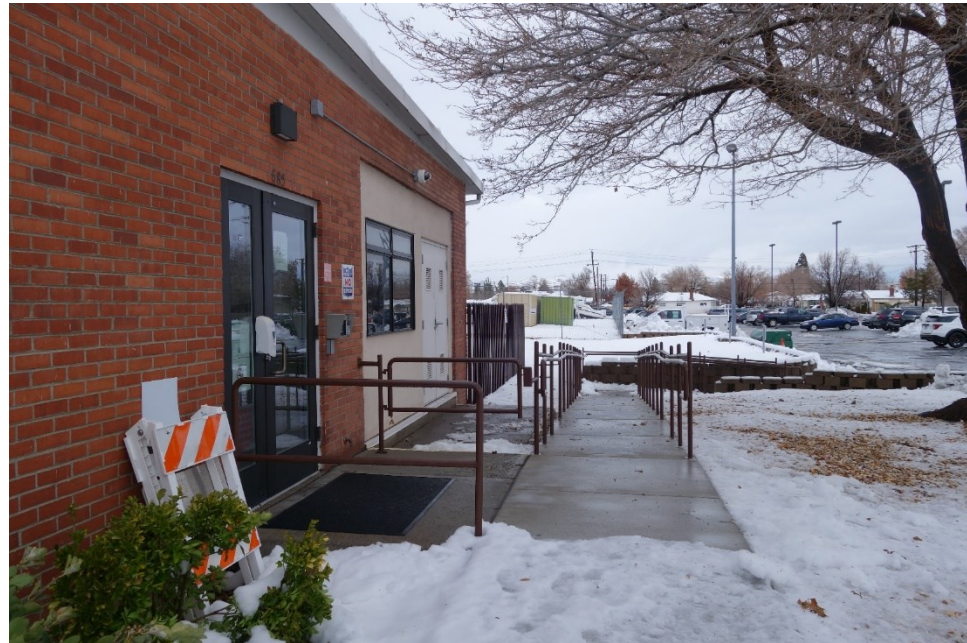
9919 PLUMB LANE READINESS CENTER SITE - USA

QUANTITY	UNITS	TOTAL	SF COST
<p>This facility has an ADA accessible ramp on the east side of the Readiness Center. This ramp is on the accessible path of travel from the accessible parking spaces to the Readiness Center. The ramp does not have proper landings, the handrails are not compliant, and it is missing edge protection. This project would provide for an upgrade to the ramp to make it fully ADA compliant. NRS 338.180, IBC - 2018, ICC/ANSI A117.1 - 2009 and the most current version of the Americans with Disabilities Act Accessible Guidelines (ADAAG) was used as a reference for this project.</p> <p>This project or a portion thereof was previously recommended in the FCA report dated 07/08/2010. It has been amended accordingly to reflect conditions observed during the most recent survey date of 01/05/2023. Note: This project was originally recommended in 2003 prior to guard rails being installed. Recommendation has been continued as the installed handrails and ramps are not compliant.</p>	1	PKG	\$50,000.00	\$ 0.00

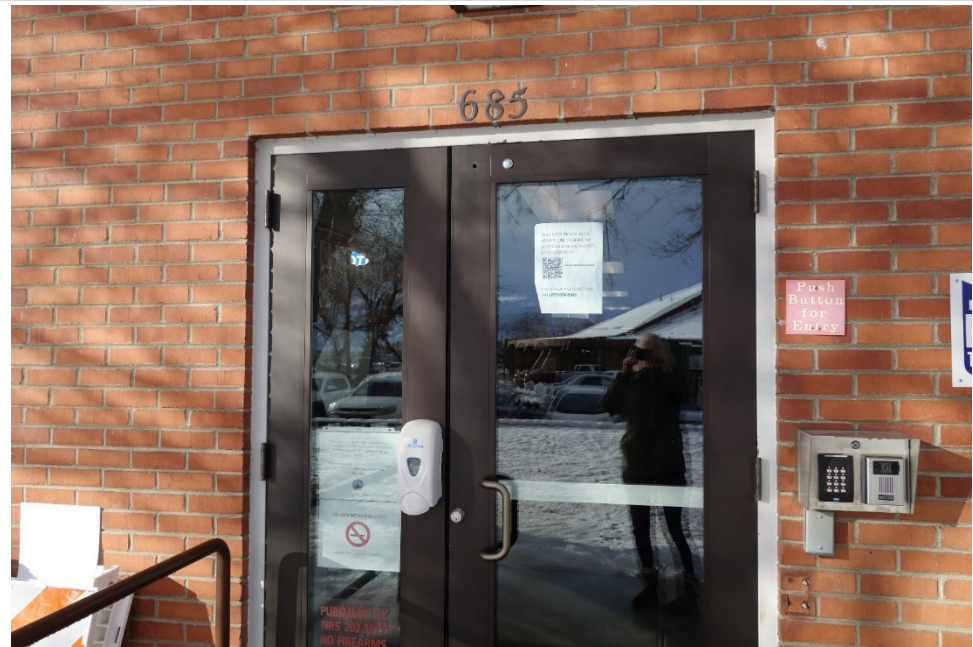
2042 PLUMB LANE READINESS CENTER

QUANTITY	UNITS	TOTAL	SF COST
The exterior entrance door on the east side of the building is on an accessible path of travel. In addition, the facility is a secured facility requiring authorization to enter. In order to make the entrance accessible, approved modifications are needed. Subject to approval, a voice communication system with signage in conjunction with powered door lock release and opener are recommended. The NRS 338.180, IBC - 2018, ICC/ANSI A117.1 - 2009 and the most current version of the Americans with Disabilities Act Accessible Guidelines (ADAAG) was used as a reference for this project.	1	PKG	\$25,000.00	\$ 2.00

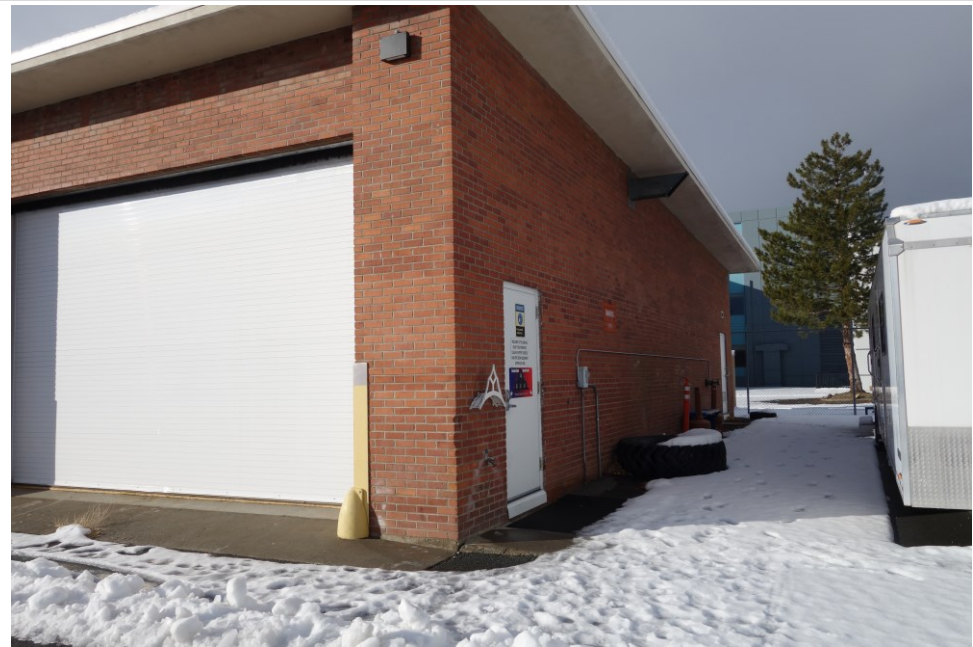
2043 STORAGE BUILDING 2

QUANTITY	UNITS	TOTAL	SF COST
The entrance on the north side of the building does not have a proper exterior landing as required by the 2018 IBC, Chapter 10, Section 1010.1.5. This project would provide for adding an exterior landing and step.	1	PKG	\$ 5,000.00	\$ 2.00

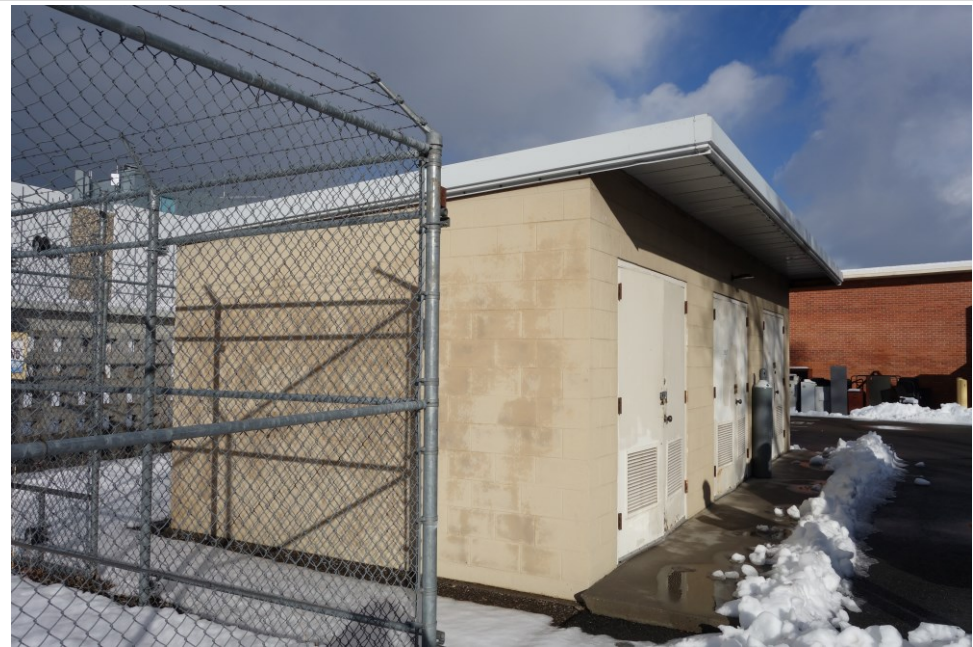
2044 STORAGE BUILDING 1

QUANTITY	UNITS	TOTAL	SF COST
The exterior metal doors are damaged from age and general wear and tear and have reached the end of their expected life. This project would provide for the replacement of the three double door assemblies with new metal doors, frames, and hardware. Removal and disposal of the existing doors is included in this estimate.	6	EA	\$12,000.00	\$ 30.00
