DEPARTMENT OF ADMINISTRATION  
STATE PUBLIC WORKS DIVISION  
FACILITY CONDITION ASSESSMENT

### PROPERTY PORTFOLIO REVIEW PROJECT ADDENDUM

9930 - SPRING MOUNTAIN RANCH STATE PARK SITE  
6375 HWY 159  
BLUE DIAMOND, NV 89004-  
CLARK COUNTY

SURVEY DATE: 03/19/2024

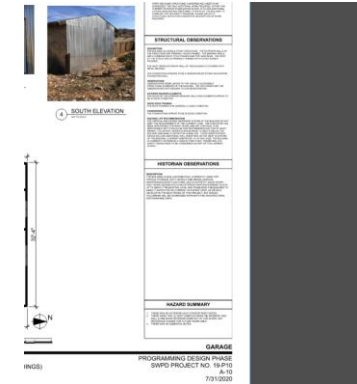
### 1155-STR-1: STRUCTURAL REINFORCEMENT

Based on the findings of structural assessment CIP 19-P10, the building has been deemed structurally deficient and requires corrective measures to ensure safety and longevity. It is recommended that exterior wall sheathing be installed on the west elevation to reinforce the structure and provide additional protection for Park staff. This improvement will address critical deficiencies, enhance structural integrity, and mitigate

potential hazards, aligning with the assessment's recommendations. Please reference 19-P10 project documentation for specific details.

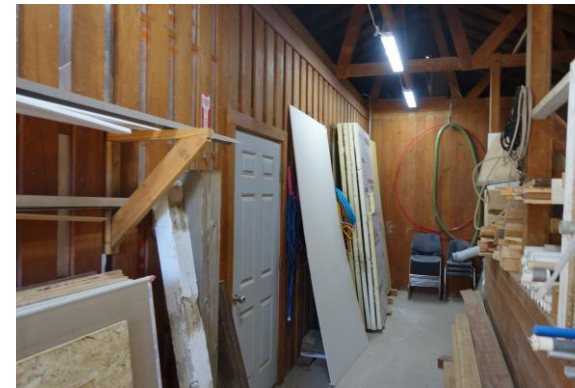
#### 1157-STR-1: STRUCTURAL REINFORCEMENT

Based on the findings of structural assessment CIP 19-P10, the building has been deemed structurally deficient and requires corrective measures to ensure safety and longevity. Per the assessment recommendations, additional framing members be added to existing load bearing walls and roof framing members. This improvement will address critical deficiencies, enhance structural integrity, and mitigate potential hazards, aligning

with the assessment's recommendations. Please reference 19-P10 project documentation for specific details.

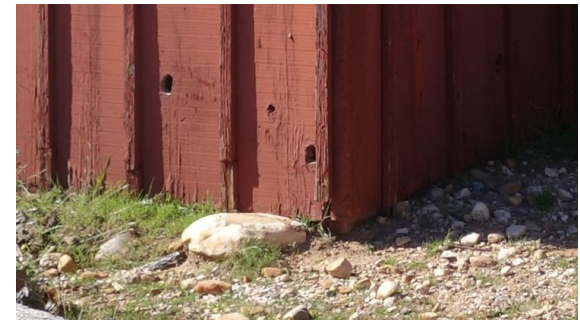
#### 1158-SIT-1: REGRADE AROUND BUILDING

There is soil contact with the building siding at multiple locations around the building. This project recommends removal and regrading to create a 6" separation between the siding and surrounding soil.

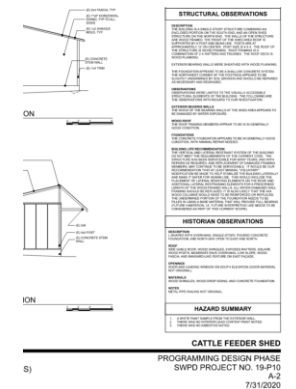
## 1159-STR-1: STRUCTURAL REINFORCEMENT

Based on the findings of structural assessment CIP 19-P10, the building has been deemed structurally deficient and requires corrective measures to ensure safety and longevity. Per the assessment recommendations, additional lateral resisting framing elements be added to existing load bearing walls and roof framing members. This improvement will address critical deficiencies, enhance structural integrity, and mitigate

potential hazards, aligning with the assessment's recommendations. Please reference 19-P10 project documentation for specific details. This project should be done prior to the ROOF REPLACEMENT project.

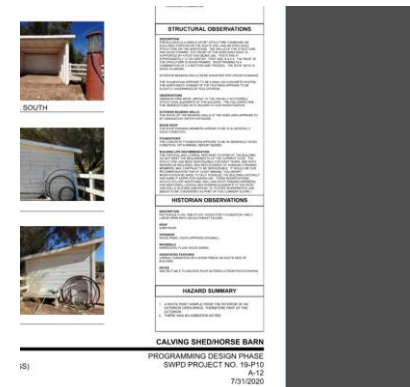
### 1160-STR-1: STRUCTURAL REINFORCEMENT

Based on the findings of structural assessment CIP 19-P10, the building has been deemed structurally deficient and requires corrective measures to ensure safety and longevity. Per the assessment recommendations, additional lateral resisting framing elements be added to existing load bearing walls and roof framing members. This improvement will address critical deficiencies, enhance structural integrity, and mitigate potential hazards, aligning with the assessment's

recommendations. Please reference 19-P10 project documentation for specific details. This project should be done prior to the ROOF REPLACEMENT project.

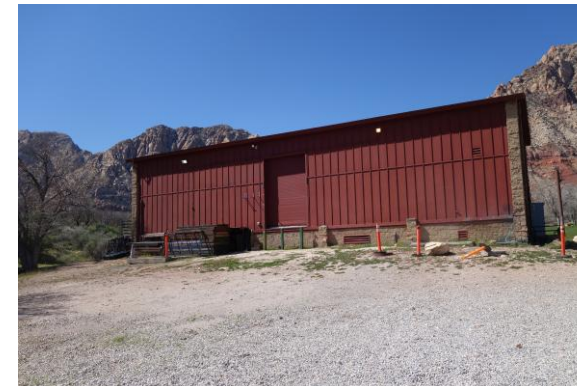
#### 1634-SIT-1: REGRADE NORTH AND EAST SIDE OF BUILDING

to reduce the steep grade will allow for a level parking pad and safer loading conditions while maintaining proper drainage and building protection.

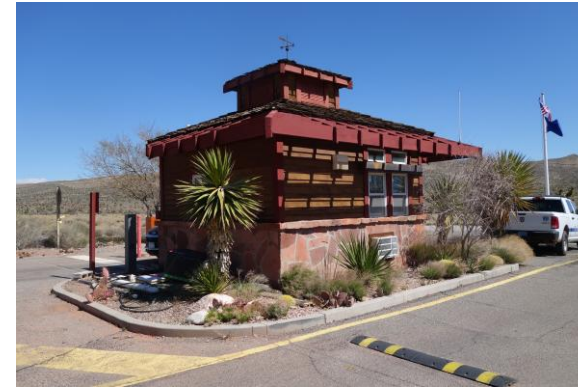
### 1635-ADA-1: ADA ACCESSIBLE PATH OF TRAVEL

Standards for Accessible Design were used as references for this project. 750 square feet of concrete was used for this estimate. It is recommended that this project coincide with the paving project.

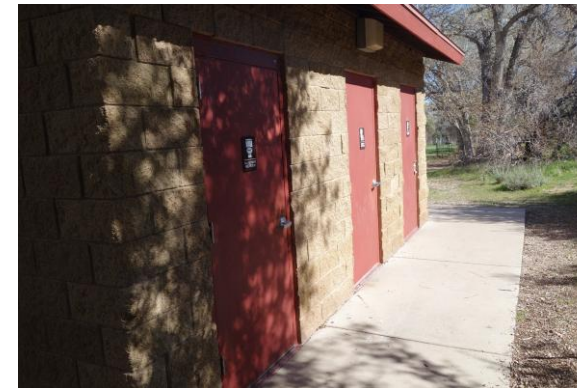
### 1150-INT-2: COMFORT STATION REFURBISHMENT

and user experience while reducing maintenance demands. A complete renovation will extend the station's useful life, ensure compliance, and provide a more functional amenity for park visitors. Due to the extent of repairs, replacement of the Comfort Station should also be considered.

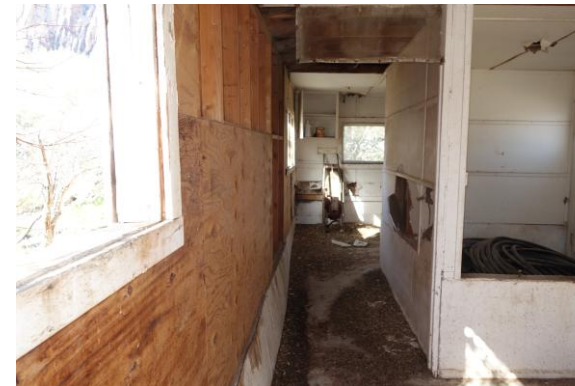
#### 1152-EXT-3: CONSERVE AND PROTECT VACANT BUILDING

removal of accumulated waste are included. Windows and doors will be secured or covered, and some will include louvers to permit ventilation of the structure.

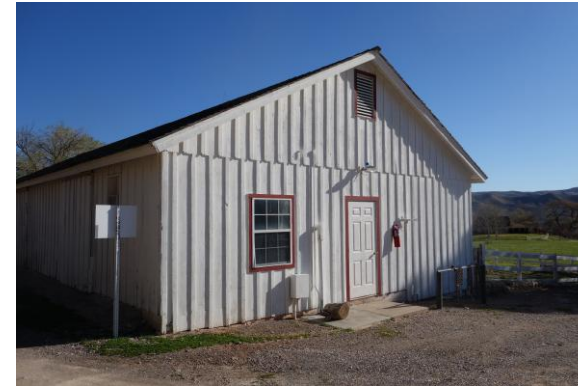
#### 1157-EXT-1: EXTERIOR FINISHES

the building be painted within the next 2 - 3 years and this project be scheduled on a cyclical basis to maintain the integrity of the structure.

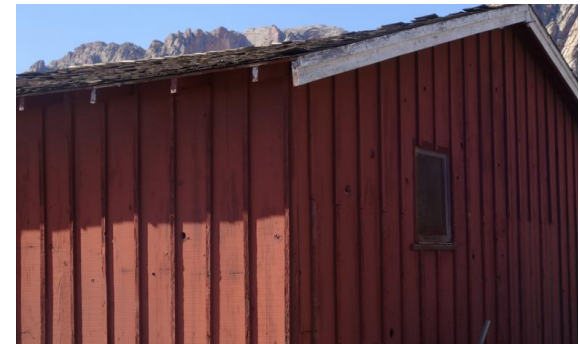
#### 1158-EXT-1: EXTERIOR FINISHES

be scheduled on a cyclical basis to maintain the integrity of the structure. Due to the historical nature of the building, this project is subject to review and approval from the State Historical Preservation Office.

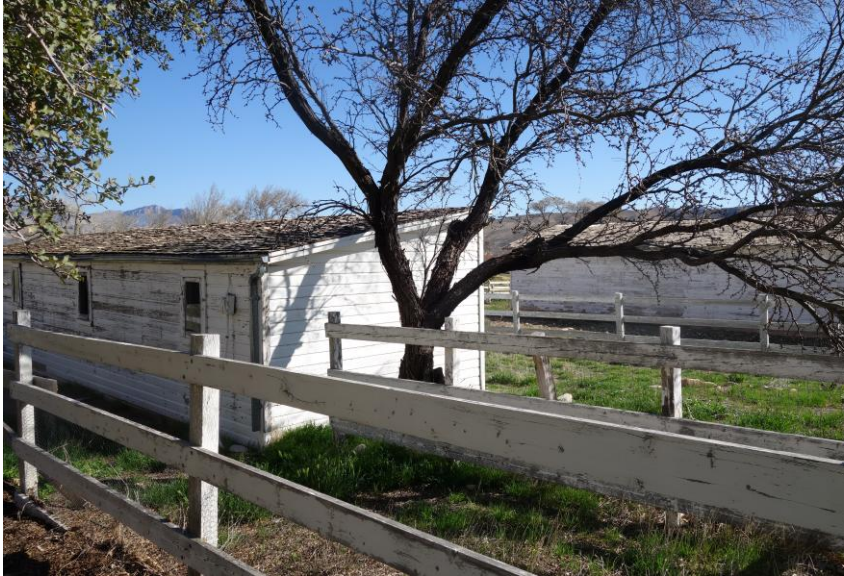
## CHICKEN COOP

The wood shingle roof on this building was in poor condition at the time of the survey. It is recommended that this building be re-roofed in the next 2 - 3 years with a new wood shingle roof and new underlayment. Due to the historical nature of the building, this project is subject to review and approval from the State Historical Preservation Office. This estimate includes removal and disposal of the old roof.

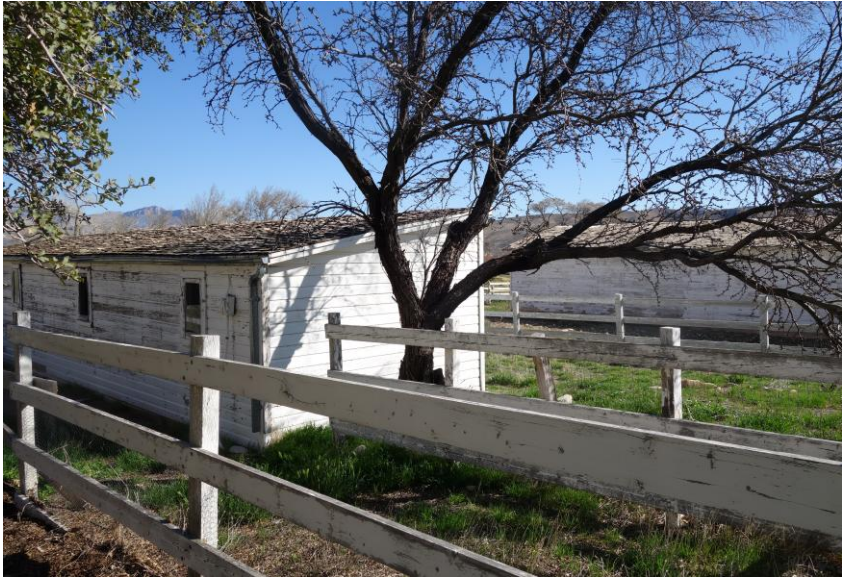
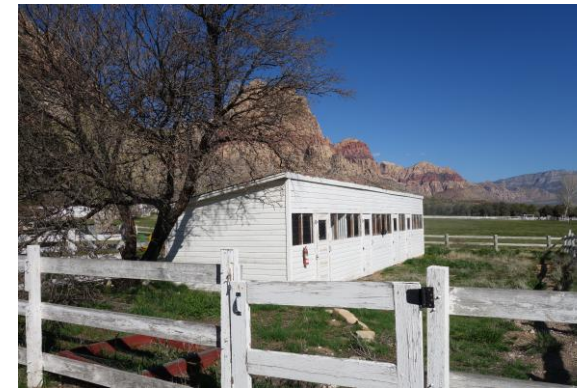
## CHICKEN COOP

The exterior finishes were in poor condition. It is important to maintain the finish, weather resistance and appearance of the building. This project would provide funding to protect the exterior of the building excluding the roof. Included in the cost is sanding, priming and painting and caulking of the flashing, fixtures and all other penetrations. It is recommended that the building be painted in the next 2 - 3 years and that this project

be scheduled on a cyclical basis to maintain the integrity of the structure. Due to the historical nature of the building, this project is subject to review and approval from the State Historical Preservation Office.

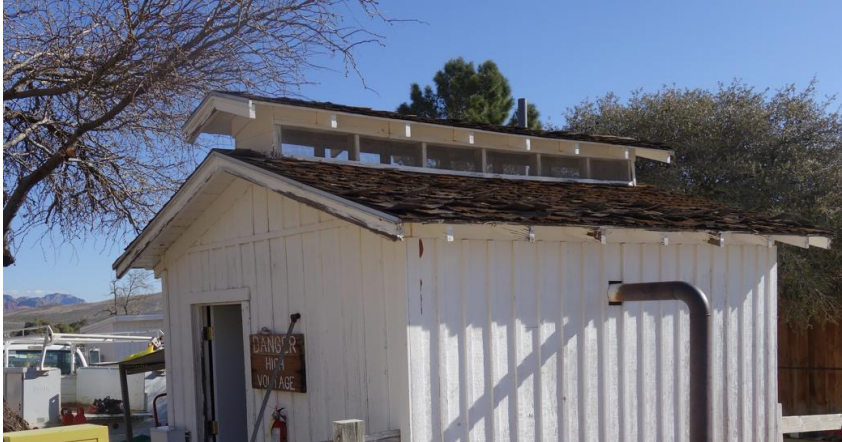
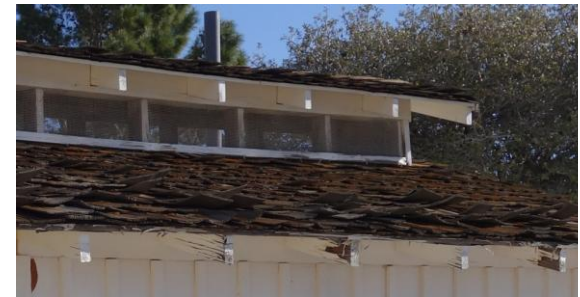
## POWER CONTROL SHED

The building was built in 1940 and the current wood shake roofing system is weathered, has reached the end of its useful life and is in need of replacement. Due to its historic nature, the structure should be re-roofed with fire retardant-treated wood shakes and underlayment. This project should be coordinated with the Nevada State Historical Preservation Office (SHPO) for possible restrictions or additional requirements. This project will fund the replacement of the

wood shingle roofing systems. This estimate includes removal and disposal of the old roof.

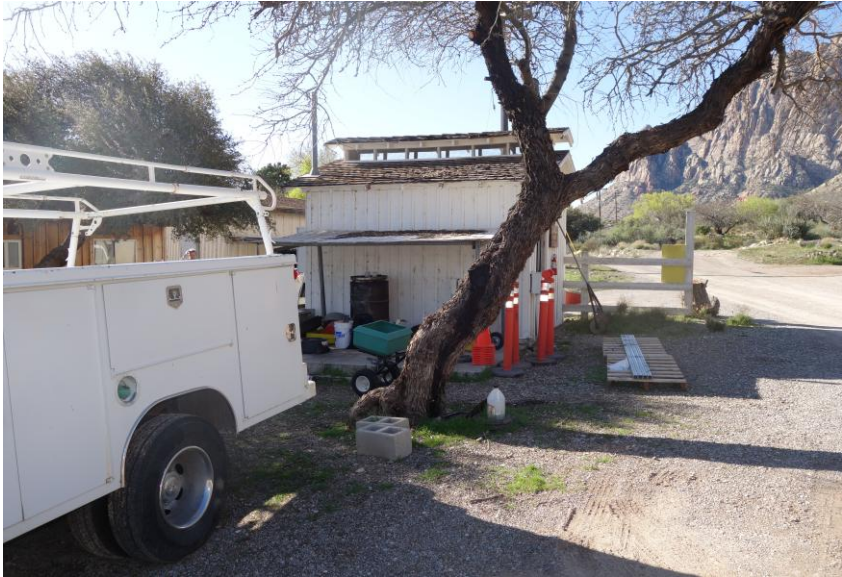
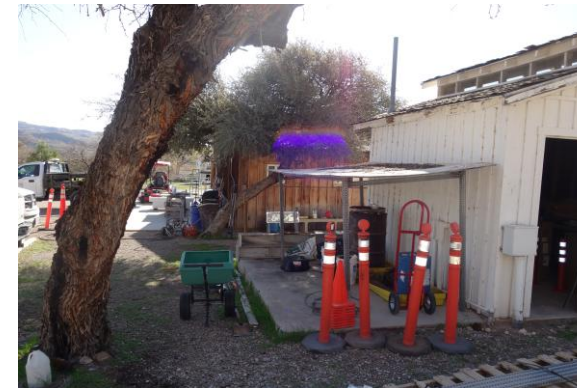
## POWER CONTROL SHED

The exterior finishes were in poor condition. It is important to maintain the finish, weather resistance and appearance of the building. This project would provide funding to protect the exterior of the building excluding the roof. Included in the cost is sanding, priming, painting and caulking of the windows, flashing, fixtures and all other penetrations. It is recommended that the building be painted in the next 2 - 3 years and that

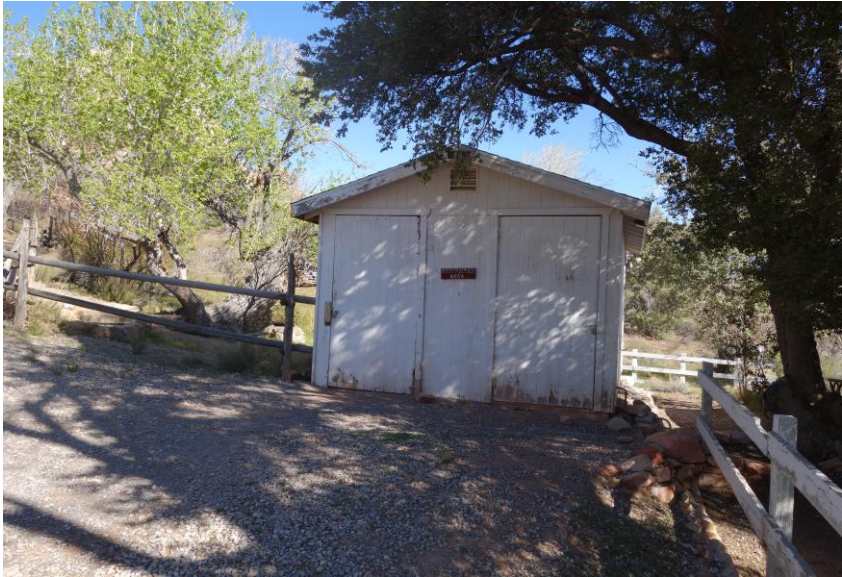
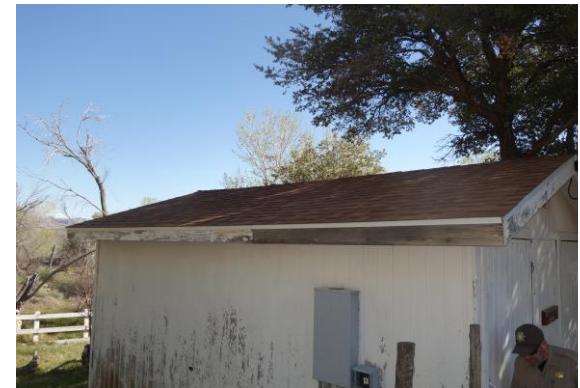
The exterior finishes were in poor condition. It is important to maintain the finish, weather resistance and appearance of the building. This project would provide funding to protect the exterior of the building excluding the roof. Included in the cost is sanding, priming, painting and caulking of the windows, flashing, fixtures and all other penetrations. It is recommended that the building be painted in the next 2 - 3 years and that

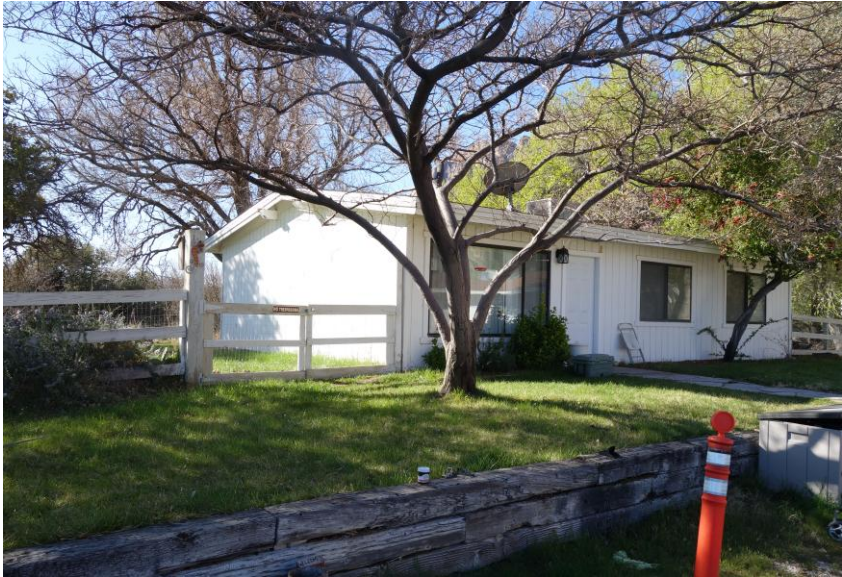
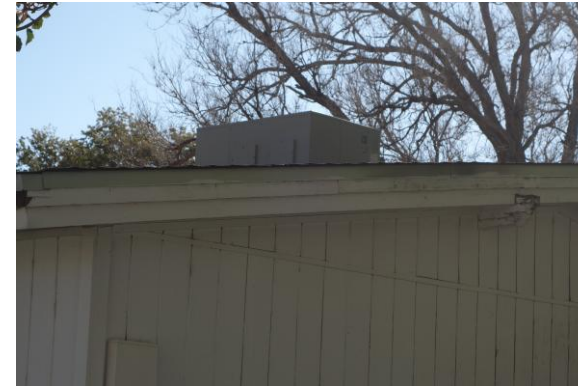
The exterior building envelope—including siding, doors and windows—is in poor condition and no longer functioning as intended. Due to the extent of deterioration, this project recommends complete removal and replacement of these components to restore the building's performance, energy efficiency, and protection from weather.

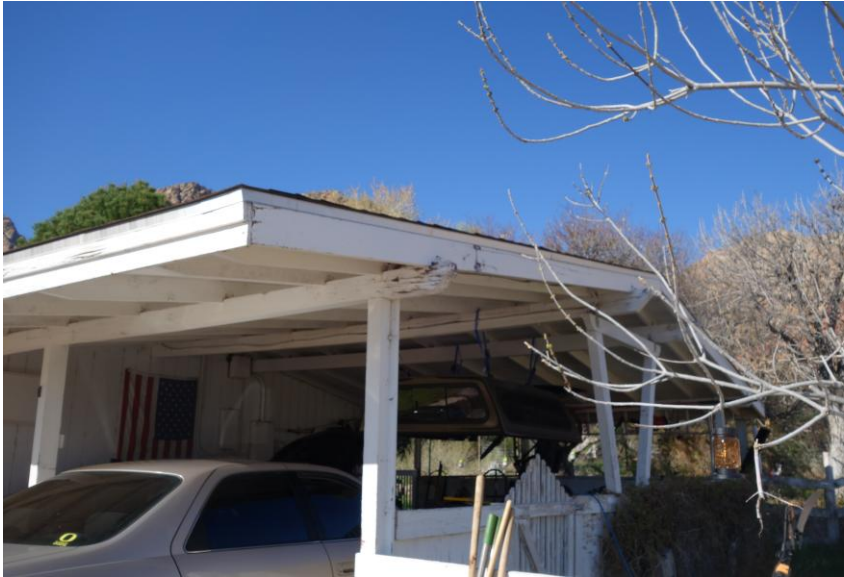
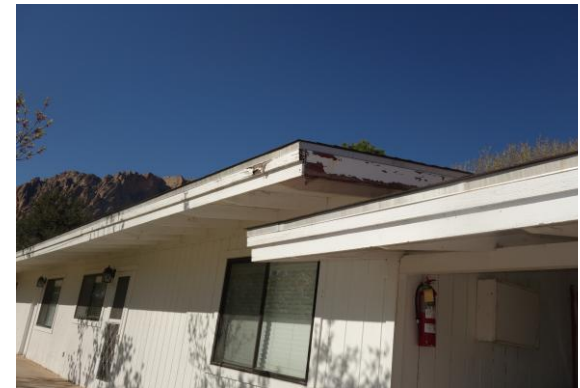
## RESIDENCE #4 - OLD BUNKHOUSE/ DUPLEX

The exterior finishes were in poor condition. It is important to maintain the finish, weather resistance and appearance of the building. This project would provide funding to protect the exterior of the building excluding the roof. Included in the cost is sanding, priming and painting and caulking of the windows, flashing, fixtures and all other penetrations and mitigating the earth to wood contact.. It is recommended that the building be

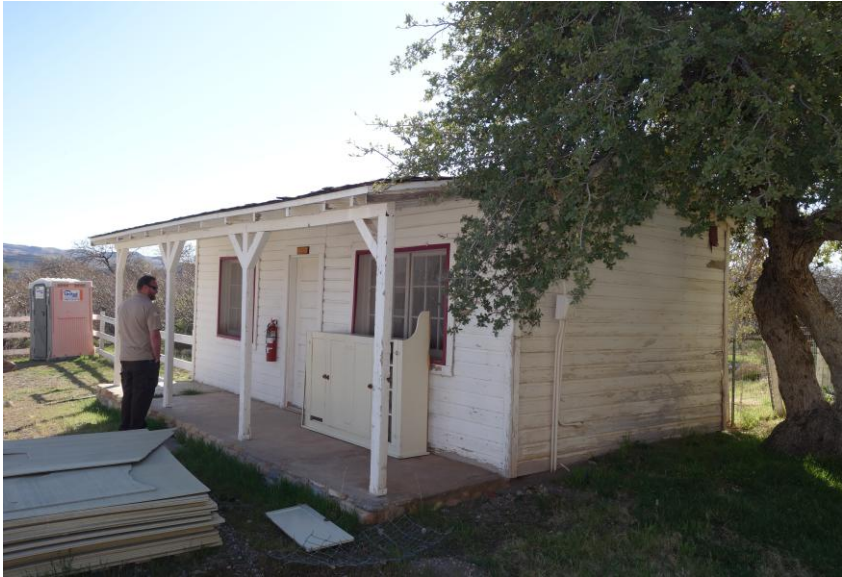
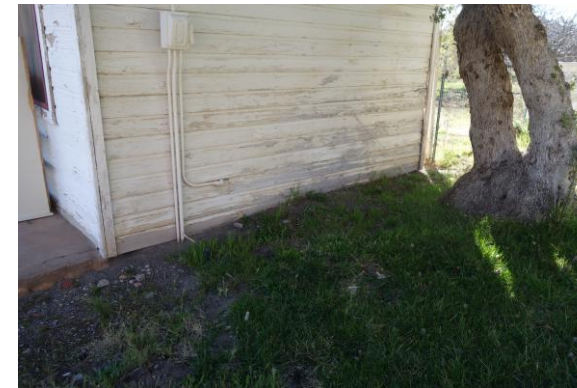
The exterior finishes were in poor condition. It is important to maintain the finish, weather resistance and appearance of the building. This project would provide funding to protect the exterior of the building excluding the roof. Included in the cost is sanding, priming and painting and caulking of the windows, doors, flashing, fixtures and all other penetrations and mitigating the earth to wood contact. It is recommended that

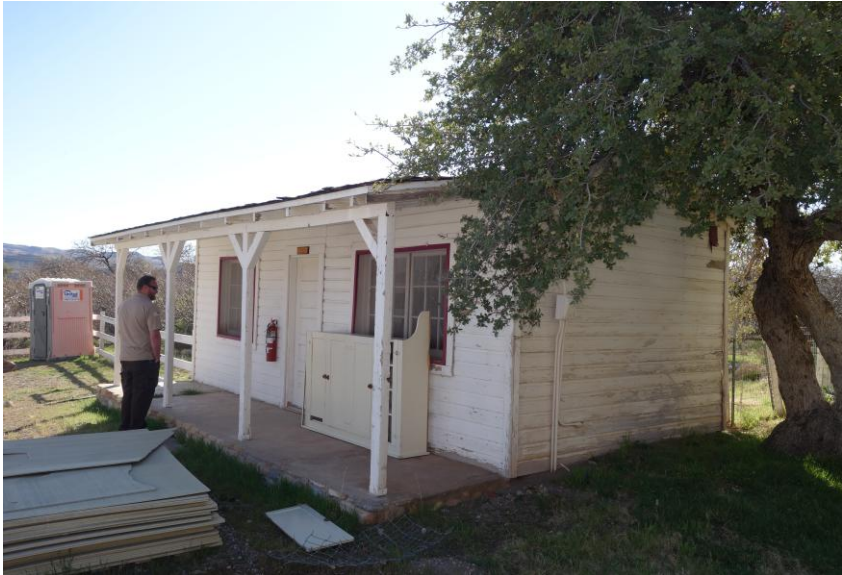
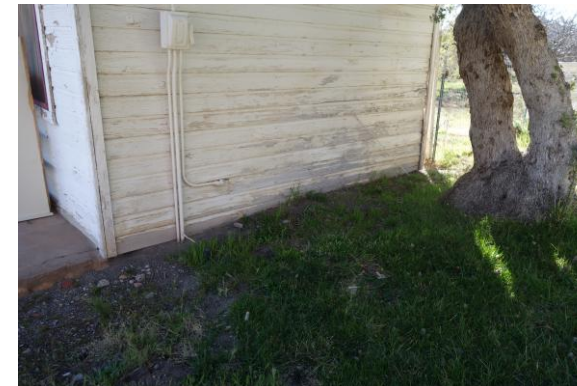
The exterior finishes were in poor condition. It is important to maintain the finish, weather resistance and appearance of the building. This project would provide funding to protect the exterior of the building excluding the roof. Included in the cost is sanding, priming and painting and caulking of the windows, doors, flashing, fixtures and all other penetrations and mitigating the earth to wood contact. It is recommended that

the building be painted in the next 2 - 3 years and that this project be scheduled on a cyclical basis to maintain the integrity of the structure. Due to the historical nature of the building, this project is subject to review and approval from the State Historical Preservation Office.

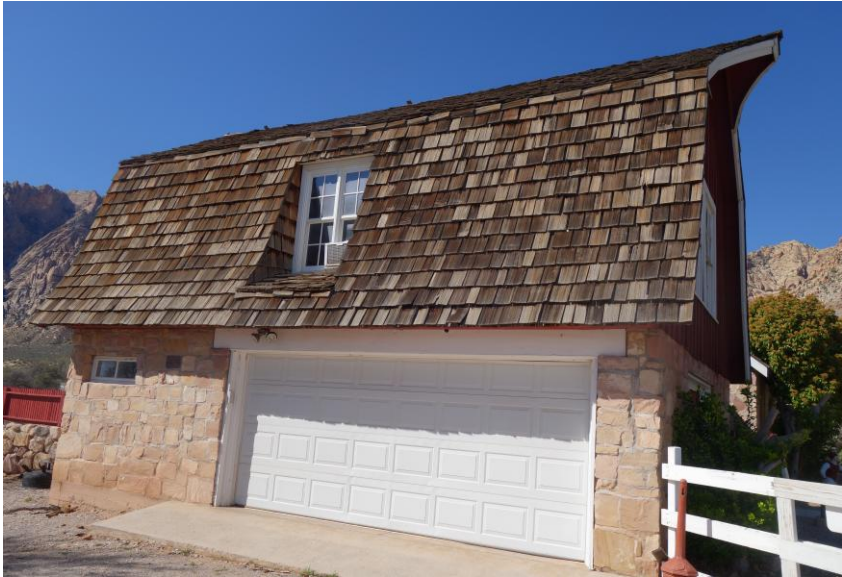
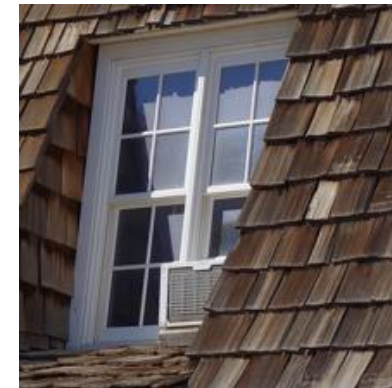
## VISITOR'S CENTER

The existing HVAC system consists of window-mounted units and a split system that are no longer suitable for the building's needs. This project recommends replacing the current equipment and supplementing it with new systems specifically selected for compatibility with historic structures. Any new HVAC system installed in a historic building should be as discreet and unobtrusive as possible, minimizing visual and

structural impact while improving performance and efficiency. The scope of work includes the complete removal and proper disposal of the existing HVAC units, along with all associated utility connections, and the installation of new equipment designed to preserve the building's historic character.

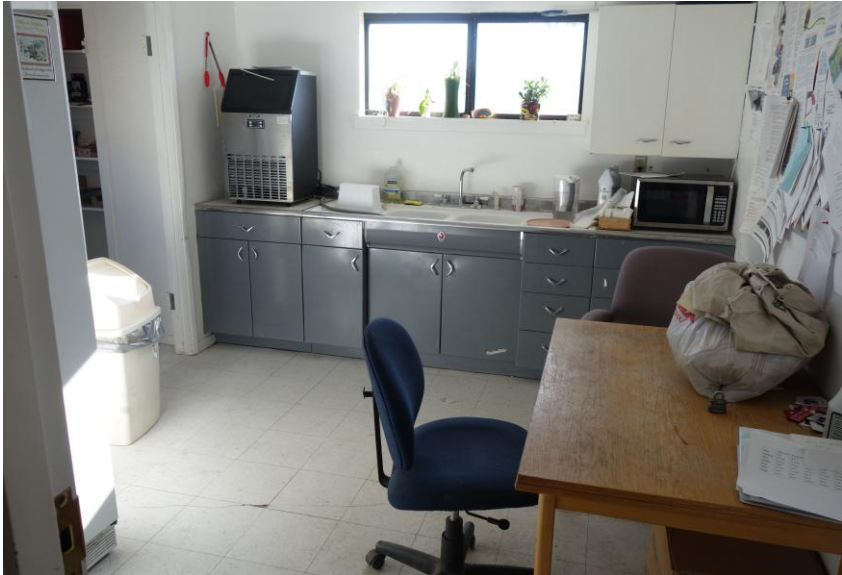
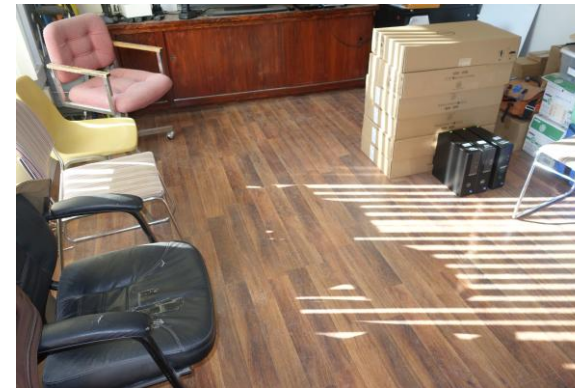
## RANGER'S OFFICE/ GUEST HOUSE

The vinyl composite tile (VCT) and other vinyl flooring is nearing the end of its useful life. There is a possibility that asbestos-containing materials (ACM) may be present in the existing floor tile and mastic; testing by a licensed abatement professional will be required. It is recommended that the flooring be replaced. This project recommends the removal and disposal of the existing flooring and the installation of new

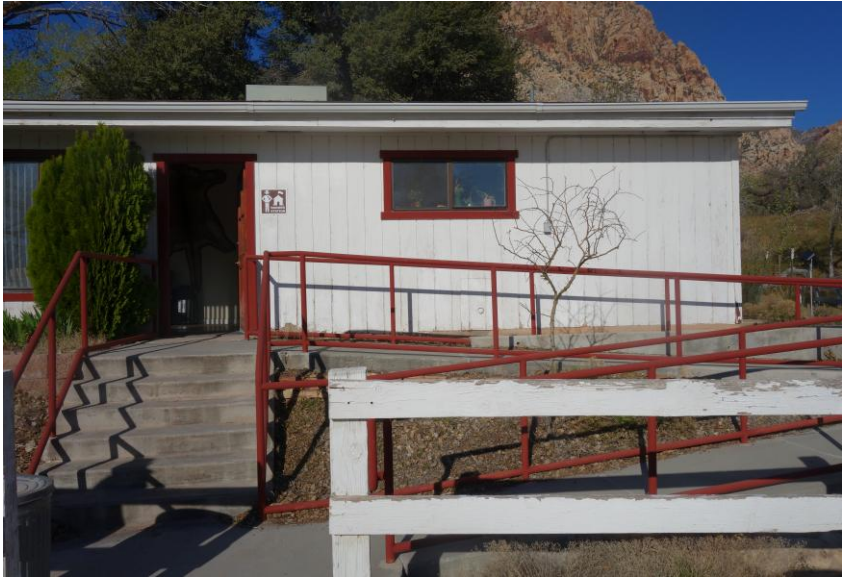
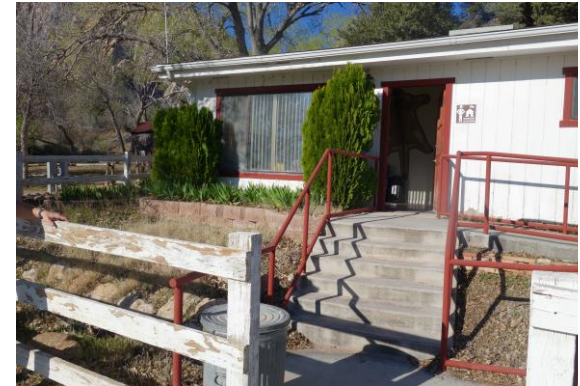
The windows are original, dual pane construction in a metal frame and have reached the end of their useful life. This project recommends replacing the windows with dual pane, higher efficiency units. This estimate is for the replacement of 10 units. Removal and disposal of the existing windows is included in this estimate.

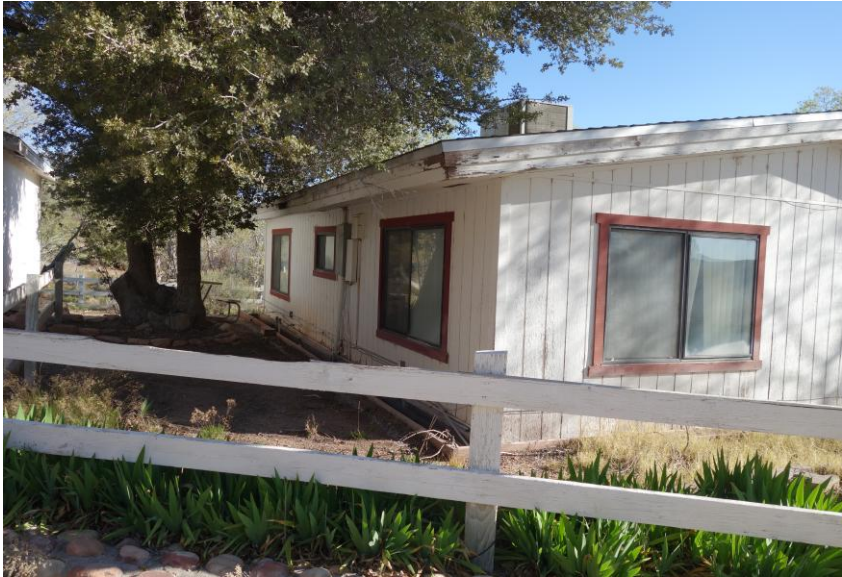
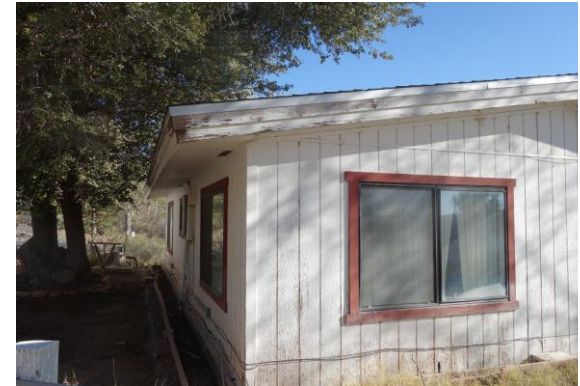
The exterior finishes were in poor condition. It is important to maintain the finish, weather resistance and appearance of the building. This project would provide funding to protect the exterior of the building excluding the roof. Included in the cost is sanding, priming and painting and caulking of the windows, flashing, fixtures and all other penetrations. It is recommended that the building be painted in the next 2 - 3 years and that

this project be scheduled on a cyclical basis to maintain the integrity of the structure.

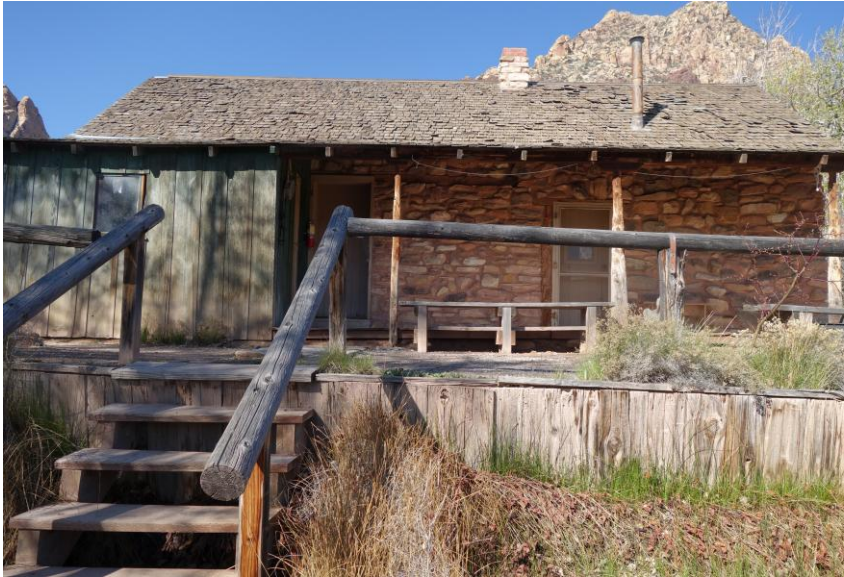
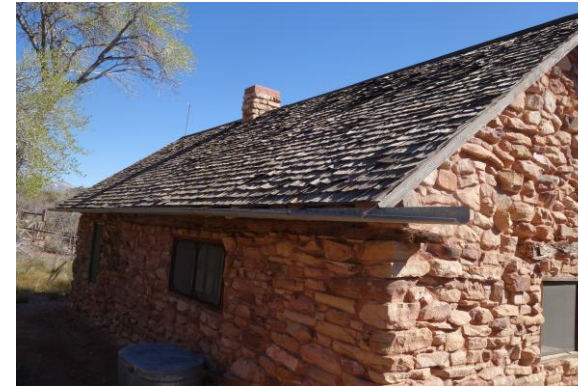
## WILSON RESIDENCE/ SANDSTONE CABIN

The building was built in 1870 and the current wood shake roofing system is weathered, has reached the end of its useful life and is in need of replacement. Due to its historic nature, the structure should be re-roofed with fire retardant-treated wood shakes and underlayment. This project should be coordinated with the Nevada State Historical Preservation Office (SHPO) for possible. The project will fund replacement

of the wood shingle roofing systems. The structure underwent a substantial reconstruction and URM exterior walls were reinforced in the 1980's according to project 19-P10. According to 19-P10, no further structural improvements recommendations were noted and therefore the roofing is recommended to be replaced.

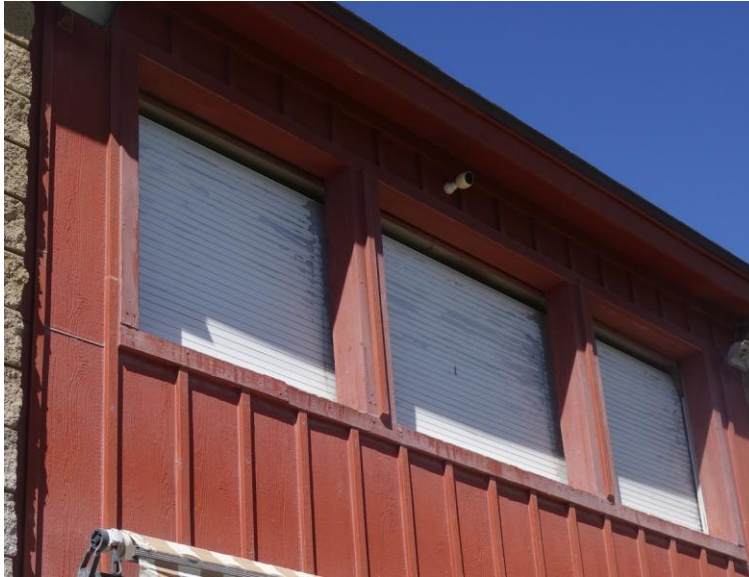
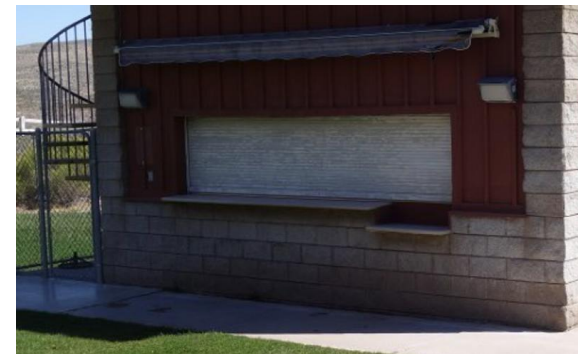
The aluminum roll-up window sashes in the building are experiencing exterior finish delamination, which could lead to significant maintenance issues as debris interferes with the roll-up mechanisms. While refurbishment may be possible, replacement is likely more cost-effective. This project recommends direct replacement of the existing sashes with new

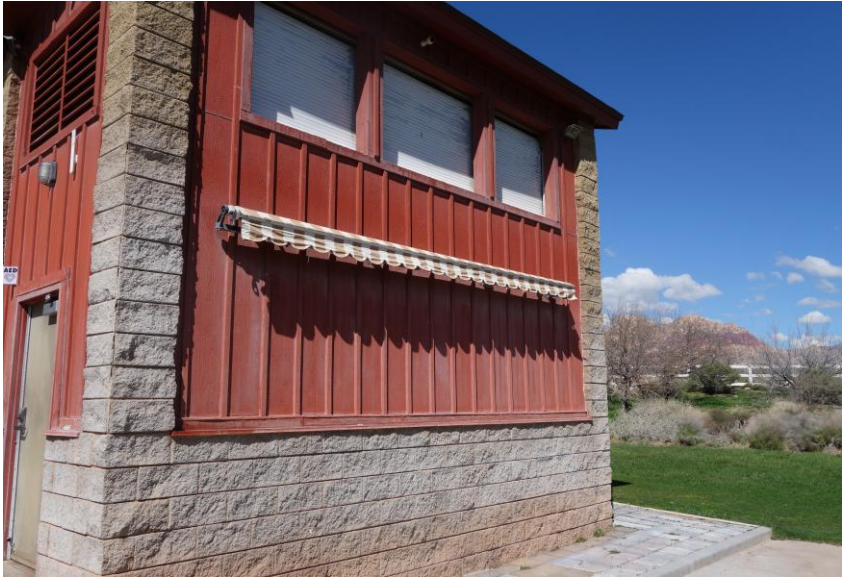
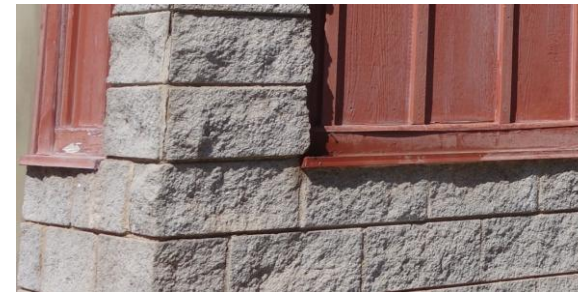
The exterior finishes were in poor condition. It is important to maintain the finish, weather resistance and appearance of the building. This project would provide funding to protect the exterior of the building excluding the roof. Included in the cost is power washing, staining the wood and caulking of the windows, flashing, fixtures and all other penetrations. It is recommended that the building be stained and caulked in the

next 3 - 4 years and that this project be scheduled on a cyclical basis to maintain the integrity of the structure.

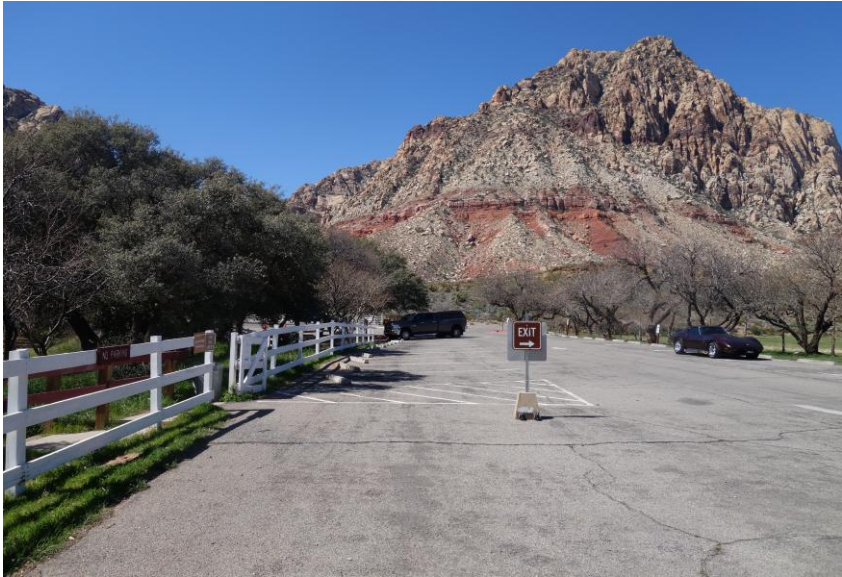
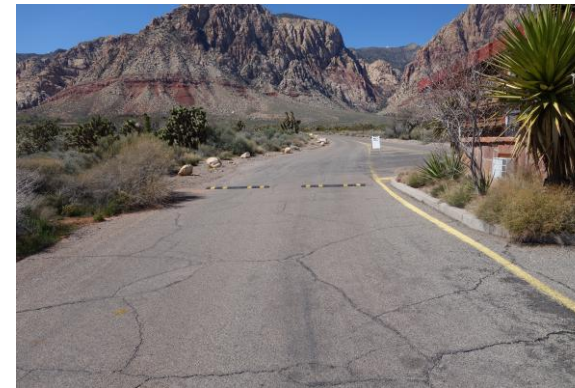
## SPRING MOUNTAIN RANCH STATE PARK SITE

The condition of the asphalt pavements was in fair condition. It is important to maintain the asphalt concrete paving on the site. This project would provide for minor crack filling and slurry sealing of the paving at the main parking lot near the Picnic Area. Striping is included in this estimate. This project should be scheduled on a 5 year cyclical basis to maintain the

integrity of the paving and prevent premature failure. 50,000 square feet of asphalt area was used to generate this estimate.

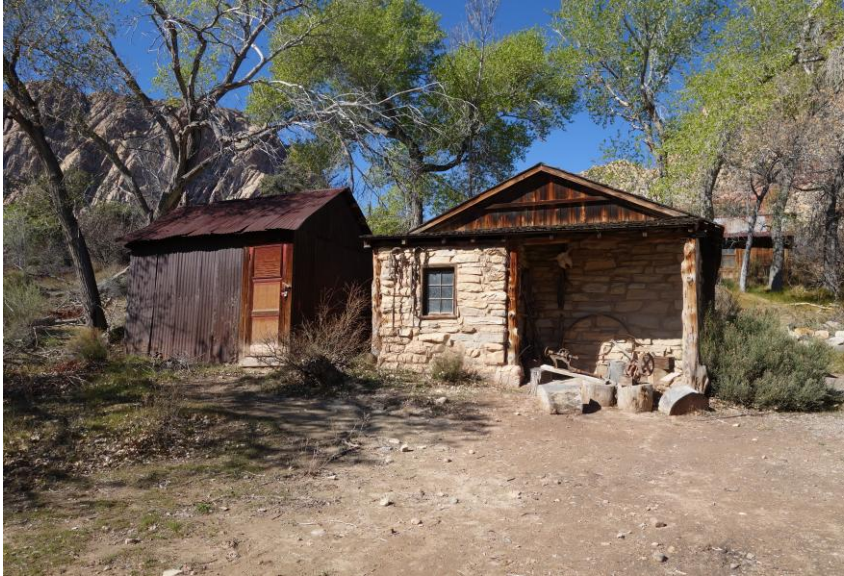
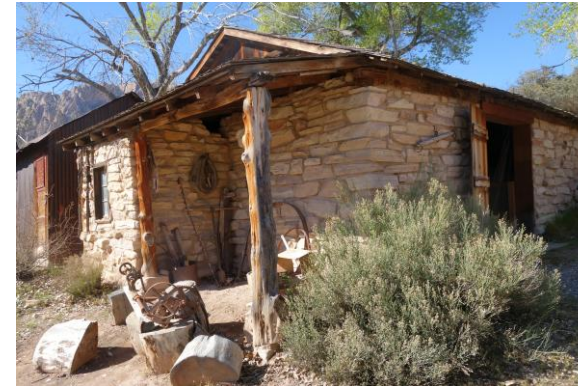
## HISTORIC BLACKSMITH SHOP

The structure is made of unreinforced stone masonry. It is over 100 years old and in fair condition. This project would provide for the cleaning, repair and re-pointing of the stone work and maintaining the exhibit. This project should be coordinated with the Nevada State Historical Preservation Office for possible restrictions or requirements which are not included in this estimate. It is recommended that the work be done in the

next 4 - 6 years and that this project be scheduled on a cyclical basis to maintain the integrity of the structure.

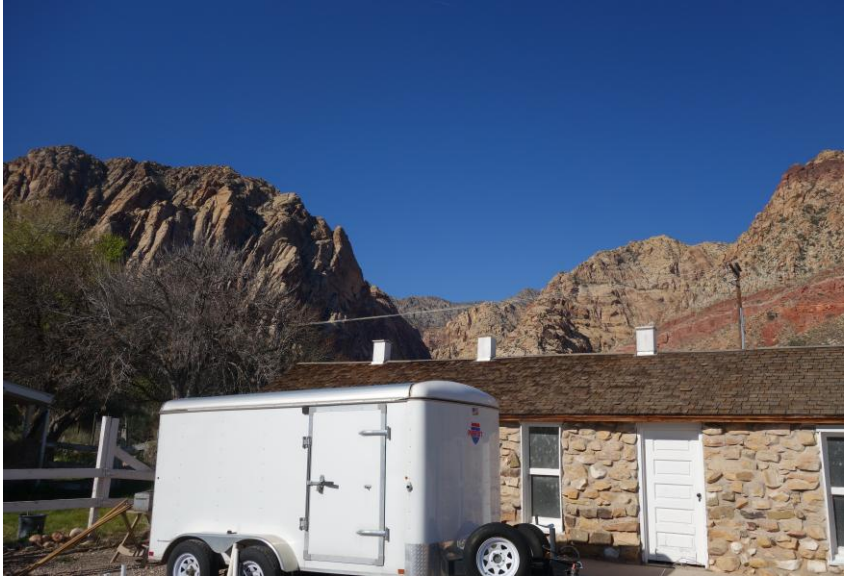
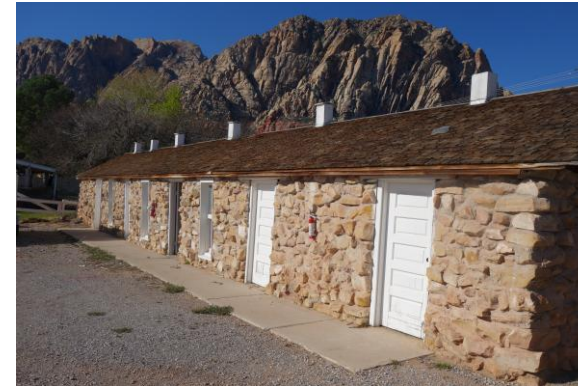
## CHINCHILLA SHED

this project be scheduled on a cyclical basis to maintain the integrity of the structure. Due to the historical nature of the building, this project is subject to review and approval from the State Historical Preservation Office.

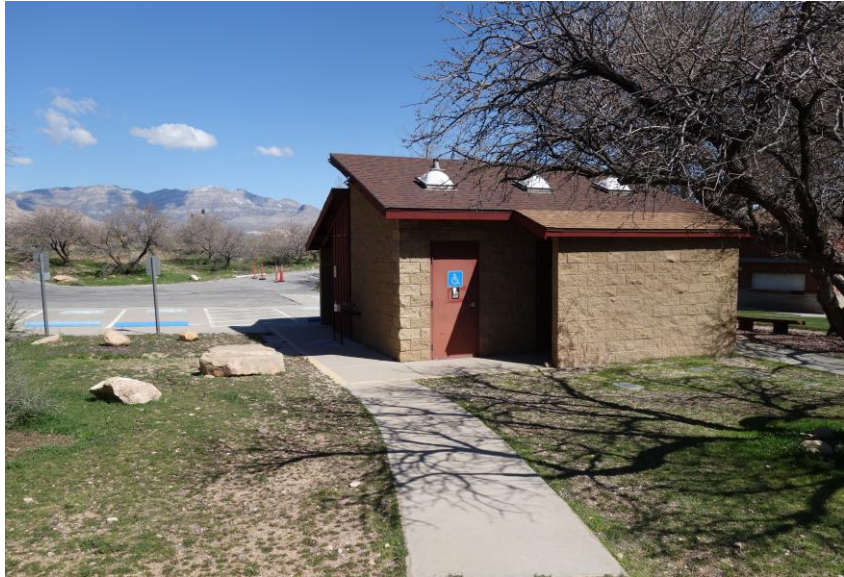
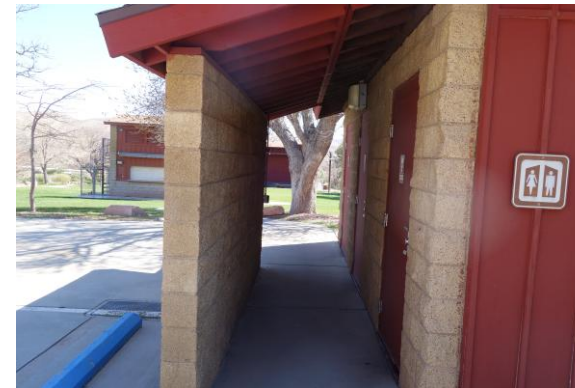
#### 1151-EXT-1: EXTERIOR FINISHES

The exterior finishes were in fair condition. It is important to maintain the finish, weather resistance and appearance of the building. The caulked control joints in the CMU of the exterior surface of this building are uniformly deteriorated and should be removed and the joints re-caulked. The metal doors and window frames should be sanded and painted on a cyclical basis.

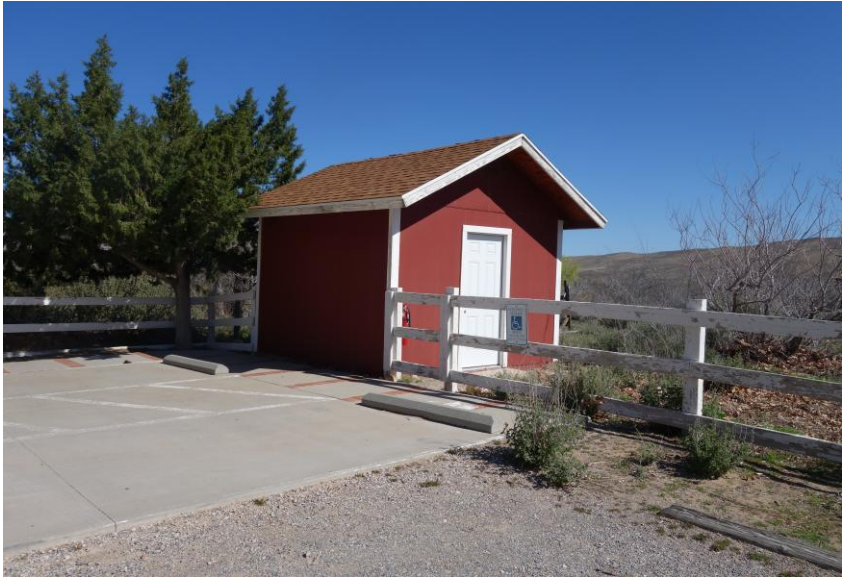
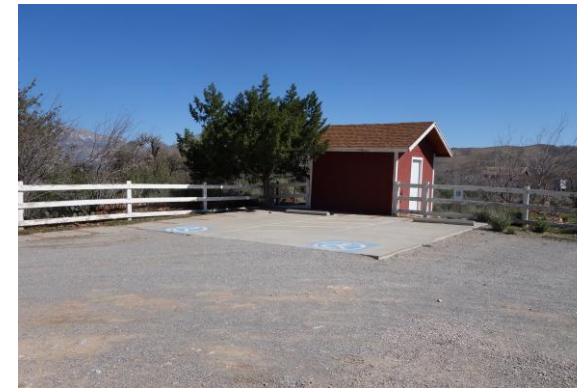
### 1153-EXT-1: EXTERIOR FINISHES

The exterior finishes were in good condition. It is important to maintain the finish, weather resistance and appearance of the building. This project would provide funding to protect the exterior of the building excluding the roof. Included in the cost is sanding, priming and painting and caulking of the flashing, fixtures and all other penetrations. It is recommended that the building be painted in the next 7 - 9 years and that this project

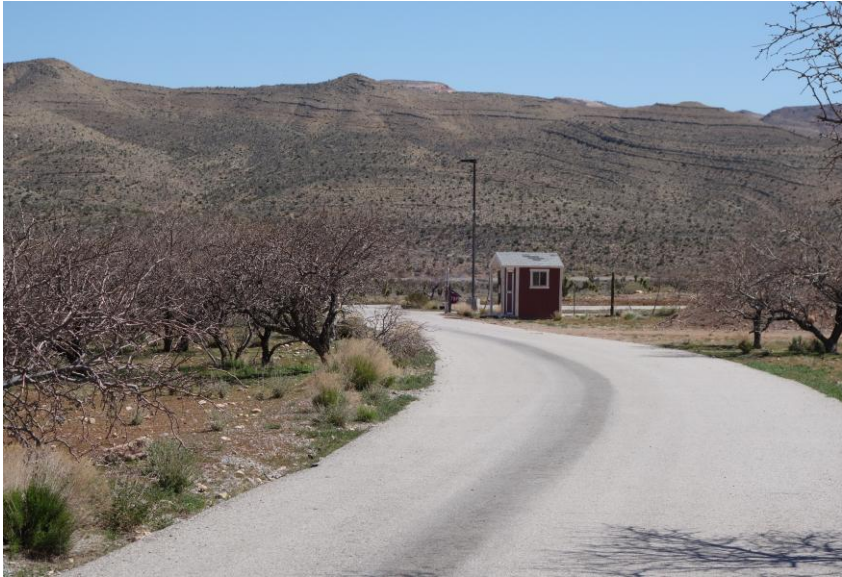
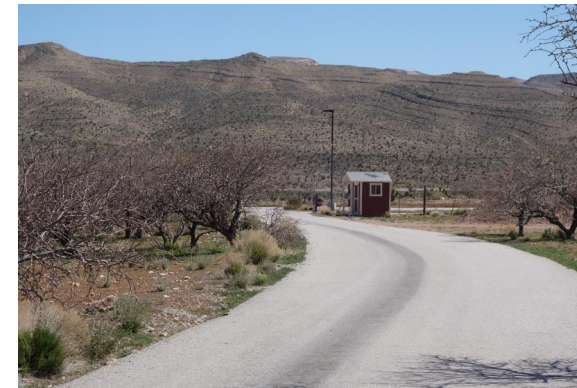
#### 1154-EXT-2: EXTERIOR FINISHES

The exterior finishes were in fair condition. It is important to maintain the finish, weather resistance and appearance of the building. This project would provide funding to protect the exterior of the building excluding the roof. Included in the cost is sanding, priming, painting and caulking of the windows, flashing, fixtures and all other penetrations. It is recommended that the building be painted in the next 5 - 7 years and that

this project be scheduled on a cyclical basis to maintain the integrity of the structure.

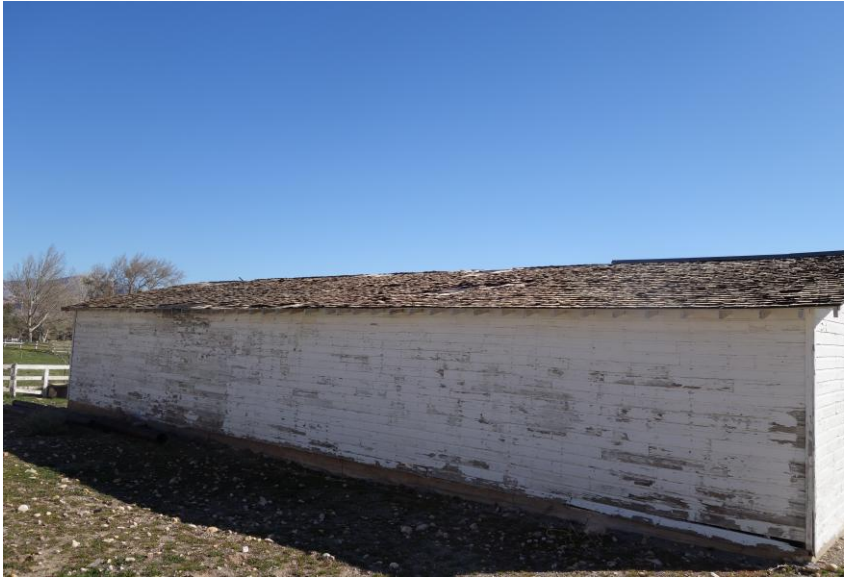
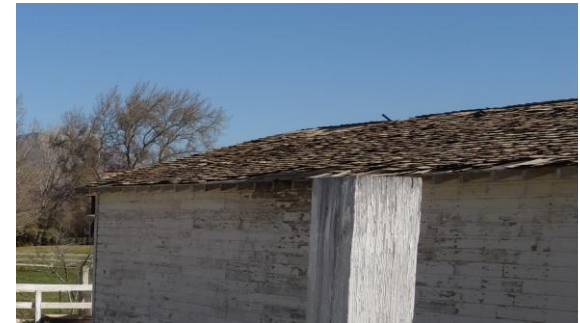
#### 1159-EXT-2: ROOF REPLACEMENT

The wood shingle roof on this building was in poor condition at the time of the survey. It is recommended that this building be re-roofed in the next 4 - 6 years with a new wood shingle roof and new underlayment. This estimate includes removal and disposal of the old roof. Due to the historical nature of the building, this project is subject to review and approval from the State Historical Preservation Office.
