DEPARTMENT OF ADMINISTRATION  
STATE PUBLIC WORKS DIVISION  
FACILITY CONDITION ASSESSMENT

### PROPERTY PORTFOLIO REVIEW PROJECT ADDENDUM

9930 - SPRING MOUNTAIN RANCH STATE PARK SITE  
6375 HWY 159  
BLUE DIAMOND, NV 89004-  
CLARK COUNTY

SURVEY DATE: 03/19/2024

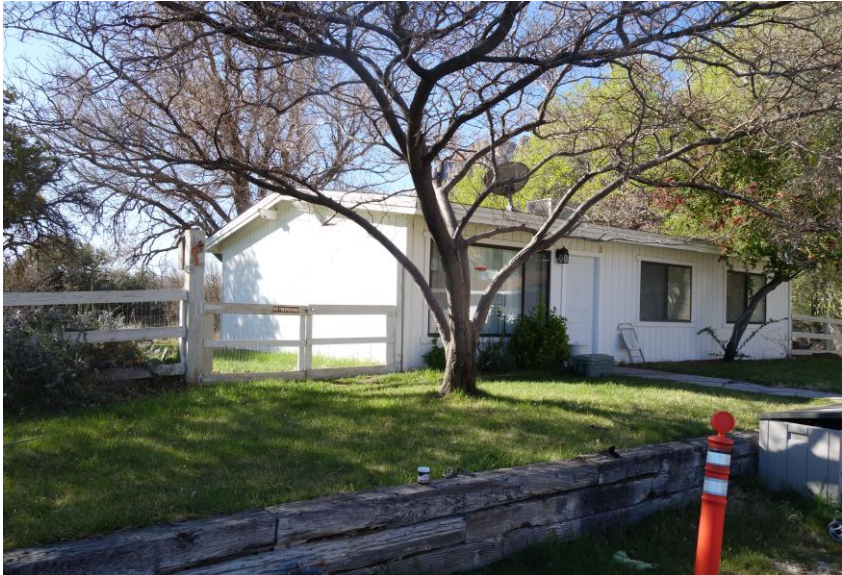
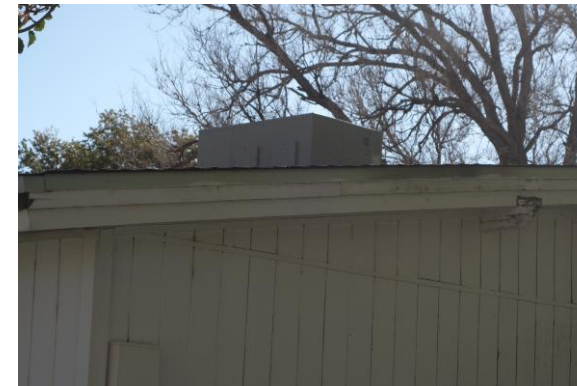
#### 1167-EXT-2: EXTERIOR FINISHES

The exterior finishes were in fair condition. It is important to maintain the finish, weather resistance and appearance of the building. This project would provide funding to protect the exterior of the building excluding the roof. Included in the cost is sanding, priming and painting and caulking of the windows, doors, flashing, fixtures and all other penetrations and mitigating the earth to wood contact. It is recommended that

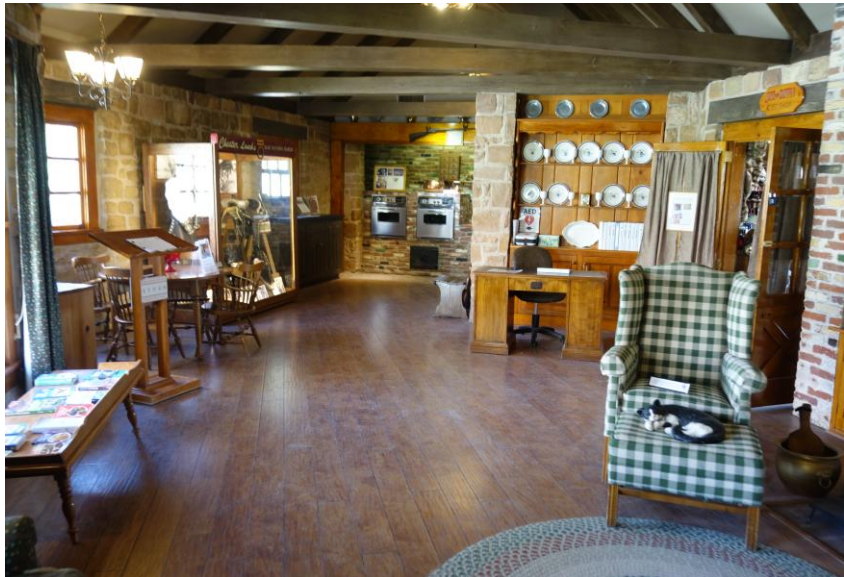
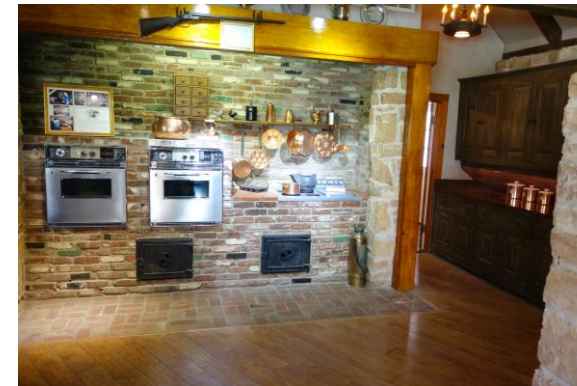
### 1172-INT-1: INTERIOR FINISHES

The interior finishes are in good condition. It is recommended that the interior walls and ceilings be painted at least once in the next 7 - 9 years. Prior to painting, all surfaces should be repaired and prepped. An epoxy-based paint should be utilized in wet areas for durability.

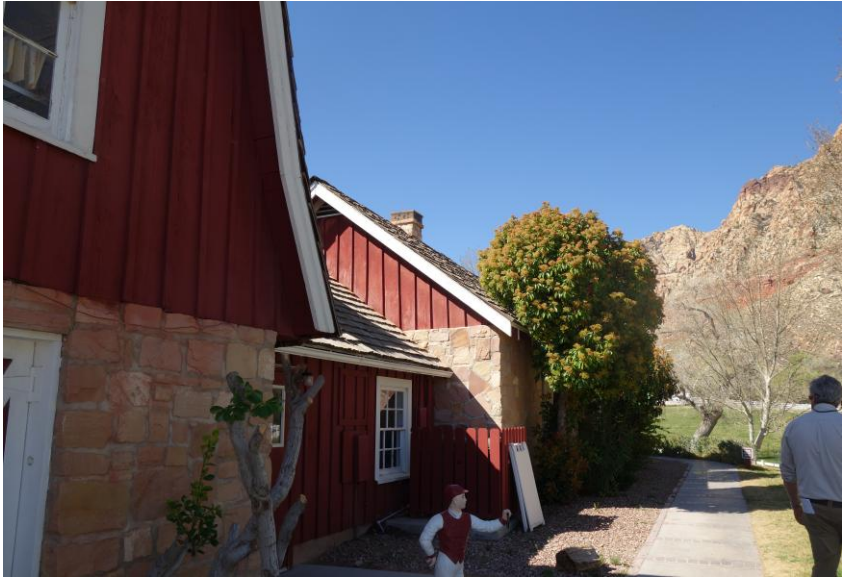
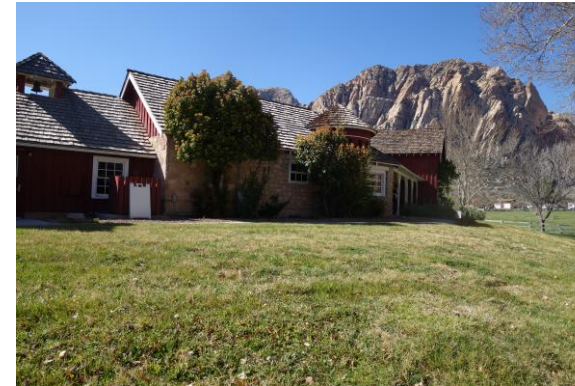
#### 1172-EXT-1: EXTERIOR FINISHES

The exterior finishes were in good condition. It is important to maintain the finish, weather resistance and appearance of the building. This project would provide funding to protect the exterior of the building excluding the roof. Included in the cost is sanding, priming and painting and caulking of the windows, doors, flashing, fixtures and all other penetrations. It is recommended that the building be painted in the next 7 - 9

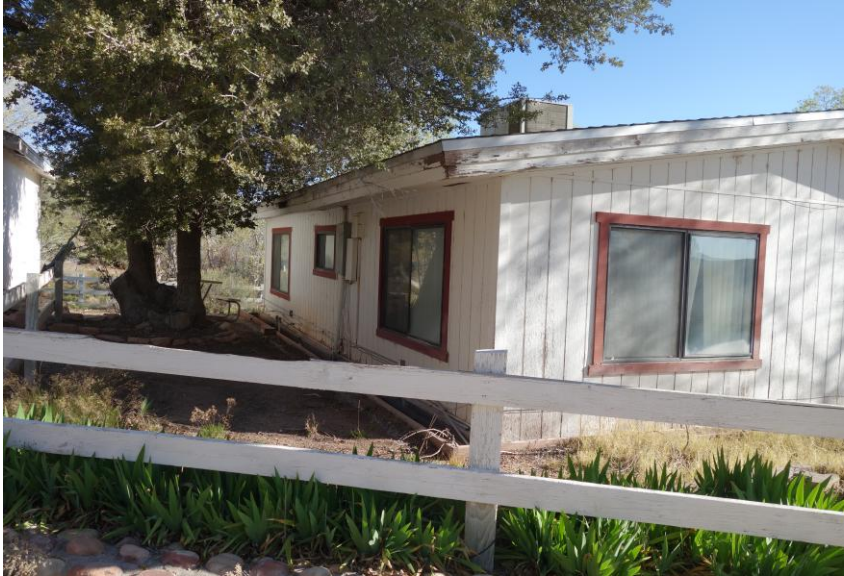
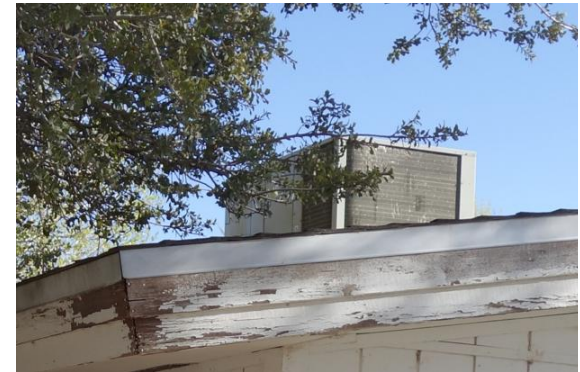
### 1173-HVA-1: HVAC REPLACEMENT

The rooftop HVAC unit is aging and recommended for replacement. It is also recommended that the unit be relocated to the ground to minimize risk of roof leaks and reduce the structural loads to the roof. This work should be completed prior to the replacement of the roof.

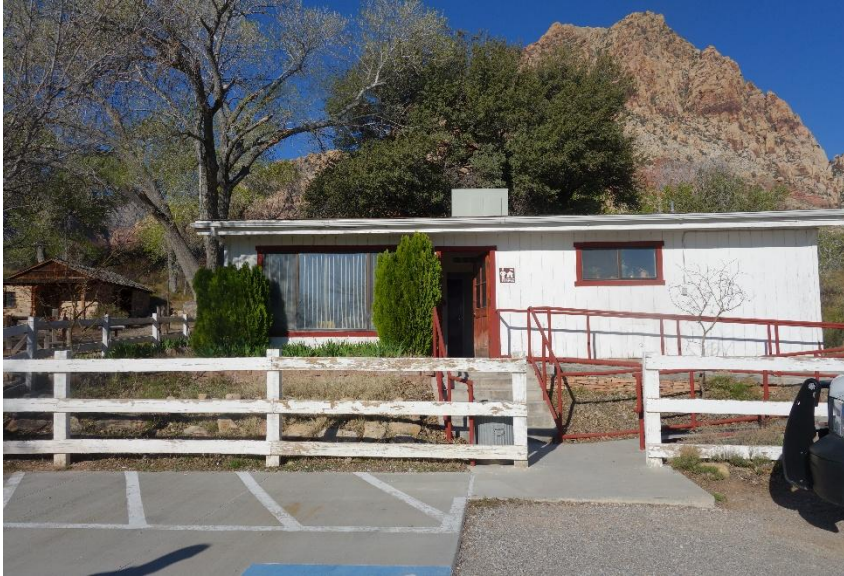
#### 1173-EXT-2: ROOF REPLACEMENT

The asphalt composition shingle roof on this building was in poor condition at the time of the survey. It is recommended that this building be re-roofed in the next 4 - 5 years with a new 50 year asphalt composition shingle roof and new underlayment. Prior to replacement, the rooftop HVAC unit is recommended to be replaced and relocated to a ground set

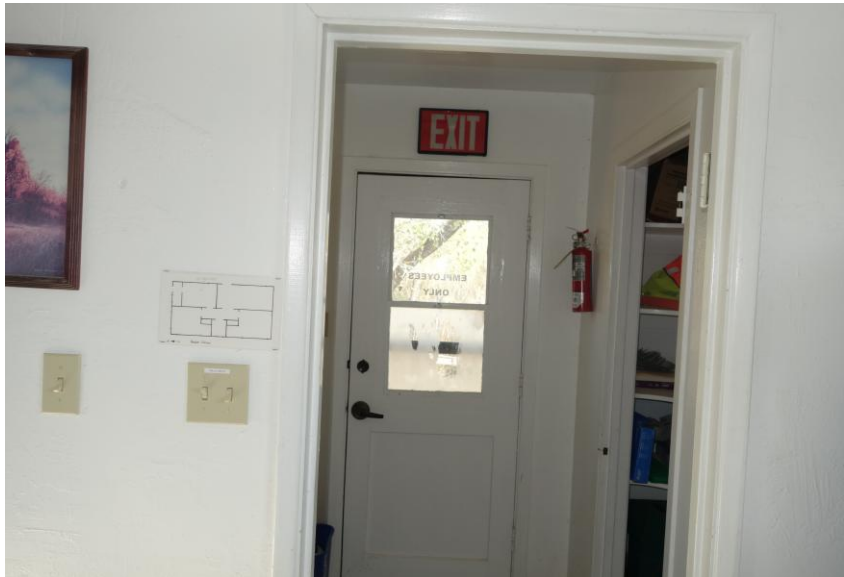
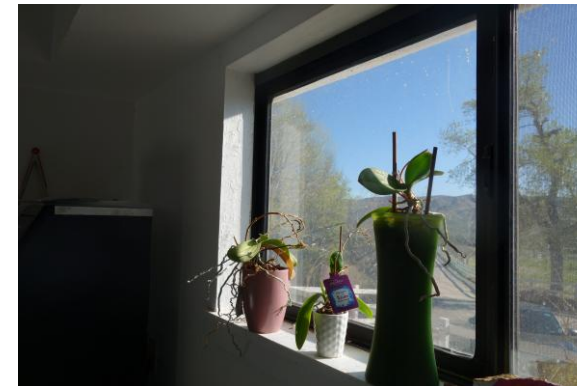
#### 1173-INT-2: INTERIOR FINISHES

The interior finishes were in good condition. It is recommended to paint the interior walls and ceilings at least once in the next 6 - 8 years and that this project be scheduled on a cyclical basis to maintain the integrity of the structure. Prior to painting, all surfaces should be repaired and adequately prepared to receive the coating. An epoxy-based paint should be utilized in wet areas for durability.

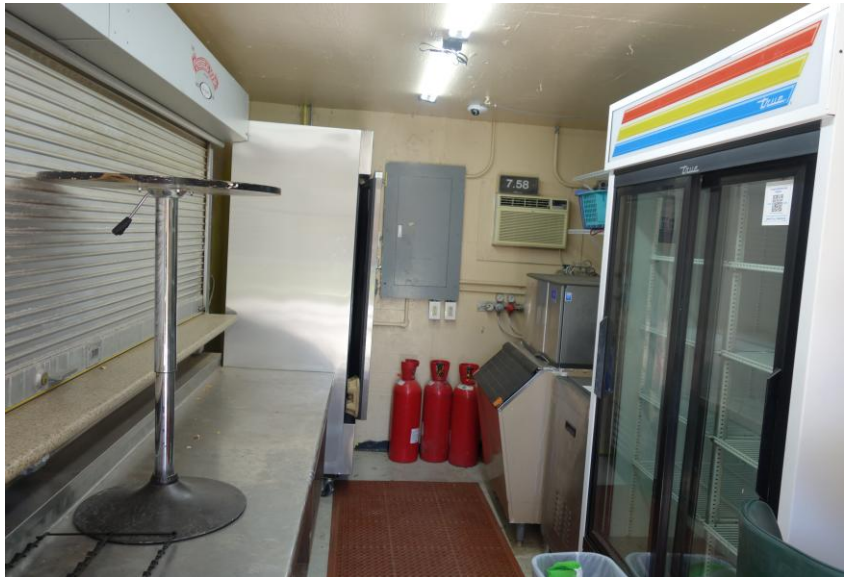
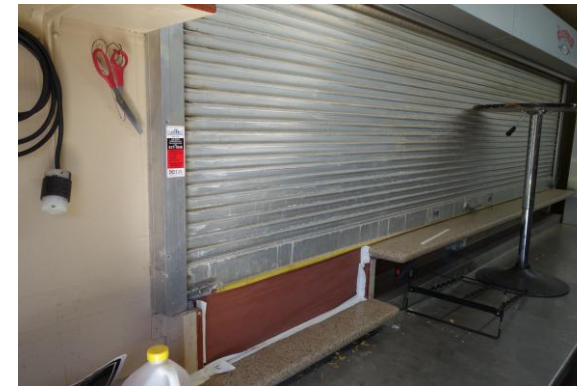
### 1633-INT-2: INTERIOR FINISHES

It is recommended to paint the interior walls and ceilings at least once in the next 4 - 5 years and that this project be scheduled on a cyclical basis to maintain the integrity of the structure. Prior to painting, all surfaces should be repaired and adequately prepared to receive the coating. An epoxy-based paint should be utilized in wet areas for durability.

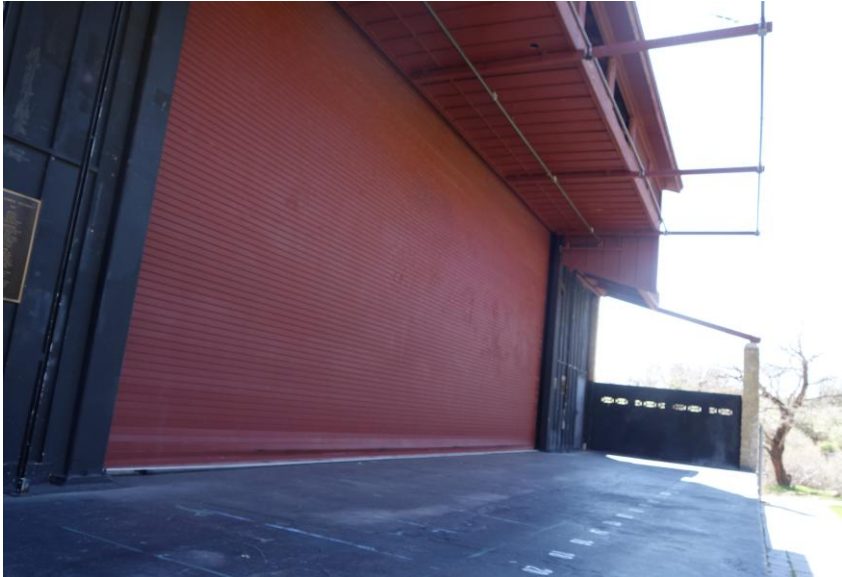
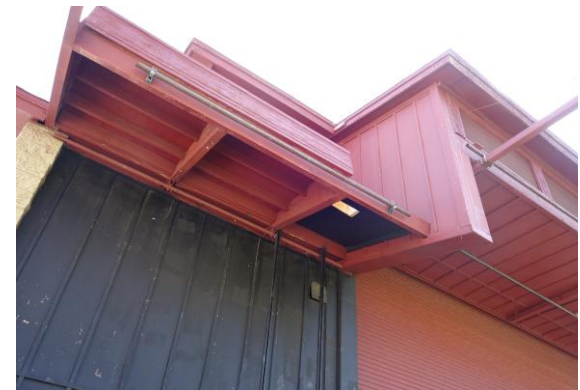
#### 1634-EXT-2: EXTERIOR FINISHES

The exterior finishes were in fair condition. It is important to maintain the finish, weather resistance and appearance of the building. This project would provide funding to protect the exterior of the building excluding the roof. Included in the cost is power washing, staining the wood and caulking of the windows, flashing, fixtures and all other penetrations. It is recommended that the building be stained and caulked in the

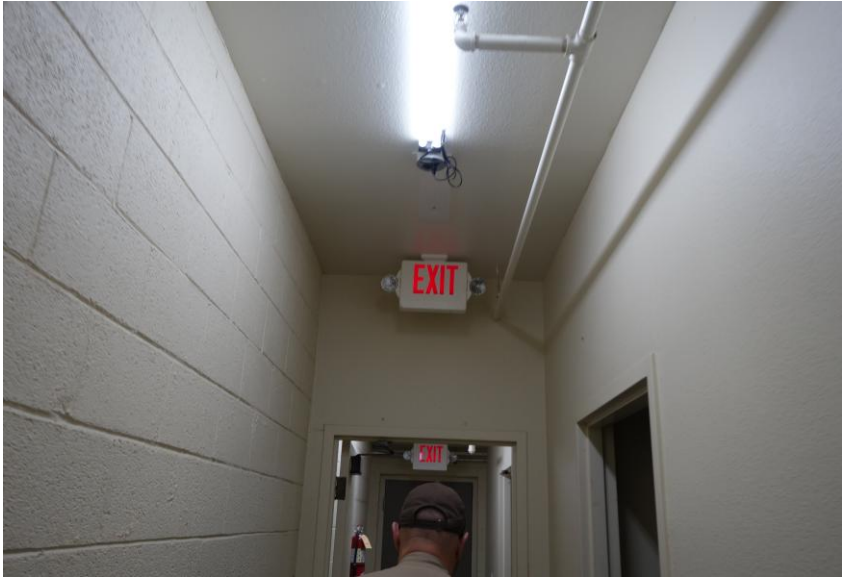
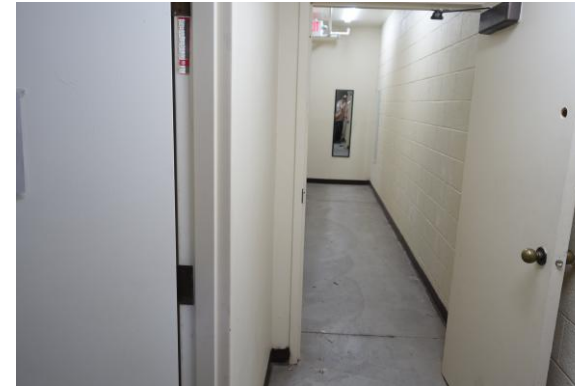
#### 1634-INT-1: INTERIOR FINISHES

The interior finishes are in good condition. It is recommended that the interior walls and ceilings be painted at least once in the next 7 - 9 years. Prior to painting, all surfaces should be repaired and prepped. An epoxy-based paint should be utilized in wet areas for durability.

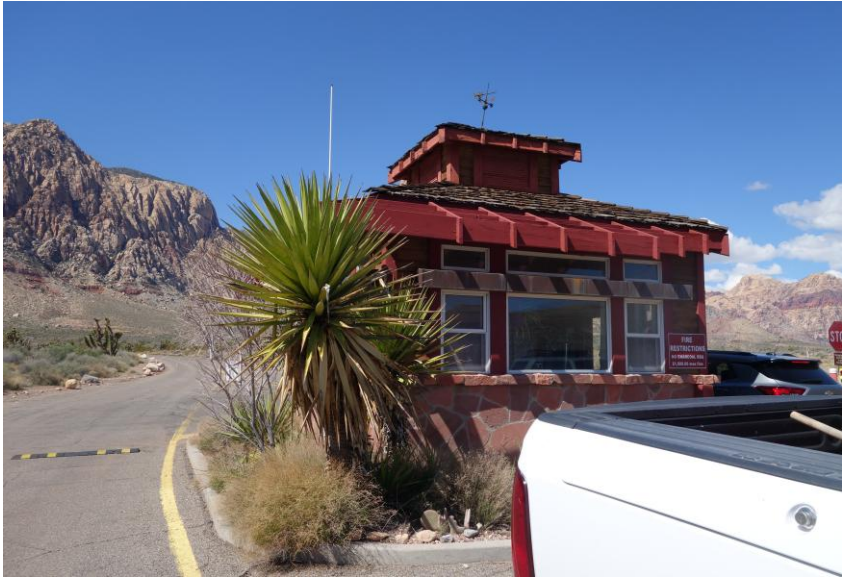
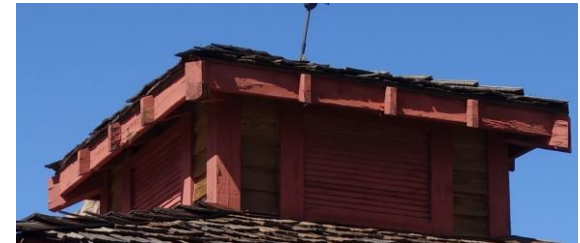
### 1635-EXT-1: EXTERIOR FINISHES

The exterior finishes were in fair condition. It is important to maintain the finish, weather resistance and appearance of the building. This project would provide funding to protect the exterior of the building excluding the roof. Included in the cost is sanding, priming and painting, cleaning and sealing the stone and caulking of the windows, flashing, fixtures and all other penetrations. It is recommended that the building be painted

in the next 4 - 6 years and that this project be scheduled on a cyclical basis to maintain the integrity of the structure.

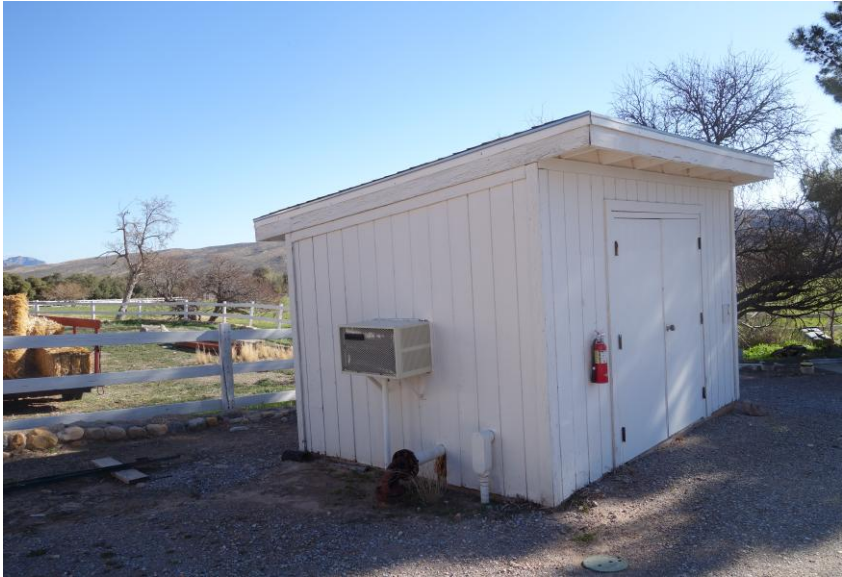
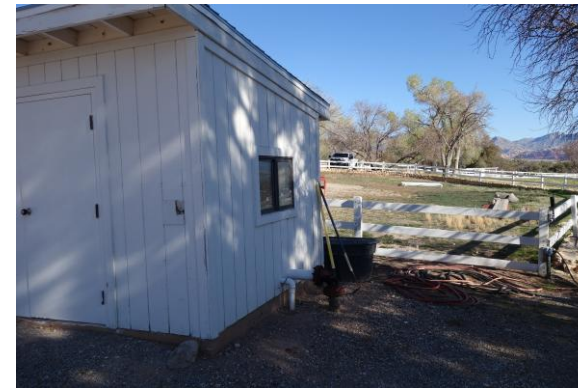
#### 1636-EXT-1: EXTERIOR FINISHES

The exterior finishes were in fair condition. It is important to maintain the finish, weather resistance and appearance of the building. This project would provide funding to protect the exterior of the building excluding the roof. Included in the cost is sanding, priming and painting and caulking of the flashing, fixtures and all other penetrations. It is recommended that the building be painted in the next 4 - 6 years and that this project

be scheduled on a cyclical basis to maintain the integrity of the structure.

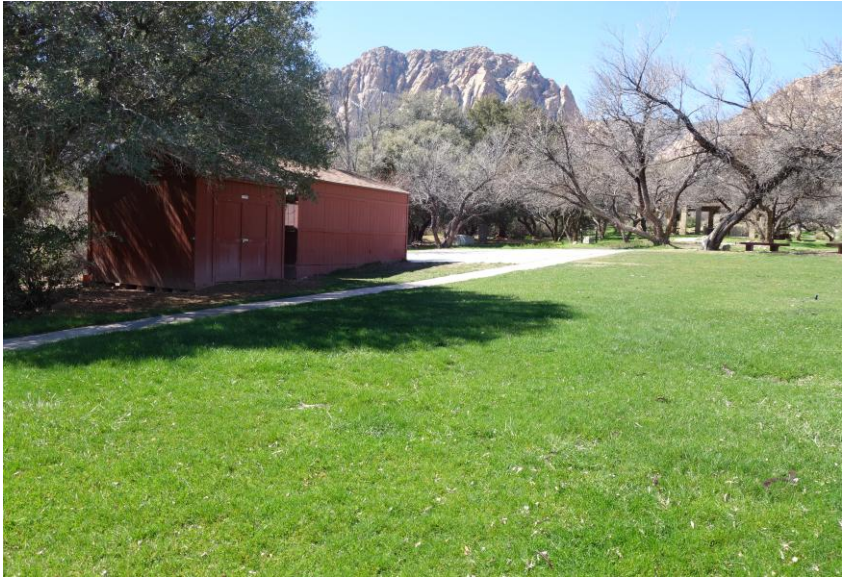
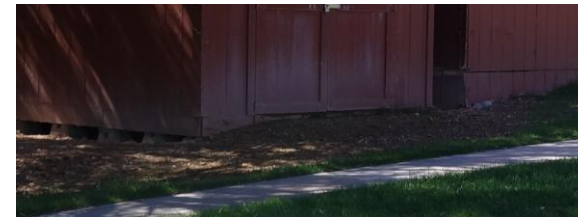
#### 2410-EXT-2: EXTERIOR FINISHES

It is important to maintain the finish, weather resistance and appearance of the building. This project would provide funding to protect the exterior of the building excluding the roof. Included in the cost is sanding, priming, painting and caulking of the flashing, fixtures and all other penetrations. It is recommended that the building be painted in the next 4 - 5

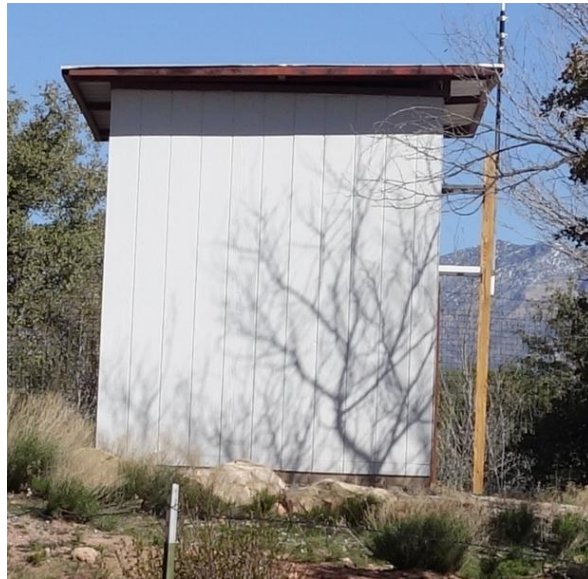
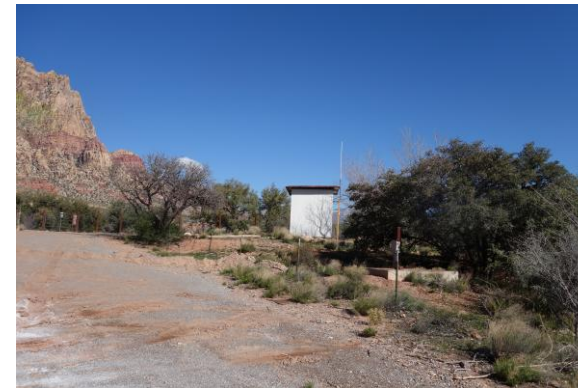
#### 3043-EXT-1: EXTERIOR FINISHES

The exterior finishes were in good condition. It is important to maintain the finish, weather resistance, and appearance of the building. This project would provide funding to protect the exterior of the building excluding the roof. Included in the cost is sanding, priming and painting, and caulking of the flashing, fixtures and all other penetrations. It is recommended that the building be painted in the next 6 - 8 years and that this project

be scheduled on a cyclical basis to maintain the integrity of the structure.

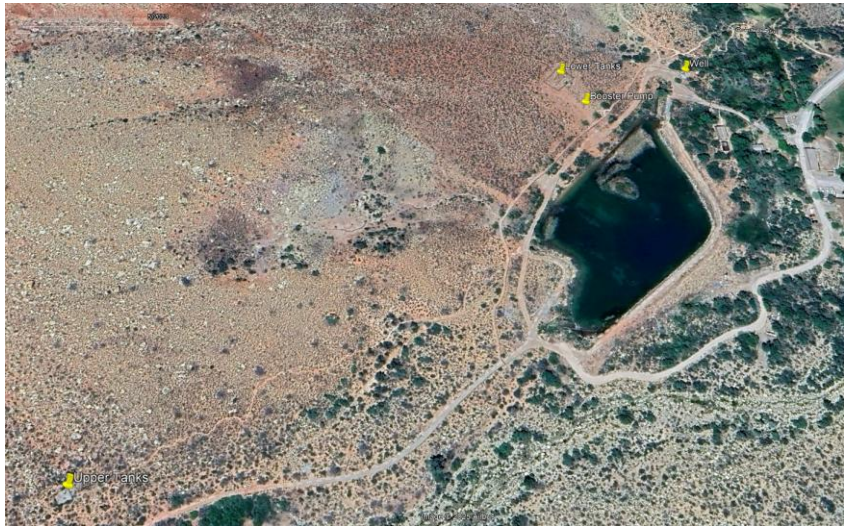
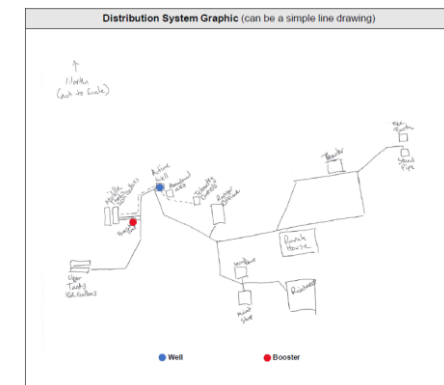
#### 9930-SIT-2: WATER UTILITY SYSTEM UPGRADE

The domestic water utility system at Spring Mountain Ranch State Park is aging and lacks redundancy, creating single points of failure that force full park closures during maintenance. Although a 2011 upgrade added 20,000 gallons of storage, the system remains vulnerable and difficult to service outside operating hours, as the park is open seven days a week and serves approximately 150,000 visitors annually. To ensure reliability, operational continuity, and ease of maintenance,

this project recommends a complete redesign of the water utility system to incorporate redundant components, improve system resilience, and allow maintenance without disrupting public access.
