STATE OF NEVADA  
STATE PUBLIC WORKS DIVISION

FACILITY CONDITION ASSESSMENT REPORT FOR:

DEPT OF CONSERVATION AND NATURAL RESOURCES  
DIVISION OF FORESTRY

SITE #: 9934 ELKO NORTHERN REGION 2 NDF HDQS. SITE  
911 FALCON WAY  
ELKO, NV 89801-4654

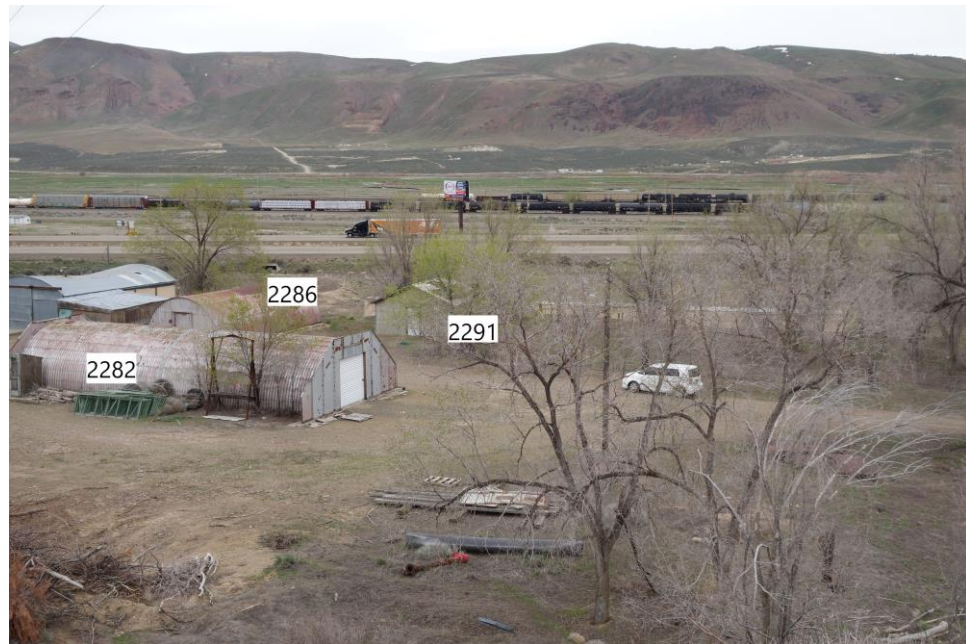
### ROOF REPLACEMENT

QUANTITY	UNITS	TOTAL	SF COST
Multiple fiberglass roofing panels are missing and others may be damaged and need replacement. This project recommends a complete replacement of all fiberglass roofing panels.	400	Square Foot	\$12,000.00	\$ 30.00

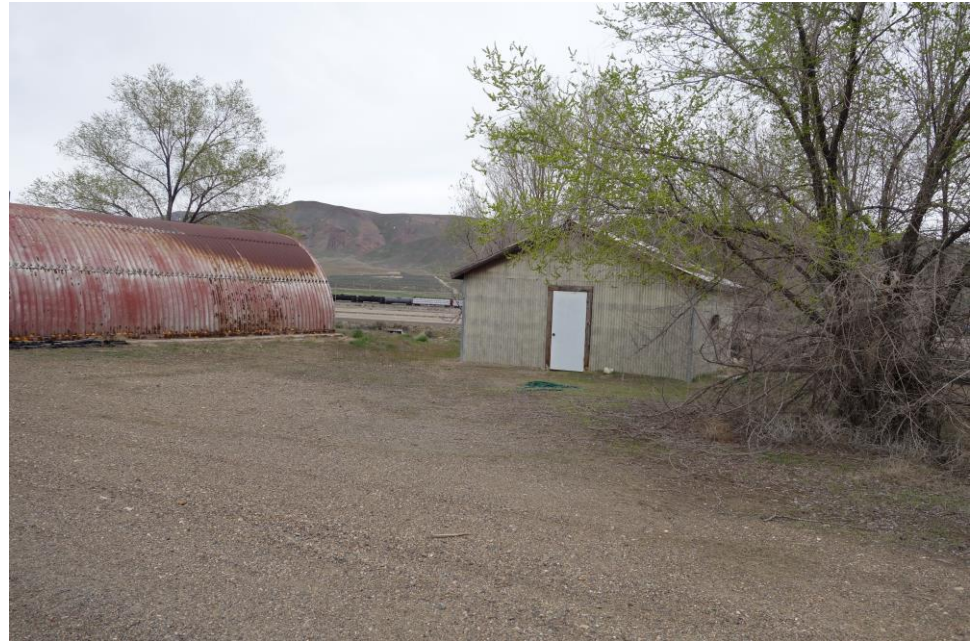
### EXTERIOR FINISHES

QUANTITY	UNITS	TOTAL	SF COST
The exterior finishes were in fair condition. It is important to maintain the finish, weather resistance and appearance of the building. This project would provide funding to protect the exterior of the building. Included in the cost is power replacement of any damaged fiberglass panels. It is recommended to inspect the building for damaged panels every 4 - 5 years and that this project be scheduled on a cyclical basis to maintain the integrity of the structure.	400	Square Foot	\$ 2,000.00	\$ 5.00

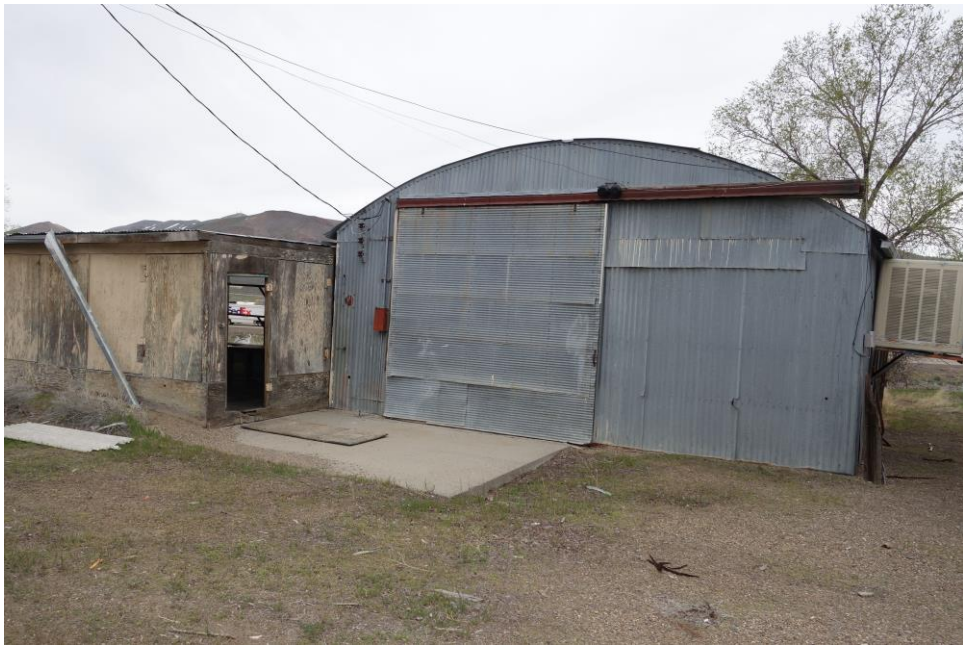
EXTERIOR FINISHES

QUANTITY	UNITS	TOTAL	SF COST
The exterior finishes were in poor condition. It is important to maintain the finish, weather resistance and appearance of the building. This project would provide funding to protect the exterior of the building. Included in the cost is power washing, priming and painting the metal panels. It is recommended to paint the building in the next 2 - 3 years and that this project be scheduled on a cyclical basis to maintain the integrity of the structure.	800	Square Foot	\$16,000.00	\$ 20.00

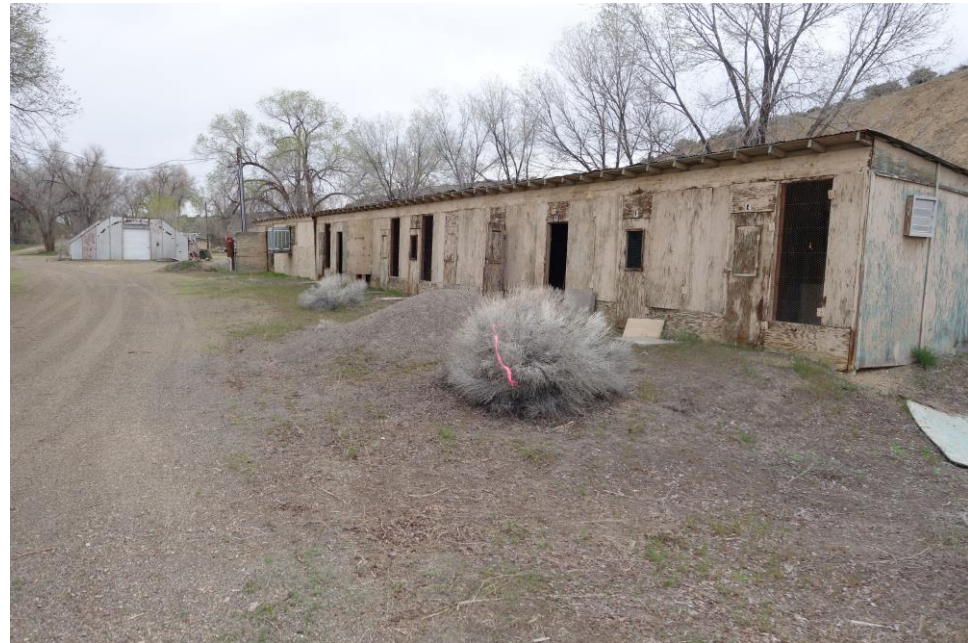
DEMOLISH STRUCTURE

QUANTITY	UNITS	TOTAL	SF COST
The structure is dilapidated and deteriorating and has reached the end of its useful life. The structure is over 50 years of age, has had continuous roof leaks and the wood has rotted. This project would provide funding for the demolition and disposal of the building.	1	Package	\$ 8,000.00	\$ 5.00
