STATE OF NEVADA
STATE PUBLIC WORKS DIVISION

FACILITY CONDITION ASSESSMENT REPORT FOR:

DEPT OF CONSERVATION AND NATURAL RESOURCES
DIVISION OF STATE PARKS

SITE #: 9935 WILD HORSE STATE RECREATION AREA SITE
HC 31 BOX 265
ELKO, NV 89801-

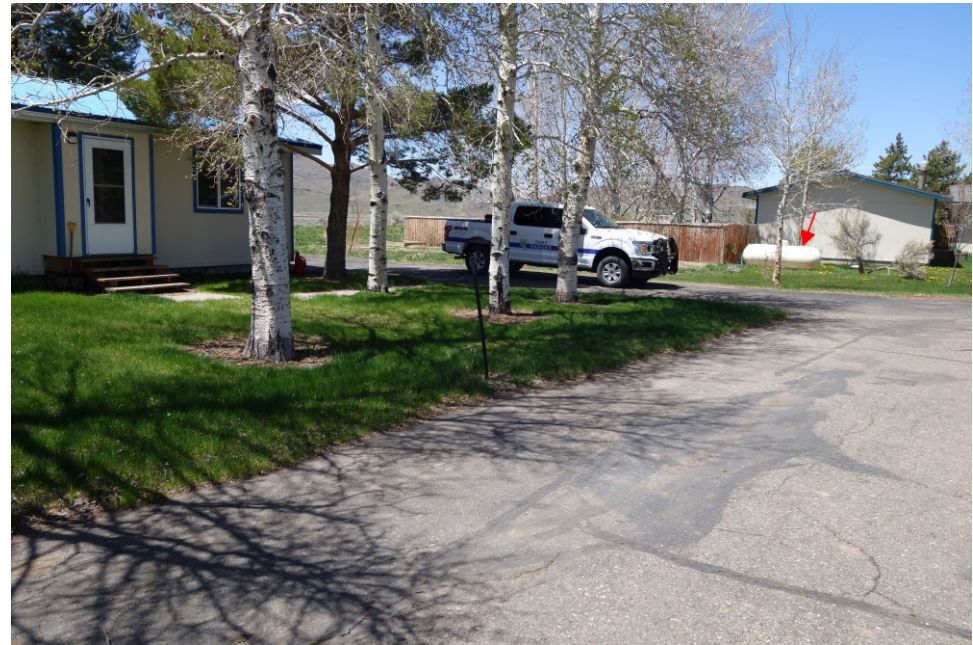
1312 RESIDENCE #1

QUANTITY	UNITS	TOTAL	SF COST
This project would provide for the installation of a seismic gas shut-off valve on the main gas service piping prior to entering the building. Alternately, for propane services or a site gas services with a single site metering station, consider installation at the tank or main meter service if it feeds multiple buildings. This estimate is based on the manufacturer Pacific Seismic Products or approved equal, equipped with the optional Model MS remote monitoring switch (to be interfaced with the direct digital control system and/or with an audible alarm). The gas piping immediately adjacent to the seismic gas valve shall be secured to the building utilizing unistrut channel bracing.	1	PKG	\$ 7,500.00	\$ 3.00

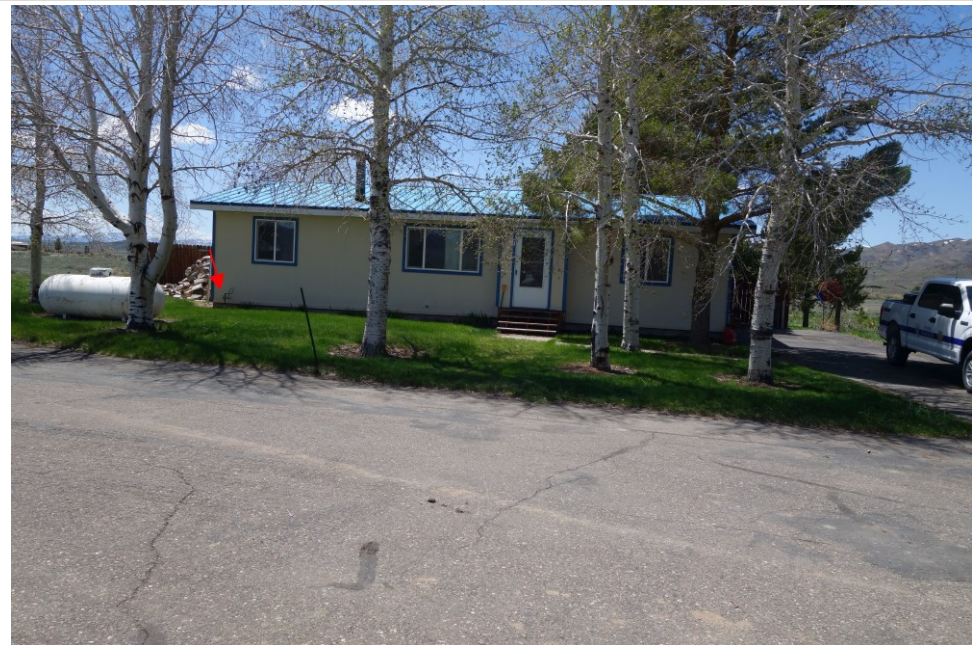
1313 RESIDENCE #2

QUANTITY	UNITS	TOTAL	SF COST
<p>This project would provide for the installation of a seismic gas shut-off valve on the main gas service piping prior to entering the building. Alternately, for propane services or a site gas services with a single site metering station, consider installation at the tank or main meter service if it feeds multiple buildings. This estimate is based on the manufacturer Pacific Seismic Products or approved equal, equipped with the optional Model MS remote monitoring switch (to be interfaced with the direct digital control system and/or with an audible alarm). The gas piping immediately adjacent to the seismic gas valve shall be secured to the building utilizing unistrut channel bracing.</p>	1	PKG	\$ 7,500.00	\$ 3.00

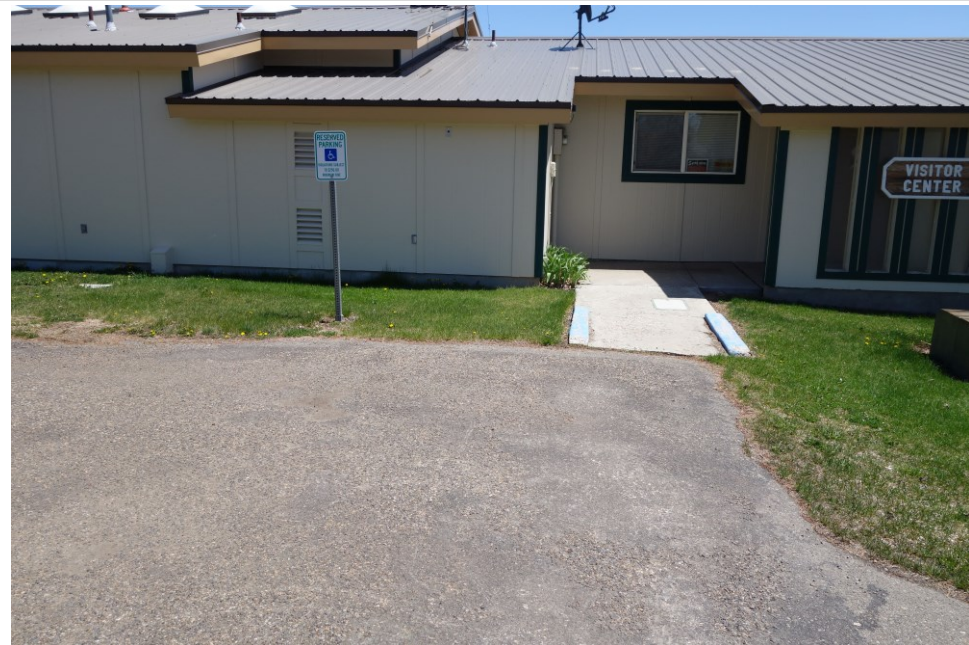
1315 PARK OFFICE/SHOP

The 2018 IBC, ICC/ANSI A117.1 - 2009, NRS 338.180 and the most current version of the ADA Standards For Accessible Design were used as a reference for this project.

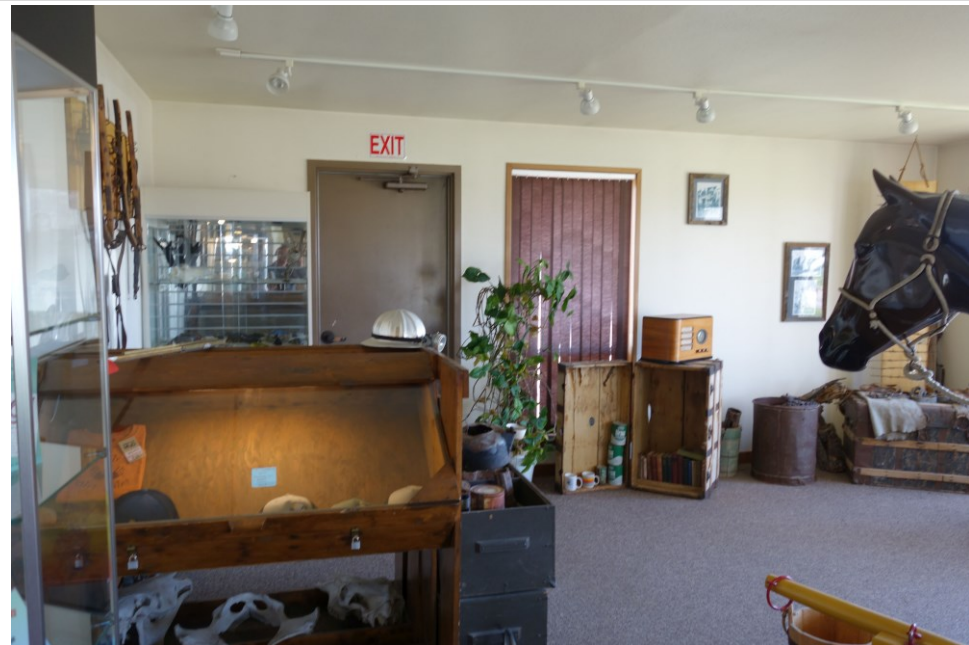
1315 PARK OFFICE/SHOP

The building does not have any exit signs or emergency lighting. This project would provide for the purchase and installation of self-illuminated or LED style exit signs with battery-backed internal systems as well as emergency exit lighting to provide illumination along the egress route. IBC - 20012 Chapter 10 was referenced for this project.

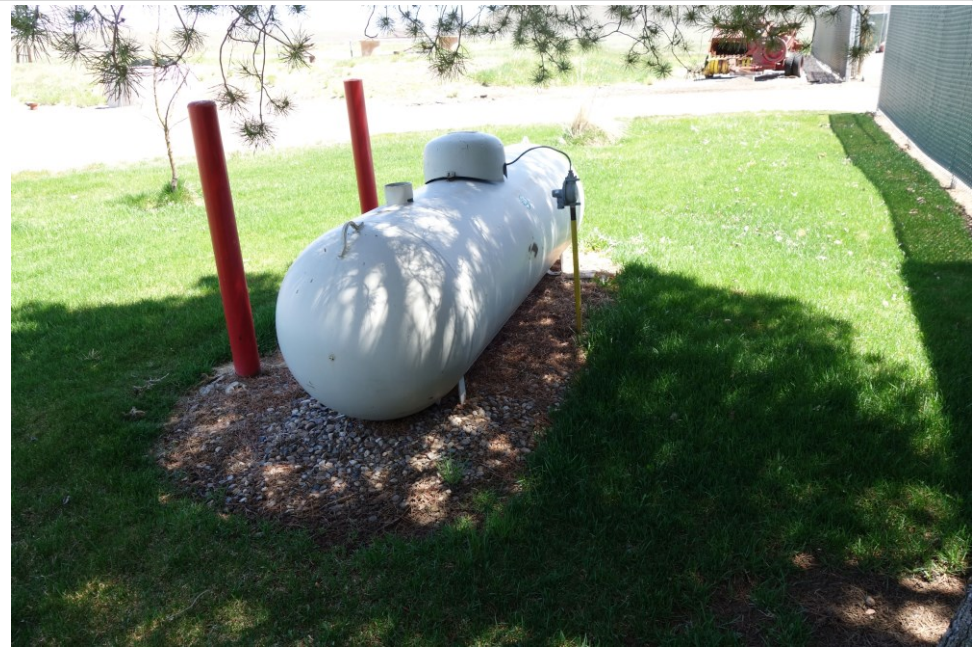
1315 PARK OFFICE/SHOP

QUANTITY	UNITS	TOTAL	SF COST
This project would provide for the installation of a seismic gas shut-off valve on the main gas service piping prior to entering the building. Alternately, for propane services or a site gas services with a single site metering station, consider installation at the tank or main meter service if it feeds multiple buildings. This estimate is based on the manufacturer Pacific Seismic Products or approved equal, equipped with the optional Model MS remote monitoring switch (to be interfaced with the direct digital control system and/or with an audible alarm). The gas piping immediately adjacent to the seismic gas valve shall be secured to the building utilizing unistrut channel bracing.	1	PKG	\$ 7,500.00	\$ 2.00

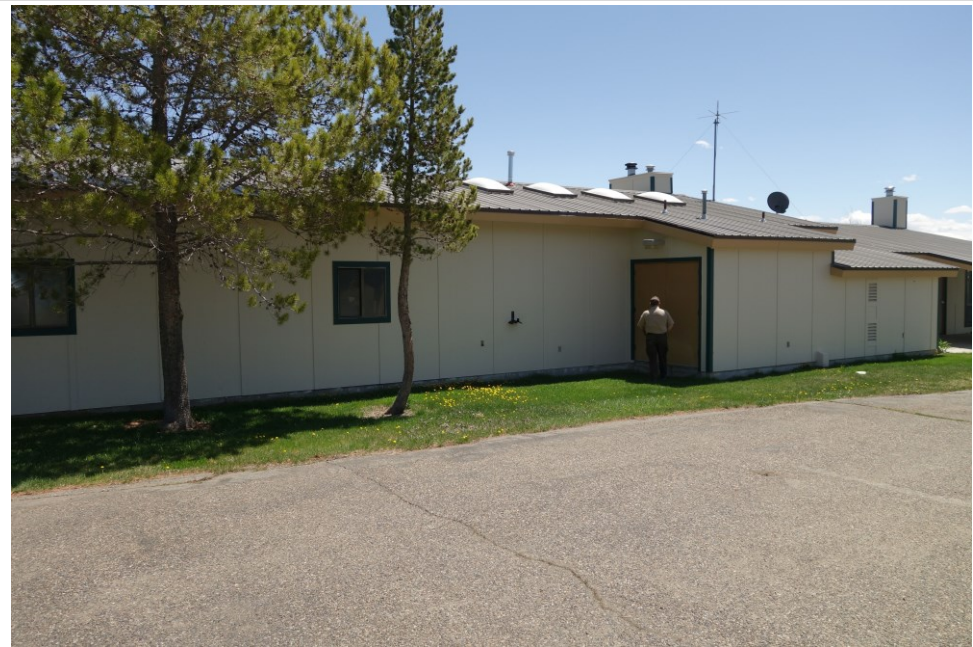
1315 PARK OFFICE/SHOP

QUANTITY	UNITS	TOTAL	SF COST
The exterior finishes were in fair condition. It is important to maintain the finish, weather resistance and appearance of the building. This project recommends work to protect the exterior building envelope, other than the roof, including painting, staining, or other applied finishes, and caulking around windows, flashing, fixtures, and other penetrations to maintain the building in good, weather tight condition. It is recommended that this project be implemented in the next 4 - 6 years and is recommended on a cyclical basis based on environmental conditions.	3400	SF	\$20,400.00	\$ 6.00

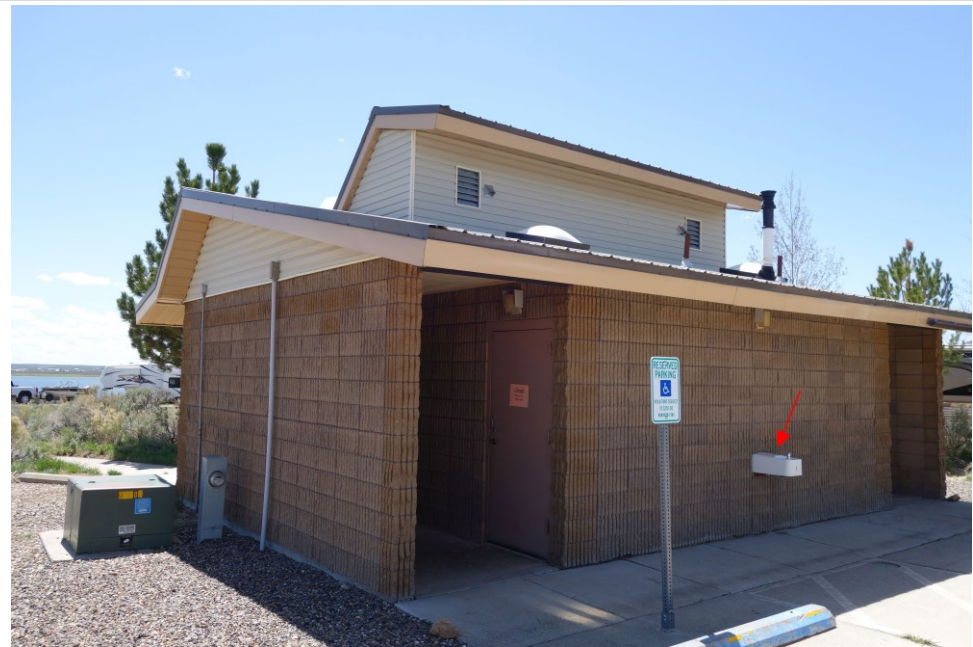
QUANTITY	UNITS	TOTAL	SF COST
This building has a water fountain on the exterior that is not ADA compliant. The 2018 IBC Section 1109.5 states where drinking fountains are provided on an exterior site, on a floor or within a secured area, no fewer than two drinking fountains shall be provided. One shall comply with the requirements for people who use a wheelchair and one shall comply with the requirements for standing persons. This project would provide funding for the purchase and installation of two drinking fountains to meet the ADA requirements to replace the single unit. Note that a bottle filler integrated into a drinking fountain does not make the water fountain accessible.	1	PKG	\$ 7,500.00	\$ 19.00

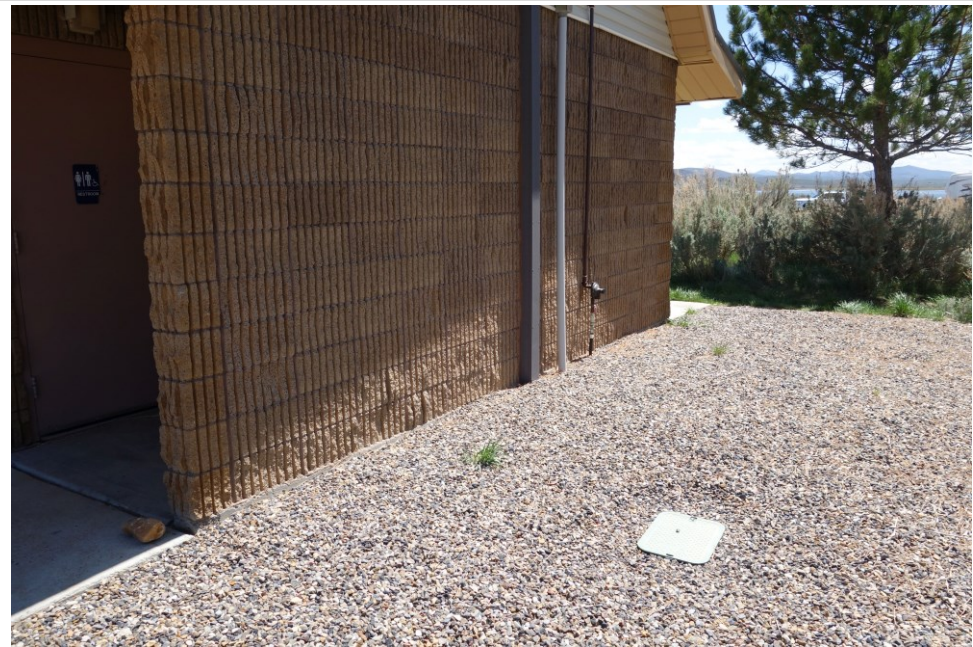
QUANTITY	UNITS	TOTAL	SF COST
This project would provide for the installation of a seismic gas shut-off valve on the main gas service piping prior to entering the building. Alternately, for propane services or a site gas services with a single site metering station, consider installation at the tank or main meter service if it feeds multiple buildings. This estimate is based on the manufacturer Pacific Seismic Products or approved equal, equipped with the optional Model MS remote monitoring switch (to be interfaced with the direct digital control system and/or with an audible alarm). The gas piping immediately adjacent to the seismic gas valve shall be secured to the building utilizing unistrut channel bracing.	1	PKG	\$ 7,500.00	\$ 19.00

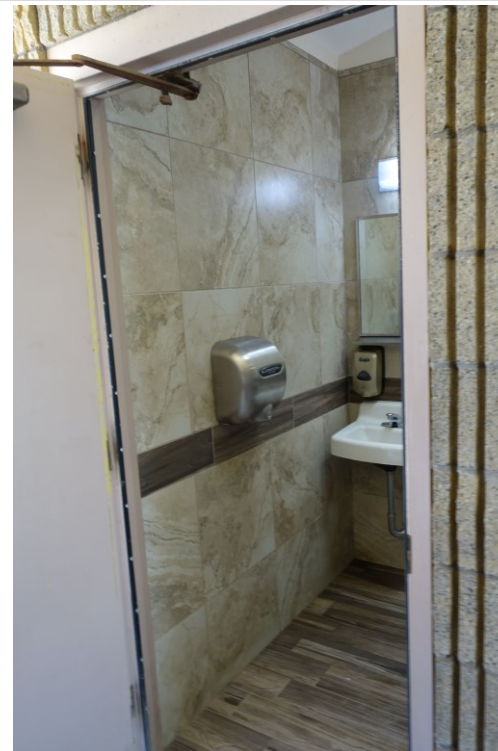
QUANTITY	UNITS	TOTAL	SF COST
The interior and exterior finishes were in good condition. It is important to maintain the finish, weather resistance and appearance of the building. This project would provide funding to protect the interior and exterior of the building. Included in the cost are cleaning and sealing the precast concrete and caulking of the windows, flashing, fixtures and all other penetrations. An epoxy paint is recommended on the interior precast concrete. It is recommended that the building be sealed and caulked in the next 6 - 8 years and that this project is scheduled on a cyclical basis to maintain the integrity of the structure.	400	SF	\$ 2,400.00	\$ 6.00

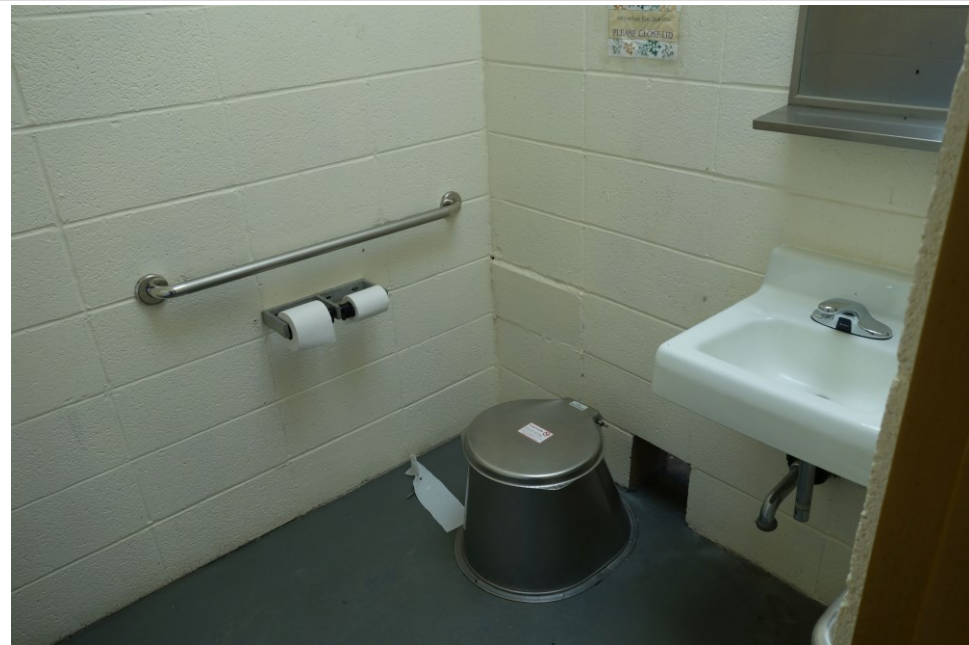
QUANTITY	UNITS	TOTAL	SF COST
The interior and exterior finishes were in fair condition. It is important to maintain the finish, weather resistance and appearance of the building. This project recommends work to protect the exterior building envelope, other than the roof, including painting, block sealing, staining, or other applied finishes, and caulking around windows, flashing, fixtures, and other penetrations to maintain the building in good, weather tight condition. It is recommended that this project be implemented in the next 4 to 5 years and is recommended on a cyclical basis based on environmental conditions.	200	SF	\$ 1,200.00	\$ 6.00

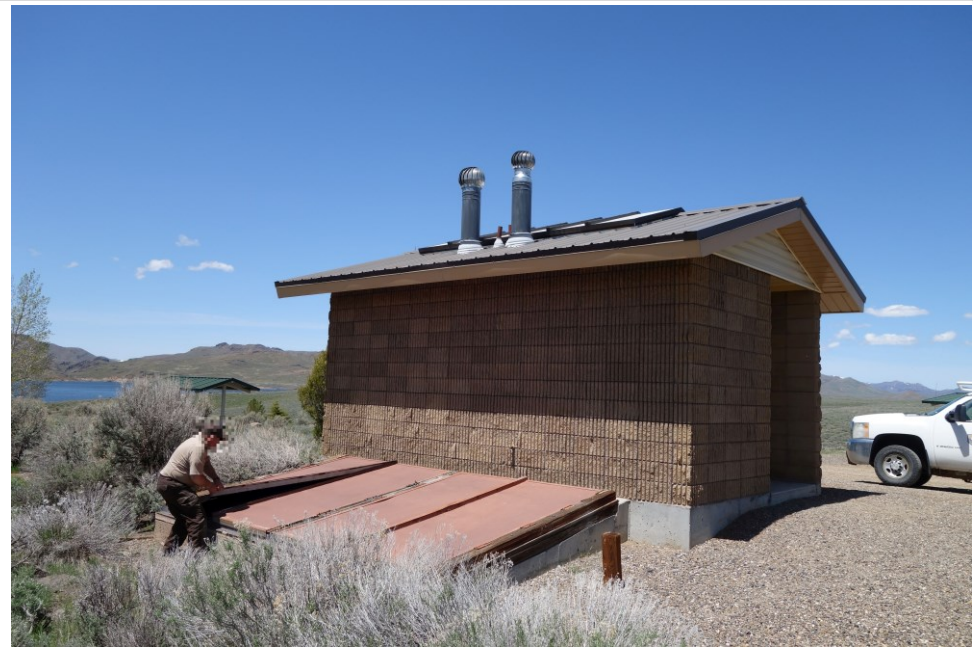
QUANTITY	UNITS	TOTAL	SF COST
The existing restroom is over 40 years old and is reaching the end of its useful life. It is becoming increasingly expensive to maintain and repair. The restroom itself does not meet accessibility requirements and there is no ADA parking and path to the restroom. This project recommends removal and replacement of the restroom and installation of accessible parking and path to the restroom. Additionally, since power and water infrastructure have been extended to the north campground, it is recommended to upgrade the facility with showers and flush toilets requiring the addition of a septic tank disposal system.	1	PKG	\$1,120,000.00	\$ 5,600.00

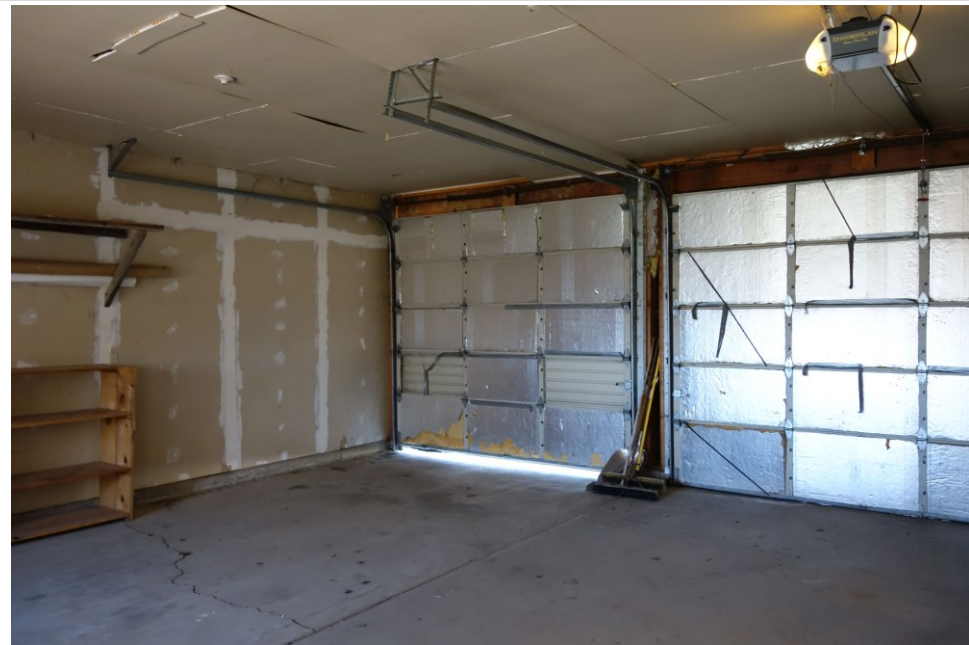
QUANTITY	UNITS	TOTAL	SF COST
The interior finishes are in poor, unpainted condition. The drywall is sagging at the ceiling in areas and is not fire taped. The project recommends re-fastening the existing drywall, fire taping and paint the interior.	672	SF	\$ 4,000.00	\$ 6.00

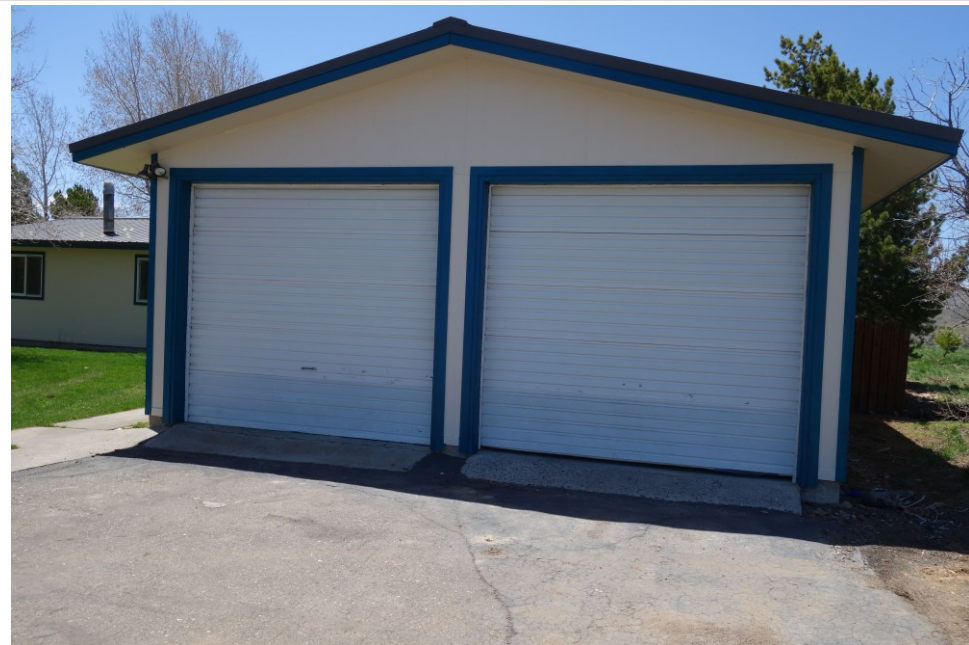
QUANTITY	UNITS	TOTAL	SF COST
The exterior finishes were in good condition. It is important to maintain the finish, weather resistance and appearance of the building. This project recommends work to protect the exterior building envelope, other than the roof, including painting, staining, or other applied finishes, and caulking around windows, flashing, fixtures, and other penetrations to maintain the building in good, weather tight condition. It is recommended that this project be implemented in the next 3 to 4 years and is recommended on a cyclical basis based on environmental conditions.	672	SF	\$ 4,000.00	\$ 6.00

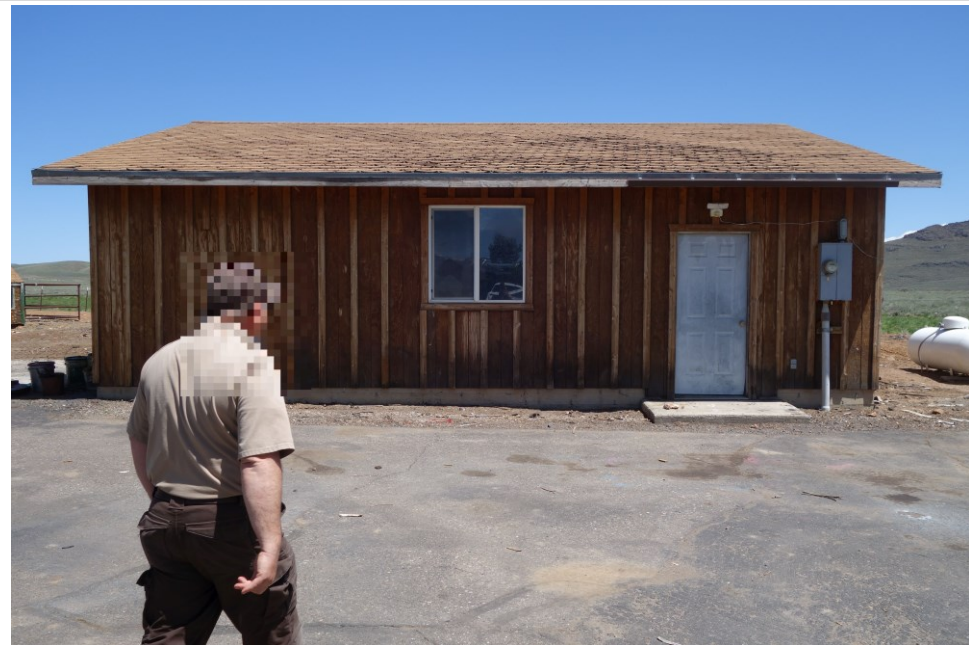
QUANTITY	UNITS	TOTAL	SF COST
The stained wood exterior is in poor condition. It is important to maintain the finish, weather resistance and appearance of the building. This project would provide funding to protect the exterior of the building excluding the roof. Included in the cost is power washing and staining the wood and caulking the windows, flashing, fixtures and all other penetrations. It is recommended that the building be stained and caulked in the next 2 - 3 years and that this project be scheduled on a cyclical basis to maintain the integrity of the structure.	900	SF	\$ 9,000.00	\$ 10.00

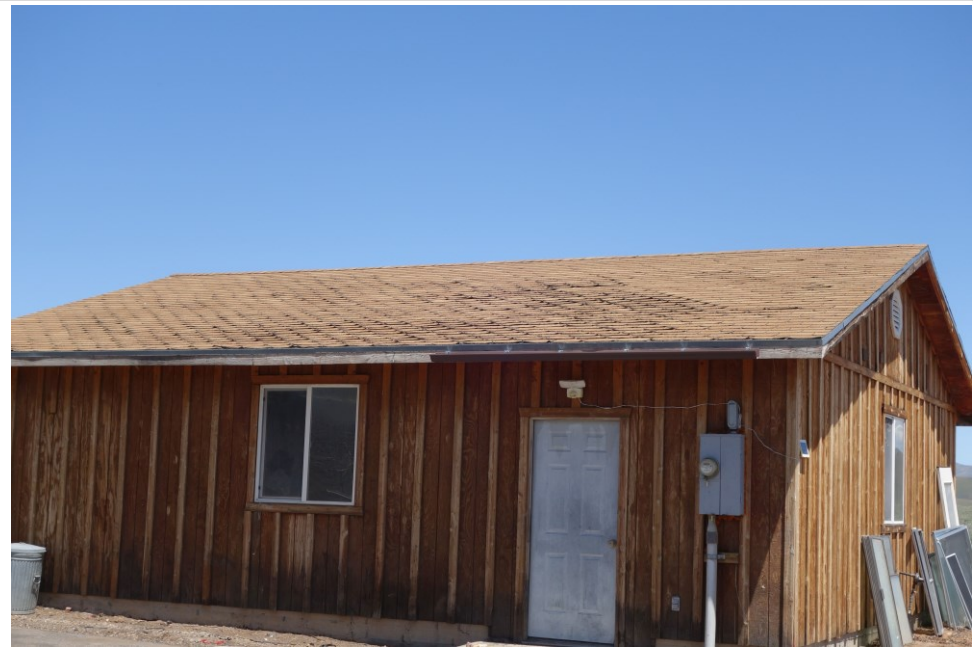
QUANTITY	UNITS	TOTAL	SF COST
The asphalt composition shingle roof on this building was in poor condition at the time of the survey. It is recommended that this building be re-roofed in the next 2 - 3 years with a new 50 year asphalt composition roofing shingle and new underlayment. This estimate includes removal and disposal of the old roofing system.	900	SF	\$13,500.00	\$ 15.00

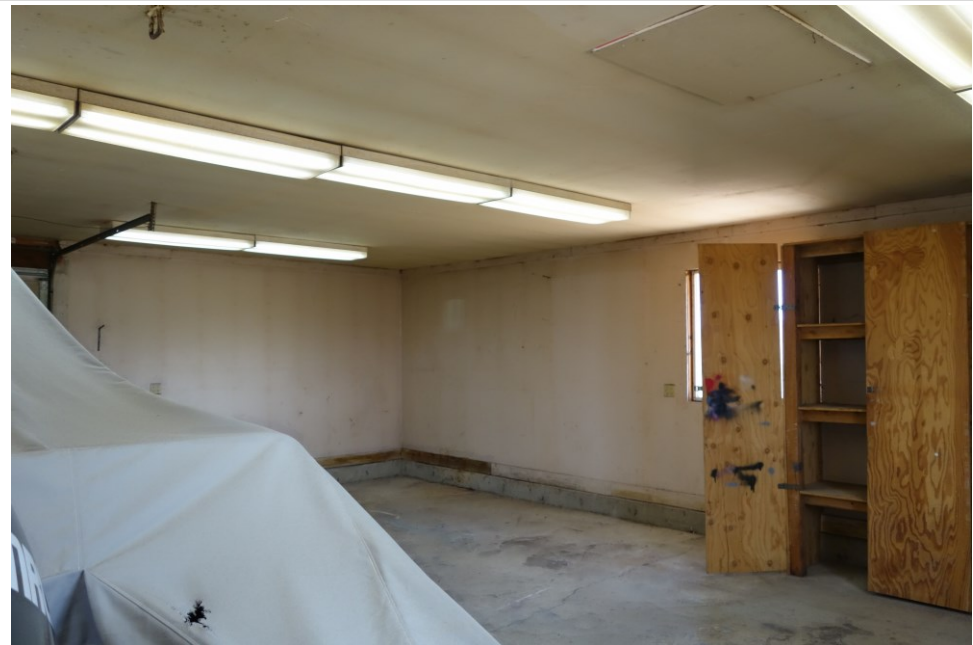
QUANTITY	UNITS	TOTAL	SF COST
The interior finishes were in poor condition. It is recommended the interior walls and ceilings be painted in the next 2 - 3 years. All surfaces should be repaired and prepped prior to painting. Building maintenance should be scheduled on a cyclical basis to maintain the integrity of the structure	900	SF	\$ 6,300.00	\$ 7.00

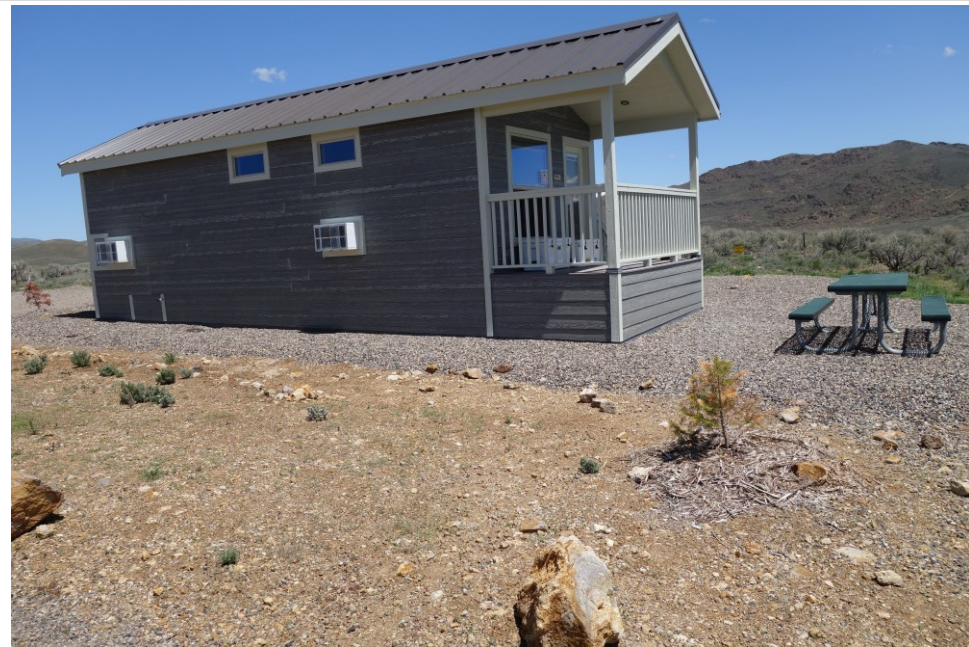
QUANTITY	UNITS	TOTAL	SF COST
The exterior finishes were in excellent condition. It is important to maintain the finish, weather resistance and appearance of the building. This project would provide funding to protect the exterior of the building excluding the roof. Included in the cost are priming and painting the siding and caulking the windows, flashing, fixtures and all other penetrations. It is recommended that the building be painted in the next 9 - 10 years and that this project be scheduled on a cyclical basis to maintain the integrity of the structure.	399	SF	\$ 2,400.00	\$ 6.00

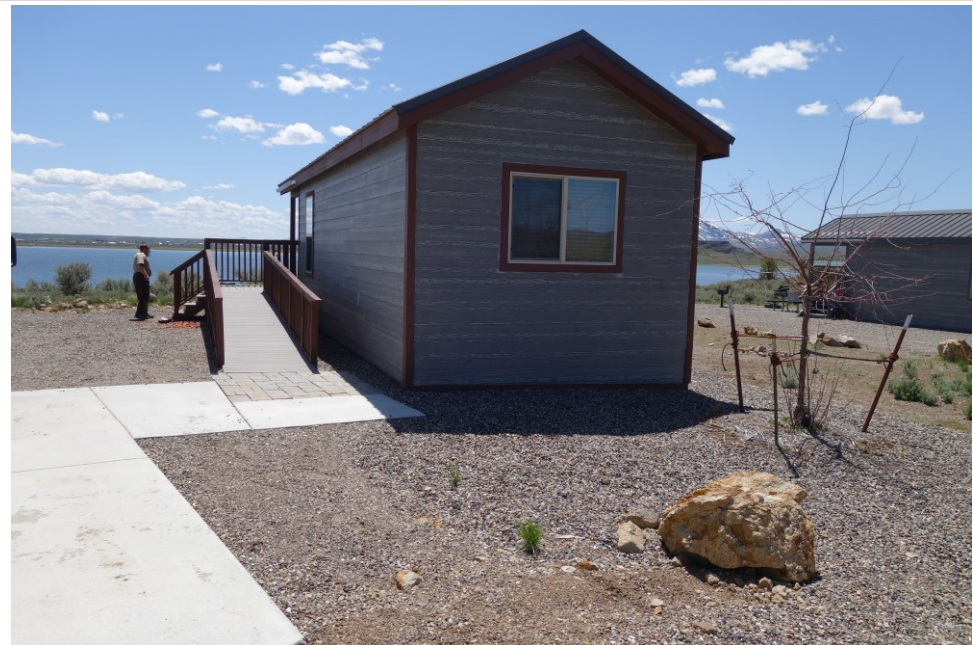
QUANTITY	UNITS	TOTAL	SF COST
The exterior finishes were in excellent condition. It is important to maintain the finish, weather resistance and appearance of the building. This project would provide funding to protect the exterior of the building excluding the roof. Included in the cost are priming and painting the siding and caulking the windows, flashing, fixtures and all other penetrations. It is recommended that the building be painted in the next 9 - 10 years and that this project be scheduled on a cyclical basis to maintain the integrity of the structure.	399	SF	\$ 2,400.00	\$ 6.00

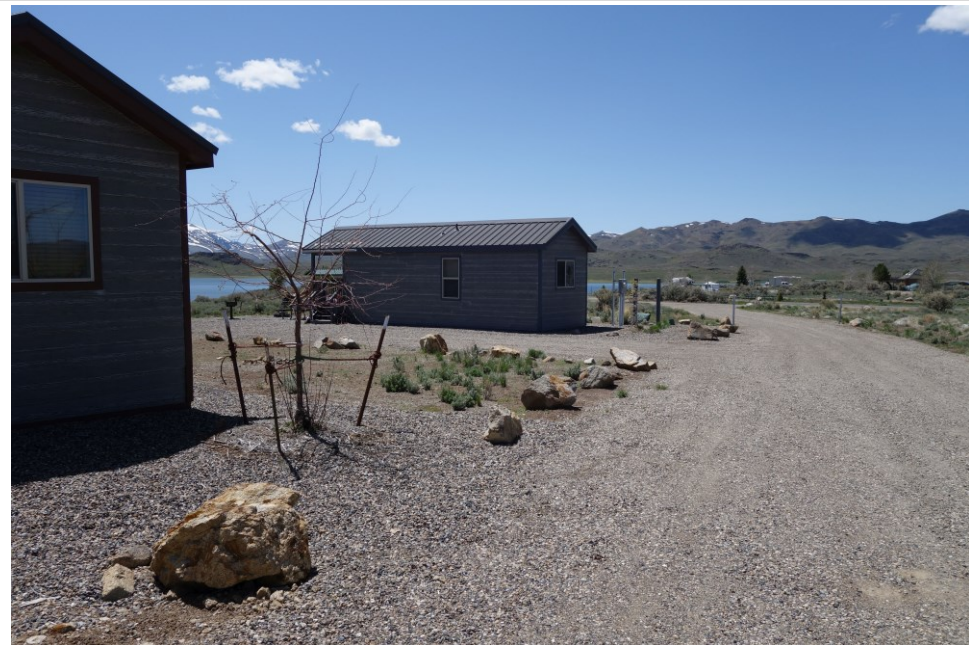
QUANTITY	UNITS	TOTAL	SF COST
The exterior finishes were in excellent condition. It is important to maintain the finish, weather resistance and appearance of the building. This project would provide funding to protect the exterior of the building excluding the roof. Included in the cost are priming and painting the siding and caulking the windows, flashing, fixtures and all other penetrations. It is recommended that the building be painted in the next 9 - 10 years and that this project be scheduled on a cyclical basis to maintain the integrity of the structure.	399	SF	\$ 2,400.00	\$ 6.00

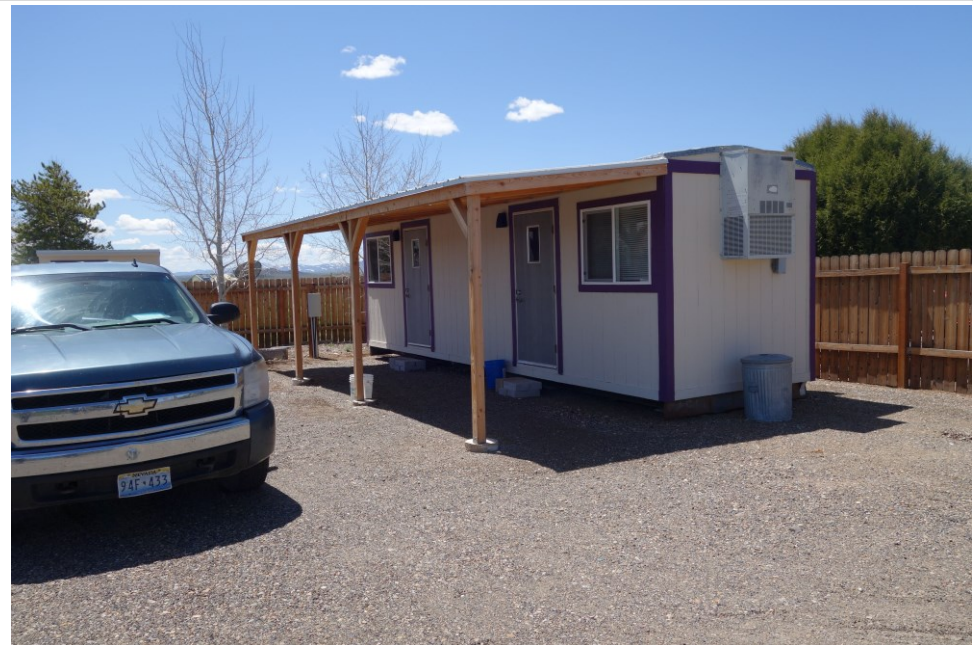
QUANTITY	UNITS	TOTAL	SF COST
The exterior finishes were in good condition. It is important to maintain the finish, weather resistance and appearance of the building. This project would provide funding to protect the exterior of the building excluding the roof. Included in the cost are priming and painting the siding and caulking the windows, flashing, fixtures and all other penetrations. It is recommended that the building be painted in the next 7 - 9 years and that this project be scheduled on a cyclical basis to maintain the integrity of the structure.	224	SF	\$ 2,200.00	\$ 10.00

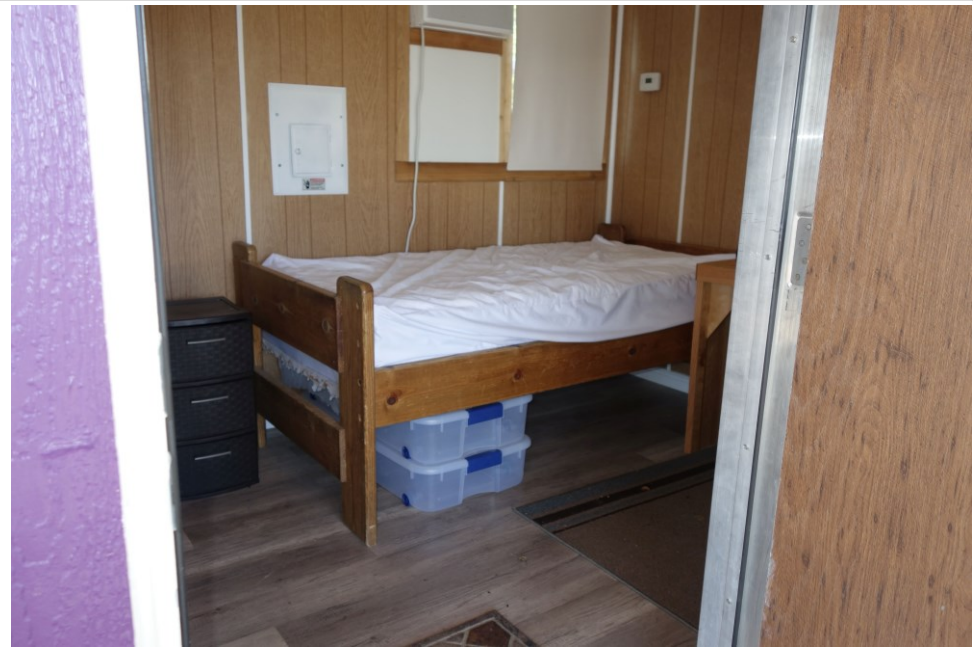
QUANTITY	UNITS	TOTAL	SF COST
The interior finishes were in good condition. It is recommended to stain the interior walls and ceilings at least once in the next 7 - 9 years and that this project be scheduled on a cyclical basis to maintain the integrity of the structure. Prior to staining, all surfaces should be repaired and adequately prepared to receive the coating. An epoxy-based stain should be utilized in wet areas for durability.	224	SF	\$ 2,200.00	\$ 10.00

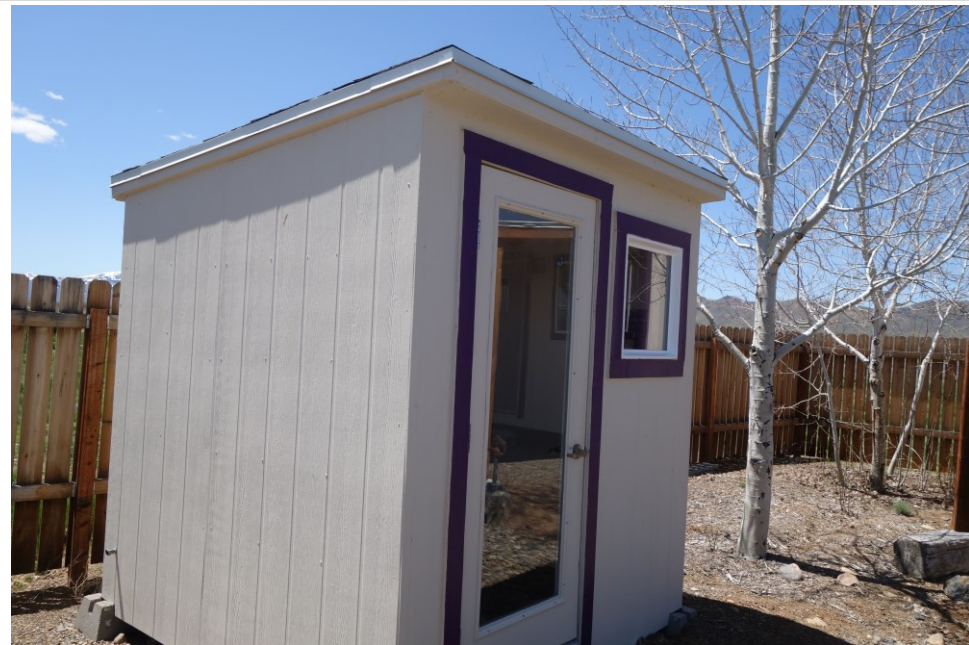
QUANTITY	UNITS	TOTAL	SF COST
The exterior finishes were in good condition. Exterior maintenance is important to maintain the finish, weather resistance and appearance of the structure. This project provides funding to protect the exterior of the building, excluding the roof. Included are the costs of sanding, priming, painting and caulking of flashing, fixtures and all other penetrations. It is recommended the building be painted in the next 7 - 9 years. Building maintenance should be scheduled on a cyclical basis to maintain the integrity of the structure.	64	PKG	\$ 600.00	\$ 9.00

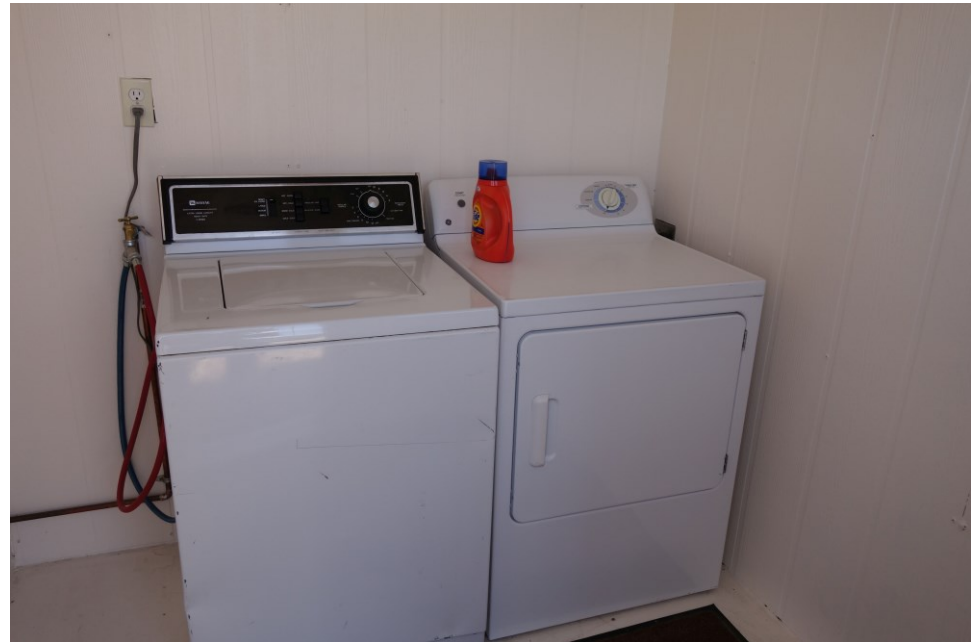
QUANTITY	UNITS	TOTAL	SF COST
The interior finishes were in good condition. It is recommended the interior walls and ceilings be painted in the next 6 - 8 years. All surfaces should be repaired and prepped prior to painting. For durability in wet areas, an epoxy-based paint should be used. Building maintenance should be scheduled on a cyclical basis to maintain the integrity of the structure	64	PKG	\$ 500.00	\$ 8.00
