STATE OF NEVADA
STATE PUBLIC WORKS DIVISION

FACILITY CONDITION ASSESSMENT REPORT FOR:

SOUTH FORK STATE RECREATION AREA SITE
139 HYLTON CT
SPRING CREEK, NV 89815-

Survey Date: 5/16/2022
Distribution Date: 12/18/2023

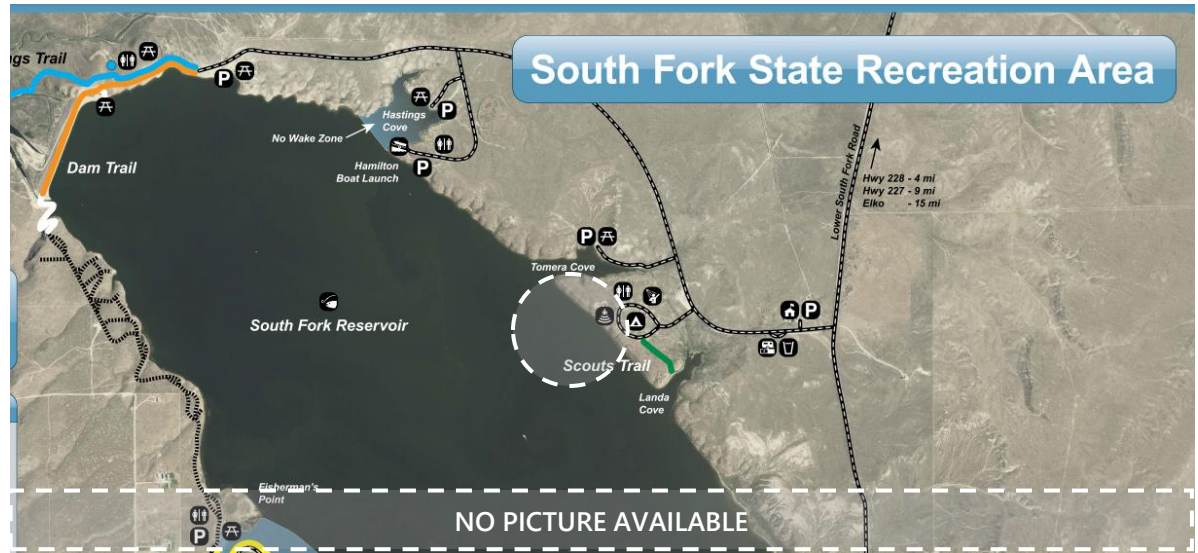
9936 SOUTH FORK STATE RECREATION AREA SITE

The campground loop and the individual campsite parking areas are not currently paved. This project would provide asphalt paving for a 10' wide access road around the campground and 10' wide parking spaces at each campsite. The estimate includes grading, compaction and installation of 4" thick asphalt cement. This project or a portion thereof was previously recommended in the FCA report dated 01/07/2007 and 07/22/2014. It has been amended accordingly to reflect conditions observed during the most recent survey date of 05/16/2023.

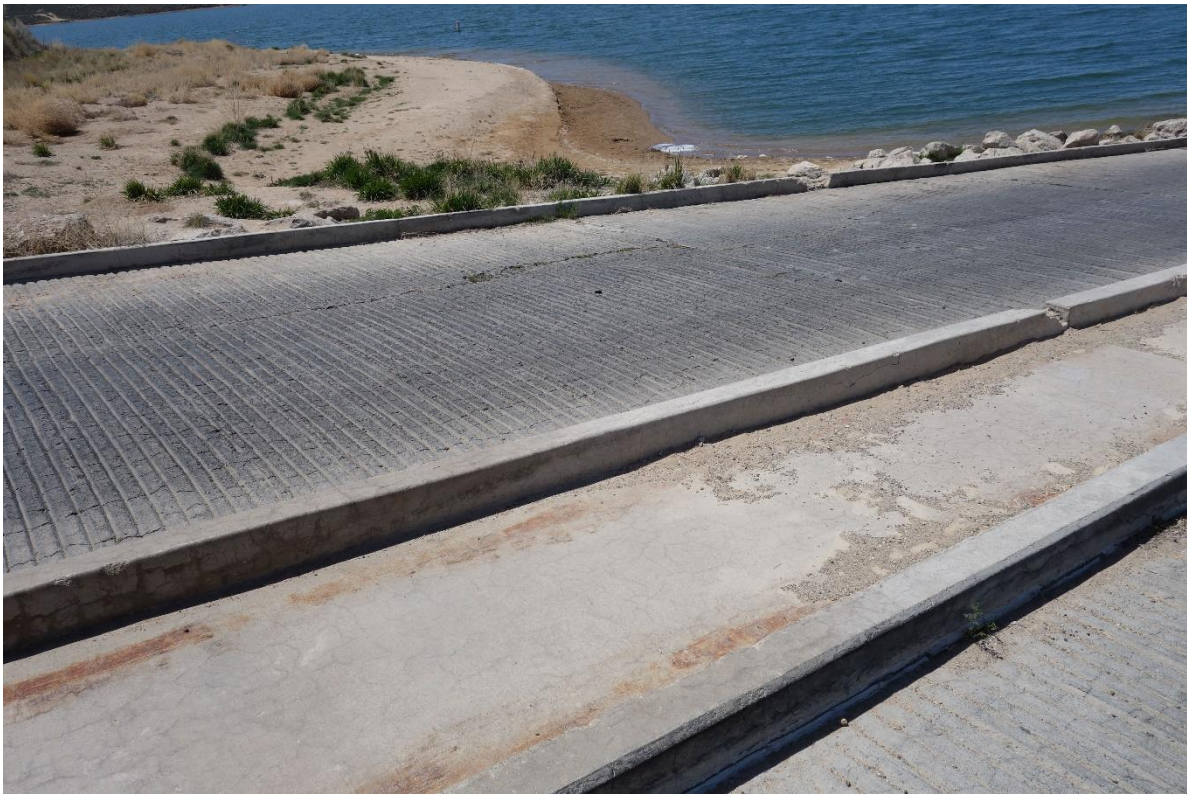
9936 SOUTH FORK STATE RECREATION AREA SITE

The boat dock and concrete ramp are approaching the end of their expected life due to extreme climatic conditions and heavy use. The existing ramp and dock should be scheduled for replacement. The concrete ramp is cracking and spalling. It is important for the concrete to be in good shape to ensure proper traction for tow vehicles and to prevent accidents. This project would provide for purchase and installation of a new boat dock and concrete ramp. Removal and disposal of the existing concrete ramp and dock is included in this estimate. This project or a portion thereof was previously recommended in the FCA report dated 01/07/2007 and 07/22/2014. It has been amended accordingly to reflect conditions observed during the most recent survey date of 05/16/2022.

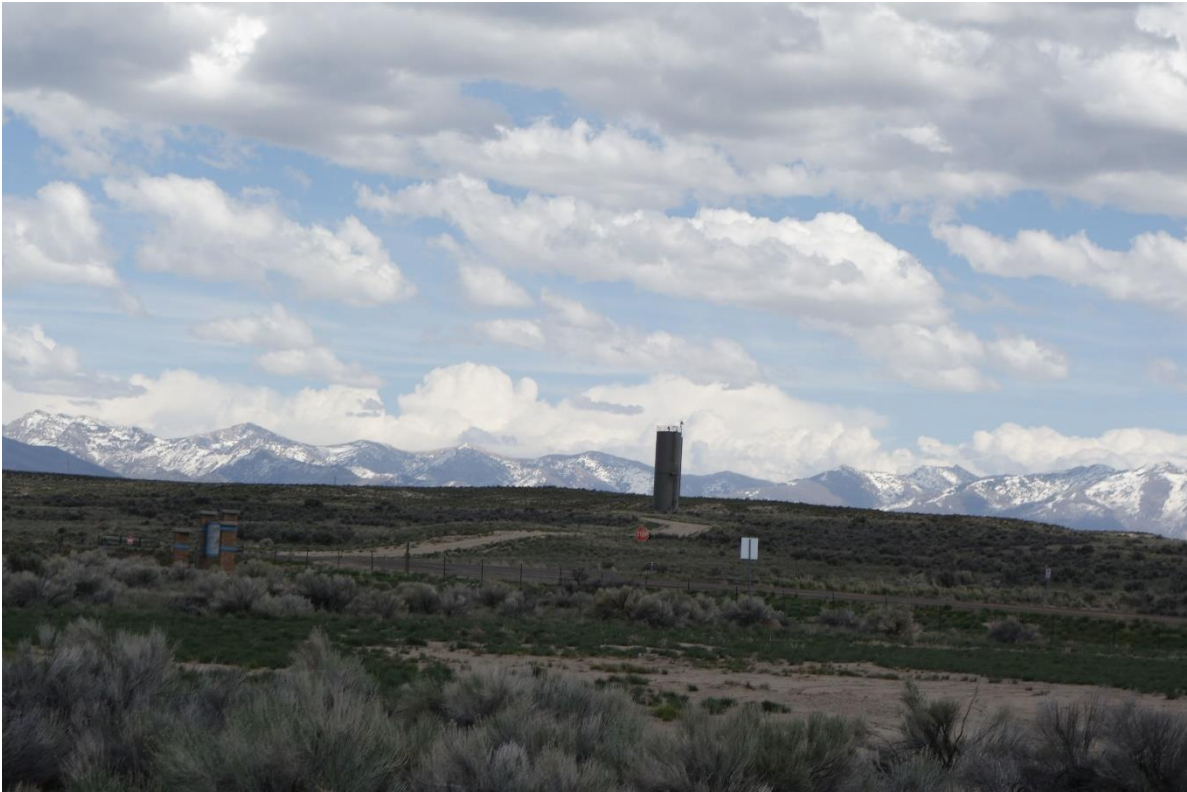
3354 WATER TANK

In addition to the periodic maintenance inspections, it is recommended a detailed maintenance/cleaning inspection be performed every 5 - 10 years depending on water quality and usage. Inspection tasks include but are not limited to exterior foundations, surfaces, equipment and controls and interior roof/sidewall structure, liners and general debris/sediment cleanup. This project would provide funding for engaging the services of a certified tank inspection company. Any required cleaning and/or repairs are not included in this estimate.

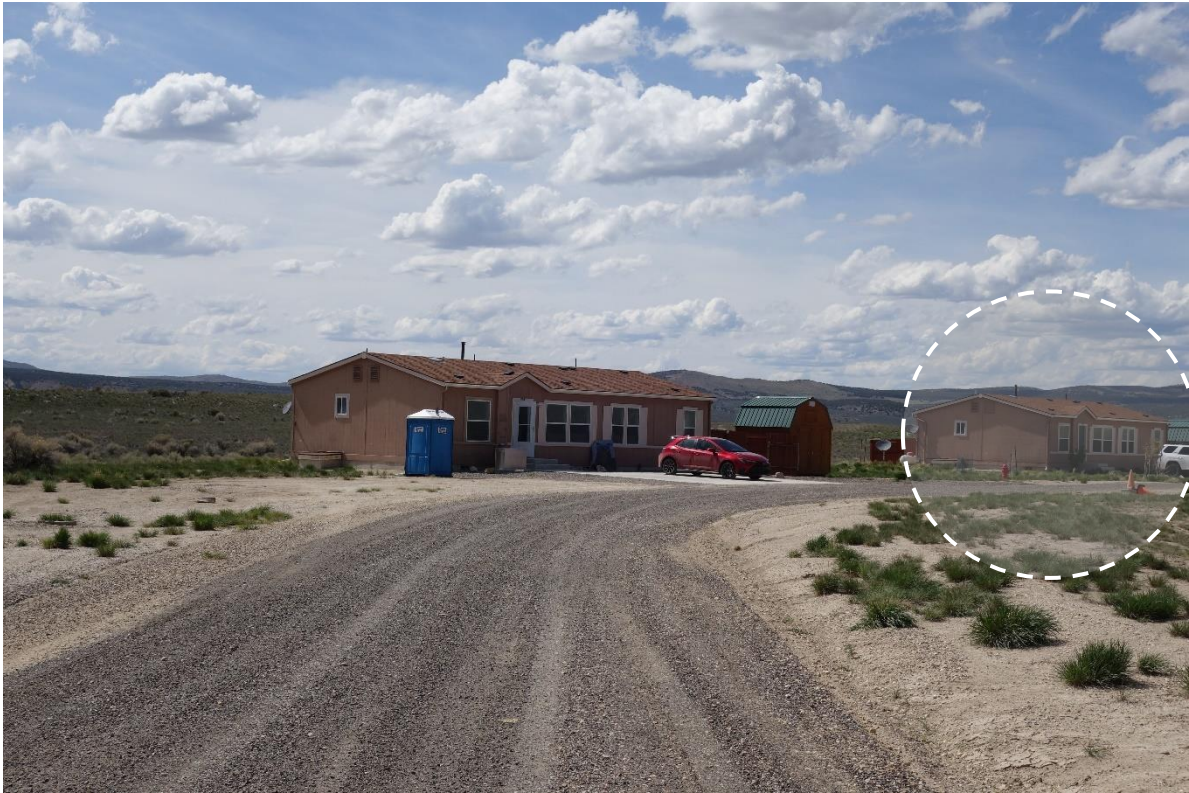
3353 RESIDENCE 2

The interior was not surveyed, or photos taken as the residence was not available but was informed that the fire suppression system has not been upgraded to a glycol system. The residence is currently protected by a standard residential fire suppression system and is at risk of freezing. Residence 1 has experienced interior damage due to freezing fire suppression piping and has been upgraded to a glycol system. This project recommends upgrading existing fire suppression system in a similar manner.

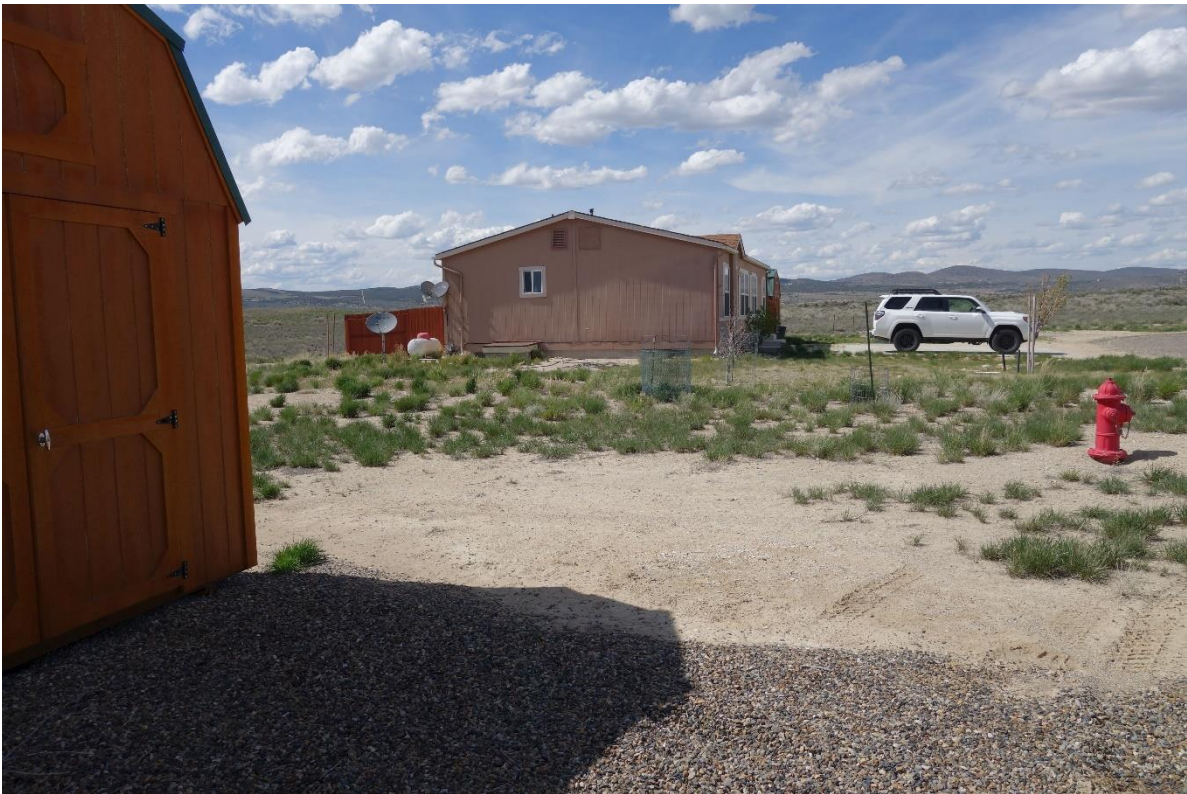
3353 RESIDENCE 2

The interior was not surveyed, or photos taken as the residence was not available but was informed that the interior finishes were in fair to good condition. It is recommended to paint the interior walls and ceilings at least once in the next 7 - 9 years and that this project is scheduled on a cyclical basis to maintain the integrity of the structure. Prior to painting, all surfaces should be repaired and prepped. An epoxy-based paint should be utilized in wet areas for durability.

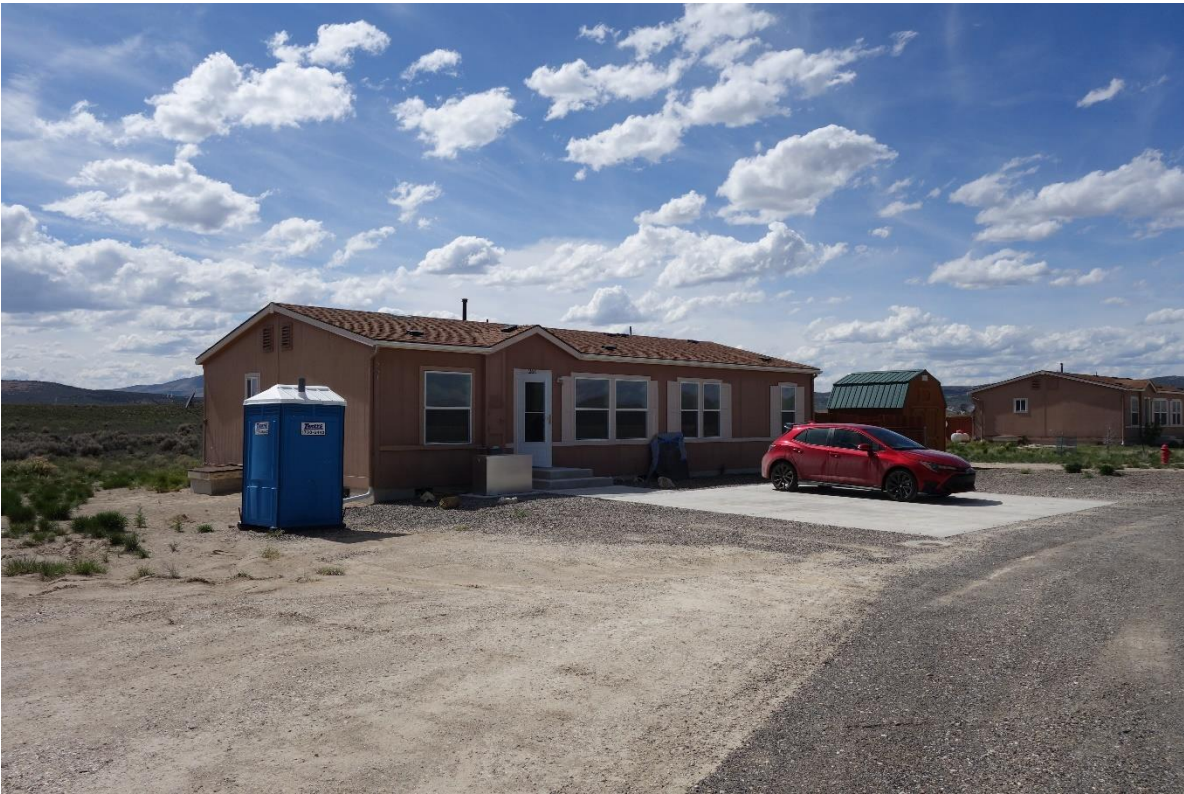
3352 RESIDENCE 1

The exterior finishes were in good condition. It is important to maintain the finish, weather resistance and appearance of the building. This project would provide funding to protect the exterior of the building excluding the roof. Included in the cost is sanding, priming and painting and caulking of the windows, flashing, fixtures and all other penetrations. It is recommended that the building be painted in the next 6 - 8 years and that this project is scheduled on a cyclical basis to maintain the integrity of the structure.

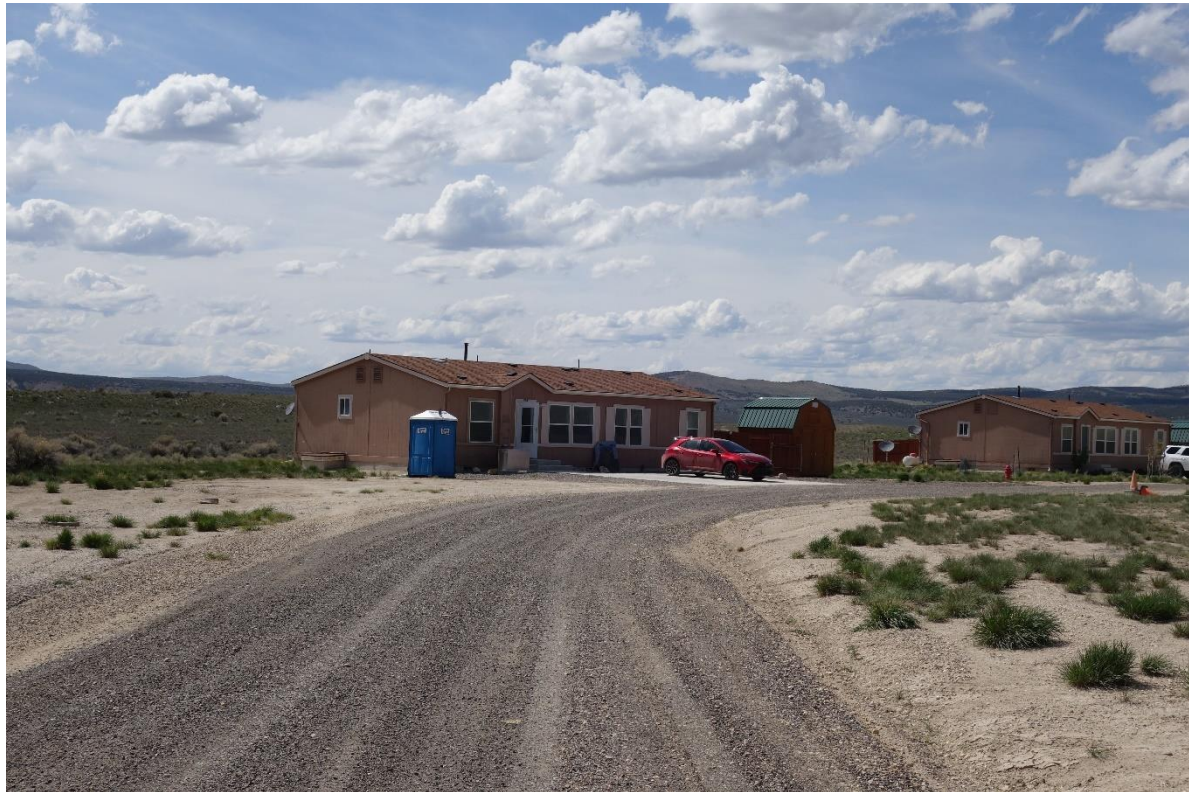
3352 RESIDENCE 1

The interior design was completed during the survey and in good condition. It is recommended to paint the interior walls and ceilings at least once in the next 7 - 9 years and that this project is scheduled on a cyclical basis to maintain the integrity of the structure. Prior to painting, all surfaces should be repaired and prepped. An epoxy-based paint should be utilized in wet areas for durability.

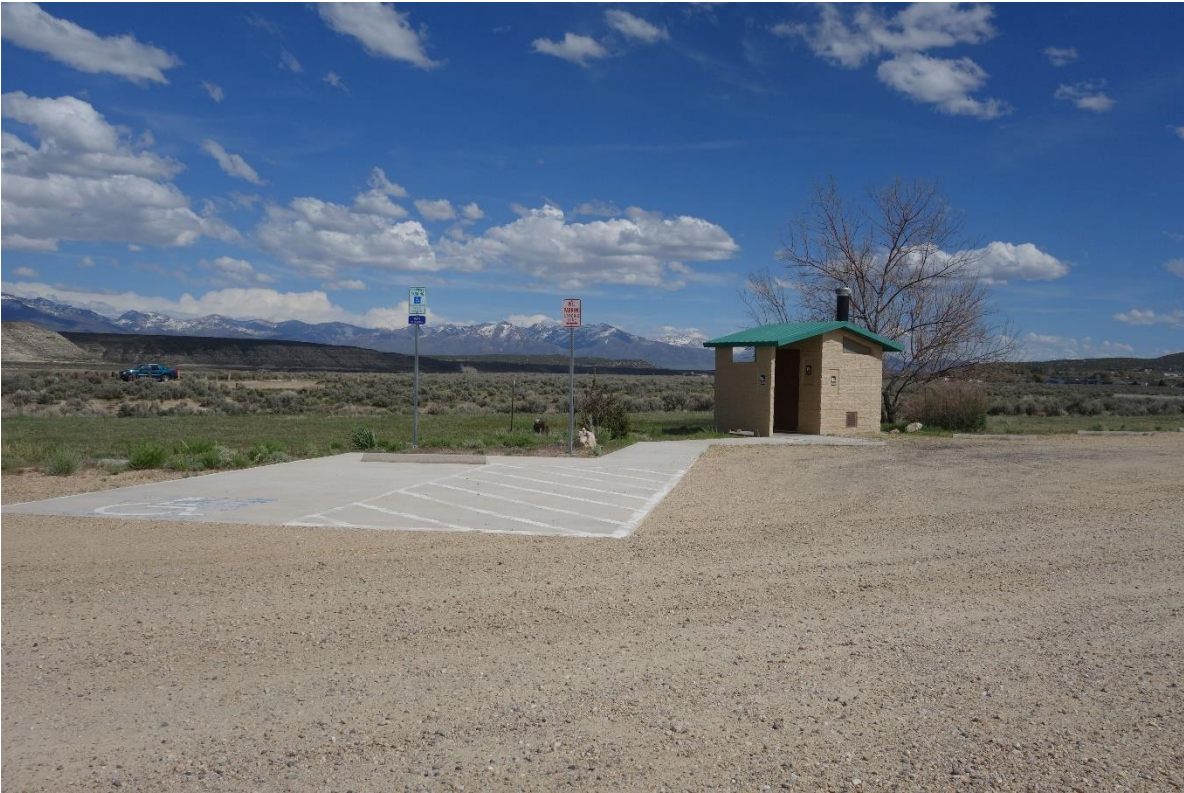
3351 COYOTE COVE CXT RESTROOM

The interior and exterior finishes were in good condition. It is important to maintain the finish, weather resistance and appearance of the building. This project would provide funding to protect the interior and exterior of the building. Included in the cost are cleaning and sealing the precast concrete and caulking of the windows, flashing, fixtures and all other penetrations. An epoxy paint is recommended on the interior precast concrete. It is recommended that the building be sealed and caulked in the next 5-7 years and that this project is scheduled on a cyclical basis to maintain the integrity of the structure.

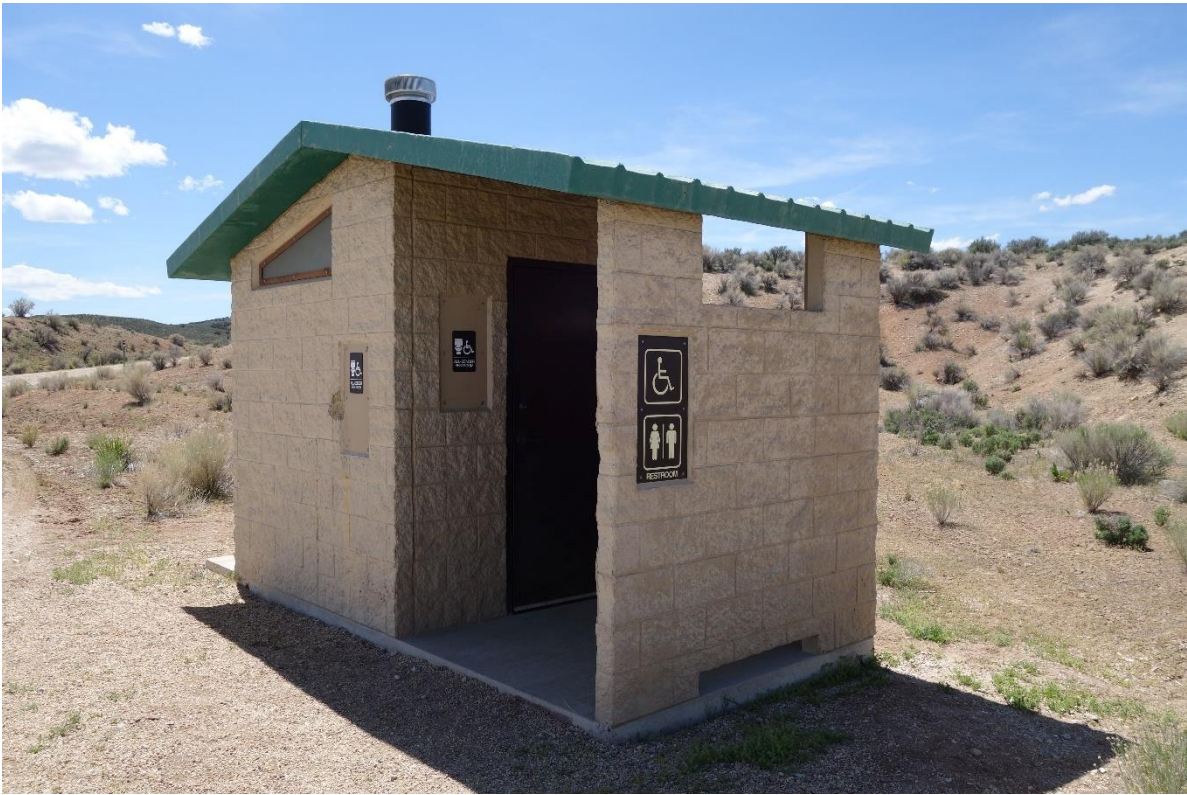
3350 SADDLE DAM CXT RESTROOM

The CXT Restroom is a precast single use structure located in the Saddle Dam area of the park. It has some ADA accessible improvements but lacks an ADA accessible parking area and route of travel to the facility.

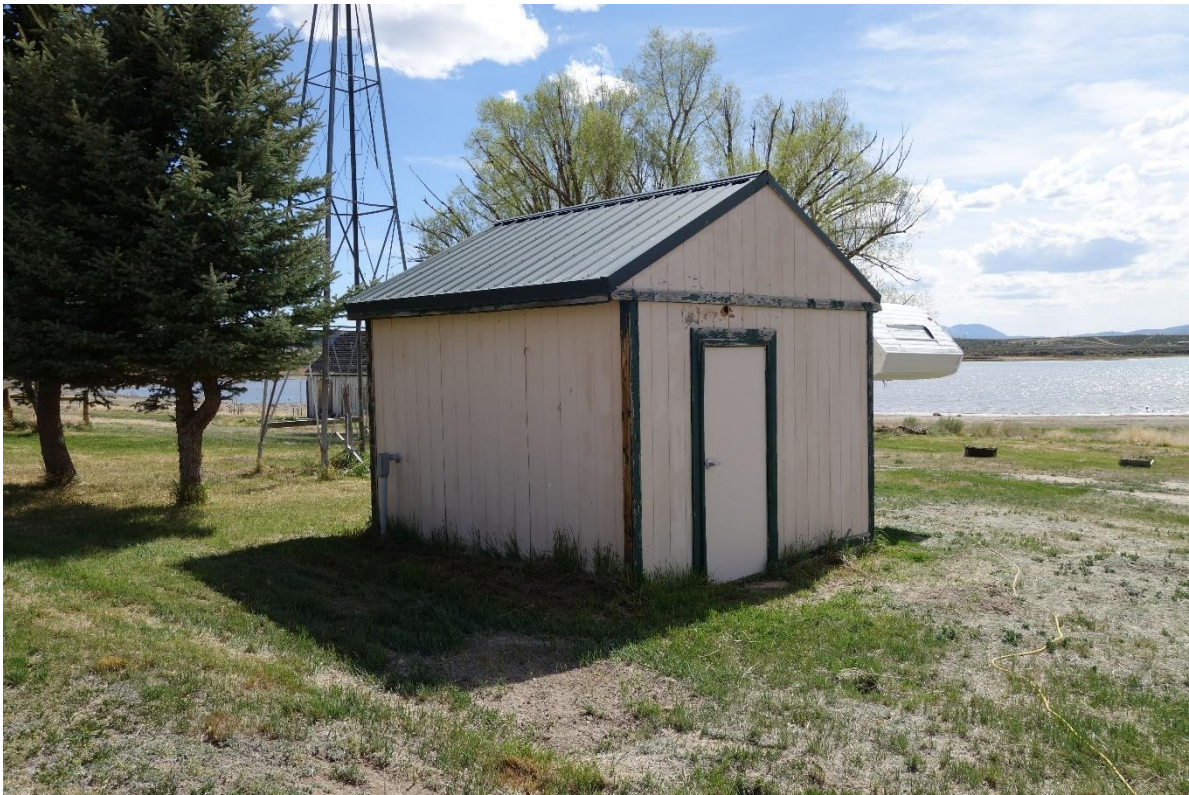
2753 IRRIGATION PUMP HOUSE

The exterior finishes were in poor condition. It is important to maintain the finish, weather resistance and appearance of the building. This project would provide funding to protect the exterior of the building excluding the roof. Included in the cost is sanding, priming and painting and caulking of the flashing, fixtures and all other penetrations. It is recommended that the building be painted in the next 2 - 3 years and that this project is scheduled on a cyclical basis to maintain the integrity of the structure.

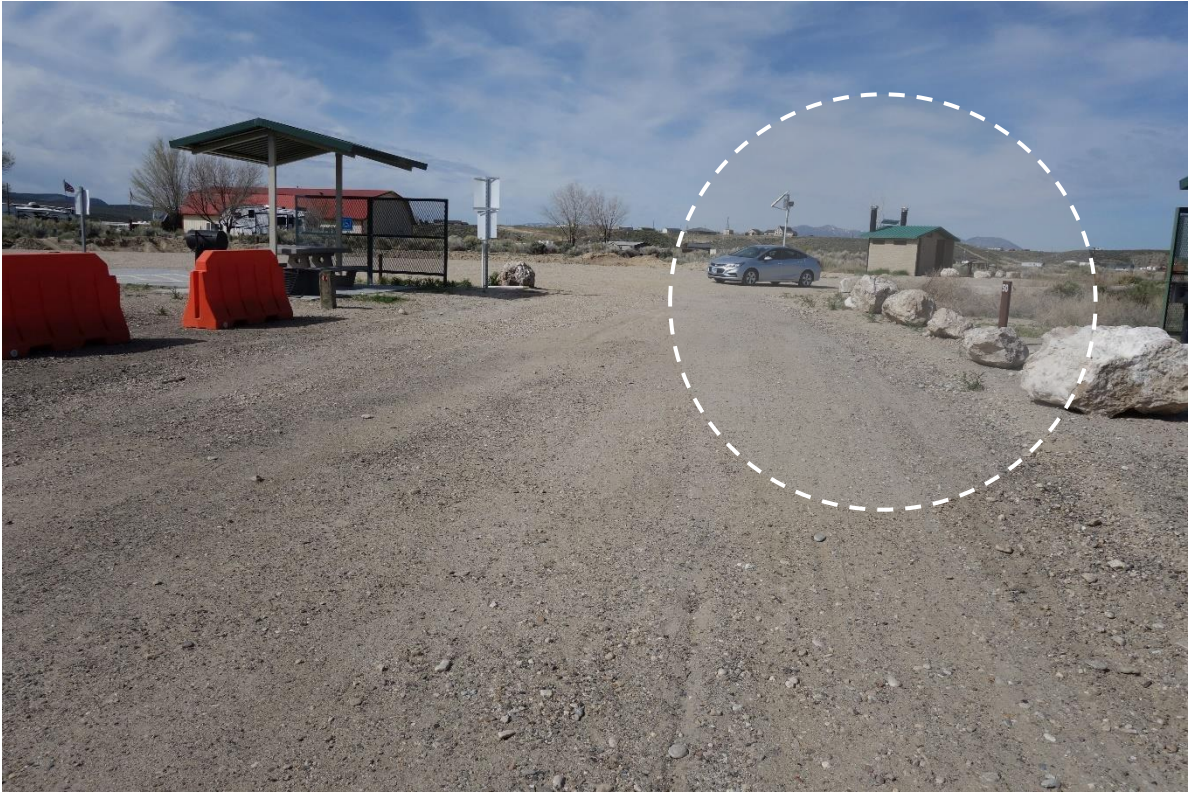
2741 CXT RESTROOM #3 WEST

This CXT restroom is a precast double unit which is located in the day use area along the west shore of the reservoir. This unit is ADA compliant but lacks an accessible parking area and route of travel to the restroom.

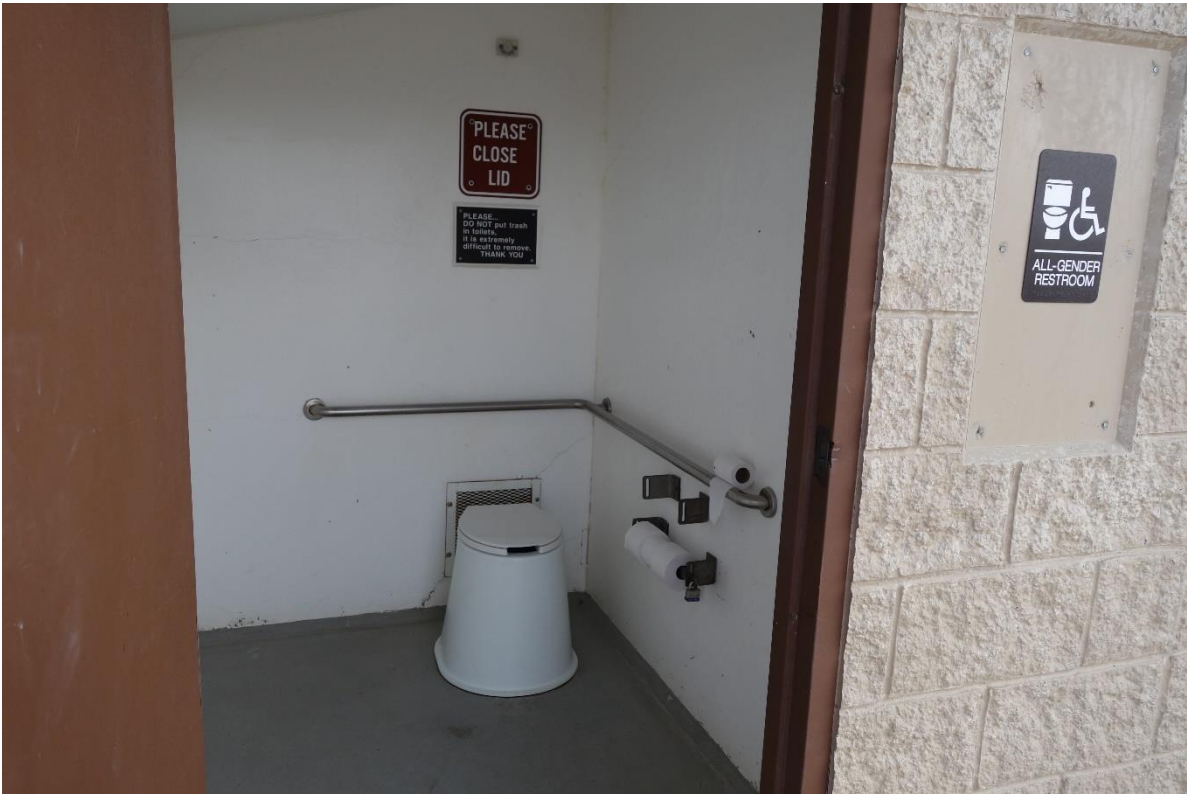
2741 CXT RESTROOM #3 WEST

The interior and exterior finishes were in fair condition. It is important to maintain the finish, weather resistance and appearance of the building. This project would provide funding to protect the interior and exterior of the building. Included in the cost are cleaning and sealing the precast concrete and caulking of the windows, flashing, fixtures and all other penetrations. An epoxy paint is recommended on the interior precast concrete. It is recommended that the building be sealed and caulked in the next 5-7 years and that this project is scheduled on a cyclical basis to maintain the integrity of the structure.

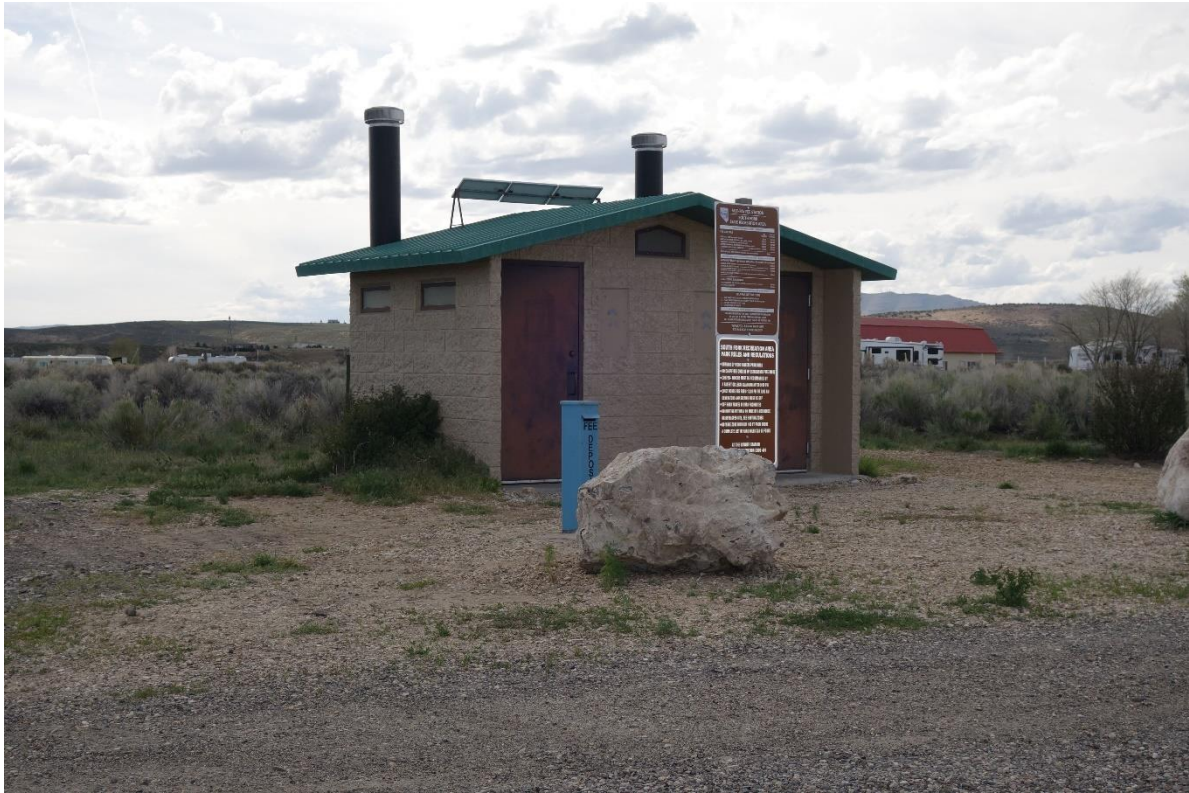
2740 CXT RESTROOM #2 WEST

This CXT restroom is a precast double unit which is located in the day use area along the west shore of the reservoir. This unit is somewhat ADA compliant but lacks an accessible parking area and route of travel to the restroom. It is in excellent condition.

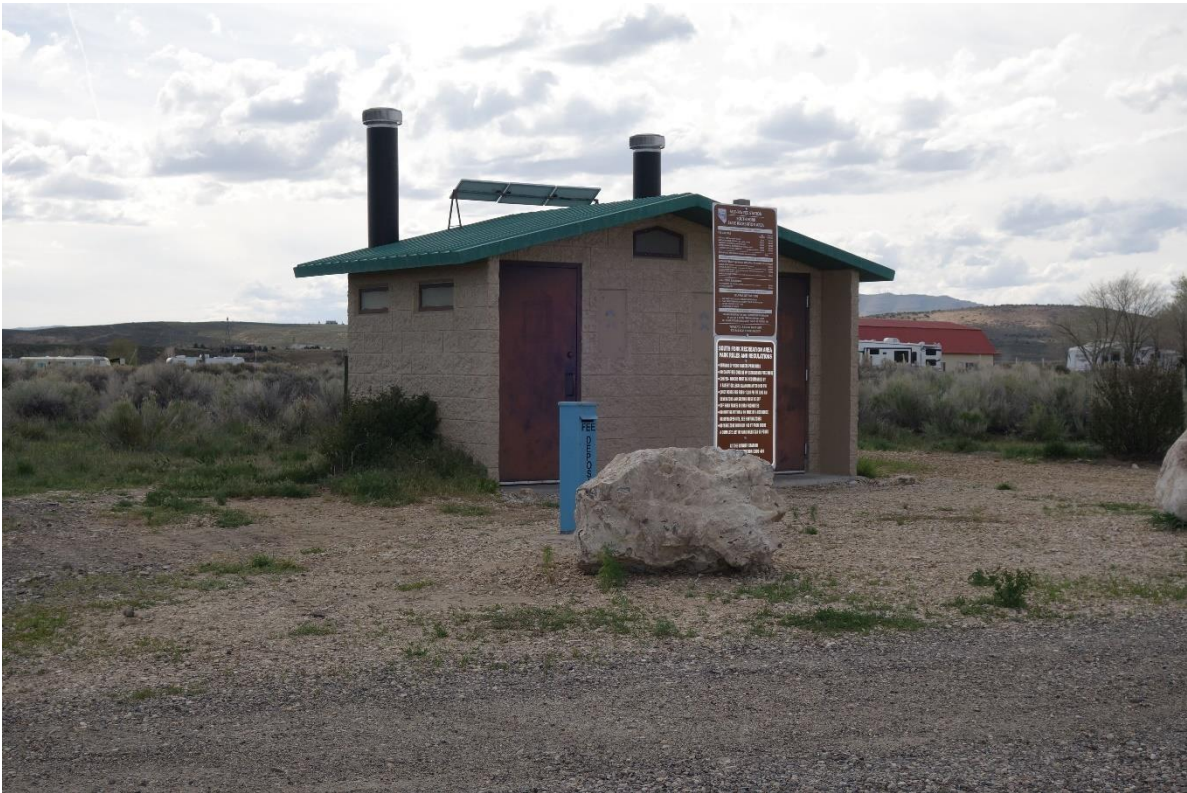
2740 CXT RESTROOM #2 WEST

The interior and exterior finishes were in fair condition. It is important to maintain the finish, weather resistance and appearance of the building. This project would provide funding to protect the interior and exterior of the building. Included in the cost are cleaning and sealing the precast concrete and caulking of the windows, flashing, fixtures and all other penetrations. An epoxy paint is recommended on the interior precast concrete. It is recommended that the building be sealed and caulked in the next 4 - 6 years and that this project is scheduled on a cyclical basis to maintain the integrity of the structure.

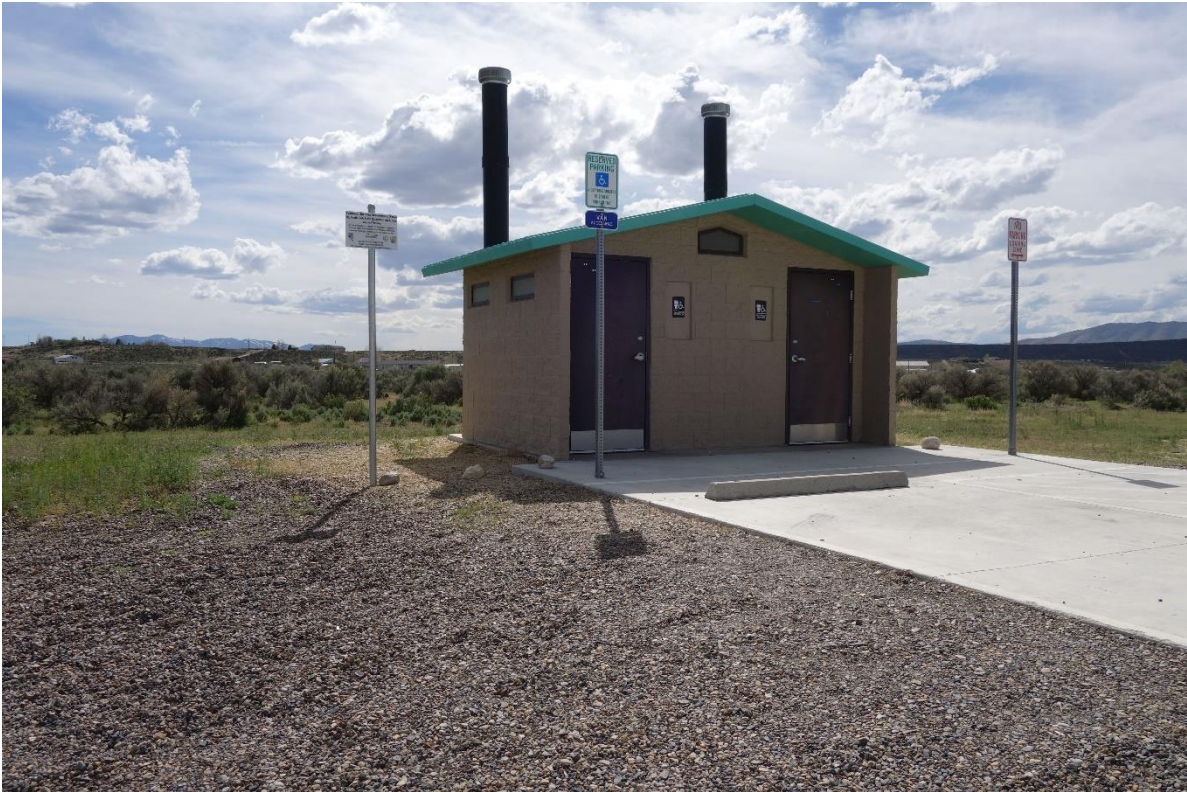
2739 CXT RESTROOM #1 WEST

This CXT restroom is a precast double unit which is located in the day use area along the west shore of the reservoir. This unit is somewhat ADA compliant. It has an accessible parking area and route of travel to the restroom.

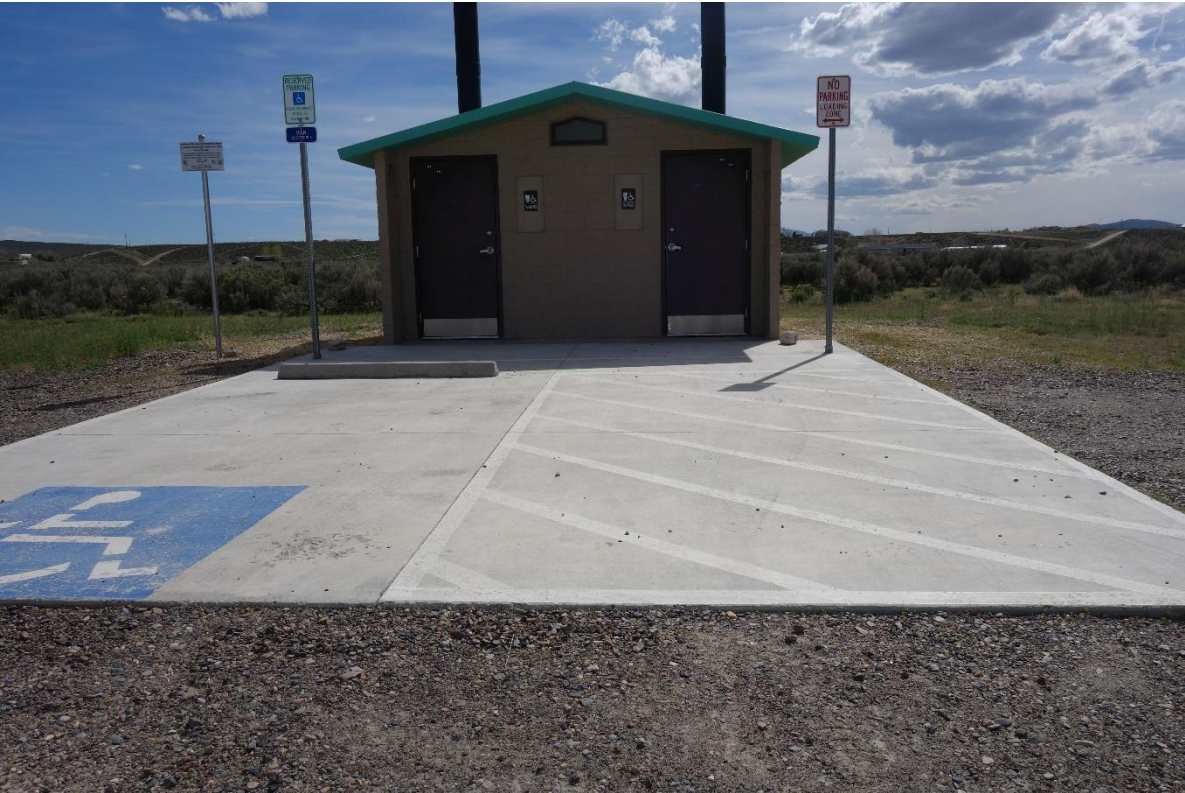
2739 CXT RESTROOM #1 WEST

The interior and exterior finishes were in good condition. It is important to maintain the finish, weather resistance and appearance of the building. This project would provide funding to protect the interior and exterior of the building. Included in the cost are cleaning and sealing the precast concrete and caulking of the windows, flashing, fixtures and all other penetrations. An epoxy paint is recommended on the interior precast concrete. It is recommended that the building be sealed and caulked in the next 7 - 9 years and that this project is scheduled on a cyclical basis to maintain the integrity of the structure.

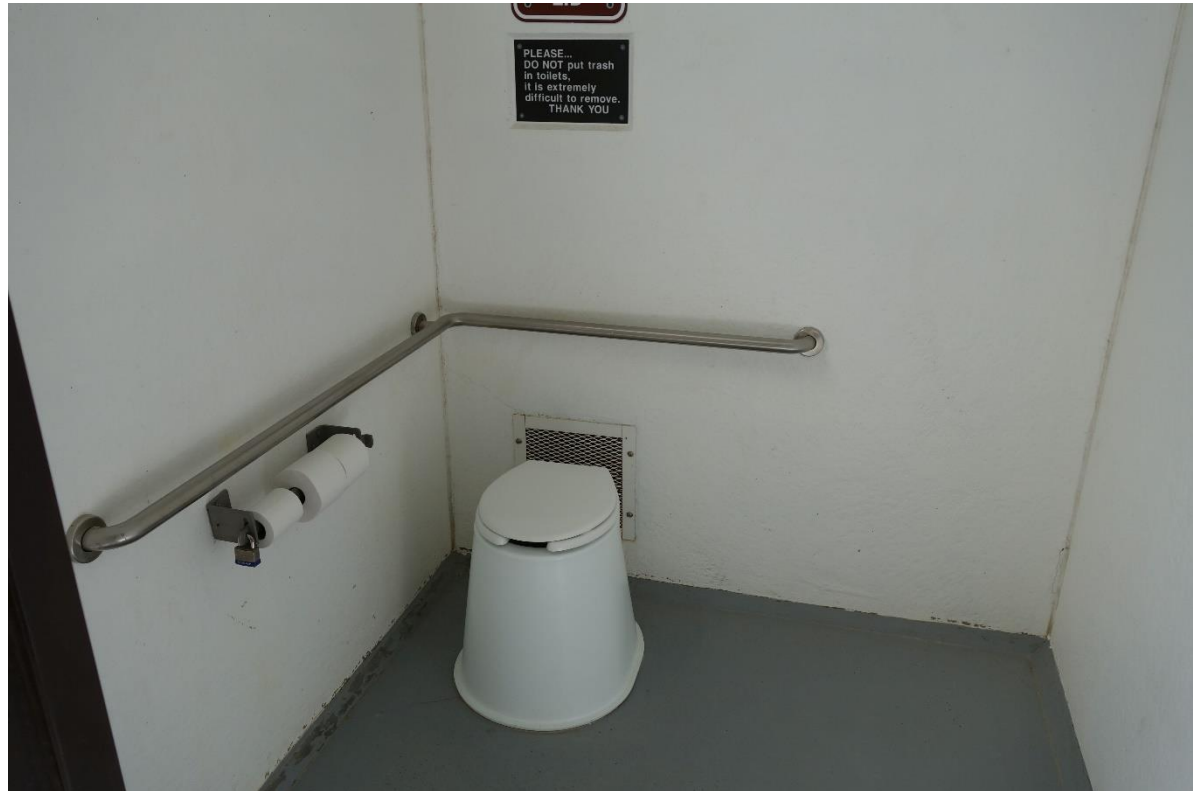
2737 FISHERMAN'S POINT CXT RESTROOM
PROJECT COST SUMMARY

The interior and exterior finishes were in fair condition. It is important to maintain the finish, weather resistance and appearance of the building. This project would provide funding to protect the interior and exterior of the building. Included in the cost are cleaning and sealing the precast concrete and caulking of the windows, flashing, fixtures and all other penetrations. An epoxy paint is recommended on the interior precast concrete. It is recommended that the building be sealed and caulked in the next 5 - 7 years and that this project is scheduled on a cyclical basis to maintain the integrity of the structure.

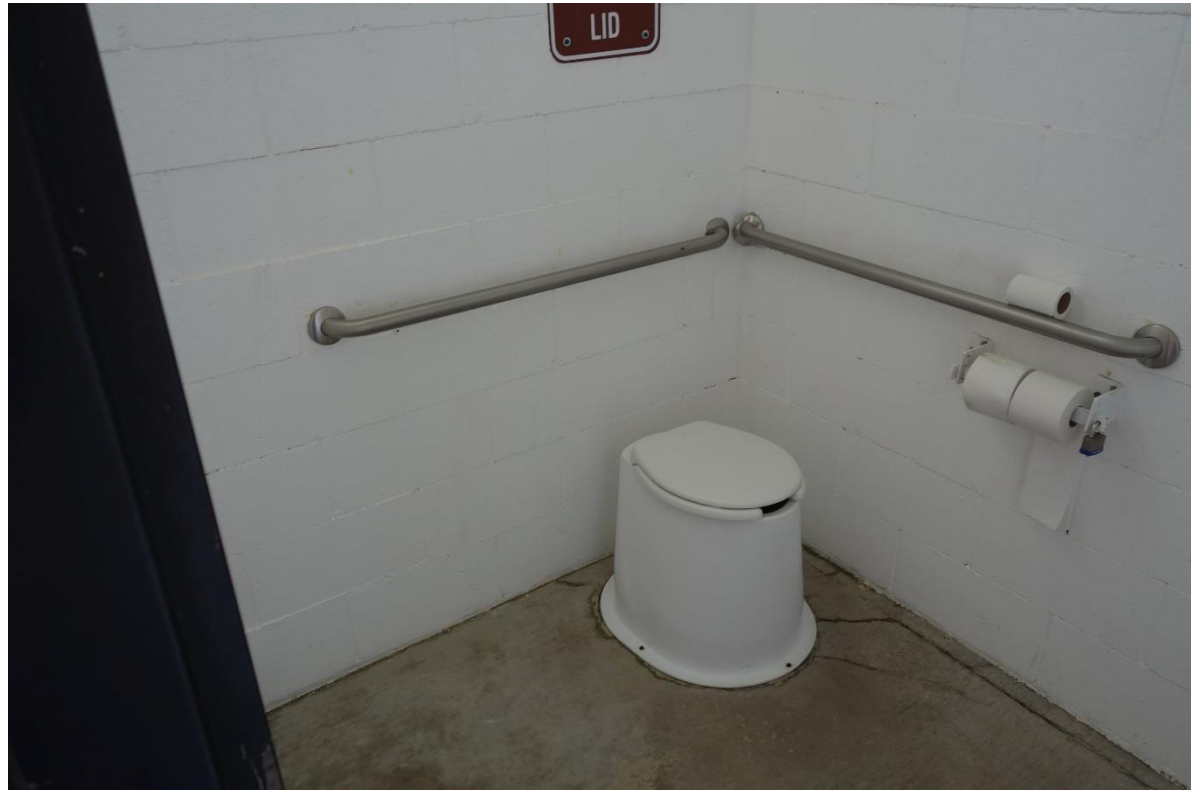
2321 EAST BOAT RAMP CXT RESTROOM
PROJECT COST SUMMARY

The interior finishes were in fair condition. It is important to maintain the finish, weather resistance and appearance of the building. This project would provide funding to protect the interior and exterior of the building. Included in the cost are cleaning and sealing the precast concrete and caulking of the windows, flashing, fixtures and all other penetrations. An epoxy paint is recommended on the interior precast concrete. It is recommended that the building be sealed and caulked in the next 4 - 7 years and that this project is scheduled on a cyclical basis to maintain the integrity of the structure.

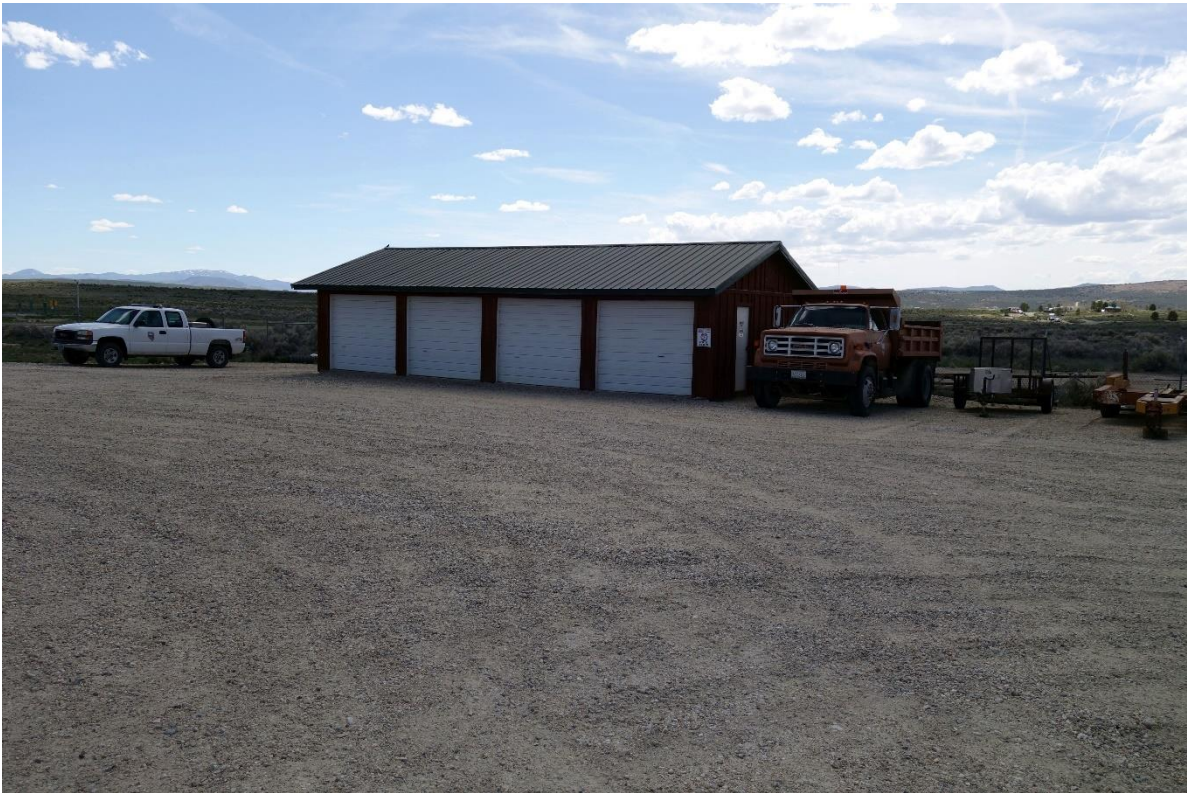
2301 GARAGE/STORAGE BUILDING
PROJECT COST SUMMARY

The exterior finishes were in fair condition. It is important to maintain the finish, weather resistance and appearance of the building. This project would provide funding to protect the exterior of the building excluding the roof. Included in the cost is power washing and staining the wood and caulking of the flashing, fixtures and all other penetrations. It is recommended that the building be stained and caulked in the next 5 - 7 years and that this project is scheduled on a cyclical basis to maintain the integrity of the structure.

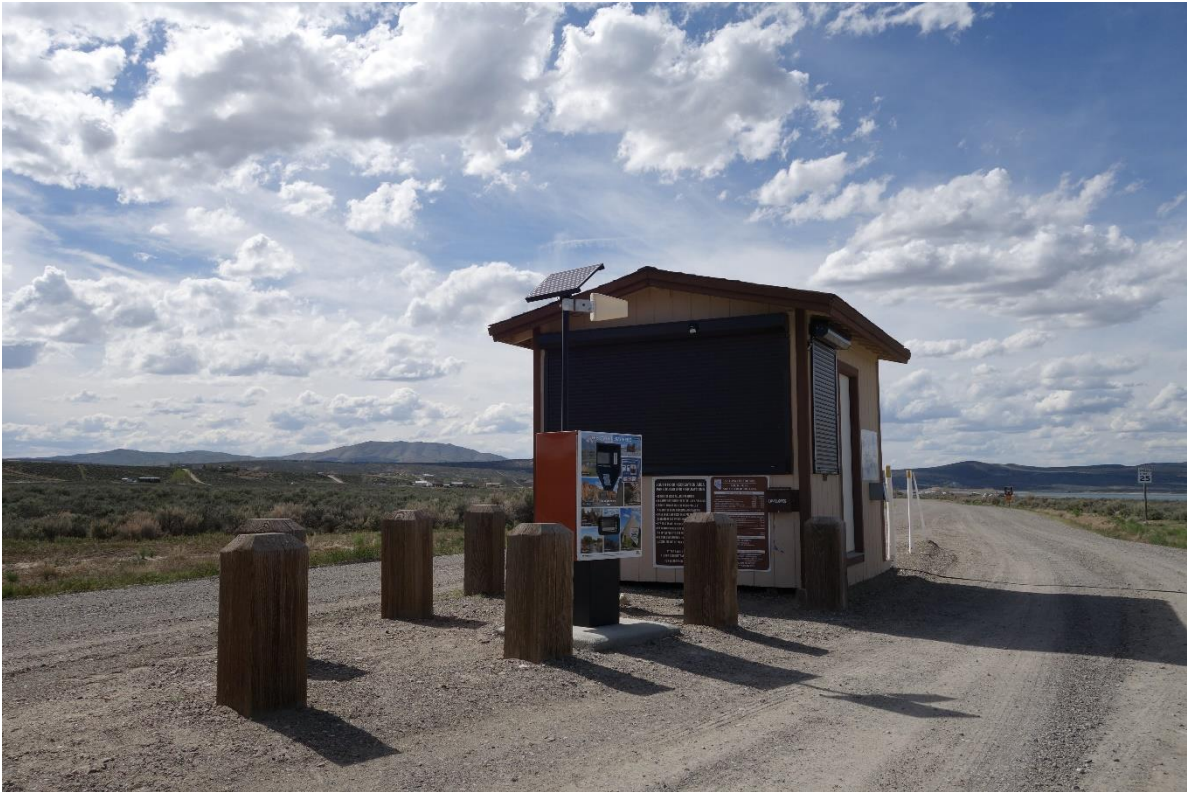
2300 WEST FEE BOOTH

The West Fee Booth is a wood framed portable structure located along the southwest entrance road to the day use area along the west shore. It is in good shape.

The wood siding of the fee booth is in direct contact with exposed earth. 2018 IBC Section 2304.12.1.5 Protection Against Decay, Wood Siding requires a minimum of 6" clearance to exposed earth. This project provides for the installation of concrete piers in compliance with Code and concrete steps for access.

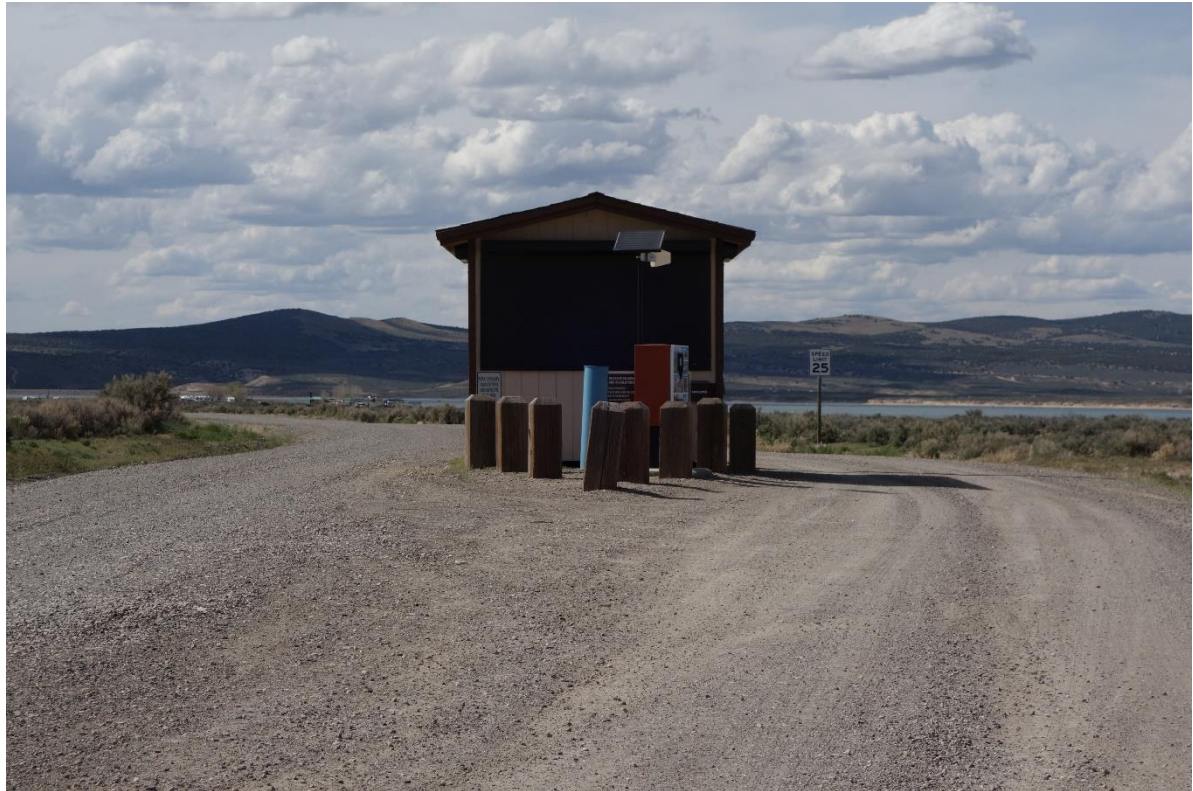
2300 WEST FEE BOOTH

The exterior finishes were in good condition. It is important to maintain the finish, weather resistance and appearance of the building. This project would provide funding to protect the exterior of the building excluding the roof. Included in the cost is sanding, priming and painting and caulking of the windows, flashing, fixtures and all other penetrations. It is recommended that the building be painted in the next 7 - 9 years and that this project is scheduled on a cyclical basis to maintain the integrity of the structure.
