STATE OF NEVADA
STATE PUBLIC WORKS DIVISION

FACILITY CONDITION ASSESSMENT REPORT FOR:

SOUTH FORK STATE RECREATION AREA SITE
139 HYLTON CT
SPRING CREEK, NV 89815-

Survey Date: 5/16/2022
Distribution Date: 12/18/2023

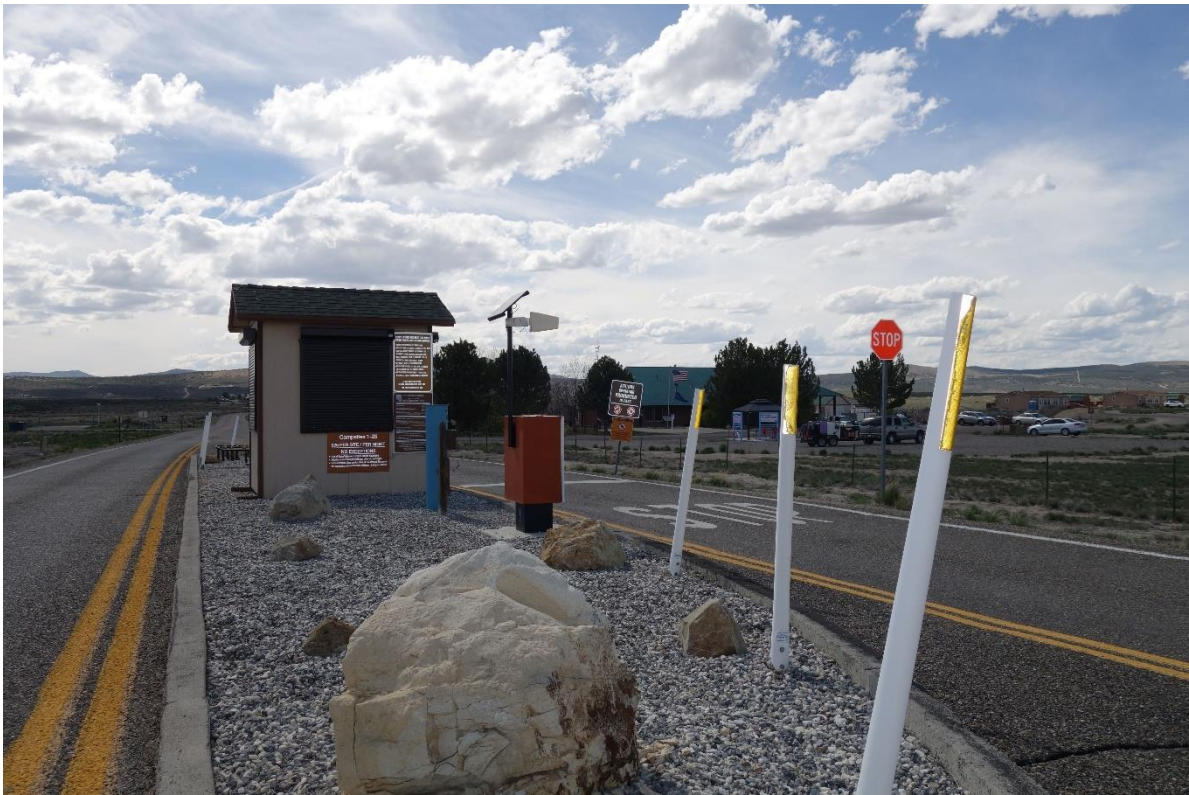
2299 EAST FEE BOOTH

The East Fee Booth is a wood framed portable structure located along the main entrance. It is in good shape.

The wood siding of the fee booth is in direct contact with exposed earth. 2018 IBC Section 2304.12.1.5 Protection Against Decay, Wood Siding requires a minimum of 6" clearance to exposed earth. This project provides for the installation of concrete piers in compliance with Code and concrete steps for access.

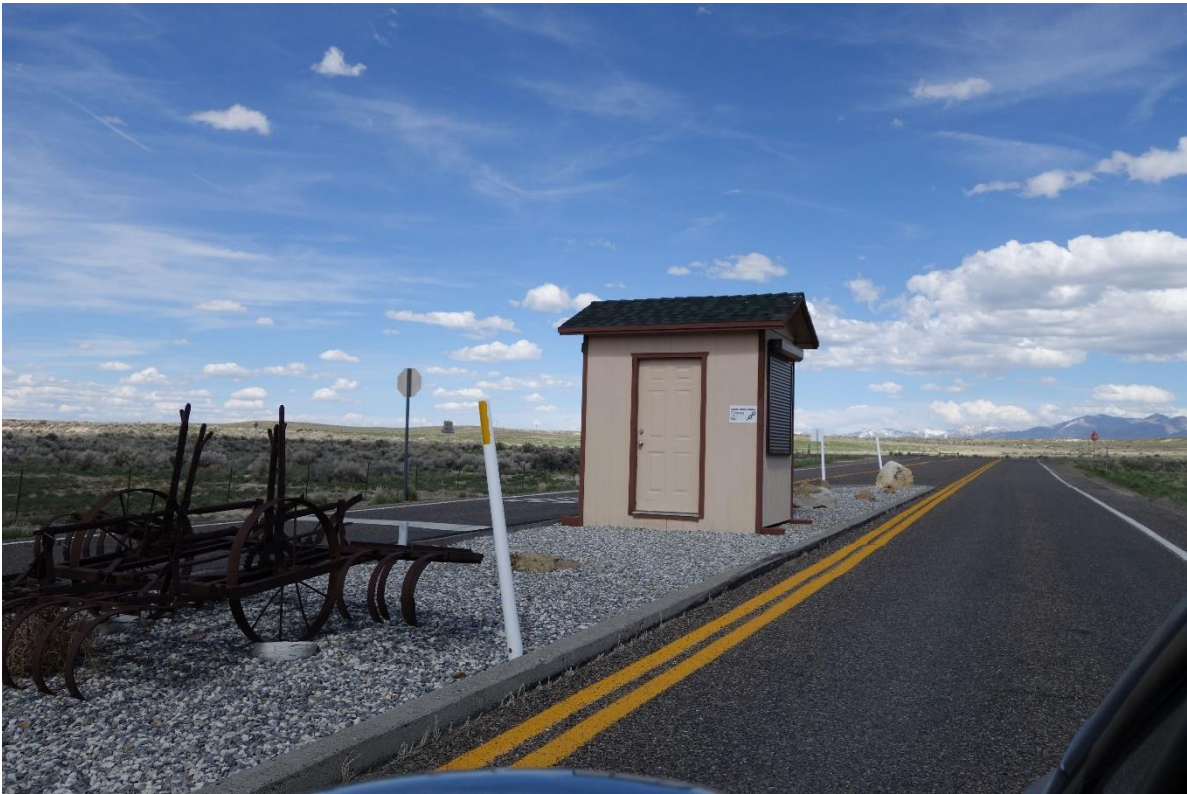
2299 EAST FEE BOOTH

The exterior finishes were in good condition. It is important to maintain the finish, weather resistance and appearance of the building. This project would provide funding to protect the exterior of the building excluding the roof. Included in the cost is sanding, priming and painting and caulking of the windows, flashing, fixtures and all other penetrations. It is recommended that the building be painted in the next 2-3 years and that this project is scheduled on a cyclical basis to maintain the integrity of the structure.

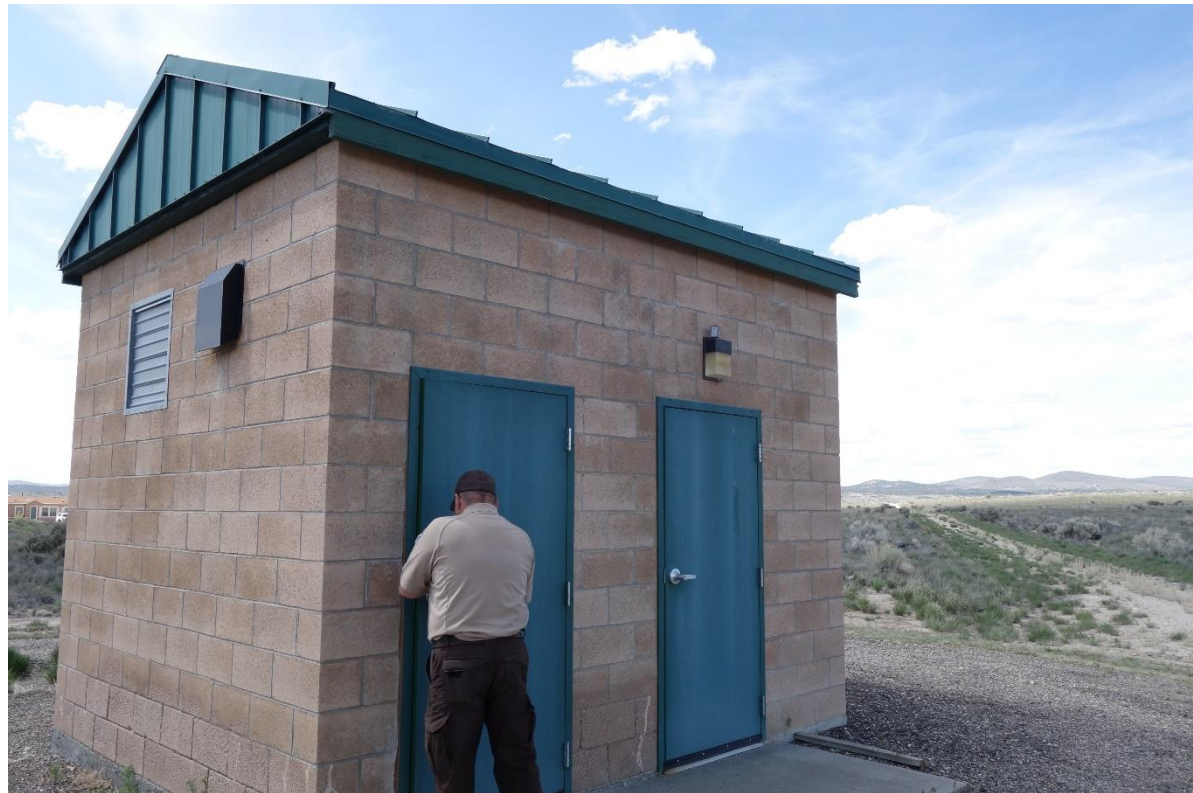
0580 PUMP HOUSE

The exterior finishes were in good condition. It is important to maintain the finish, weather resistance and appearance of the building. This project would provide funding to protect the exterior of the building excluding the roof. Included in the cost are cleaning and sealing the concrete masonry units, painting the wood and metal trim and caulking of the flashing, fixtures and all other penetrations. It is recommended that the building be sealed and caulked in the next 8 - 10 years and that this project is scheduled on a cyclical basis to maintain the integrity of the structure.

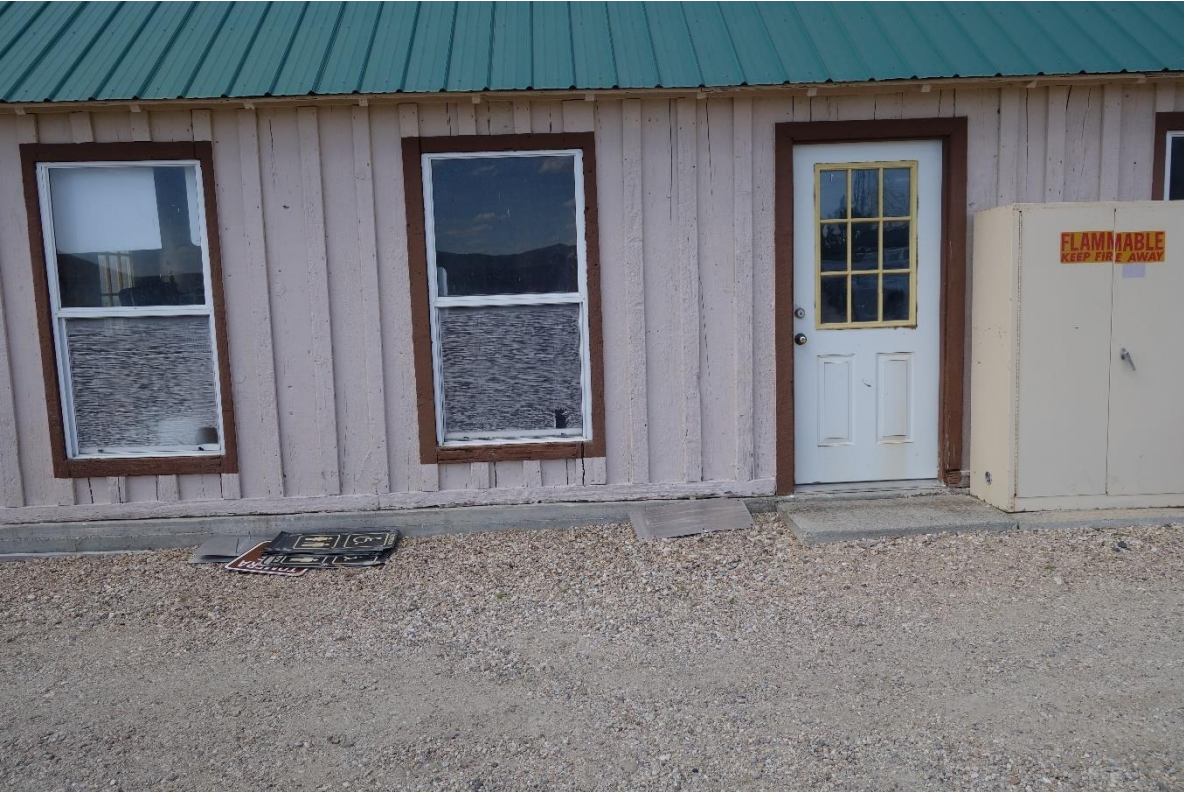
0578 STORAGE BUILDING

The exterior finishes were in good condition. It is important to maintain the finish, weather resistance and appearance of the building. This project would provide funding to protect the exterior of the building excluding the roof. Included in the cost is sanding, priming and painting and caulking of the windows, flashing, fixtures and all other penetrations. It is recommended that the building be painted in the next 7 - 9 years and that this project is scheduled on a cyclical basis to maintain the integrity of the structure.

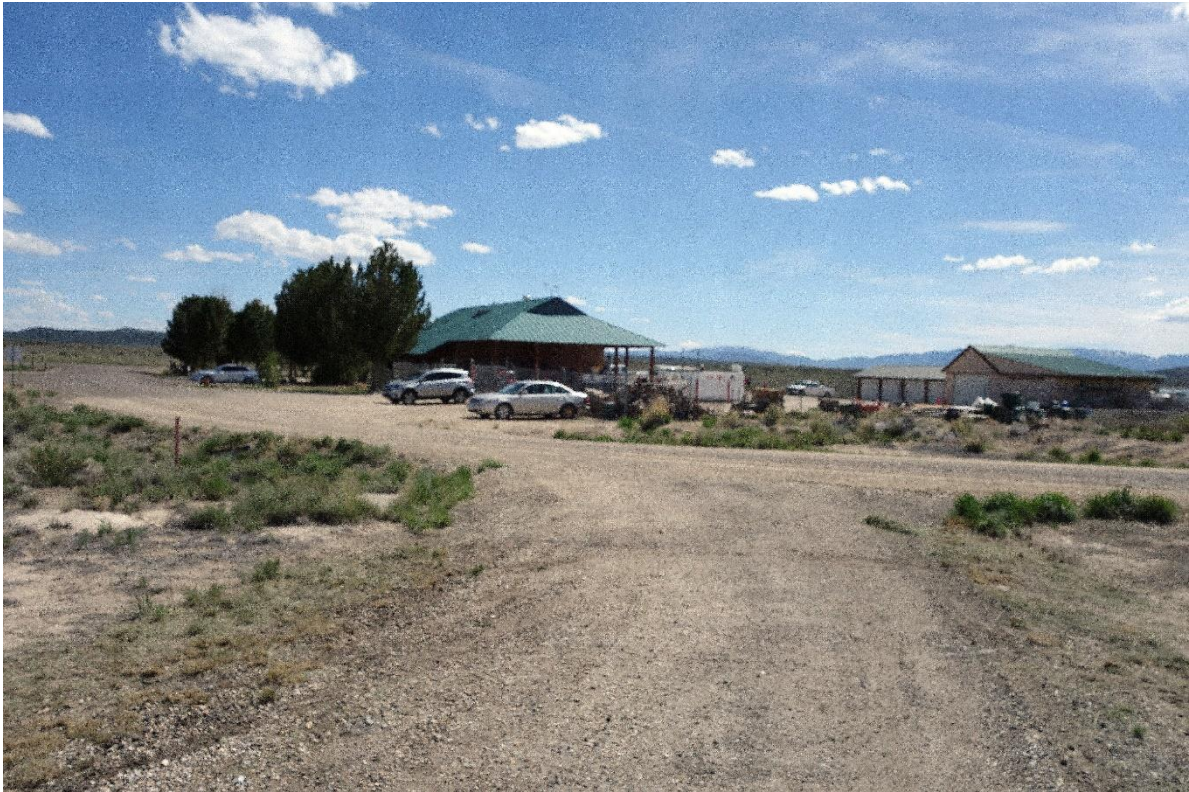
0547 PARK OFFICE/SHOP

The Park Office/Shop is a wood framed structure with an exterior insulation and finish system (EIFS) on a concrete slab-on-grade foundation. It has a standing seam metal roof. This facility contains a public visitation area, offices, restrooms, conference room and a shop. Heat is provided by propane fired heaters in the shop and a forced air furnace for the office space. The facility also has a fire sprinkler system.

The building needs sidewalk replacement, a concrete slab under the carport and replacement of the garage door aprons. The existing concrete is cracked and failing and is due for replacement. The four-bay carport on the North side of the building is not paved and the dirt is insufficient for the heavy use and extreme climate. The drainage away from the building is also insufficient due to erosion of the dirt which also makes it difficult to remove snow from the perimeter of the building. This project would provide for 1,500 square feet of concrete to replace deteriorated concrete sidewalks and aprons, and installation of a proper parking space under the carport and improved drainage in compliance with IBC 2018 Section 2304.12.2.2 Protection Against Decay, Posts or Columns. This project should be implemented concurrently with the Structural Post Protection project.

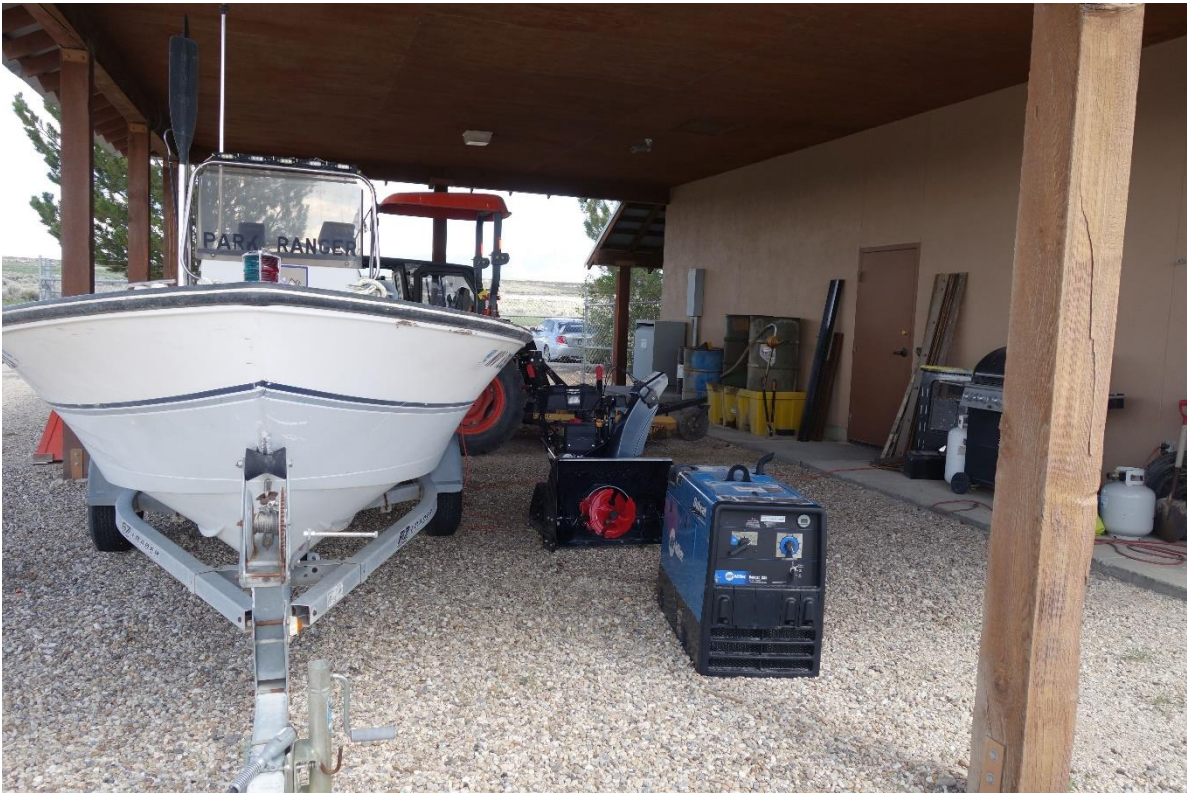
0547 PARK OFFICE/SHOP

The exterior finishes were in good condition. It is important to maintain the finish, weather resistance and appearance of the building. This project would provide funding to protect the exterior of the building excluding the roof. Included in the cost is power washing, priming and painting and caulking of the windows, flashing, fixtures and all other penetrations. It is recommended that the building be painted in the next 7 - 9 years and that this project is scheduled on a cyclical basis to maintain the integrity of the structure.

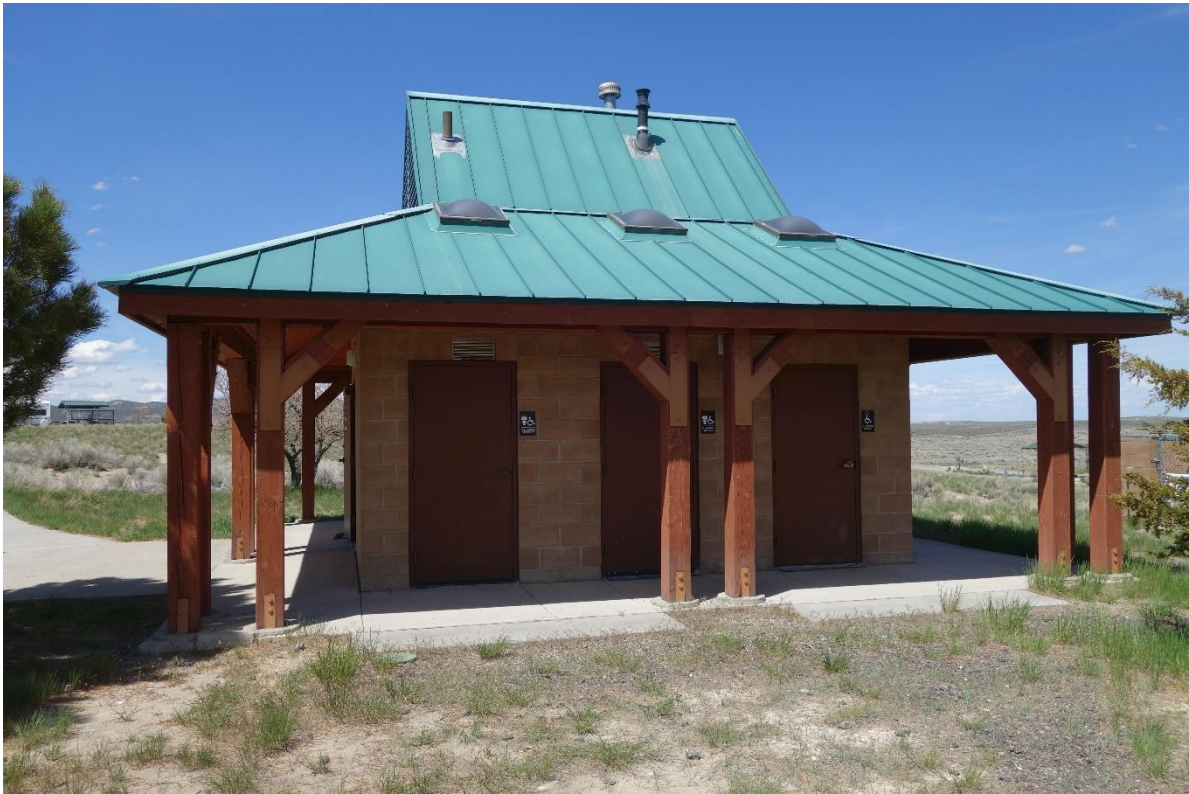
0546 CAMPGROUND COMFORT STATION

The Campground Comfort Station is a concrete masonry unit and wood post and beam structure. It contains restrooms and showers for both Men and Women. The restrooms and showers are mostly ADA compliant and there is an ADA accessible route of travel and parking space to the restrooms. The two ADA campsites nearby have an ADA accessible route to the building. It has a propane fired on demand water heater unit and furnace in the janitorial closet.

The interior finishes were in fair condition; however, the shower rooms needed new finishes. It is recommended to paint the shower rooms and ceilings at least once in the next 4 - 6 years and that this project is scheduled on a cyclical basis to maintain the integrity of the structure. Prior to painting, all surfaces should be repaired and prepped. An epoxy-based paint should be utilized in wet areas for durability.

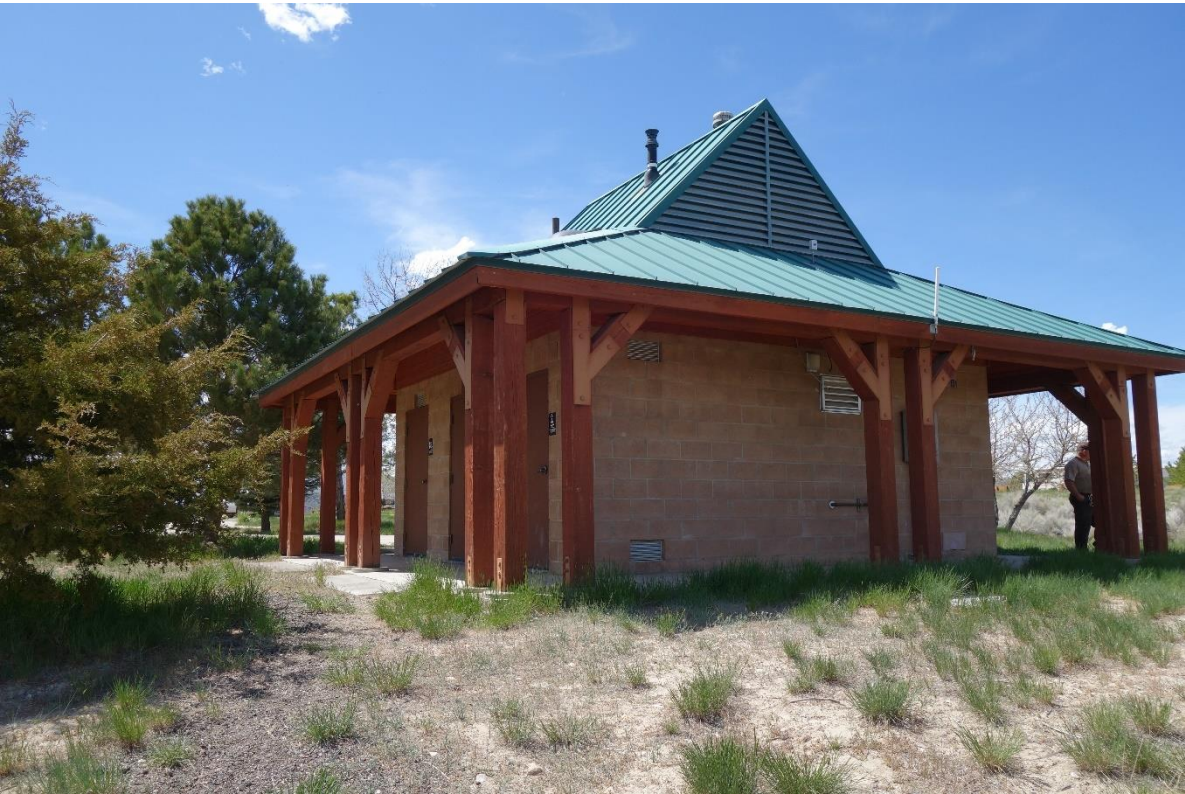
0546 CAMPGROUND COMFORT STATION
PROJECT COST SUMMARY

The exterior finishes were in good condition. It is important to maintain the finish, weather resistance and appearance of the building. This project would provide funding to protect the exterior of the building excluding the roof. Included in the cost is sanding, priming and painting and caulking of the windows, flashing, fixtures and all other penetrations. It is recommended that the building be painted in the next 7 - 9 years and that this project is scheduled on a cyclical basis to maintain the integrity of the structure.
