STATE OF NEVADA STATE PUBLIC WORKS DIVISION

FACILITY CONDITION ASSESSMENT REPORT FOR:

DEPT OF HEALTH AND HUMAN SERVICES
DIVISION OF CHILD AND FAMILY SERVICES
NYTC

SITE #: 9938 NEVADA YOUTH TRAINING CENTER SITE - ELKO
100 YOUTH CENTER RD
ELKO, NV 89801-9565

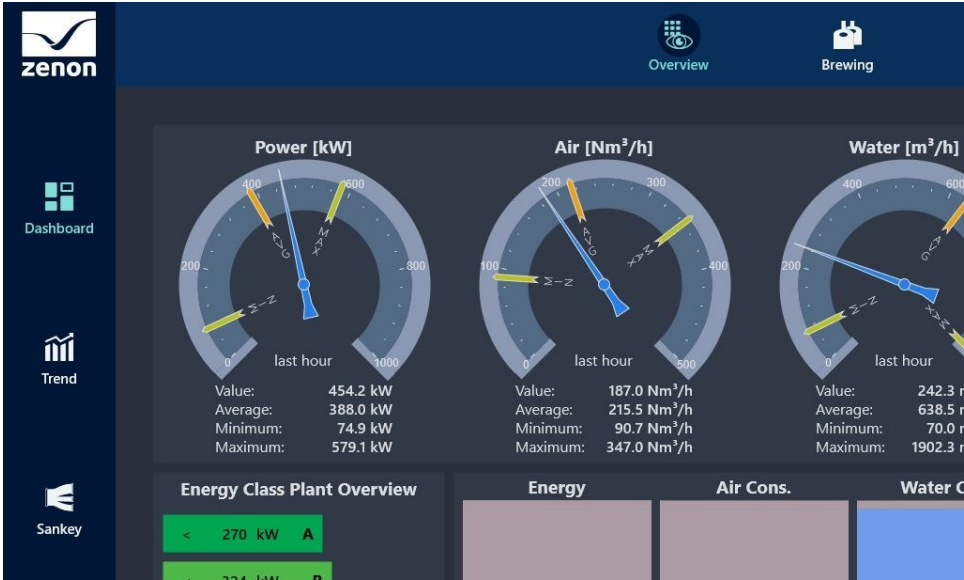
QUANTITY	UNITS	TOTAL	SF COST
<p>This project recommends the installation of an Energy Management System (EMS) for the site. This system will monitor and control the heating, ventilation, and air conditioning through a central computer system. Electronic sensors will be installed on each piece of equipment which will feed information into the computer system. The maintenance staff can then control and monitor the equipment remotely which will significantly lower energy costs. This system will provide detailed reports on energy consumption allowing the maintenance staff to analyze and customize the energy used by the facility.</p> <p>This project is in design under CIP 23-M02(10).</p> <p>This project or a portion thereof was previously recommended in the FCA report dated 08/22/2007 and 09/18/2013. It has been amended accordingly to reflect conditions observed during the most recent survey date of 05/09/2023.</p>	1	Package	\$500,000.00	-

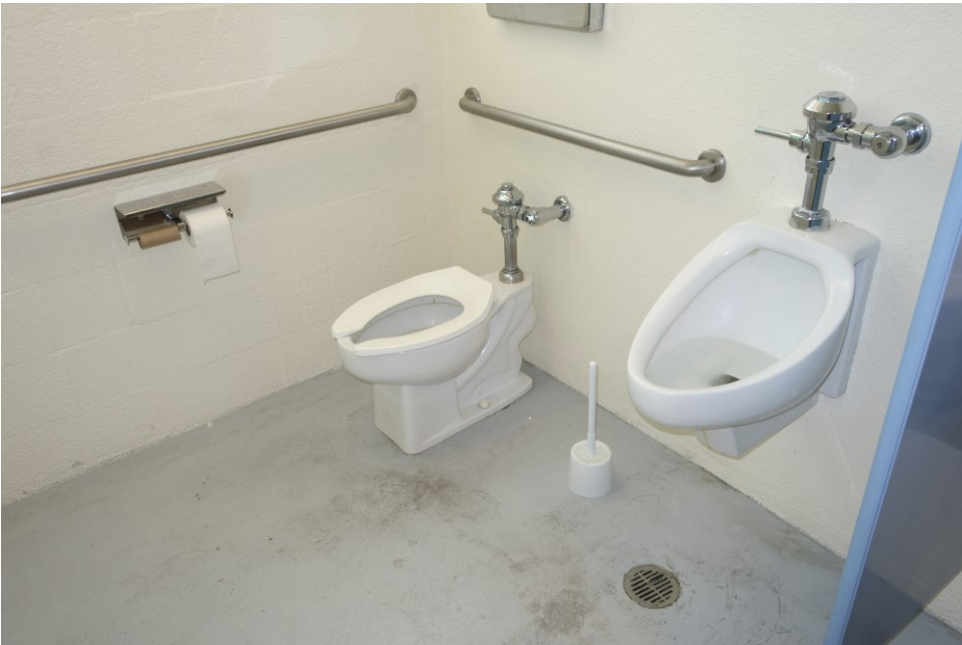
QUANTITY	UNITS	TOTAL	SF COST
<p>The building does not have an accessible restroom. The existing restroom does not meet the ADA requirements. A complete retrofit is necessary. This project would provide funding for remodeling the men's and women's restrooms per ADA regulations. Items may include a new sink, toilet, hardware, mirrors, fixtures, flooring and paint. The 2018 IBC, ICC/ANSI A117.1-2009, NRS 338.180 and the most current version of the ADA Standards for Accessible Design were used as a reference for this project.</p> <p>This project is in design under CIP 23-S02(6) and the estimate is based off that project.</p>	1	Package	\$75,000.00	\$ 19.00

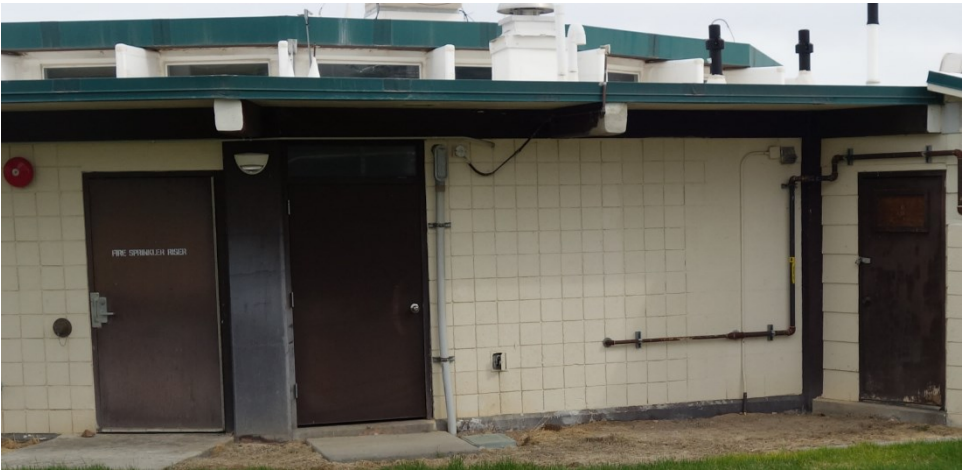
TYPICAL

QUANTITY	UNITS	TOTAL	SF COST
<p>The 3 exterior wood man doors appear to be original to the building. They are damaged from age and general wear and tear. This project would provide for the replacement of the wood doors with new metal doors, frames and hardware. Removal and disposal of the existing doors and painting of the new doors is included in this estimate.</p> <p>This project or a portion thereof was previously recommended in the FCA reports dated 09/18/2013. It has been amended accordingly to reflect conditions observed during the most recent survey date of 05/09/2023.</p>	3	Each	\$ 9,500.00	\$ 2.00

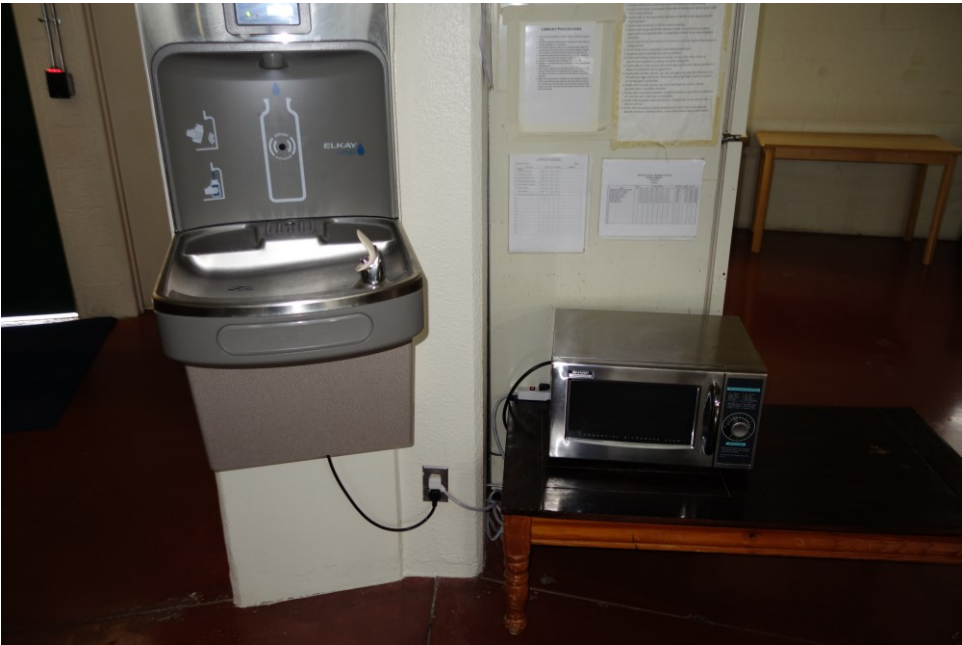
QUANTITY	UNITS	TOTAL	SF COST
<p>This building contains a water fountain that is not ADA compliant. The 2018 IBC Section 1109.5 states where drinking fountains are provided on an exterior site, on a floor or within a secured area, no fewer than two drinking fountains shall be provided. One shall comply with the requirements for people who use a wheelchair and one shall comply with the requirements for standing persons. This project would provide funding for the purchase and installation of one drinking fountain to meet the ADA requirements. Note that a bottle filler integrated into a drinking fountain does not make the water fountain accessible.</p> <p>This project or a portion thereof was previously recommended in the FCA reports dated 09/18/2013. It has been amended accordingly to reflect conditions observed during the most recent survey date of 05/09/2023.</p>	1	Each	\$ 2,500.00	\$ 1.00

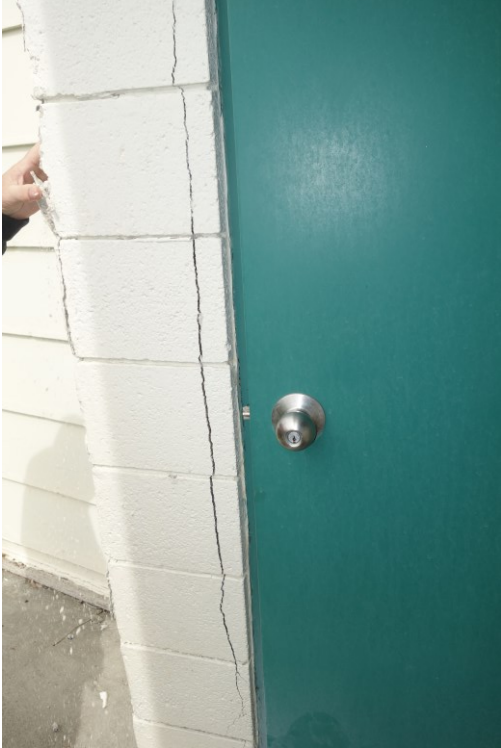
QUANTITY	UNITS	TOTAL	SF COST
<p>The exterior metal door at the rear entrance is damaged from age and general wear and tear and has reached the end of its expected life. This project would provide for the replacement of the door assembly with new a metal door, frame and hardware. Removal and disposal of the existing door is included in this estimate.</p> <p>This project or a portion thereof was previously recommended in the FCA report dated 08/22/2007 and 09/18/2013. It has been amended accordingly to reflect conditions observed during the most recent survey date of 05/09/2023.</p>	1	Each	\$ 8,000.00	\$ 2.00

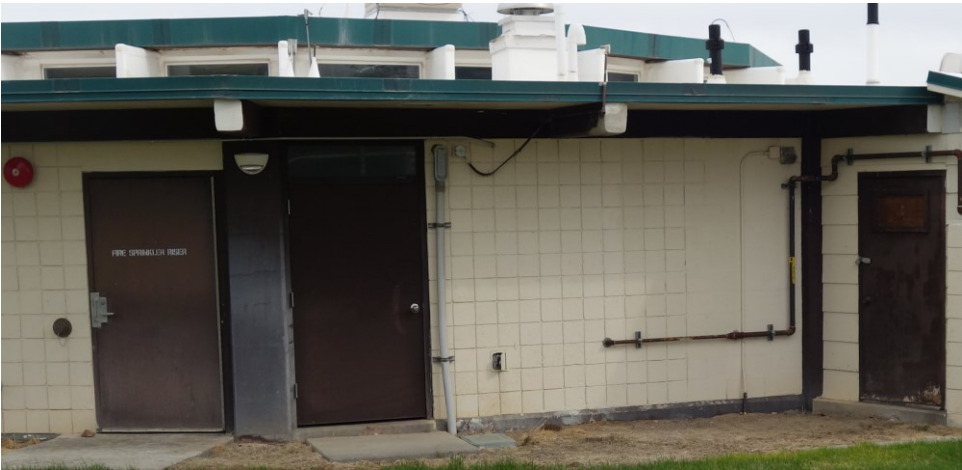
QUANTITY	UNITS	TOTAL	SF COST
<p>The exterior metal door at the rear entrance is damaged from age and general wear and tear and has reached the end of its expected life. This project would provide for the replacement of the door assembly with new a metal door, frame and hardware. Removal and disposal of the existing door is included in this estimate.</p> <p>This project or a portion thereof was previously recommended in the FCA report dated 08/22/2007. It has been amended accordingly to reflect conditions observed during the most recent survey date of 09/18/2013.</p>	1	Package	\$ 8,000.00	\$ 2.00

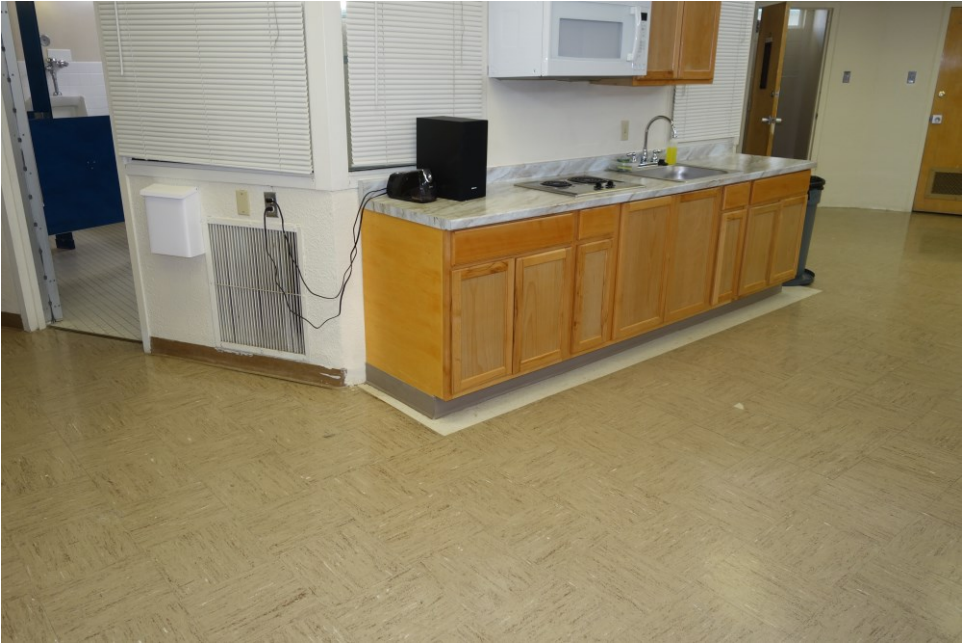
QUANTITY	UNITS	TOTAL	SF COST
The interior finishes are in good condition. It is recommended that the interior walls and ceilings be painted at least once in the next 7 - 9 years and that this project be scheduled on a cyclical basis to maintain the integrity of the structure. Prior to painting, all surfaces should be repaired and prepped. An epoxy-based paint should be utilized in wet areas for durability.	3847	Square Foot	\$23,000.00	\$ 6.00

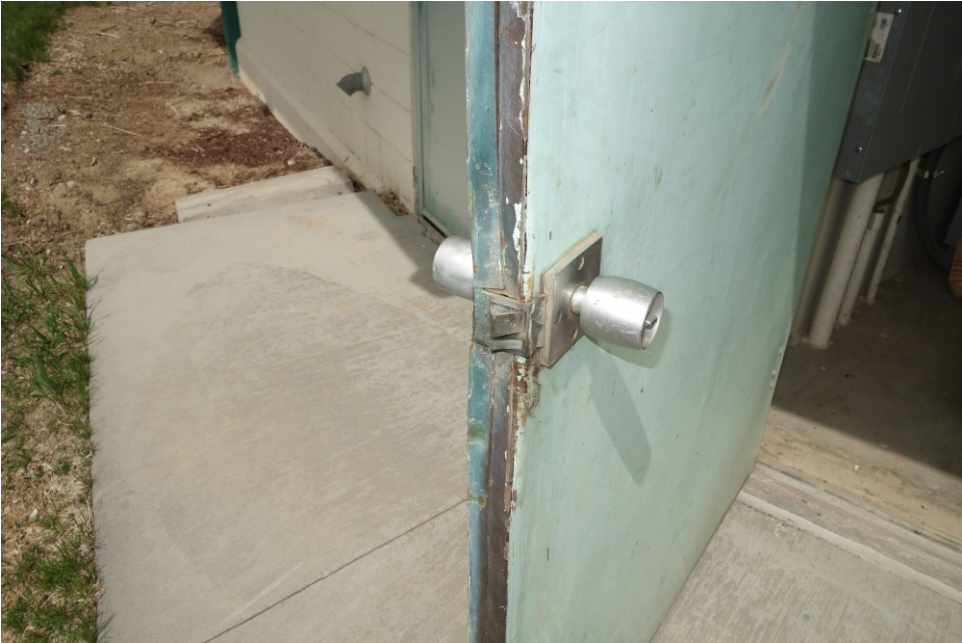
QUANTITY	UNITS	TOTAL	SF COST
The existing sleeping room door locks are older and problematic. They are not designed for this application and have become a security and safety concern for the inhabitants. The existing locks require constant maintenance because they do not hold up to the abuse by the residents. This project would provide for a new electric door control system including magnetic locks, control panel and all required electrical connections.	1	Package	\$75,000.00	\$ 19.00

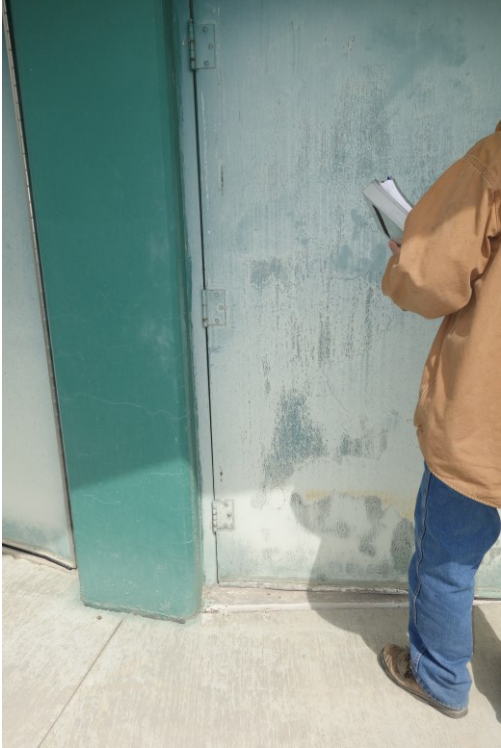
QUANTITY	UNITS	TOTAL	SF COST
The exterior finishes were in fair condition. It is important to maintain the finish, weather resistance and appearance of the building. This project would provide funding to protect the exterior of the building excluding the roof. Included in the cost is sanding, priming and painting and caulking of the windows, flashing, fixtures and all other penetrations. It is recommended that the building be painted in the next 5 - 7 years and that this project be scheduled on a cyclical basis to maintain the integrity of the structure.	3847	Square Foot	\$23,000.00	\$ 6.00

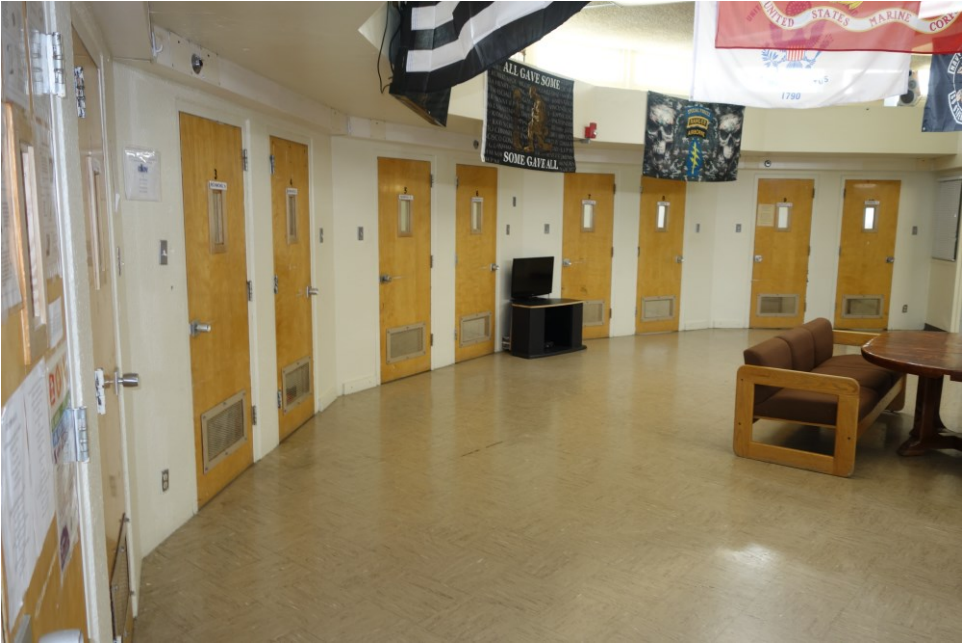
QUANTITY	UNITS	TOTAL	SF COST
The interior finishes are in fair condition. It is recommended that the interior walls and ceilings be painted at least once in the next 5 - 7 years and that this project be scheduled on a cyclical basis to maintain the integrity of the structure. Prior to painting, all surfaces should be repaired and prepped. An epoxy-based paint should be utilized in wet areas for durability.	3847	Square Foot	\$23,000.00	\$ 6.00

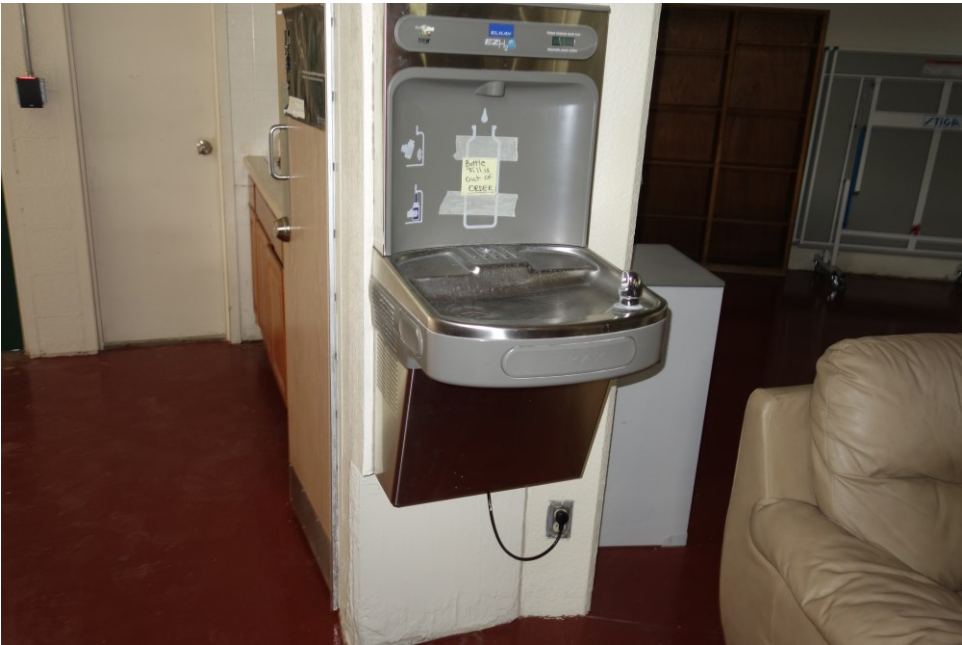
QUANTITY	UNITS	TOTAL	SF COST
<p>This building contains a water fountain that is not ADA compliant. The 2018 IBC Section 1109.5 states where drinking fountains are provided on an exterior site, on a floor or within a secured area, no fewer than two drinking fountains shall be provided. One shall comply with the requirements for people who use a wheelchair and one shall comply with the requirements for standing persons. This project would provide funding for the purchase and installation of one drinking fountain to meet the ADA requirements. Note that a bottle filler integrated into a drinking fountain does not make the water fountain accessible.</p> <p>This project or a portion thereof was previously recommended in the FCA reports dated 09/18/2013. It has been amended accordingly to reflect conditions observed during the most recent survey date of 05/09/2023.</p>	1	Each	\$ 2,500.00	\$ 1.00

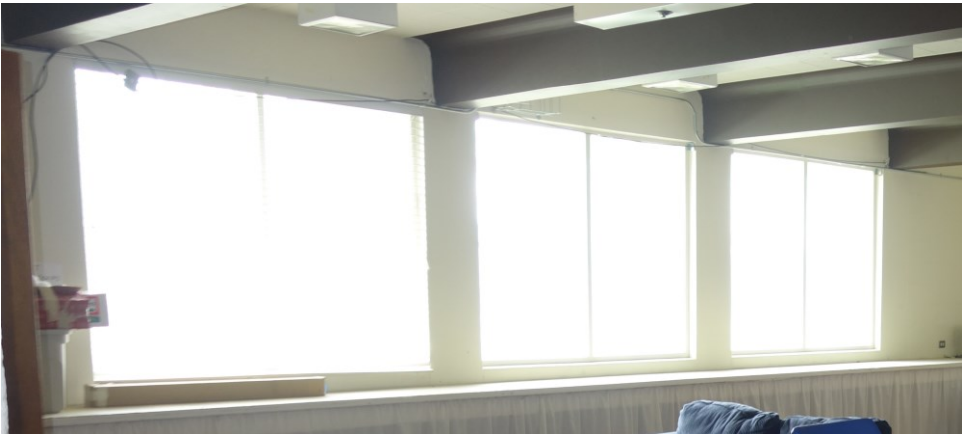
QUANTITY	UNITS	TOTAL	SF COST
<p>The building is constructed of concrete masonry units (CMU) with no insulation. The windows are original to the building, and of single pane construction. Buildings of this type are not energy efficient. This project recommends adding an exterior insulating finish system (EIFS) over the CMU and replacing the windows with new dual-pane, higher efficiency units.</p> <p>This project or a portion there of was previously recommended in the FCA reports dated 08/19/2002, 08/22/2007 and 09/18/2013. It has been amended accordingly to reflect conditions observed during the most recent survey date of 05/09/2023.</p>	1	Package	\$234,500.00	\$ 59.00

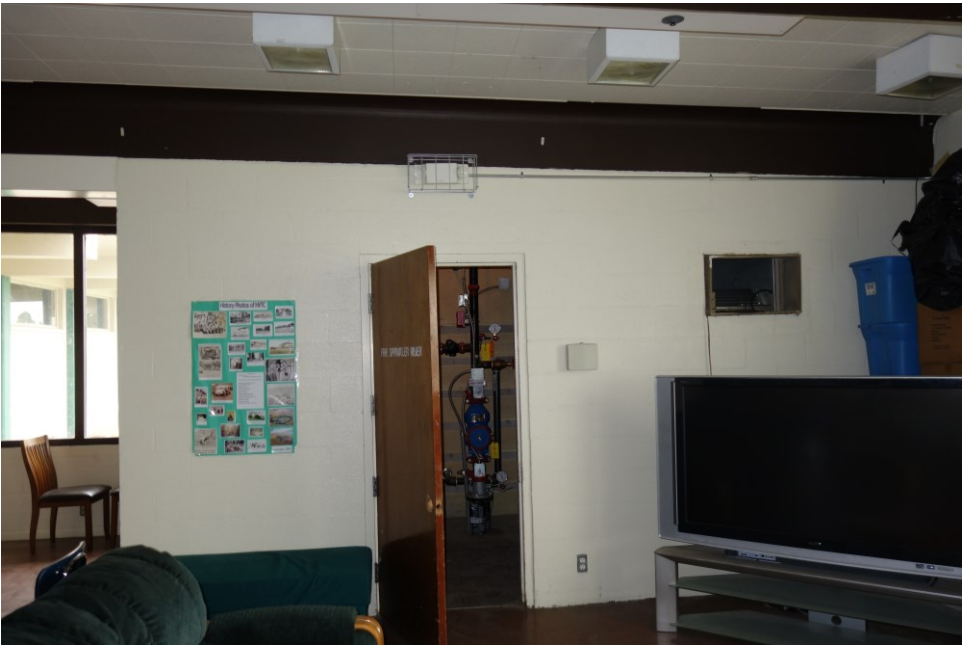
QUANTITY	UNITS	TOTAL	SF COST
<p>The existing lighting fixtures are the older fluorescent type, and are not energy efficient. This project will upgrade fixtures to higher efficiency units with a longer life cycle T-8 LED lamps. Occupancy sensors will be installed in restrooms, utility closets and other low occupancy areas for additional savings. Any electrical wiring upgrades are not included in this estimate.</p> <p>This project is in design under CIP 21-S08(6).</p> <p>This project or a portion there of was previously recommended in the FCA reports dated 08/19/2002, 08/22/2007 and 09/18/2013. It has been amended accordingly to reflect conditions observed during the most recent survey date of 05/09/2023.</p>	3990	Square Foot	\$ 8,000.00	\$ 2.00

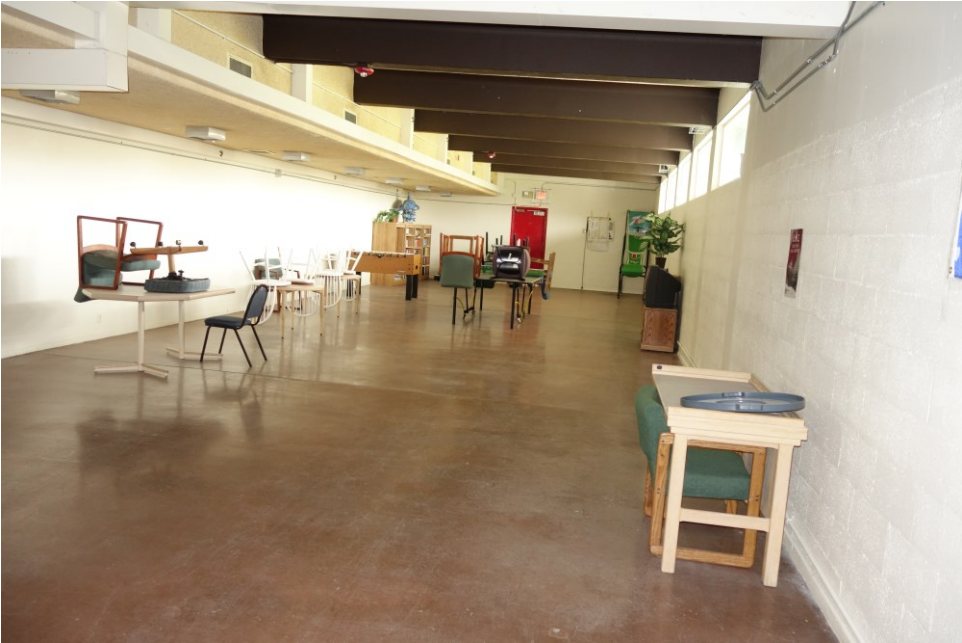
QUANTITY	UNITS	TOTAL	SF COST
The interior finishes are in fair condition. It is recommended that the interior walls and ceilings be painted at least once in the next 4 - 5 years and that this project be scheduled on a cyclical basis to maintain the integrity of the structure. Prior to painting, all surfaces should be repaired and prepped. An epoxy-based paint should be utilized in wet areas for durability.	3990	Square Foot	\$23,900.00	\$ 6.00

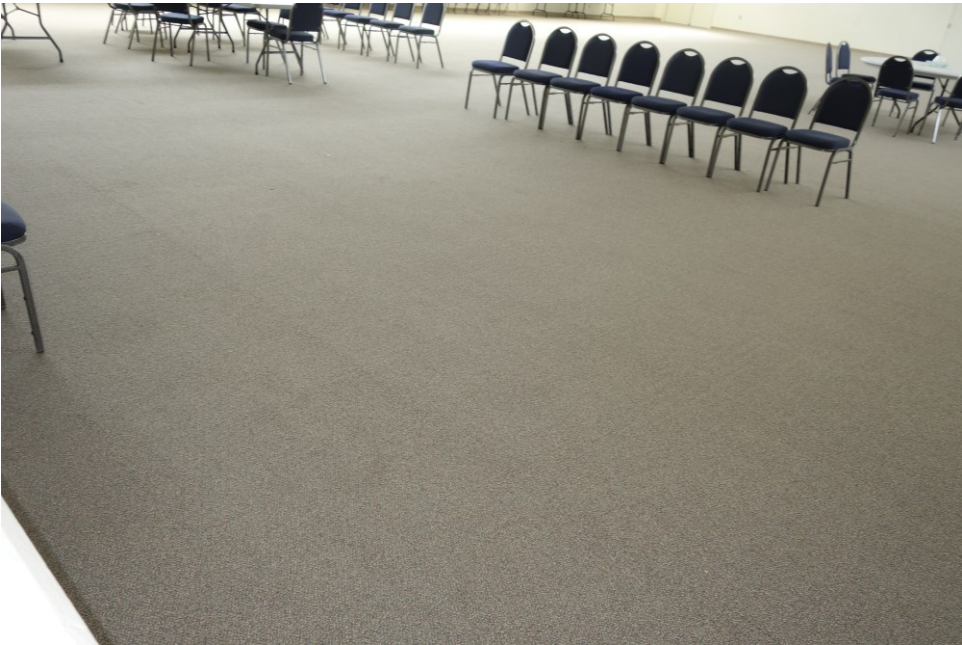
QUANTITY	UNITS	TOTAL	SF COST
The carpet in the multipurpose room is starting to wear and reaching the end of their useful life. It is recommended that the flooring be replaced. This project would provide for removal and disposal of the existing flooring and installation of new heavy duty commercial grade carpet in the next 6 - 8 years.	5100	Square Foot	\$72,600.00	\$ 5.00

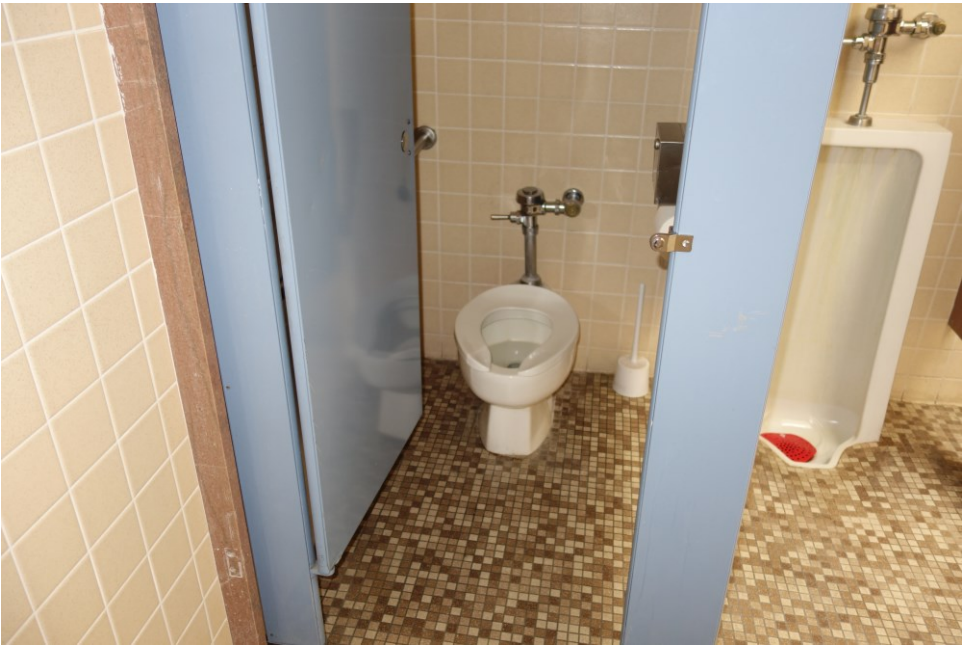
QUANTITY	UNITS	TOTAL	SF COST
<p>The Men's and Women's designated ADA restrooms do not meet the Americans with Disabilities Act (ADA) requirements. A complete retrofit is necessary. This project would provide funding for remodeling the Men's and Women's restrooms into ADA compliant restrooms. These items may include a new sink, toilet, hardware, mirrors, fixtures, flooring and paint. The 2018 IBC, ICC/ANSI A117.1 - 2009, NRS 338.180 and the most current version of the ADA Standards For Accessible Design were used as a reference for this project.</p> <p>This project or a portion thereof was previously recommended in the FCA report dated 08/23/2007 and 09/18/2013. It has been amended accordingly to reflect conditions observed during the most recent survey date of 05/09/2023.</p>	2	Each	\$140,000.00	\$ 7.00

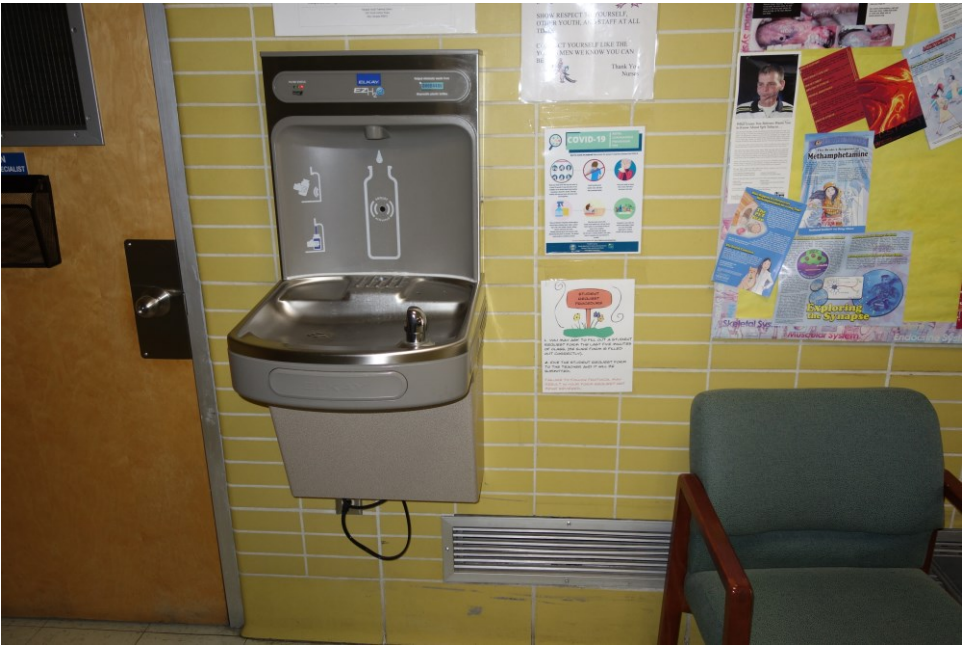
QUANTITY	UNITS	TOTAL	SF COST
<p>This building contains a water fountain that is not ADA compliant. The 2018 IBC Section 1109.5 states where drinking fountains are provided on an exterior site, on a floor or within a secured area, no fewer than two drinking fountains shall be provided. One shall comply with the requirements for people who use a wheelchair and one shall comply with the requirements for standing persons. This project would provide funding for the purchase and installation of one drinking fountain to meet the ADA requirements. Note that a bottle filler integrated into a drinking fountain does not make the water fountain accessible.</p> <p>This project or a portion thereof was previously recommended in the FCA report dated 08/23/2007 and 09/18/2013. It has been amended accordingly to reflect conditions observed during the most recent survey date of 05/09/2023.</p>	2	Each	\$ 5,000.00	\$ 0.00

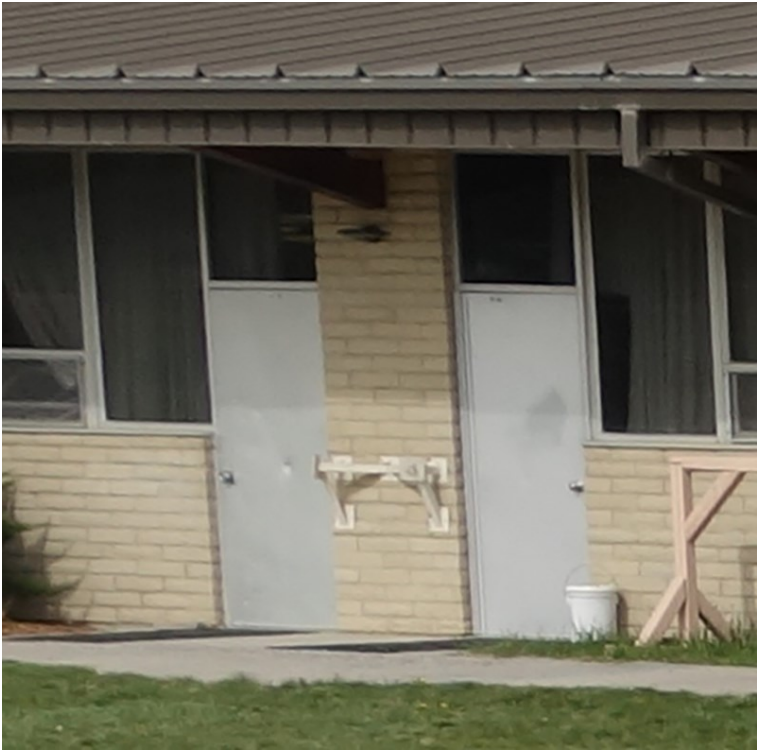
QUANTITY	UNITS	TOTAL	SF COST
<p>The existing exterior metal doors and frames appear to be original to the building. They are damaged from age and general wear and tear. This project would provide for the replacement and installation of 15 new hollow metal doors, frames and hardware. Removal and disposal of the existing doors and painting of the new doors is included in this estimate.</p> <p>This project or a portion there of was previously recommended in the FCA reports dated 08/19/2002 and 08/23/2007. It has been amended accordingly to reflect conditions observed during the most recent survey date of 09/18/2013.</p>	15	Each	\$60,000.00	\$ 3.00

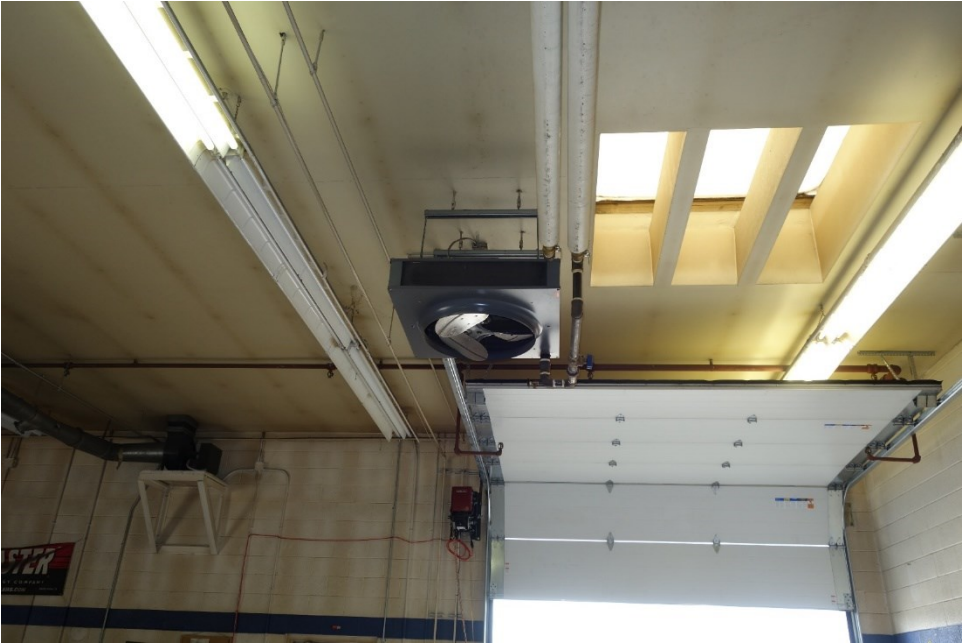
QUANTITY	UNITS	TOTAL	SF COST
<p>The existing HVAC system consists of a closed loop hot water system served by a boiler and several evaporative coolers. The boiler and water treatment systems are in good condition. Several ceiling mounted heating units are not operational due to missing parts and they have reached the end of their expected life. There are also several evaporative coolers that are not working or are in need of replacement. This project would provide for replacing all of the heating units and evaporative coolers.</p> <p>This project is in construction under CIP 21-M02(8)</p> <p>This project or a portion thereof was previously recommended in the FCA report dated 08/22/2007 and 09/18/2013. It has been amended accordingly to reflect conditions observed during the most recent survey date of 05/09/2023.</p>	11264	Square Foot	\$614,000.00	\$ 55.00

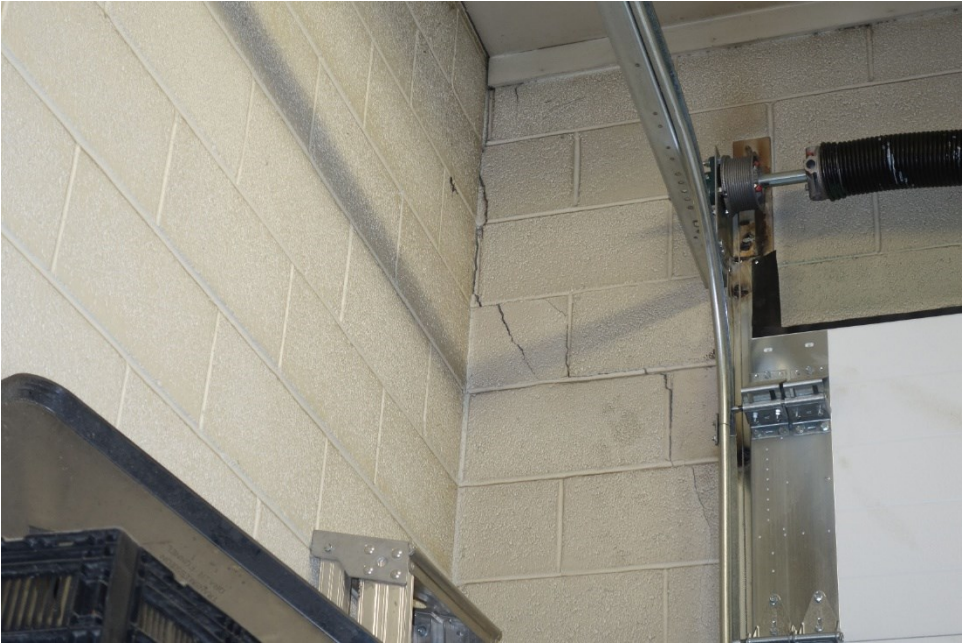
QUANTITY	UNITS	TOTAL	SF COST
The CMU exterior wall has noticeable cracks located near the top opening of an overhead door, possibly caused by stress concentrations at the corner of the opening. This project would provide for an assessment to be done by a Structural Engineer to identify the cause and whether repairs are needed. Future recommendations and cost for possible repairs are not included in this project.	1	Package	\$ 5,000.00	\$ 0.00

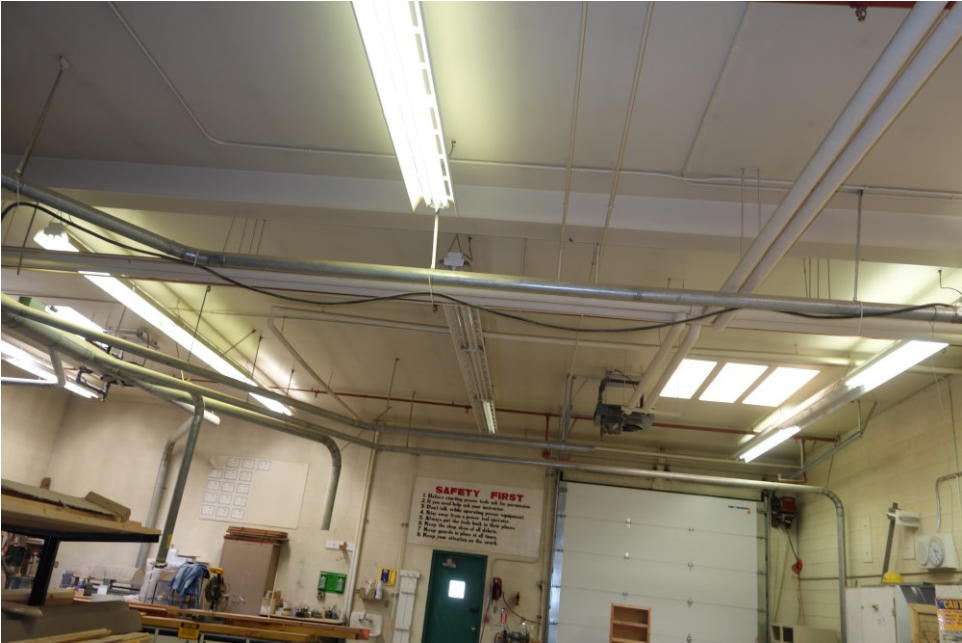
QUANTITY	UNITS	TOTAL	SF COST
<p>The existing lighting fixtures are the older fluorescent type, and are not energy efficient. This project will upgrade fixtures to higher efficiency units with a longer life cycle. F28 T-8 lamps with electronic ballasts are suggested. Occupancy sensors will be installed in restrooms, closets and other low occupancy areas for additional savings. Any electrical wiring upgrades are not included in this estimate.</p> <p>This project is in design under CIP 21-S08(6).</p> <p>This project or a portion there of was previously recommended in the FCA reports dated 08/19/2002, 08/22/2007 and 09/18/2013. It has been amended accordingly to reflect conditions observed during the most recent survey date of 052/09/2023.</p>	11264	Square Foot	\$56,300.00	\$ 5.00

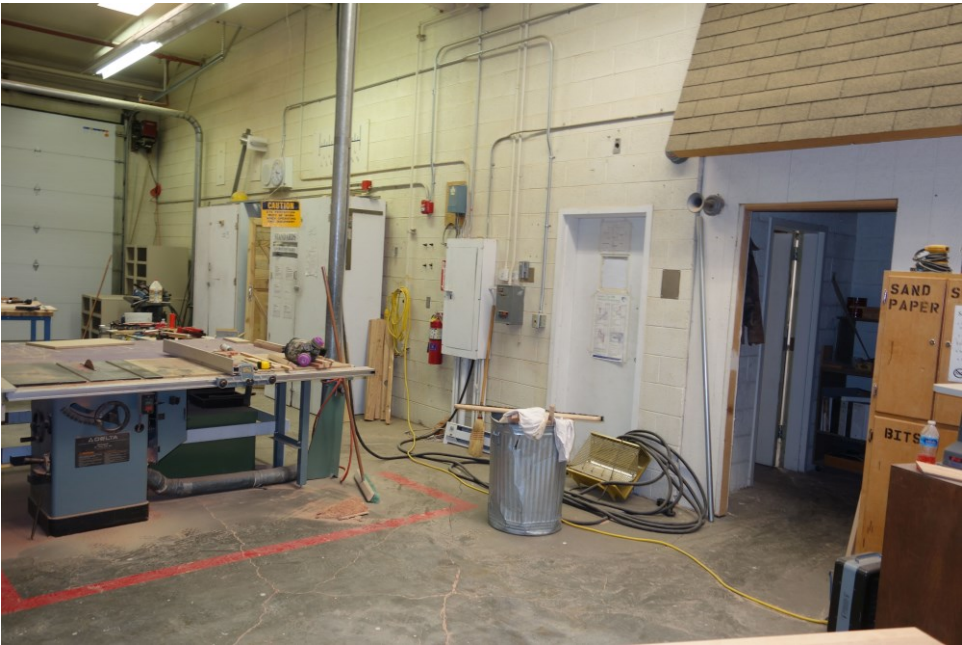
QUANTITY	UNITS	TOTAL	SF COST
<p>The interior doors in this building are hollow core wood units and are damaged from general wear and tear. This project would provide for the installation of new solid core metal interior doors including frames, lever action door handles, hardware and paint. Removal and disposal of the existing doors is included in this cost estimate. A total of 10 interior doors was used in this estimate.</p> <p>This project or a portion thereof was previously recommended in the FCA report dated 08/22/2007 and 09/18/2013. It has been amended accordingly to reflect conditions observed during the most recent survey date of 05/09/2023.</p>	10	Each	\$15,000.00	\$ 1.00

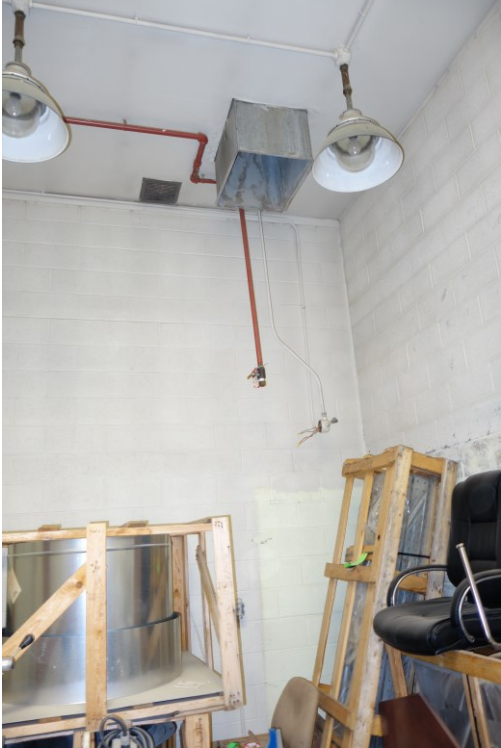
QUANTITY	UNITS	TOTAL	SF COST
<p>The building has a paint room which is used by the wood shop, automotive repair shop and various other uses. The equipment is antiquated and obsolete and is not presently used. This project provides funding to remodel the paint booth/ room in order to bring it up to current standards, including necessary electrical, egress and OSHA upgrades.</p> <p>This project or a portion there of was previously recommended in the FCA reports dated 08/19/2002, 08/22/2007 and 09/18/2013. It has been amended accordingly to reflect conditions observed during the most recent survey date of 05/09/2023.</p>	1	Package	\$75,000.00	\$ 7.00

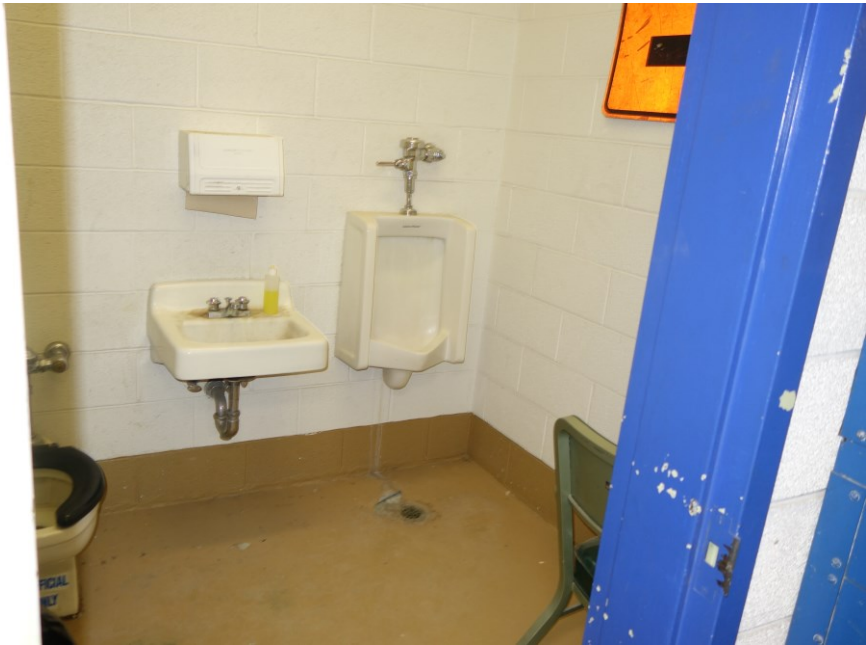
QUANTITY	UNITS	TOTAL	SF COST
<p>The four restrooms in the building are original to the building and in overall poor condition. The finishes, fixtures, cabinets, toilets, showers and exhaust fans are showing signs of wear and deterioration and none of them meet the Americans with Disabilities Act (ADA) requirements. A complete retrofit of each restroom is necessary. This project would provide funding for construction of four unisex accessible restrooms. These items may include a new sink, toilet, hardware, mirrors, fixtures, flooring and paint. The 2018 IBC, ICC/ANSI A117.1 - 2009, NRS 338.180 and the most current version of the ADA Standards For Accessible Design were used as a reference for this project.</p> <p>This project or a portion thereof was previously recommended in the FCA report dated 08/22/2007, 09/18/2013 and 09/18/2013. It has been amended accordingly to reflect conditions observed during the most recent survey date of 05/09/2023.</p>	4	Each	\$80,000.00	\$ 7.00

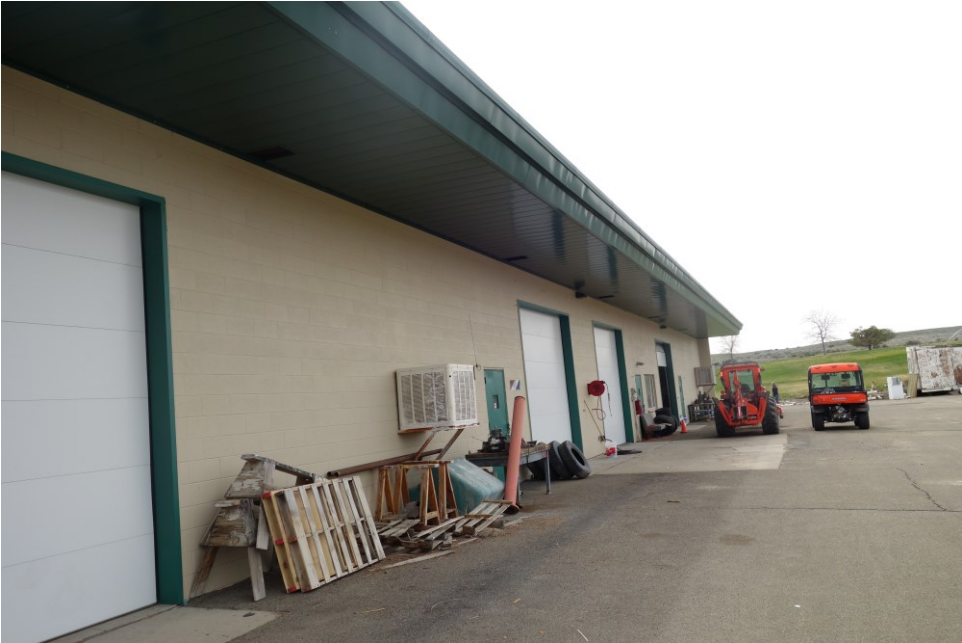
QUANTITY	UNITS	TOTAL	SF COST
The exterior finishes were in fair condition. It is important to maintain the finish, weather resistance and appearance of the building. This project would provide funding to protect the exterior of the building excluding the roof. Included in the cost is painting the concrete masonry unit walls and caulking of the windows, flashing, fixtures and all other penetrations. It is recommended that the building be painted and caulked in the next 4 - 6 years and that this project be scheduled on a cyclical basis to maintain the integrity of the structure.	11264	Square Foot	\$56,300.00	\$ 5.00

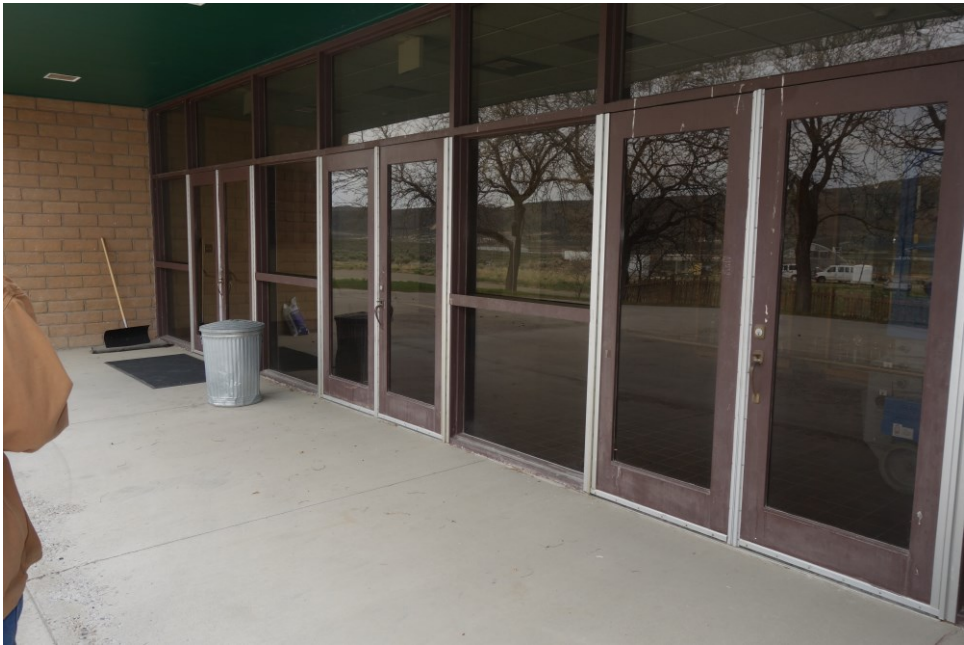
QUANTITY	UNITS	TOTAL	SF COST
<p>The entrances to the building are a mix of single leaf and double leaf commercial grade metal door assemblies and a storefront entrance system at the main entrance. None of these are ADA compliant. The doors and frames are old damaged and are in need of replacement. This project would provide for the installation of new metal door assemblies with lever-operated hardware and a new storefront entrance system complete with all required ADA accessible hardware. Painting of the new doors and removal and disposal of the old doors is included in this estimate. 10 doors were used for this estimate. The 2018 IBC, ICC/ANSI A117.1 - 2009, NRS 338.180 and the most current version of the ADA Standards For Accessible Design were used as a reference for this project.</p> <p>This project or a portion thereof was previously recommended in the FCA report dated 08/22/2007 and 09/18/2013. It has been amended accordingly to reflect conditions observed during the most recent survey date of 05/09/2023.</p>	10	Package	\$239,700.00	\$ 16.00

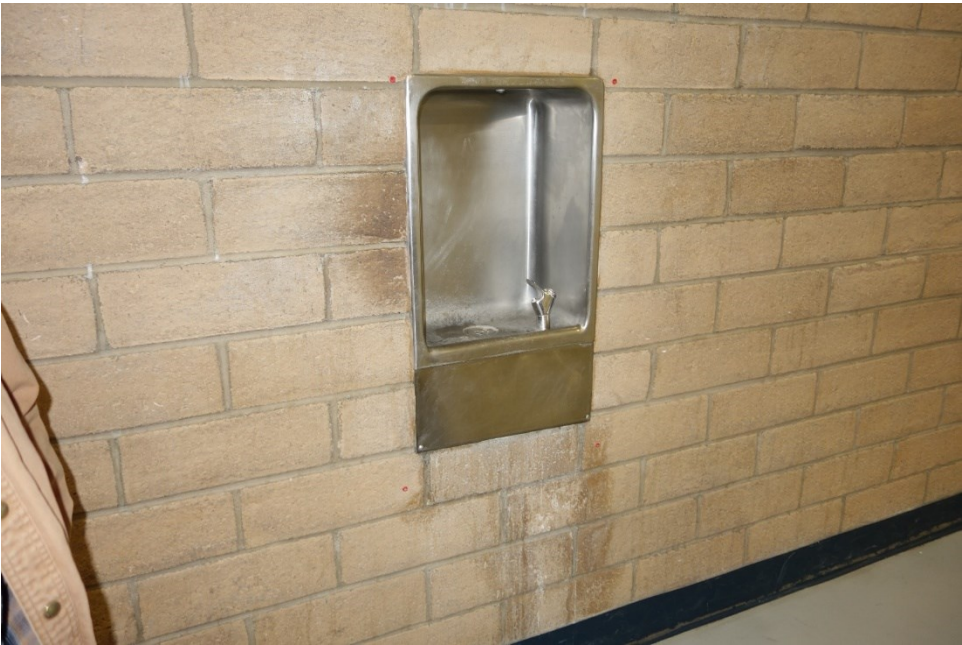
QUANTITY	UNITS	TOTAL	SF COST
<p>This building contains a water fountain that is not ADA compliant. The 2018 IBC Section 1109.5 states where drinking fountains are provided on an exterior site, on a floor or within a secured area, no fewer than two drinking fountains shall be provided. One shall comply with the requirements for people who use a wheelchair and one shall comply with the requirements for standing persons. This project would provide funding for the purchase and installation of two drinking fountains to meet the ADA requirements.</p> <p>This project or a portion thereof was previously recommended in the FCA report dated 09/18/2013. It has been amended accordingly to reflect conditions observed during the most recent survey date of 05/09/2023.</p>	1	Each	\$ 2,500.00	\$ 0.00

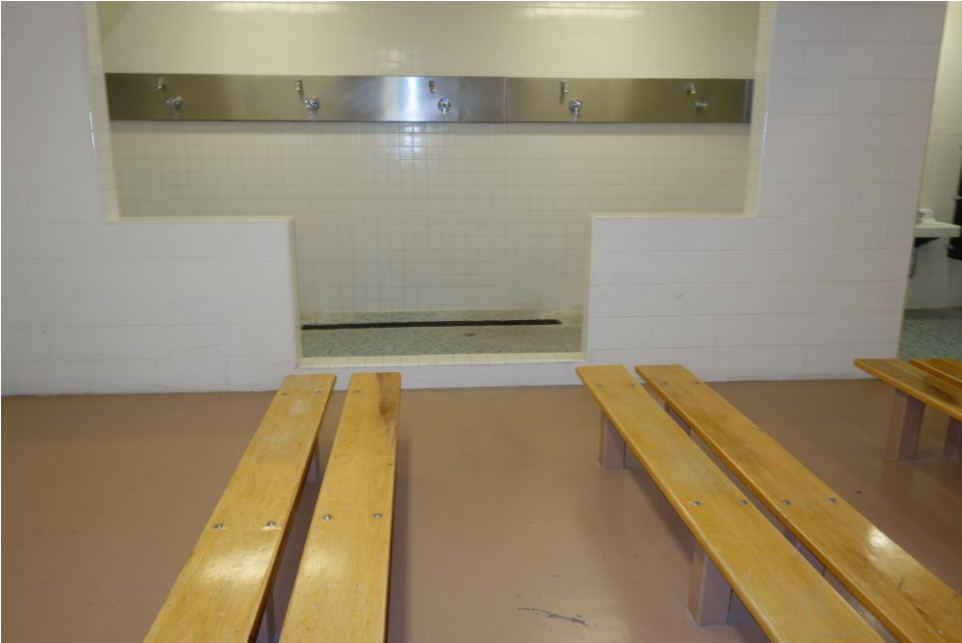
QUANTITY	UNITS	TOTAL	SF COST
<p>The restroom and shower fixtures in the locker rooms are worn and damaged from many years of use including the water closets, urinals, lavatories, faucets, shower heads and handles. Many fixtures are or have been leaking and have caused extensive scaling and staining to the fixtures themselves. It is recommended that all fixtures be replaced with new ADA compliant units. This project includes removal and disposal of the existing fixtures and installation of new fixtures. The 2018 IBC, ICC/ANSI A117.1 - 2009, NRS 338.180 and the most current version of the ADA Standards For Accessible Design were used as a reference for this project.</p> <p>This project or a portion thereof was previously recommended in the FCA report dated 08/22/2007 and 09/18/2013. It has been amended accordingly to reflect conditions observed during the most recent survey date of 05/09/2023.</p>	1	Package	\$50,000.00	\$ 3.00

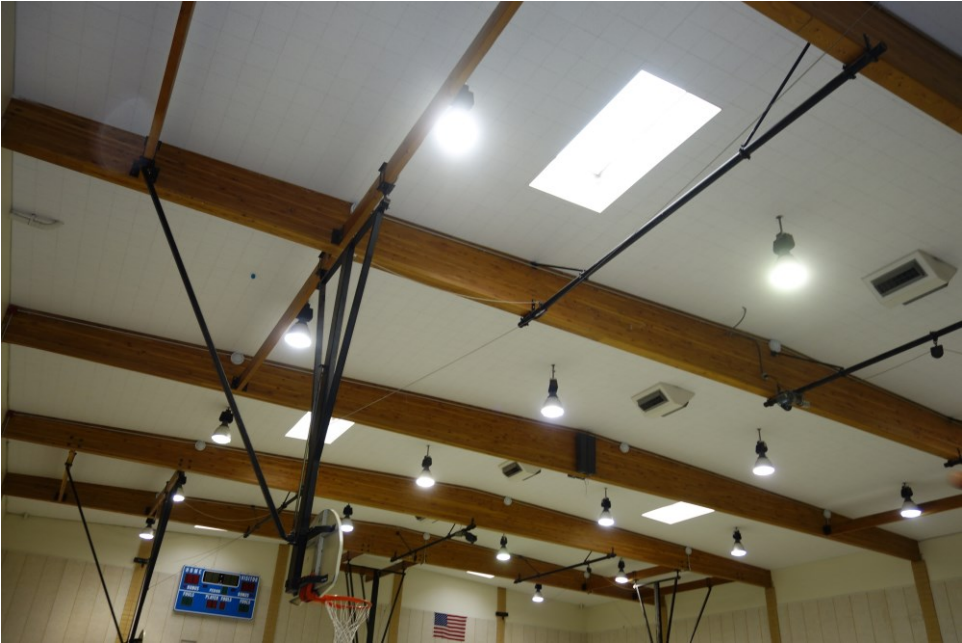
QUANTITY	UNITS	TOTAL	SF COST
<p>The existing lighting fixtures are the older fluorescent type, and are not energy efficient. This project will upgrade T-12 lamps to T-8 lamps with electronic ballasts and upgrade the HID (high intensity discharge) lamps to current standards, resulting in increased efficiency and reduced costs associated with illumination and HVAC load. Occupancy sensors will be installed in restrooms and other low occupancy areas for additional savings. Any electrical wiring upgrades are not included in this estimate.</p> <p>This project is in design under CIP 21-S08(6).</p> <p>This project or a portion there of was previously recommended in the FCA reports dated 08/19/2002, 08/22/2007 and 09/18/2013. It has been amended accordingly to reflect conditions observed during the most recent survey date of 05/09/2023.</p>	15316	Square Foot	\$76,600.00	\$ 5.00
