STATE OF NEVADA STATE PUBLIC WORKS DIVISION

FACILITY CONDITION ASSESSMENT REPORT FOR:

DEPT OF HEALTH AND HUMAN SERVICES
DIVISION OF CHILD AND FAMILY SERVICES
NYTC

SITE #: 9938 NEVADA YOUTH TRAINING CENTER SITE - ELKO
100 YOUTH CENTER RD
ELKO, NV 89801-9565

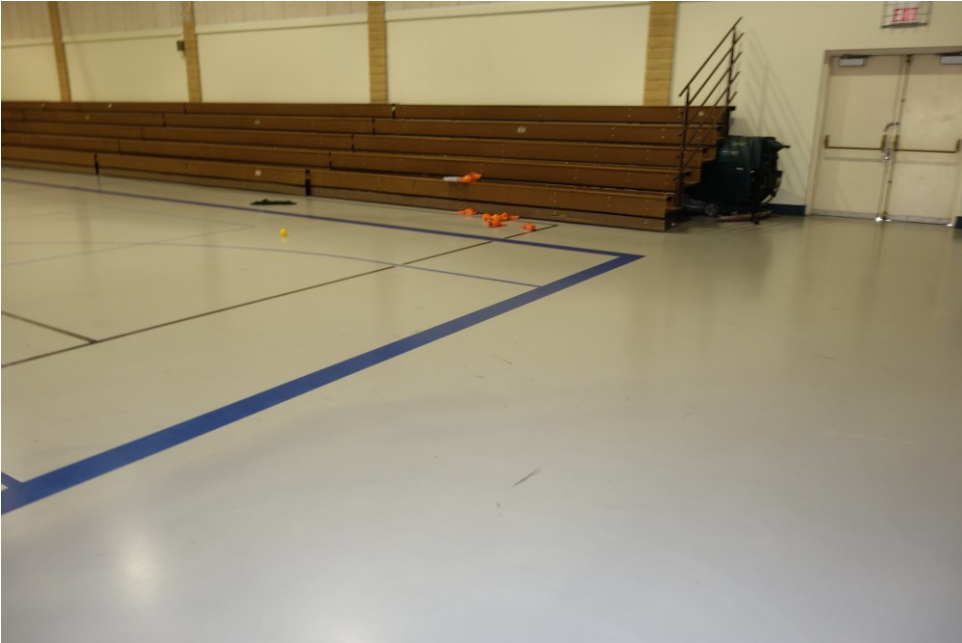
QUANTITY	UNITS	TOTAL	SF COST
<p>The existing rubber flooring in the gymnasium is reaching the end of its useful life. This project would provide for the removal of the existing flooring and installation of a new wood floor. A 25/32" thick maple on a sleeper system was used for this estimate.</p> <p>This project or a portion thereof was previously recommended in the FCA report dated 08/22/2007 and 09/18/2013. It has been amended accordingly to reflect conditions observed during the most recent survey date of 05/09/2023.</p>	8268	Square Foot	\$611,100.00	\$ 40.00

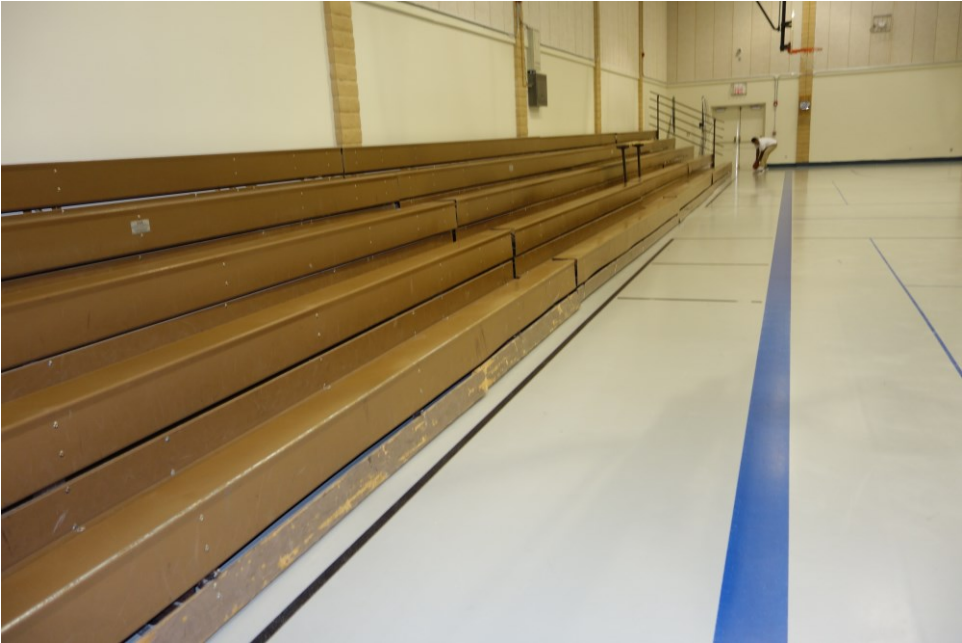
QUANTITY	UNITS	TOTAL	SF COST
<p>The existing wood bleachers in the gymnasium are reaching the end of their useful life. This project would provide for the removal and disposal of the existing bleachers and installation of new bleachers. Wood, manually telescoping bleachers to seat 500 people were used for this estimate.</p> <p>This project or a portion thereof was previously recommended in the FCA report dated 08/22/2007 and 09/18/2013.. It has been amended accordingly to reflect conditions observed during the most recent survey date of 05/09/2023.</p>	500	Each	\$160,000.00	\$ 10.00

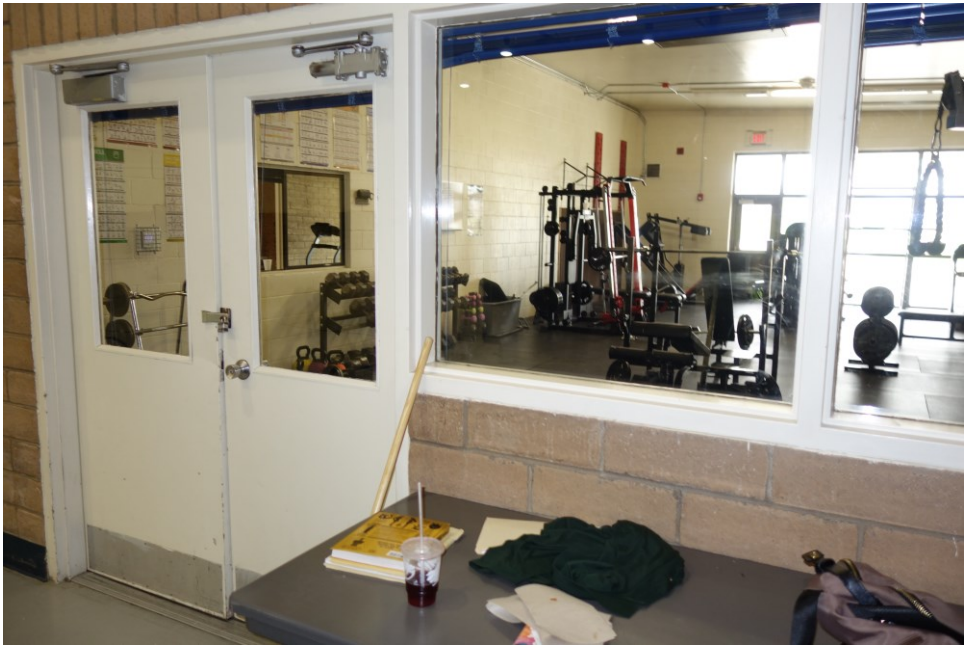
QUANTITY	UNITS	TOTAL	SF COST
<p>The interior doors in this building are hollow core metal units and most are damaged from general wear and tear. This project would provide for the installation of new solid core interior doors including frames, lever action door handles, hardware and paint. Removal and disposal of the existing doors is included in this cost estimate. A total of 14 interior doors was used in this estimate.</p> <p>This project or a portion thereof was previously recommended in the FCA report dated 08/22/2007 and 09/18/2013. It has been amended accordingly to reflect conditions observed during the most recent survey date of 05/09/2023.</p>	14	Each	\$28,000.00	\$ 2.00

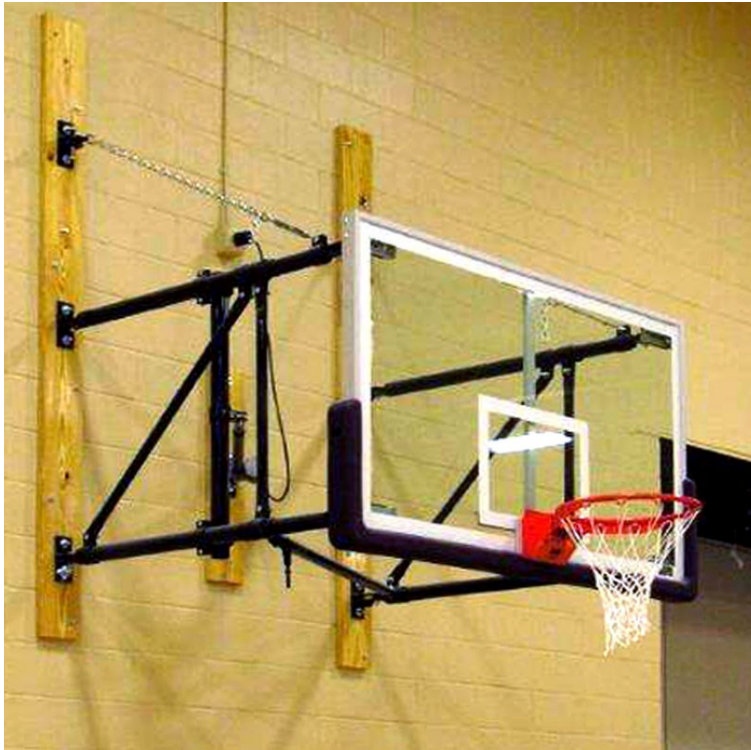
0233 GYMNASIUM

QUANTITY	UNITS	TOTAL	SF COST
<p>The existing backstops in the gymnasium are reaching the end of their useful life and should be scheduled for replacement. The cables and mechanisms are worn out and do not function properly. This project would provide for the removal and disposal of the existing backstops and installation of new ones. An electrically operated, ceiling suspended, fold up basketball backstop was used for this estimate.</p> <p>This project or a portion thereof was previously recommended in the FCA report dated 08/22/2007 and 09/18/2013. It has been amended accordingly to reflect conditions observed during the most recent survey date of 05/09/2023.</p>	6	Each	\$120,000.00	\$ 8.00

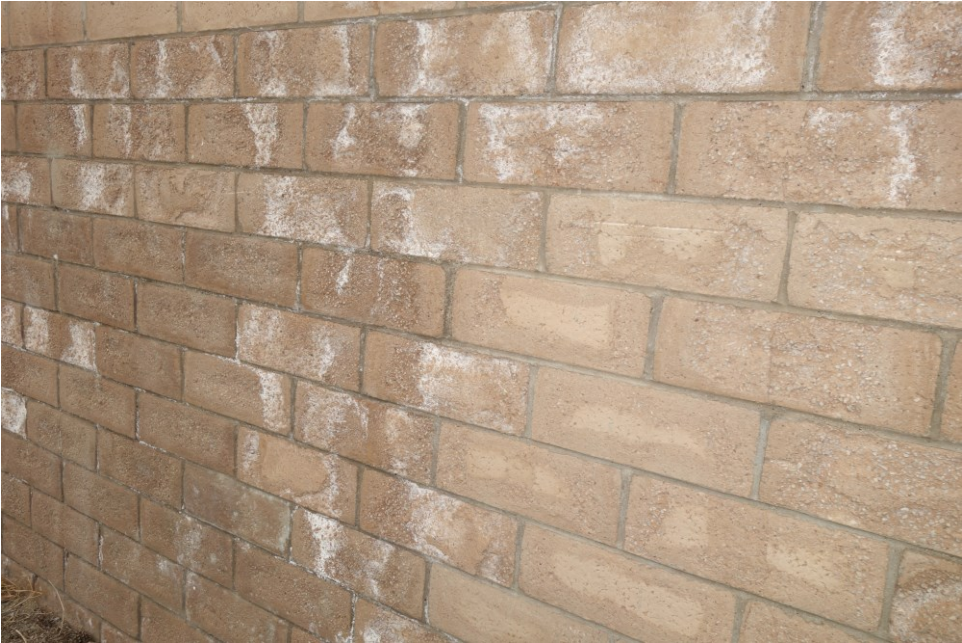
0233 GYMNASIUM

QUANTITY	UNITS	TOTAL	SF COST
The exterior finishes were in fair condition. It is important to maintain the finish, weather resistance and appearance of the building. This project would provide funding to protect the exterior of the building excluding the roof. Included in the cost are cleaning and sealing the brick masonry and caulking of the windows, flashing, fixtures and all other penetrations. It is recommended that the building be sealed and caulked in the next 4 - 6 years and that this project be scheduled on a cyclical basis to maintain the integrity of the structure.	15316	Square Foot	\$76,580.00	\$ 5.00

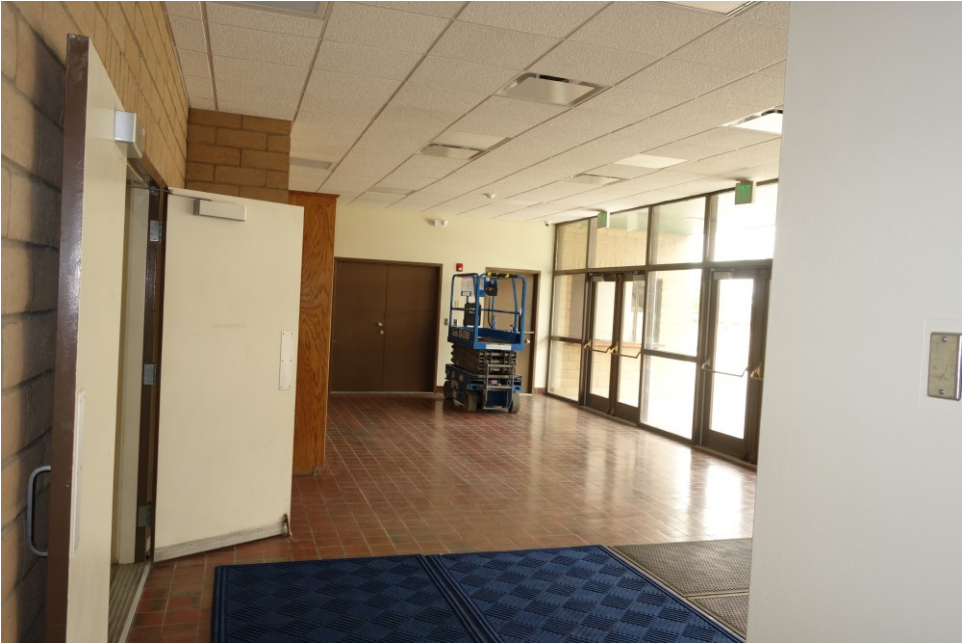
0233 GYMNASIUM

QUANTITY	UNITS	TOTAL	SF COST
The interior finishes are in fair condition. It is recommended that the interior walls and ceilings be painted at least once in the next 4 - 6 years and that this project be scheduled on a cyclical basis to maintain the integrity of the structure. Prior to painting, all surfaces should be repaired and prepped. An epoxy-based paint should be utilized in wet areas for durability.	15316	Square Foot	\$91,900.00	\$ 6.00

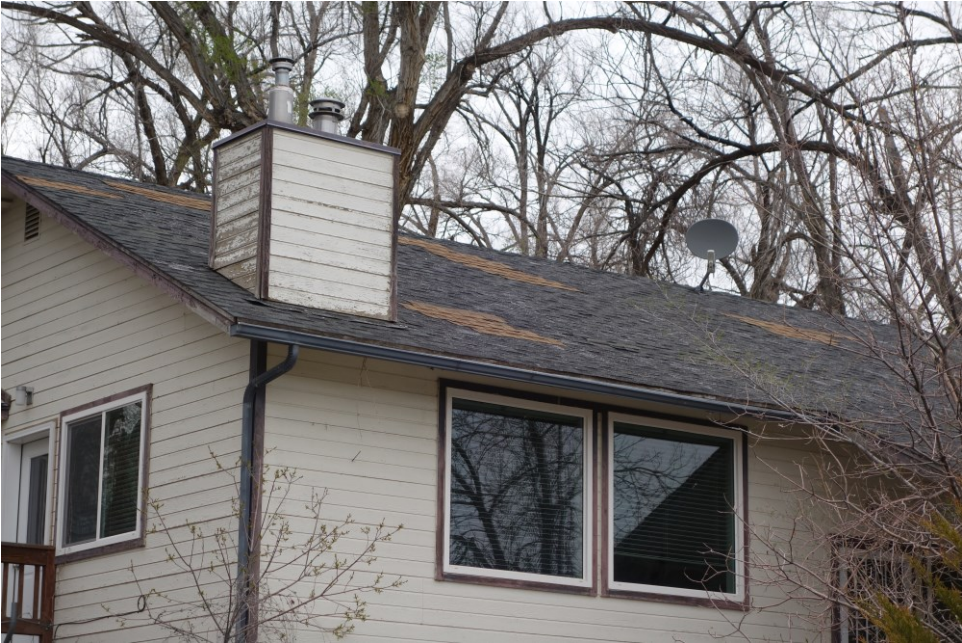
0234 SUPERINTENDENT'S RESIDENCE

QUANTITY	UNITS	TOTAL	SF COST
<p>The asphalt composition shingle roof on this building was in poor condition at the time of the survey. It is recommended that this building be re-roofed in the next 1-2 years with a new 50 year asphalt composition roofing shingle and new underlayment. This estimate includes removal and disposal of the old roofing.</p> <p>This project or a portion there of was previously recommended in the FCA reports dated 08/19/2002, 08/22/2007 and 09/18/2013. It has been amended accordingly to reflect conditions observed during the most recent survey date of 05/09/2023.</p>	1456	Square Foot	\$32,000.00	\$ 22.00

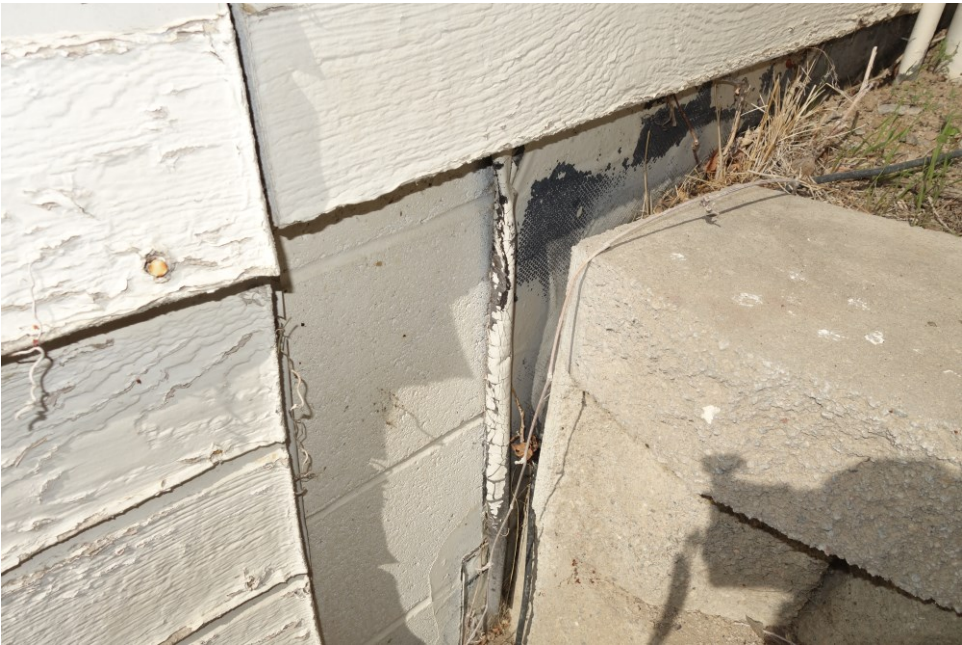
0234 SUPERINTENDENT'S RESIDENCE

QUANTITY	UNITS	TOTAL	SF COST
<p>The house has considerable damage to the siding and foundation from improper drainage. The grade does not slope away from the rear of the building. This is causing water to pool up against the rear wall and damage siding and the concrete foundation walls. This project would create positive flow away from the building by regrading and installing French drains as needed.</p> <p>This project or a portion thereof was previously recommended in the FCA report dated 08/22/2007 and 09/18/2013. It has been amended accordingly to reflect conditions observed during the most recent survey date of 05/09/2023.</p>	1	Package	\$15,000.00	\$ 10.00

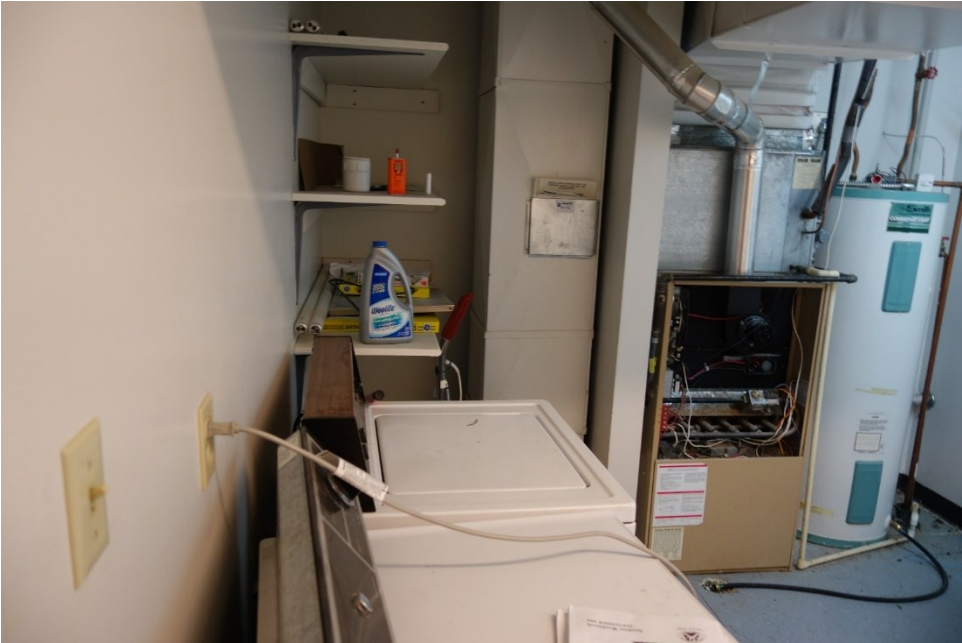
0234 SUPERINTENDENT'S RESIDENCE

QUANTITY	UNITS	TOTAL	SF COST
<p>The existing HVAC system consists of a natural gas fired furnace installed in 1987 and a split system air conditioner installed in 1990. The equipment is not energy efficient and has reached the end of its expected and useful life. The R-22 refrigerant in the cooling system is no longer EPA compliant and its production was phased out completely January 1, 2020. This project would provide for installation of new HVAC equipment and cleaning of the existing duct work and grilles. This project includes removal and disposal of the existing HVAC units and all required connections to utilities.</p> <p>This project or a portion thereof was previously recommended in the FCA report dated 09/18/2013. It has been amended accordingly to reflect conditions observed during the most recent survey date of 05/09/2023.</p>	1456	Square Foot	\$29,100.00	\$ 20.00

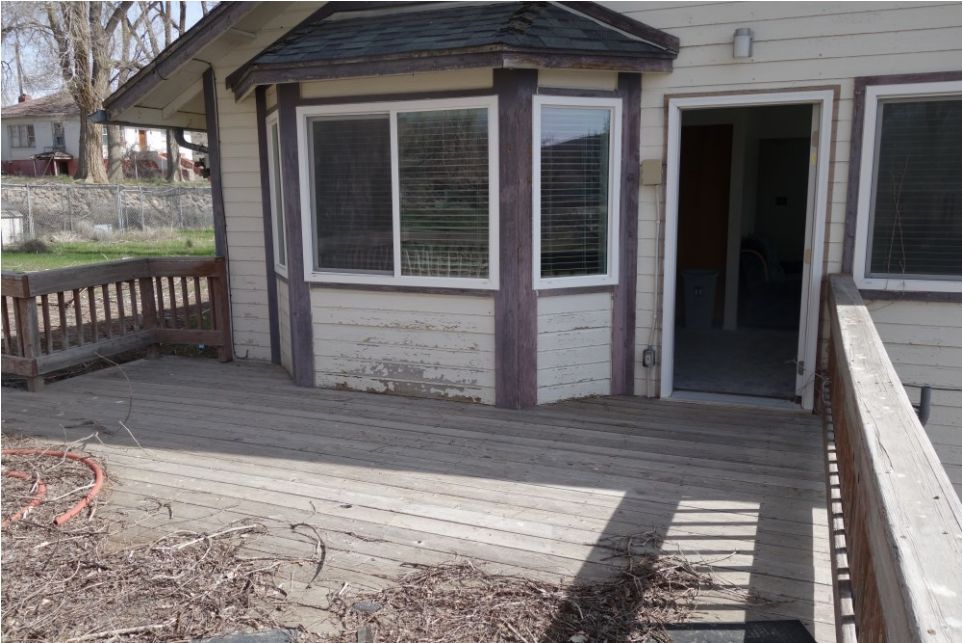
0234 SUPERINTENDENT'S RESIDENCE

QUANTITY	UNITS	TOTAL	SF COST
The exterior finishes were in poor condition. It is important to maintain the finish, weather resistance and appearance of the building. This project would provide funding to protect the exterior of the building excluding the roof. Included in the cost is sanding, priming and painting and caulking of the windows, flashing, fixtures and all other penetrations. It is recommended that the building be painted in the next 2 - 3 years and that this project be scheduled on a cyclical basis to maintain the integrity of the structure. This project should be implemented concurrently with the EXTERIOR SIDING REPAIRS project.	1456	Square Foot	\$15,000.00	\$ 10.00

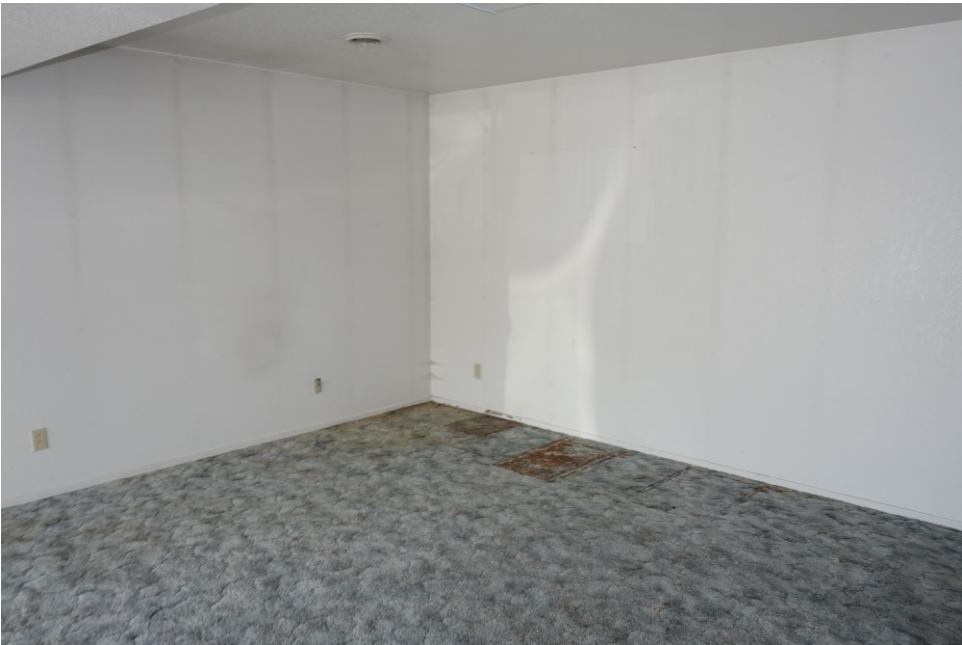
0234 SUPERINTENDENT'S RESIDENCE

QUANTITY	UNITS	TOTAL	SF COST
<p>The carpet in the building is showing signs of extreme wear and should be scheduled for replacement. It is recommended that the carpet be replaced with heavy duty commercial grade carpet in the next 2 - 3 years.</p> <p>This project or a portion thereof was previously recommended in the FCA report dated 09/18/2013. It has been amended accordingly to reflect conditions observed during the most recent survey date of 05/09/2023.</p>	1200	Square Foot	\$14,400.00	\$ 10.00

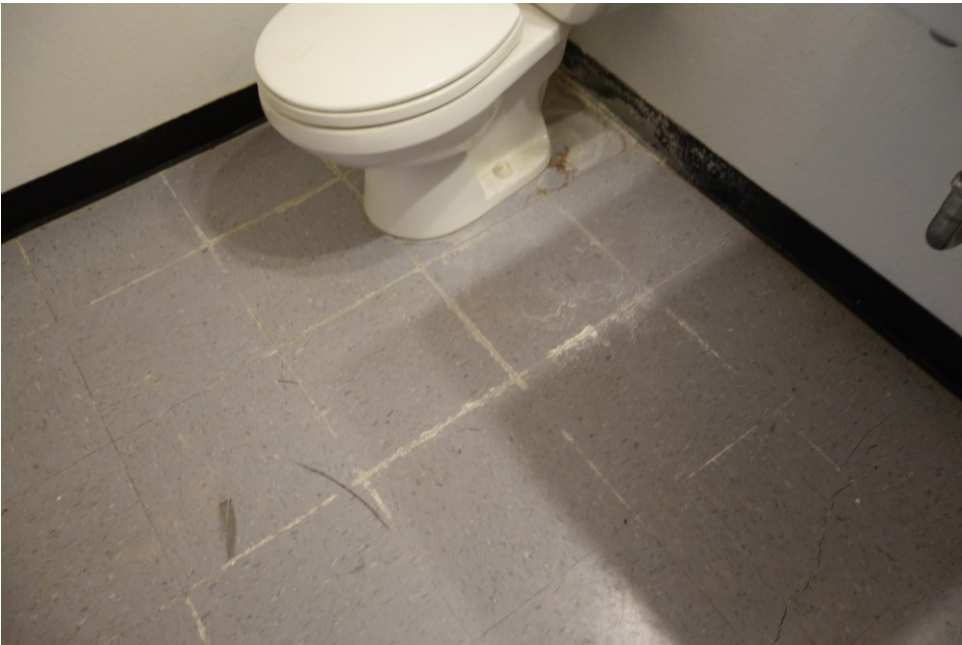
0234 SUPERINTENDENT'S RESIDENCE

QUANTITY	UNITS	TOTAL	SF COST
The 3 restrooms in the residence appear to be original to the building and show signs of cosmetic damage and wear. The basement bathroom floor shows signs of water damage. The damage appears to surround the toilet indicating that the source of water most likely is from the toilet itself. The three bathrooms are in need of complete refurbishment including replacement flooring, fixtures, shower surrounds, casework and paint.	3	Each	\$45,000.00	\$ 31.00

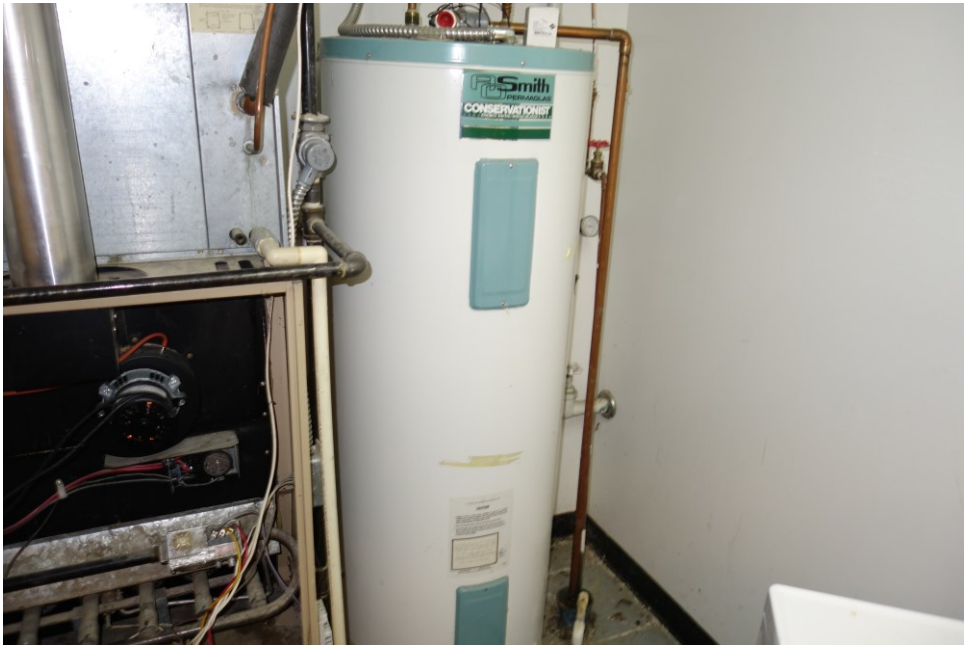
0234 SUPERINTENDENT'S RESIDENCE

QUANTITY	UNITS	TOTAL	SF COST
<p>There is a 50 gallon natural gas-fired water heater in the building. The average life span of a water heater is eight to ten years. With the passage of time and constant use, this unit is showing signs of wear and should be scheduled for replacement in the next 2 - 3 years. It is recommended that a new gas-fired water heater be installed. Removal and disposal of the existing equipment is included in this estimate.</p> <p>This project or a portion thereof was previously recommended in the FCA report dated 09/18/2013. It has been amended accordingly to reflect conditions observed during the most recent survey date of 05/09/2023.</p>	1	Each	\$ 2,500.00	\$ 2.00

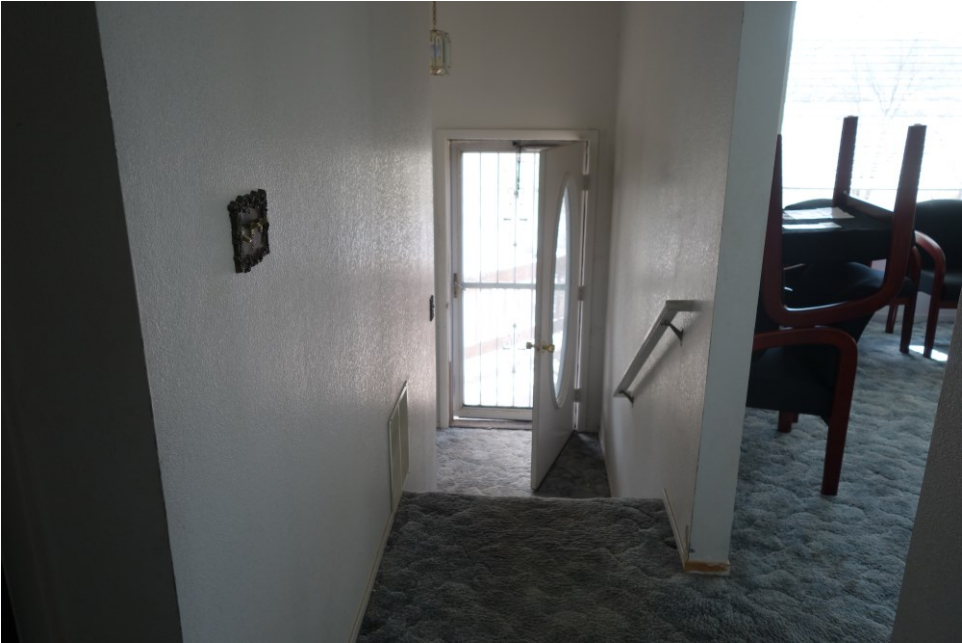
QUANTITY	UNITS	TOTAL	SF COST
The interior finishes are in poor condition. It is recommended that the interior walls and ceilings be painted at least once in the next 4 - 6 years and that this project be scheduled on a cyclical basis to maintain the integrity of the structure. Prior to painting, all surfaces should be repaired and prepped. An epoxy-based paint should be utilized in wet areas for durability.	1456	Square Foot	\$ 7,300.00	\$ 5.00

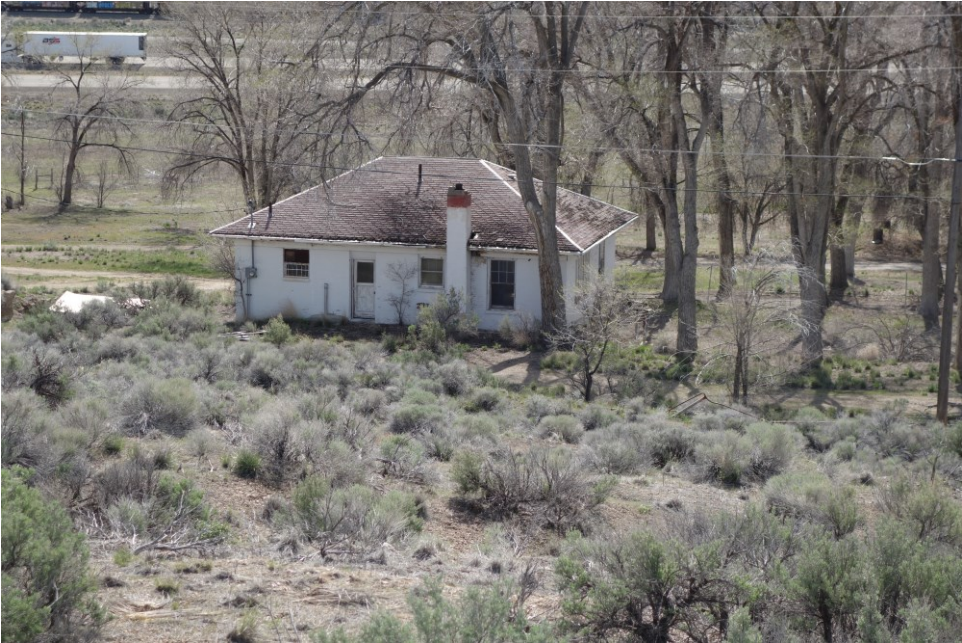
QUANTITY	UNITS	TOTAL	SF COST
<p>This residence is vacant and currently used for incidental storage. The structure is deteriorating including broken windows, doors falling off and roof failing. The broken windows in the building have allowed pigeons, bats and other pests access to the building, with related health hazards and allowed rain to enter the building. In order to preserve the building for future rehabilitation and reuse, this project recommends mothballing it in accordance with the Department of Interior Recommended Guidelines in Preservation Brief 31. Windows and doors will be secured and covered, some with louvers to permit ventilation of the structure. A sump and drain system will keep water from the under floor areas and basement.</p> <p>This project or a portion thereof was previously recommended in the FCA report dated 08/23/2007 and 09/18/2013. It has been amended accordingly to reflect conditions observed during the most recent survey date of 05/09/2023.</p>	890	Square Foot	\$22,300.00	\$ 25.00

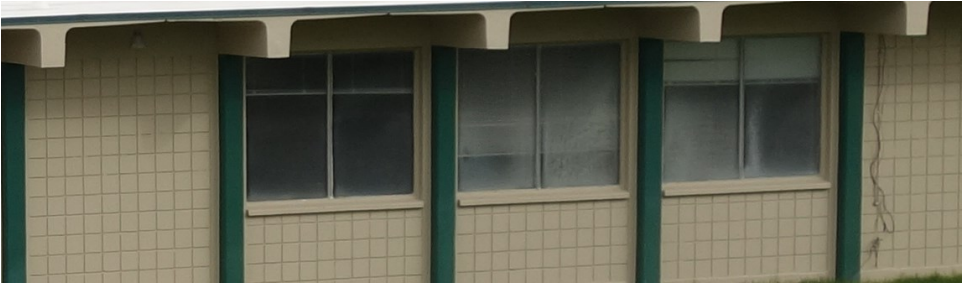
0535 ADVENTURER COTTAGE

QUANTITY	UNITS	TOTAL	SF COST
<p>The building is constructed of concrete masonry units (CMU) with no insulation. The windows are original to the building, and of single pane construction. Buildings of this type are not energy efficient. This project recommends adding an exterior insulating finish system (EIFS) over the CMU and replacing the windows with new dual-pane, higher efficiency units. This estimate includes removal and disposal of the existing windows.</p> <p>This project or a portion there of was previously recommended in the FCA reports dated 08/19/2002, 08/22/2007 and 09/18/2013. It has been amended accordingly to reflect conditions observed during the most recent survey date of 05/09/2023.</p>	1	Package	\$234,400.00	\$ 59.00

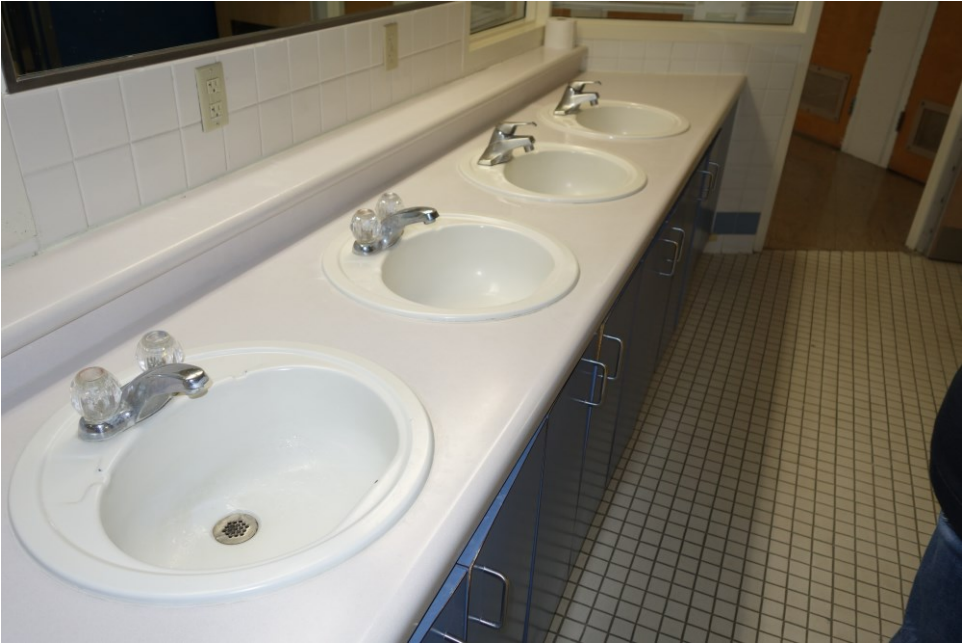
0535 ADVENTURER COTTAGE

QUANTITY	UNITS	TOTAL	SF COST
<p>The sink faucets and shower valves were replaced in 1995. The systems installed have not held up well under the high usage typical in a building of this type, and are beginning to fail. This project recommends replacing the faucets and shower mixing control valves with heavy duty rated commercial grade units and includes disposal of the existing fixtures.</p> <p>This project or a portion there of was previously recommended in the FCA reports dated 08/19/2002 and 08/22/2007. It has been amended accordingly to reflect conditions observed during the most recent survey date of 09/18/2013.</p>	1	Package	\$12,500.00	\$ 3.00

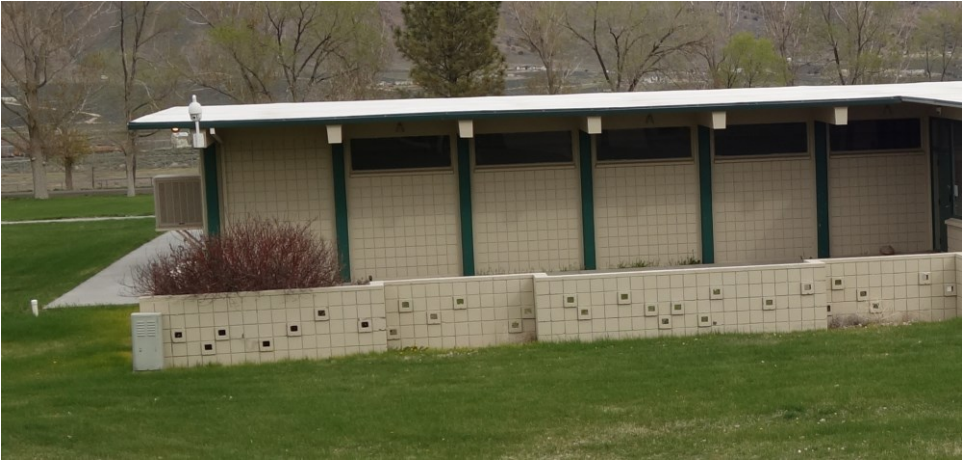
0535 ADVENTURER COTTAGE

QUANTITY	UNITS	TOTAL	SF COST
The exterior finishes were in fair condition. It is important to maintain the finish, weather resistance and appearance of the building. This project would provide funding to protect the exterior of the building excluding the roof. Included in the cost is sanding, priming and painting and caulking of the windows, flashing, fixtures and all other penetrations. It is recommended that the building be painted in the next 4 - 6 years and that this project be scheduled on a cyclical basis to maintain the integrity of the structure.	3990	Square Foot	\$23,900.00	\$ 6.00

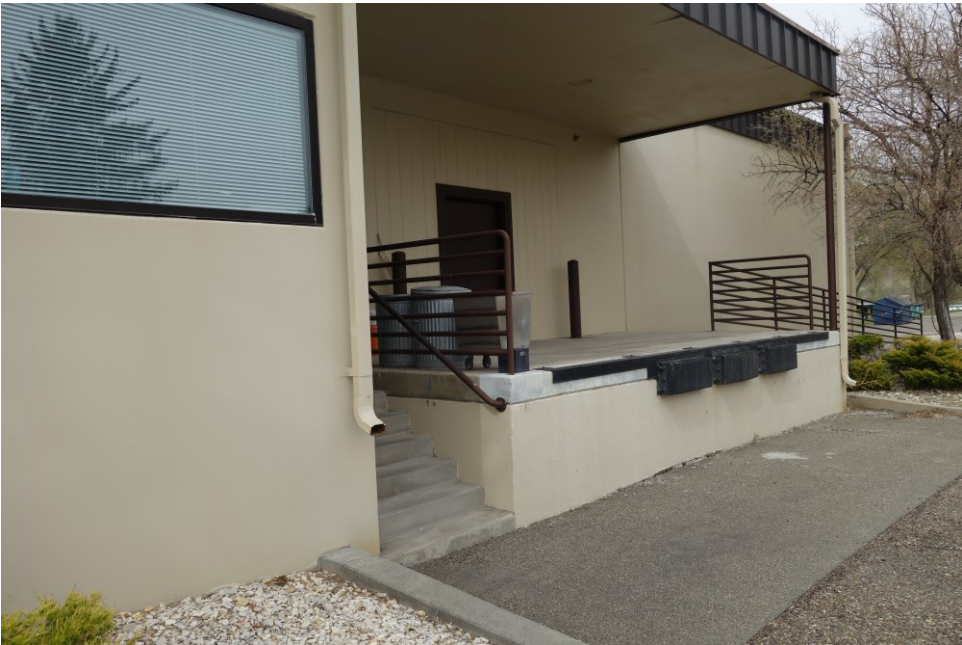
QUANTITY	UNITS	TOTAL	SF COST
<p>The exterior stair handrails on the concrete stairs are older and do not meet code for safety or accessibility. The gripping surfaces are incorrect and they do not have compliant extensions at the top and bottom of the stair. This project recommends the replacement of the handrails on both sides of the stairs. Removal and disposal of the existing railing is included. The 2018 IBC, ICC/ANSI A117.1 - 2009, NRS 338.180 and the most current version of the ADA Standards For Accessible Design were used as a reference for this project.</p> <p>This project or a portion thereof was previously recommended in the FCA report dated 08/21/2007 and 09/18/2013. It has been amended accordingly to reflect conditions observed during the most recent survey date of 05/09/2023.</p>	1	Package	\$ 5,000.00	\$ 1.00

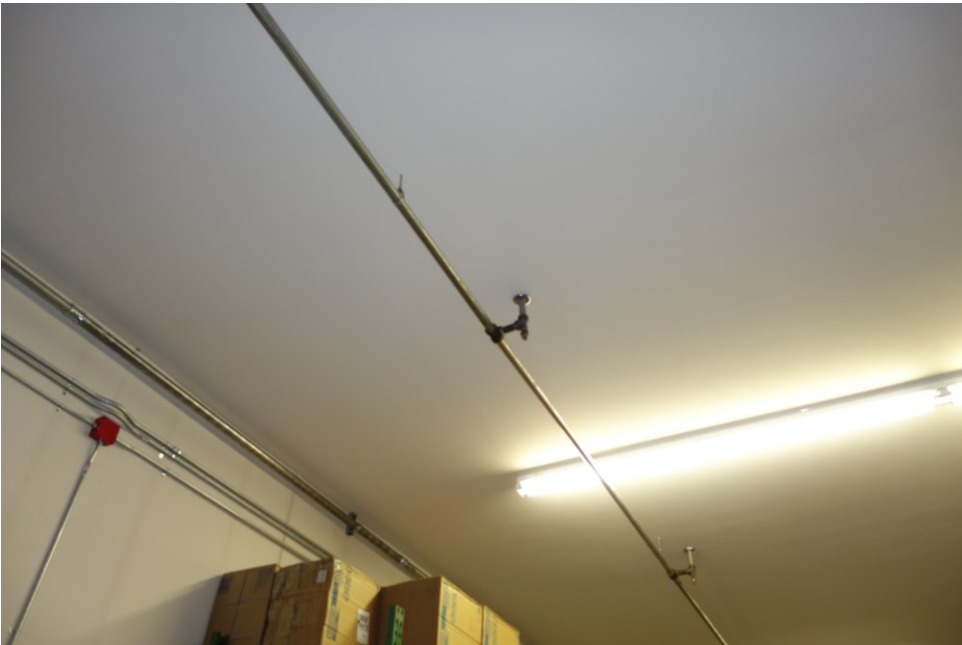
QUANTITY	UNITS	TOTAL	SF COST
<p>The existing lighting fixtures are the older fluorescent type, and are not energy efficient. This project will upgrade fixtures to higher efficiency units with a longer life cycle. F28 T-8 lamps with electronic ballasts are suggested. Occupancy sensors will be installed in restrooms, closets and other low occupancy areas for additional savings. Any electrical wiring upgrades are not included in this estimate.</p> <p>This project is in design under CIP 21-S08(6).</p> <p>This project or a portion there of was previously recommended in the FCA reports dated 08/19/2002, 08/22/2007 and 09/18/2013. It has been amended accordingly to reflect conditions observed during the most recent survey date of 05/09/2023.</p>	7240	Square Foot	\$36,200.00	\$ 5.00

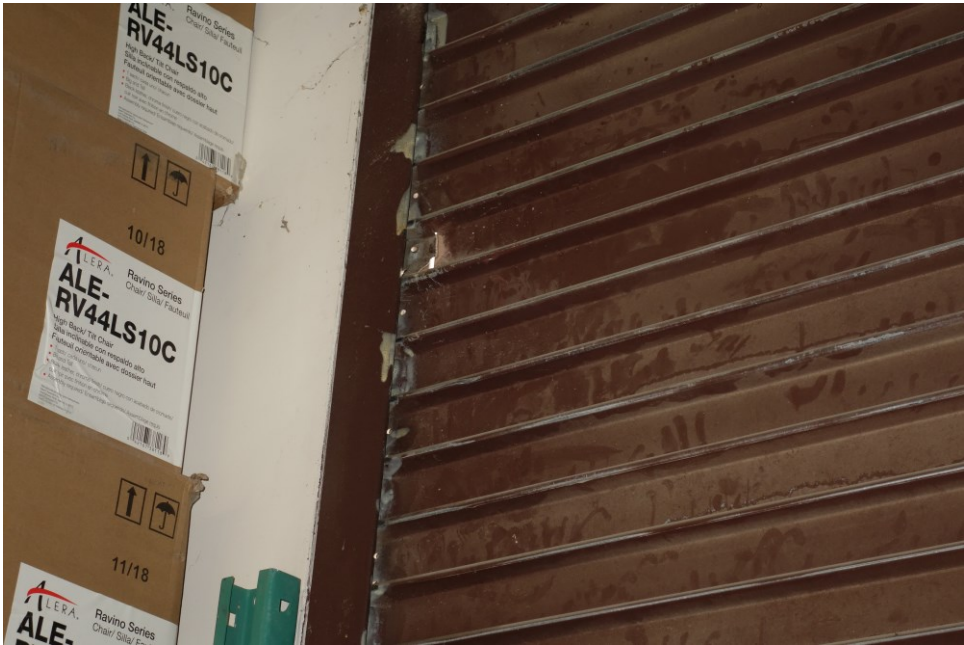
QUANTITY	UNITS	TOTAL	SF COST
<p>The existing 10' x 12' roll-up door does not function properly due to age and abuse and repair parts are difficult to find. It is also uninsulated and not energy efficient. This project would provide for the removal and disposal of the existing door and the purchase and installation of a new manually operated insulated roll-up door.</p> <p>This project or a portion there of was previously recommended in the FCA reports dated 08/19/2002, 08/22/2007 and 09/18/2013. It has been amended accordingly to reflect conditions observed during the most recent survey date of 05/09/2023.</p>	1	Each	\$20,000.00	\$ 3.00

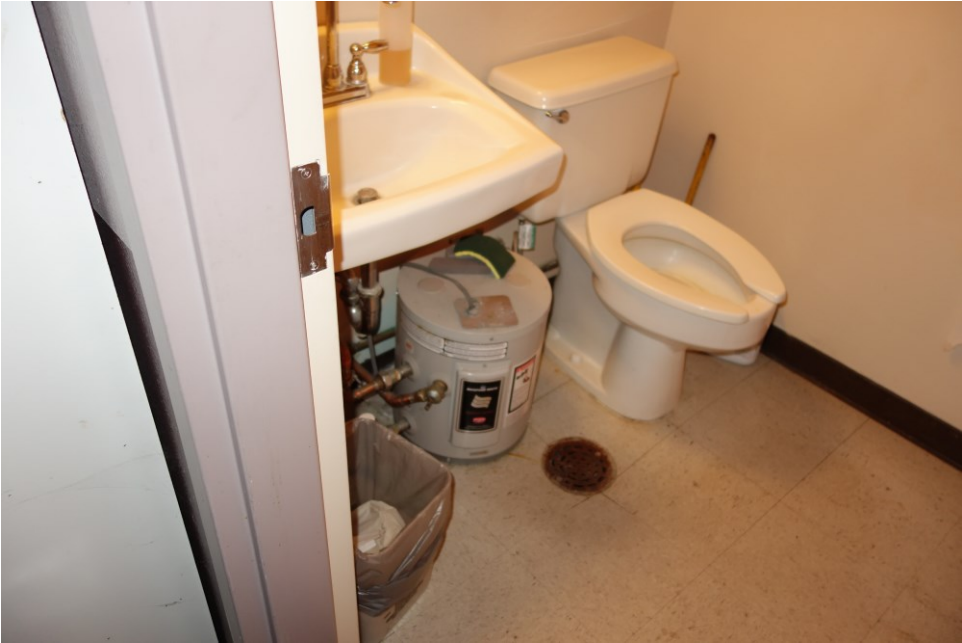
QUANTITY	UNITS	TOTAL	SF COST
2018 IBC Section 1210 requires the installation of smooth, hard, nonabsorbent surfaces in the following restroom areas: on floors in toilet, bathing and shower rooms that extend upward onto the walls at least 4 inches, within 2 feet of the sides of urinals and water closets to a height of not less than 4 feet above the floor and in shower compartments to a height not less than 70 inches above the drain inlet. Accessories such as grab bars, towel bars, paper dispensers and soap dishes, provided on or within walls, shall be installed and sealed to protect structural elements from moisture. This project recommends the installation of Fiberglass Reinforced Panel (FRP) or an equal material to comply with this code section. This project or a portion thereof was previously recommended in the FCA report dated 08/21/2007 and 09/18/2013. It has been amended accordingly to reflect conditions observed during the most recent survey date of 05/09/2023.	1	Package	\$ 4,000.00	\$ 1.00

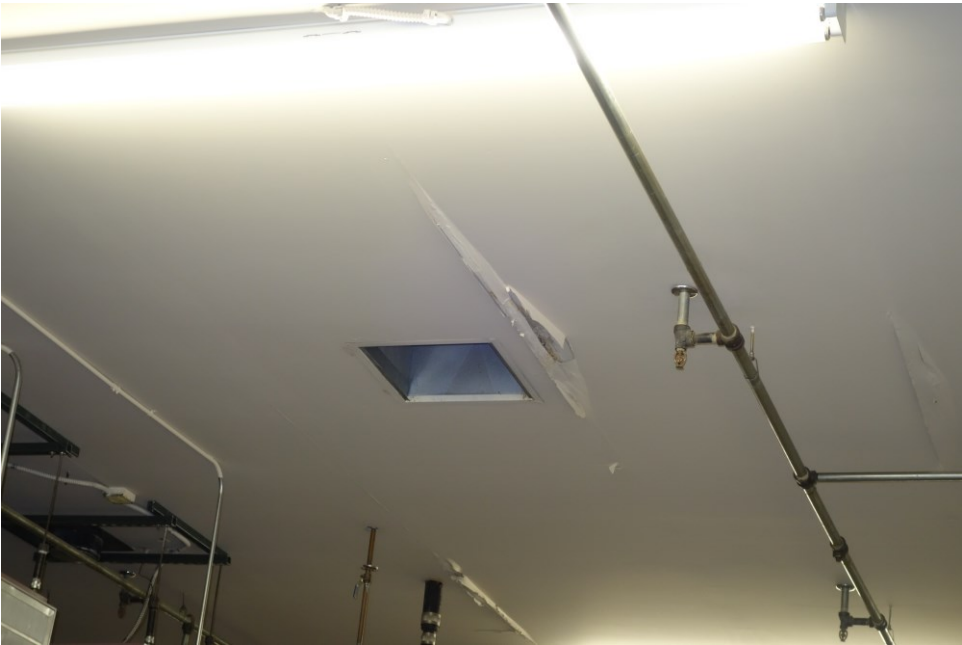
QUANTITY	UNITS	TOTAL	SF COST
The ceiling is damaged in multiple locations due to roof leaks. Once the roofing system has been replaced, the damaged ceiling needs repairs including patching and re-taping seams, finishing mud to match texture and paint.	1	Package	\$ 2,500.00	\$ 0.00

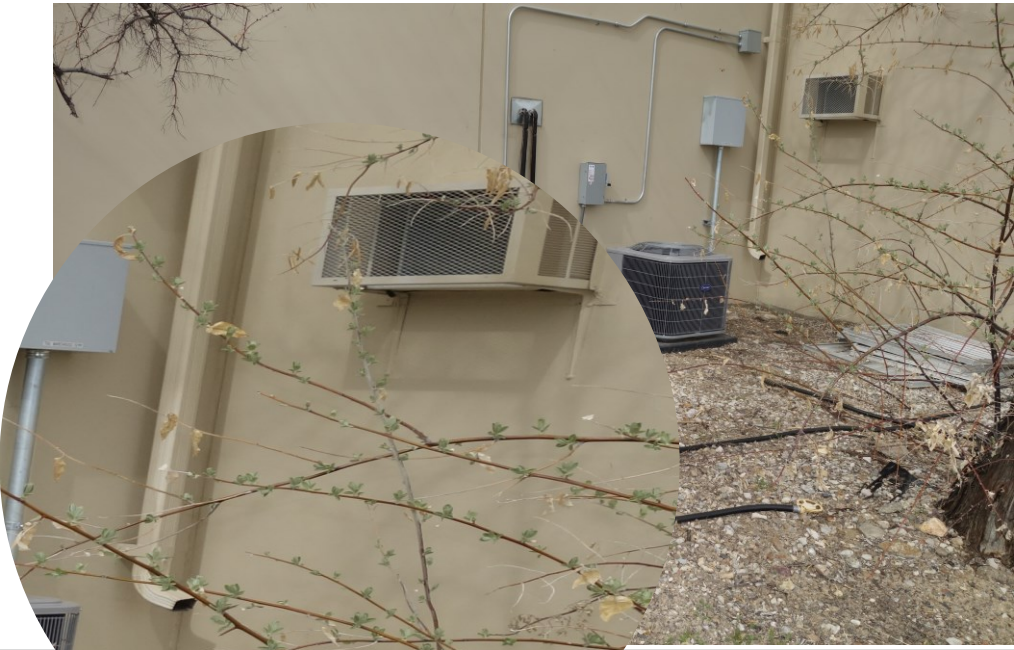
QUANTITY	UNITS	TOTAL	SF COST
<p>The roof drain downspouts currently terminate within inches of the building with no continuous drainage away from the foundation. This is causing the water to pool next to the foundation and damage the foundation and walls. This project would provide for the extension of the roof drains from the downspouts to approximately 5'-0" away from the perimeter of the building to prevent pooling and damage to the building.</p> <p>This project or a portion thereof was previously recommended in the FCA report dated 09/18/2013. It has been amended accordingly to reflect conditions observed during the most recent survey date of 05/09/2023.</p>	1	Package	\$ 5,000.00	\$ 1.00

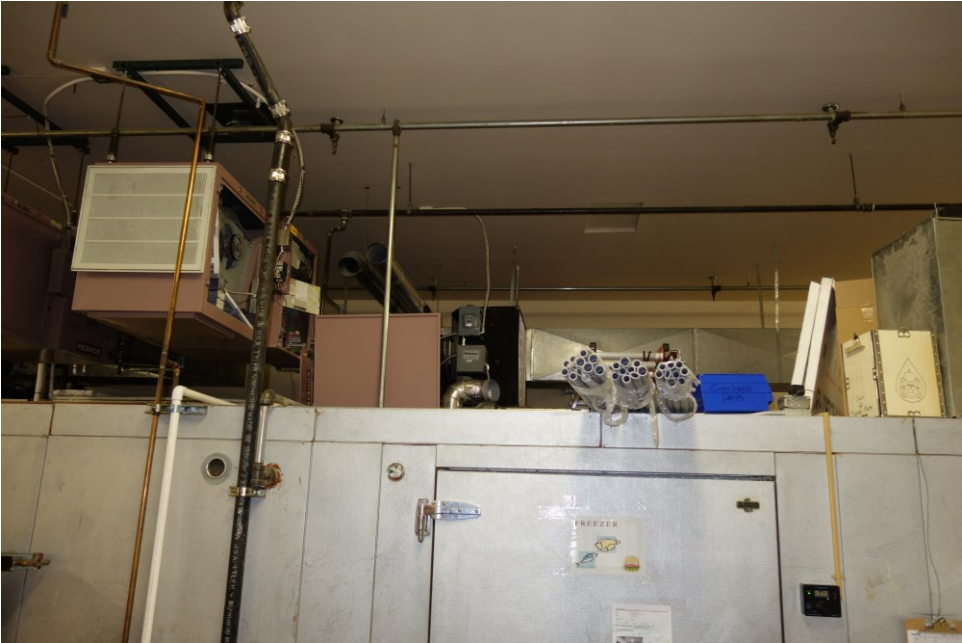
QUANTITY	UNITS	TOTAL	SF COST
The walk-in cooler and freezer refrigeration systems are reaching the end of their useful life and planned for replacement in the next 4 - 6 years. This project recommends removal and installation of the existing systems including all necessary electrical modifications.	1	Package	\$255,000.00	\$ 35.00

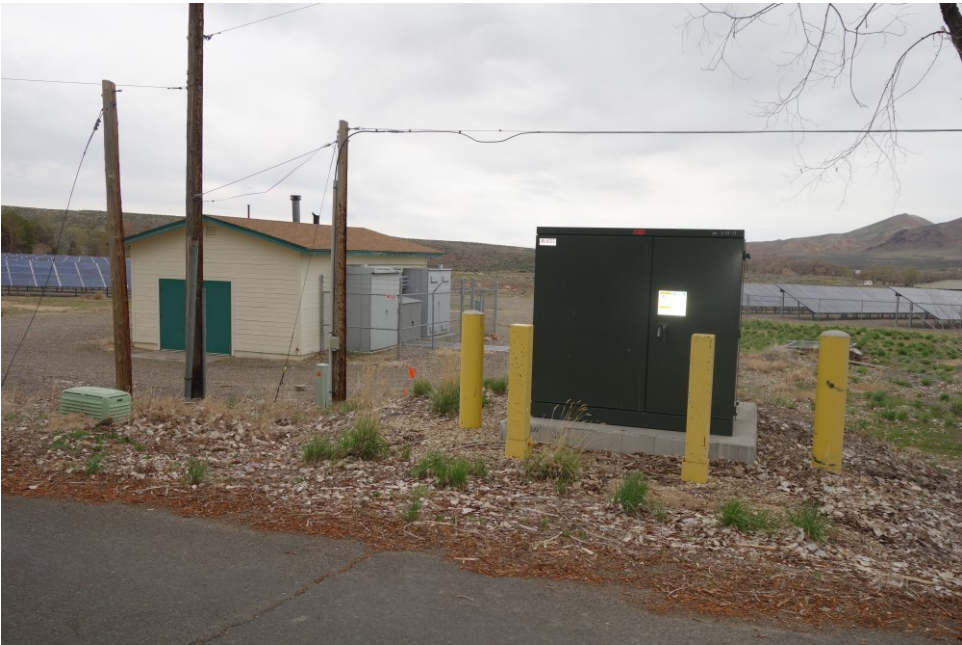
QUANTITY	UNITS	TOTAL	SF COST
The exterior finishes were in good condition. It is important to maintain the finish, weather resistance and appearance of the building. This project would provide funding to protect the exterior of the building excluding the roof. Included in the cost is sanding, priming and painting and caulking of the vents, flashing, fixtures and all other penetrations. It is recommended that the building be painted in the next 7 - 9 years and that this project be scheduled on a cyclical basis to maintain the integrity of the structure.	520	Square Foot	\$ 5,200.00	\$ 10.00

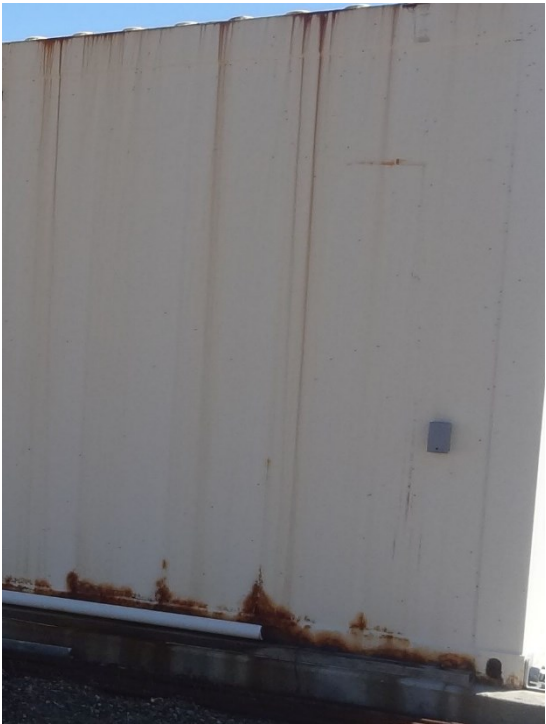
QUANTITY	UNITS	TOTAL	SF COST
The exterior finishes were in poor condition. It is important to maintain the finish, weather resistance and appearance of the building. The structure is rusting due to moisture infiltration and will fail if not sealed properly. This project would provide funding to protect the structure and exterior of the building. Included in the cost is the caulking and sealing of the flashing, fixtures and all other penetrations. It is recommended that the building be caulked and sealed in the next 3 - 4 years and that this project be scheduled on a cyclical basis to maintain the integrity of the structure.	1	Package	\$ 2,500.00	\$ 20.00

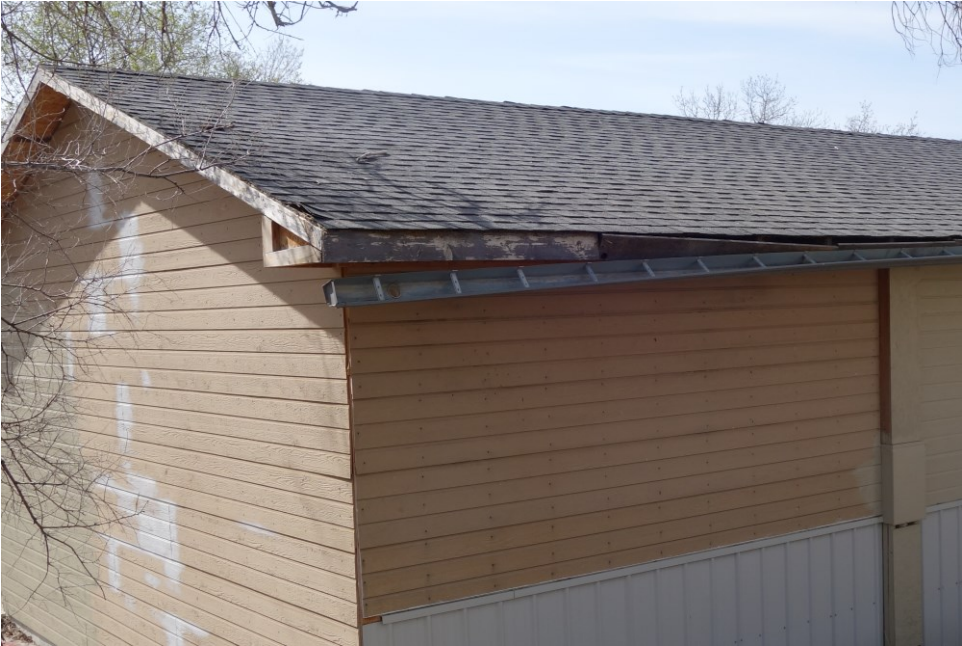
QUANTITY	UNITS	TOTAL	SF COST
A visual survey of the building appears to show the roof fascia has failed resulting in the attached gutters pulling away from the eave and also failing. Without the rain gutters, damage due to water infiltration to the north side siding and foundation will result. This project recommends immediate replacement of the roof fascia and replacement of the rain gutters. This project should be implemented concurrently with the ROOF REPLACEMENT project.	1	Package	\$10,000.00	\$ 13.00

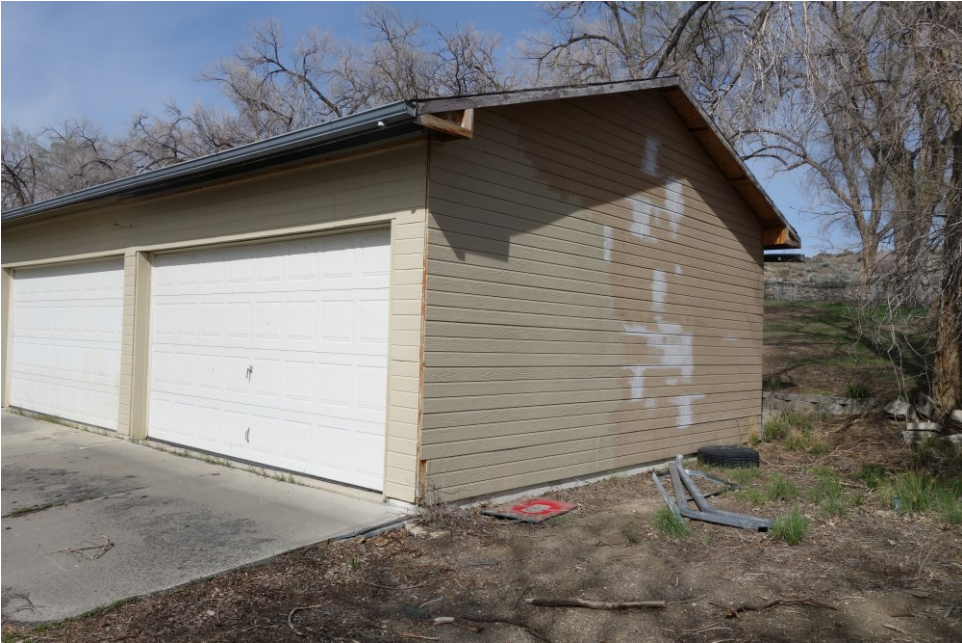
QUANTITY	UNITS	TOTAL	SF COST
The exterior finishes were in poor condition. It is important to maintain the finish, weather resistance and appearance of the building. This project would provide funding to protect the exterior of the building excluding the roof. Included in the cost is sanding, priming and painting and caulking of the windows, flashing, fixtures and all other penetrations. It is recommended that the building be painted in the next 2 - 3 years and that this project be scheduled on a cyclical basis to maintain the integrity of the structure.	750	Square Foot	\$ 3,750.00	\$ 5.00
