STATE OF NEVADA STATE PUBLIC WORKS DIVISION

FACILITY CONDITION ASSESSMENT REPORT FOR:

DEPT OF HEALTH AND HUMAN SERVICES
DIVISION OF CHILD AND FAMILY SERVICES
NYTC

SITE #: 9938 NEVADA YOUTH TRAINING CENTER SITE - ELKO
100 YOUTH CENTER RD
ELKO, NV 89801-9565

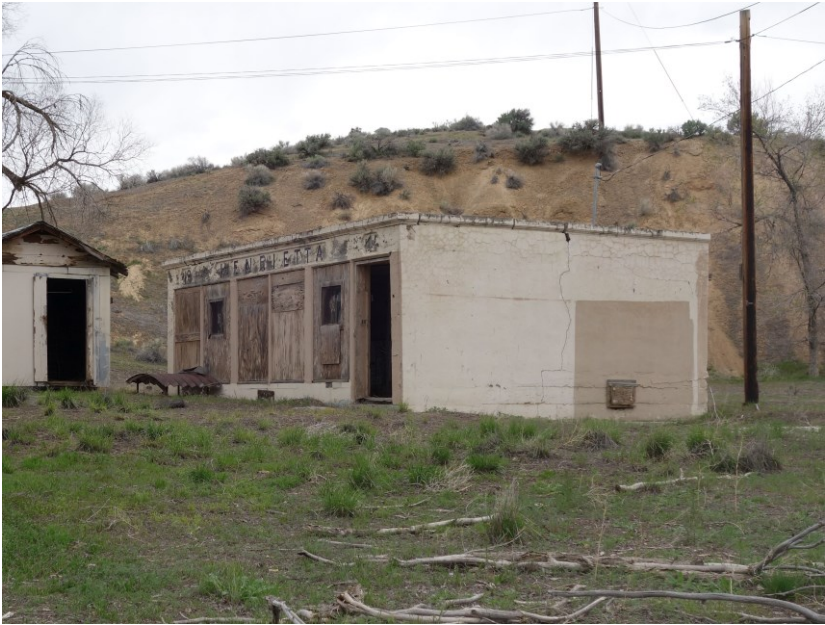
The Henrietta building is a wood and concrete framed structure. It is located in the bird farm area and is not being used. The roof is beginning to collapse. The building is in poor shape. No projects will be recommended based on the building value. All repairs, alterations or demolition should be reviewed by the State Historical Preservation Office (SHPO).

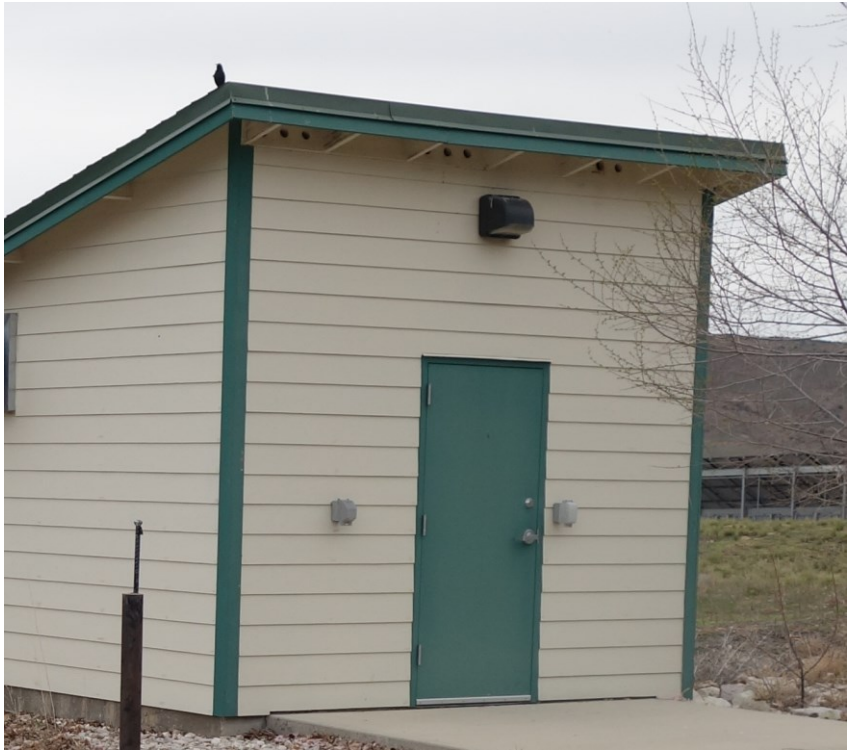
Well #4 is a wood framed structure with a composition asphalt shingle roof on a concrete slab on grade foundation. The well has been abandoned. The building is currently used for storage. Well House #4 is located on the north portion of the site.

QUANTITY	UNITS	TOTAL	SF COST
The exterior finishes are in good condition. Exterior maintenance is important to maintain the finish, weather resistance and appearance of the structure. This project provides funding to protect the exterior of the building, excluding the roof. Included are the costs of sanding, priming, painting and caulking of flashing, fixtures and all other penetrations. It is recommended the building be painted in the next 6 - 8 years. Building maintenance should be scheduled on a cyclical basis to maintain the integrity of the structure.	128	Square Foot	\$ 2,600.00	\$ 20.00

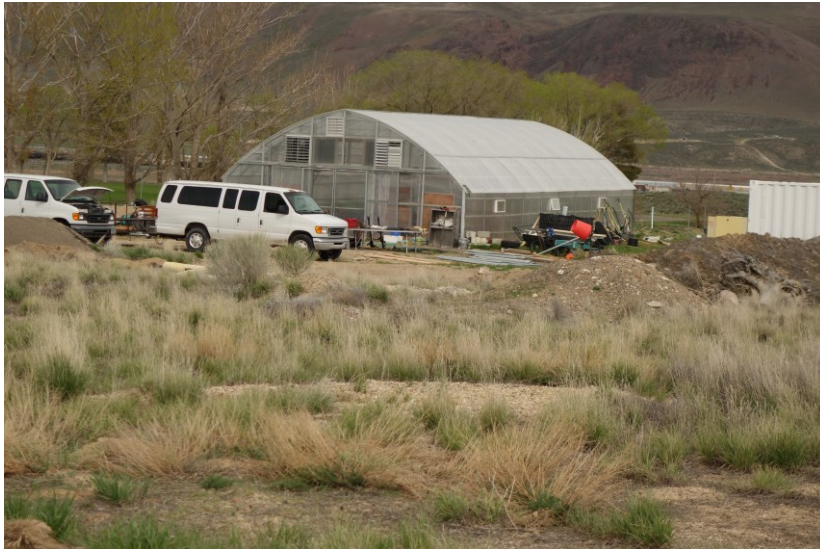
4305 – GREENHOUSE #2 OCCUPIED

The Greenhouse is a corrugated fiberglass structure located south of the Classrooms and Infirmary building.

QUANTITY	UNITS	TOTAL	SF COST
The exterior finishes were in good condition. It is important to maintain the finish, weather resistance and appearance of the structure. This project recommends work to protect the exterior building envelope including repairs to the exterior membrane and caulking around flashing, fixtures, and other penetrations to maintain the building in good, weather tight condition. It is recommended that this project be implemented in the next 6 - 8 years and it is also recommended that this project be scheduled on a cyclical basis to maintain the integrity of the structure.	1800	Square Foot	\$ 1,800.00	\$ 1.00

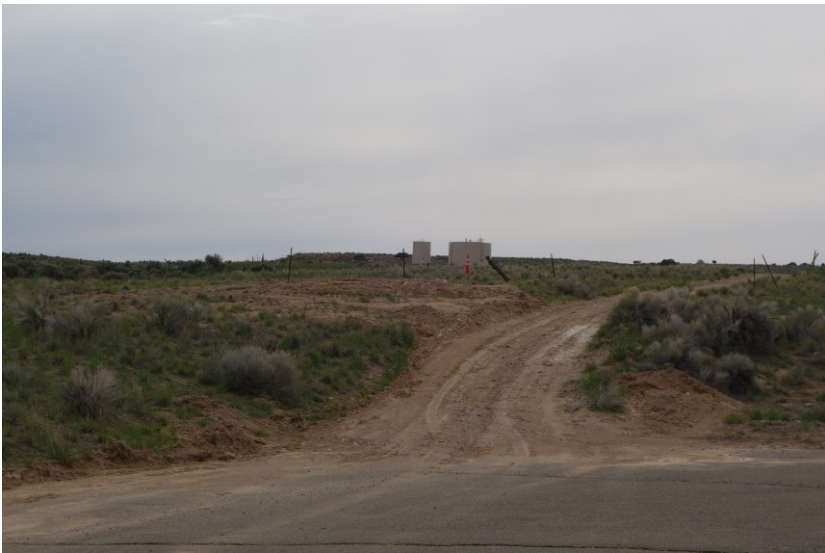
The water tank #1 is a welded steel tank with a capacity of 427,879 gallons. It is located on the far West edge of the NYTC site. The exterior of the tank was refinished in 2017.

QUANTITY	UNITS	TOTAL	SF COST
In addition to the recommended annual maintenance inspections also recommended is a detailed maintenance cleaning and inspection every 5 - 10 years depending on water quality and usage. Inspection tasks include but no limited to exterior foundations, surfaces, equipment and controls and interior roof/sidewall structure, liners and general debris/sediment cleanup. This project would provide funding for engaging the services of a certified tank inspection company. Any required cleaning and/or repairs are not included in this estimate.	1	Package	\$10,000.00	-

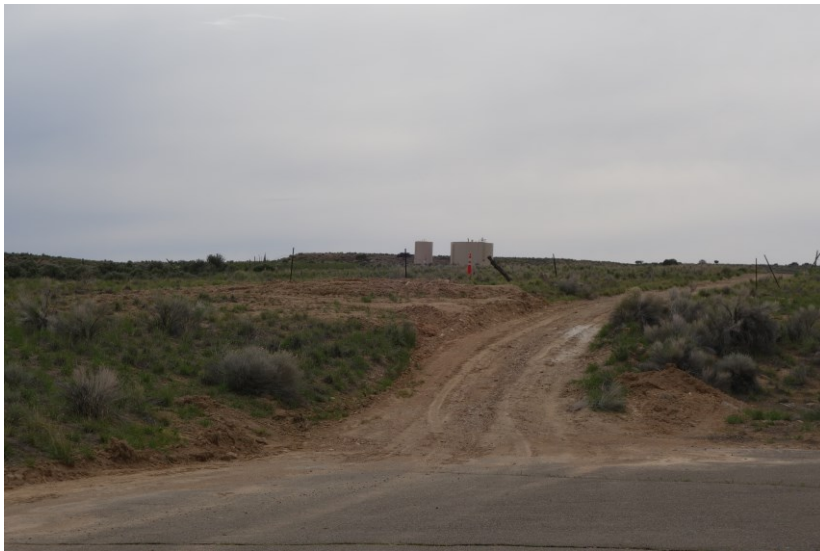
4307 – WATER TANK #2 OCCUPIED

The water tank #2 is a welded steel tank with a capacity of approximately 79,600 gallons. The exterior of the tank was refinished in 2017. It is located on the far West edge of the NYTC site and was installed prior to Water Tank #1.

QUANTITY	UNITS	TOTAL	SF COST
In addition to the recommended annual maintenance inspections also recommended is a detailed maintenance cleaning and inspection every 5 - 10 years depending on water quality and usage. Inspection tasks include but no limited to exterior foundations, surfaces, equipment and controls and interior roof/sidewall structure, liners and general debris/sediment cleanup. This project would provide funding for engaging the services of a certified tank inspection company. Any required cleaning and/or repairs are not included in this estimate.	1	Package	\$10,000.00	-
