State of Nevada
Department of Wildlife
Steptoe Valley Wildlife Management Area
Facility Condition Analysis

STEPTOE VALLEY WILDLIFE MANAGEMENT AREA

Site Number: 9940
STATE OF NEVADA PUBLIC WORKS DIVISION
FACILITY CONDITION ANALYSIS

Report Printed in October 2011

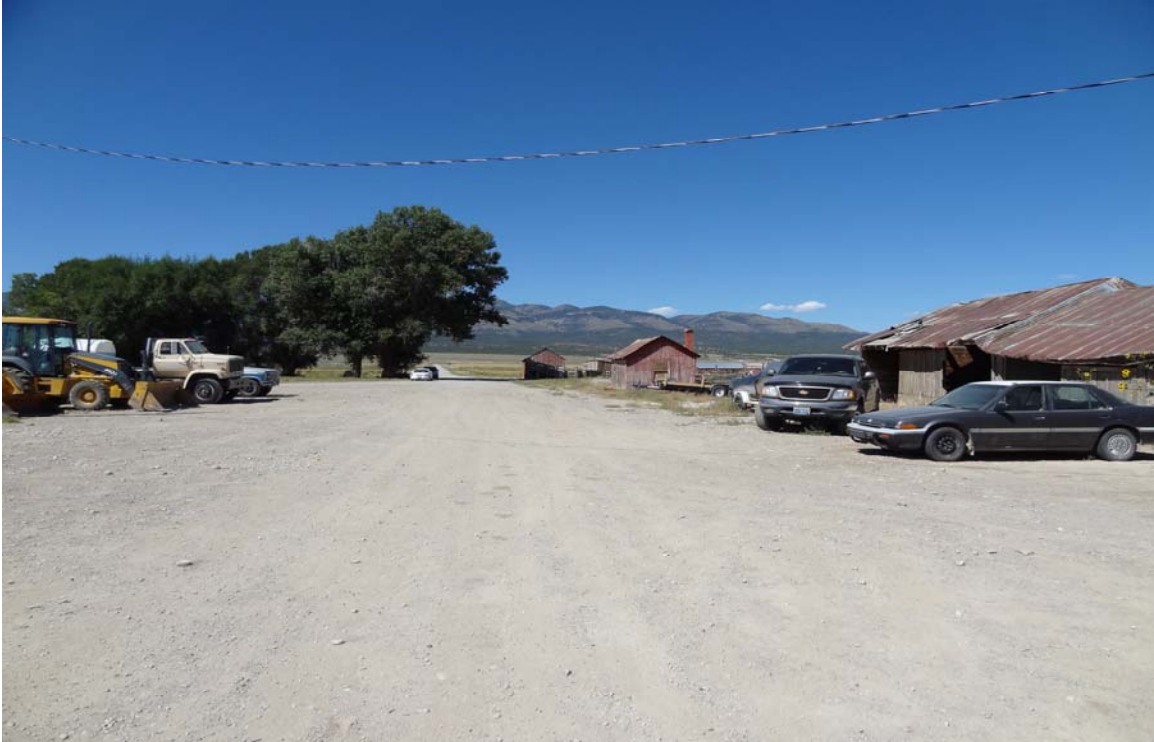
Steptoe Valley Wildlife Management Area - Site #9940

Description: View of the main WMA office / maintenance complex looking west.
