DEPARTMENT OF ADMINISTRATION
STATE PUBLIC WORKS DIVISION
FACILITY CONDITION ASSESSMENT

PROPERTY PORTFOLIO REVIEW PROJECT ADDENDUM

NORTHEAST REGION
ELY STATE PRISON COMPLEX
9941 - ELY STATE PRISON SITE
4569 N STATE ROUTE 490
ELY, NV 89301-
WHITE PINE COUNTY

SURVEY DATE: 04/23/2024

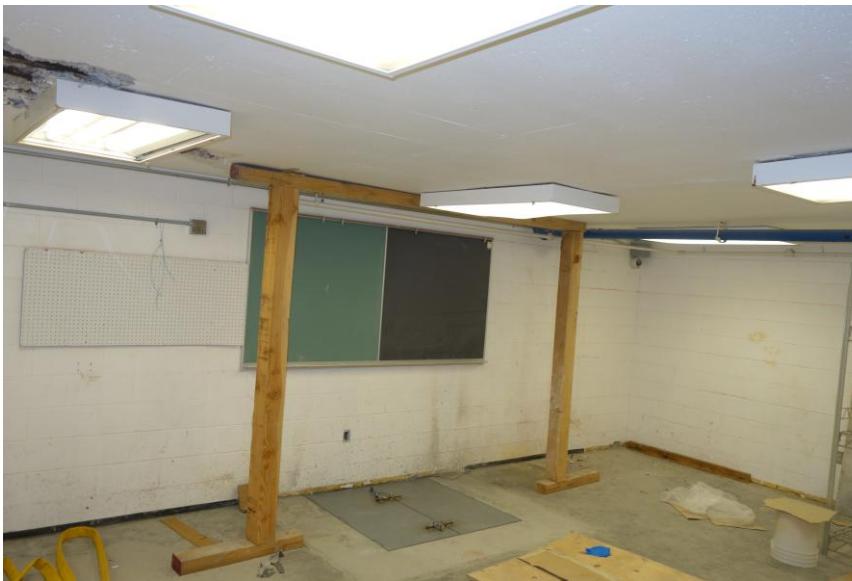
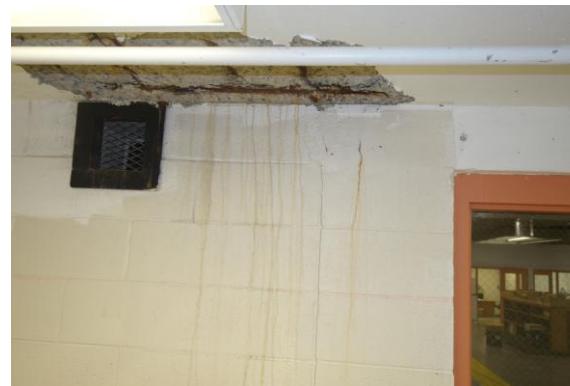
BUILDING #10 - WORK & RECREATION

A 1,500 square foot mechanical mezzanine is structurally compromised. The existing concrete mezzanine floor is spalled, cracked and exposed rebar is severely deteriorated. Temporary shoring is in place to prevent structural failure. This project will remove the failed mezzanine components and replace any part that is structurally necessary for building stability.

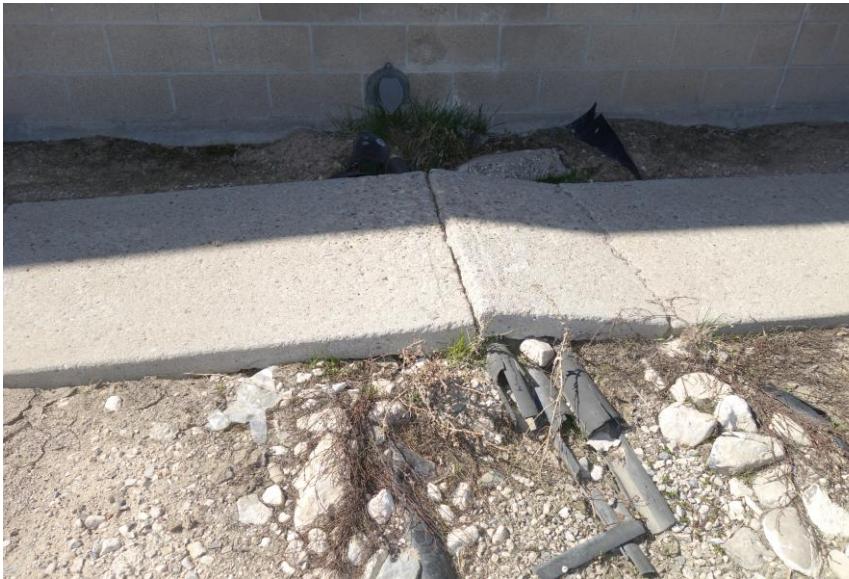
ELY STATE PRISON SITE

The campus includes a network of concrete pedestrian pathways, including accessible routes to each building. However, many sections have deteriorated or settled over time, resulting in noncompliant slopes and trip hazards. Additionally, ADA-compliant parking and accessible routes to public entrances are limited. This project proposes the replacement of damaged sidewalks, incorporating all necessary accessibility upgrades in accordance with a professionally developed, sitewide accessibility plan. The construction estimate is based on an assumed area of 20,000 square feet.

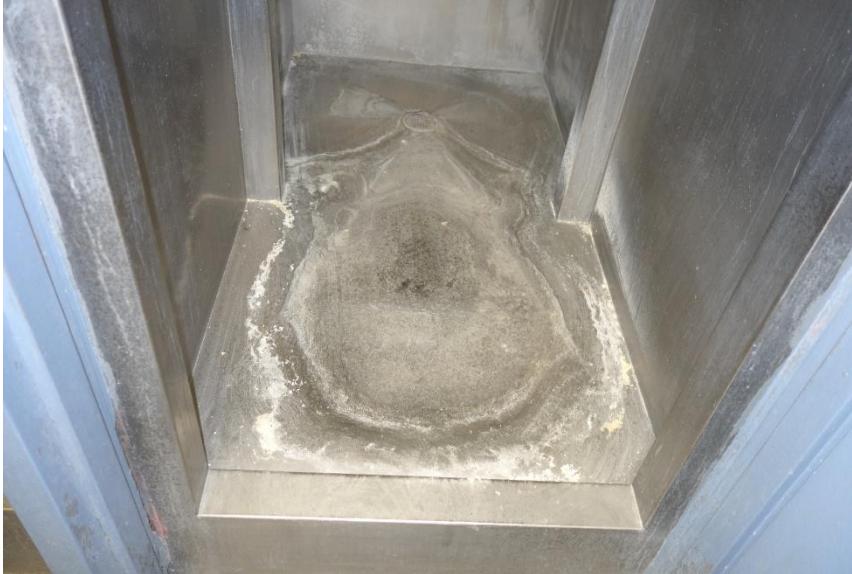
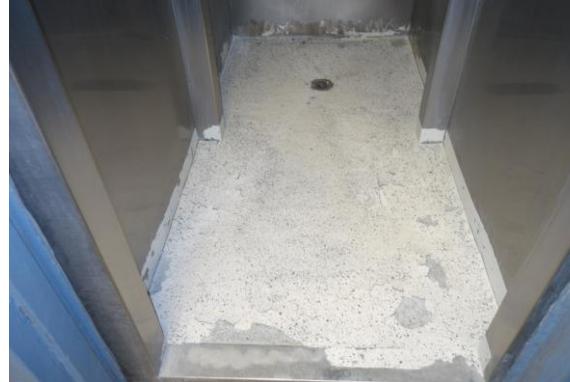
HOUSING UNIT #8

The existing showers, original to the facility and nearly 40 years old, have inadequately supported steel pans that have sagged over time, causing leaks into adjacent areas and ongoing maintenance issues. Complete demolition and replacement are recommended with new stainless-steel shower stalls designed to meet Prison Rape Elimination Act (PREA) standards, including individual shower gate doors with electronic locks to improve safety, security, and hygiene.

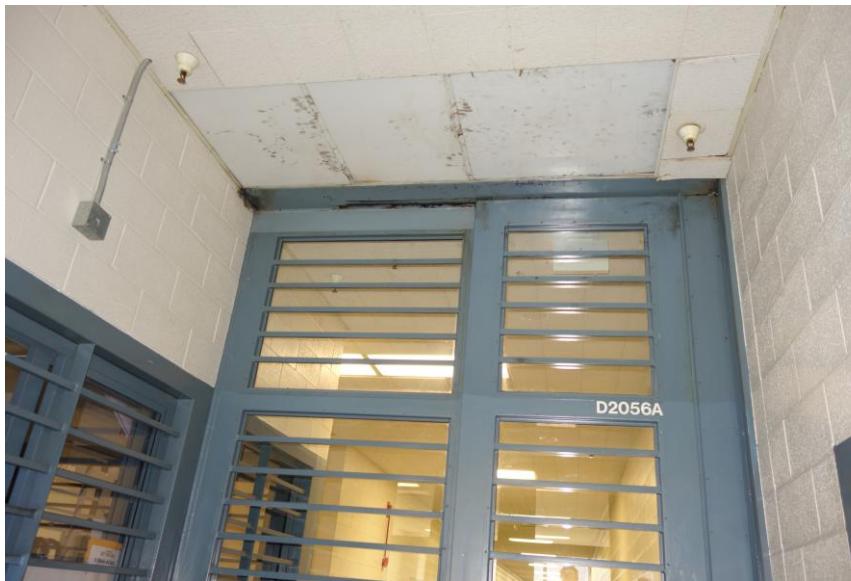
BUILDING #9 - SCHEDULED SERVICES

The Sallyport doors are original and approaching 40 years old. They are a main point of personnel traffic in and out of the prison and heavily used. Door tracks are worn and replacement parts are difficult to source. This project will design and construct replacement door motors, tracks and controls.

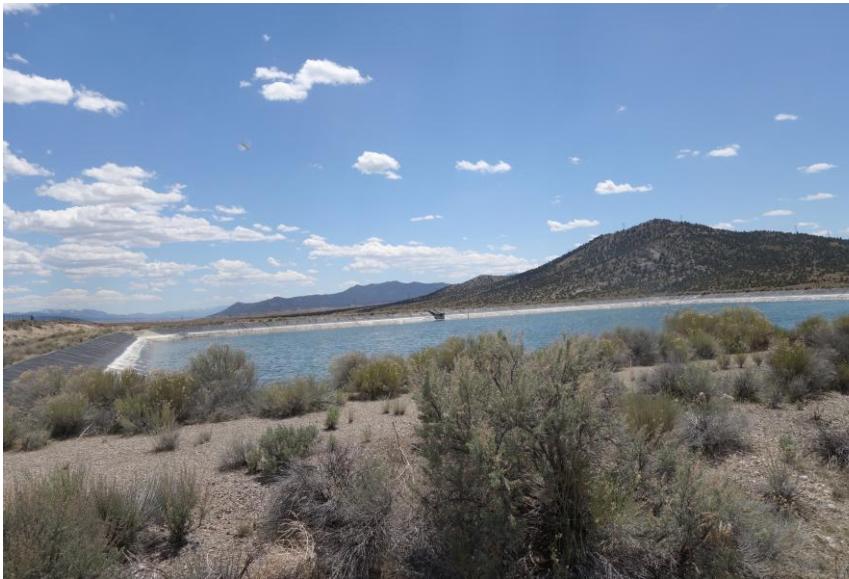
ELY STATE PRISON SITE

The waste water treatment systems is approaching 40 years old and in need of upgrades. One of the retention pond liners is torn and aerator inoperable reducing the capacity and redundancy of the plant. Sewage treatment equipment is also original and reaching the end of life. This project will replace the aerators and pond liners.

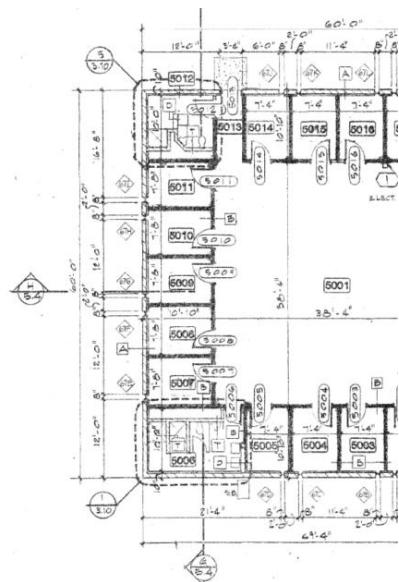
The building's two restrooms are original construction and in poor condition. This project will fund the complete refurbishment of the restrooms. The scope of work may include tile replacement, installation of new sinks, toilets, showers, hardware, mirrors, fixtures, flooring, and finishes to improve functionality, appearance, and overall condition. The refurbishment should be executed in compliance with applicable accessibility codes.

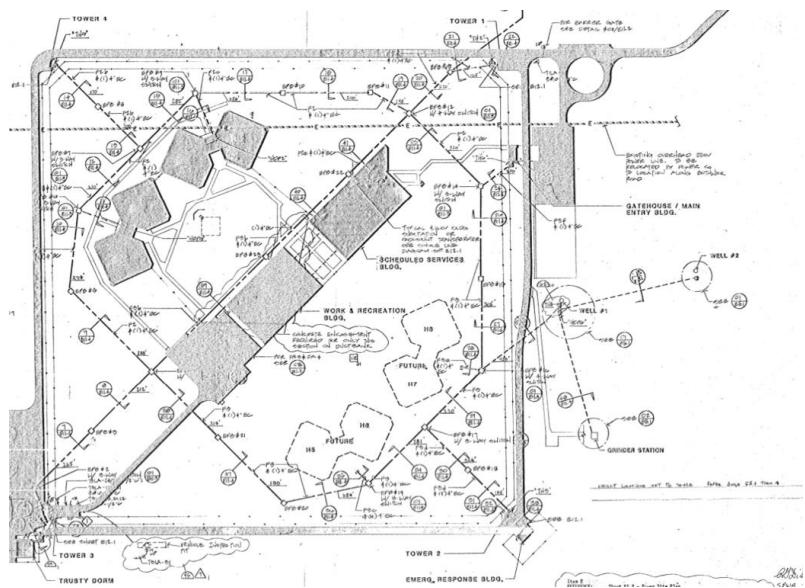
ELY STATE PRISON SITE

The Ely State Prison site has several manholes with 4160V equipment installed below grade and the drainage doesn't prevent water accumulations. Due to their location, staff are required to manually inspect and, when needed, lower sump pumps into the hole to drain the excess water. This creates a potential electrocution hazard. This project provides funding to install catch basins, French drains and additional drain piping as needed to carry the water away from the manholes.

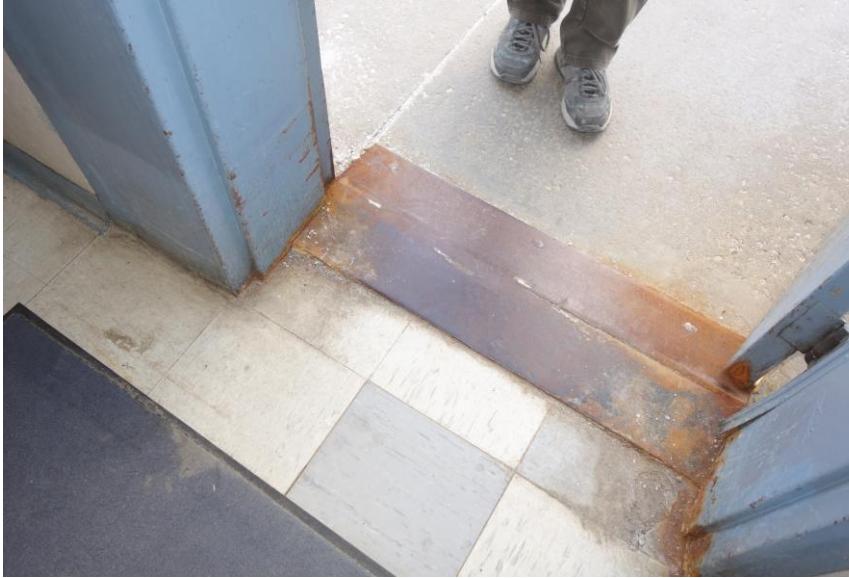
BUILDING #14 - GATEHOUSE

The Sallyport doors are original and approaching 40 years old. They are a main point of personnel traffic in and out of the prison and heavily used. Door are worn and replacement parts are difficult to source. This project will design and construct replacement doors and controls.

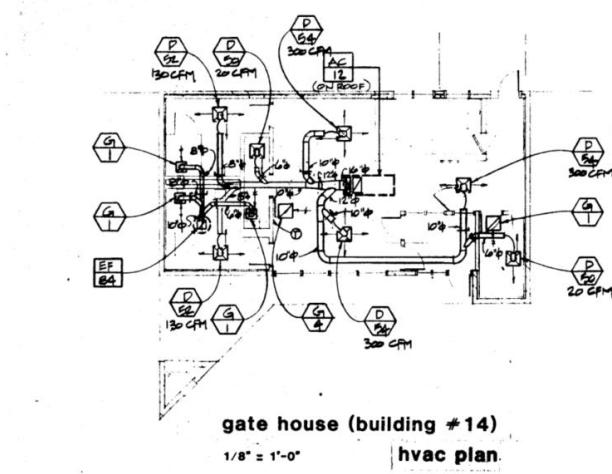
The existing HVAC system consists of a small rooftop unit. They are not energy efficient and have reached the end of their expected and useful life. This project would provide for installation of new HVAC units, ductwork and piping modifications, temperature control modifications, testing, balancing and commissioning.

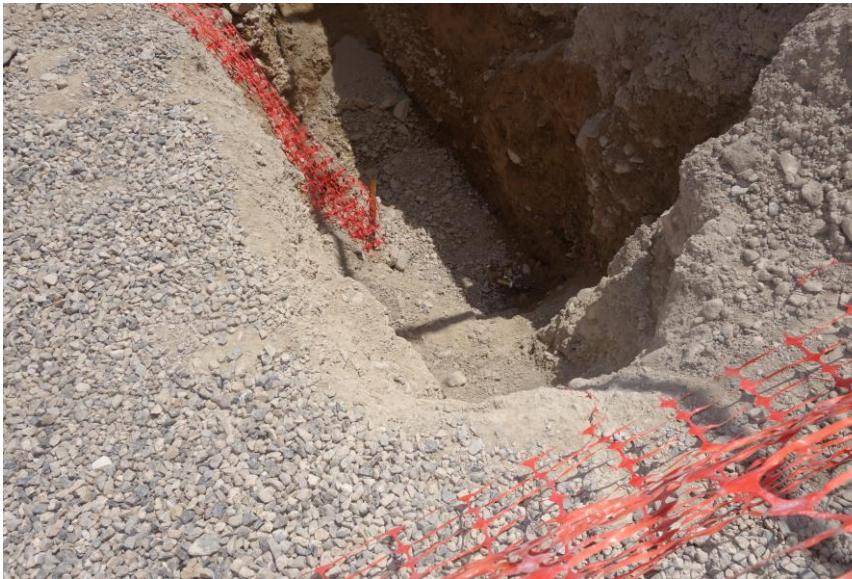
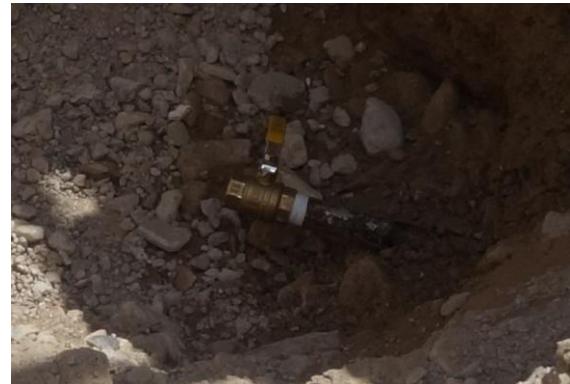
ELY STATE PRISON SITE

The main underground potable water distribution system on site is PVC; however, a recent failure of a 1" galvanized steel underground lateral off the main caused significant damage and unplanned repair costs. This incident suggests the possible presence of other buried galvanized piping in the system. A survey is recommended to identify the extent of galvanized piping, locate all water main isolation valves, and provide remediation recommendations to prevent future failures and improve system reliability.

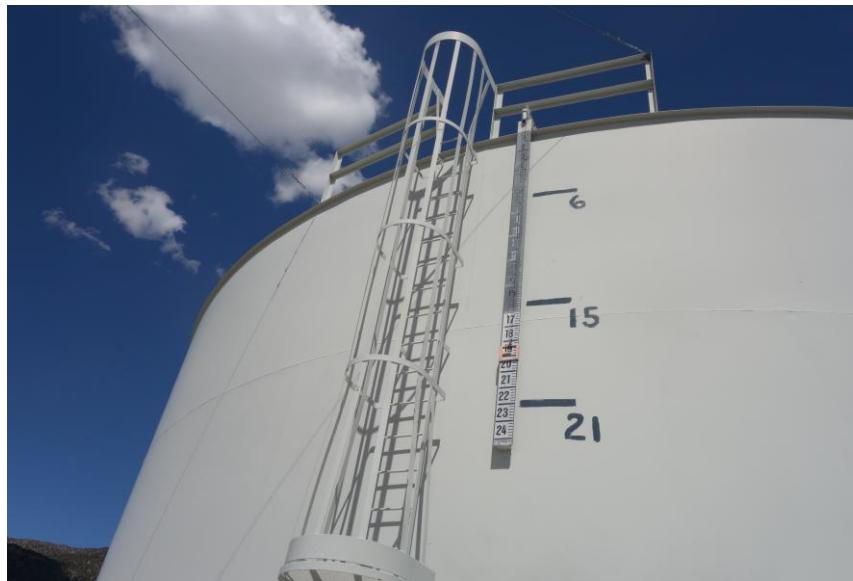
WATER TANK

In addition to the manufacturer's recommended annual maintenance, a comprehensive inspection and cleaning is advised every 5 to 10 years, depending on water quality and system usage. This detailed inspection includes, but is not limited to, evaluation of exterior foundations, surfaces, equipment, controls, interior roof and sidewall structures, liners, and removal of debris or sediment. This project proposes funding to engage a certified tank inspection company. Costs for any necessary cleaning or repairs are not included in this estimate.

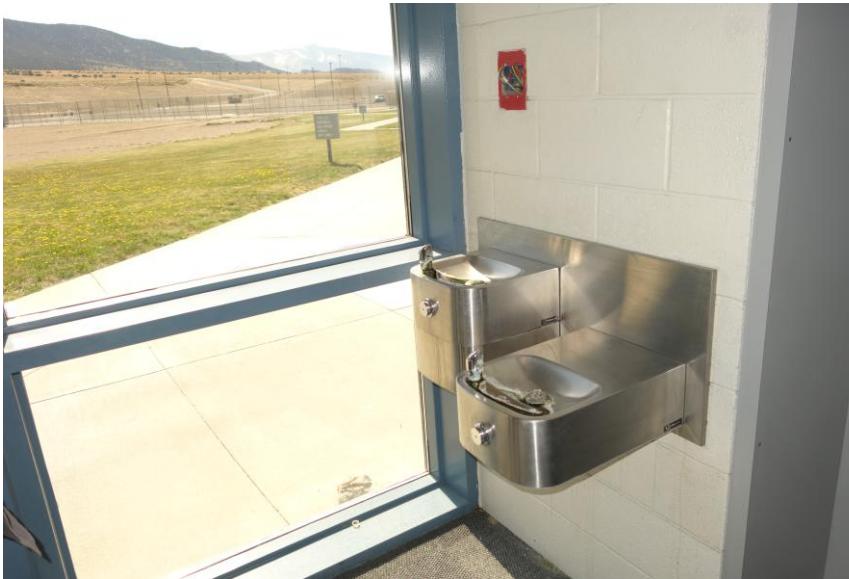
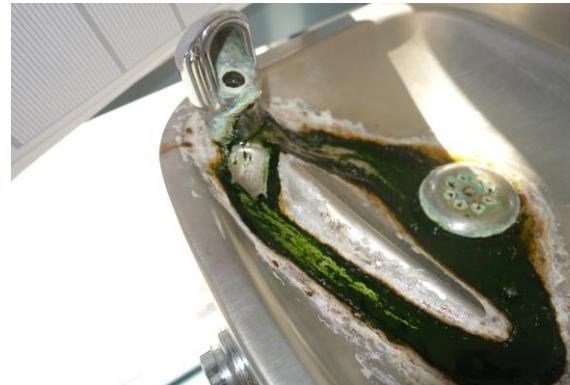
BUILDING #9 - SCHEDULED SERVICES

The existing water fountain has failed, visibly built up mineral scale or is not complaint with Accessible Standards. For whatever reason, the drinking fountain needs to be replaced. This project recommends the removal of the existing water fountain and replacement with a dual height drinking fountain compliant with accessibility standards. Note that a bottle filler integrated into a drinking fountain is for convenience and does not make the water fountain accessible.

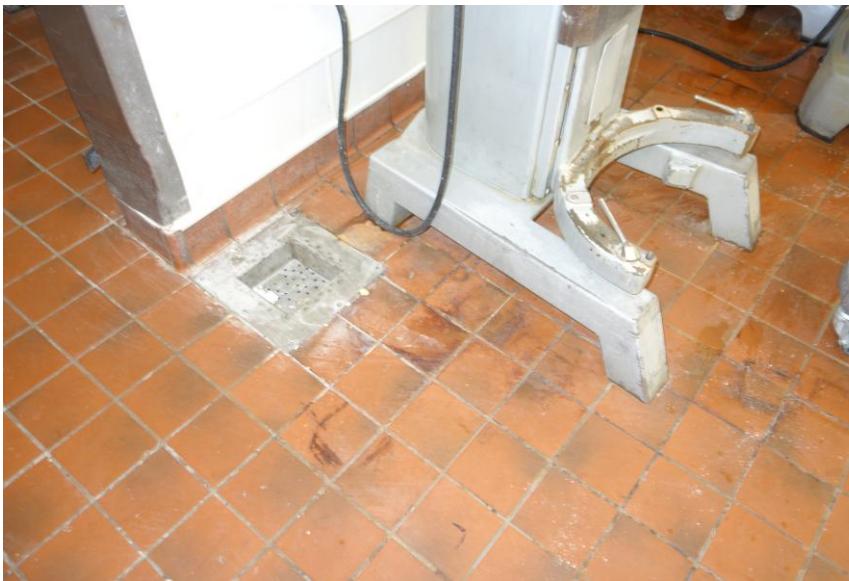
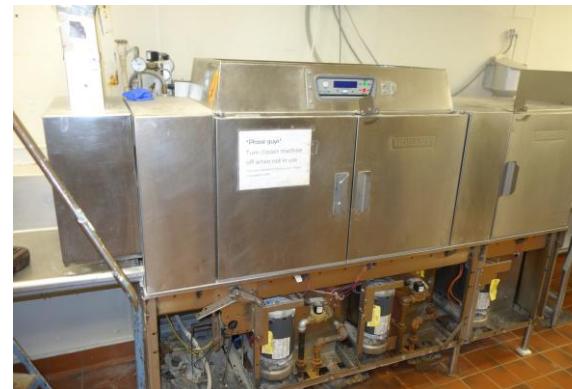
BUILDING #10 - WORK & RECREATION

recommends a comprehensive inspection of the sewer and vent system to evaluate its overall integrity. The costs associated with this inspection are exclusive of any potential repair or replacement work.

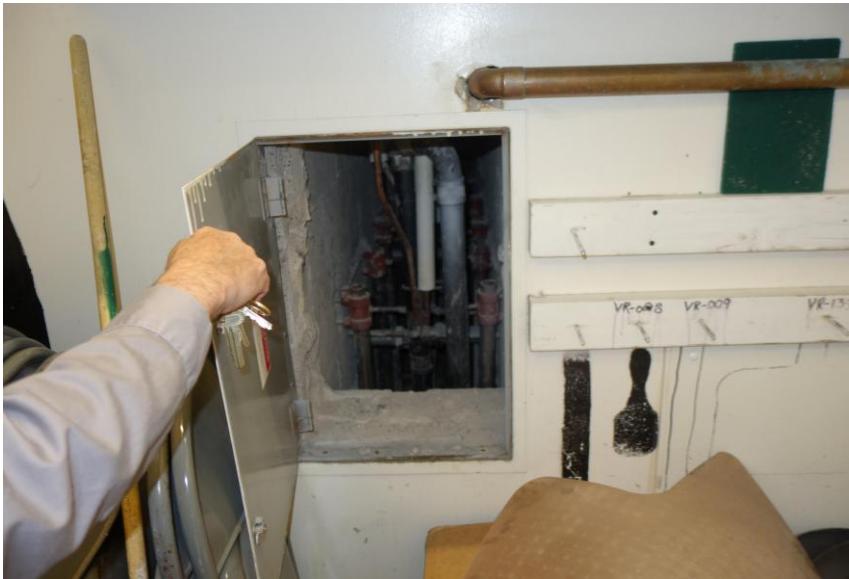
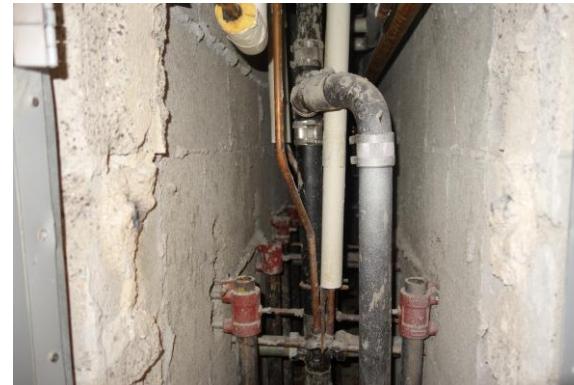
BUILDING #9 - SCHEDULED SERVICES

recommends a comprehensive inspection of the sewer and vent system to evaluate its overall integrity. The costs associated with this inspection are exclusive of any potential repair or replacement work.

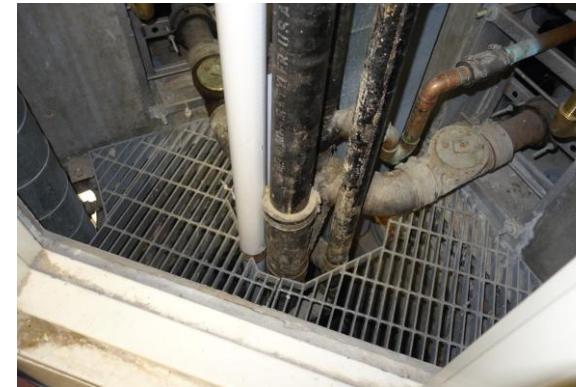
Image Applicable to Housing Units 1-8

The building was constructed during a period when a variety of materials were commonly used for the building drain, waste, and vent piping. Typical materials from this era include cast iron with lead and oakum joints, galvanized steel for vent lines, vitrified clay pipe for underground systems, and a low-cost, lightweight pipe made from compressed tar paper (commonly known as Orangeburg). Given the potential variability in materials and age-related deterioration, it is important to assess both the type and condition of the piping located within and beneath the building. This project

recommends a comprehensive inspection of the sewer and vent system to evaluate its overall integrity. The costs associated with this inspection are exclusive of any potential repair or replacement work.

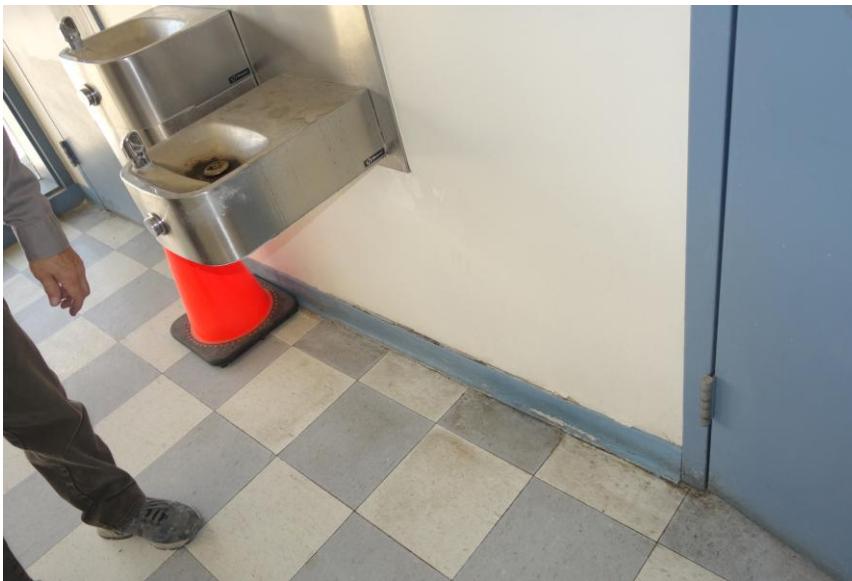
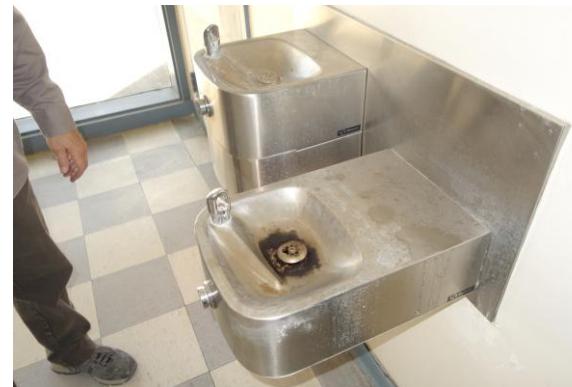
BUILDING #14 - GATEHOUSE

The existing water fountain has failed, visibly built up mineral scale or is not complaint with Accessible Standards. For whatever reason, the drinking fountain needs to be replaced. This project recommends the removal of the existing water fountain and replacement with a dual height drinking fountain compliant with accessibility standards. Note that a bottle filler integrated into a drinking fountain is for convenience and does not make the water fountain accessible.

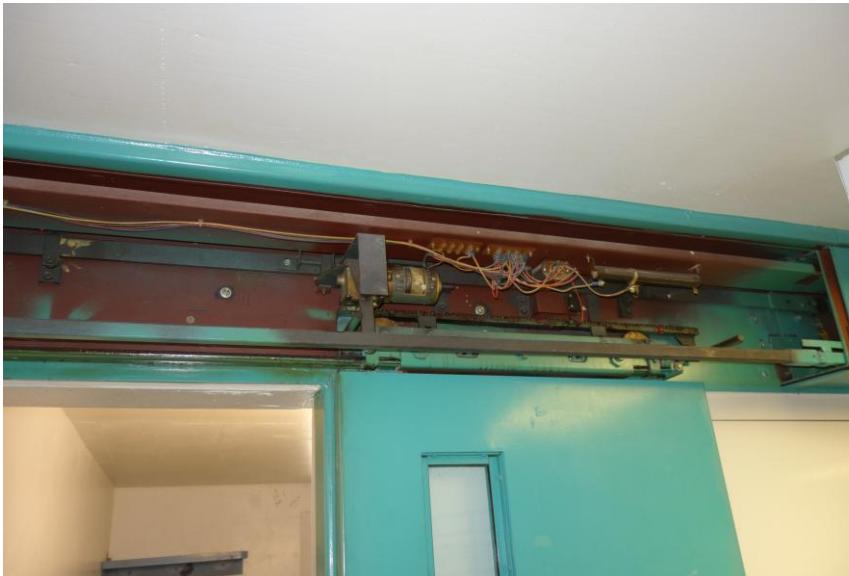
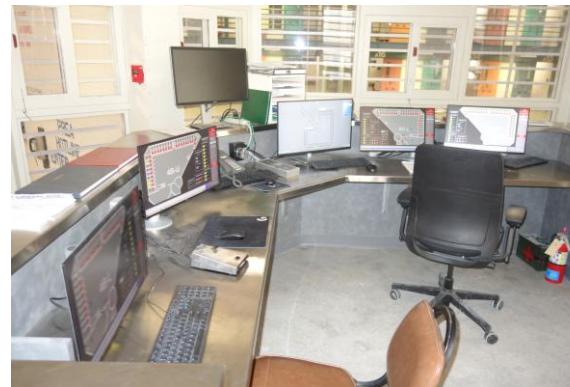
HOUSING UNIT #1

The door controls, door locks and intercom systems are approximatley 30 years old and parts are no longer available. This project will replace the intercoms, locks and controls in the Housing Unit.

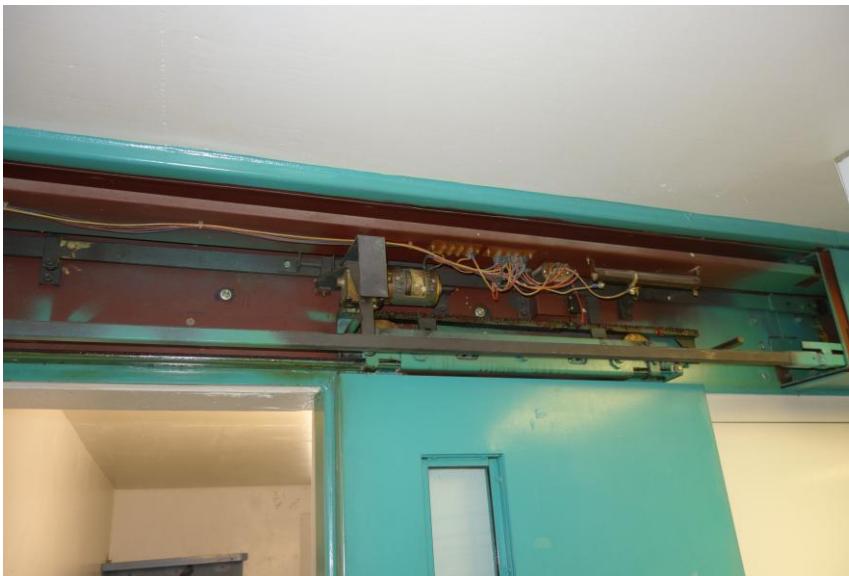
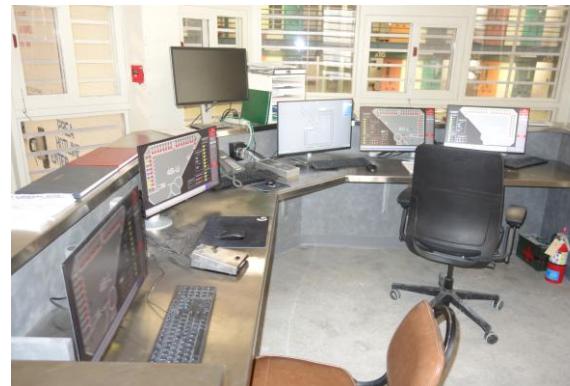
HOUSING UNIT #2

The door controls, door locks and intercom systems are approximatley 30 years old and parts are no longer available. This project will replace the intercoms, locks and controls in the Housing Unit.

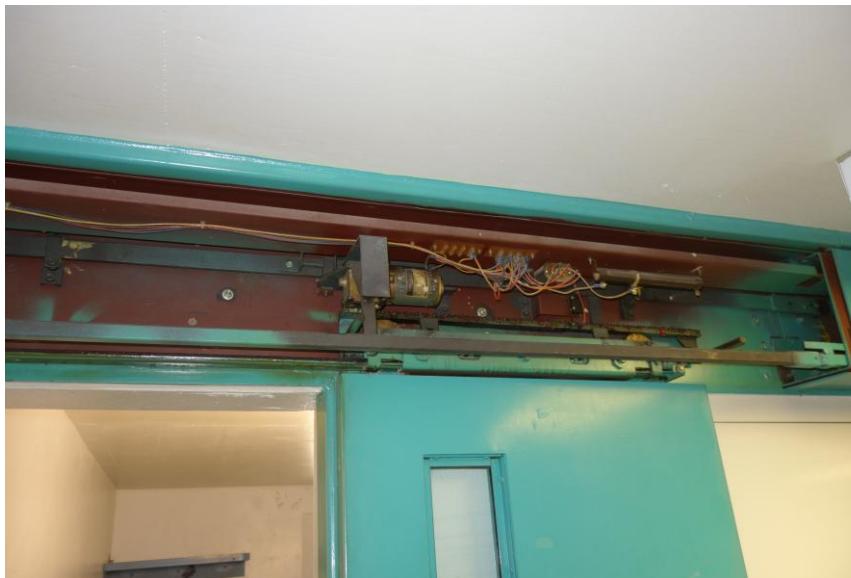
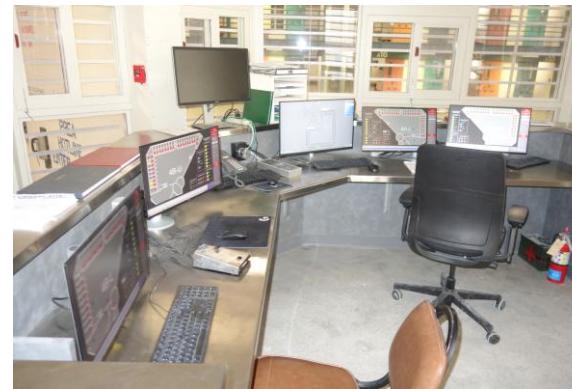
HOUSING UNIT #7

The door controls, door locks and intercom systems are approximatley 30 years old and parts are no longer available. This project will replace the intercoms, locks and controls in the Housing Unit.

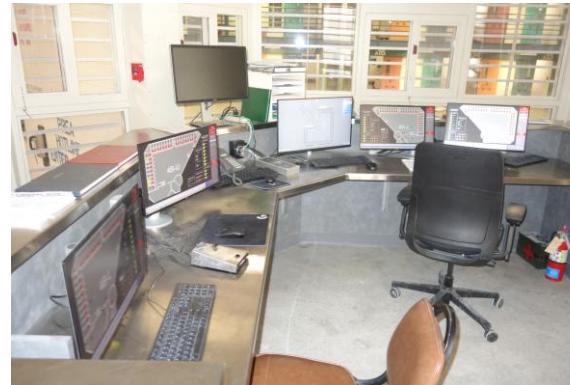
Image Applicable to Housing Units 1-8

The door controls, door locks and intercom systems are approximatley 30 years old and parts are no longer available. This project will replace the intercoms, locks and controls in the Housing Unit.

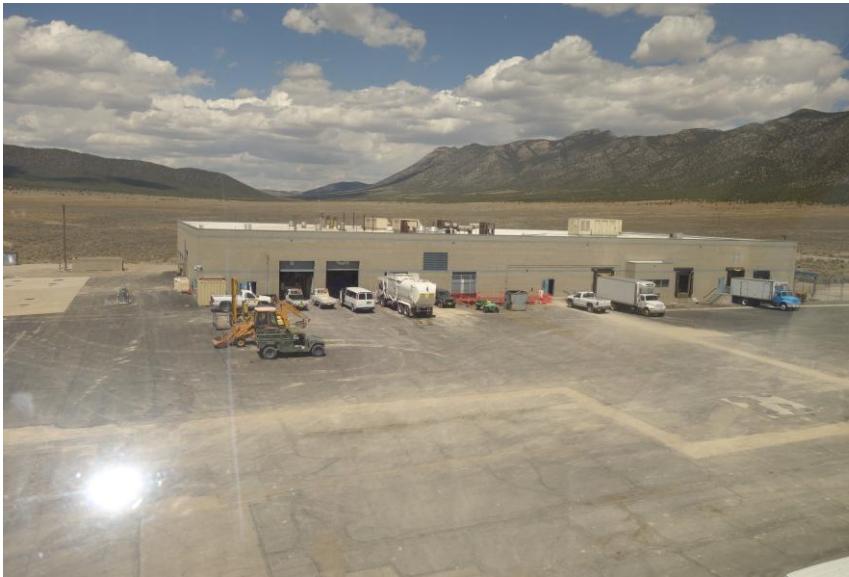
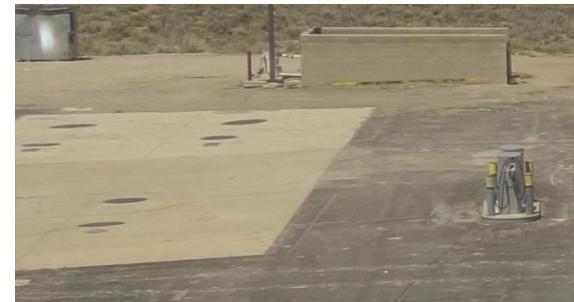
ELY STATE PRISON SITE

The three underground fuel storage tanks (UST's) supplying the Fuel Island appear to be original construction installed in 1987. Due to the age of underground piping and tanks, the potential for leaks is very high. The fuel dispensing systems are also original and have reached the end of their service life. Due to the existing conditions, the entire system is recommended to be replaced with above ground fuel storage tanks (AST's) system suitable for a corrections site. Soil contaminant removal and remediation are not included in this estimate.

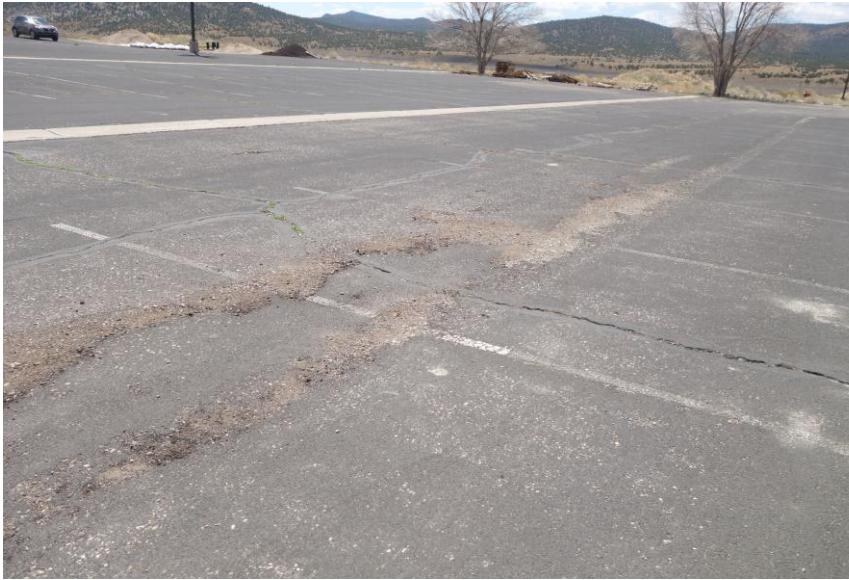
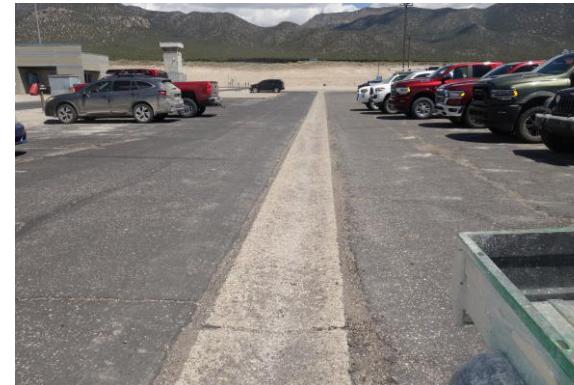
The existing pavement system has significantly deteriorated, with concrete valley gutters exhibiting extensive spalling, widespread alligator cracking throughout the asphalt, and substantial surface ravelling. To address these issues, this project recommends replacing the concrete valley gutters, removing and patching severely deteriorated asphalt areas, and applying a microsurface overlay to restore surface integrity and extend the pavement's service life.

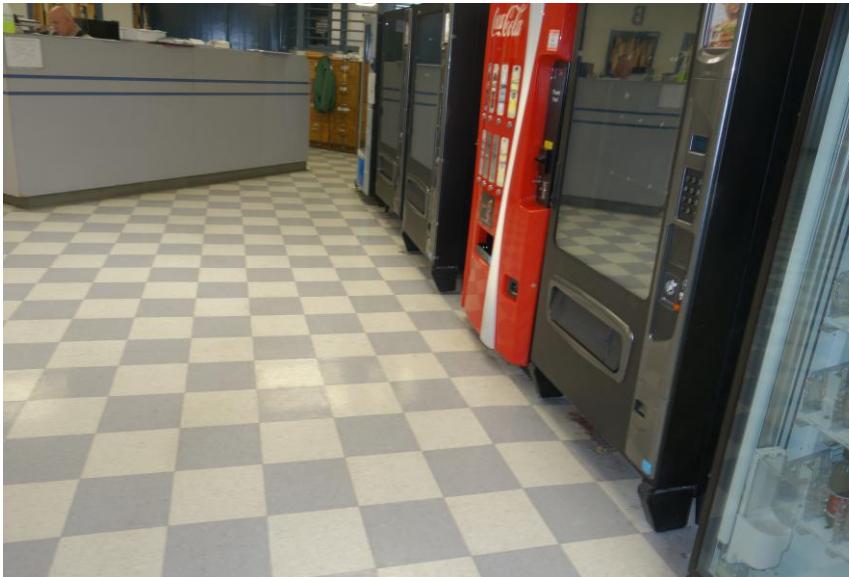
BUILDING #9 - SCHEDULED SERVICES

The sheet vinyl flooring in the Infirmary and vinyl composition tile (VCT) in the Library, Chapel and the Visitor's Room is approaching the end of its useful life and has some damage. It is recommended that the flooring in these areas be replaced. This project would provide for 17,000 square feet of new 12x12 VCT and sheet vinyl to be installed. Removal and disposal of the old, damaged flooring is included in this estimate.

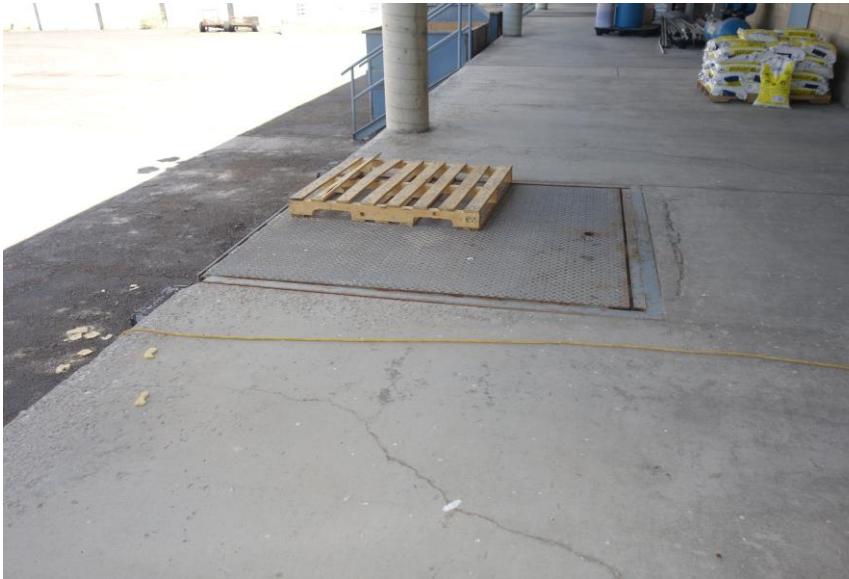
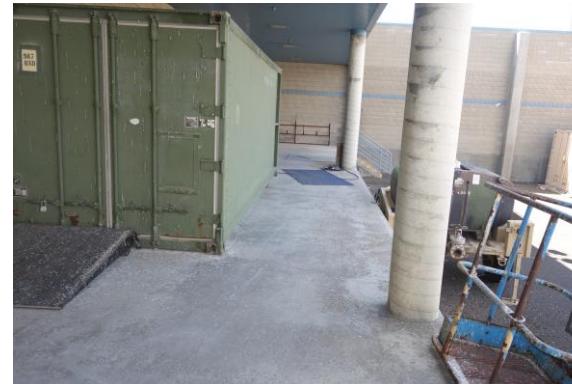
BUILDING #10 - WORK & RECREATION

The three manual dock levelers at the loading dock are original to the building and have reached the end of their service life. These units are heavily utilized in support of food service and other inmate-related operations. This project proposes the replacement of all three manual dock levelers with new manual units. The scope also includes the removal and disposal of the existing equipment, as well as the replacement of deteriorated concrete surrounding the levelers to ensure proper installation and long-term performance.

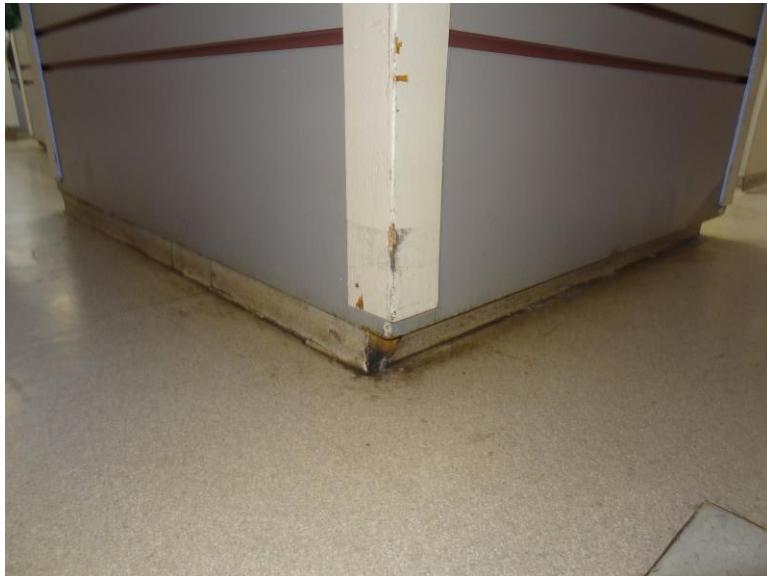
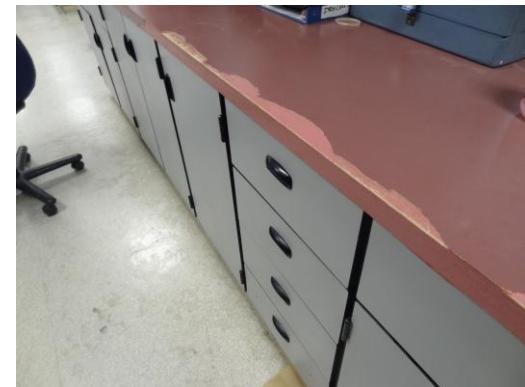
BUILDING #9 - SCHEDULED SERVICES

The countertops throughout the building are showing signs of wear and tear particularly at the Formica edges and corners. The quality of construction and installation were inadequate for the high usage at these facilities, and the counter tops are delaminating and failing. This project recommends the replacement of the existing damaged countertops with heavy duty, quality finishes. The countertops should be constructed of a highly durable product to minimize swelling and damage from water exposure. This estimate includes disposal of the existing materials.

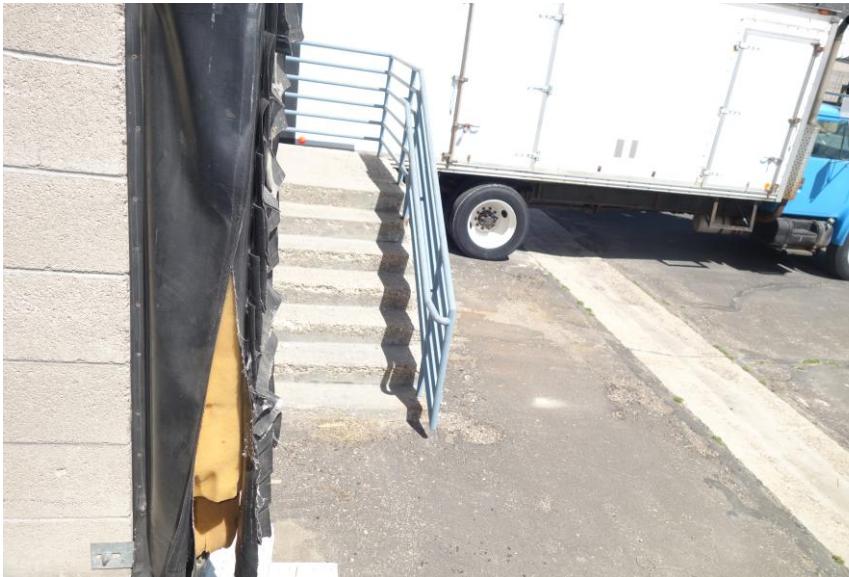
BUILDING #11 - WAREHOUSE/CENTRAL PLANT

Four of the loading dock doors on the building are equipped with dock seals designed to facilitate truck unloading during inclement weather. However, the existing seals are damaged and no longer provide effective protection or functionality. This project recommends the complete replacement of all four dock seals to restore proper weatherproofing and operational efficiency.

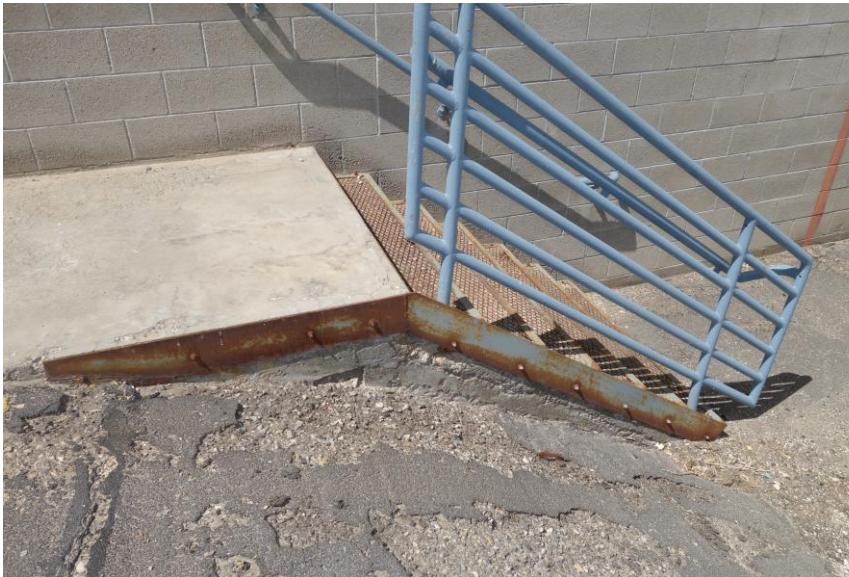
BUILDING #11 - WAREHOUSE/CENTRAL PLANT

The 2 sets of exterior concrete stairs on the south side of the building are spalled and cracking. This has also compromised the structural anchoring of the guard rails. This project recommends a complete replacement of the concrete stairs, including the guard rails with a new stair system in accordance to applicable codes.

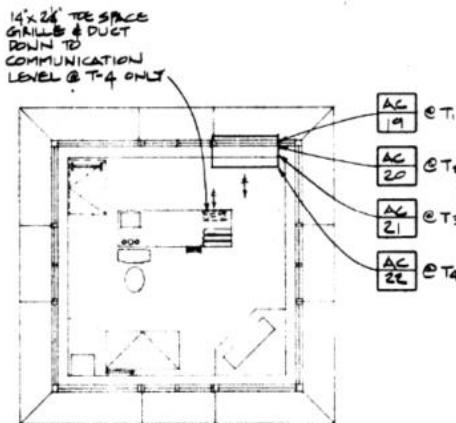
Image Applicable to Towers 1-4

The combination in-wall HVAC unit and small electric heater are original to the building and should be scheduled for replacement. They are not energy efficient and have reached the end of their expected and useful life. This project would provide for installation of a new combination unit and electric heater. This project includes removal and disposal of the existing HVAC units and all required connections to utilities.

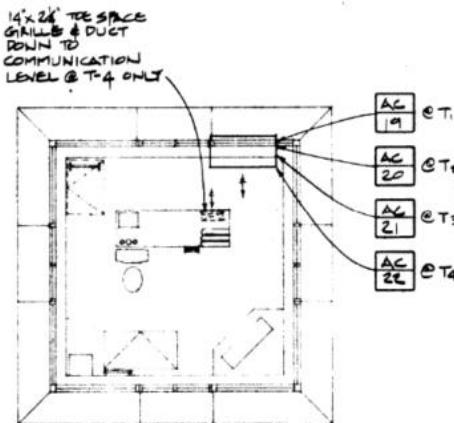
Image Applicable to Towers 1-4

The combination in-wall HVAC unit and small electric heater are original to the building and should be scheduled for replacement. They are not energy efficient and have reached the end of their expected and useful life. This project would provide for installation of a new combination unit and electric heater. This project includes removal and disposal of the existing HVAC units and all required connections to utilities.

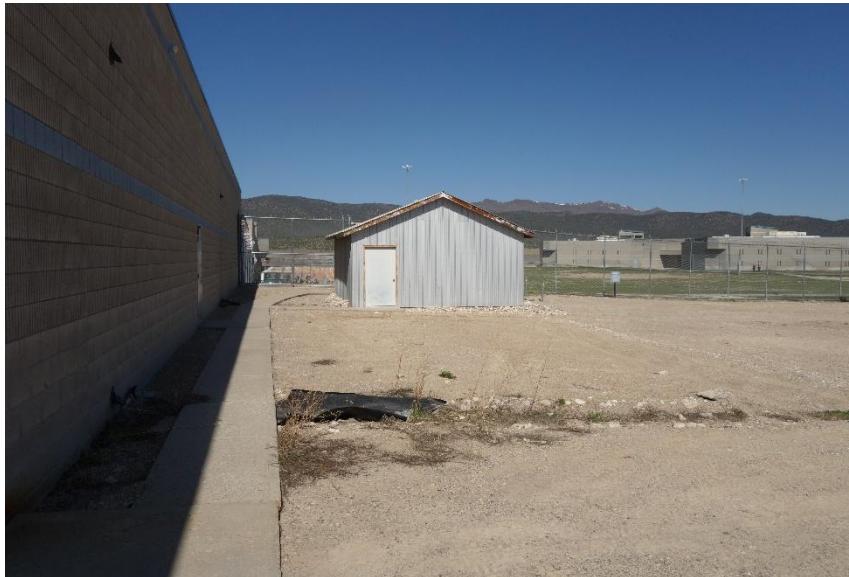
EQUIPMENT STORAGE

The wood fascia around the eaves of the roof is worn and weathered. This project would provide for a pre-finished sheetmetal overlay to protect the unsightly and weather checked wood fascia.

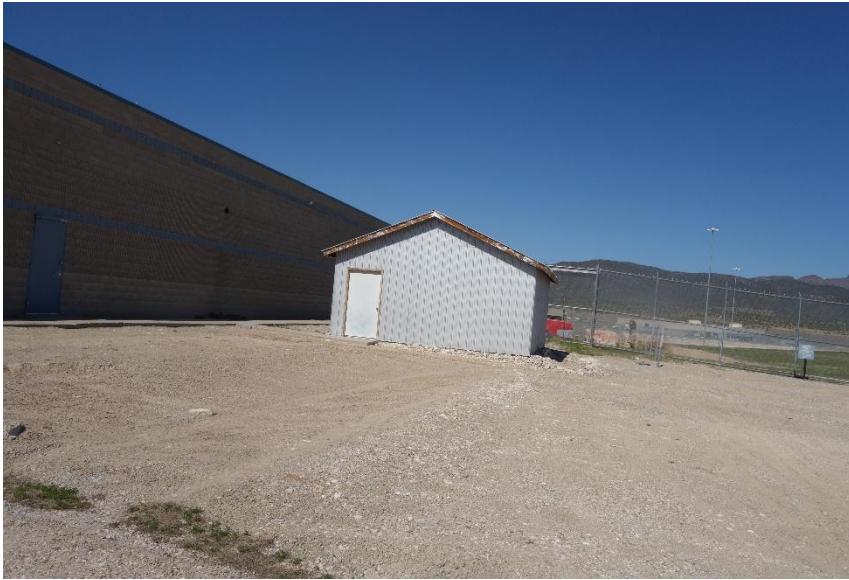
EQUIPMENT STORAGE

The existing exterior door is hung on a wood jamb with wood trim that weathers and creates additional maintenance. The project recommends the removal and replacement of the exterior door with a metal door system suitable for a pre-engineered metal building which provides a prefinished metal door & jamb system that requires no maintenance.

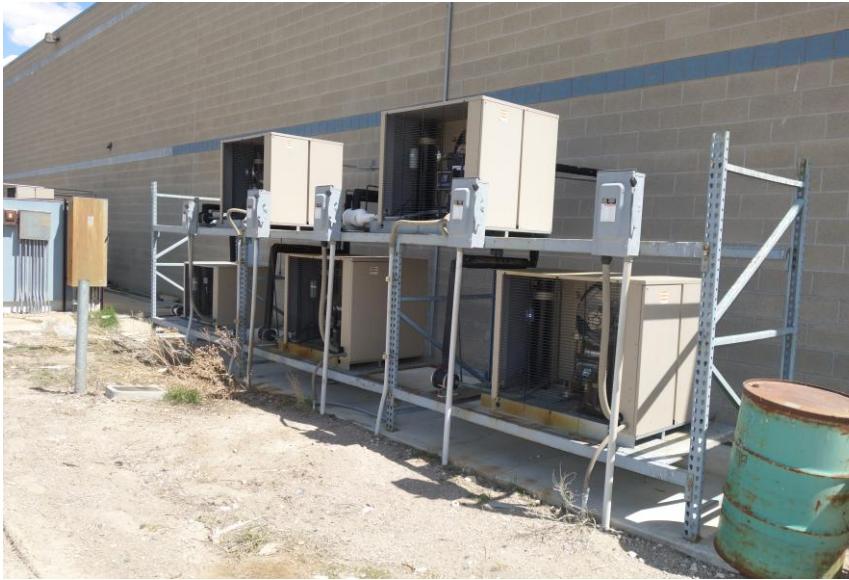
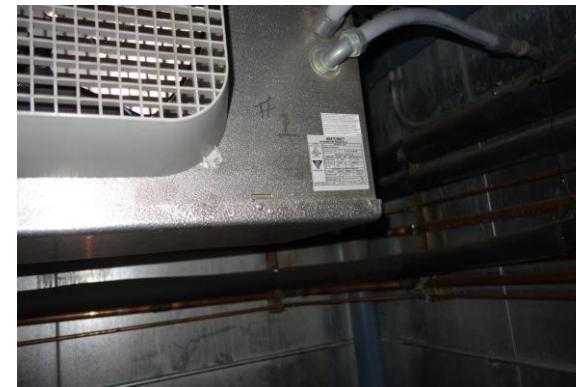
BUILDING #11 - WAREHOUSE/CENTRAL PLANT

The walk-in coolers and freezers are critical to the site's culinary operations. Currently, the refrigeration systems serving these units are 13 years old, nearing the typical 15 - 20 year life expectancy for such equipment. To ensure continued, reliable operation and prevent potential service disruptions, this project proposes the replacement of the refrigeration systems, including associated refrigerant lines.

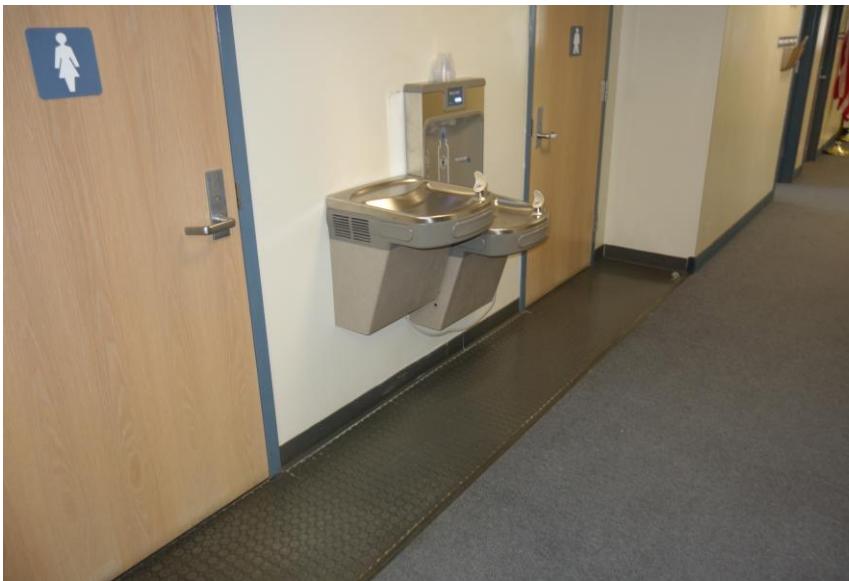
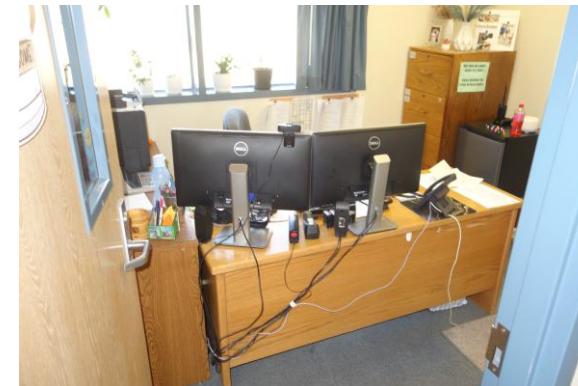
BUILDING #9 - SCHEDULED SERVICES

The interior finishes are in fair condition. It is recommended that the interior walls and ceilings be repainted within the next 5 - 7 years. Prior to painting, all surfaces should be properly repaired and prepared to ensure a durable and uniform finish. In wet or high humidity areas, the use of an epoxy-based paint is recommended to enhance moisture resistance and durability. To preserve the quality of interior finishes and support the longevity of the structure, ongoing building maintenance should be scheduled on a regular, cyclical basis.

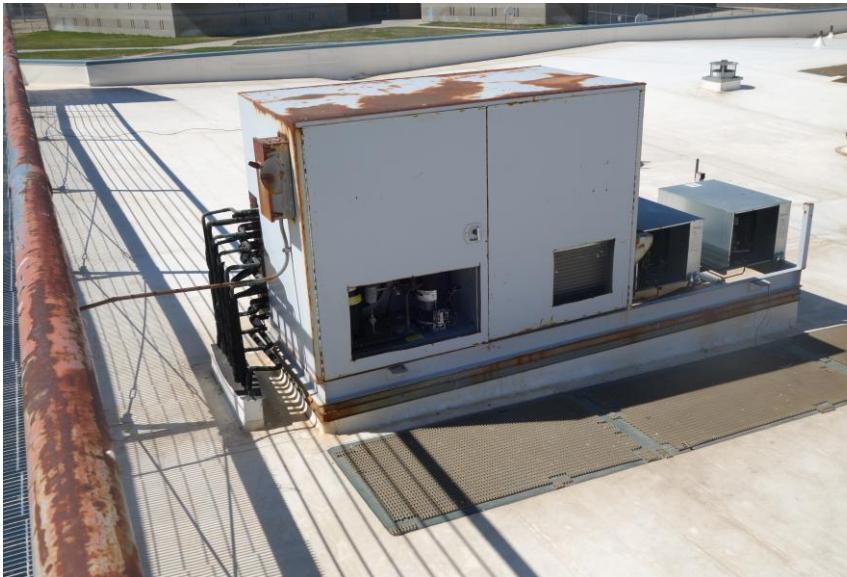
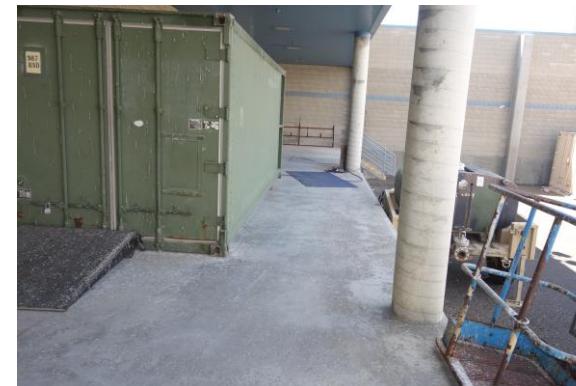
BUILDING #10 - WORK & RECREATION

The walk-in coolers and freezers are critical to the site's culinary operations. Currently, the refrigeration systems serving these units are 9 years old, nearing the typical 15 - 20 year life expectancy for such equipment. To ensure continued, reliable operation and prevent potential service disruptions, this project proposes the replacement of the refrigeration systems, including associated refrigerant lines.
