DEPARTMENT OF ADMINISTRATION
STATE PUBLIC WORKS DIVISION
FACILITY CONDITION ASSESSMENT

PROPERTY PORTFOLIO REVIEW PROJECT ADDENDUM

NORTHEAST REGION
ELY STATE PRISON COMPLEX
9941 - ELY STATE PRISON SITE
4569 N STATE ROUTE 490
ELY, NV 89301-
WHITE PINE COUNTY

SURVEY DATE: 04/23/2024

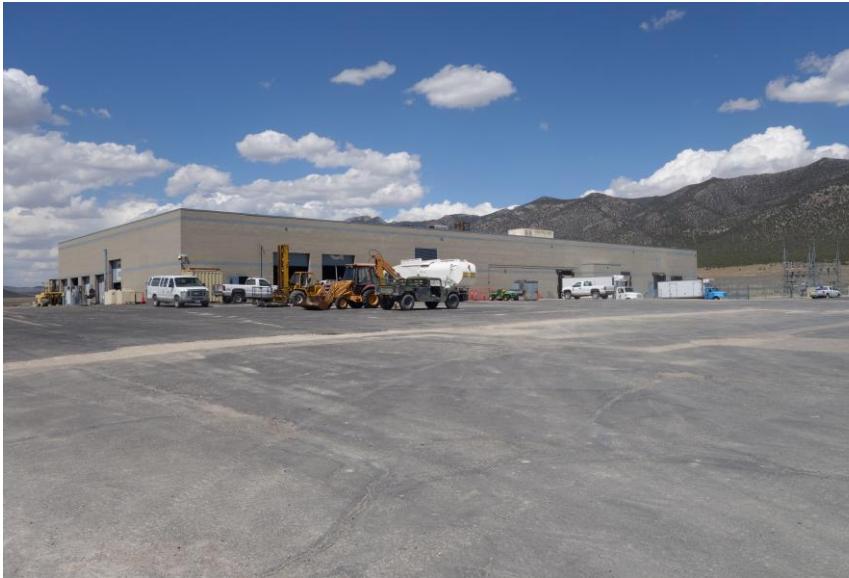
1425-EXT-2: EXTERIOR FINISHES

The exterior finishes of the building are in fair condition, and maintaining the building's finish, weather resistance, and appearance is essential. This project will fund improvements to protect the exterior envelope of the building, excluding the roof. The scope includes painting, staining, or sealing the exterior walls and doors, caulking around windows, flashing, fixtures, and all other exterior penetrations. It is recommended that this work be completed within the next 6 - 8 years and scheduled on a recurring maintenance cycle to preserve the structural integrity and visual condition of the facility.

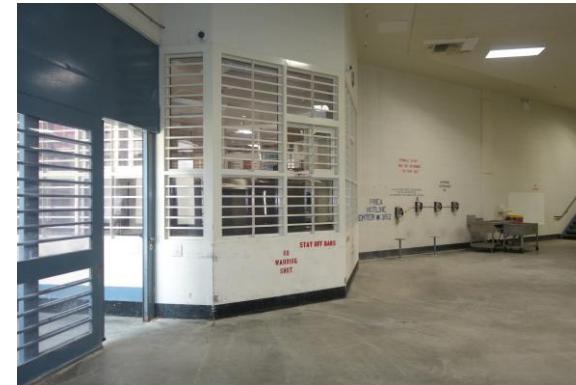
1418-INT-1: INTERIOR FINISHES

The interior finishes are in fair condition. It is recommended that the interior walls and ceilings be repainted within the next 5 - 7 years. Prior to painting, all surfaces should be properly repaired and prepared to ensure a durable and uniform finish. In wet or high humidity areas, the use of an epoxy-based paint is recommended to enhance moisture resistance and durability. To preserve the quality of interior finishes and support the longevity of the structure, ongoing building maintenance should be scheduled on a regular, cyclical basis.

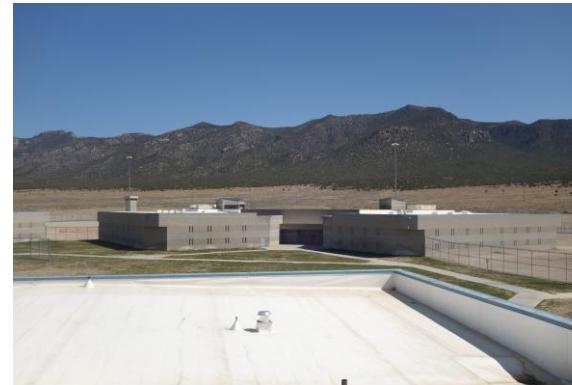
0699-EXT-2: EXTERIOR FINISHES

The exterior finishes of the building are in fair condition, and maintaining the building's finish, weather resistance, and appearance is essential. This project will fund improvements to protect the exterior envelope of the building, excluding the roof. The scope includes painting, staining, or sealing the exterior walls and doors, caulking around windows, flashing, fixtures, and all other exterior penetrations. It is recommended that this work be completed within the next 6 - 8 years and scheduled on a recurring

maintenance cycle to preserve the structural integrity and visual condition of the facility.

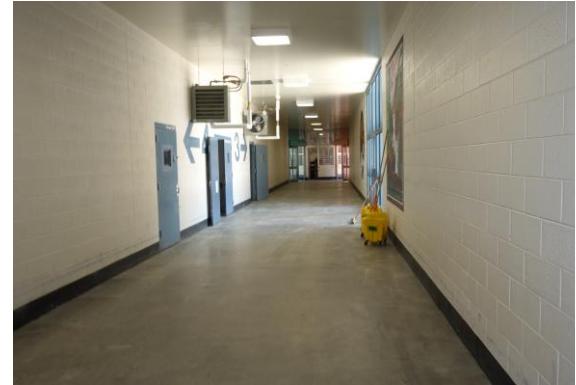
1417-INT-1: INTERIOR FINISHES

The interior finishes are in fair condition. It is recommended that the interior walls and ceilings be repainted within the next 5 - 7 years. Prior to painting, all surfaces should be properly repaired and prepared to ensure a durable and uniform finish. In wet or high humidity areas, the use of an epoxy-based paint is recommended to enhance moisture resistance and durability. To preserve the quality of interior finishes and support the longevity of the structure, ongoing building maintenance should be scheduled on a regular, cyclical basis.

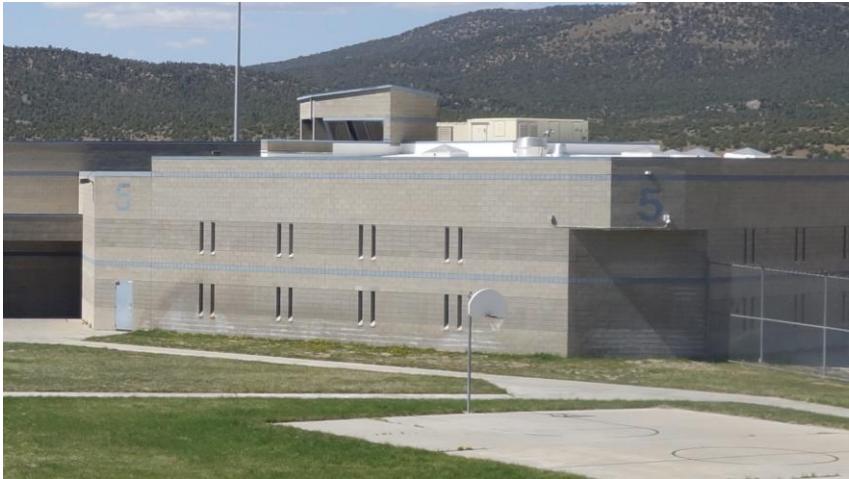
1419-EXT-2: EXTERIOR FINISHES

The exterior finishes of the building are in fair condition, and maintaining the building's finish, weather resistance, and appearance is essential. This project will fund improvements to protect the exterior envelope of the building, excluding the roof. The scope includes painting, staining, or sealing the exterior walls and doors, caulking around windows, flashing, fixtures, and all other exterior penetrations. It is recommended that this work be completed within the next 6 - 8 years and scheduled on a recurring maintenance cycle to preserve the structural integrity and visual condition of the facility.

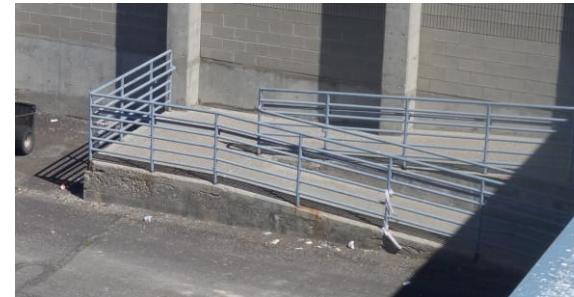
1424-ADA-2: WALKING RAMP REPLACEMENT

The walking ramp on the West side of the building in the loading dock is failing and should be planned for replacement. One of the guard rail post anchors is fully exposed compromising the structural integrity. This project recommends a complete replacement of the ramp and guard rail system.

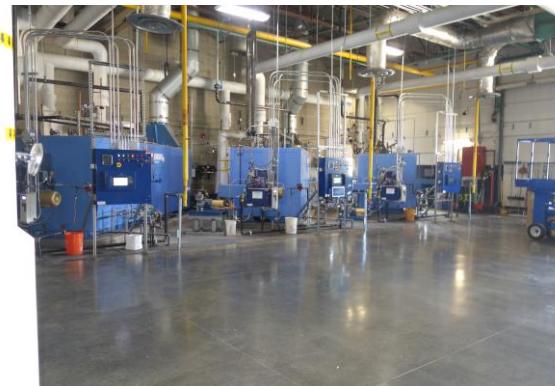
1425-INT-1: INTERIOR FINISHES

The interior finishes are in fair condition. It is recommended that the painted interior walls and ceilings be repainted within the next 5 - 7 years. Prior to painting, all surfaces should be properly repaired and prepared to ensure a durable and uniform finish. In wet or high humidity areas, the use of an epoxy-based paint is recommended to enhance moisture resistance and durability. To preserve the quality of interior finishes and support the longevity of the structure, ongoing building maintenance should be scheduled on a regular, cyclical basis.

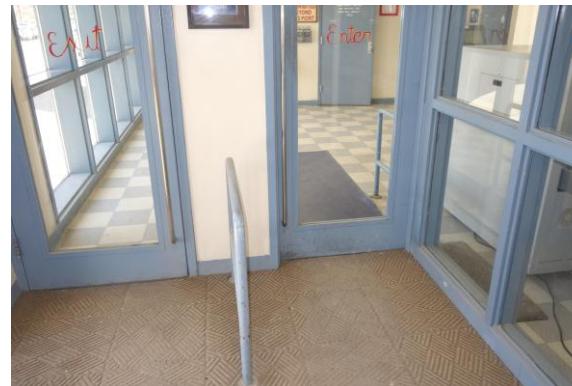
1428-INT-1: INTERIOR FINISHES

The interior finishes are in fair condition. It is recommended that the interior walls and ceilings be repainted within the next 5 - 7 years. Prior to painting, all surfaces should be properly repaired and prepared to ensure a durable and uniform finish. In wet or high humidity areas, the use of an epoxy-based paint is recommended to enhance moisture resistance and durability. To preserve the quality of interior finishes and support the longevity of the structure, ongoing building maintenance should be scheduled on a regular, cyclical basis.
