# STATE OF NEVADA STATE PUBLIC WORKS DIVISION

## FACILITY CONDITION ASSESSMENT REPORT FOR:

DEPT OF HEALTH AND HUMAN SERVICES  
DIVISION OF CHILD AND FAMILY SERVICES  
CYC

Survey Date: 3/6/2024  
Distribution Date: 8/21/2024

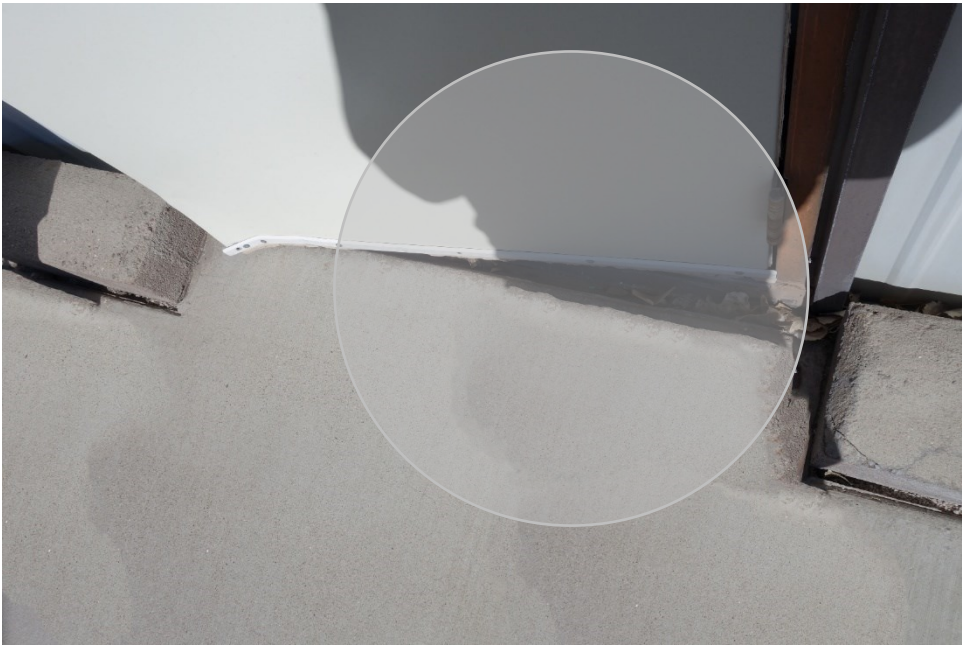
0199 CYC MENTAL HEALTH BUILDING

QUANTITY	UNITS	TOTAL	SF COST
<p>The ADA provides for accessibility to sites and services for people with physical limitations. At the threshold between the entrance door and the landing there is a large gap. The gap is large enough to compromise the compliance of the path of travel and should be altered. This project would provide for installing an extended threshold to cover the gap and bring the path of travel into compliance with the code. The 2018 IBC, ICC/ANSI A117.1 - 2009 and the most current version of the ADAAG were used as references for this project.</p> <p>This project or a portion thereof was previously recommended in the FCA report dated 09/21/2010 and 03/01/2017. It has been amended accordingly to reflect conditions observed during the most recent survey date of 03/06/2024.</p>	1	Package	\$ 1,500.00	\$ 1.00

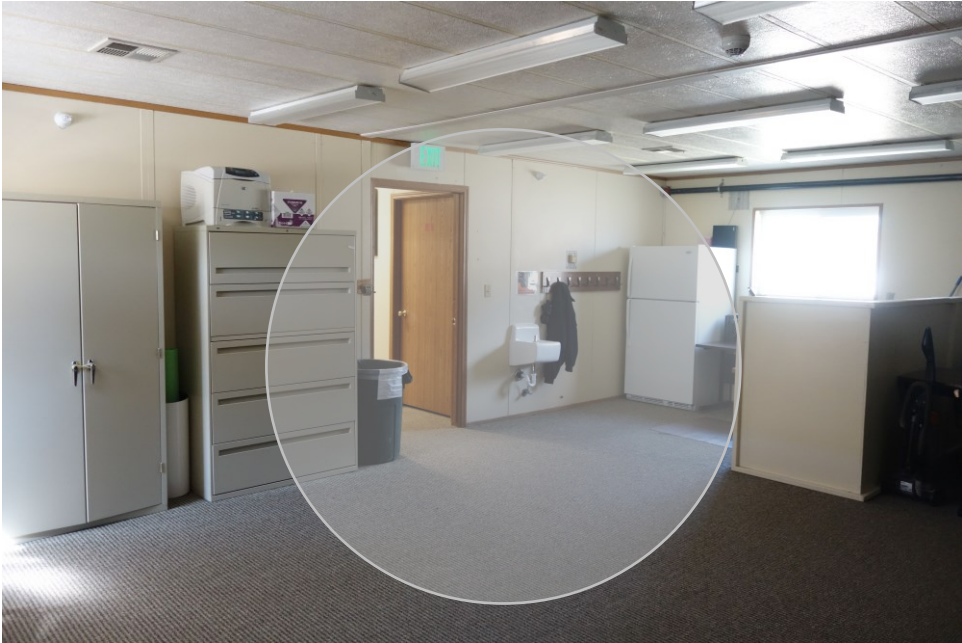
0199 CYC MENTAL HEALTH BUILDING

QUANTITY	UNITS	TOTAL	SF COST
<p>This building contains two water fountains that are not ADA compliant. The 2018 IBC Section 1109.5 states where drinking fountains are provided on an exterior site, on a floor or within a secured area, no fewer than two drinking fountains shall be provided. One shall comply with the requirements for people who use a wheelchair and one shall comply with the requirements for standing persons. This project would provide funding for the purchase and installation of two drinking fountains to meet the ADA requirements.</p> <p>This project or a portion thereof was previously recommended in the FCA report dated 03/01/2017. It has been amended accordingly to reflect conditions observed during the most recent survey date of 03/06/2024.</p>	2	Each	\$ 5,000.00	\$ 3.00

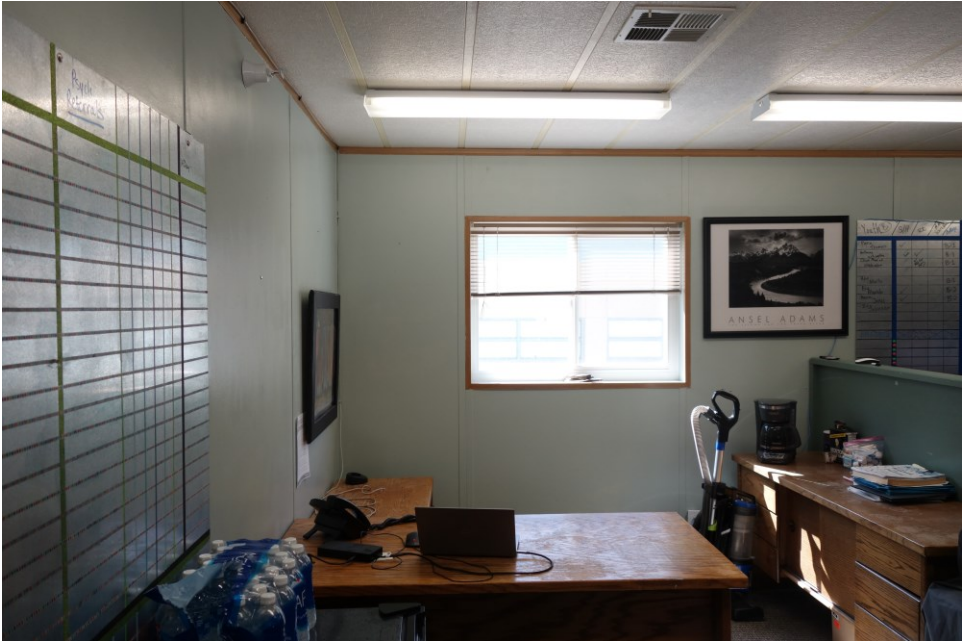
QUANTITY	UNITS	TOTAL	SF COST
The interior finishes are in good condition. It is recommended that the interior walls and ceilings be painted at least once in the next 8 - 10 years and that this project be scheduled on a cyclical basis to maintain the integrity of the structure. Prior to painting, all surfaces should be repaired and prepped. An epoxy-based paint should be utilized in wet areas for durability.	1800	Square Foot	\$10,800.00	\$ 6.00

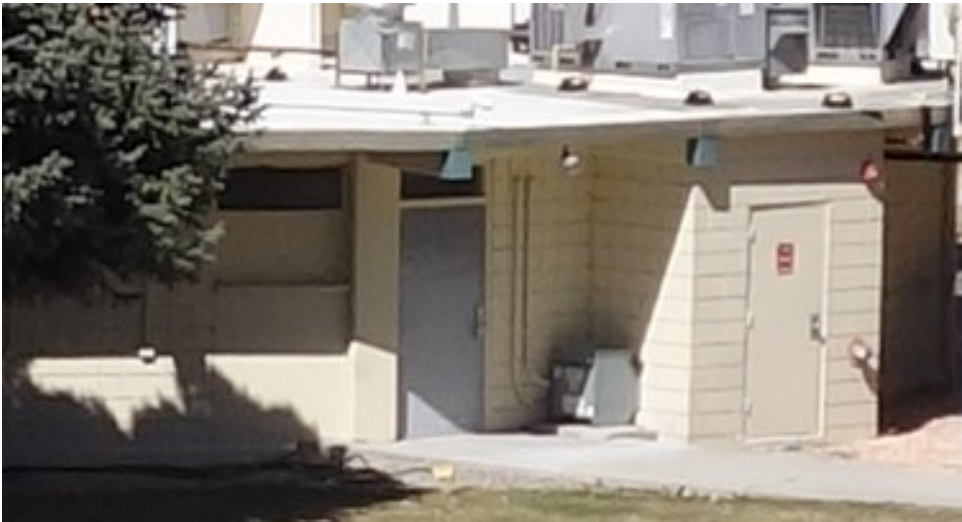
0211 CYC CURRIE DORMITORY

QUANTITY	UNITS	TOTAL	SF COST
<p>The building exterior is constructed of Concrete Masonry Unit (CMU) with no insulation. The windows are original to the building and single pane construction. Buildings of this type are not energy efficient. This project recommends adding an Exterior Insulation Finish System (EIFS) over the CMU and replacing the windows with a behavior health rated polycarbonate safety glazing, dual pane, high efficiency units.</p> <p>This project or a portion thereof was previously recommended in the FCA report dated 09/21/2010 and 03/01/2017. It has been amended accordingly to reflect conditions observed during the most recent survey date of 03/06/2024.</p>	1	Package	\$1,008,300.00	\$ 241.00

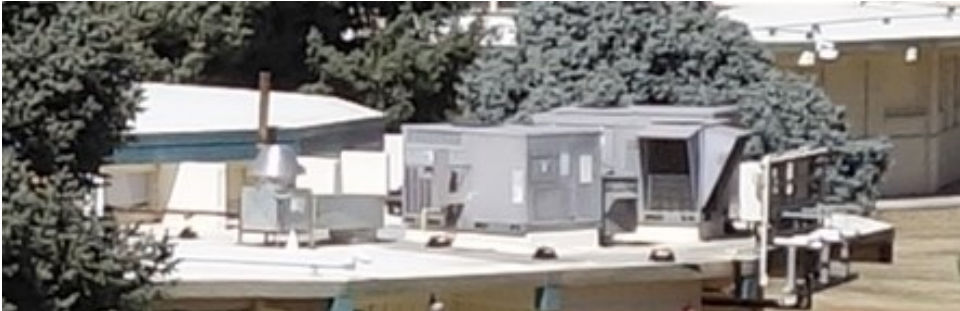
0211 CYC CURRIE DORMITORY

QUANTITY	UNITS	TOTAL	SF COST
There are 3 HVAC gas fired rooftop packaged units (RTU's) installed on the roof in 2007. They are in fair condition but will be reaching the end of their expected life in the next 3 - 5 years. The R-22 refrigerant in the cooling system is no longer EPA compliant and its production was phased out completely January 1, 2020. This project recommends the RTU's be replaced in the next 5 - 10 years. This project estimate includes installation of the new HVAC units, and cleaning of the existing duct work and grilles. This project also includes removal and disposal of the existing HVAC system and all required connections to utilities.	4185	Square Foot	\$159,400.00	\$ 38.00

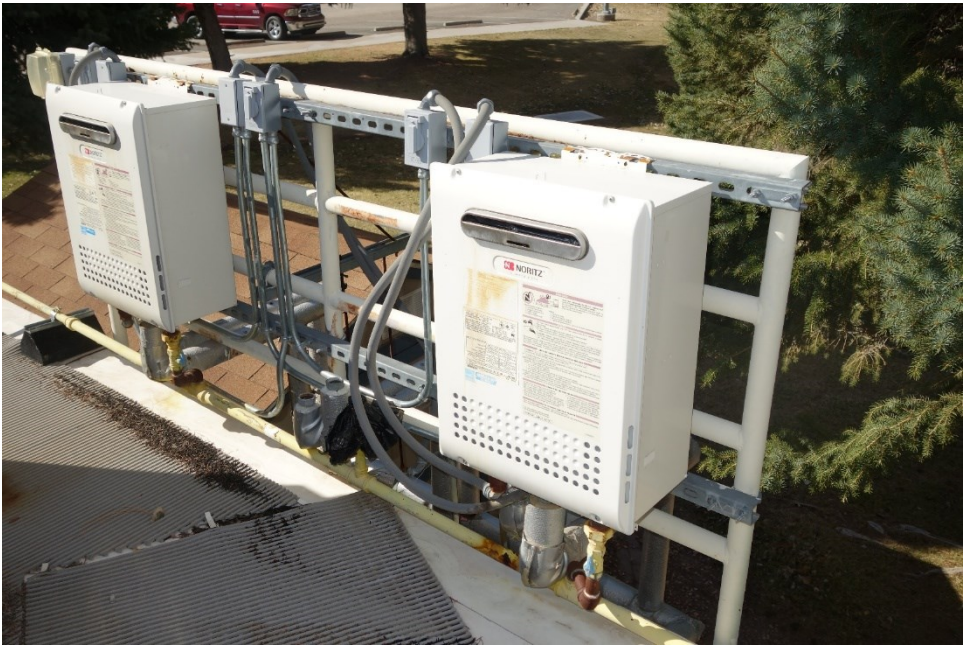
QUANTITY	UNITS	TOTAL	SF COST
<p>There are 2 gas fired tankless water heaters located on the roof installed in 2016. They are in fair condition but will be reaching the end of their expected life in the next 8 - 10 years. This project recommends the water heaters be replaced in the next 8 - 10 years. This project also includes removal and disposal of the existing system and all required connections to utilities.</p>	4185	Square Foot	\$20,900.00	\$ 5.00

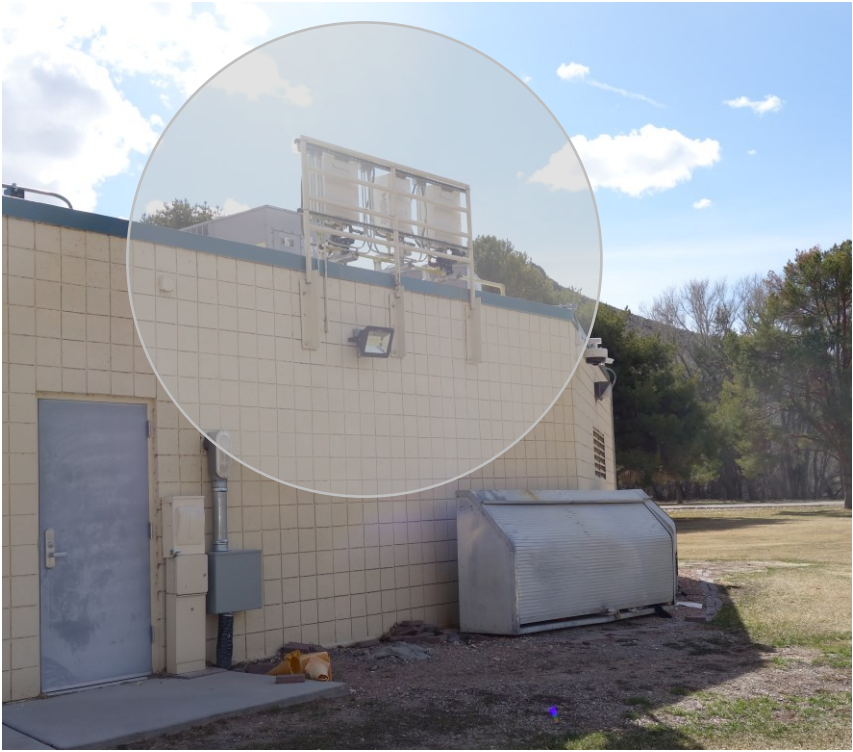
QUANTITY	UNITS	TOTAL	SF COST
There are 2 gas fired tankless water heaters located on the roof installed in 2016. They are in fair condition but will be reaching the end of their expected life in the next 8 - 10 years. This project recommends the water heaters be replaced in the next 8 - 10 years. This project also includes removal and disposal of the existing system and all required connections to utilities.	4185	Square Foot	\$20,900.00	\$ 5.00

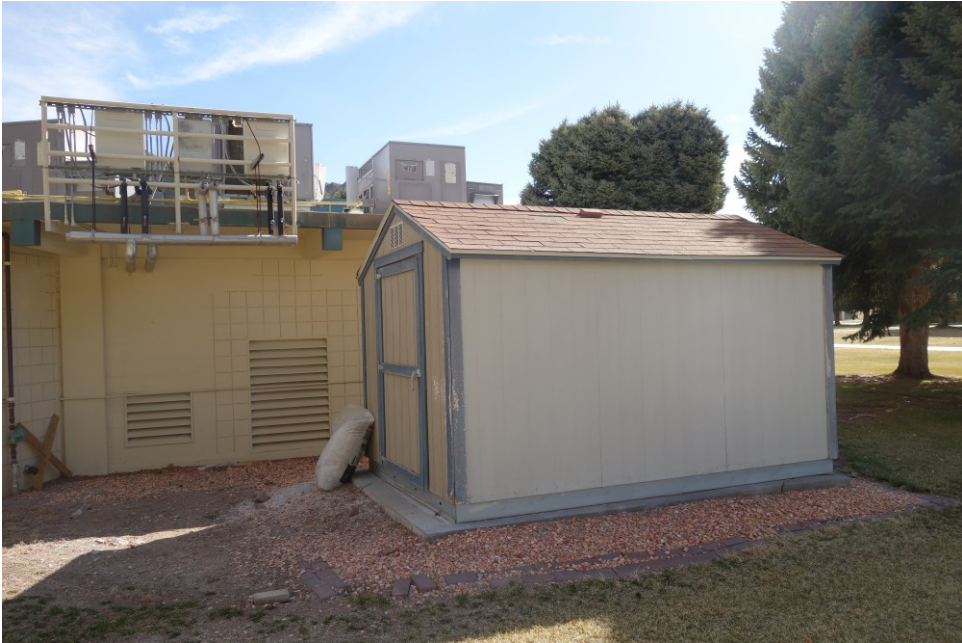
QUANTITY	UNITS	TOTAL	SF COST
There are 2 gas fired tankless water heaters located on the roof installed in 2016. They are in fair condition but will be reaching the end of their expected life in the next 8 - 10 years. This project recommends the water heaters be replaced in the next 8 - 10 years. This project also includes removal and disposal of the existing system and all required connections to utilities.	4185	Square Foot	\$20,900.00	\$ 5.00

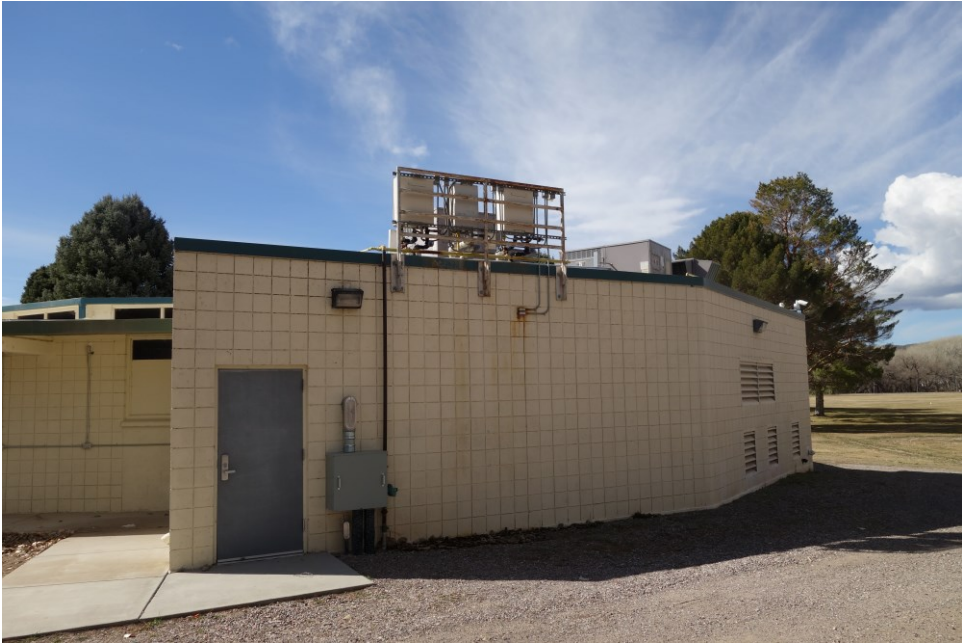
QUANTITY	UNITS	TOTAL	SF COST
There are 2 gas fired tankless water heaters located on the roof installed in 2016. They are in fair condition but will be reaching the end of their expected life in the next 8 - 10 years. This project recommends the water heaters be replaced in the next 8 - 10 years. This project also includes removal and disposal of the existing system and all required connections to utilities.	4185	Square Foot	\$20,900.00	\$ 5.00

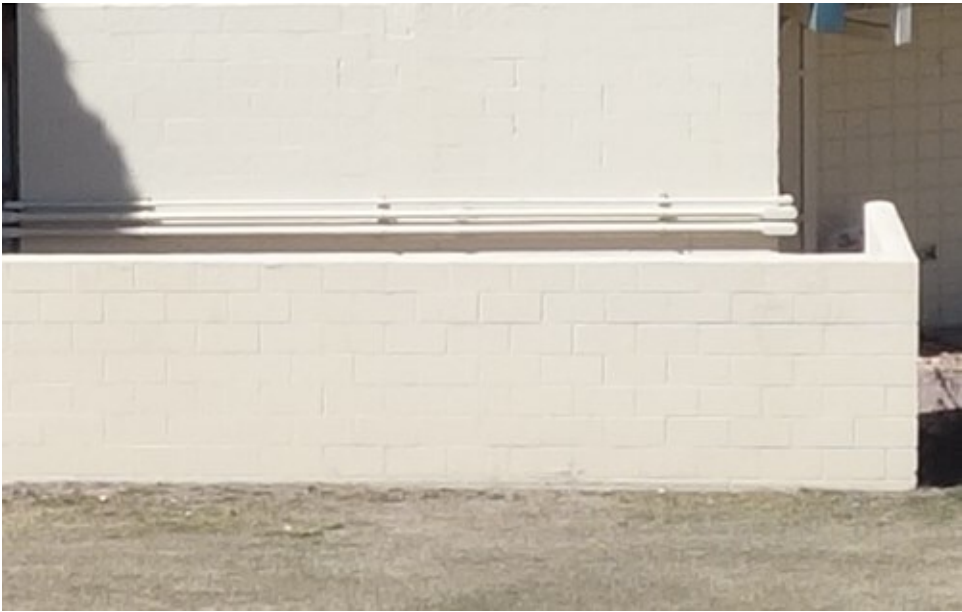
0218 CYC ADMINISTRATION

QUANTITY	UNITS	TOTAL	SF COST
The exterior finishes were in fair condition. It is important to maintain the finish, weather resistance and appearance of the building. This project would provide funding to protect the exterior of the building excluding the roof. Included in the cost are painting the concrete masonry unit walls and caulking of the windows, flashing, fixtures and all other penetrations. It is recommended that the building be painted and caulked in the next 4 - 5 years and that this project be scheduled on a cyclical basis to maintain the integrity of the structure.	4185	Square Foot	\$41,900.00	\$ 10.00

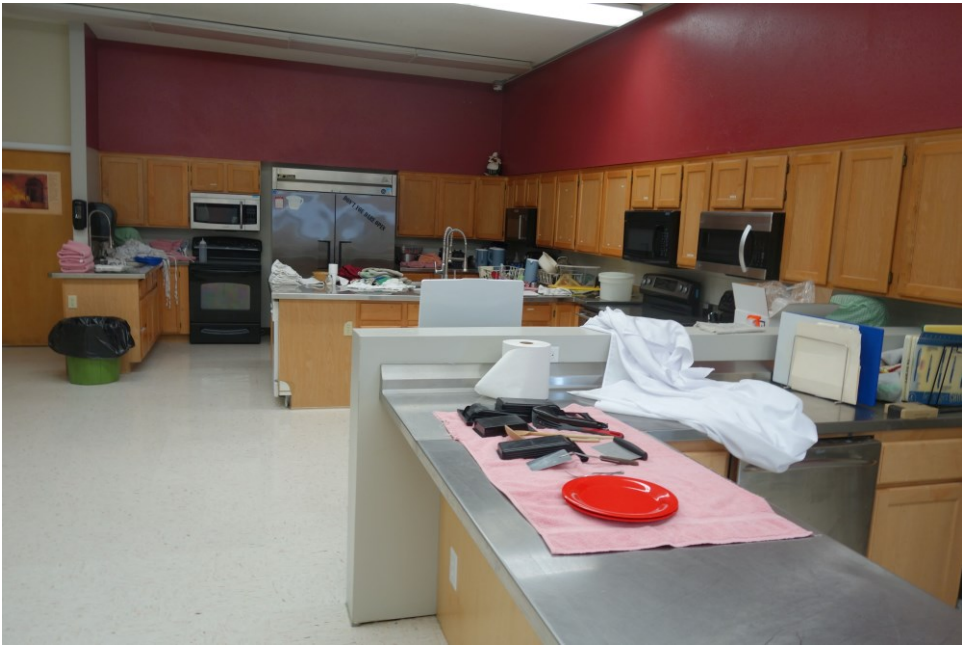
0219 CYC SCHOOL - OLD

QUANTITY	UNITS	TOTAL	SF COST
<p>The building does not have an accessible restroom and the Culinary lab area is not accessible. The existing restroom does not meet the ADA requirements. A complete retrofit is necessary. This project would provide funding for remodeling the Men's and Women's restrooms per ADA regulations. It will also make the necessary modifications to the Culinary area to accommodate accessible needs. Items may include a new sink, toilet, hardware, mirrors, fixtures, flooring and paint. The 2018 IBC, ICC/ANSI A117.1 - 2009, NRS 338.180 and the most current version of the ADA Standards for Accessible Design were used as references for this project.</p> <p>This project or a portion thereof was previously recommended in the FCA report dated 04/09/2002, 09/21/2010 and 03/01/2017. It has been amended accordingly to reflect conditions observed during the most recent survey date of 03/06/2024.</p>	1	Package	\$313,000.00	\$ 27.00

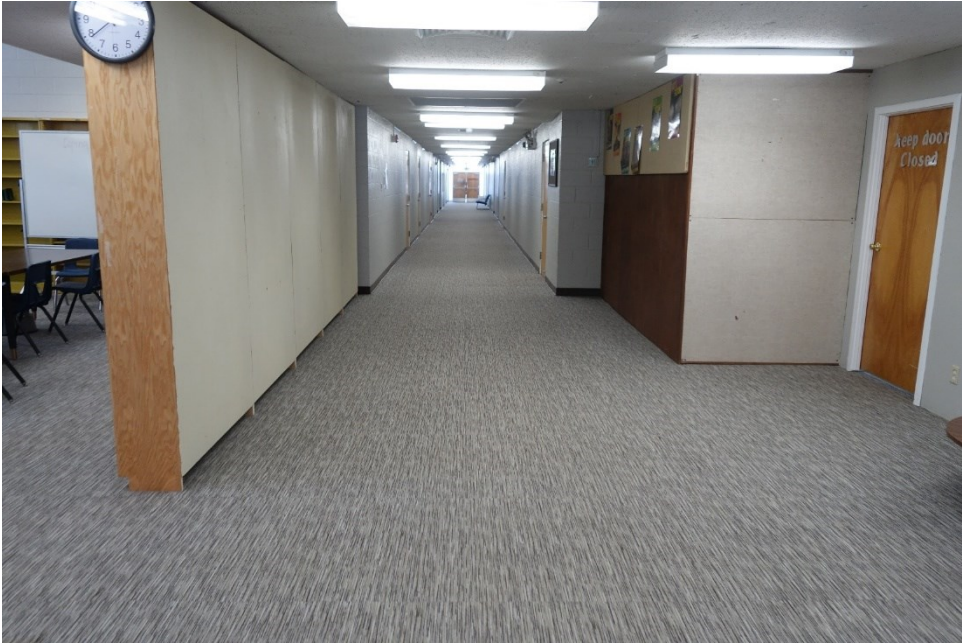
QUANTITY	UNITS	TOTAL	SF COST
The interior finishes are in good condition. It is recommended that the interior walls and ceilings be painted at least once in the next 7 - 9 years and that this project be scheduled on a cyclical basis to maintain the integrity of the structure. Prior to painting, all surfaces should be repaired and prepped. An epoxy-based paint should be utilized in wet areas for durability.	11760	Square Foot	\$117,600.00	\$ 10.00

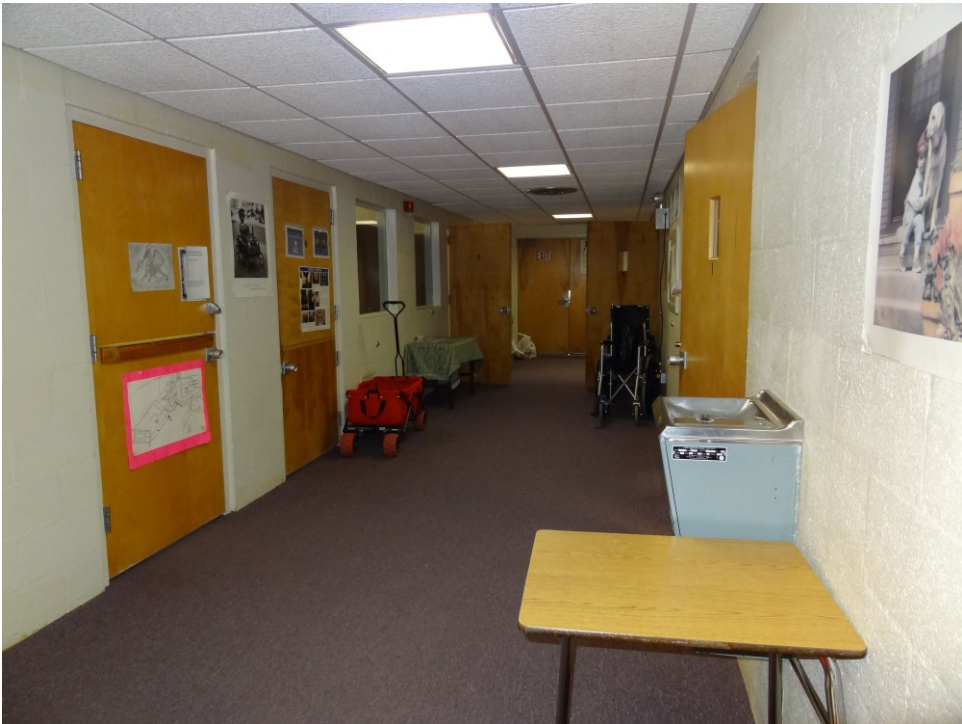
QUANTITY	UNITS	TOTAL	SF COST
<p>The existing door handles are round knob type and are not ADA compliant. This project would provide for the installation of new lever action door hardware on all doors in the facility. This estimate is for 15 units. NRS 338.180, IBC - 2018, ICC/ANSI A117.1 - 2009 and the most current version of the ADAAG were used as references for this project.</p> <p>This project or a portion thereof was previously recommended in the FCA report dated 09/21/2010 and 03/01/2017. It has been amended accordingly to reflect conditions observed during the most recent survey date of 03/06/2024.</p>	15	Each	\$15,000.00	\$ 10.00

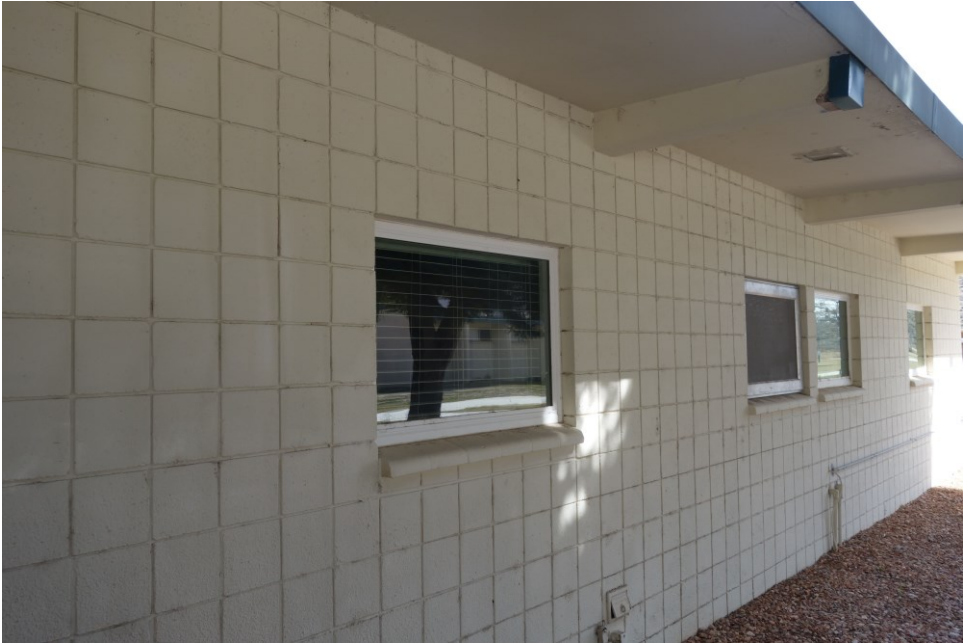
0220 CYC EVALUATION / INFIRMARY

QUANTITY	UNITS	TOTAL	SF COST
The building exterior is constructed of Concrete Masonry Unit (CMU) with no insulation. The windows are original to the building and single pane construction. Buildings of this type are not energy efficient. This project recommends adding an Exterior Insulation Finish System (EIFS) over the CMU and replacing the windows with a behavior health rated polycarbonate safety glazing, dual pane, high efficiency units.	1	Package	\$148,500.00	\$ 94.00

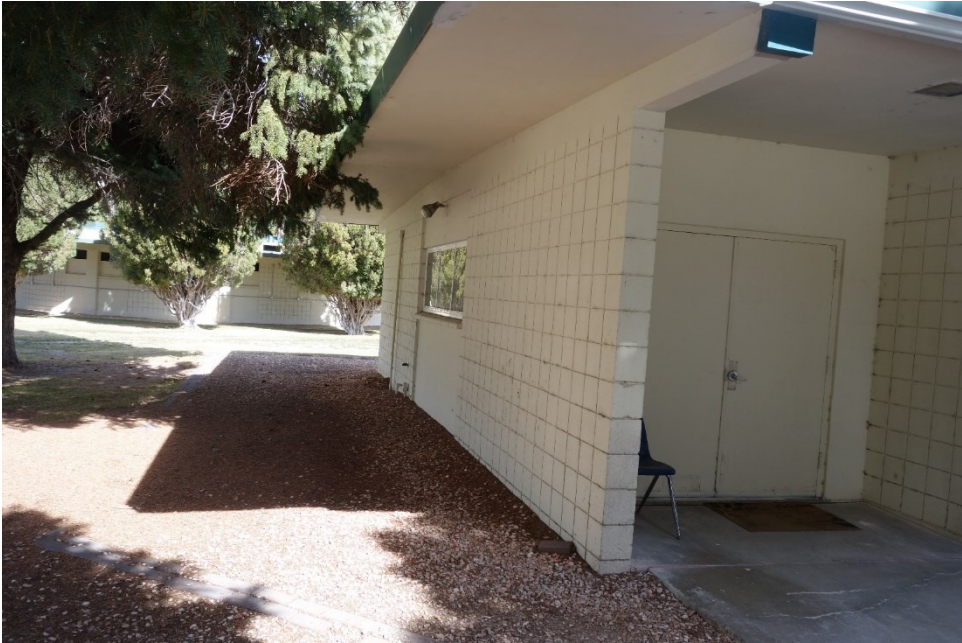
0220 CYC EVALUATION / INFIRMARY

QUANTITY	UNITS	TOTAL	SF COST
The exterior finishes were in fair condition. It is important to maintain the finish, weather resistance and appearance of the building. This project would provide funding to protect the exterior of the building excluding the roof. Included in the cost are painting the concrete masonry unit walls and caulking of the windows, flashing, fixtures and all other penetrations. It is recommended that the building be painted and caulked in the next 4 - 6 years and that this project be scheduled on a cyclical basis to maintain the integrity of the structure.	1578	Square Foot	\$23,800.00	\$ 15.00

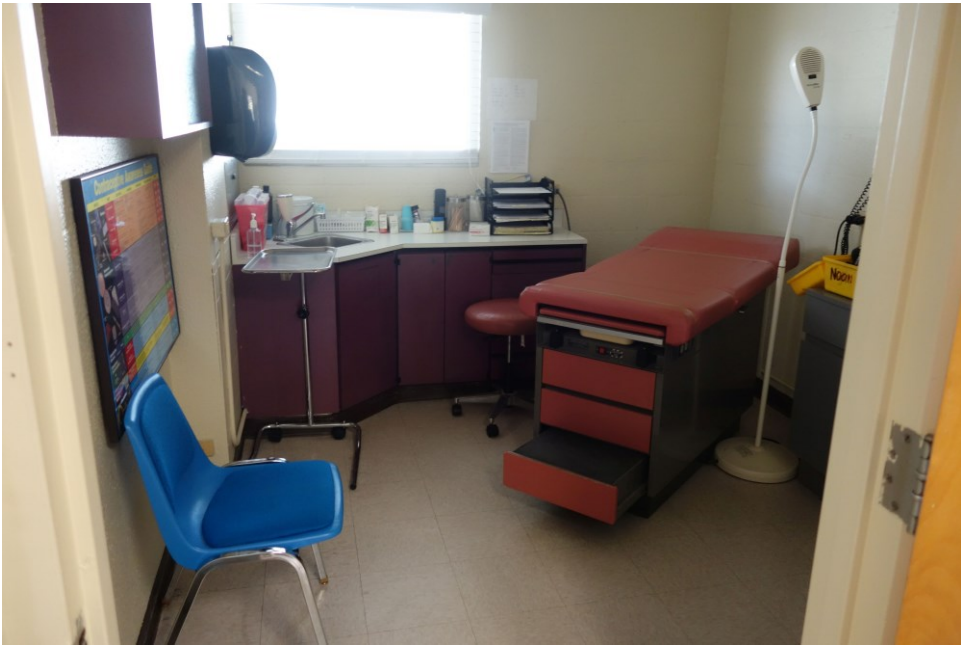
The interior finishes are in good condition. It is recommended that the interior walls and ceilings be painted at least once in the next 6 - 8 years and that this project be scheduled on a cyclical basis to maintain the integrity of the structure. Prior to painting, all surfaces should be repaired and prepped. An epoxy-based paint should be utilized in wet areas for durability.

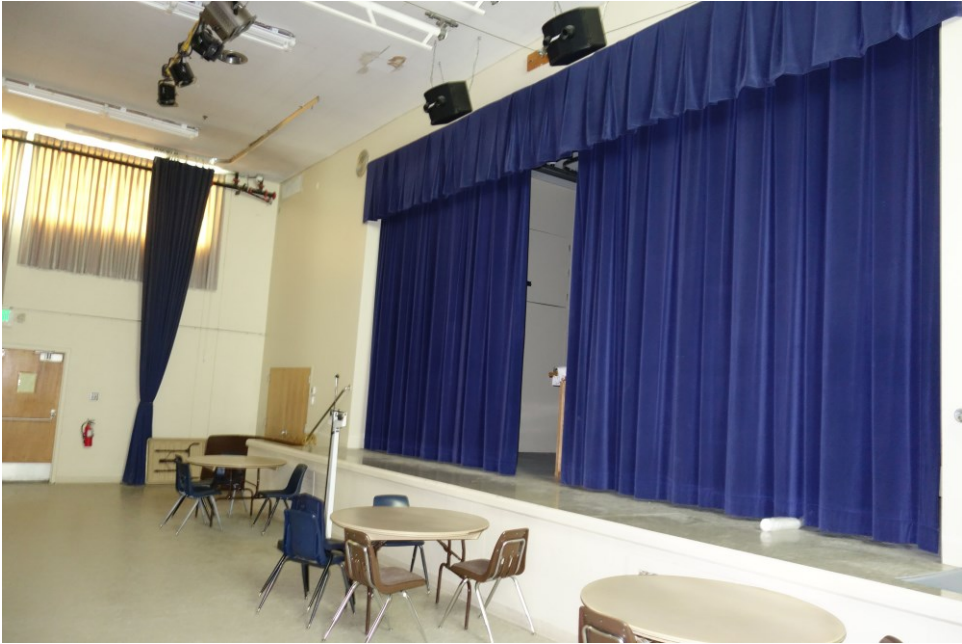
0221 CYC MULTI-PURPOSE BUILDING

QUANTITY	UNITS	TOTAL	SF COST
<p>The auditorium is lacking an accessible path to the stage. The stage is required to have an accessible path to it per the ADA regulations. This project would provide for an accessible ramp or powered lift to access the stage. NRS 338.180, IBC - 2018, ICC/ANSI A117.1 - 2009 and the most current version of the ADAAG were used as references for this project.</p> <p>This project or a portion thereof was previously recommended in the FCA report dated 09/21/2010 and 03/01/2017. It has been amended accordingly to reflect conditions observed during the most recent survey date of 03/06/2024.</p>	1	Package	\$52,500.00	\$ 1.00

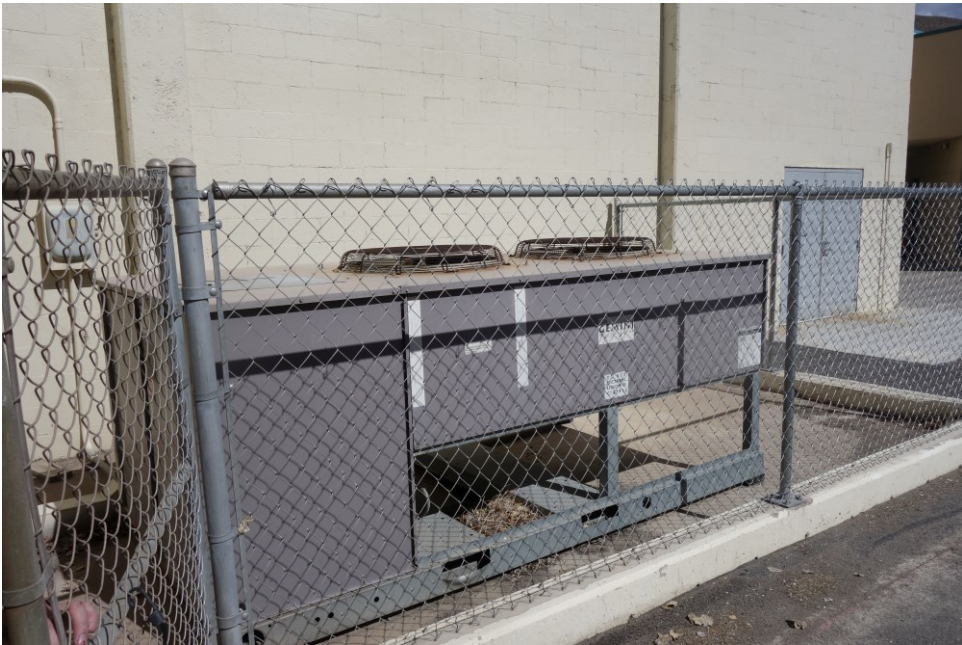
0221 CYC MULTI-PURPOSE BUILDING

QUANTITY	UNITS	TOTAL	SF COST
<p>There is only one boiler supplying the Culinary and general heating for the Gymnasium. Loss of the single boiler will shut down the Culinary operation on which the site depends. Additionally, the air handling unit (AHU) supplying conditioned air to the Gymnasium is original to the building and approaching 60 years of operation. The AHU &amp; condensing unit operate on an R-22 refrigerant. The R-22 refrigerant in the cooling system is no longer EPA compliant and its production was phased out completely January 1, 2020. This project recommends adding a boiler for redundancy and replacing the AHU, condensing unit and all associated piping.</p>	1	Package	\$678,900.00	\$ 19.00

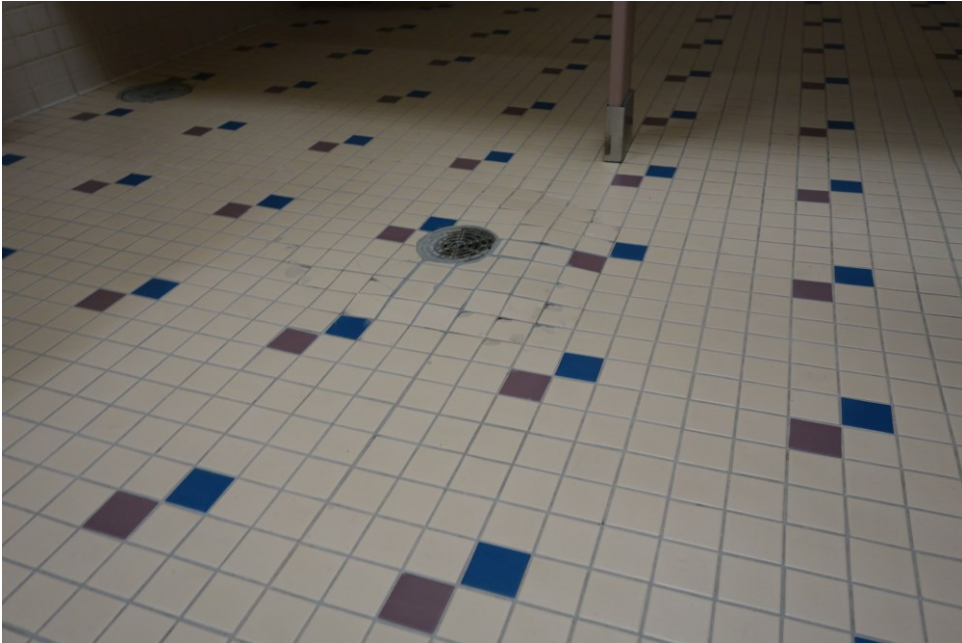
0221 CYC MULTI-PURPOSE BUILDING

QUANTITY	UNITS	TOTAL	SF COST
The locker room concrete slab floor has heaved in different areas and possibly failing under the floor tile. This project recommends the removal of portions of the floor tile to further determine the extent of the concrete slab failure. Removal of portions of the concrete slab may be necessary to complete the investigation. Repair costs are not included in this estimate.	1	Package	\$25,000.00	\$ 1.00

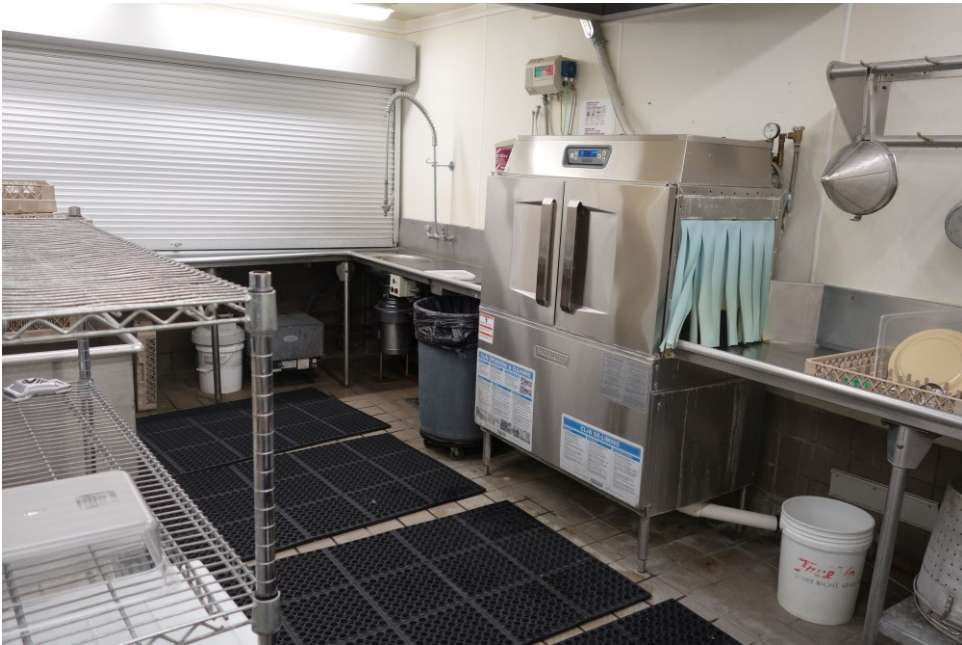
QUANTITY	UNITS	TOTAL	SF COST
The current dishwashing work surfaces do not slope properly to drain leaving ponding water and additional work to maintain sanitary operations. This project recommends the adjustment or replacement of the stainless steel work surfaces and table legs to ensure proper drainage of water to drain. Proper work surface working heights must be maintained.	1	Package	\$25,000.00	\$ 1.00

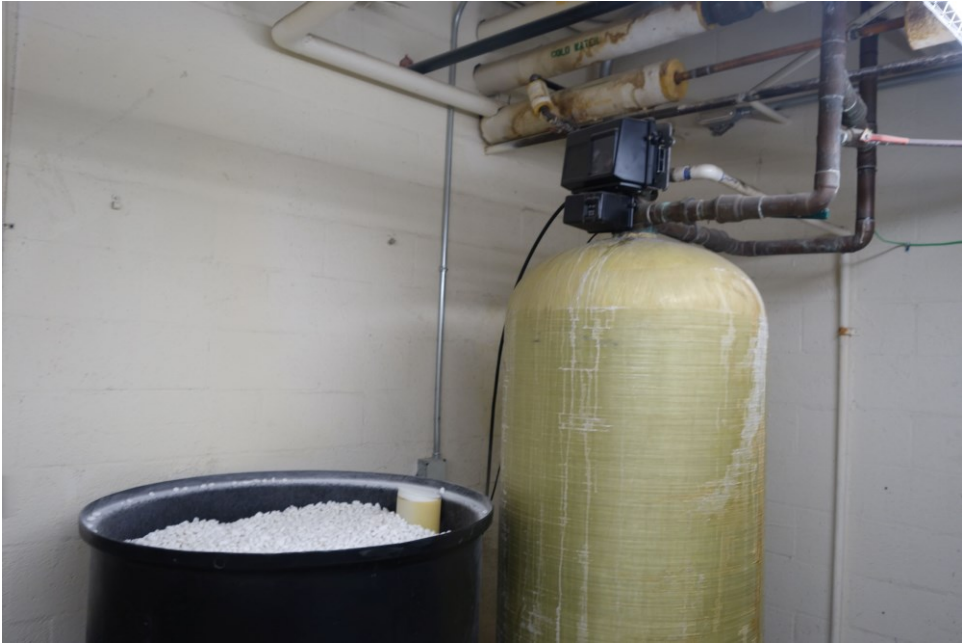
QUANTITY	UNITS	TOTAL	SF COST
<p>The existing water softening/ treatment system in the building only serves the boiler for the Laundry and Culinary. The other boiler and the rest of the HVAC equipment should have a water treatment system as well. Failure to treat the water can cause wear and tear on the domestic water supply lines, plumbing fixtures and HVAC equipment. This project would provide for the purchase and installation of water softeners/ treatment systems to serve all of the mechanical and plumbing equipment.</p> <p>This project or a portion thereof was previously recommended in the FCA report dated 09/21/2010 and 03/01/2017. It has been amended accordingly to reflect conditions observed during the most recent survey date of 03/06/2024.</p>	1	Package	\$40,000.00	\$ 1.00

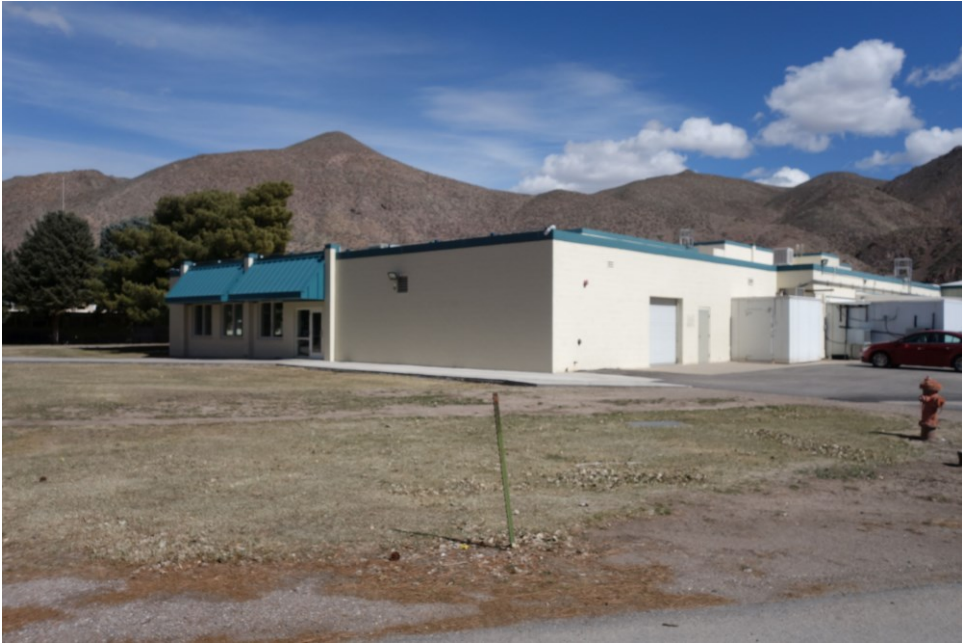
QUANTITY	UNITS	TOTAL	SF COST
The exterior finishes were in good condition. It is important to maintain the finish, weather resistance and appearance of the building. This project would provide funding to protect the exterior of the building excluding the roof. Included in the cost is painting the stucco and concrete masonry unit walls and caulking of the windows, flashing, fixtures and all other penetrations. It is recommended that the building be painted and caulked in the next 7 - 9 years and that this project be scheduled on a cyclical basis to maintain the integrity of the structure.	36630	Square Foot	\$366,300.00	\$ 10.00

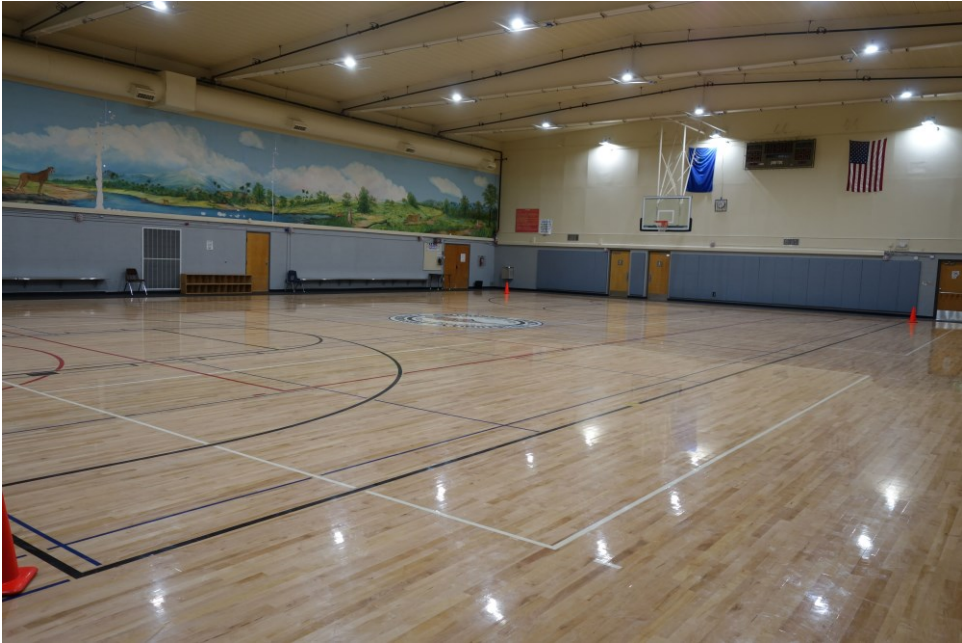
QUANTITY	UNITS	TOTAL	SF COST
The interior finishes are in good condition. It is recommended that the interior walls and ceilings be painted at least once in the next 8 - 10 years and that this project be scheduled on a cyclical basis to maintain the integrity of the structure. Prior to painting, all surfaces should be repaired and prepped. An epoxy-based paint should be utilized in wet areas for durability.	36630	Square Foot	\$366,300.00	\$ 10.00

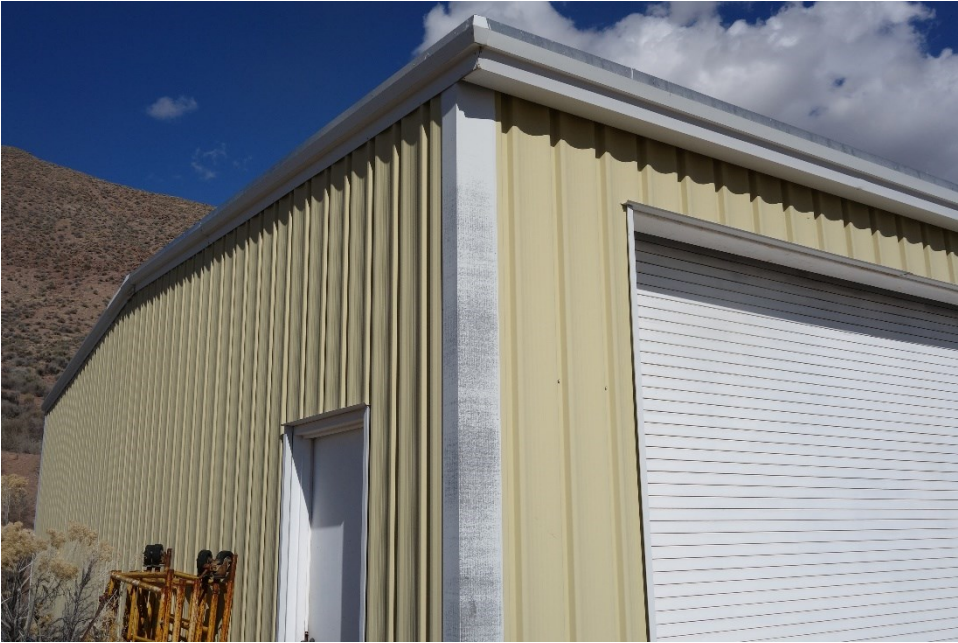
QUANTITY	UNITS	TOTAL	SF COST
The pre-finished metal exterior finishes were in fair condition. It is important to maintain the finish, weather resistance and appearance of the building. This project would provide funding to protect the exterior of the building and inspect the roof for leaks. Included in the cost is caulking and flashing repairs of all penetrations through the wall and roof panels. It is recommended that the building be caulked and sealed in the next 8 - 10 years and that this project be scheduled on a cyclical basis to maintain the integrity of the structure.	2000	Square Foot	\$ 4,000.00	\$ 2.00

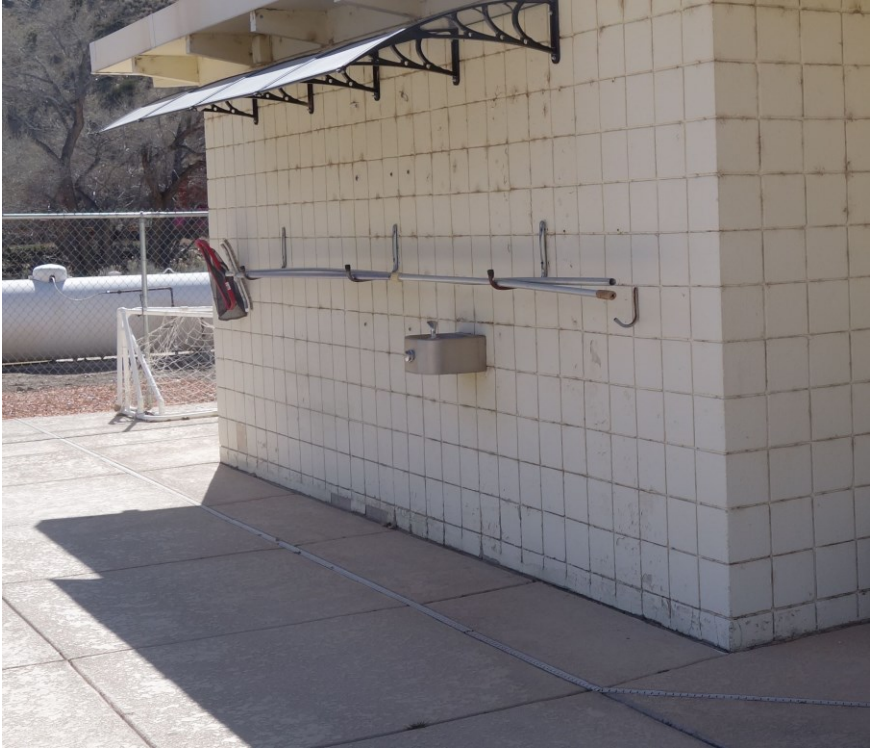
QUANTITY	UNITS	TOTAL	SF COST
<p>This building contains a water fountain that is not ADA compliant. The 2018 IBC Section 1109.5 states where drinking fountains are provided on an exterior site, on a floor or within a secured area, no fewer than two drinking fountains shall be provided. One shall comply with the requirements for people who use a wheelchair and one shall comply with the requirements for standing persons. This project would provide funding for the purchase and installation of two drinking fountains to meet the ADA requirements.</p> <p>This project or a portion thereof was previously recommended in the FCA report dated 03/01/2017. It has been amended accordingly to reflect conditions observed during the most recent survey date of 03/06/2024.</p>	1	Each	\$ 5,000.00	\$ 2.00

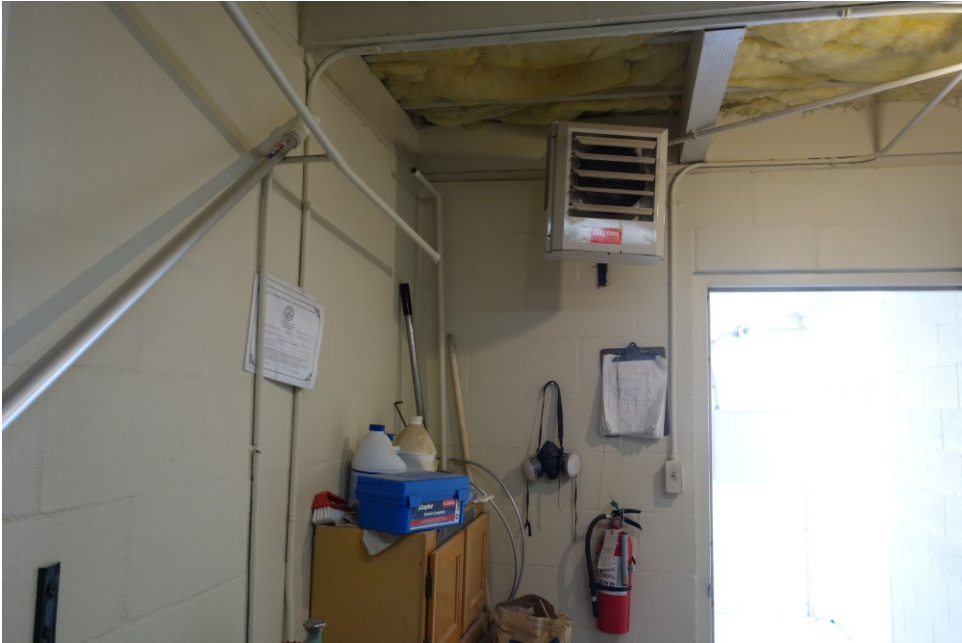
QUANTITY	UNITS	TOTAL	SF COST
<p>The building contains hazardous materials (i.e. pool chemicals). Per IFC 2012 Hazardous Materials, and in accordance with NFPA; where hazardous materials are stored, dispensed or used, Section 5003 states the proper use and application is to have mechanical exhaust and ventilation, and hazard identification signs shall be installed. Refer to Section 5004 and 5005 for the proper use and setup. It is important to comply with all applicable codes. This project would provide for all requirements in IFC 2018, to include Section 105 permits and inspections through the State Fire Marshal's Office and the State Public Works Division.</p> <p>This project or a portion thereof was previously recommended in the FCA report dated 03/01/2017. It has been amended accordingly to reflect conditions observed during the most recent survey date of 03/06/2024.</p>	1	Package	\$62,300.00	\$ 31.00

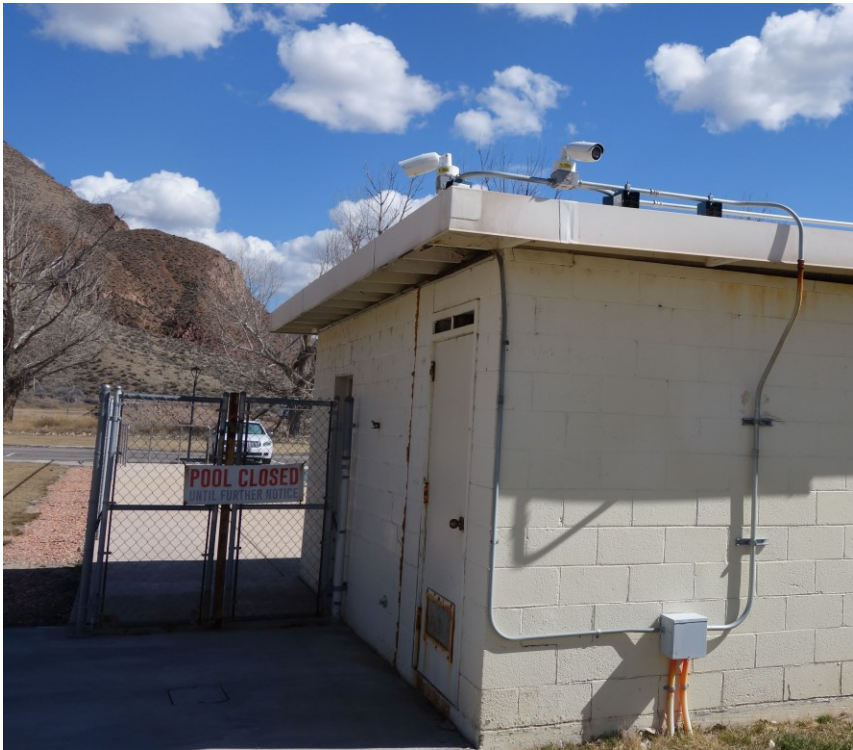
QUANTITY	UNITS	TOTAL	SF COST
The exterior metal doors are damaged from age and general wear and tear and have reached the end of their expected life. This project would provide for the replacement of the south double door assembly and the north single door assembly with new metal doors, frames and hardware. Removal and disposal of the existing doors is included in this estimate.	2	Each	\$ 5,000.00	\$ 2.00

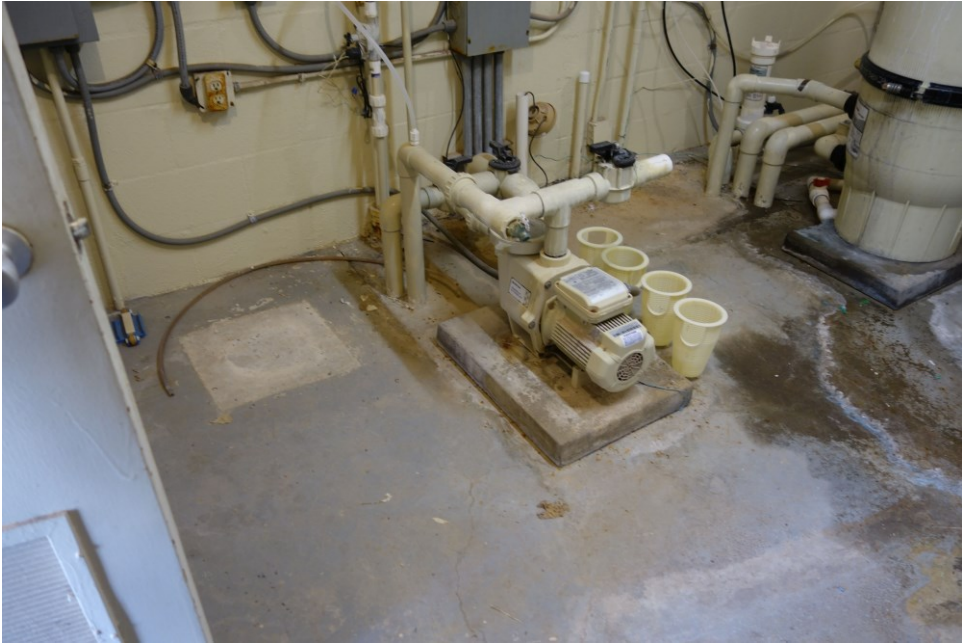
QUANTITY	UNITS	TOTAL	SF COST
<p>The existing pool circulation pump, water filter, heater, chemical feeder, clocks and plumbing were in poor condition at the time of the survey. The pool equipment is beyond its useful life expectancy. This project would provide for the purchase and installation of new pool equipment and all required connections to utilities.</p> <p>This project or a portion thereof was previously recommended in the FCA report dated 03/01/2017. It has been amended accordingly to reflect conditions observed during the most recent survey date of 03/06/2024.</p>	1	Package	\$100,000.00	\$ 50.00

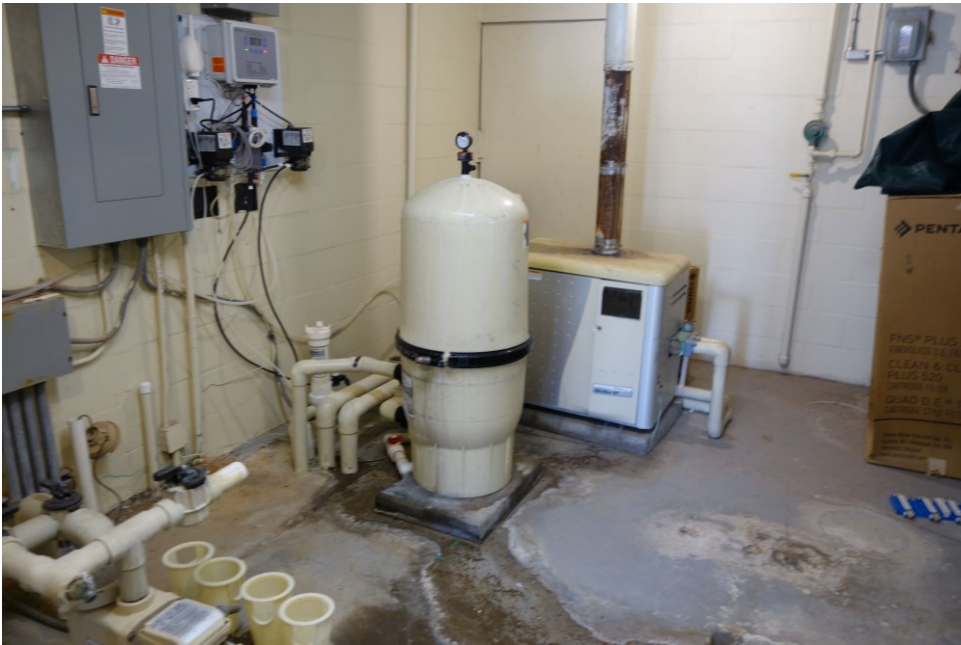
There is a flue vent in the building which does not comply with UMC 2012 chapter 8, chimneys and vents. The flue vent was installed with an improper flue and per section 804 direct vent terminations vent terminals direct vented appliances shall be installed in accordance with the manufacturer's installation instructions. The flue vent is taped and does not allow for the proper air flow. It is recommended that the flue vent be replaced per UMC and the manufacturer's instructions. This project would provide funding to replace the flue vent.
