# STATE OF NEVADA STATE PUBLIC WORKS DIVISION

## FACILITY CONDITION ASSESSMENT REPORT FOR:

DEPT OF HEALTH AND HUMAN SERVICES  
DIVISION OF CHILD AND FAMILY SERVICES  
CYC

Survey Date: 3/6/2024  
Distribution Date: 8/21/2024

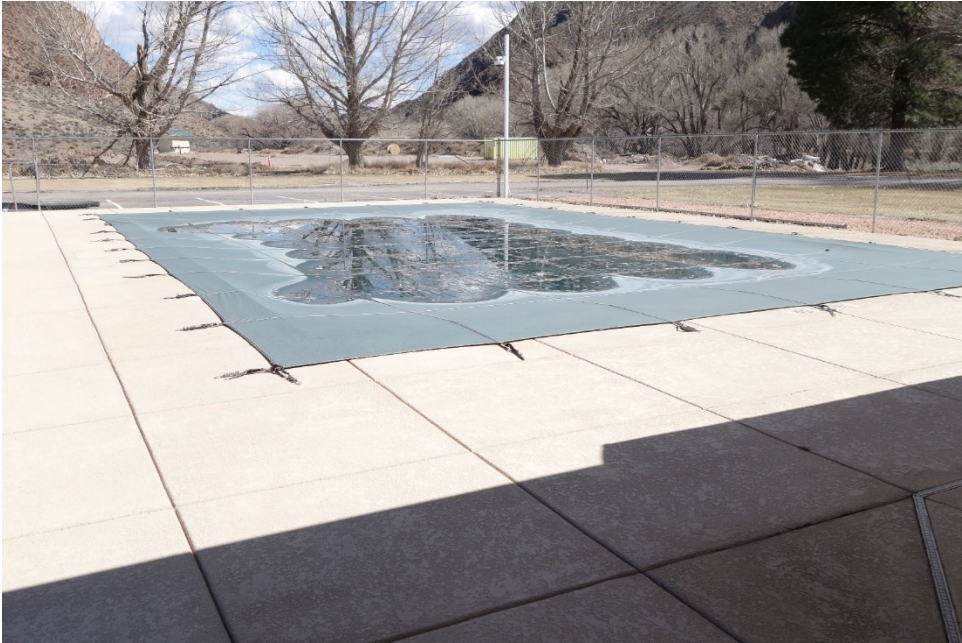
QUANTITY	UNITS	TOTAL	SF COST
The pool plaster surface has degraded and in need of re-plastering. The pool cover is also deteriorating and needing replacement. This project recommends a complete draining of the pool, prep and re-plaster including installation of a new pool cover.	1	Package	\$30,000.00	\$ 15.00

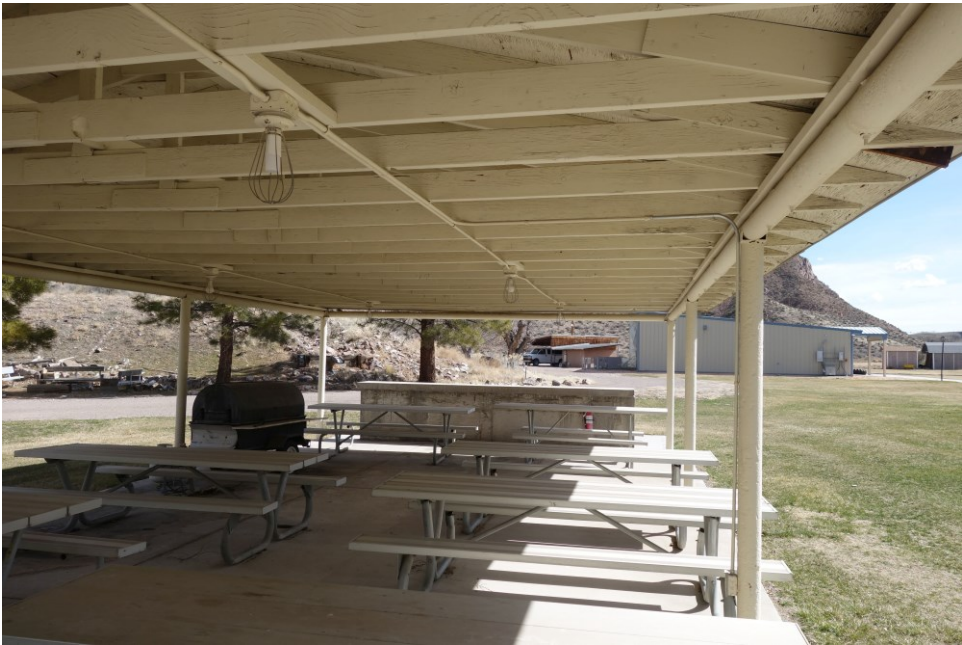
QUANTITY	UNITS	TOTAL	SF COST
<p>The structure is built of steel posts and beams, a wood framed roof structure and a concrete slab-on-grade foundation. All of these structural elements are showing signs of failing and the structure should be removed. This project provides for the demolition of the structure, concrete slab, site prep, repour monolithic slab and erection of a pre-engineered metal shade structure.</p> <p>This project or a portion thereof was previously recommended in the FCA report dated 09/21/2010, 03/01/2017. It has been amended accordingly to reflect conditions observed during the most recent survey date of 03/06/2024.</p>	1	Package	\$157,500.00	\$ 163.00

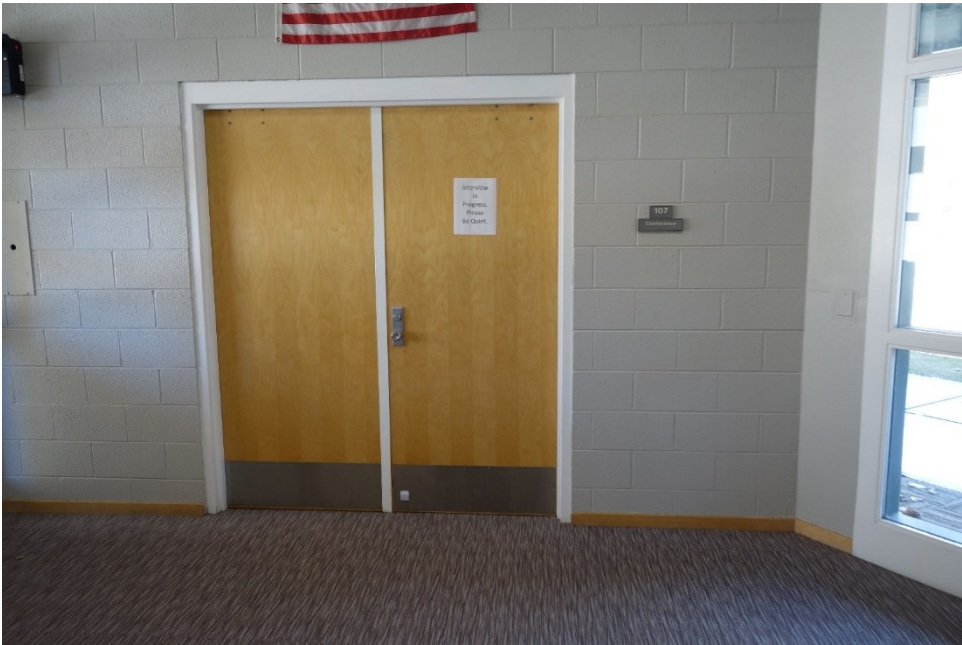
QUANTITY	UNITS	TOTAL	SF COST
<p>The building does not have a designated accessible office and the door handles are not compliant with the ADA. This project would provide for an accessible office area, path of travel throughout the building and ADA compliant lever action door hardware. NRS 338.180, IBC - 2018, ICC/ANSI A117.1 - 2009 and the most current version of the ADAAG were used as references for this project.</p> <p>This project or a portion thereof was previously recommended in the FCA report dated 03/01/2017. It has been amended accordingly to reflect conditions observed during the most recent survey date of 03/06/2024.</p>	1	Package	\$25,000.00	\$ 1.00

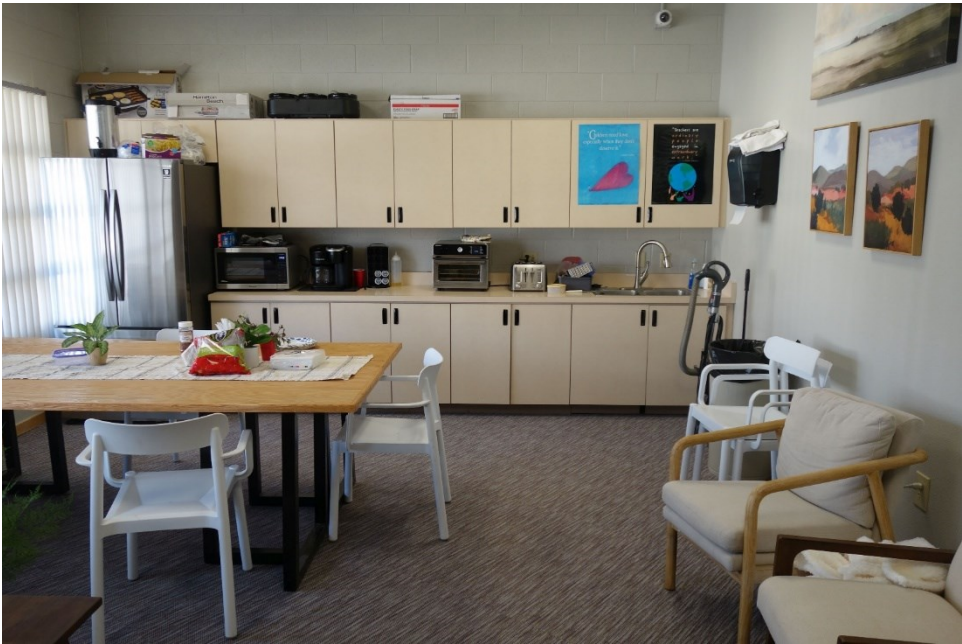
QUANTITY	UNITS	TOTAL	SF COST
<p>The kitchenette and associated cabinets in the employee break room are original to the building. The quality of construction and installation were inadequate for the high usage at this facility, and the cabinets and countertops are delaminating and failing. This project recommends the replacement of the existing kitchen countertops, cabinets, and associated equipment with heavy duty, quality components. The cabinets should be finished inside and outside with a melamine or similar finish which encapsulates the door, frame, and shelving. The countertops should be constructed of a highly durable product, such as stainless steel, over a moisture resistant underlayment to minimize swelling and damage from water exposure. ADA compliance according to NRS 338.180, IBC - 2018, ICC/ANSI A117.1 - 2009 and the most current version of the ADA Standards for Accessible Design should be incorporated into the design such as providing an accessible sink. This estimate includes removal and disposal of the existing materials.</p> <p>This project or a portion thereof was previously recommended in the FCA report dated 03/01/2017. It has been amended accordingly to reflect conditions observed during the most recent survey date of 03/06/2024.</p>	1	Each	\$28,900.00	\$ 1.00

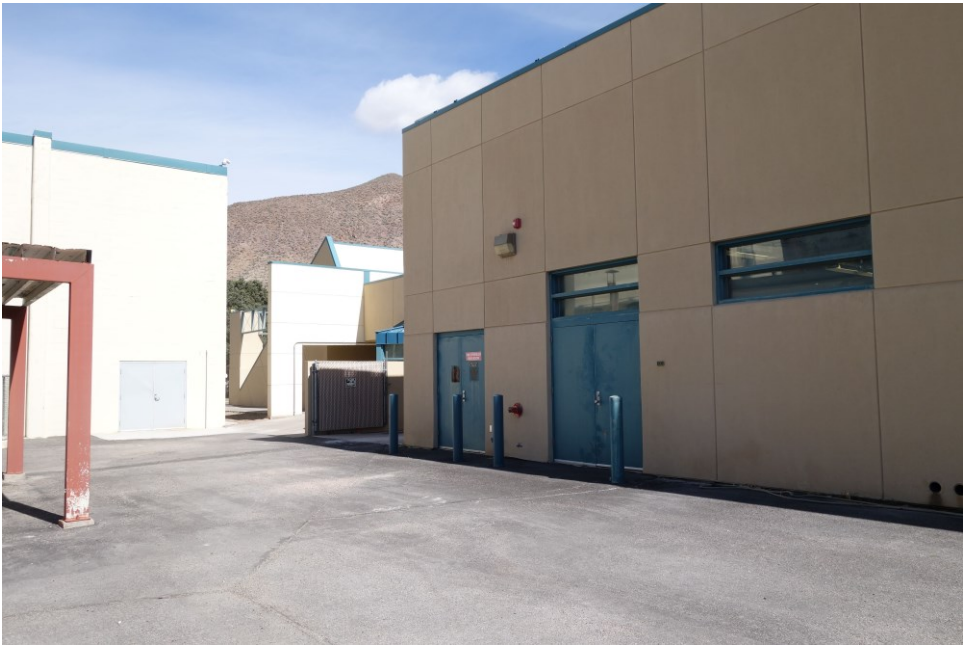
QUANTITY	UNITS	TOTAL	SF COST
<p>The existing exterior metal doors and frames appear to be original to the building. They are damaged from age and general wear and tear. This project would provide for the replacement and installation of eight new metal doors, frames and hardware. Removal and disposal of the existing doors and painting of the new doors is included in this estimate.</p> <p>This project or a portion thereof was previously recommended in the FCA report dated 03/01/2017. It has been amended accordingly to reflect conditions observed during the most recent survey date of 03/06/2024.</p>	8	Each	\$40,000.00	\$ 2.00

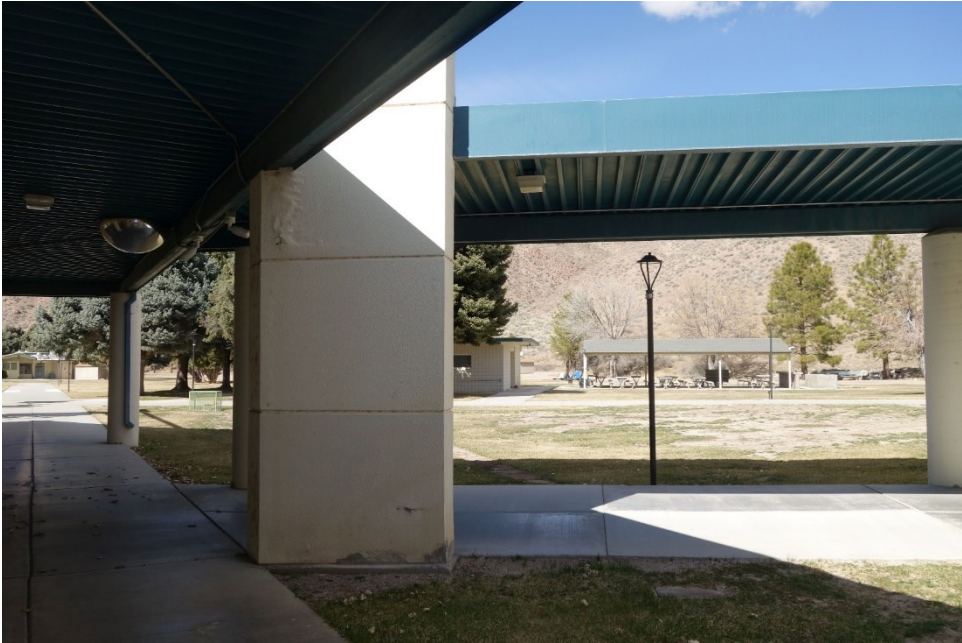
QUANTITY	UNITS	TOTAL	SF COST
Multiple column wraps supporting the building canopy on the building's east side shows signs of water damage and infiltration. The source of the infiltration has not been located. This project recommends removing the top of the column wraps to fully expose all sources of leaks, add proper flashing and sealing and re-install and paint the column wraps.	1	Package	\$25,000.00	\$ 1.00

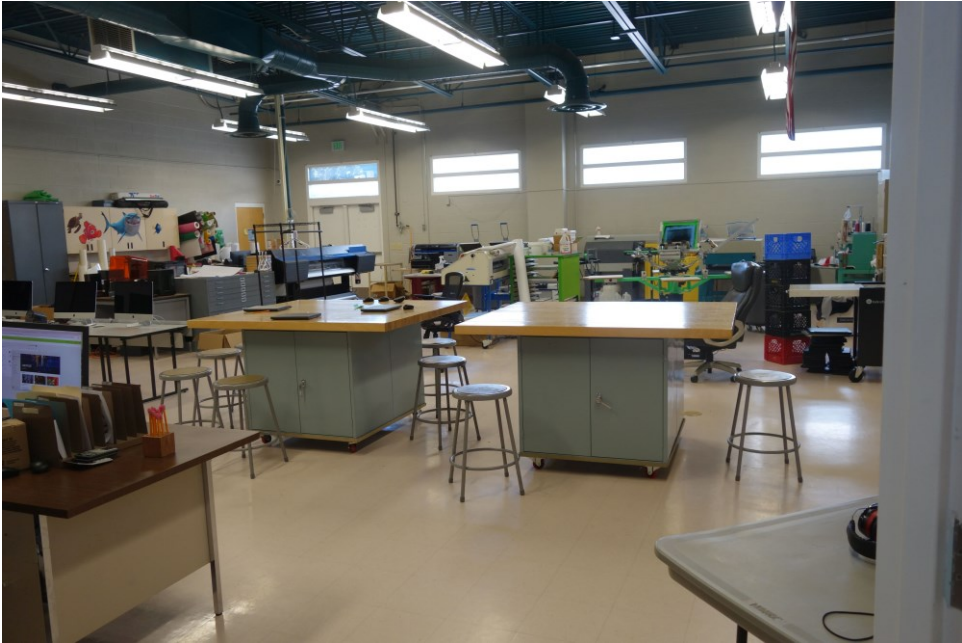
QUANTITY	UNITS	TOTAL	SF COST
<p>The classroom that teaches silk screening does not have a sink or an area to clean up after the silk screening activities. This project recommends installing a new sink with plumbing for the use and cleanup of the silk screening functions.</p> <p>This project or a portion thereof was previously recommended in the FCA report dated 03/01/2017. It has been amended accordingly to reflect conditions observed during the most recent survey date of 03/06/2024.</p>	1	Package	\$15,000.00	\$ 1.00

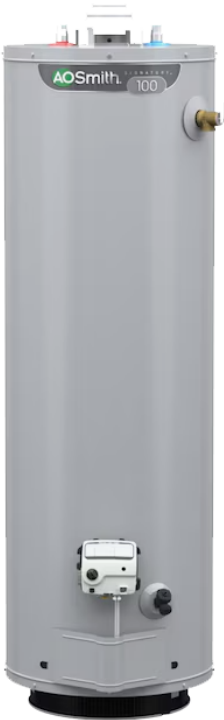
There is a 119 gallon electric water heater in the building. The average life span of a water heater is eight to ten years. With the passage of time and constant use, this unit is showing signs of wear and should be scheduled for replacement in the next 2-3 years. It is missing proper seismic bracing and an expansion tank. It is recommended that a new electric water heater be installed. Removal and disposal of the existing equipment is included in this estimate.

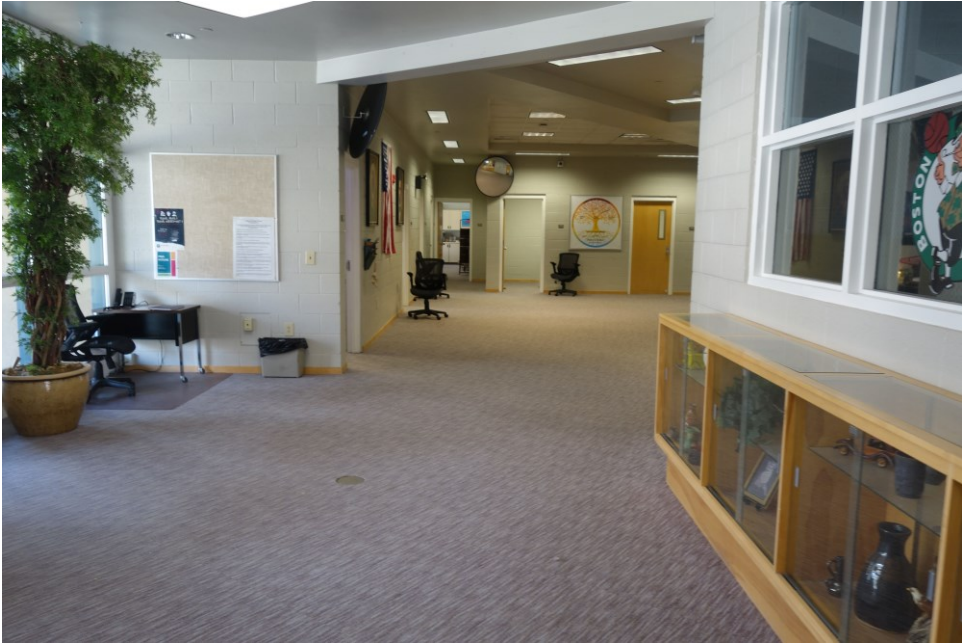
QUANTITY	UNITS	TOTAL	SF COST
The interior finishes were in good condition. It is recommended that the interior walls and ceilings be painted at least once in the next 7 - 9 years and that this project be scheduled on a cyclical basis to maintain the integrity of the structure. Prior to painting, all surfaces should be repaired and prepped. An epoxy-based paint should be utilized in wet areas for durability.	22000	Square Foot	\$220,000.00	\$ 10.00

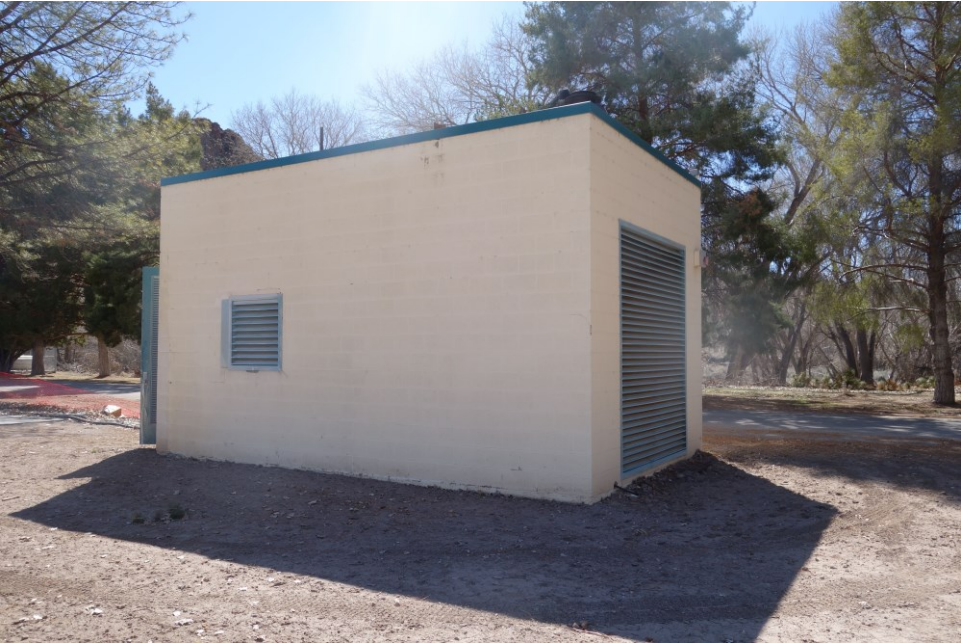
QUANTITY	UNITS	TOTAL	SF COST
The exterior metal finishes were in poor condition. It is important to maintain the finish, weather resistance and appearance of the building. This project would provide funding to protect the exterior of the building excluding the roof. Included in the cost is painting the concrete masonry unit walls and caulking of the vents, flashing, fixtures and all other penetrations. It is recommended that the building be painted and caulked in the next 2 - 3 years and that this project be scheduled on a cyclical basis to maintain the integrity of the structure.	300	Square Foot	\$ 3,000.00	\$ 10.00

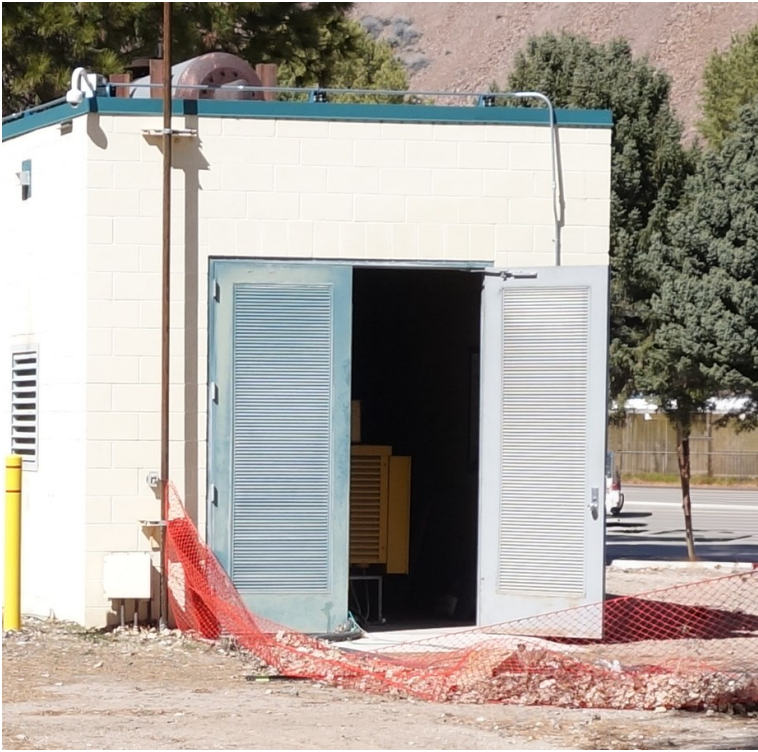
QUANTITY	UNITS	TOTAL	SF COST
<p>The exterior metal doors are damaged from age and general wear and tear and have reached the end of their expected life. This project would provide for the replacement of the double door assembly with new metal doors, frame and hardware. Removal and disposal of the existing doors is included in this estimate.</p> <p>This project or a portion thereof was previously recommended in the FCA report dated 09/21/2010 and 03/01/2017. It has been amended accordingly to reflect conditions observed during the most recent survey date of 03/06/2024.</p>	2	Each	\$ 5,000.00	\$ 17.00

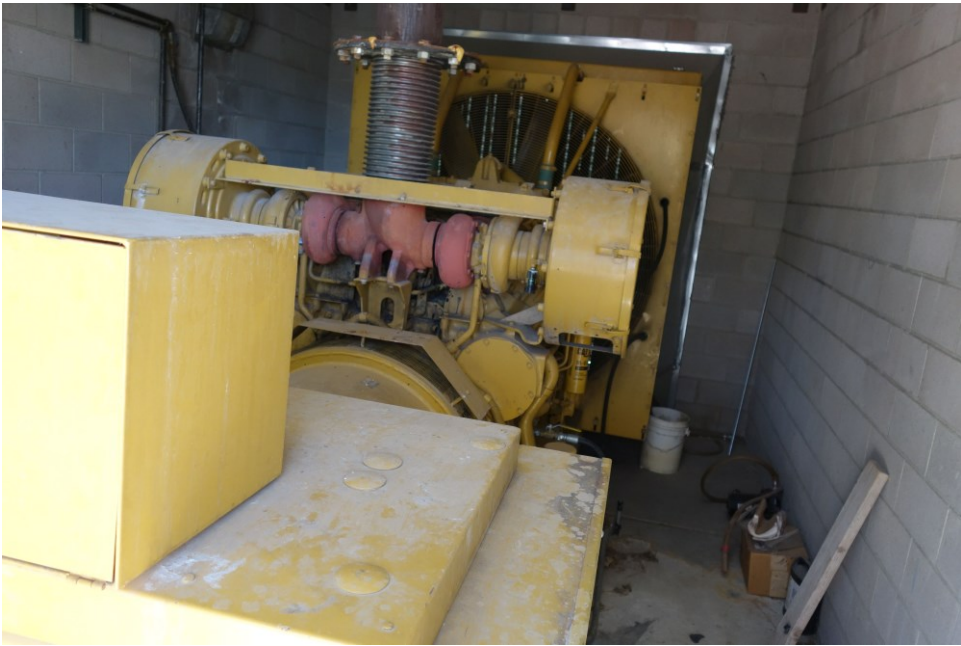
QUANTITY	UNITS	TOTAL	SF COST
The interior finishes are in good condition. It is recommended that the interior walls and ceilings be painted at least once in the next 2-3 years and that this project be scheduled on a cyclical basis to maintain the integrity of the structure. Prior to painting, all surfaces should be repaired and prepped.	300	Square Foot	\$ 3,000.00	\$ 10.00

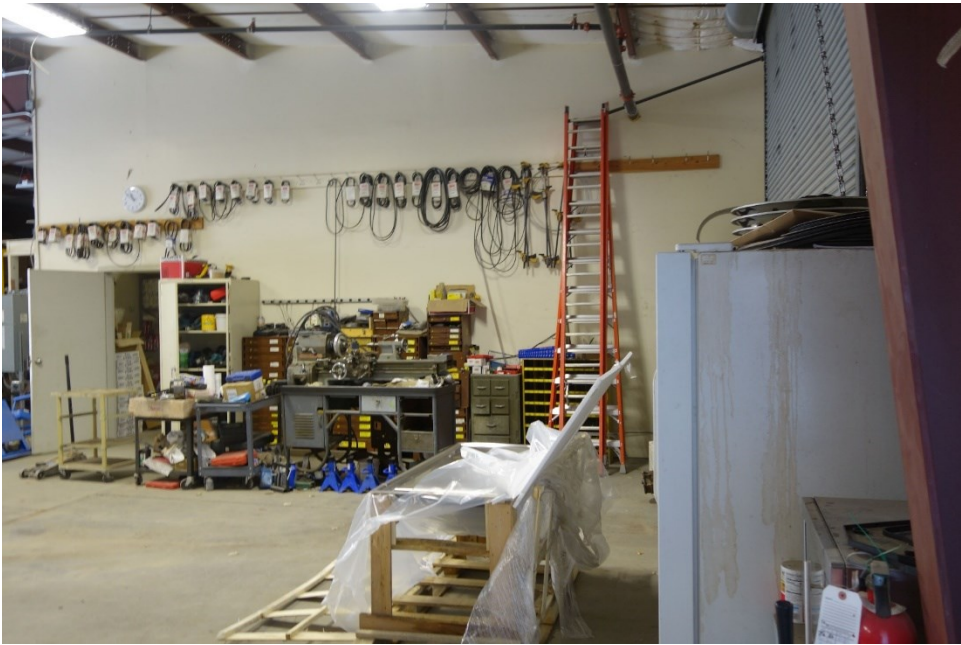
QUANTITY	UNITS	TOTAL	SF COST
The interior finishes were in good condition. About one quarter of the interior has finished gypsum board walls. It is recommended that the interior finished walls be painted at least once in the next 6 - 8 years and that this project be scheduled on a cyclical basis to maintain the integrity of the structure. Prior to painting, all surfaces should be repaired and prepped.	6000	Square Foot	\$60,000.00	\$ 10.00

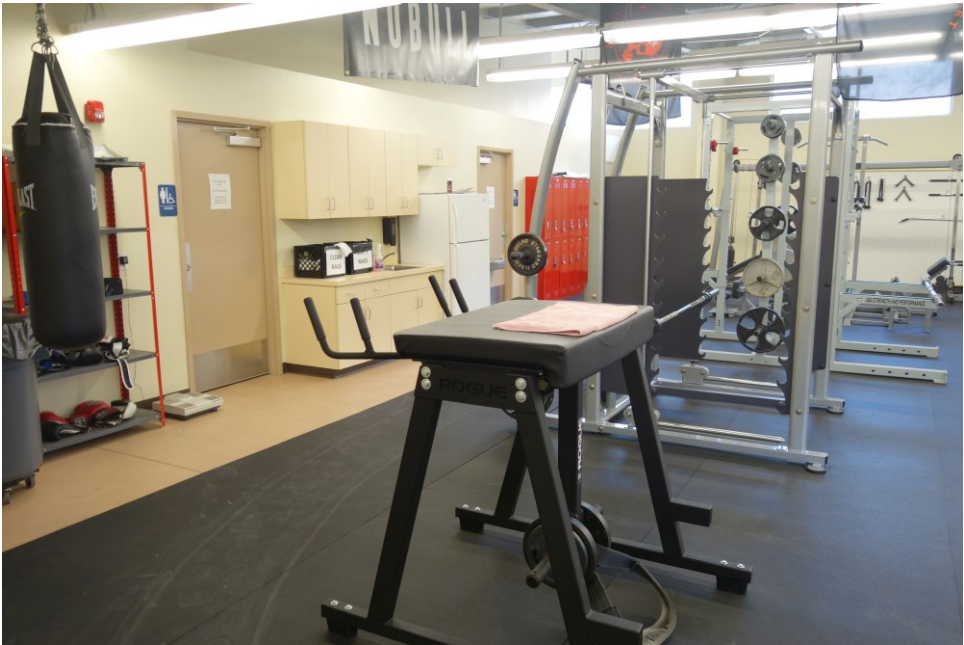
QUANTITY	UNITS	TOTAL	SF COST
The interior finishes are in good condition. It is recommended that the interior walls and ceilings be painted at least once in the next 6 - 8 years and that this project be scheduled on a cyclical basis to maintain the integrity of the structure. Prior to painting, all surfaces should be repaired and prepped. An epoxy-based paint should be utilized in wet areas for durability.	3060	Square Foot	\$15,300.00	\$ 5.00

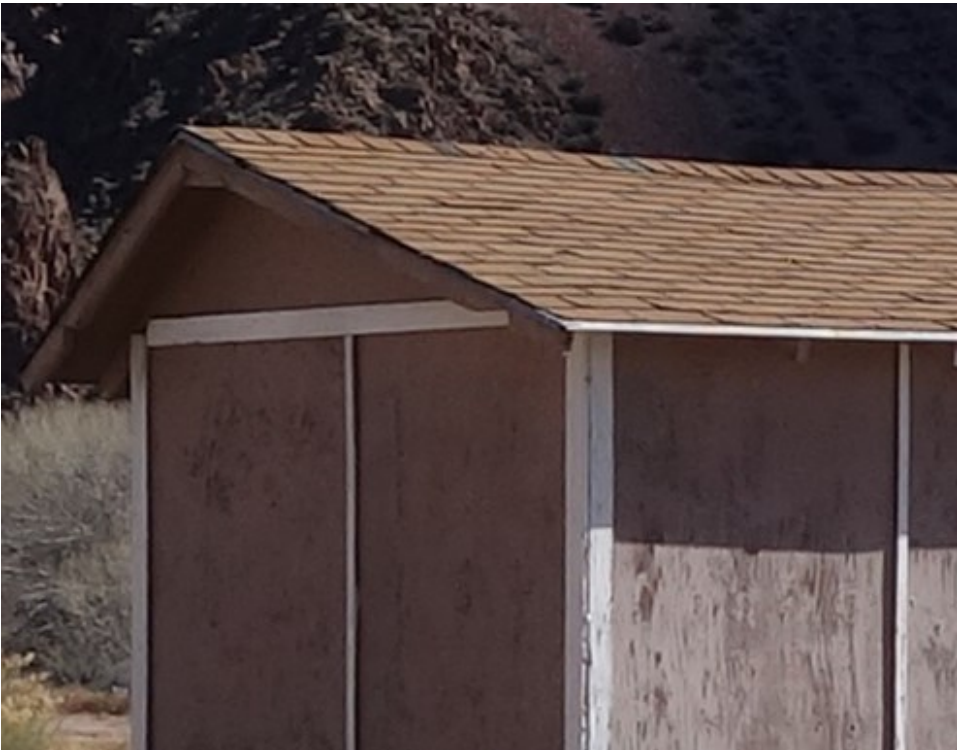
QUANTITY	UNITS	TOTAL	SF COST
The asphalt composition shingle roof on this building was in poor condition at the time of the survey. It is recommended that this building be re-roofed in the next 2 - 3 years with a new 50 year asphalt composition roofing shingle and new underlayment. This estimate includes removal and disposal of the old roofing system.	1	Package	\$ 2,500.00	\$ 26.00

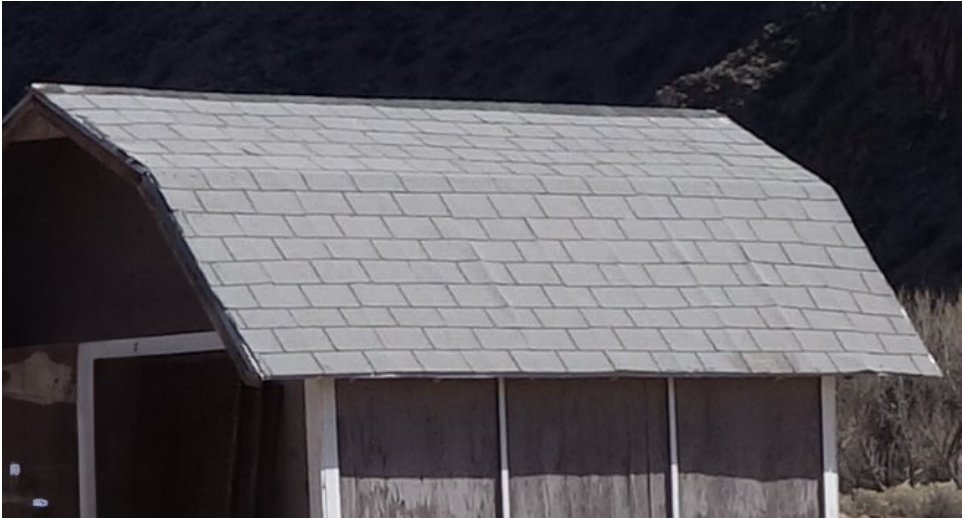
QUANTITY	UNITS	TOTAL	SF COST
The asphalt composition shingle roof on this building was in poor condition at the time of the survey. It is recommended that this building be re-roofed in the next 2 - 3 years with a new 50 year asphalt composition roofing shingle and new underlayment. This estimate includes removal and disposal of the old roofing system.	1	Package	\$ 2,500.00	\$ 31.00

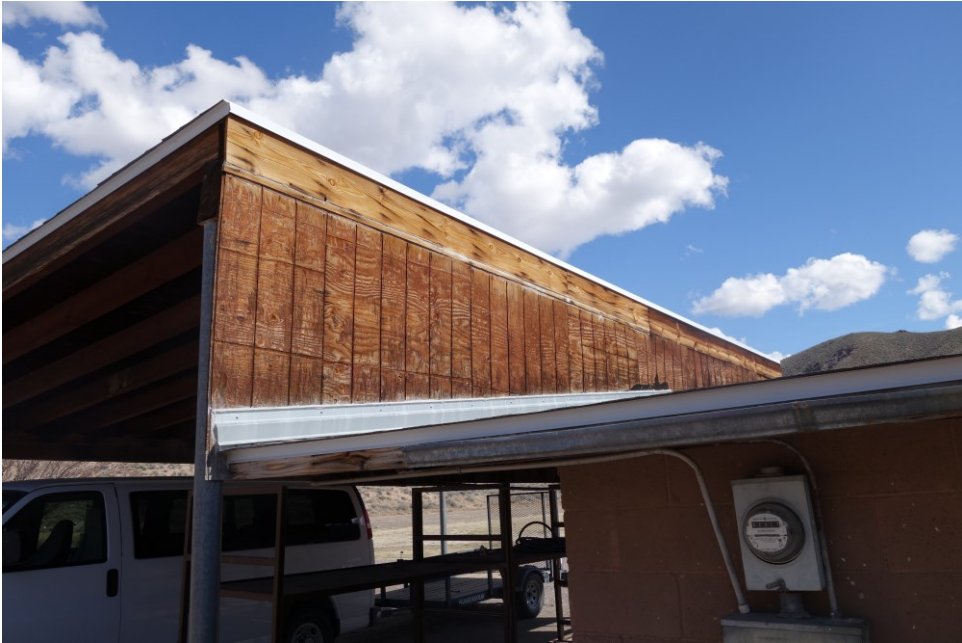
QUANTITY	UNITS	TOTAL	SF COST
The exterior wood finishes are in poor condition. It is important to maintain the finish, weather resistance and appearance of the building. This project would provide funding to protect the exterior of the building excluding the roof. Included in the cost is sealing the concrete masonry units, sanding, priming and painting the wood siding and caulking of the windows, flashing, fixtures and all other penetrations. It is recommended that the building be painted in the next 2 - 3 years and that this project be scheduled on a cyclical basis to maintain the integrity of the structure.	800	Square Foot	\$16,000.00	\$ 20.00

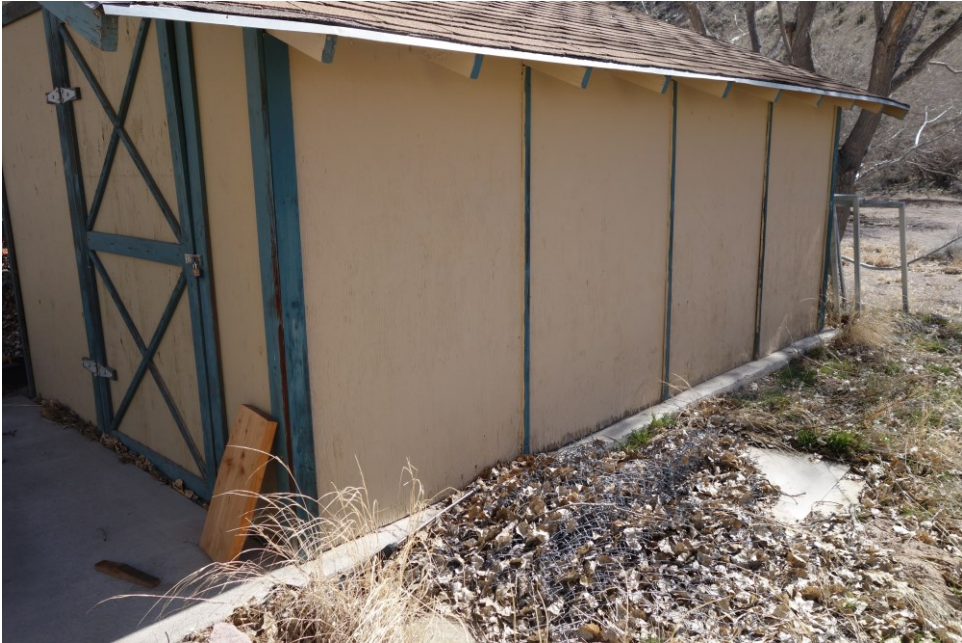
QUANTITY	UNITS	TOTAL	SF COST
The exterior finishes were in poor condition. It is important to maintain the finish, weather resistance and appearance of the building. This project would provide funding to protect the exterior of the building excluding the roof. Included in the cost is sanding, priming and painting and caulking of the windows, flashing, fixtures and all other penetrations. It is recommended that the building be painted in the next 2 - 3 years and that this project be scheduled on a cyclical basis to maintain the integrity of the structure.	416	Square Foot	\$ 6,200.00	\$ 15.00

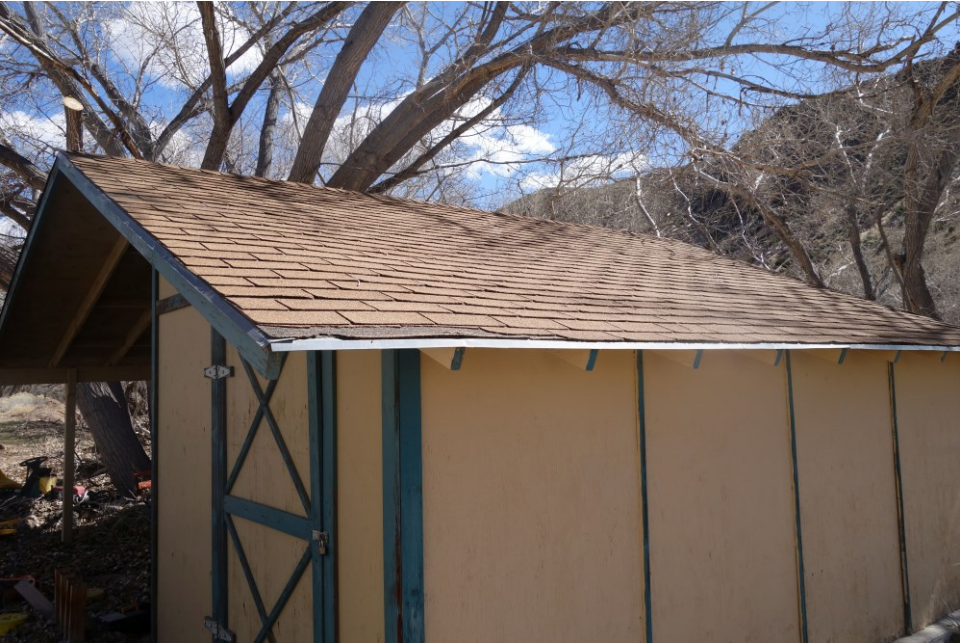
QUANTITY	UNITS	TOTAL	SF COST
The asphalt composition shingle roof on this building was in poor condition at the time of the survey. It is recommended that this building be re-roofed in the next 2 - 3 years with a new 50 year asphalt composition shingle roof and new underlayment. This estimate includes removal and disposal of the old roof.	416	Square Foot	\$10,400.00	\$ 25.00

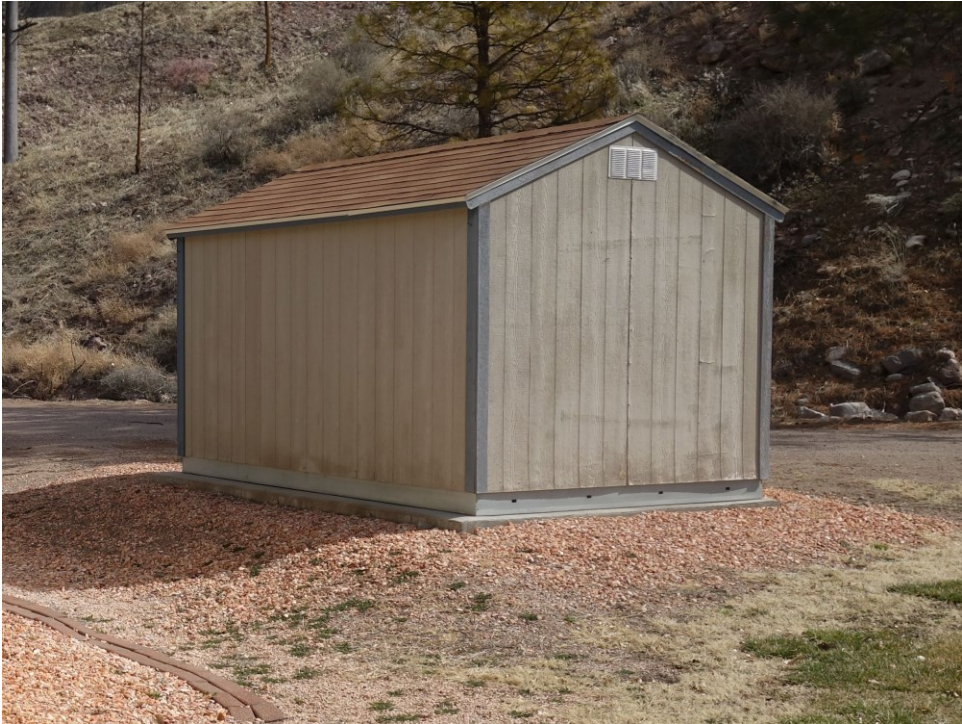
QUANTITY	UNITS	TOTAL	SF COST
The exterior finishes were in poor condition. It is important to maintain the finish, weather resistance and appearance of the building. This project would provide funding to protect the exterior of the building excluding the roof. Included in the cost is sanding, priming and painting and caulking of the windows, flashing, fixtures and all other penetrations. It is recommended that the building be painted in the next 2 - 3 years and that this project be scheduled on a cyclical basis to maintain the integrity of the structure.	96	Square Foot	\$ 1,500.00	\$ 16.00

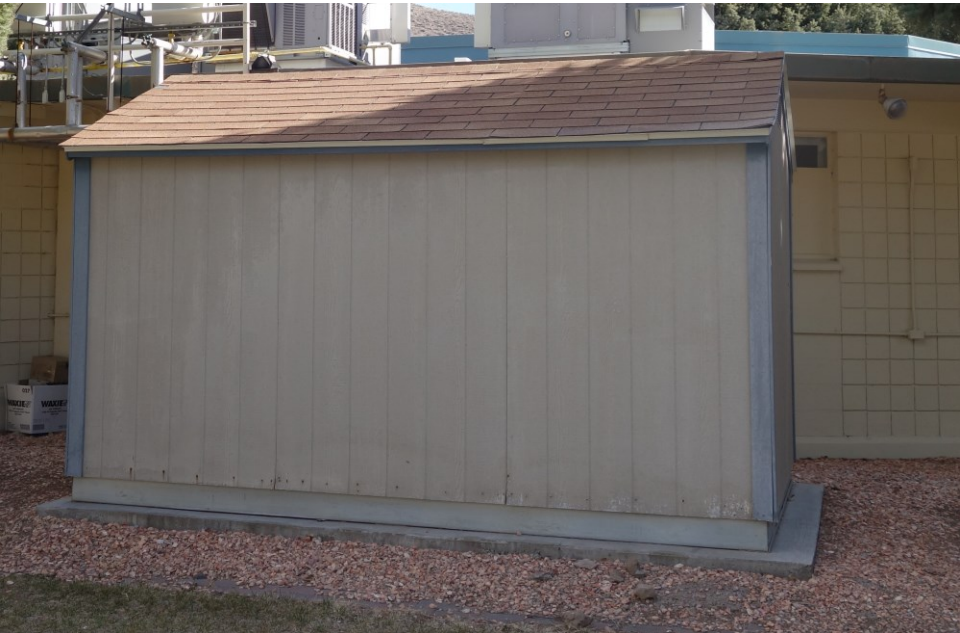
QUANTITY	UNITS	TOTAL	SF COST
The exterior finishes were in poor condition. It is important to maintain the finish, weather resistance and appearance of the building. This project would provide funding to protect the exterior of the building excluding the roof. Included in the cost is sanding, priming and painting and caulking of the windows, flashing, fixtures and all other penetrations. It is recommended that the building be painted in the next 2 - 3 years and that this project be scheduled on a cyclical basis to maintain the integrity of the structure.	96	Square Foot	\$ 1,500.00	\$ 16.00

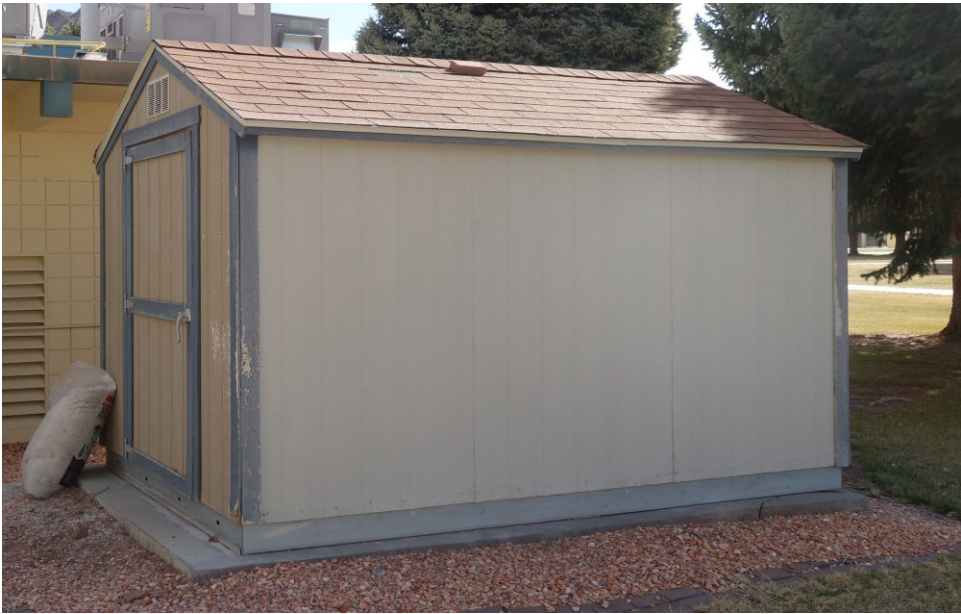
The exterior finishes were in poor condition. It is important to maintain the finish, weather resistance and appearance of the building. This project would provide funding to protect the exterior of the building excluding the roof. Included in the cost is sanding, priming and painting and caulking of the windows, flashing, fixtures and all other penetrations. It is recommended that the building be painted in the next 2 - 3 years and that this project be scheduled on a cyclical basis to maintain the integrity of the structure.

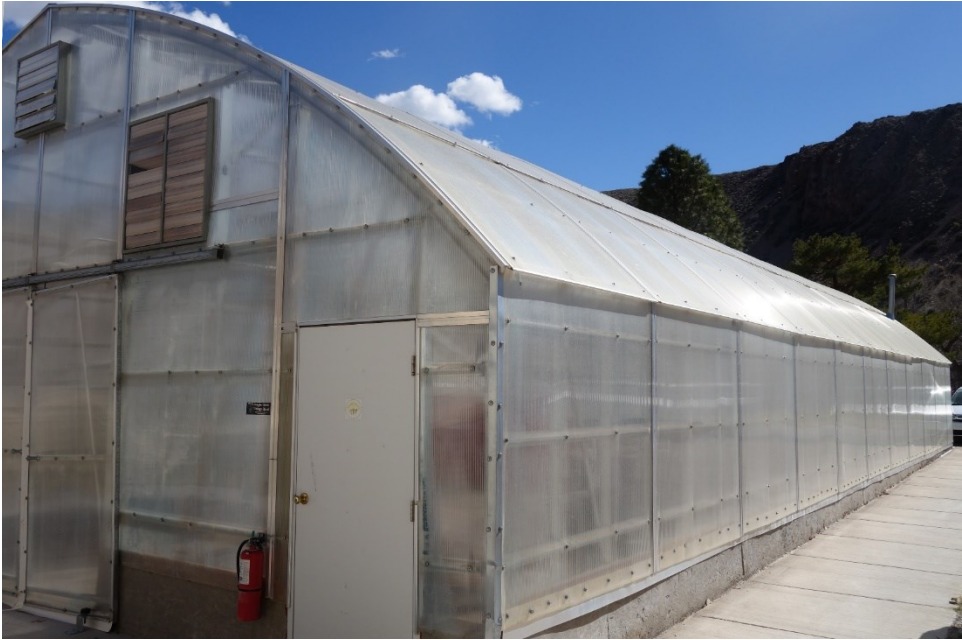
QUANTITY	UNITS	TOTAL	SF COST
The exterior finishes were in good condition. It is important to maintain the finish, weather resistance and appearance of the structure. This project recommends work to protect the exterior building envelope including repairs to the exterior membrane and caulking around flashing, fixtures, and other penetrations to maintain the building in good, weather tight condition. It is recommended that this project be implemented in the next 6 - 8 years and it is also recommended that this project be scheduled on a cyclical basis to maintain the integrity of the structure.	1800	Square Foot	\$ 1,800.00	\$ 1.00

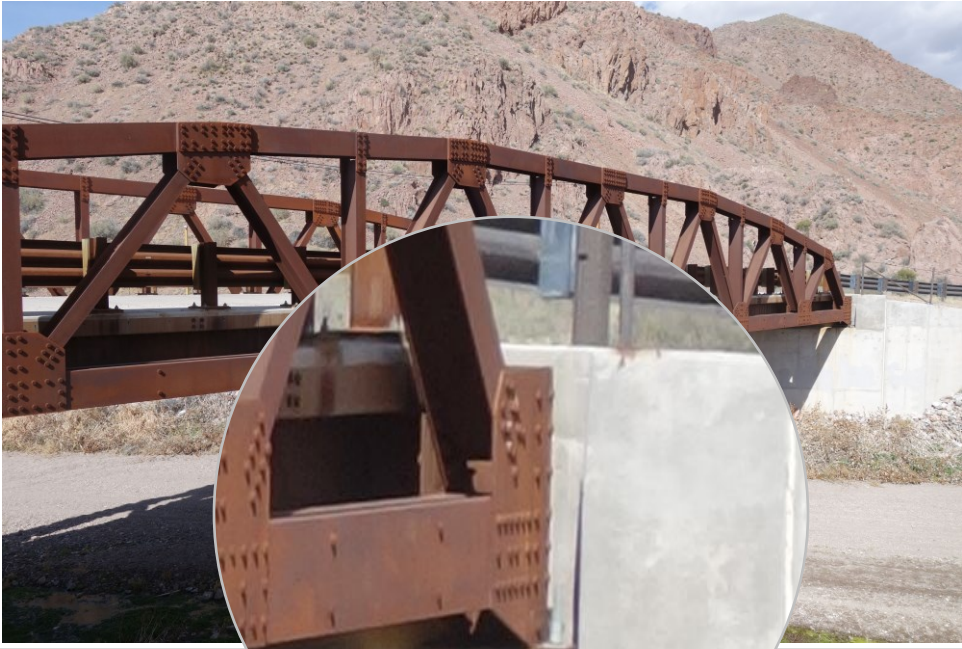
QUANTITY	UNITS	TOTAL	SF COST
Properly seat jam nut on elastomeric bearing plate per NDOT Maintenance & Inspection Report dated 10-11-2017. A copy of the report was provided to the CYC Superintendent.  This project or a portion thereof was previously recommended in the FCA report dated 03/01/2017. It has been amended accordingly to reflect conditions observed during the most recent survey date of 03/06/2024.	0		\$ 100.00	\$ 0.00

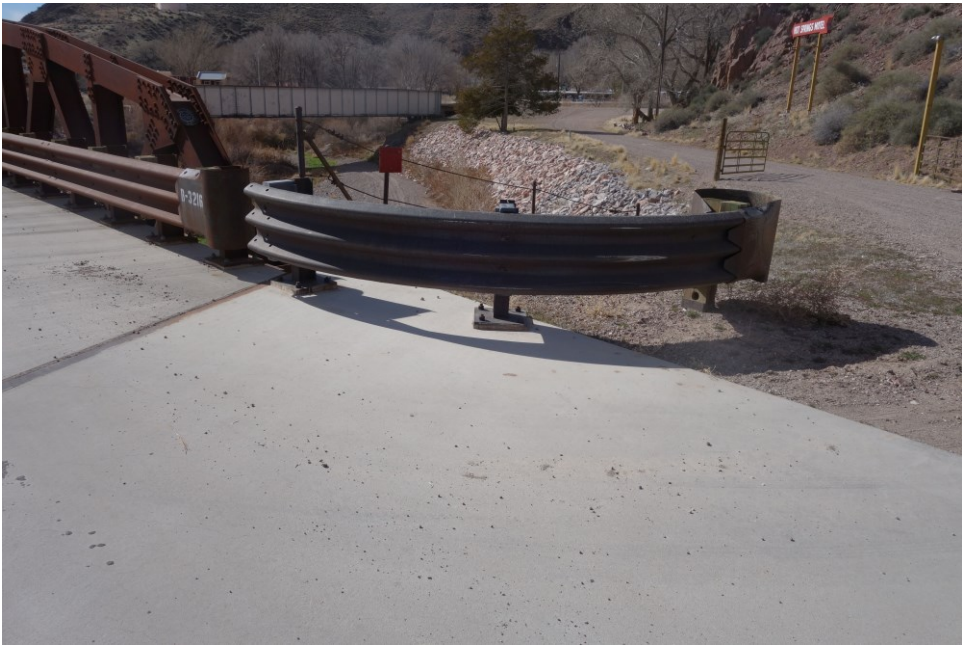
3246 CALIENTE BRIDGE

QUANTITY	UNITS	TOTAL	SF COST
Install transition between each of the approach guardrails and the bridge guardrails per NDOT Maintenance & Inspection Report dated 10-11-2017. A copy of the report was provided to the CYC Superintendent. The transition piece shall meet AASHTO standards.  This project or a portion thereof was previously recommended in the FCA report dated 03/01/2017. It has been amended accordingly to reflect conditions observed during the most recent survey date of 03/06/2024.	4	Each	\$10,000.00	\$ 4.00

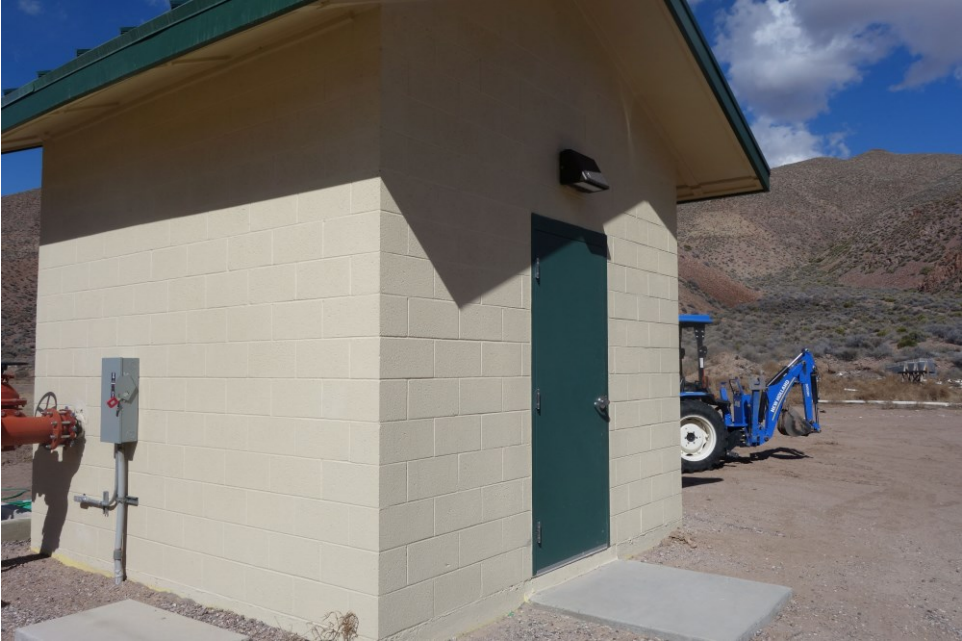
QUANTITY	UNITS	TOTAL	SF COST
The exterior finishes are in good condition. Exterior maintenance is important to maintain the finish, weather resistance and appearance of the structure. This project provides funding to protect the exterior of the building, excluding the roof. Included are the costs of sanding, priming, painting and caulking of flashing, fixtures and all other penetrations. It is recommended the building be painted in the next 8 - 10 years. Building maintenance should be scheduled on a cyclical basis to maintain the integrity of the structure.	1	Package	\$ 2,500.00	\$ 14.00
