DEPARTMENT OF ADMINISTRATION
STATE PUBLIC WORKS DIVISION
FACILITY CONDITION ASSESSMENT

PROPERTY PORTFOLIO REVIEW PROJECT ADDENDUM

SOUTH REGION
INDIAN SPRINGS CORRECTIONAL CENTER COMPLEX
9952 - HIGH DESERT STATE PRISON SITE
22010 COLD CREEK RD
INDIAN SPRINGS, NV 89018-
CLARK COUNTY

SURVEY DATE: 01/22/2025

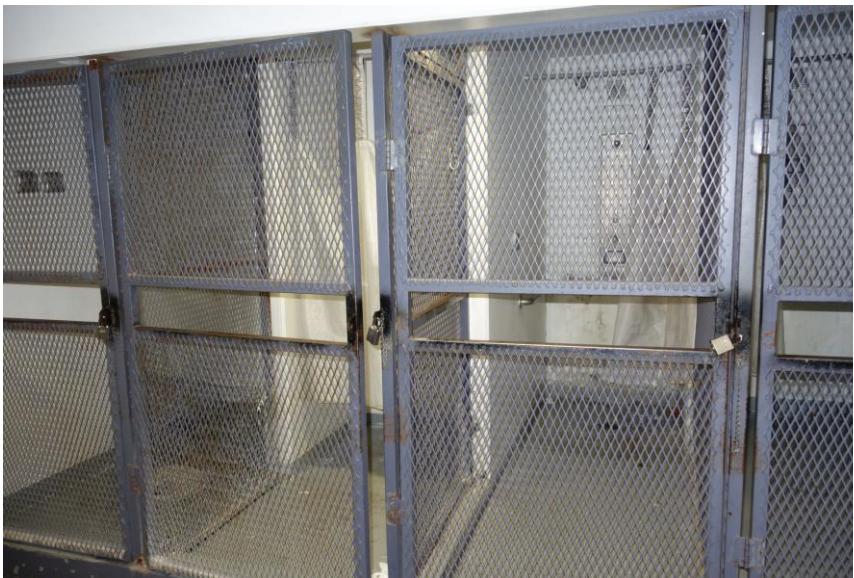
The showers in the housing unit are 25 years old with aging accessibility provisions. A complete retrofit is necessary. This project would provide funding to line the existing shower stalls with stainless steel, liquid applied flooring, and replacement of shower fixtures & controls. The refurbishment shall also include retrofitting the required number of showers in compliance with ADA Accessibility Standards and PREA requirements.

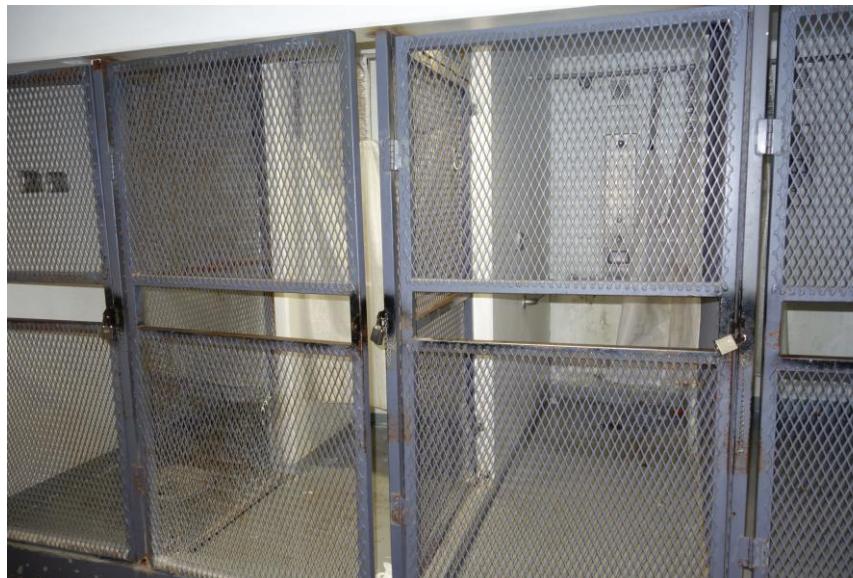
The showers in the housing unit are 25 years old with aging accessibility provisions. A complete retrofit is necessary. This project would provide funding to line the existing shower stalls with stainless steel, liquid applied flooring, and replacement of shower fixtures & controls. The refurbishment shall also include retrofitting the required number of showers in compliance with ADA Accessibility Standards and PREA requirements.

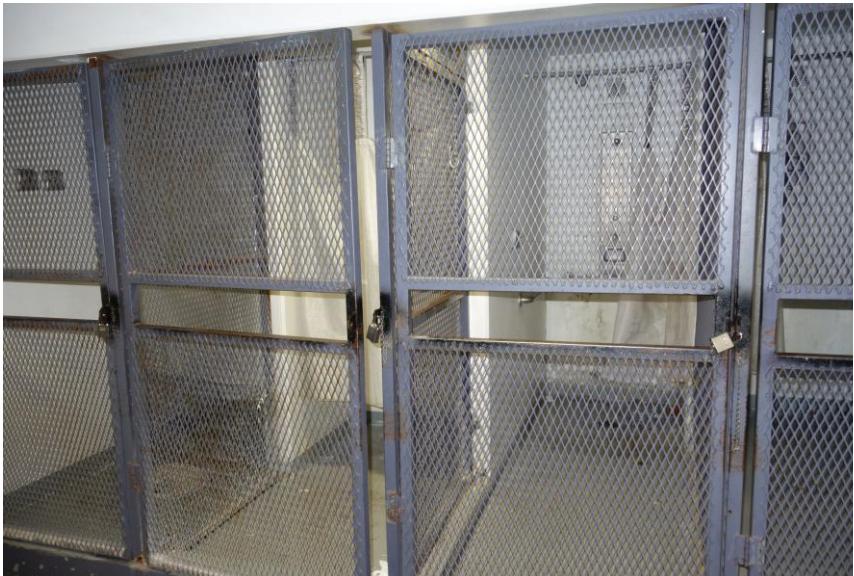
HOUSING UNIT #8

The showers in the housing unit are 25 years old with aging accessibility provisions. A complete retrofit is necessary. This project would provide funding to line the existing shower stalls with stainless steel, liquid applied flooring, and replacement of shower fixtures & controls. The refurbishment shall also include retrofitting the required number of showers in compliance with ADA Accessibility Standards and PREA requirements.

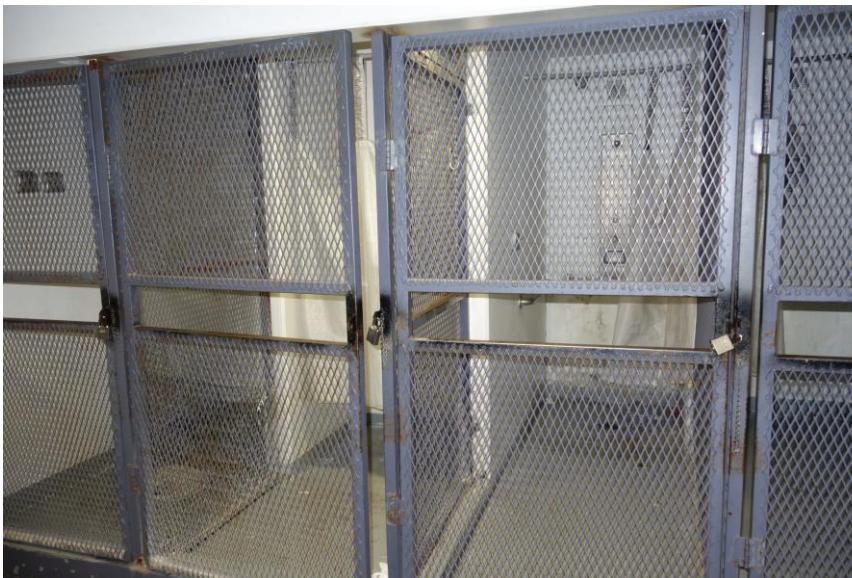
HOUSING UNIT #2

The showers in the housing unit are 25 years old with aging accessibility provisions. A complete retrofit is necessary. This project would provide funding to line the existing shower stalls with stainless steel, liquid applied flooring, and replacement of shower fixtures & controls. The refurbishment shall also include retrofitting the required number of showers in compliance with ADA Accessibility Standards and PREA requirements.

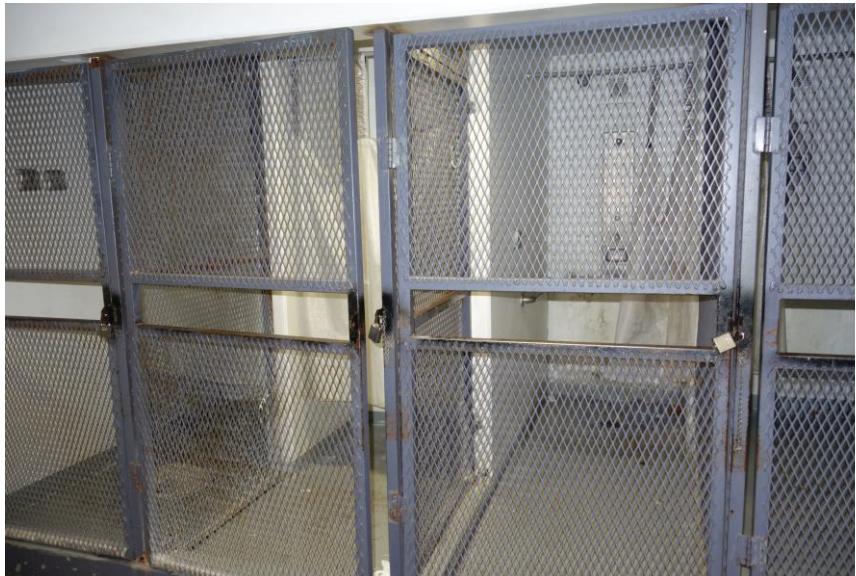
The showers in the housing unit are 25 years old with aging accessibility provisions. A complete retrofit is necessary. This project would provide funding to line the existing shower stalls with stainless steel, liquid applied flooring, and replacement of shower fixtures & controls. The refurbishment shall also include retrofitting the required number of showers in compliance with ADA Accessibility Standards and PREA requirements.

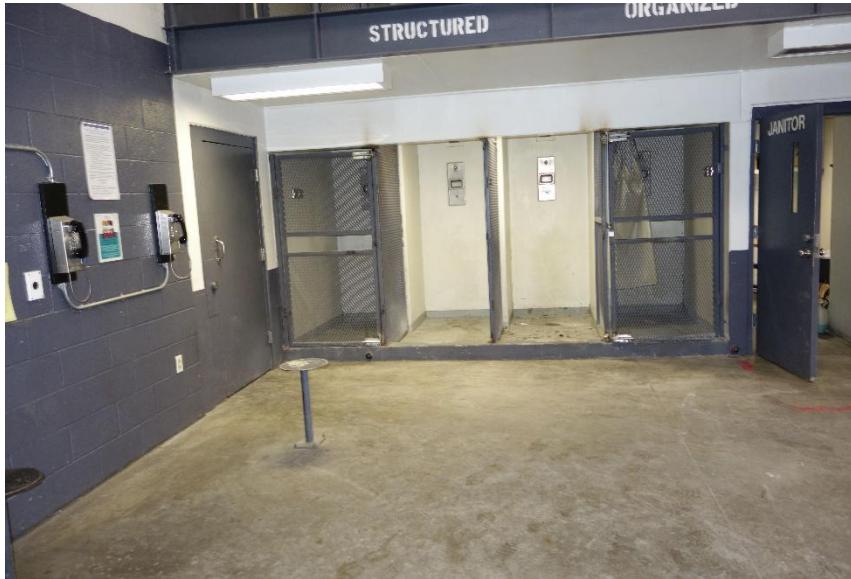
HOUSING UNIT #3

The showers in the housing unit are 25 years old with aging accessibility provisions. A complete retrofit is necessary. This project would provide funding to line the existing shower stalls with stainless steel, liquid applied flooring, and replacement of shower fixtures & controls. The refurbishment shall also include retrofitting the required number of showers in compliance with ADA Accessibility Standards and PREA requirements.

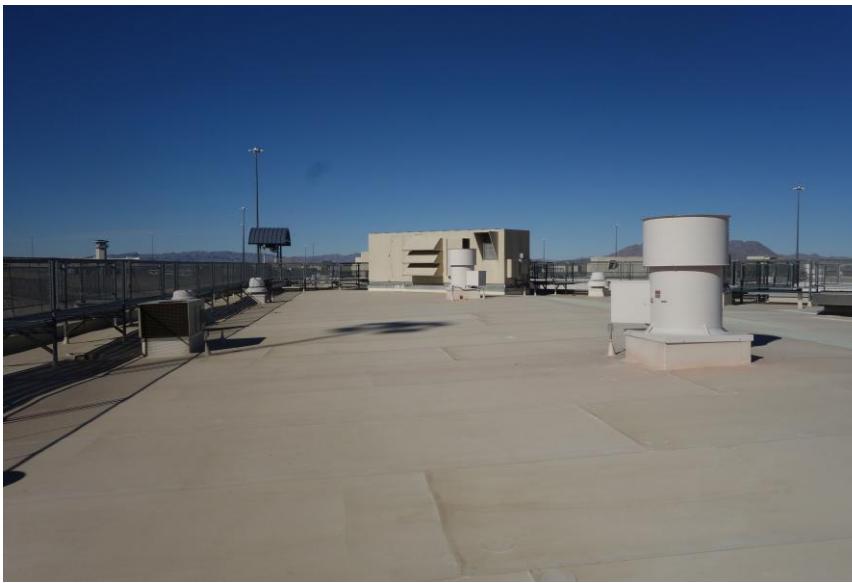
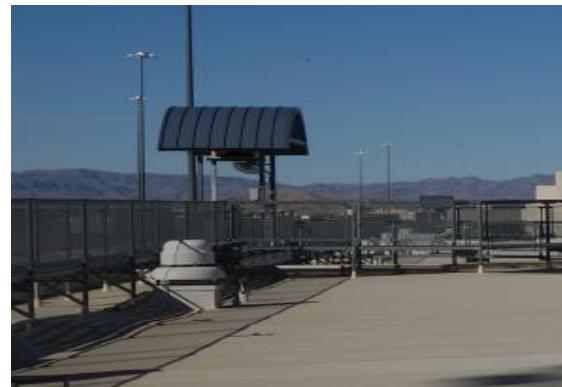
2089-HVA-3: EVAPORATIVE COOLER REPLACEMENT

There is an open guard stationed on the catwalk between Housing Units 3 & 4. They have one overhead swamp cooler to keep them cool in the warmer months. At the time of the survey the swamp cooler was not working. It is severely scaled and has reached the end of its useful and expected life. This project would provide for a new evaporative cooler to be installed including all required connections to utilities. The estimate includes removal and disposal of the old cooler.

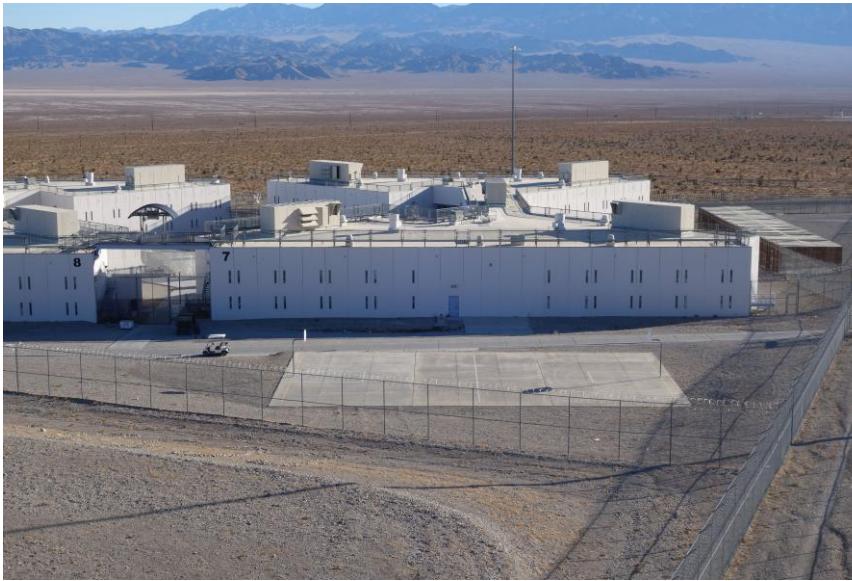
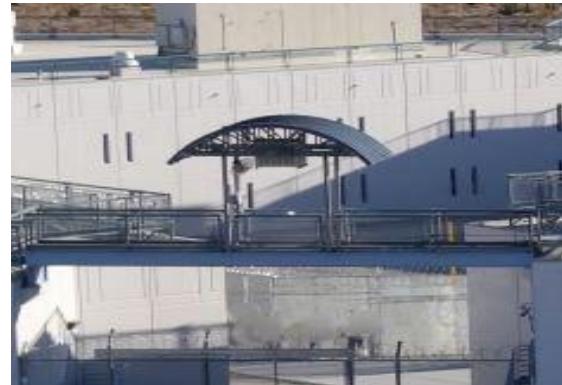
2173-HVA-3: EVAPORATIVE COOLER REPLACEMENT

There is an open guard stationed on the catwalk between Housing Units 7 & 8. They have one overhead swamp cooler to keep them cool in the warmer months. At the time of the survey the swamp cooler was not working. It is severely scaled and has reached the end of its useful and expected life. This project would provide for a new evaporative cooler to be installed including all required connections to utilities. The estimate includes removal and disposal of the old cooler.

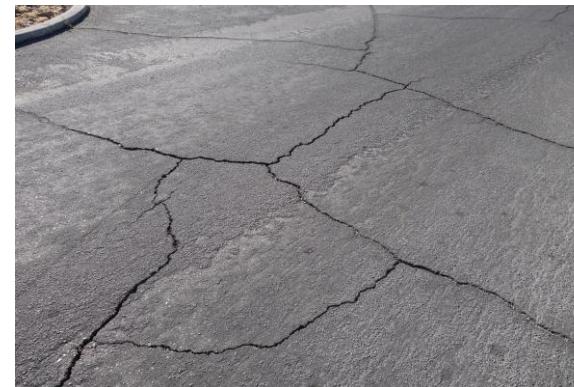
9952-SIT-5: PATCH, CRACK & SLURRY SEAL ASPHALT PAVING

The sitewide asphalt paving, including roadways inside the secure area are aging. This project would provide for replacement of deteriorated paving, crack filling and microsurface sealing. Microsurface sealing process is recommended to account for pavement deformations, subsidence or other minor anomalies. Striping is included in this estimate.

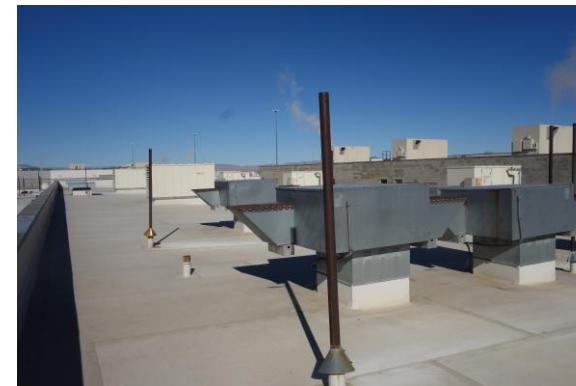
2091-EXT-3: ROOF REPLACEMENT

The roof on this building was in fair condition at the time of the survey. The statewide roofing program has set the useful life of an average roof at 20 years. The roof warranty expires at the end of the same time frame. The temperature fluctuations throughout the year, consistent wind which blows sand and dirt on to the roof membrane, and constant exposure to the sun are contributing factors to wear and deterioration. The current roofing system was installed in 2000. It is recommended that this building be re-roofed in the next 2 - 3 years to be consistent with the roofing program and the end of the warranty period.

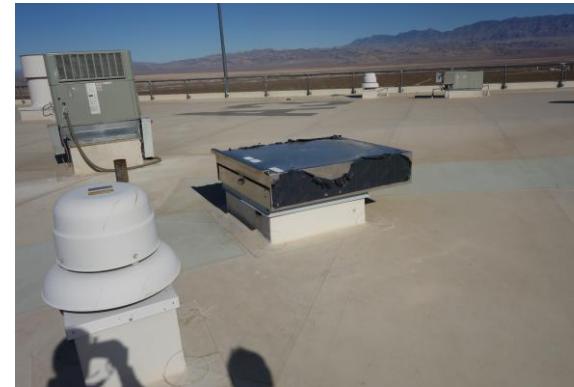
2089-EXT-2: ROOF REPLACEMENT

The roof on this building was in fair condition at the time of the survey. The statewide roofing program has set the useful life of an average roof at 20 years. The roof warranty expires at the end of the same time frame. The temperature fluctuations throughout the year, consistent wind which blows sand and dirt on to the roof membrane, and constant exposure to the sun are contributing factors to wear and deterioration. The current roofing system was installed in 2000. It is recommended that this building be re-roofed in the next 2 - 3 years to be consistent with the roofing program and the end of the warranty period.

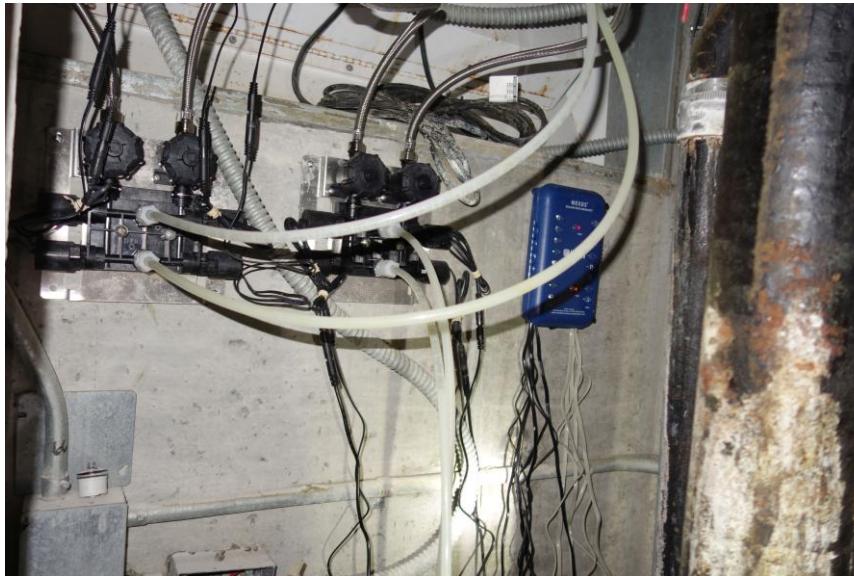
2087-PLM-2: CELL WATER CONTROL SYSTEMS REPLACEMENT

This building is equipped with cell water control systems that are outdated and should be scheduled for replacement. Problems exist with the current water control systems. It is increasingly difficult to find replacement parts and experienced repairmen to service the equipment. It is recommended to replace the water control systems. This project includes the replacement of the water controllers, piping, valves, access panels and all connections to the existing utilities.

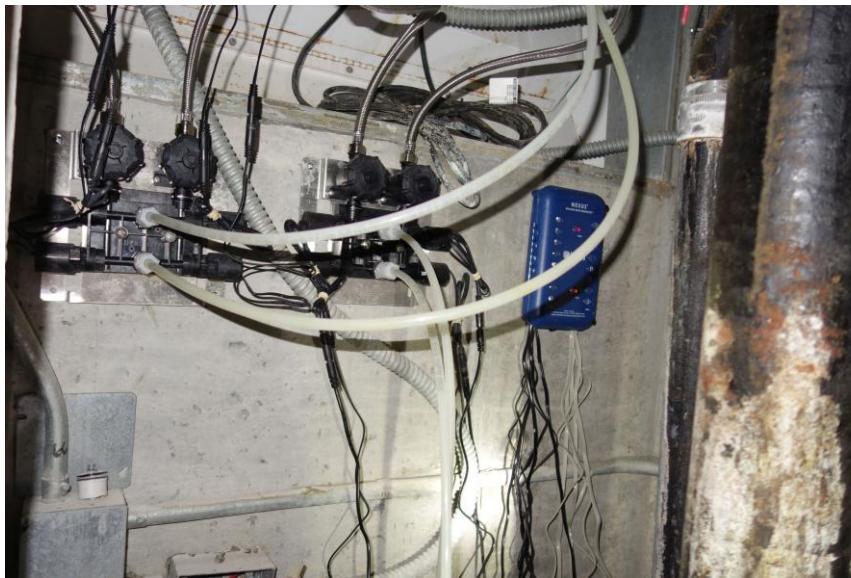
2088-PLM-2: CELL WATER CONTROL SYSTEMS REPLACEMENT

This building is equipped with cell water control systems that are outdated and should be scheduled for replacement. Problems exist with the current water control systems. It is increasingly difficult to find replacement parts and experienced repairmen to service the equipment. It is recommended to replace the water control systems. This project includes the replacement of the water controllers, piping, valves, access panels and all connections to the existing utilities.

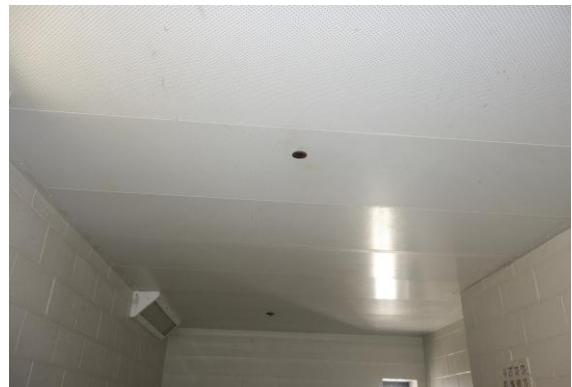
2090-INT-1: INTERIOR FINISHES

The interior finishes were in poor condition. It is recommended to paint the interior walls and ceilings at least once in the next 2 - 3 years and that this project be scheduled on a cyclical basis to maintain the integrity of the structure. Prior to painting, all surfaces should be repaired and prepped. An epoxy-based paint should be utilized in wet areas for durability.

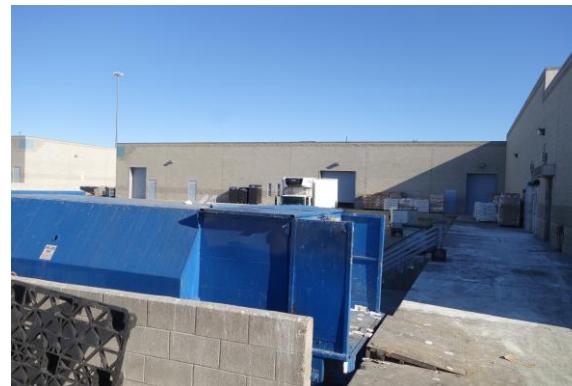
2091-EXT-6: DOCK LEVELER REPLACEMENT

The four manual dock levelers located on the loading dock are original to the building and are at the end of their useful life. They are used heavily for the food service and other inmate services activities. This project recommends the replacement of the four manual dock levelers with new manual dock levelers. Removal and disposal of the existing equipment is included in this project.

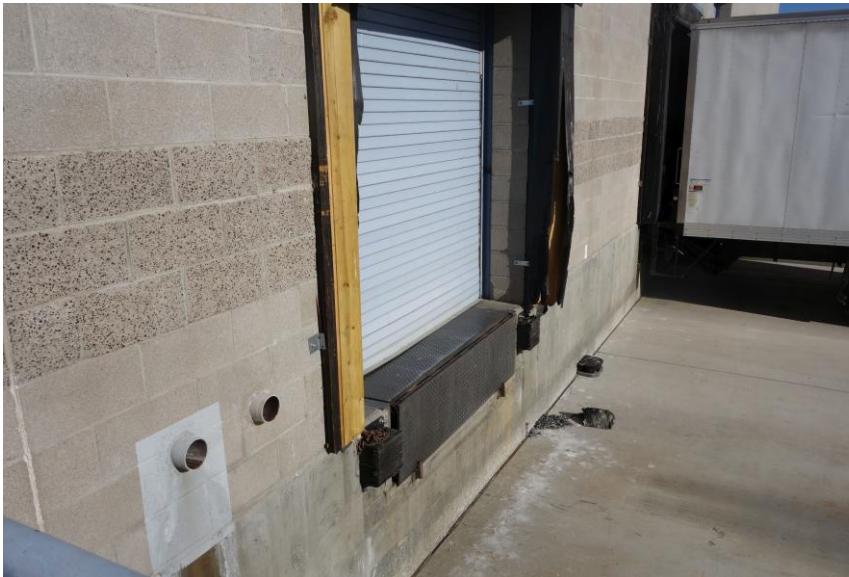
2178-EXT-4: DOCK LEVELER REPLACEMENT

The three manual dock levelers located at the Warehouse freight doors that are original to the building and are at the end of their useful life. They are used heavily for all warehouse activities. This project recommends the replacement of the three manual dock levelers with new manual dock levlers. Removal and disposal of the existing equipment is included in this project.

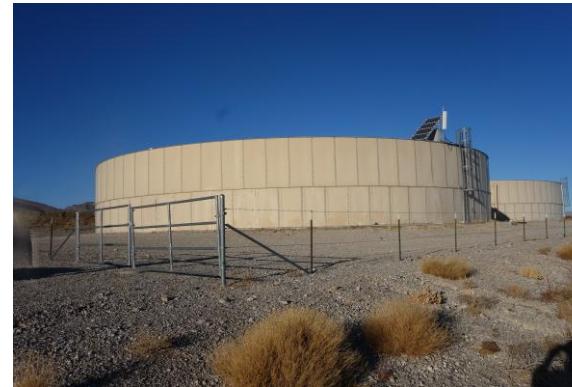
NEW STRUCTURAL - 1/7/2025 3224-STR-1: TANK INSPECTION

In addition to the annual maintenance inspections recommended by the manufacturer, the manufacturer is also recommending a detailed maintenance/cleaning inspection every 5 - 10 years depending on water quality and usage. Inspection tasks include but no limited to exterior foundations, surfaces, equipment and controls and interior roof/sidewall structure, liners and general debris/sediment cleanup. The last known detailed inspection was performed in approximately 2015 under CIP 13-M42. This project would provide funding for engaging the services of a certified tank inspection company. Any required cleaning and/or repairs are not included in this estimate.

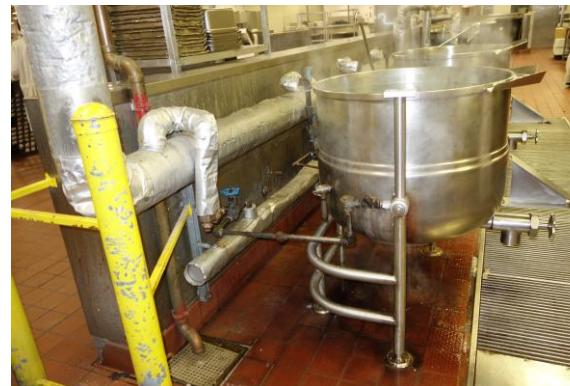
2091-INT-3: FLOORING REPLACEMENT

Areas of the floor tile in the culinary area are damaged around drains and cooking equipment. Portions of the tile grout is missing. It is recommended that the tile and grout in these areas be replaced. This project would provide for removal and disposal of the existing flooring and installation of new culinary grade tile in the next 2 - 4 years.

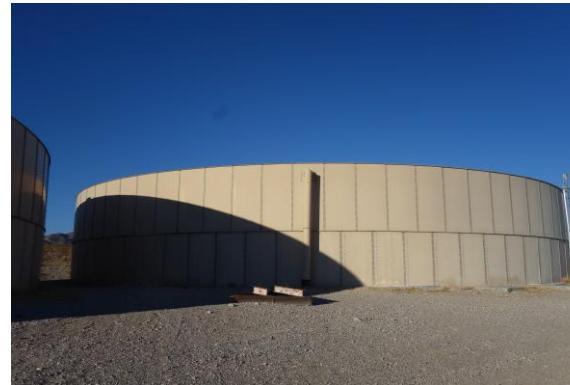
NEW STRUCTURAL - 1/7/2025 3225-STR-1: TANK INSPECTION

In addition to the annual maintenance inspections recommended by the manufacturer, the manufacturer is also recommending a detailed maintenance/cleaning inspection every 5 - 10 years depending on water quality and usage. Inspection tasks include but no limited to exterior foundations, surfaces, equipment and controls and interior roof/sidewall structure, liners and general debris/sediment cleanup. This project would provide funding for engaging the services of a certified tank inspection company. Any required cleaning and/or repairs are not included in this estimate.

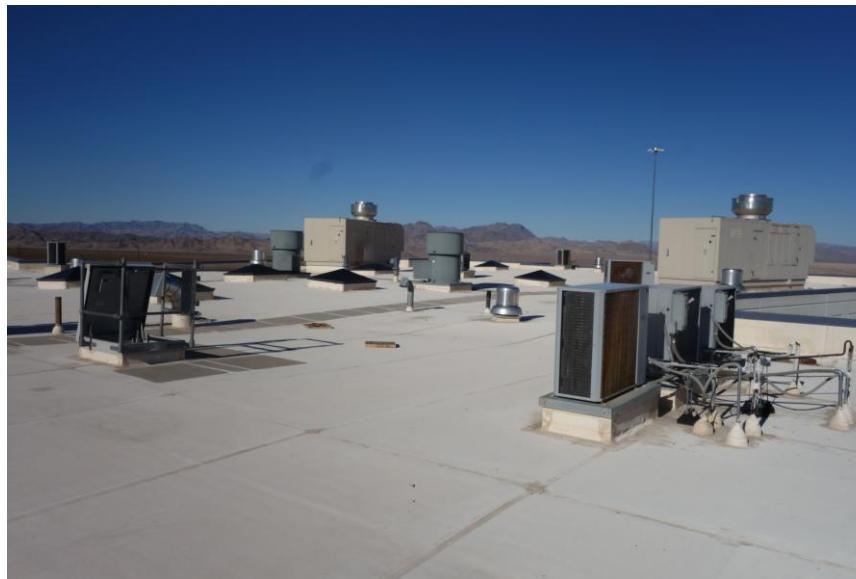
NEW BUILDING EXTERIOR - 1/7/2025

The roof on this building was in fair condition at the time of the survey. The statewide roofing program has set the useful life of an average roof at 20 years. The roof warranty expires at the end of the same time frame. The temperature fluctuations throughout the year, consistent wind which blows sand and dirt on to the roof membrane, and constant exposure to the sun are contributing factors to wear and deterioration. The current roofing system was installed in 2008. It is recommended that this building be re-roofed in the next 8 - 10 years to be consistent with the roofing program and the end of the warranty period.

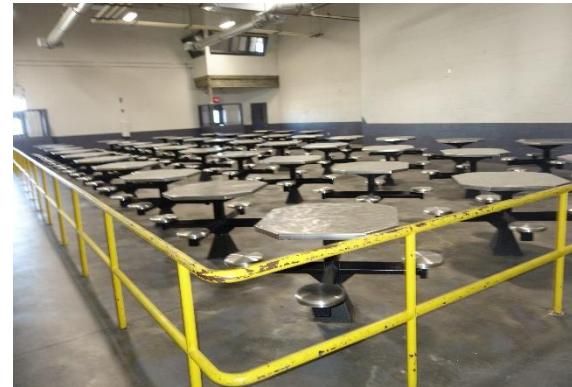
**DEFERRED BUILDING INTERIOR - 3/27/2025****2091-INT-2: INTERIOR FINISHES**

The interior finishes were in fair condition. The Inmate Services/Culinary/Dining building has painted CMU walls. All flooring is sealed concrete and non-slip tile. It is recommended that the interior walls be painted and/or sealed at least once in the next 6 - 8 years. This also includes the sealing of the floor and floor tile maintenance in the kitchen and bakery area. Prior to painting or sealing, all surfaces should be repaired and prepped. An epoxy-based paint should be utilized in wet areas for durability.

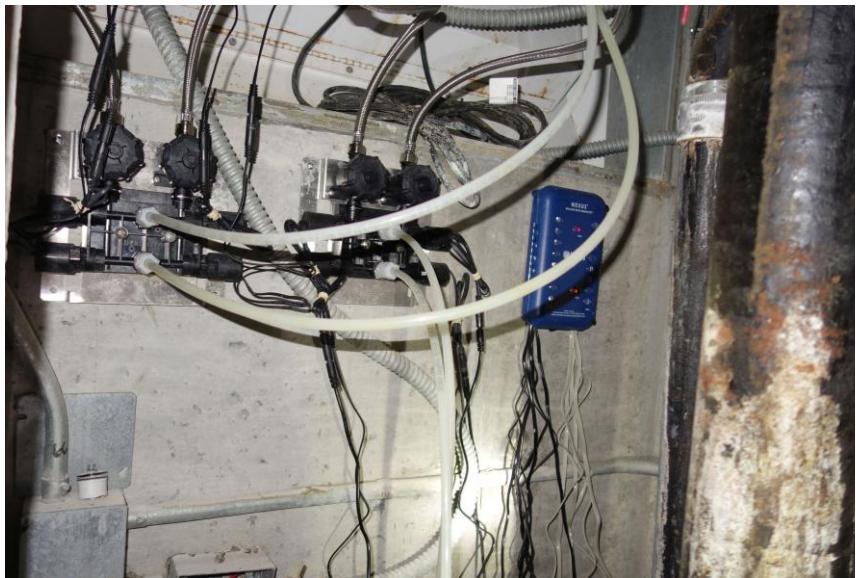
IN PROGRESS PLUMBING - 3/31/2025

This building is equipped with cell water control systems that are outdated and should be scheduled for replacement. Problems exist with the current water control systems. It is increasingly difficult to find replacement parts and experienced repairmen to service the equipment. It is recommended to replace the water control systems. This project includes the replacement of the water controllers, piping, valves, access panels and all connections to the existing utilities.

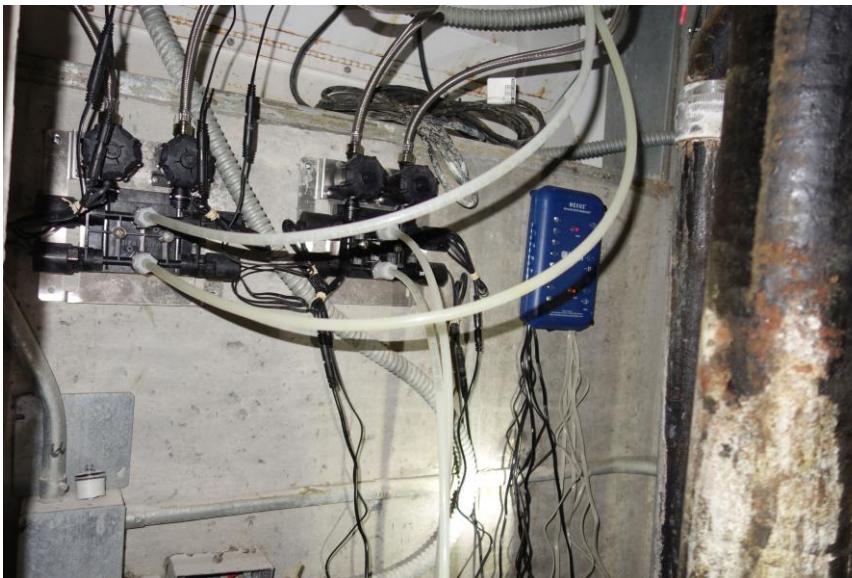
IN PROGRESS PLUMBING - 3/21/2025

This building is equipped with cell water control systems that are outdated and should be scheduled for replacement. Problems exist with the current water control systems. It is increasingly difficult to find replacement parts and experienced repairmen to service the equipment. It is recommended to replace the water control systems. This project includes the replacement of the water controllers, piping, valves, access panels and all connections to the existing utilities.

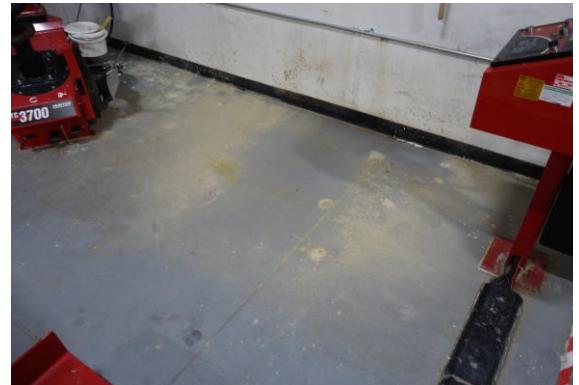
DEFERRED BUILDING INTERIOR - 4/2/2025

The interior finishes were in good condition. It is recommended to paint the interior walls and ceilings at least once in the next 7 - 9 years and that this project be scheduled on a cyclical basis to maintain the integrity of the structure. Prior to painting, all surfaces should be repaired and prepped. An epoxy-based paint should be utilized in wet areas for durability.

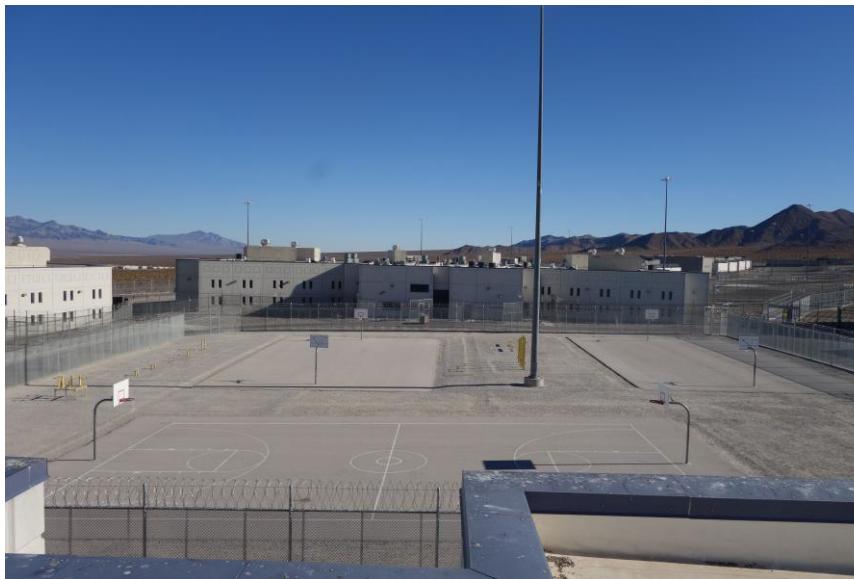
DEFERRED BUILDING EXTERIOR - 4/2/2025

The exterior finishes were in good condition. It is important to maintain the finish, weather resistance and appearance of the building. This project would provide funding to protect the exterior of the building excluding the roof. Included in the cost are cleaning and painting the concrete walls, painting the doors and trim and caulking the windows, flashing, fixtures and all other penetrations. It is recommended that the building be painted and caulked in the next 7 - 9 years and that this project be scheduled on a cyclical basis to maintain the integrity of the structure.

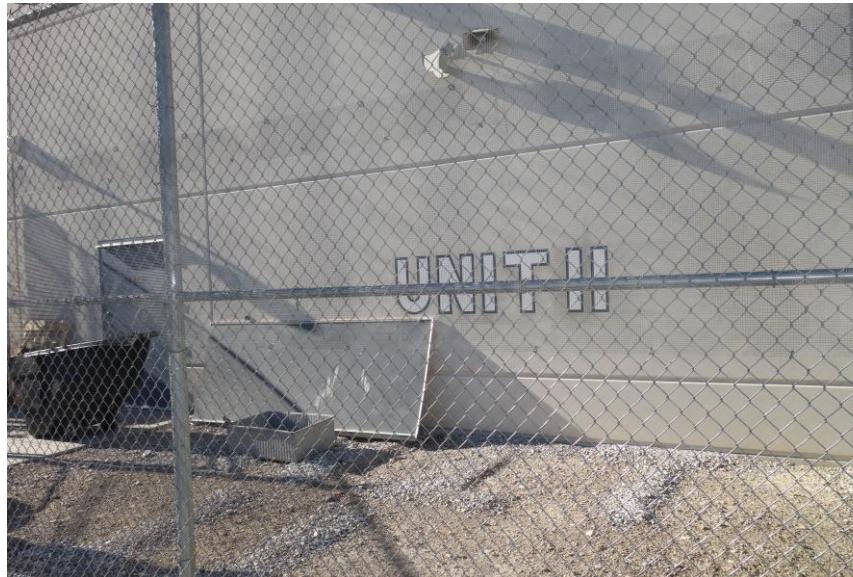
DEFERRED BUILDING EXTERIOR - 4/2/2025

The exterior finishes were in good condition. It is important to maintain the finish, weather resistance and appearance of the building. This project would provide funding to protect the exterior of the building excluding the roof. Included in the cost are cleaning and painting the concrete walls, painting the doors and trim and caulking the windows, flashing, fixtures and all other penetrations. It is recommended that the building be painted and caulked in the next 7 - 9 years and that this project be scheduled on a cyclical basis to maintain the integrity of the structure.

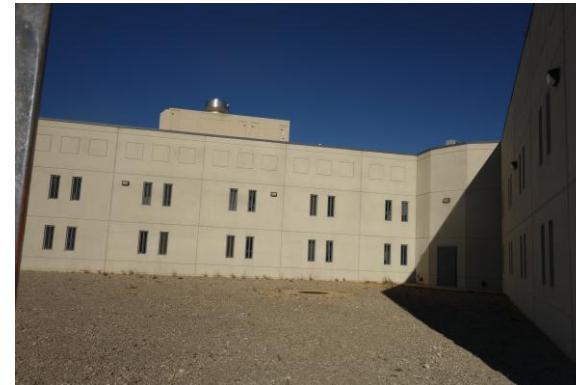
DEFERRED BUILDING EXTERIOR - 4/2/2025

The exterior finishes were in good condition. It is important to maintain the finish, weather resistance and appearance of the building. This project would provide funding to protect the exterior of the building excluding the roof. Included in the cost are cleaning and painting the concrete walls, painting the doors and trim and caulking the windows, flashing, fixtures and all other penetrations. It is recommended that the building be painted and caulked in the next 7 - 9 years and that this project be scheduled on a cyclical basis to maintain the integrity of the structure.

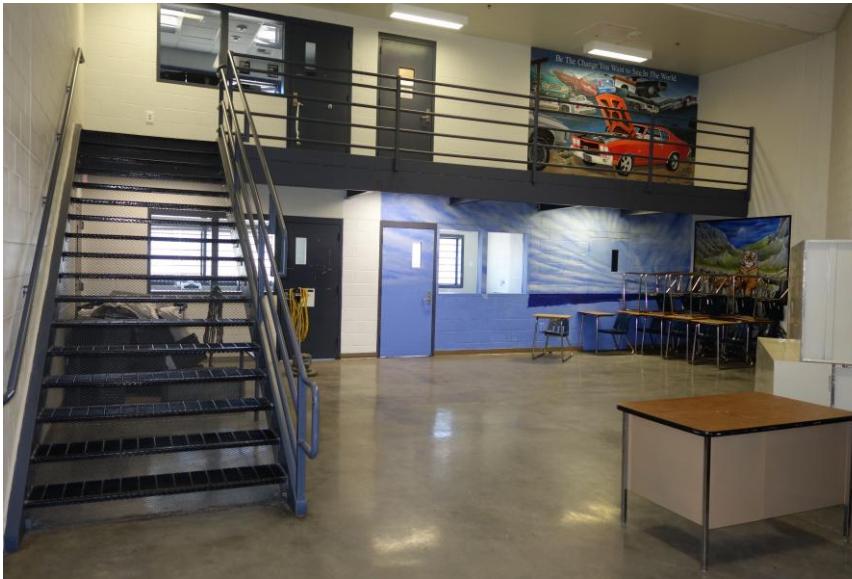
DEFERRED BUILDING INTERIOR - 4/2/2025

The interior finishes were in fair condition. It is recommended the interior walls and ceilings be painted in the next 6 - 8 years. All surfaces should be repaired and prepped prior to painting. For durability in wet areas, an epoxy-based paint should be used. Building maintenance should be scheduled on a cyclical basis to maintain the integrity of the structure.

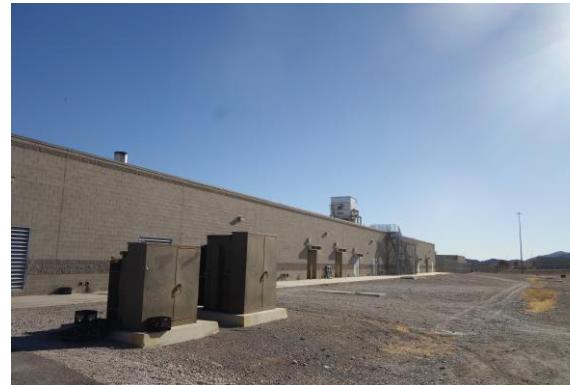
NEW BUILDING EXTERIOR - 3/27/2025

The exterior finishes were in fair condition. It is important to maintain the finish, weather resistance and appearance of the building. The caulked control joints in the CMU of the exterior surface of this building are uniformly deteriorated and should be removed and the joints re-caulked. The metal doors and window frames should be sanded and painted in the next 4 - 6 years.

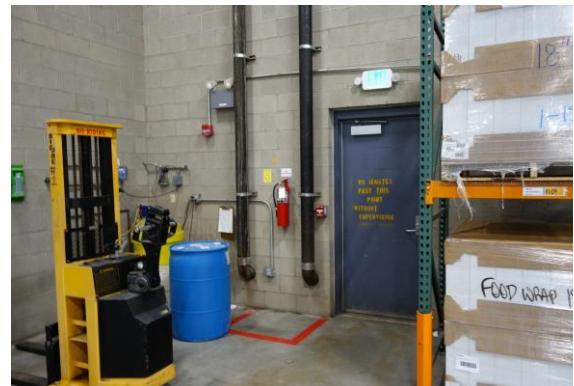
DEFERRED BUILDING INTERIOR - 4/2/2025

The interior finishes were in good condition. It is recommended to paint the interior walls and ceilings at least once in the next 7 - 9 years and that this project be scheduled on a cyclical basis to maintain the integrity of the structure. Prior to painting, all surfaces should be repaired and prepped. An epoxy-based paint should be utilized in wet areas for durability.

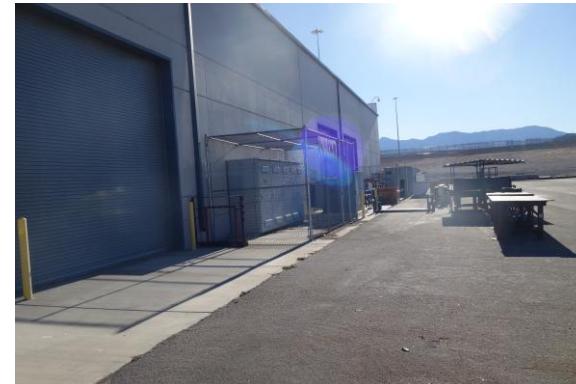
DEFERRED BUILDING EXTERIOR - 4/2/2025

The exterior finishes were in good condition. It is important to maintain the finish, weather resistance and appearance of the building. This project would provide funding to protect the exterior of the building excluding the roof. Included in the cost are cleaning and painting the concrete walls, painting the doors and trim and caulking the windows, flashing, fixtures and all other penetrations. It is recommended that the building be painted and caulked in the next 7 - 9 years and that this project be scheduled on a cyclical basis to maintain the integrity of the structure.

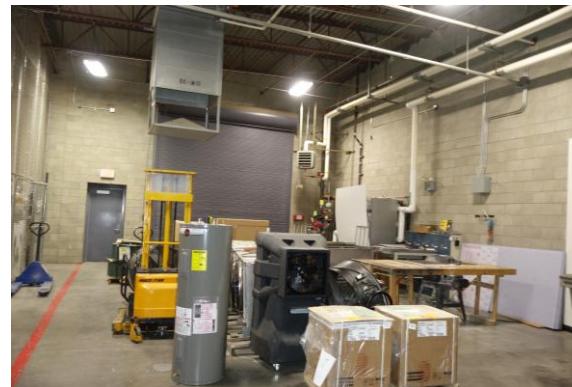
DEFERRED BUILDING INTERIOR - 4/2/2025

The interior finishes were in good condition. It is recommended to paint the interior walls and ceilings at least once in the next 7 - 9 years and that this project be scheduled on a cyclical basis to maintain the integrity of the structure. Prior to painting, all surfaces should be repaired and prepped. An epoxy-based paint should be utilized in wet areas for durability.

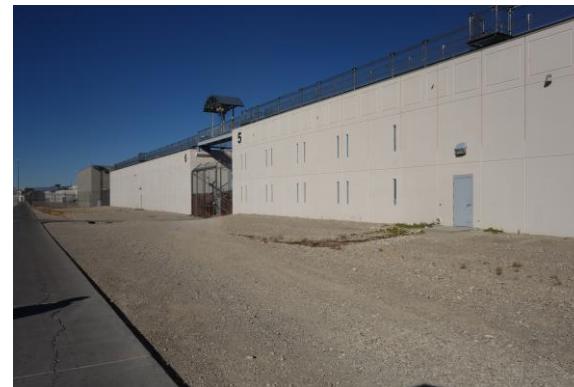
NEW BUILDING EXTERIOR - 3/18/2025

The exterior finishes were in good condition. It is important to maintain the finish, weather resistance and appearance of the building. This project would provide funding to protect the exterior of the building excluding the roof. Included in the cost are cleaning and painting the concrete walls, painting the doors and trim and caulking the windows, flashing, fixtures and all other penetrations. It is recommended that the building be painted and caulked in the next 7 - 9 years and that this project be scheduled on a cyclical basis to maintain the integrity of the structure.

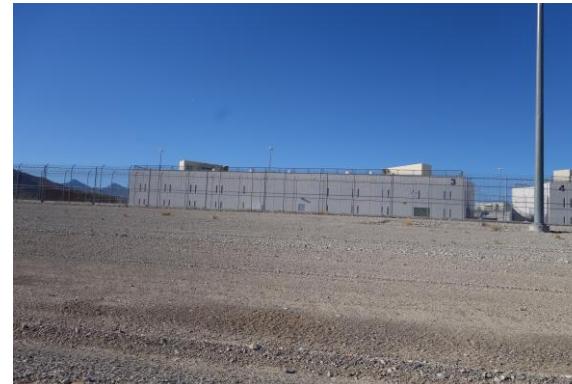
NEW BUILDING EXTERIOR - 3/18/2025

The exterior finishes were in good condition. It is important to maintain the finish, weather resistance and appearance of the building. This project would provide funding to protect the exterior of the building excluding the roof. Included in the cost are cleaning and painting the concrete walls, painting the doors and trim and caulking the windows, flashing, fixtures and all other penetrations. It is recommended that the building be painted and caulked in the next 7 - 9 years and that this project be scheduled on a cyclical basis to maintain the integrity of the structure.

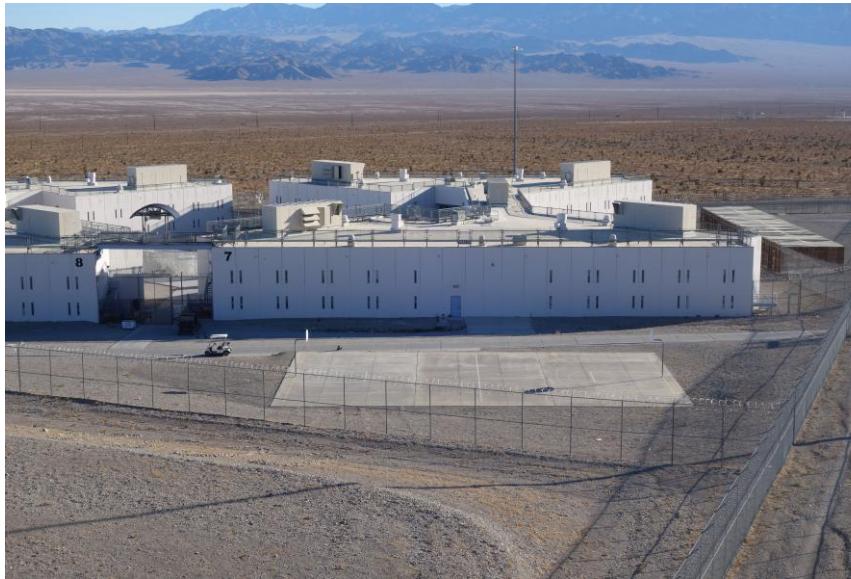
NEW BUILDING EXTERIOR - 3/18/2025

The exterior finishes were in good condition. It is important to maintain the finish, weather resistance and appearance of the building. This project would provide funding to protect the exterior of the building excluding the roof. Included in the cost are cleaning and painting the concrete walls, painting the doors and trim and caulking the windows, flashing, fixtures and all other penetrations. It is recommended that the building be painted and caulked in the next 7 - 9 years and that this project be scheduled on a cyclical basis to maintain the integrity of the structure.

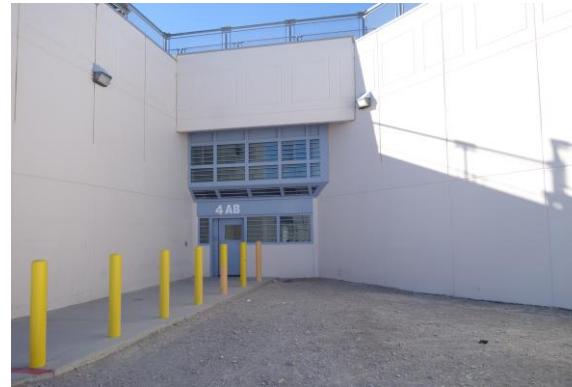
NEW BUILDING EXTERIOR - 3/14/2025

The exterior finishes were in good condition. It is important to maintain the finish, weather resistance and appearance of the building. This project would provide funding to protect the exterior of the building excluding the roof. Included in the cost are cleaning and painting the concrete walls, painting the doors and trim and caulking the windows, flashing, fixtures and all other penetrations. It is recommended that the building be painted and caulked in the next 7 - 9 years and that this project be scheduled on a cyclical basis to maintain the integrity of the structure.

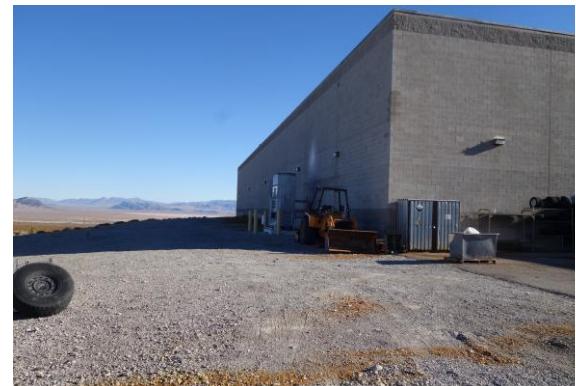
2178-EXT-3: EXTERIOR FINISHES

The exterior finishes were in fair condition. It is important to maintain the finish, weather resistance and appearance of the building. The caulked control joints in the CMU of the exterior surface of this building are uniformly deteriorated and should be removed and the joints re-caulked. The metal doors and window frames should be sanded and painted in the next 4 - 6 years.

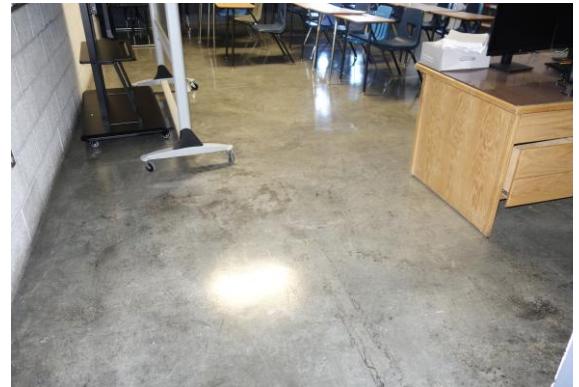
2092-INT-4: INTERIOR FINISHES

The interior finishes were in good condition. It is recommended to paint the interior walls and ceilings at least once in the next 7 - 9 years and that this project be scheduled on a cyclical basis to maintain the integrity of the structure. Prior to painting, all surfaces should be repaired and prepped. An epoxy-based paint should be utilized in wet areas for durability.

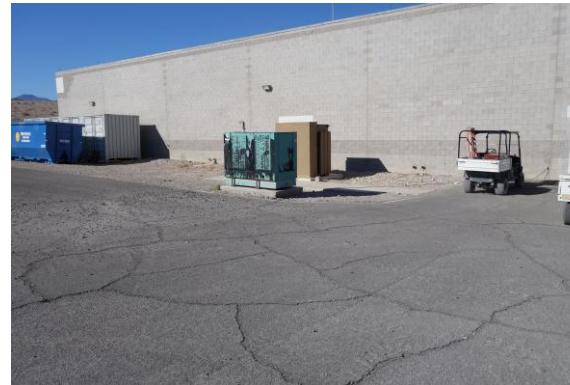
2097-EXT-3: EXTERIOR FINISHES

The exterior finishes were in fair condition. It is important to maintain the finish, weather resistance and appearance of the building. The caulked control joints in the CMU of the exterior surface of this building are uniformly deteriorated and should be removed and the joints re-caulked. The metal doors and window frames should be sanded and painted in the next 4 - 6 years.

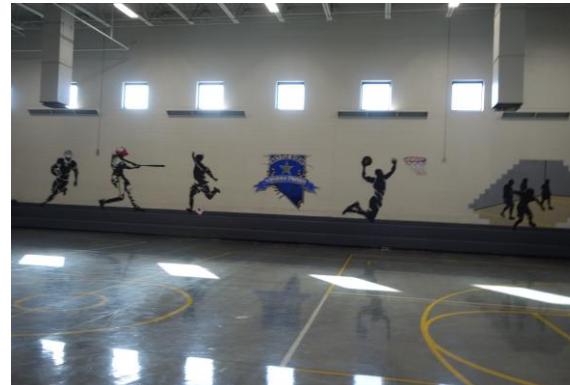
2506-INT-3: INTERIOR FINISHES

The interior finishes were in good condition. It is recommended to paint the interior walls and ceilings at least once in the next 8 - 10 years and that this project be scheduled on a cyclical basis to maintain the integrity of the structure. Prior to painting, all surfaces should be repaired and prepped. An epoxy-based paint should be utilized in wet areas for durability.

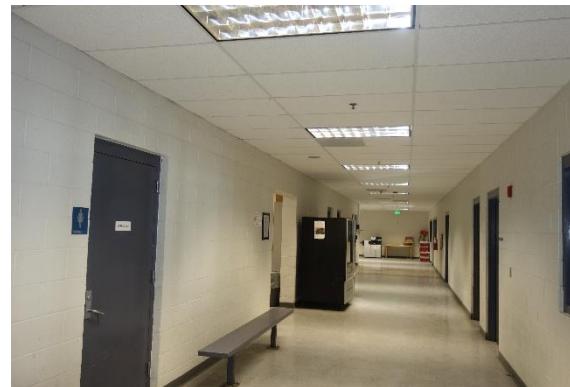
2099-INT-1: INTERIOR FINISHES

The interior finishes were in good condition. It is recommended to paint the interior walls and ceilings at least once in the next 7 - 9 years and that this project be scheduled on a cyclical basis to maintain the integrity of the structure. Prior to painting, all surfaces should be repaired and prepped. An epoxy-based paint should be utilized in wet areas for durability.

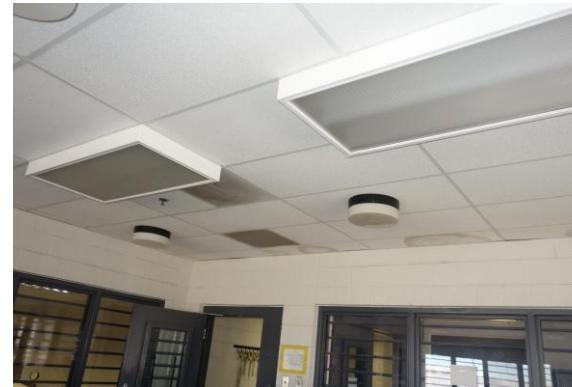
2093-INT-1: INTERIOR FINISHES

The interior finishes were in fair condition. It is recommended to paint the interior walls and ceilings at least once in the next 4 - 6 years and that this project be scheduled on a cyclical basis to maintain the integrity of the structure. Prior to painting, all surfaces should be repaired and prepped. An epoxy-based paint should be utilized in wet areas for durability.

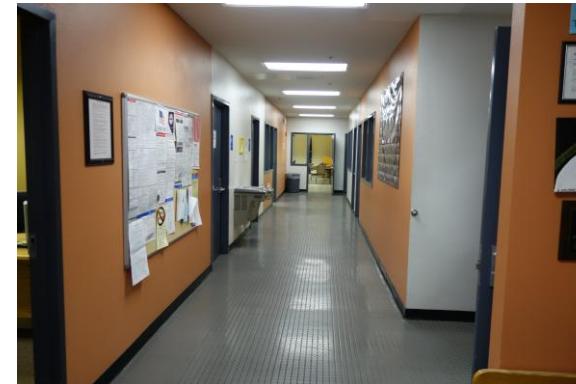
2094-INT-1: INTERIOR FINISHES

The interior finishes were in good condition. It is recommended the interior walls and ceilings be painted in the next 7 - 9 years. All surfaces should be repaired and prepped prior to painting. For durability in wet areas, an epoxy-based paint should be used. Building maintenance should be scheduled on a cyclical basis to maintain the integrity of the structure.

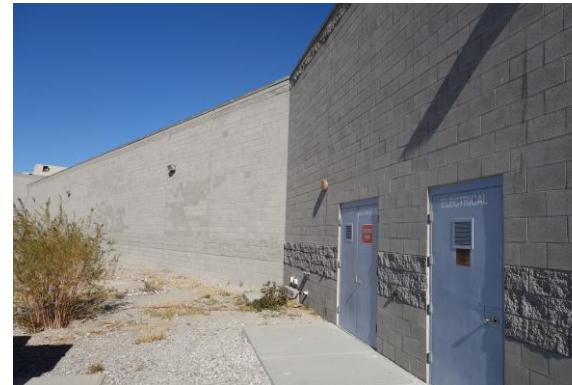
2092-EXT-2: EXTERIOR FINISHES

The exterior finishes were in fair condition. It is important to maintain the finish, weather resistance and appearance of the building. The caulked control joints in the CMU of the exterior surface of this building are uniformly deteriorated and should be removed and the joints re-caulked. The metal doors and window frames should be sanded and painted in the next 4 - 6 years.

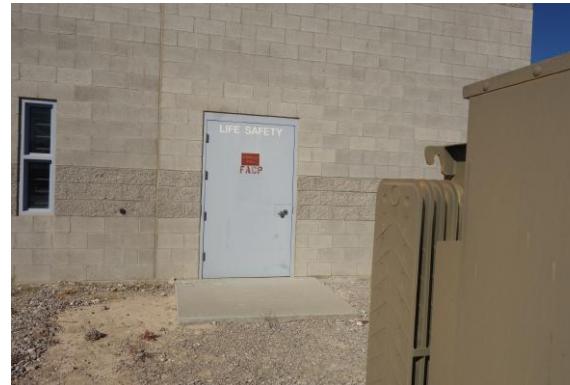
2099-EXT-3: EXTERIOR FINISHES

The exterior finishes were in fair condition. It is important to maintain the finish, weather resistance and appearance of the building. The caulked control joints in the CMU of the exterior surface of this building are uniformly deteriorated and should be removed and the joints re-caulked. The metal doors and window frames should be sanded and painted in the next 4 - 6 years.

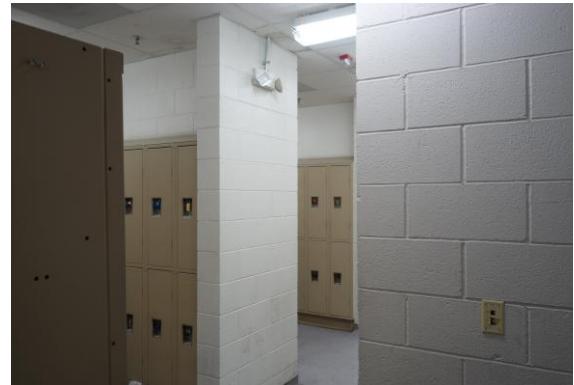
2095-INT-1: INTERIOR FINISHES

The interior finishes were in good condition. It is recommended to paint the interior walls and ceilings at least once in the next 7 - 9 years and that this project be scheduled on a cyclical basis to maintain the integrity of the structure. Prior to painting, all surfaces should be repaired and prepped. An epoxy-based paint should be utilized in wet areas for durability.

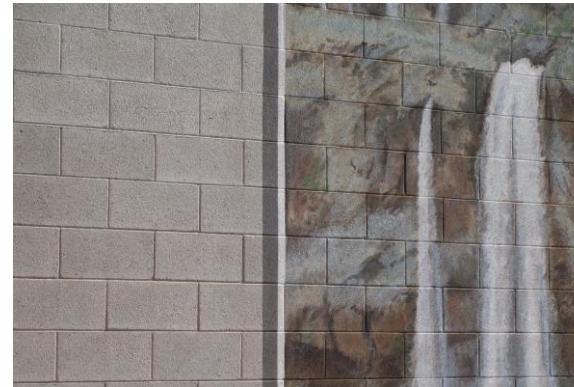
2093-EXT-4: EXTERIOR FINISHES

The exterior finishes were in fair condition. It is important to maintain the finish, weather resistance and appearance of the building. The caulked control joints in the CMU of the exterior surface of this building are uniformly deteriorated and should be removed and the joints re-caulked. The metal doors and window frames should be sanded and painted in the next 4 - 6 years.

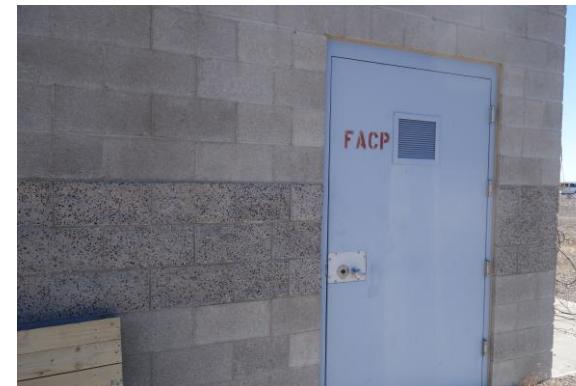
2094-EXT-3: EXTERIOR FINISHES

The exterior finishes were in fair condition. It is important to maintain the finish, weather resistance and appearance of the building. The caulked control joints in the CMU of the exterior surface of this building are uniformly deteriorated and should be removed and the joints re-caulked. The metal doors and window frames should be sanded and painted in the next 4 - 6 years.
