DEPARTMENT OF ADMINISTRATION
STATE PUBLIC WORKS DIVISION
FACILITY CONDITION ASSESSMENT

PROPERTY PORTFOLIO REVIEW PROJECT ADDENDUM

SOUTH REGION
INDIAN SPRINGS CORRECTIONAL CENTER COMPLEX
9952 - HIGH DESERT STATE PRISON SITE
22010 COLD CREEK RD
INDIAN SPRINGS, NV 89018-
CLARK COUNTY

SURVEY DATE: 01/22/2025

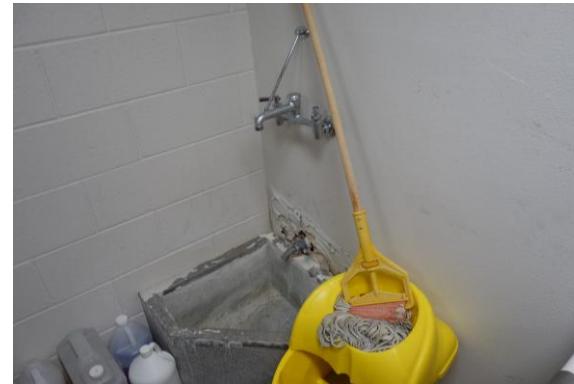
2098-INT-1: INTERIOR FINISHES

The interior finishes were in good condition. It is recommended to paint the interior walls and ceilings at least once in the next 7 - 9 years and that this project be scheduled on a cyclical basis to maintain the integrity of the structure. Prior to painting, all surfaces should be repaired and prepped. An epoxy-based paint should be utilized in wet areas for durability.

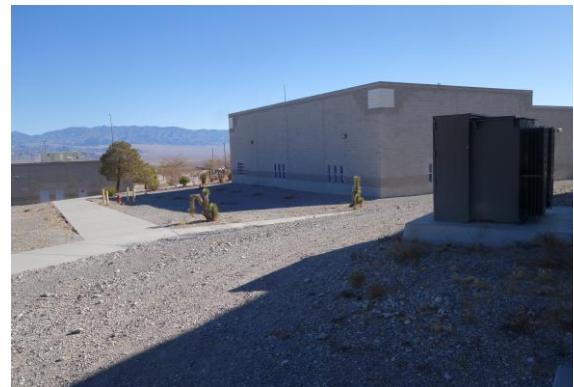
2095-EXT-4: EXTERIOR FINISHES

The exterior finishes were in fair condition. It is important to maintain the finish, weather resistance and appearance of the building. The caulked control joints in the CMU of the exterior surface of this building are uniformly deteriorated and should be removed and the joints re-caulked. The metal doors and window frames should be sanded and painted in the next 4 - 6 years.

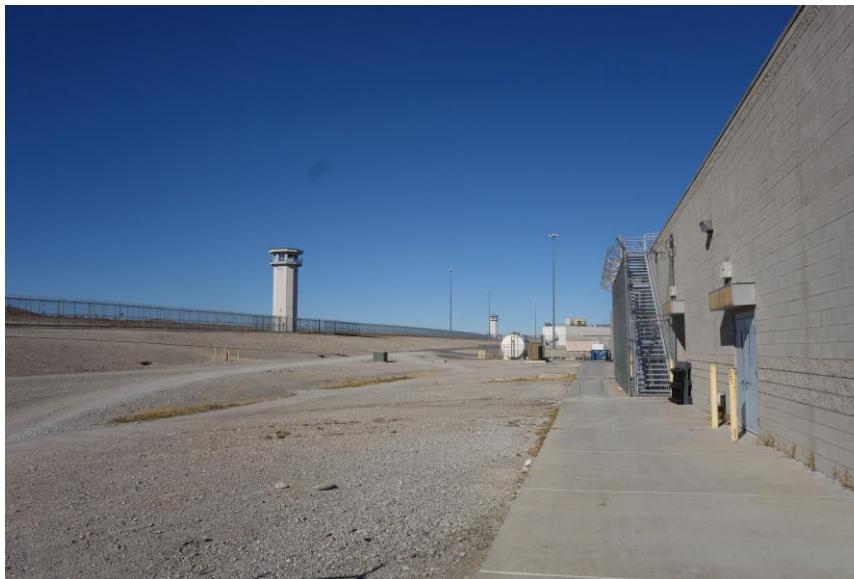
2101-EXT-4: EXTERIOR FINISHES

The exterior finishes were in good condition. It is important to maintain the finish, weather resistance and appearance of the building. This project would provide funding to protect the exterior of the building excluding the roof. Included in the cost are cleaning and painting the concrete walls, painting the doors and trim and caulking the windows, flashing, fixtures and all other penetrations. It is recommended that the building be painted and caulked in the next 7 - 9 years and that this project be scheduled on a cyclical basis to maintain the integrity of the structure.

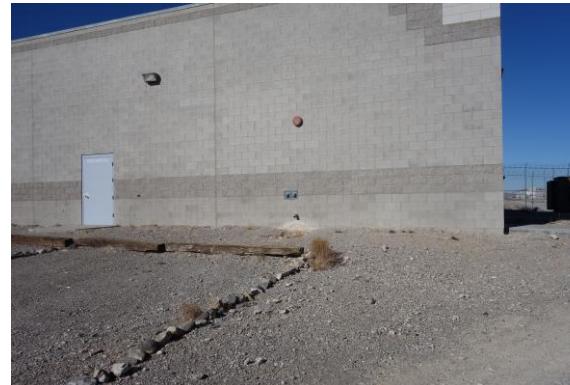
2098-EXT-4: EXTERIOR FINISHES

The exterior finishes were in fair condition. It is important to maintain the finish, weather resistance and appearance of the building. The caulked control joints in the CMU of the exterior surface of this building are uniformly deteriorated and should be removed and the joints re-caulked. The metal doors and window frames should be sanded and painted in the next 4 - 6 years.

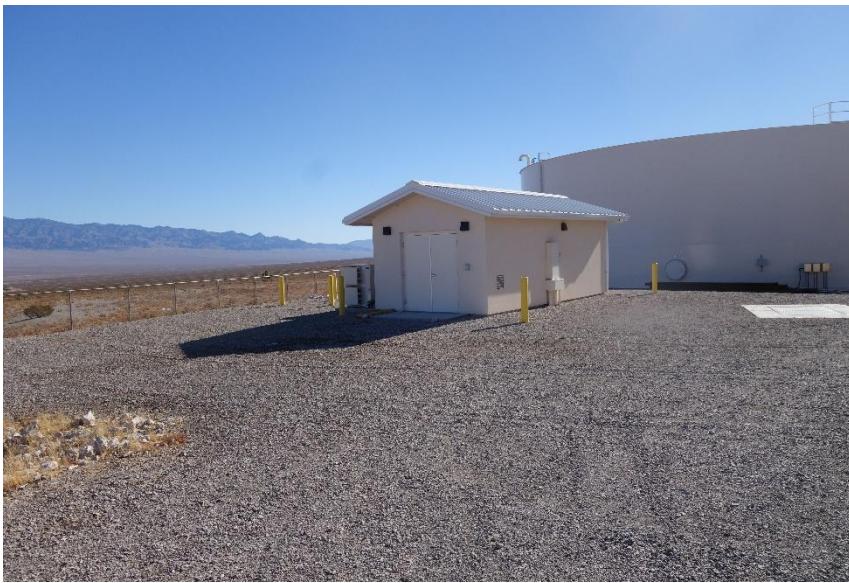
PUMP HOUSE #3

It is important to maintain the finish, weather resistance and appearance of the building. This project would provide funding to protect the exterior of the building excluding the roof. Included in the cost are cleaning and sealing the concrete masonry units and caulking flashing, fixtures and all other penetrations. It is recommended that the building be sealed and caulked in the next 2-3 years and that this project be scheduled on a cyclical basis to maintain the integrity of the structure.

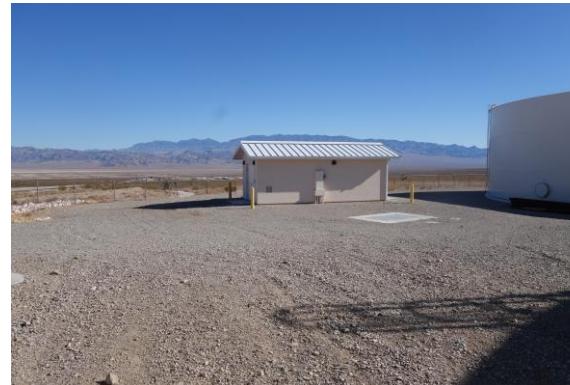
NEW BUILDING EXTERIOR - 1/10/2025

The exterior finishes were in good condition. It is important to maintain the finish, weather resistance and appearance of the building. This project would provide funding to protect the exterior of the building excluding the roof. Included in the cost are cleaning and painting the concrete walls, painting the doors and trim and caulking the windows, flashing, fixtures and all other penetrations. It is recommended that the building be painted and caulked in the next 7 - 9 years and that this project be scheduled on a cyclical basis to maintain the integrity of the structure.

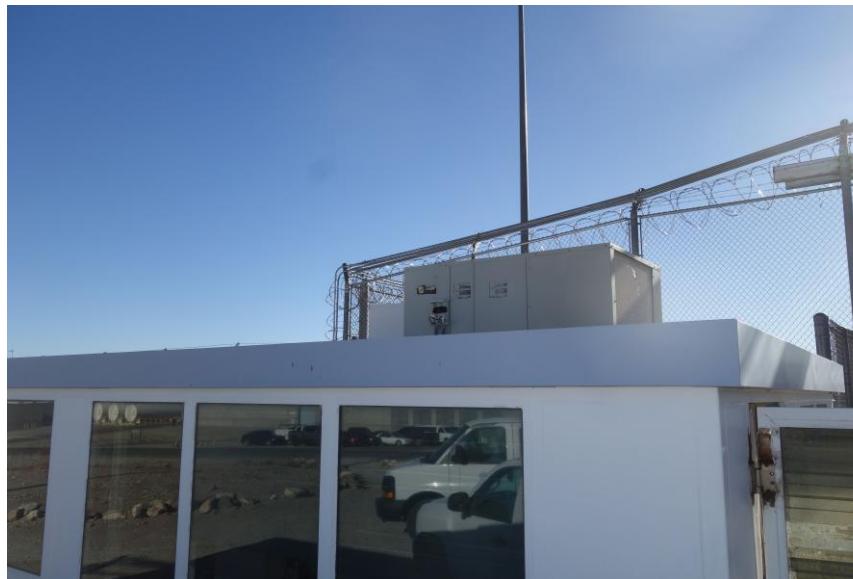
SALLYPORT

The heat pumps in the building should be scheduled for replacement. They are not energy efficient and have reached the end of their expected and useful life. This project would provide for installation of new heat pump units and the cleaning of the existing ducting and grilles. This project includes removal and disposal of the existing heat pump units and all required connections to utilities.

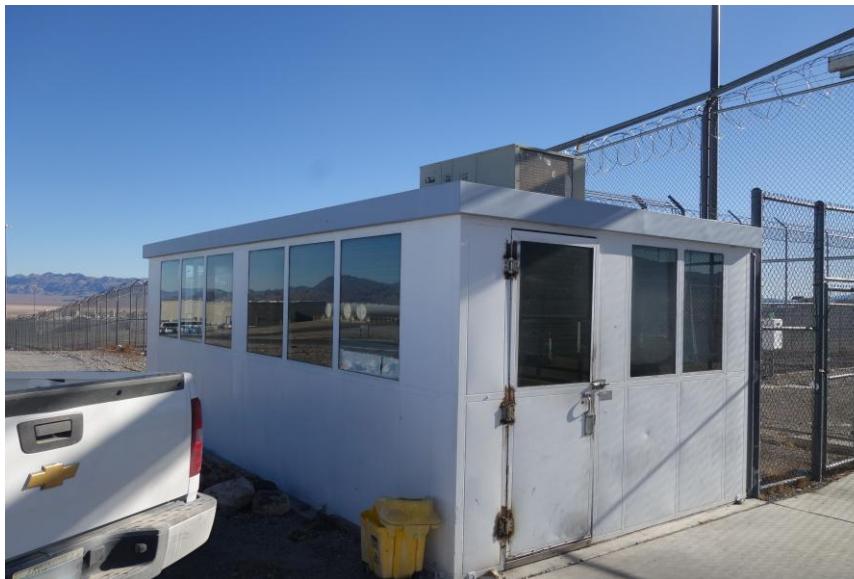
SALLYPORT

The exterior finishes were in good condition. It is important to maintain the finish, weather resistance and appearance of the building. This project would provide funding to protect the exterior of the building excluding the roof. Included in the cost is power washing the prefinished metal panels, caulking the windows, repair flashing, fixtures and all other penetrations. It is recommended to this work in the next 8 - 10 years and that this project be scheduled on a cyclical basis to maintain the integrity of the structure.

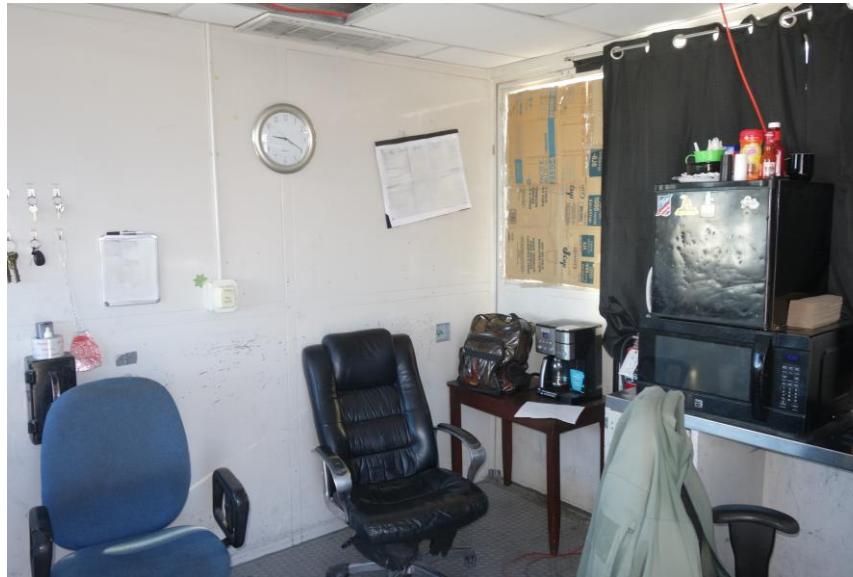
SALLYPORT

The interior finishes were in fair condition. It is recommended the interior walls and ceilings be painted in the next 6 - 8 years. All surfaces should be repaired and prepped prior to painting. For durability in wet areas, an epoxy-based paint should be used. Building maintenance should be scheduled on a cyclical basis to maintain the integrity of the structure.
