LAHONTAN STATE RECREATION AREA SITE

Site Number: 9959
STATE OF NEVADA PUBLIC WORKS DIVISION
FACILITY CONDITION ANALYSIS

Report distributed in October 2021

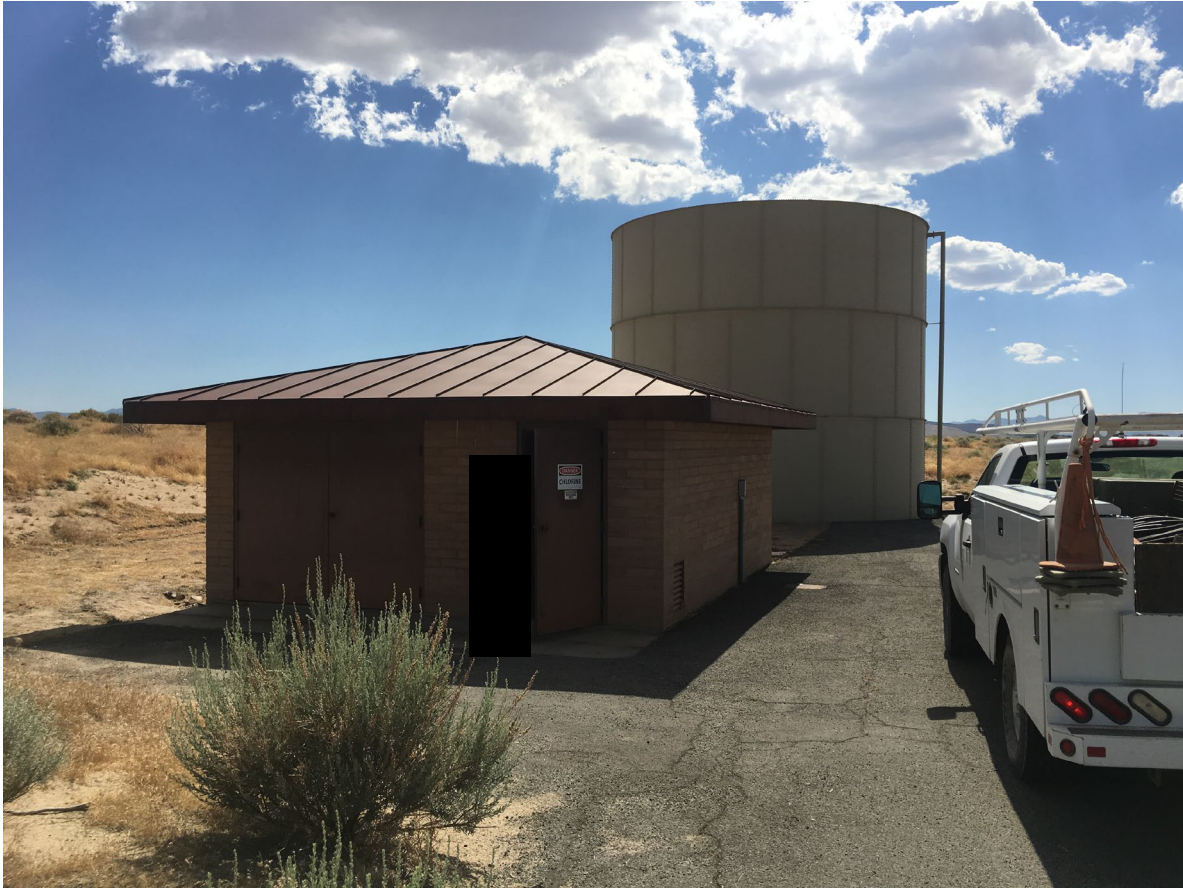
LD Garage #5- Building #3057
Description: Exterior of the Structure.
