# STATE OF NEVADA STATE PUBLIC WORKS DIVISION

FACILITY CONDITION ASSESSMENT REPORT FOR:

DEPT OF CORRECTIONS  
LOVELOCK CORRECTIONAL CENTER

Survey Date: 4/04/2023  
Distribution Date: 11/20/2024

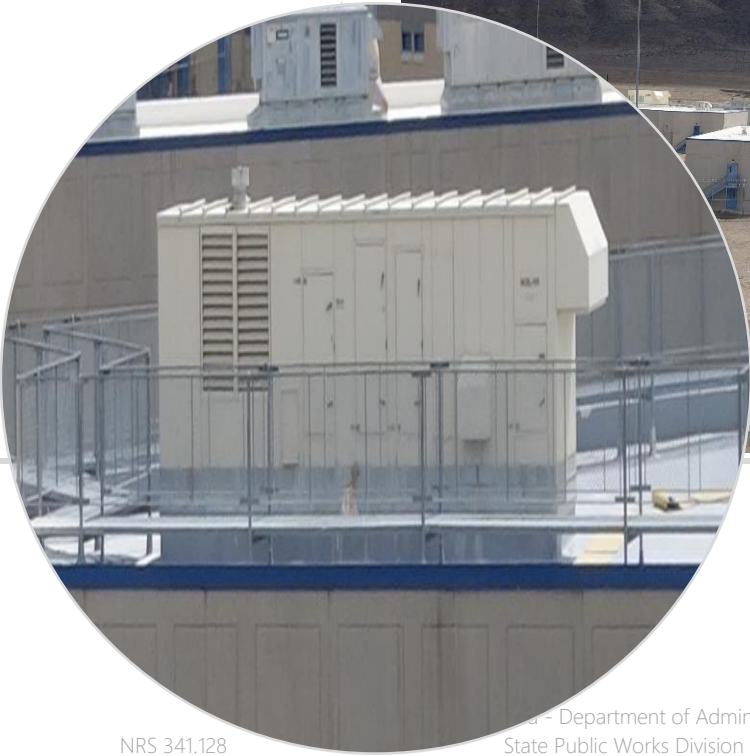
The large rooftop air handling units were replaced approximately 6 years ago. However the balance of smaller AHU's, exhaust fans and VAV boxes with re-heat coils are original and have reached the end of their useful life. This project recommends replacement of the balance of mechanical equipment including fan coil units, exhaust fans, reheat coils.

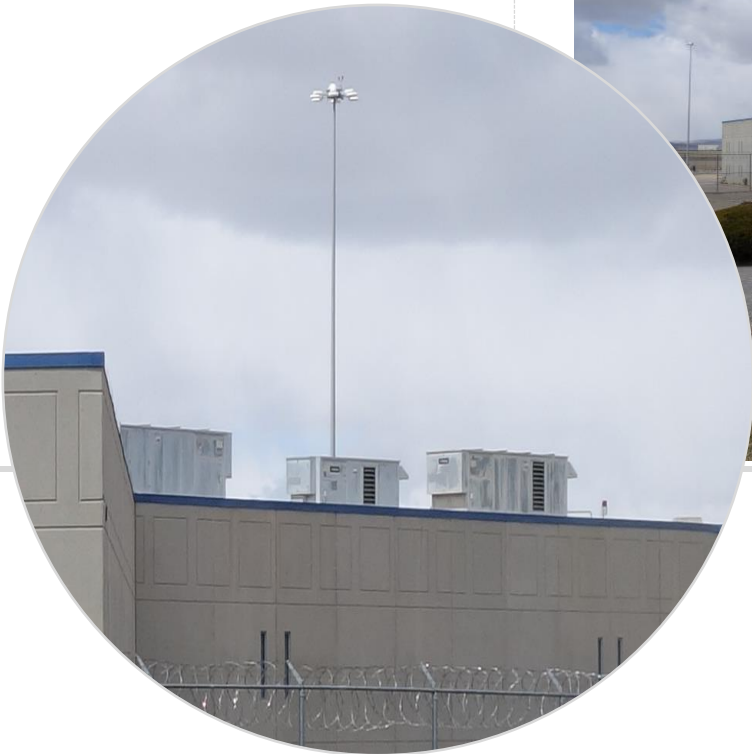
QUANTITY	UNITS	TOTAL	SF COST
The large rooftop air handling units were replaced approximately 6 years ago. However the balance of smaller AHU's, exhaust fans and VAV boxes with re-heat coils are original and have reached the end of their useful life. This project recommends replacement of the balance of mechanical equipment including fan coil units, exhaust fans, reheat coils.	1	PKG	\$97,500.00	\$ 2.00

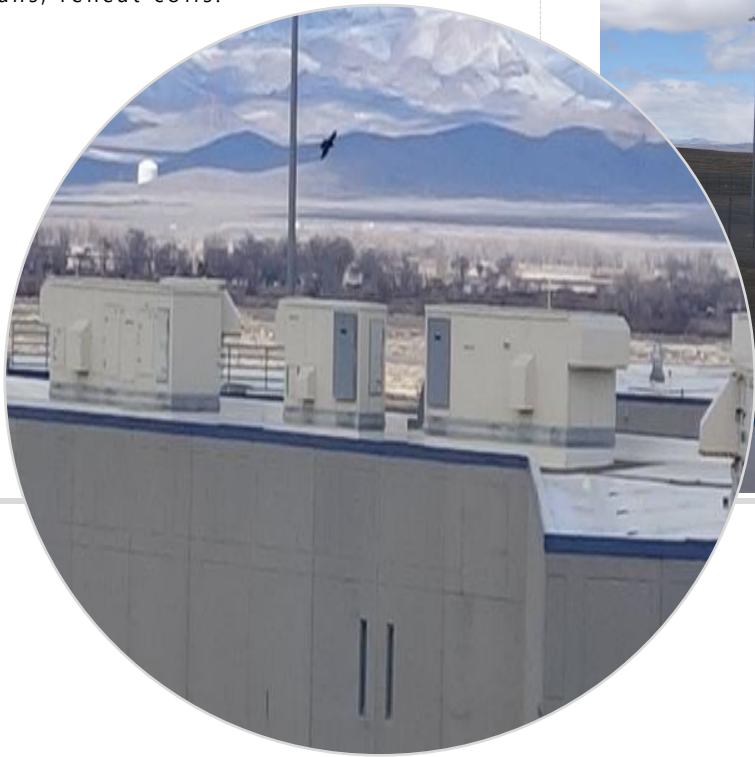
QUANTITY	UNITS	TOTAL	SF COST
The large rooftop air handling units were replaced approximately 6 years ago. However the balance of smaller AHU's, exhaust fans and VAV boxes with re-heat coils are original and have reached the end of their useful life. This project recommends replacement of the balance of mechanical equipment including fan coil units, exhaust fans, reheat coils.	1	PKG	\$97,500.00	\$ 2.00

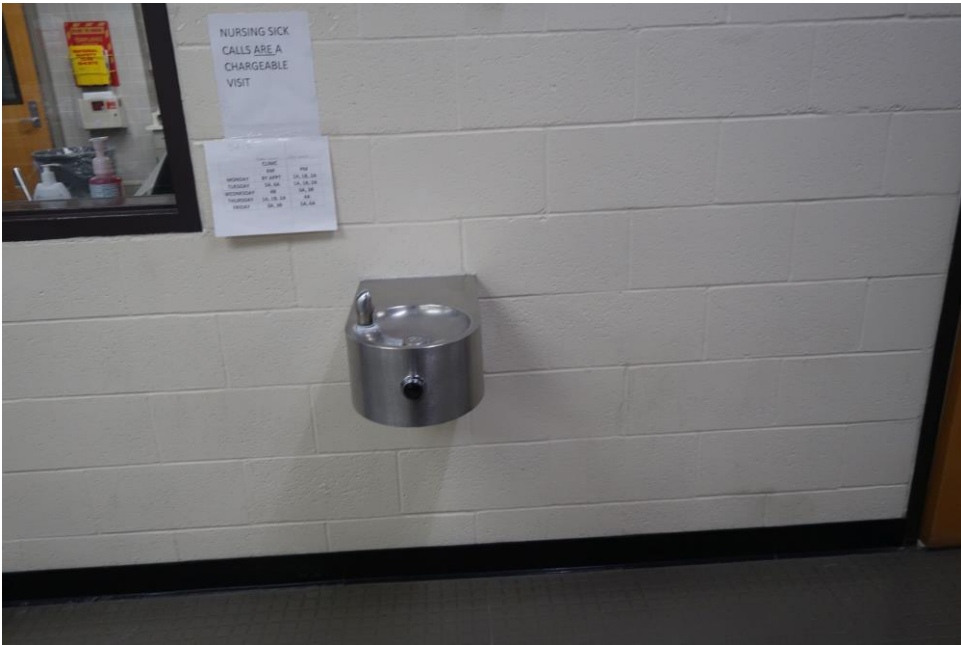
This building contains water fountains that are not ADA compliant. The 2018 IBC Section 1109.5 states where drinking fountains are provided on an exterior site, on a floor or within a secured area, no fewer than two drinking fountains shall be provided. One shall comply with the requirements for people who use a wheelchair and one shall comply with the requirements for standing persons. This project would provide funding for the purchase and installation of 2 drinking fountains to meet the ADA requirements. Note that a bottle filler integrated into a drinking fountain does not make the water fountain accessible. If drinking fountains are located in an exit access, it is recommended to review exit access requirements for projections into exit access width.

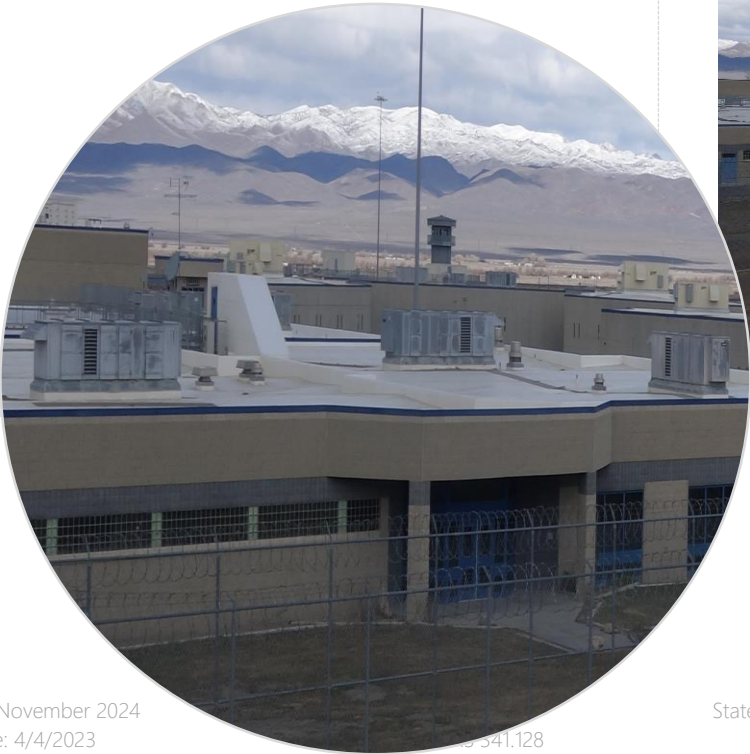
QUANTITY	UNITS	TOTAL	SF COST
The HVAC equipment is approaching 30 years of operation and has reached the end of it's serviceable life. This project recommends replacement of the air handling units, fan coil units, exhaust fans, reheat coils and water heaters in the next 2 - 3 years.	1	PKG	\$1,922,000.00	\$ 63.00

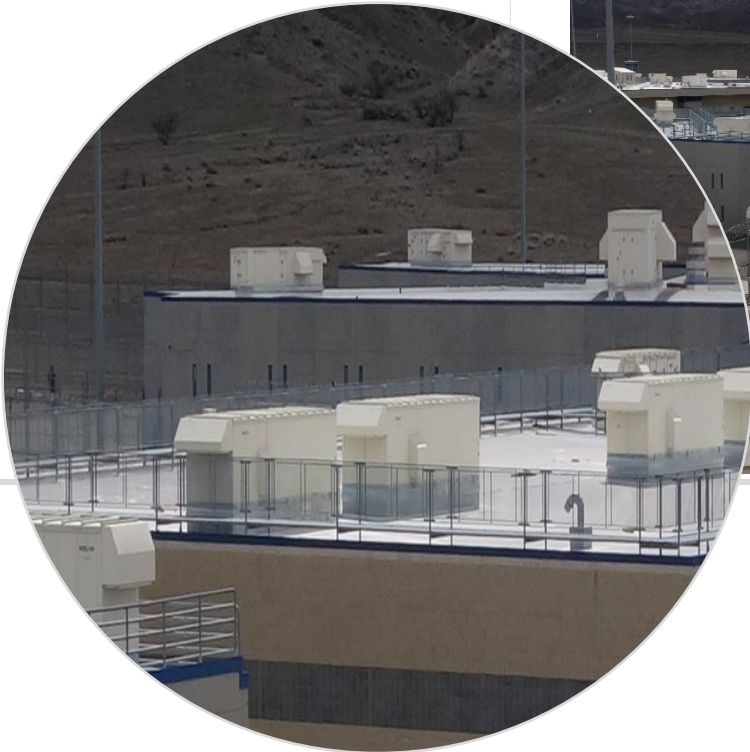
QUANTITY	UNITS	TOTAL	SF COST
The rooftop air handling units (AHU's) over the laundry area were replaced approximately 6 years ago. However the balance of rooftop AHU's, exhaust fans are original are have reached the end of their useful life. This project recommends replacement of the balance of mechanical equipment including 4 RTU's, exhaust fans and other miscellaneous mechanical equipment.	1	PKG	\$1,046,000.00	\$ 39.00

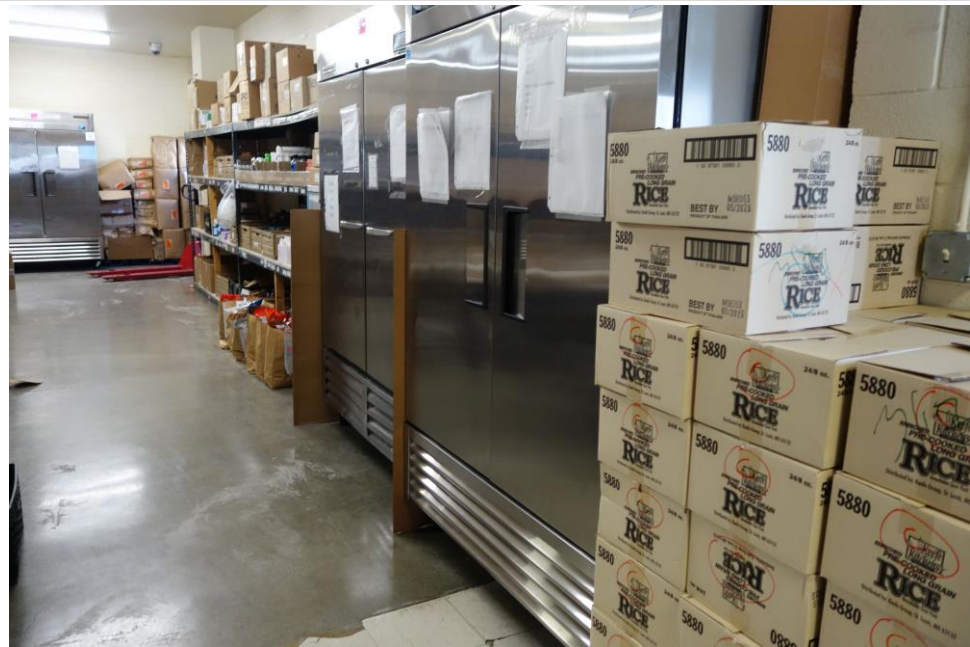
The interior finishes are in fair condition. This project would provide funding to maintain the interior of the building. Included in the cost is painting the walls and ceilings, sealing the exposed masonry, repairing cracks in the masonry and replacing grout and caulk as needed. An epoxy-based paint should be utilized in wet areas for durability. It is recommended that the interior of the building be painted, sealed and repaired in the next 6 - 8 years and that this project be scheduled on a cyclical basis to maintain the integrity of the structure.

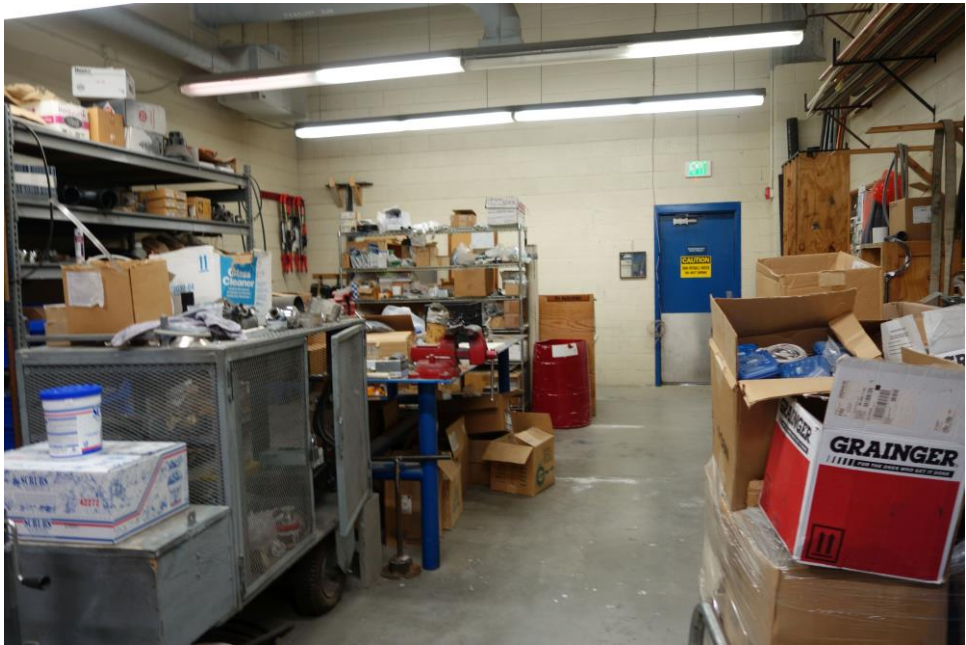
QUANTITY	UNITS	TOTAL	SF COST
Multiple rooms within the building including HVAC, Welding, Electronics and Electrical rooms are without emergency egress lighting. This project would provide for the purchase and installation of self-illuminated or LED style exit signs with battery-backed internal systems as well as emergency egress lighting to provide illumination along the egress route. IBC 2018 Chapter 10 was referenced for this project.	1	PKG	\$10,000.00	\$ 0.00

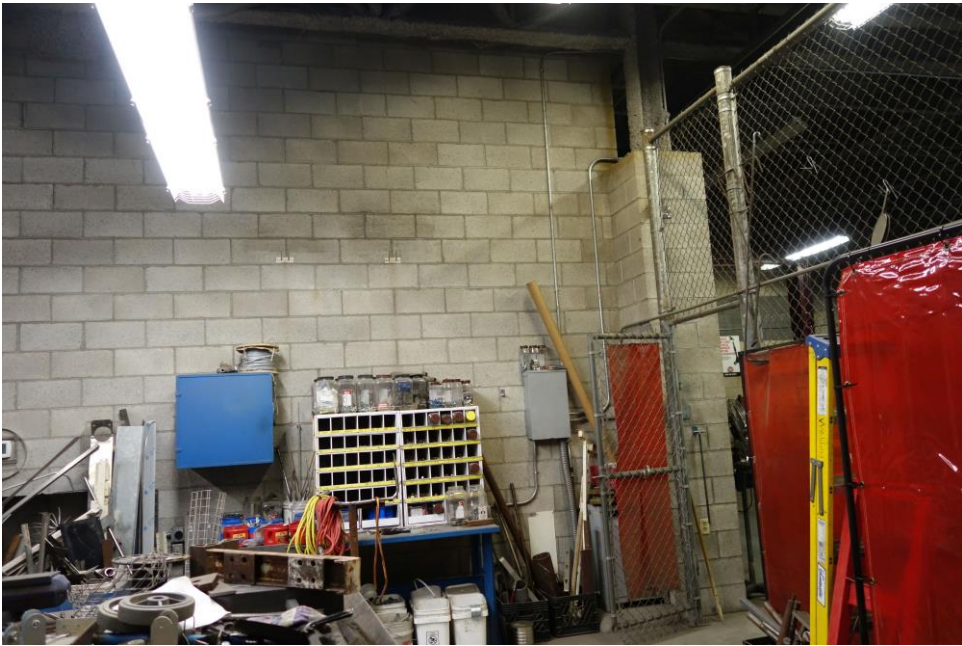
QUANTITY	UNITS	TOTAL	SF COST
The welding area of the building is lacking immediate access to a fire extinguisher. International Fire Code Section 906 Table 906.1 requires that additional portable fire extinguishers shall be installed in "Welding and other hot work" areas. They shall be provided for employee use and selected and distributed based on the classes of anticipated workplace fires and on the size and degree of hazard which would affect their use. This project would provide funding for the purchase and installation of 2 fire extinguishers, cabinets, and the hardware necessary to install them.	1	PKG	\$ 1,500.00	\$ 0.00

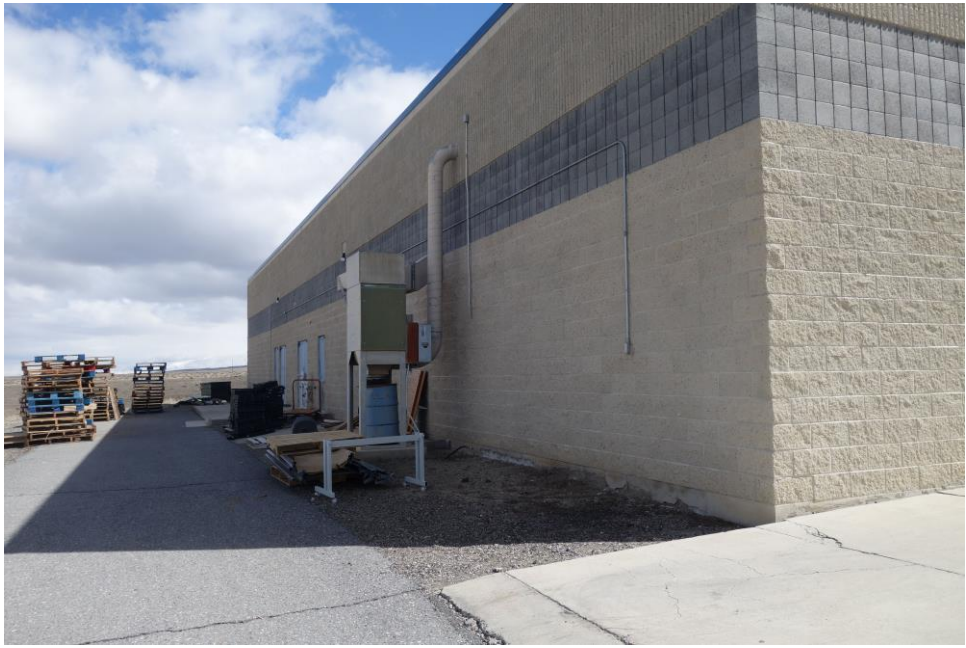
QUANTITY	UNITS	TOTAL	SF COST
<p>The building has carpentry shop and welding shops which do not have sufficient dust collection systems. There is a fan and motor in the carpentry shop, but no ducting to the tables or equipment. In order to reduce the possibility of damage or injury, each piece of equipment should have complete collection capability. It is assumed that the existing equipment in the carpentry shop does not work or will need to be replaced in the near future. This project recommends installing a complete new dust collection system in each shop.</p> <p>This project or a portion thereof was previously recommended in the FCA report dated 03/09/2010. It has been amended accordingly to reflect conditions observed during the most recent survey date of 04/04/2023.</p>	1	PKG	\$60,000.00	\$ 3.00

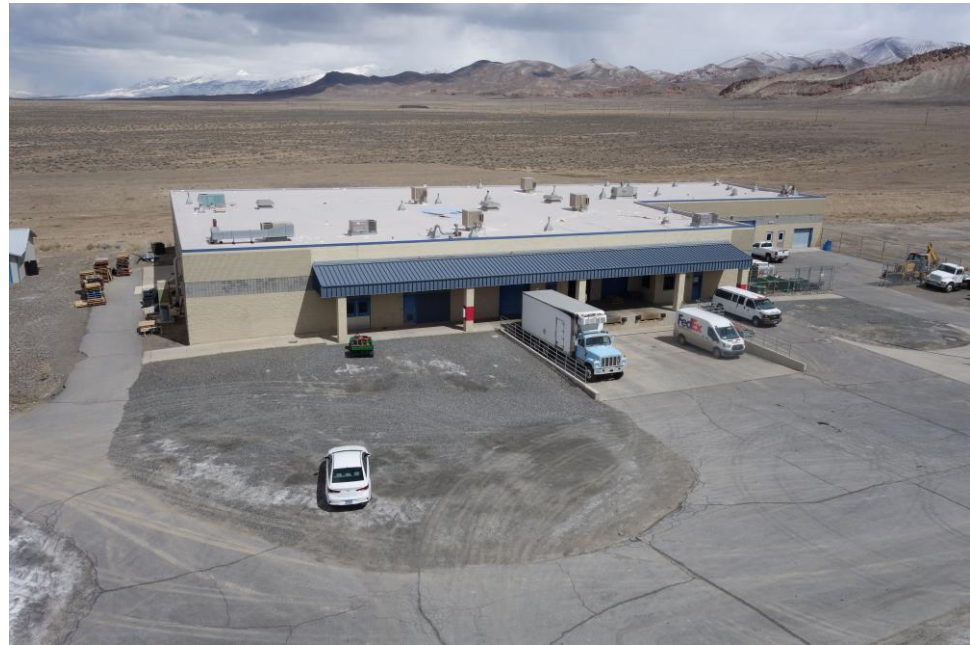
The roof on this building is original construction and has reached the end of its useful life. The statewide roofing program has set the useful life of an average roof at 20 years. The roof warranty expires at the end of the same time frame. The temperature fluctuations throughout the year, consistent wind which blows sand and dirt on to the roof membrane, and constant exposure to the sun are contributing factors to wear and deterioration. The current roofing system was installed in 1993. It is recommended that this building be re-roofed in the next 2 - 3 years to be consistent with the roofing program and the end of the warranty period.

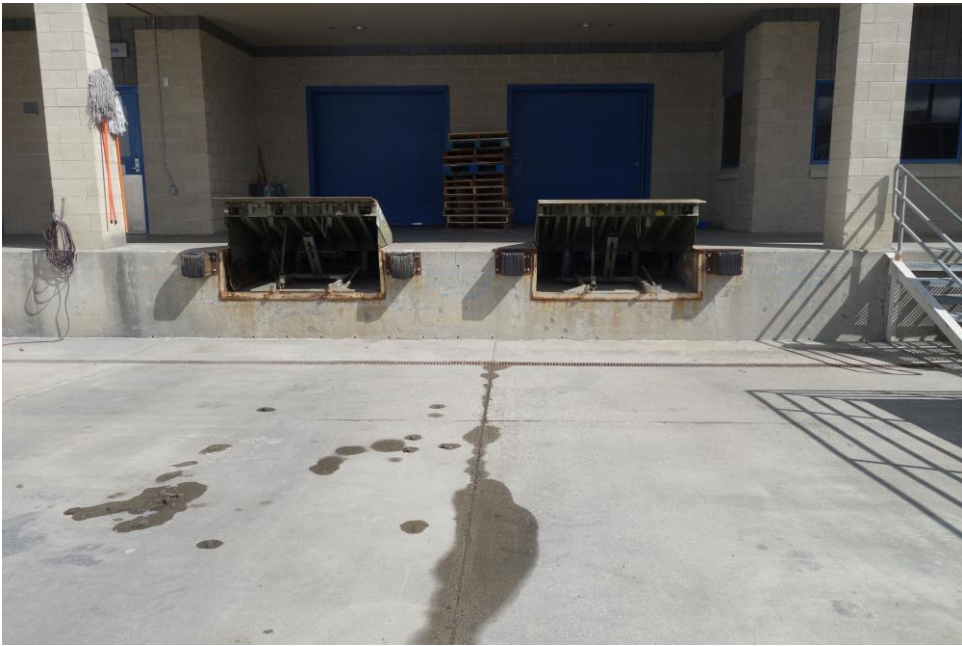
QUANTITY	UNITS	TOTAL	SF COST
The building has 3 manual dock levelers that are failing. The structural concrete surrounding the dock levelers is also failing and needs replacement. This project recommends an extensive refurbishment of the loading dock including removal and replacement of structural concrete supporting the dock levelers, manual dock levelers and dock bumpers.	1	PKG	\$ 0.00	\$141,000.00

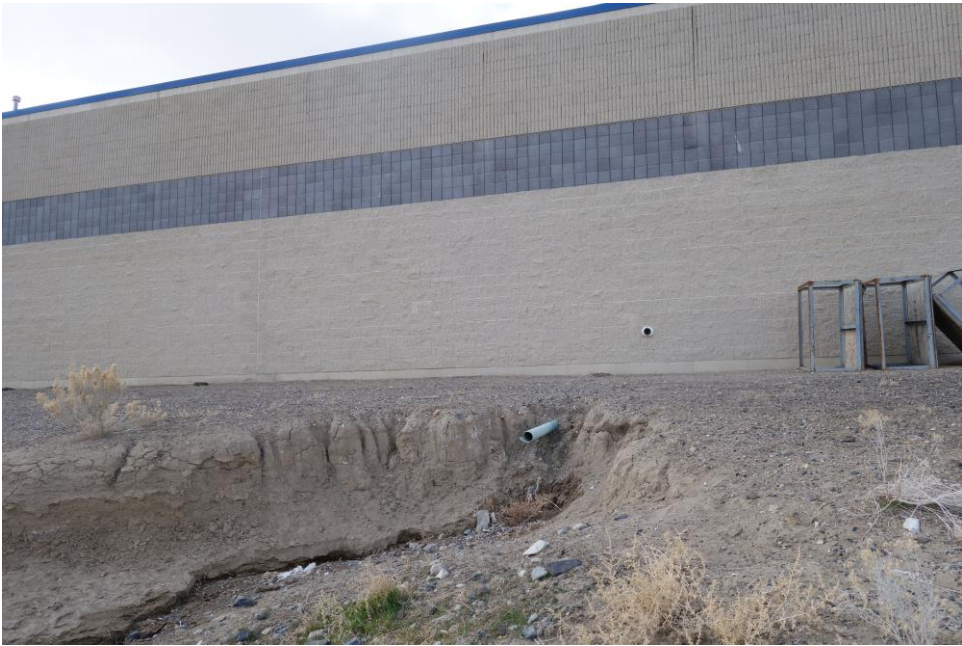
QUANTITY	UNITS	TOTAL	SF COST
A visual survey of the northeast side of the building appears to show a broken storm drain pipe causing the embankment to erode to within 5 feet of the building footing. This project recommends the repair and extension of the storm drain piping approximately 20'. The storm drain should be supported by compacted structural fill and erosion protection rubble should be installed at the piping discharge to the bottom of the adjacent wash.	1	PKG	\$15,000.00	\$ 1.00

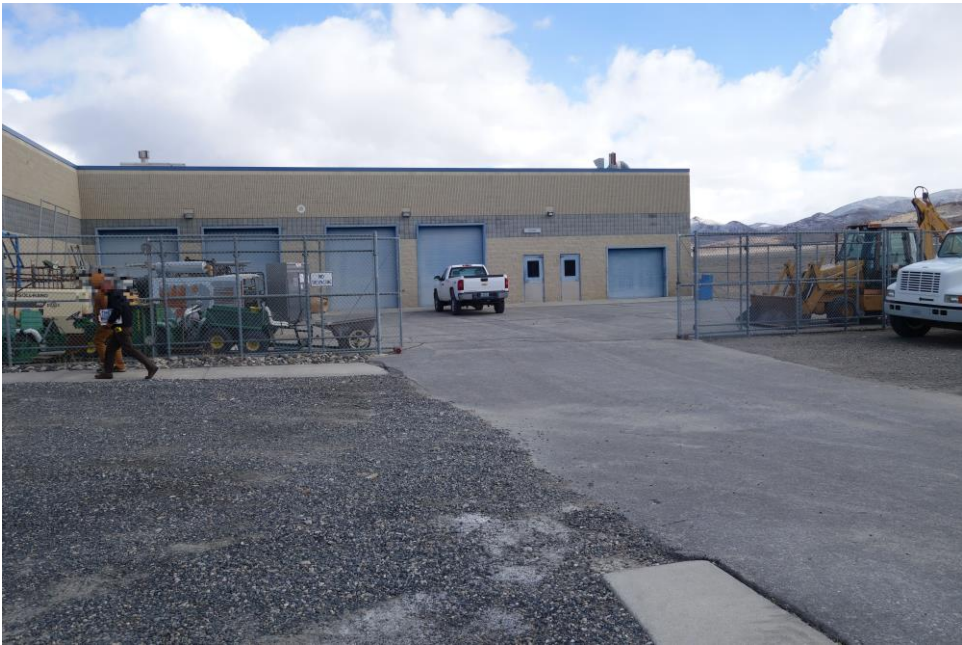
QUANTITY	UNITS	TOTAL	SF COST
The exterior finishes were in fair condition with all exterior metal finishes in need of re-painting. It is important to maintain the finish, weather resistance and appearance of the building. This project would provide funding to protect the exterior of the building. Included in the cost are cleaning and sealing the concrete masonry walls, painting the window frames and flashing and caulking the windows, flashing, fixtures and all other penetrations. It is recommended that the building be sealed, painted and caulked in the next 4 - 6 years and that this project be scheduled on a cyclical basis to maintain the integrity of the structure.	23000	SF	\$69,000.00	\$ 3.00

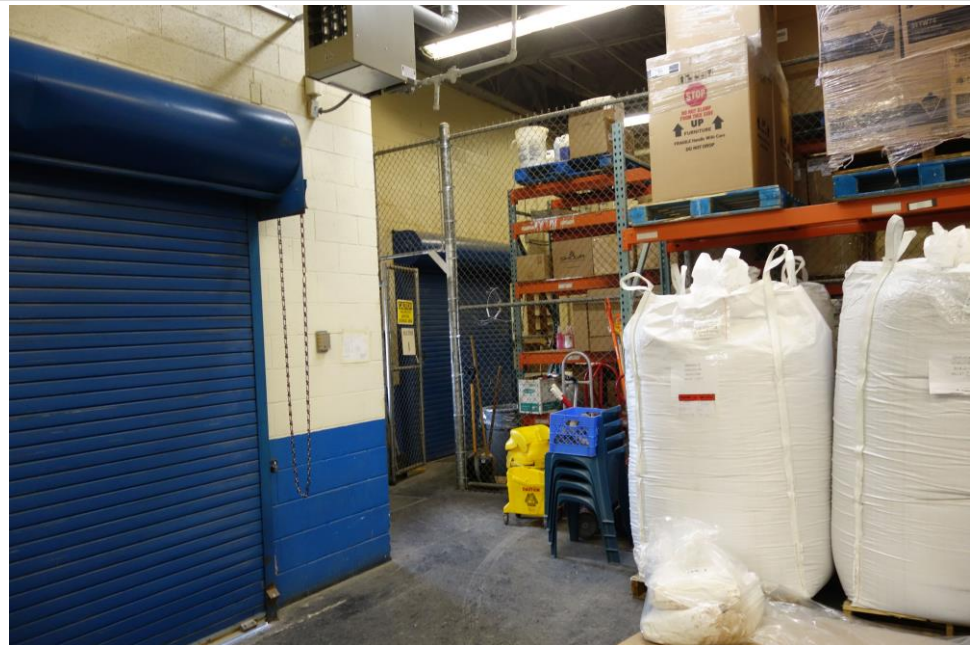
QUANTITY	UNITS	TOTAL	SF COST
The interior finishes are in fair condition. This project would provide funding to maintain the interior of the building. Included in the cost is painting the walls and ceilings, sealing the exposed masonry, repairing cracks in the masonry and replacing grout and caulk as needed. An epoxy-based paint should be utilized in wet areas for durability. It is recommended that the interior of the building be painted, sealed and repaired in the next 4 - 6 years and that this project be scheduled on a cyclical basis to maintain the integrity of the structure.	23000	SF	\$115,000.00	\$ 5.00

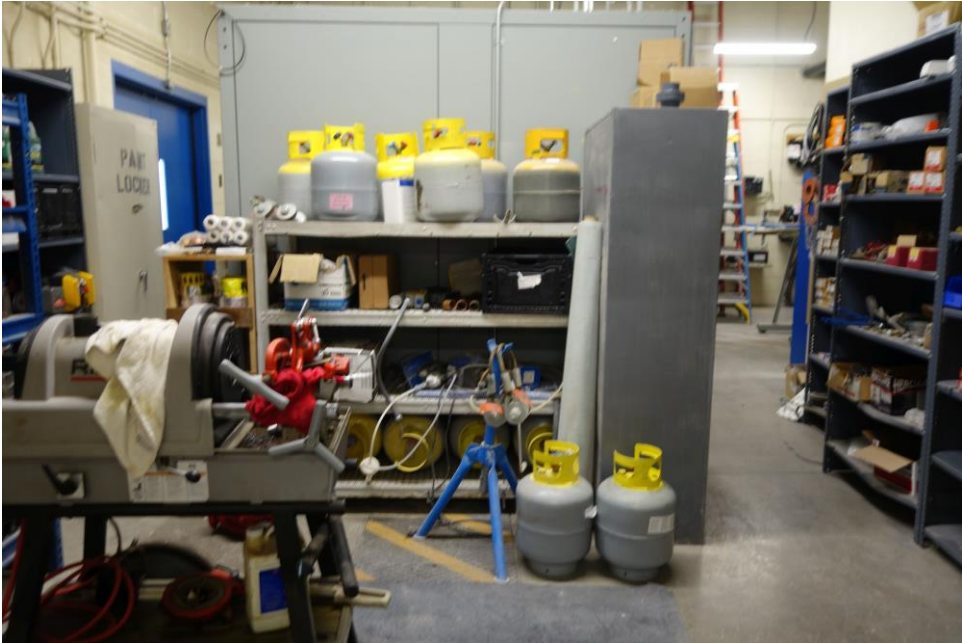
QUANTITY	UNITS	TOTAL	SF COST
There are many different paints, stains, oils and other hazardous or flammable products on open shelves throughout the building. This does not meet OSHA standards for hazardous materials containment. This project would provide 5 hazardous materials storage cabinets in the building and install placards on the building exterior in accordance with OSHA 1910.106 (d).	5	EA	\$37,500.00	\$ 5.00

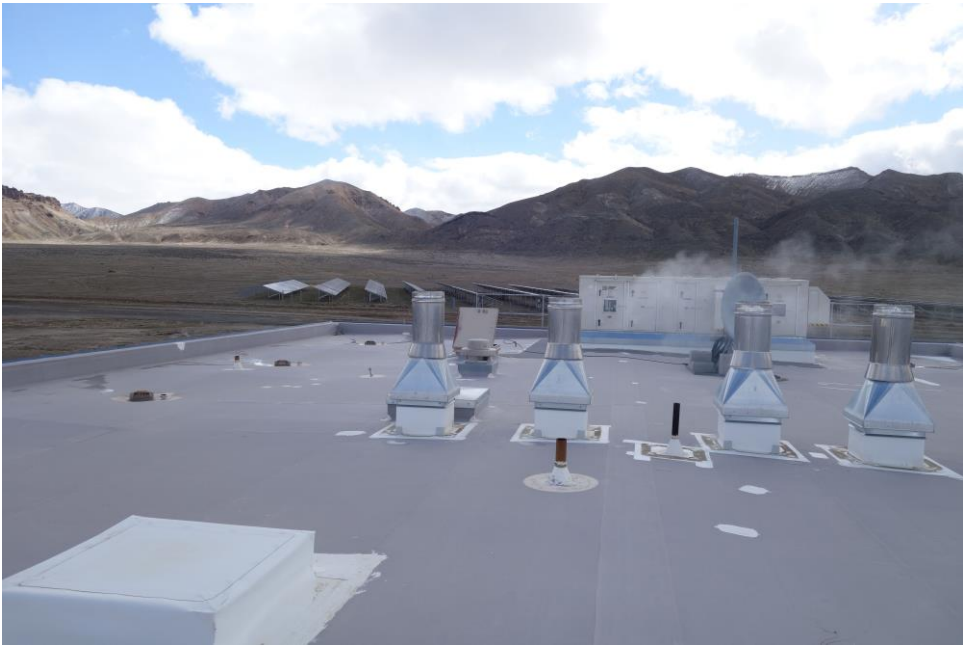
QUANTITY	UNITS	TOTAL	SF COST
<p>The roof on this building is original 1993 construction. The statewide roofing program has set the useful life of an average roof at 20 years. The roof warranty expires at the end of the same time frame. The temperature fluctuations throughout the year, consistent wind which blows sand and dirt on to the roof membrane, and constant exposure to the sun are contributing factors to wear and deterioration. The current roofing system was installed in 1993. It is recommended that this building be re-roofed in the next 2 - 3 years to be consistent with the roofing program and the end of the warranty period.</p> <p>This project or a portion thereof was previously recommended in the FCA report dated 7/10/2003 and 3/9/2010. It has been amended accordingly to reflect conditions observed during the most recent survey date of 4/4/2023.</p>	7400	SF	\$155,400.00	\$ 21.00

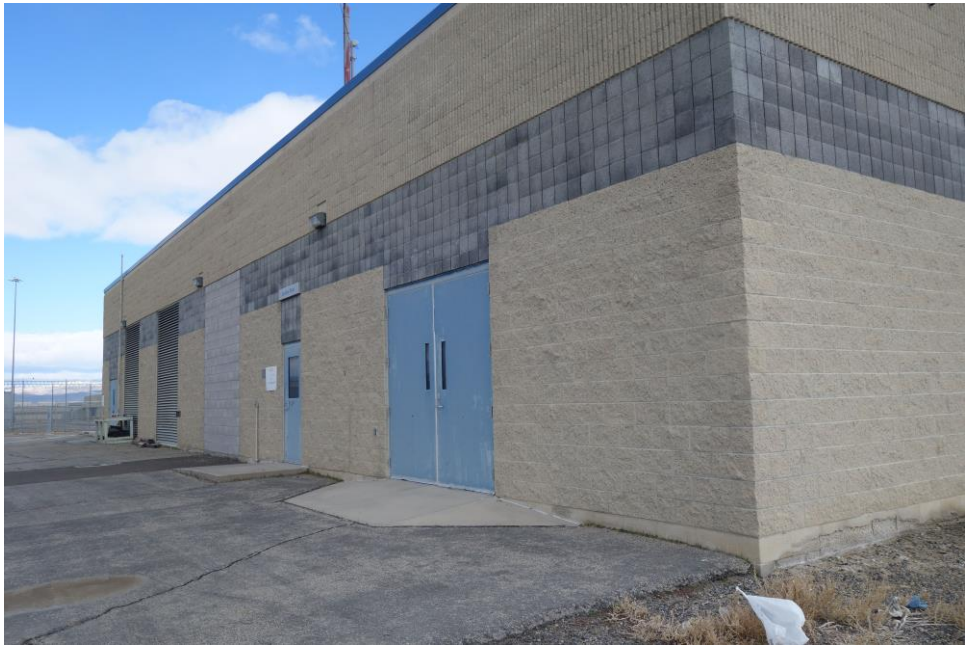
QUANTITY	UNITS	TOTAL	SF COST
The exterior finishes were in fair condition with all exterior metal finishes in need of re-painting. It is important to maintain the finish, weather resistance and appearance of the building. This project would provide funding to protect the exterior of the building. Included in the cost are cleaning and sealing the concrete masonry walls, painting the window frames and flashing and caulking the windows, flashing, fixtures and all other penetrations. It is recommended that the building be sealed, painted and caulked in the next 4 - 6 years and that this project be scheduled on a cyclical basis to maintain the integrity of the structure.	7400	SF	\$37,000.00	\$ 5.00

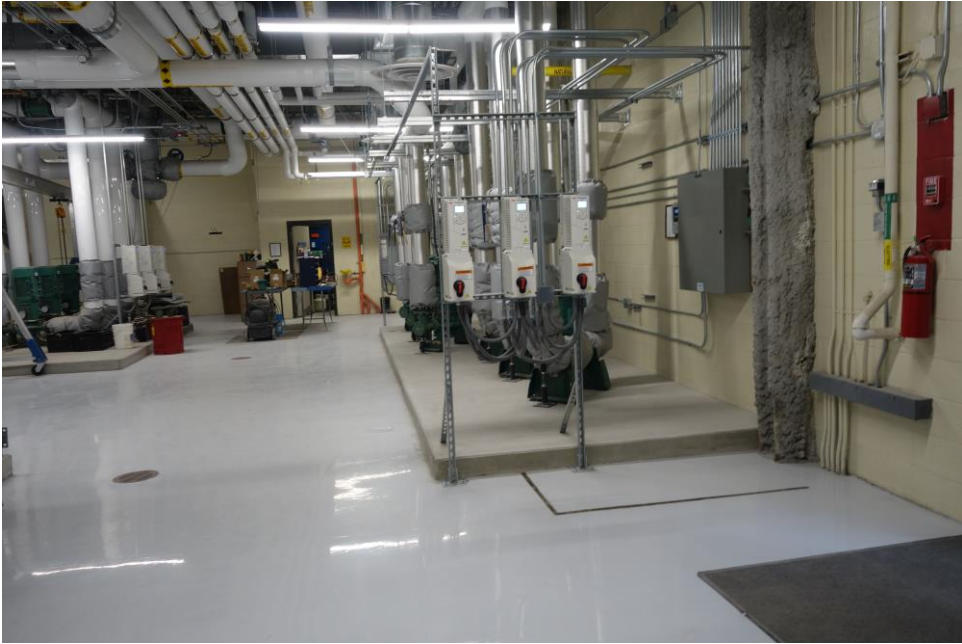
QUANTITY	UNITS	TOTAL	SF COST
The interior finishes are in good condition. This project would provide funding to maintain the interior of the building. Included in the cost is painting the walls and ceilings, sealing the exposed masonry, repairing cracks in the masonry and replacing grout and caulk as needed. An epoxy-based paint should be utilized in wet areas for durability. It is recommended that the interior of the building be painted, sealed and repaired in the next 7 - 9 years and that this project be scheduled on a cyclical basis to maintain the integrity of the structure.	7400	SF	\$37,000.00	\$ 5.00

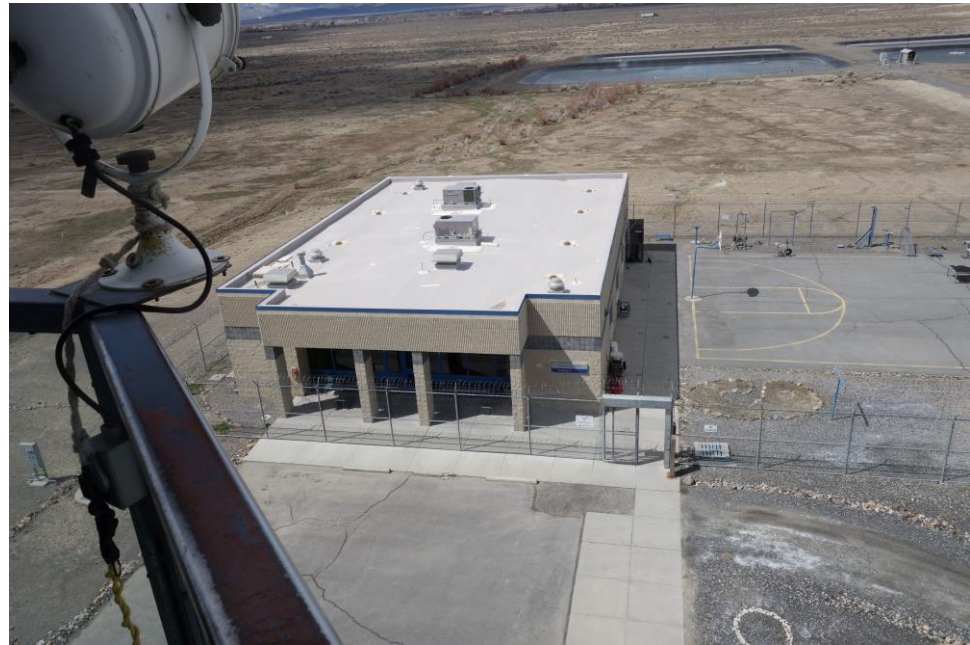
The roof on this building is original construction and has reached the end of its useful life. The statewide roofing program has set the useful life of an average roof at 20 years. The roof warranty expires at the end of the same time frame. The temperature fluctuations throughout the year, consistent wind which blows sand and dirt on to the roof membrane, and constant exposure to the sun are contributing factors to wear and deterioration. The current roofing system was installed in 1993. It is recommended that this building be re-roofed in the next 2 - 3 years to be consistent with the roofing program and the end of the warranty period.

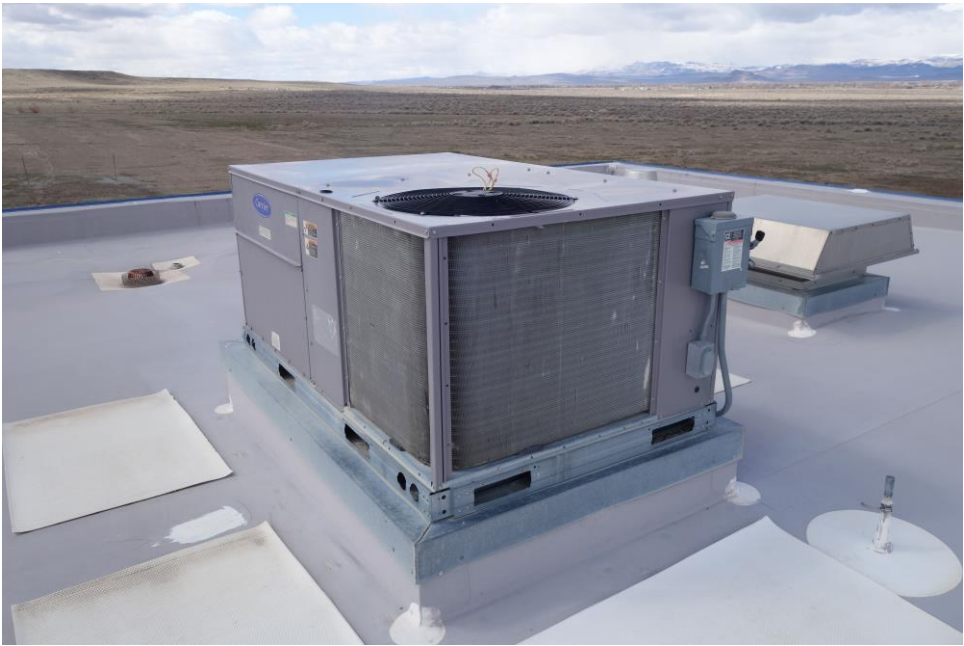
QUANTITY	UNITS	TOTAL	SF COST
The building is conditioned by two rooftop units (RTU's). One was replaced in 2016 and in good working order. The other is older and is reaching the end of its useful life. The R-22 refrigerant in the cooling system is no longer EPA compliant and its production was phased out completely January 1, 2020. This project would provide for installation of a new RTU and cleaning the existing duct work and grilles. This project includes removal and disposal of the existing HVAC system and all required connections to utilities.	1	PKG	\$45,000.00	\$ 12.00

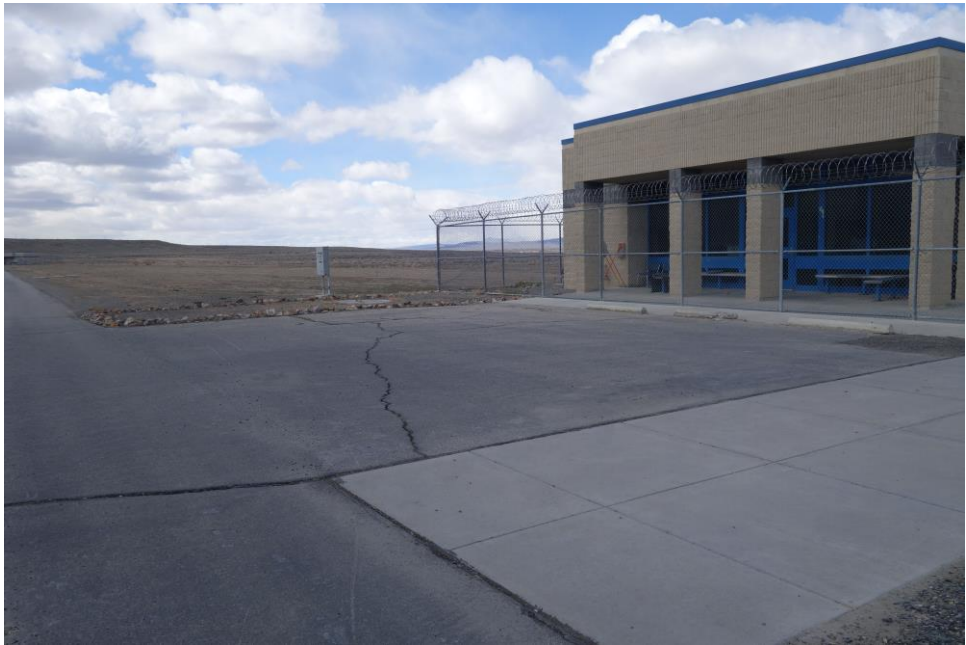
QUANTITY	UNITS	TOTAL	SF COST
The exterior finishes were in fair condition. It is important to maintain the finish, weather resistance and appearance of the building. This project would provide funding to protect the exterior of the building. Included in the cost are cleaning and sealing the concrete masonry walls, painting the window frames and flashing and caulking the windows, flashing, fixtures and all other penetrations. It is recommended that the building be sealed, painted and caulked in the next 6 - 8 years and that this project be scheduled on a cyclical basis to maintain the integrity of the structure.	3700	SF	\$18,500.00	\$ 5.00

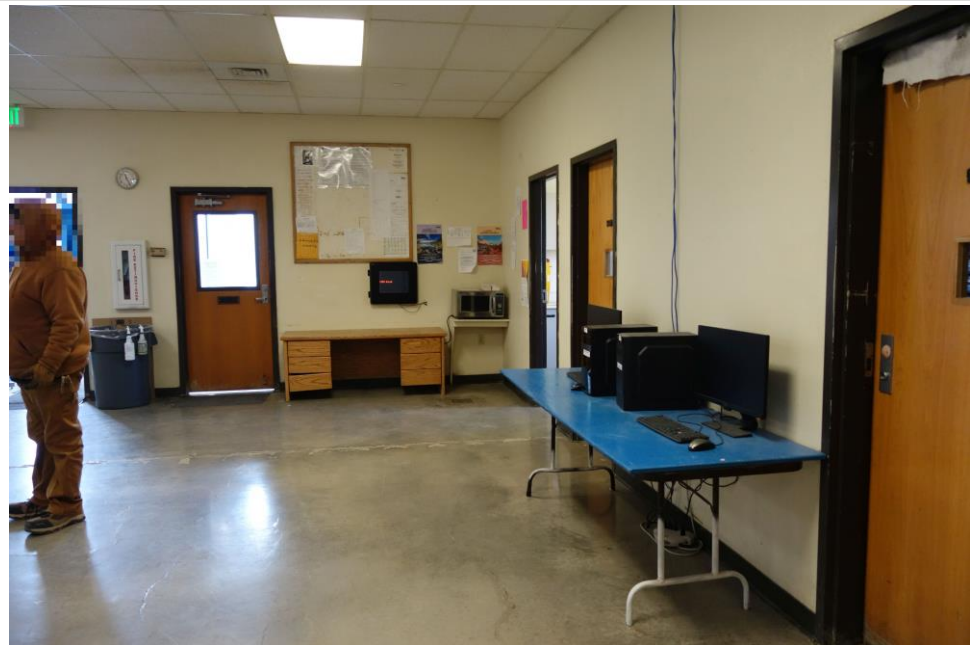
QUANTITY	UNITS	TOTAL	SF COST
The interior finishes are in fair condition. It is recommended that the interior walls and ceilings be painted at least once in the next 4 - 6 years. Prior to painting, all surfaces should be repaired and prepped. An epoxy-based paint should be utilized in wet areas for durability.	3700	SF	\$18,500.00	\$ 5.00

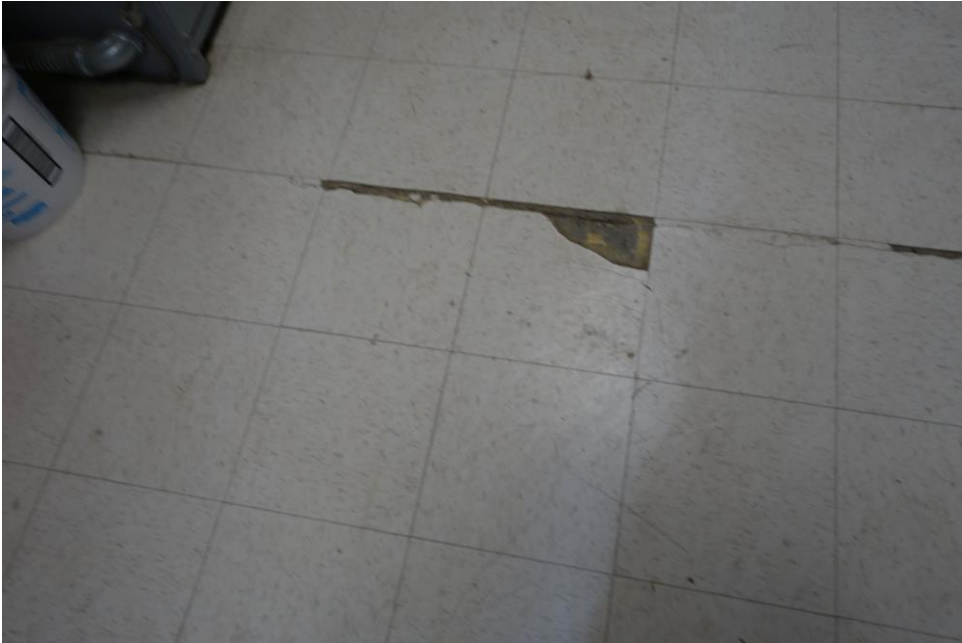
QUANTITY	UNITS	TOTAL	SF COST
The VCT (vinyl composite tile) in the building is damaged and reaching the end of their useful life. It is recommended that the flooring be replaced. This project would provide for removal and disposal of the existing flooring and installation of new 12x12 VCT with a 4" base in the next 2 - 3 years.	1275	SF	\$18,200.00	\$ 14.00

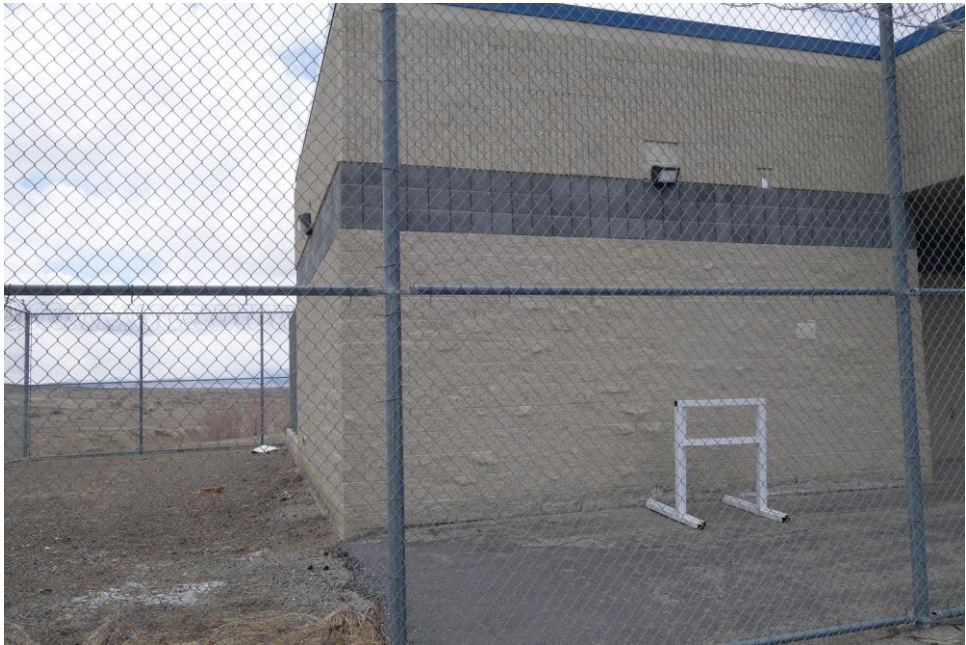
QUANTITY	UNITS	TOTAL	SF COST
The exterior finishes were in fair condition. It is important to maintain the finish, weather resistance and appearance of the building. This project would provide funding to protect the exterior of the building. Included in the cost are cleaning and sealing the concrete masonry walls, painting the flashing and caulking the flashing, fixtures and all other penetrations. It is recommended that the building be sealed, painted and caulked in the next 2 - 3 years and that this project be scheduled on a cyclical basis to maintain the integrity of the structure.	1275	SF	\$ 8,900.00	\$ 7.00

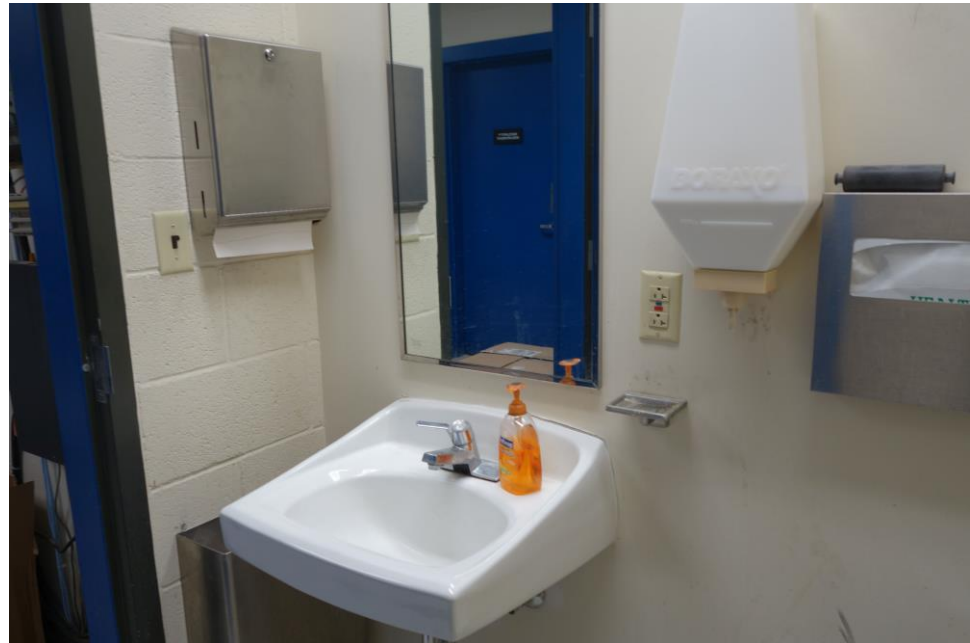
QUANTITY	UNITS	TOTAL	SF COST
The interior finishes are in fair condition. It is recommended that the interior walls and ceilings be painted at least once in the next 4 - 6 years. Prior to painting, all surfaces should be repaired and prepped. An epoxy-based paint should be utilized in wet areas for durability.	1275	SF	\$ 6,375.00	\$ 5.00

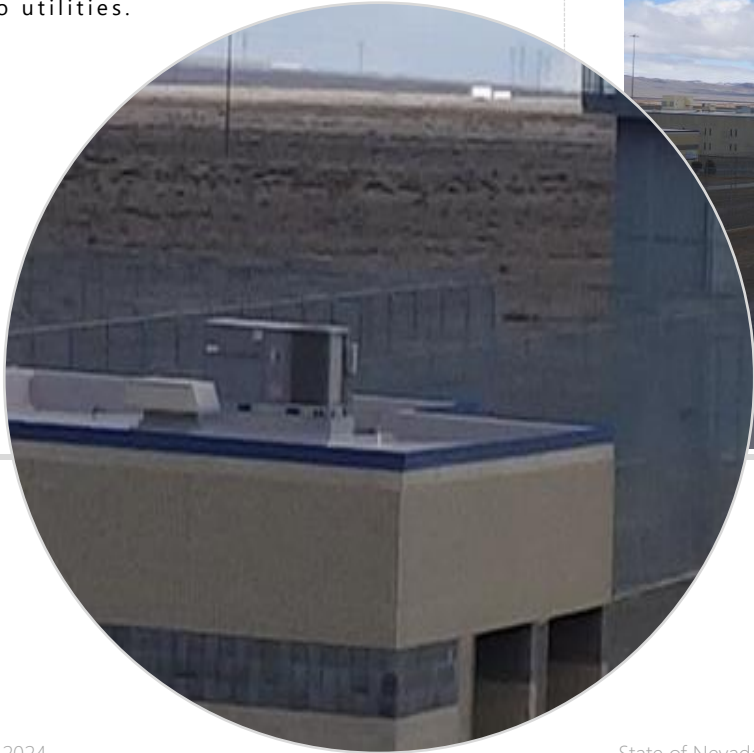
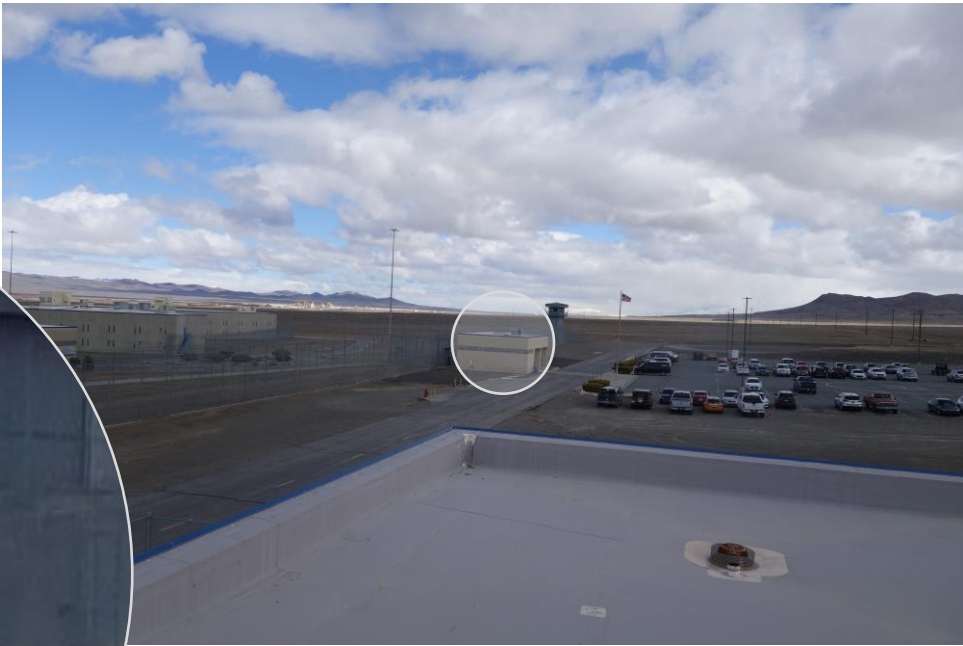
QUANTITY	UNITS	TOTAL	SF COST
The building is conditioned by a single rooftop unit (RTU's). It is older and reaching the end of its useful life. The R-22 refrigerant in the cooling system is no longer EPA compliant and its production was phased out completely January 1, 2020. This project would provide for installation of a new RTU and cleaning the existing duct work and grilles. This project includes removal and disposal of the existing HVAC system and all required connections to utilities.	1	PKG	\$45,000.00	\$ 30.00

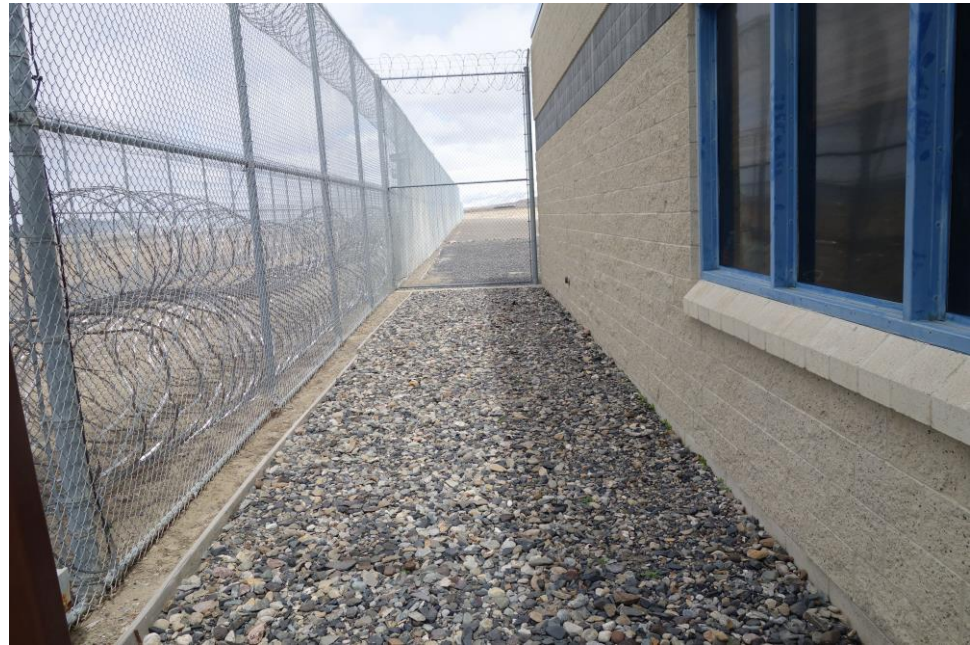
It is important to maintain the finish, weather resistance and appearance of the building. This project would provide funding to protect the exterior of the building. Included in the cost are cleaning and sealing the concrete masonry walls, painting the window frames and flashing and caulking the windows, flashing, fixtures and all other penetrations. It is recommended that the building be sealed, painted and caulked in the next 6 - 8 years and that this project be scheduled on a cyclical basis to maintain the integrity of the structure.

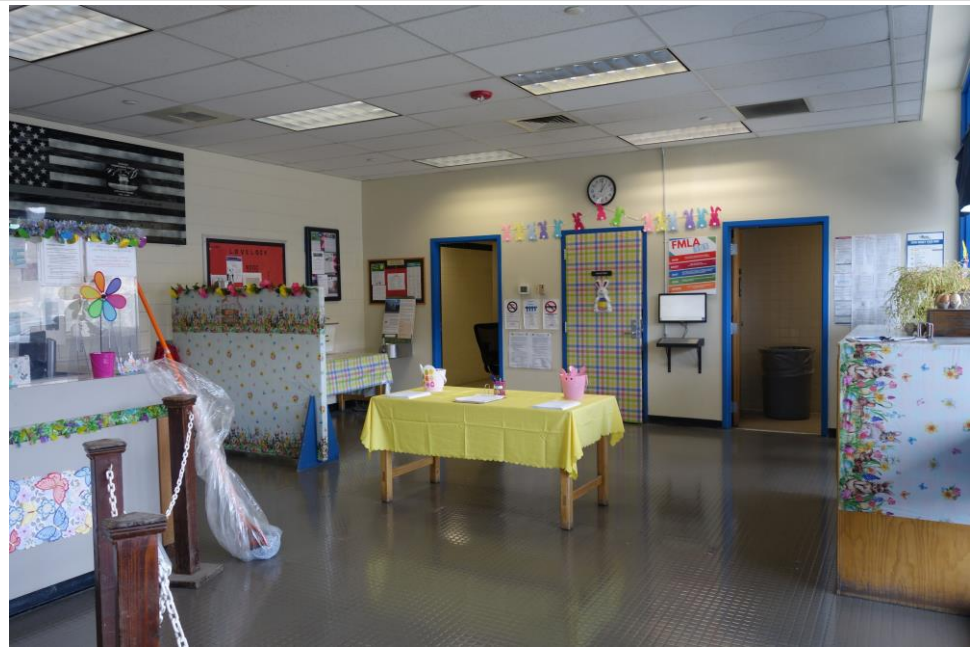
QUANTITY	UNITS	TOTAL	SF COST
The interior finishes are in fair condition. It is recommended that the interior walls and ceilings be painted at least once in the next 4 - 6 years. Prior to painting, all surfaces should be repaired and prepped. An epoxy-based paint should be utilized in wet areas for durability.	1515	SF	\$10,600.00	\$ 7.00
