# STATE OF NEVADA STATE PUBLIC WORKS DIVISION

FACILITY CONDITION ASSESSMENT REPORT FOR:

DEPT OF CORRECTIONS  
LOVELOCK CORRECTIONAL CENTER

Survey Date: 4/04/2023  
Distribution Date: 11/20/2024

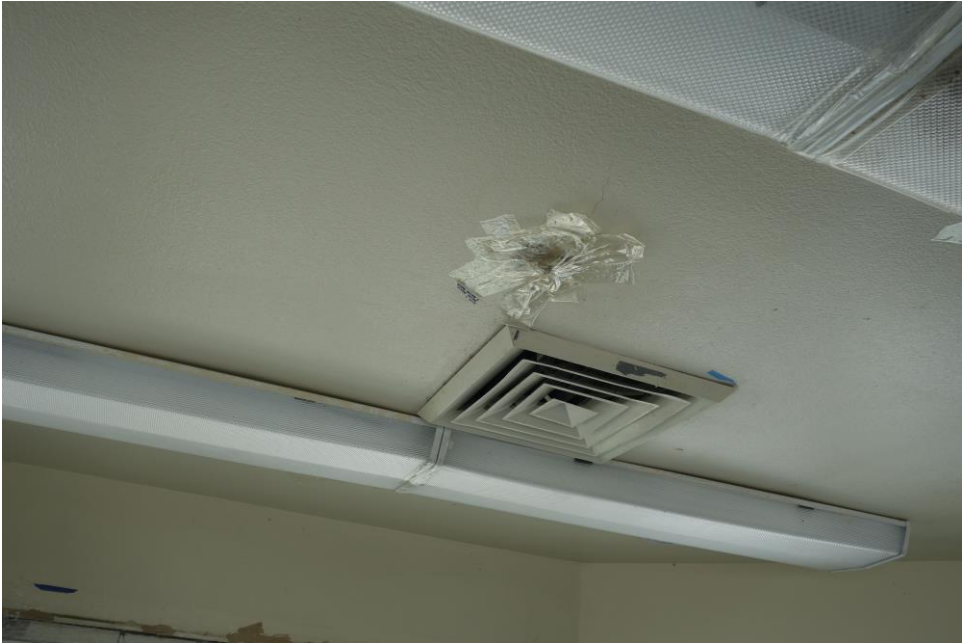
QUANTITY	UNITS	TOTAL	SF COST
The Guard Tower interiors are original 1993 construction, over 30 years old and in need of a complete refurbishment. The recommended improvements include plumbing & sewer, HVAC, window replacement, sliding door, spot lights, electronic locking mechanism, insulation, any structural reinforcement of the floor, interior finishes and flooring.	1	PKG	\$405,000.00	\$ 1,007.00

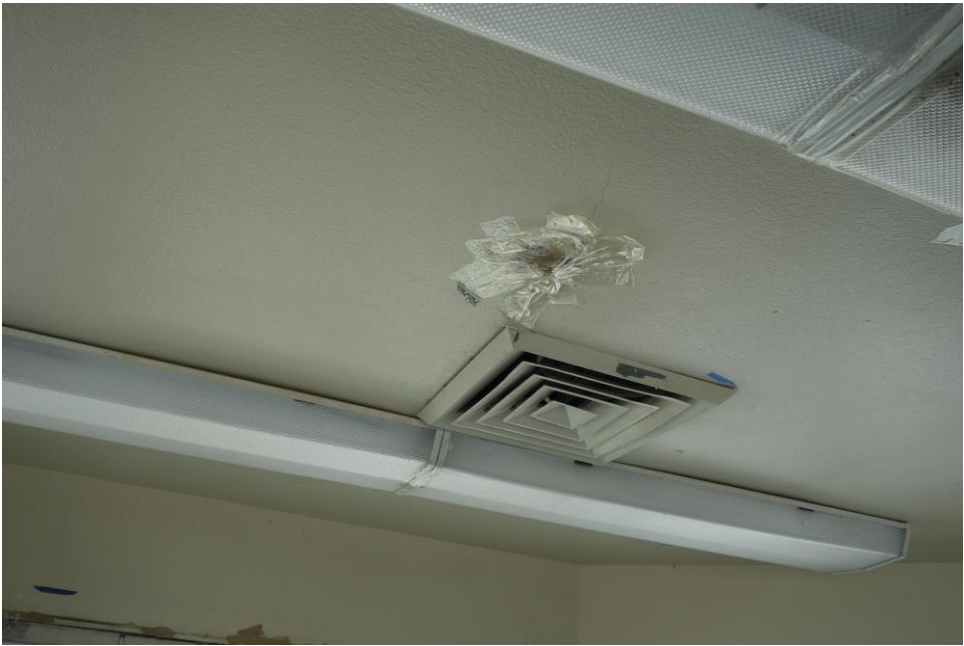
QUANTITY	UNITS	TOTAL	SF COST
The Guard Tower interiors are original 1993 construction, over 30 years old and in need of a complete refurbishment. The recommended improvements include plumbing & sewer, HVAC, window replacement, sliding door, spot lights, electronic locking mechanism, insulation, any structural reinforcement of the floor, interior finishes and flooring. In addition, due to roof leaks, a single ply membrane overly of the existing roofing is included in this estimate.	1	PKG	\$405,000.00	\$ 1,007.00

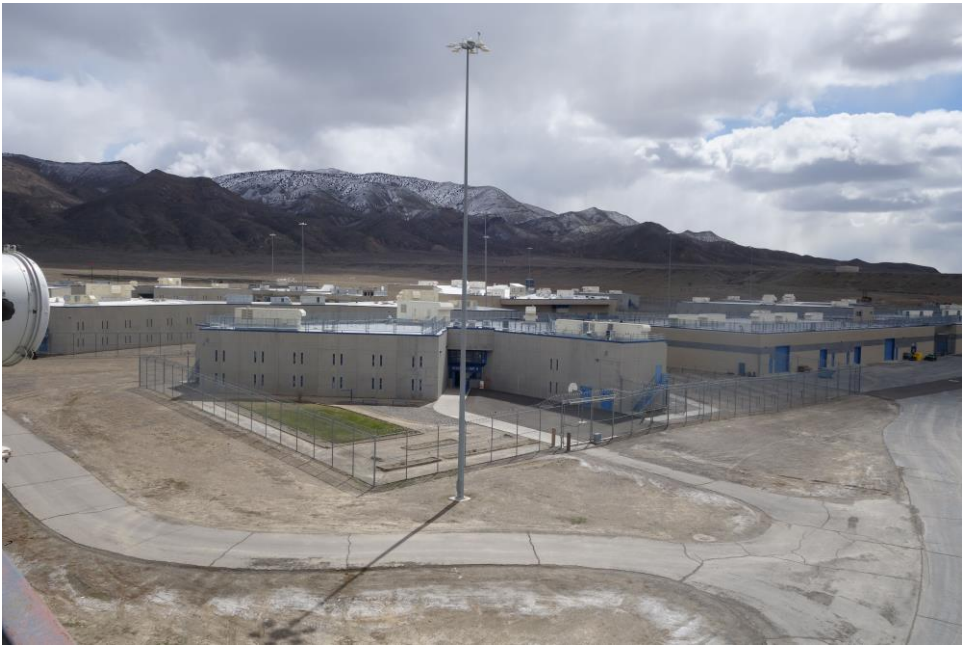
QUANTITY	UNITS	TOTAL	SF COST
The HVAC equipment is approaching 30 years of operation and has reached the end of it's serviceable life. This project recommends replacement of the air handling units, furnaces with remote condensing units and exhaust fans in the next 2 - 3 years.	1	PKG	\$2,179,700.00	\$ 95.00

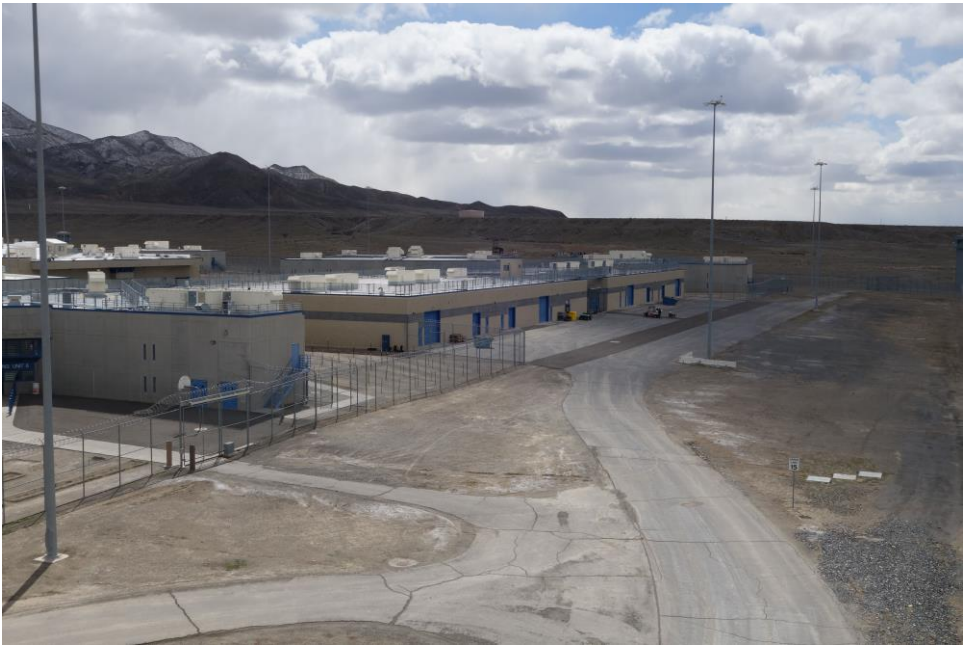
QUANTITY	UNITS	TOTAL	SF COST
The exterior finishes were in fair condition. It is important to maintain the finish, weather resistance and appearance of the building. This project would provide funding to protect the exterior of the building. Included in the cost are cleaning and sealing the concrete walls, painting the window frames and flashing and caulking the windows, flashing, fixtures and all other penetrations. It is recommended that the building be sealed, painted and caulked in the next 6 - 8 years and that this project be scheduled on a cyclical basis to maintain the integrity of the structure.	23000	SF	\$46,000.00	\$ 2.00

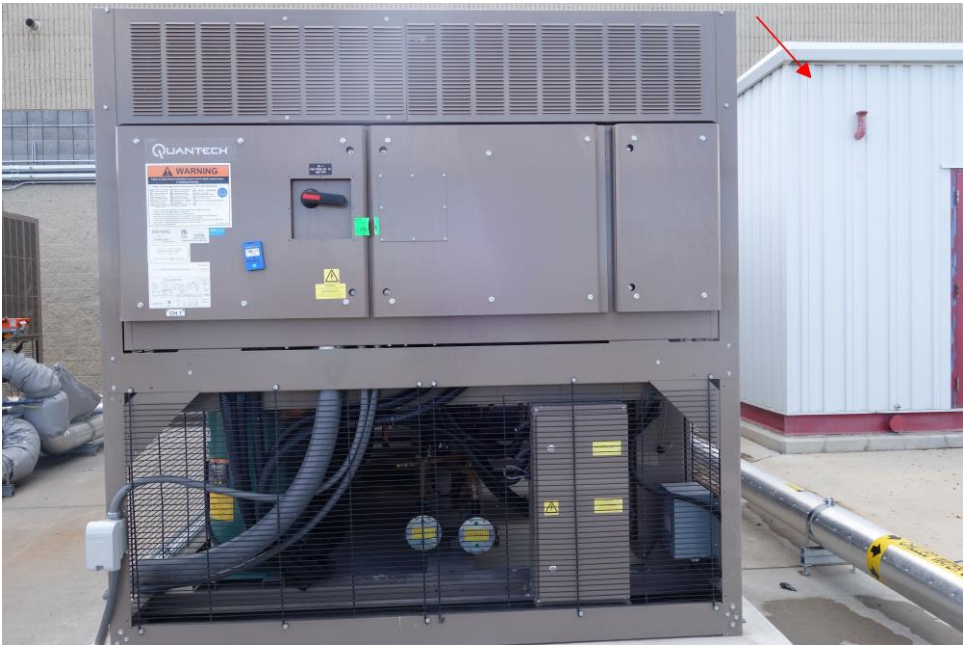
EXTERIOR FINISHES

QUANTITY	UNITS	TOTAL	SF COST
The exterior finishes were in good condition. It is important to maintain the finish, weather resistance, and appearance of the building. This project would provide funding to protect the exterior of the building. Included in the cost is the caulking and sealing of the flashing, fixtures, and all other penetrations. It is recommended that the building be caulked and sealed in the next 7 - 9 years and that this project be scheduled on a cyclical basis to maintain the integrity of the structure.	192	SF	\$ 1,900.00	\$ 10.00

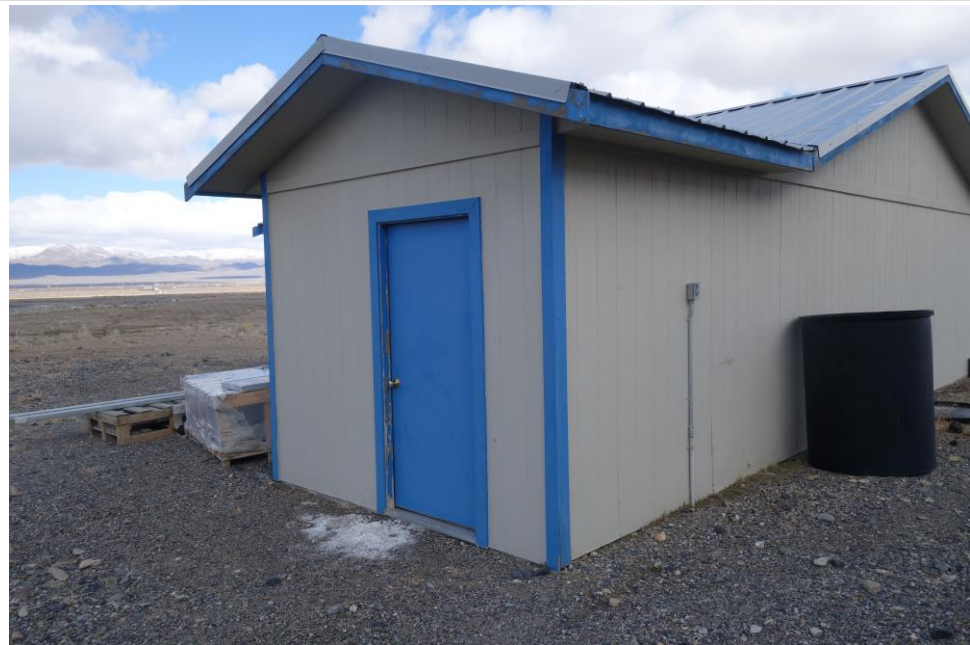
### EXTERIOR FINISHES

QUANTITY	UNITS	TOTAL	SF COST
The exterior finishes are in poor condition. It is important to maintain the finish, weather resistance, and appearance of the building. This project would provide funding to protect the exterior of the building. Included in the cost is sanding, priming, painting, and caulking of the flashing, fixtures, and all other penetrations. It is recommended that the building be painted in the next 2 - 3 years and that this project be scheduled on a cyclical basis to maintain the integrity of the structure.	676	SF	\$ 6,800.00	\$ 10.00

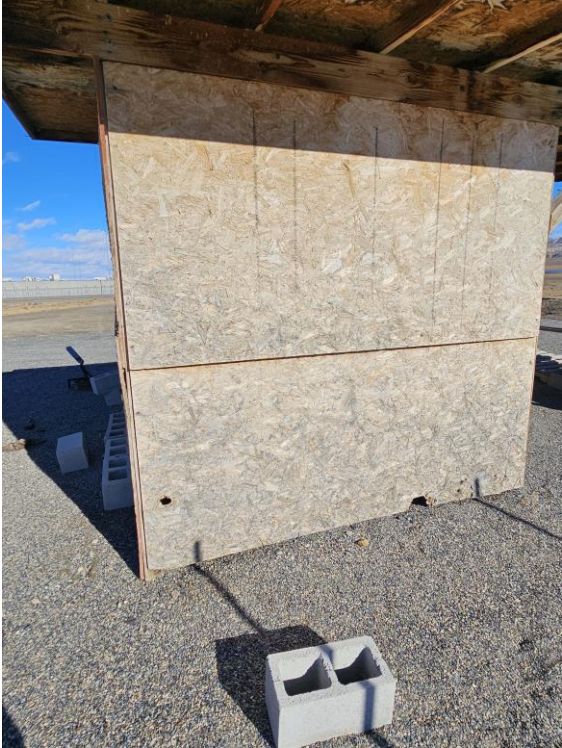
EXTERIOR FINISHES

QUANTITY	UNITS	TOTAL	SF COST
The exterior finishes were in poor condition. It is important to maintain the finish, weather resistance and appearance of the building. The wood posts, plywood cladding and fascia are all unpainted. It is recommended that the building be painted in the next 2 - 3 years and that this project be scheduled on a cyclical basis to maintain the integrity of the structure.	1	PKG	\$ 5,000.00	\$ 16.00

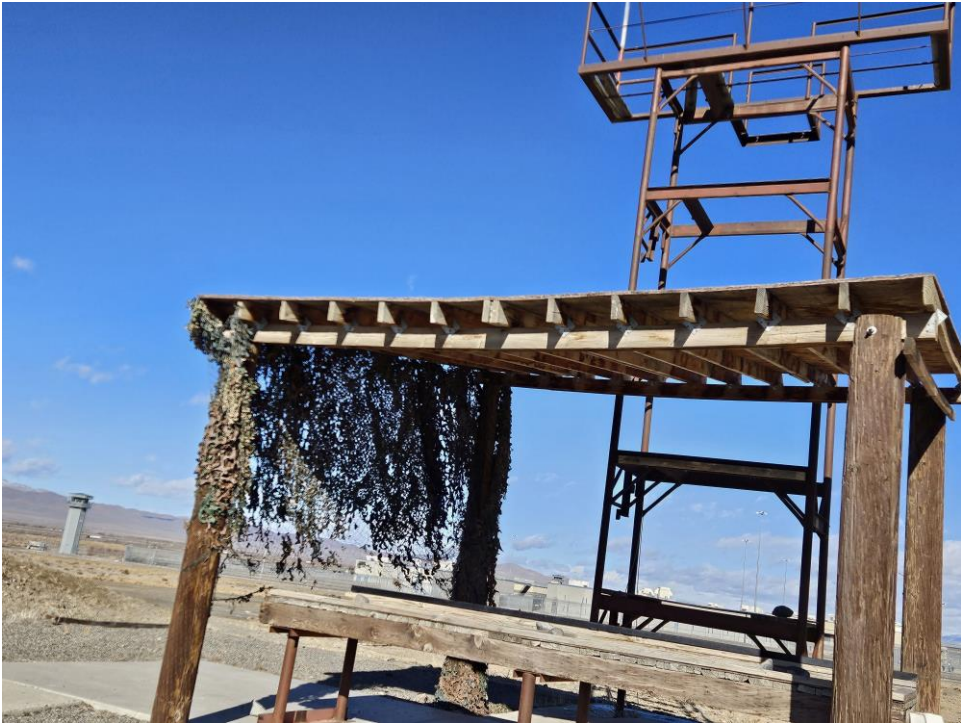
SHADE STRUCTURE REPLACEMENT

The shade structure is failing and in poor condition. The beams supporting the roof structure are sagging, there is no roofing protecting the roof sheeting. The rifle bench is severely weathered and deteriorating. The entire structure should be demolished and replaced with a new pre-engineered shade structure and bench rest tables.
