STATE OF NEVADA
STATE PUBLIC WORKS DIVISION

FACILITY CONDITION ASSESSMENT REPORT FOR:

DEPT OF TOURISM & CULTURAL AFFAIRS
MUSEUMS & HISTORY
MUSEUMS
LOSTCITY

Survey Date: 2/7/2023
Distribution Date: 8/15/2023

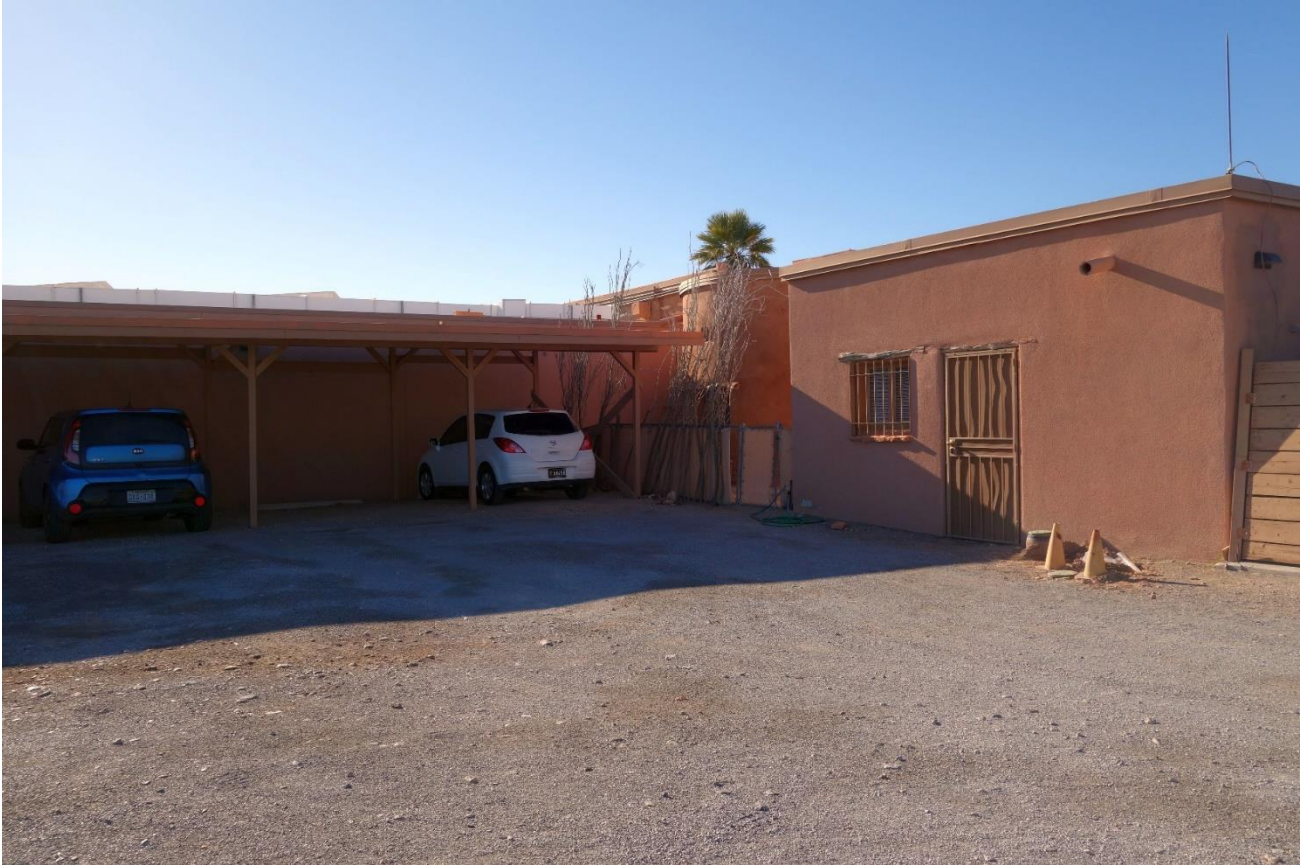
The Museum Carport is a wood post and beam structure with a single-ply roofing system. The roof was replaced in 2014. It is located along the north side of the museum and is in good shape.

The exterior finishes are in good condition. It is important to maintain the finish, weather resistance and appearance of the structure. This project would provide for painting of the structure, and it is recommended that this project is scheduled on a cyclical basis to maintain the integrity of the structure.

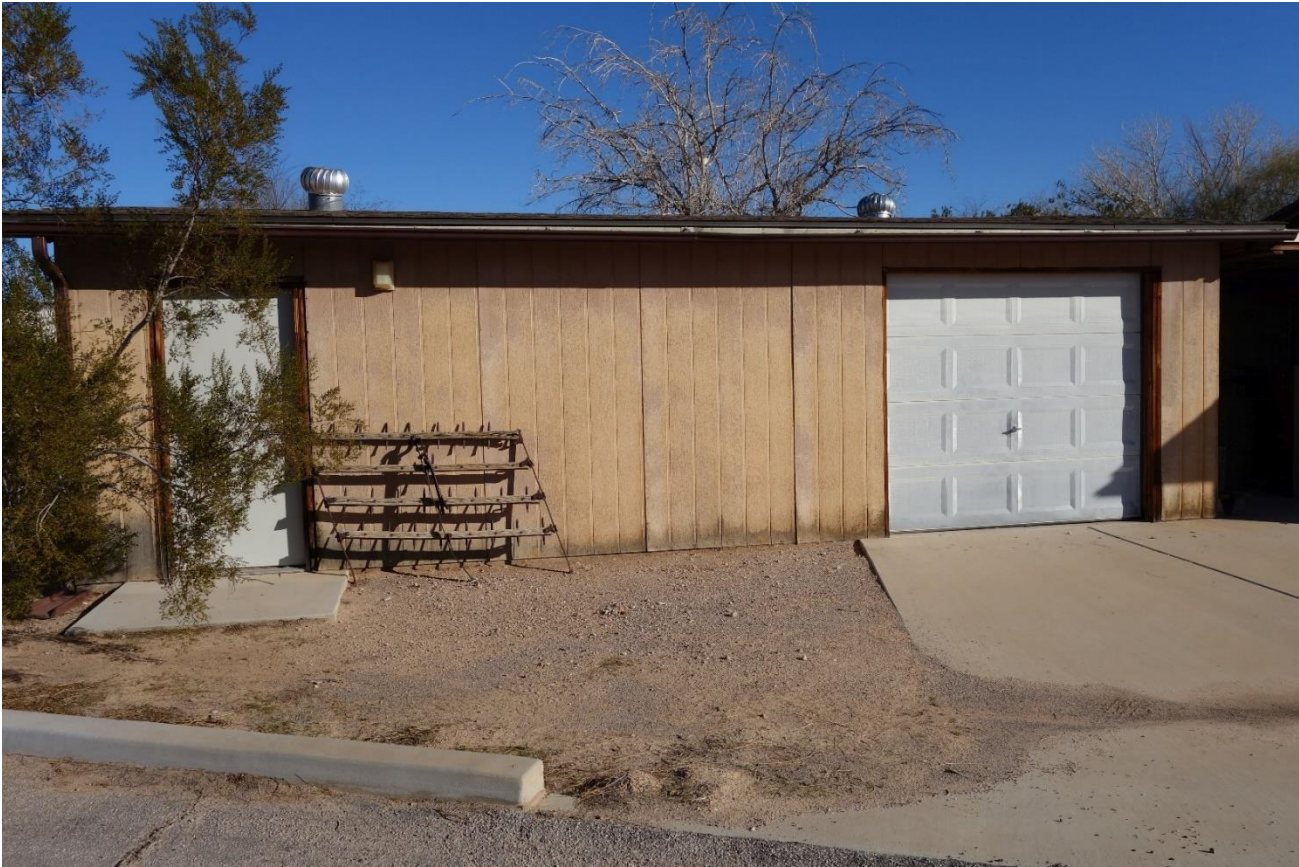
The Lost City Storage Building is a wood framed structure with an asphalt composition roofing system on a concrete foundation.

The roofing system was replaced in 2014.

The exterior finishes were in poor condition. It is important to maintain the finish, weather resistance and appearance of the building. This project would provide funding to protect the exterior of the building excluding the roof. Included in the cost is sanding, priming and painting and caulking of the windows, flashing, fixtures and all other penetrations. It is recommended that the building be painted in the next 2 - 4 years and that this project is scheduled on a cyclical basis to maintain the integrity of the structure.

The building has a painted masonite siding that is due for replacement. The existing siding is in poor condition and will no longer hold paint. This project recommends removing the masonite siding and replacing it with T1-11 panels finished with an oil-based stain.

There are continuous locations on the building perimeter where soils are in contact with wood and siding materials. 2018 IBC Section 2304.12 Protection Against Decay and Termites requires a minimum of 8" clearance between the earth and wood structural members. This project provides for the removal of excess soil and to provide the required soil clearances.

This project should be implemented concurrently with the Exterior Siding Replacement project.

This project should be implemented concurrently with the Exterior Finishes project. This project or a portion thereof was previously recommended in the FCA report dated 11/04/2009 and 01/29/2014. It has been amended accordingly to reflect conditions observed during the most recent survey date of 02/07/2023.

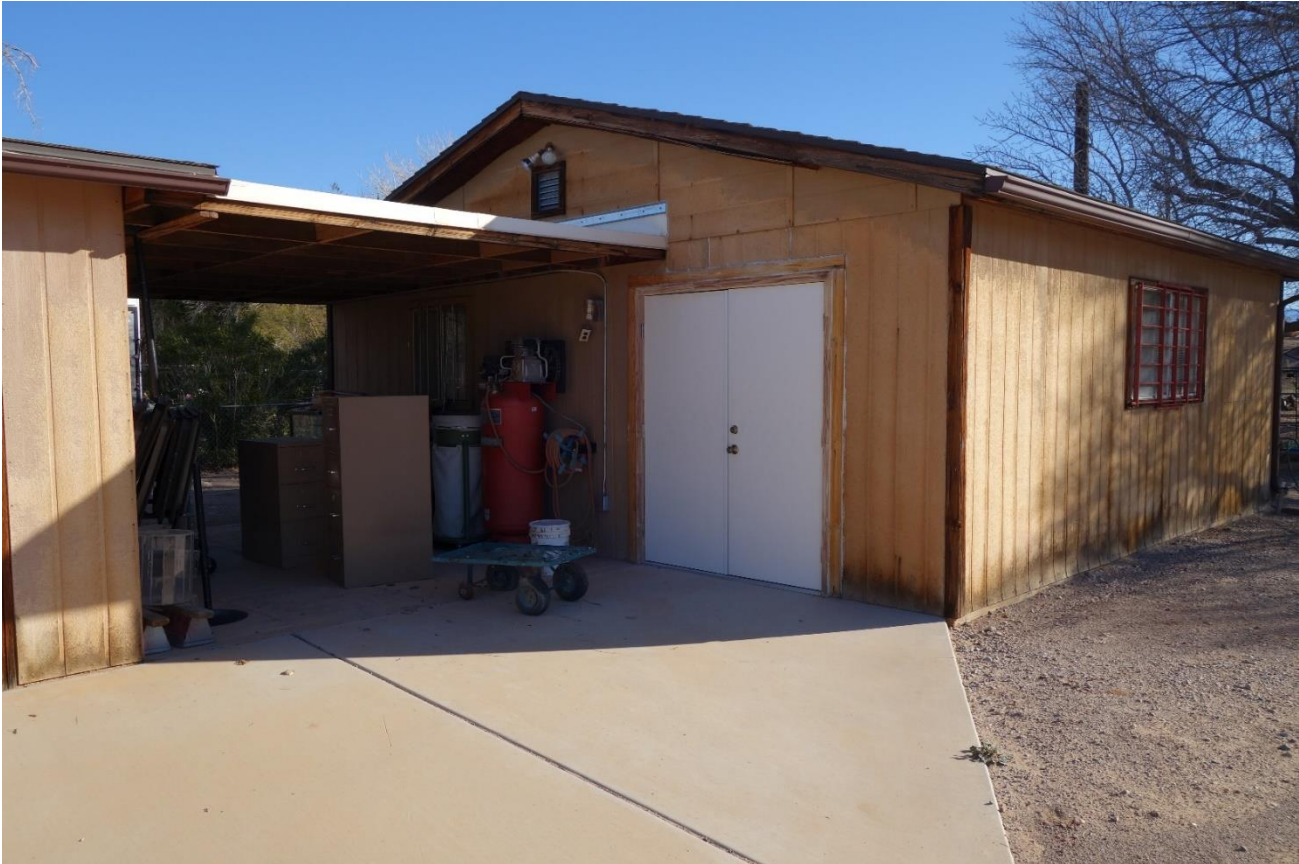
The Lost City Museum Workshop is a wood framed structure with an asphalt composition roofing system on a concrete foundation. The roofing system was replaced in 2014. There is a wood working area with a dust extraction system which is in good working order.

The electrical panel at this facility is recognized as a potential hazard. Sylvania Zinsco and Federal Pacific Stab-Loc panels were part of a recall and should be replaced. This project would provide funding for the removal and replacement of the Zinsco electrical panel.

One of the two exterior wood man doors appear to be original to the building. They are damaged from age and general wear and tear. This project would provide for the replacement of the wood doors with new metal doors, frames and hardware. Removal and disposal of the existing doors and painting of the new doors is included in this estimate. This project or a portion thereof was previously recommended in the FCA reports dated 01/29/2023. It has been amended accordingly to reflect conditions observed during the most recent survey date of 02/07/2023.

The exterior finishes were in very poor condition. It is important to maintain the finish, weather resistance and appearance of the building. This project would provide funding to protect the exterior of the building excluding the roof. Included in the cost is sanding, priming and painting and caulking of the windows, flashing, fixtures and all other penetrations. It is recommended that the building be painted in the next 2 - 4 years and that this project is scheduled on a cyclical basis to maintain the integrity of the structure.

The shop has a painted masonite siding that is due for replacement. The existing siding is in poor condition and will no longer hold paint. This project recommends removing the masonite siding and replacing it with T1-11 panels finished with an oil-based stain.

The windows are original, single pane construction in metal frames. These older windows are drafty and not energy efficient. This project recommends replacing the windows with dual pane, higher efficiency units. This estimate is for the replacement of 3 units. Removal and disposal of the existing windows is included in this estimate. This project or a portion thereof was previously recommended in the FCA report dated 01/29/2014. It has been amended accordingly to reflect conditions observed during the most recent survey date of 02/07/2023.

This project should be implemented concurrently with the Exterior Siding Replacement project.

This project should be implemented concurrently with the Exterior Finishes project. This project or a portion thereof was previously recommended in the FCA report dated 11/04/2009 and 01/29/2014. It has been amended accordingly to reflect conditions observed during the most recent survey date of 02/07/2023.

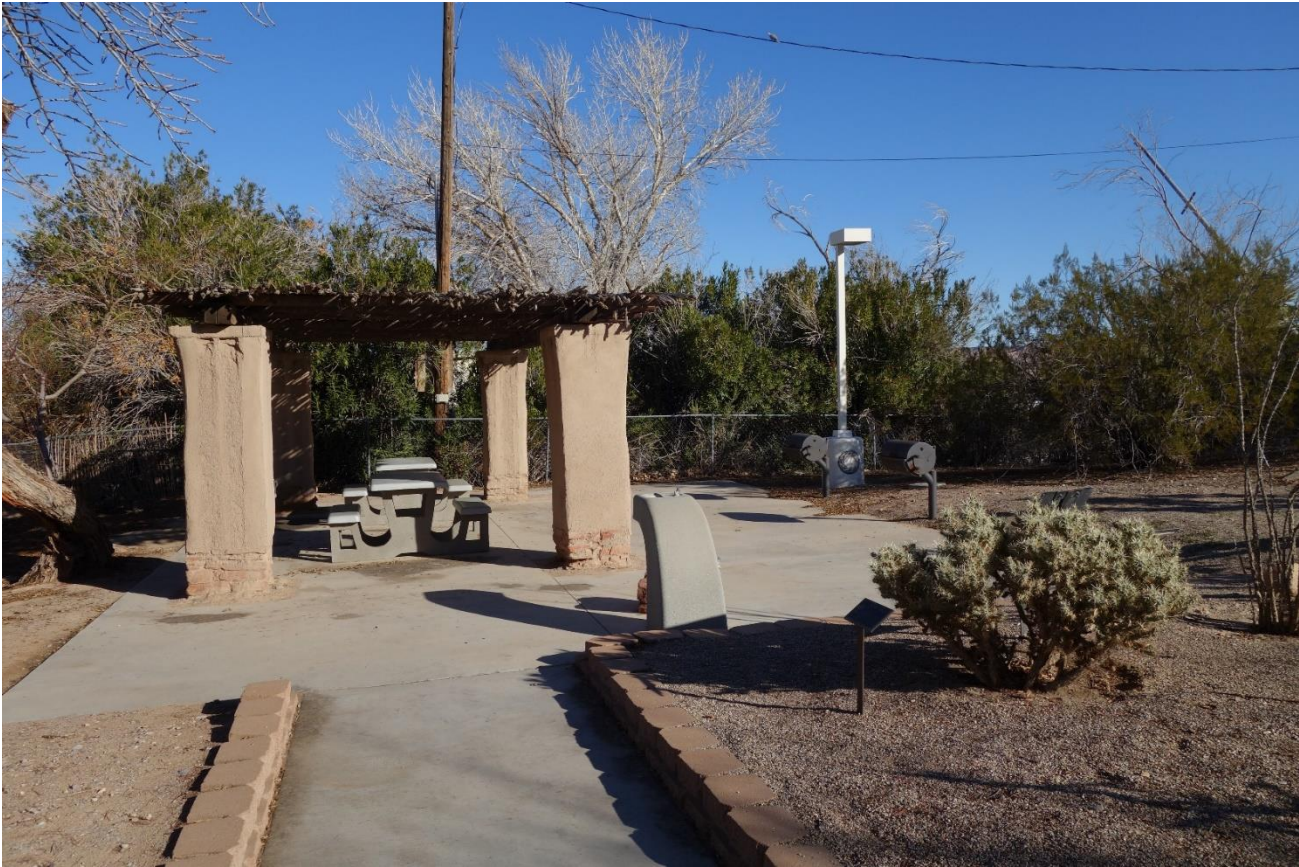
The Lost City Museum Ramada is a wood framed structure with adobe style columns and has an ocotillo lath roof for shade. It is located in the picnic area and has an ADA accessible route to parking in the lower parking lot.

It is important to maintain the finish, weather resistance and appearance of the structure. This project would provide for repairing the adobe coating, sealing and staining the wood beams and refurbishing the ocatillo branch shade material. It is recommended that this project is scheduled on a cyclical basis to maintain the integrity of the structure.

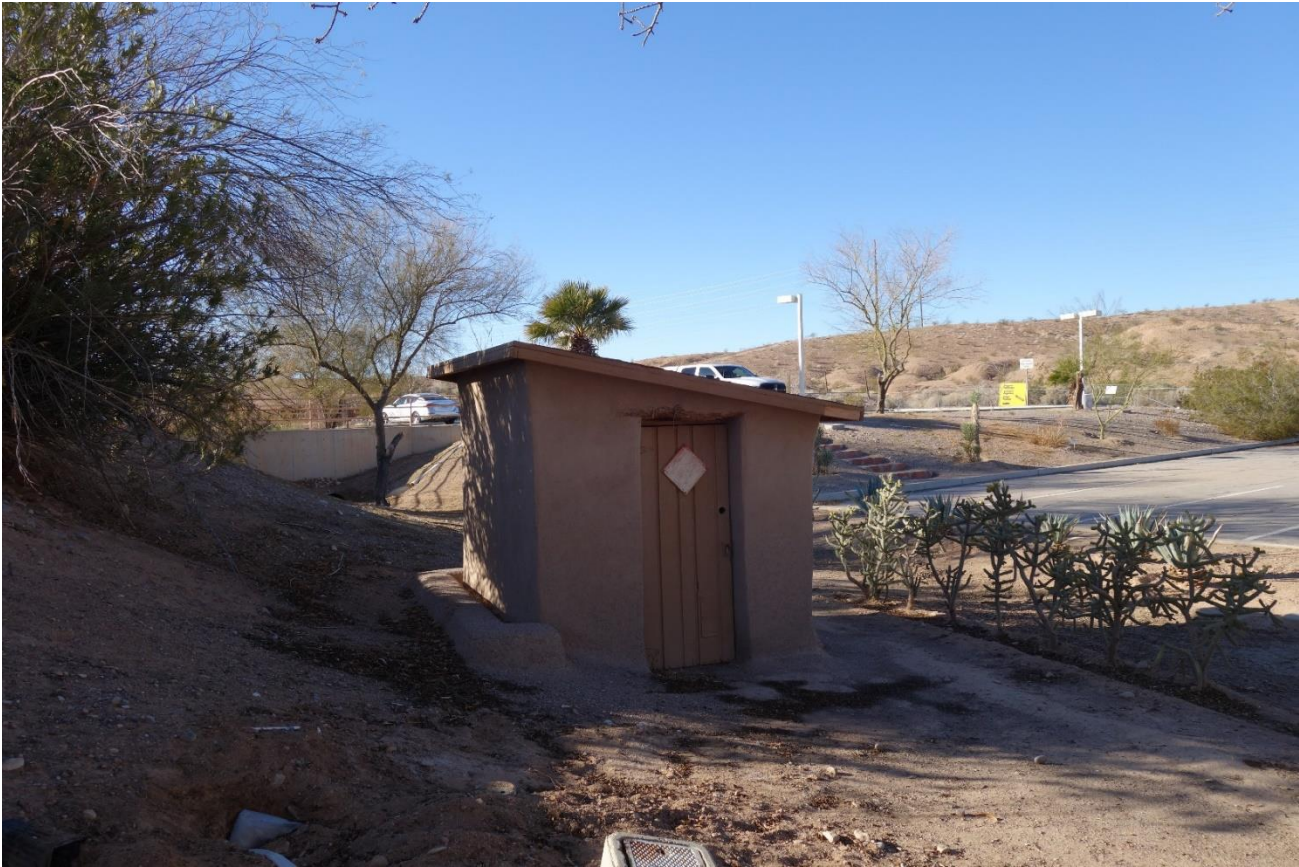
The Lost City Pump House is an adobe and wood framed structure with a composition roofing system. The site has been connected to municipal water, so the structure is currently used for storage.

The exterior finishes were in good condition with the exception of the roof fascia. It is important to maintain the finish, weather resistance and appearance of the building. This project would provide funding to replace or refinish the roof fascia that is cracked and weathered. Included in the cost is repairing the cracks and applying a new layer of adobe coating over the masonry. It is recommended that the building be repaired in the next 6 - 8 years and that this project be scheduled on a cyclical basis to maintain the integrity of the structure.
