STATE OF NEVADA  
STATE PUBLIC WORKS DIVISION

FACILITY CONDITION ASSESSMENT REPORT FOR:

DEPT OF CORRECTIONS  
THREE LAKES VALLEY CONSERVATION CAMP

Survey Date: 4/19/2022  
Distribution Date: 8/24/2023

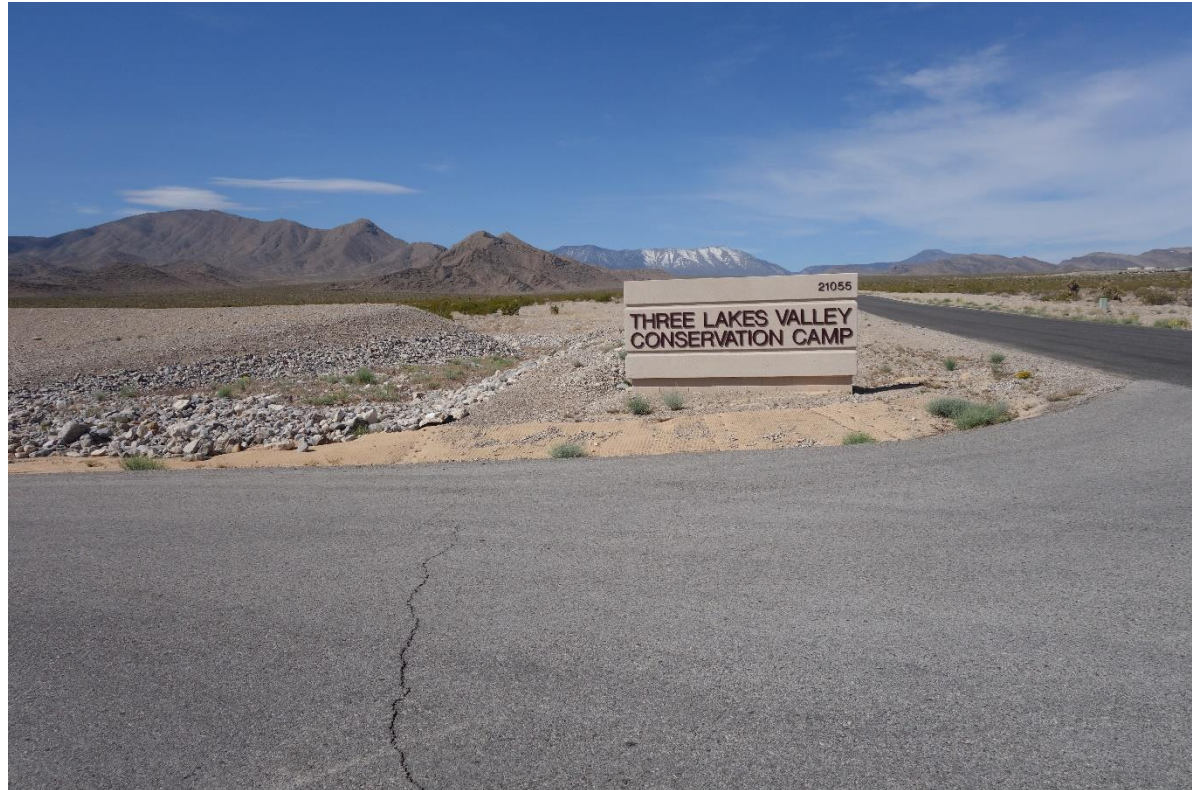
**9967 THREE LAKES VALLEY CONSERVATION CAMP**

It is important to maintain the asphalt concrete paving on the site. This project would provide for minor crack filling and sealing of the paving site wide including access roads, parking areas and the maintenance yard. Striping is included in this estimate. This project should be scheduled on a 5-year cyclical basis to maintain the integrity of the paving and prevent premature failure. 415,000 square feet of asphalt area was used to generate this estimate.

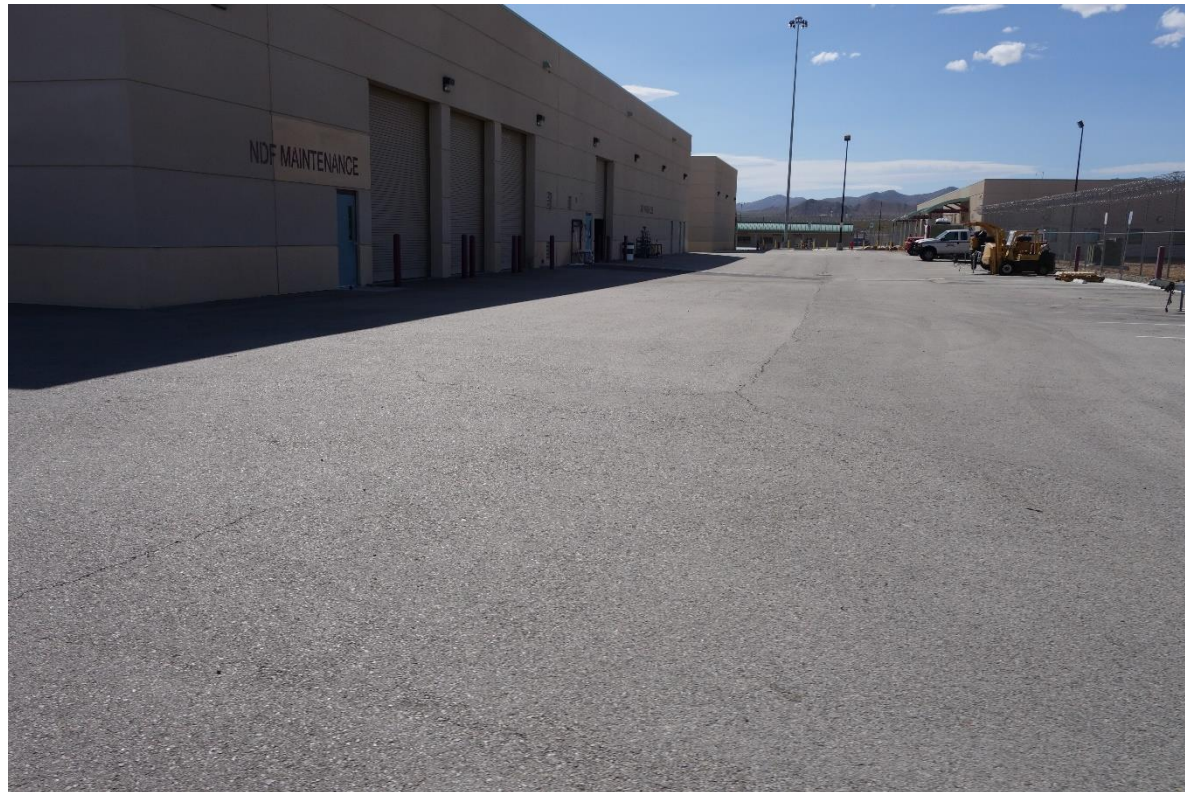
**3093 NDF OFFICE/SHOP E**

A visual survey of the two evaporatively cooled air handling units (AHU's) are failing prematurely and reducing their expected life. Lack of maintenance has caused the heating coil to plug with mineral scale due to moisture carry-over from the evaporative cooling section. Moisture carry-over is indicative of air velocities well above the unit specifications caused by a lack of air balance. The severe degree of scaling renders coil cleaning ineffective and a complete replacement of the heating coil is recommended.

showing signs of corrosion likely caused by the same moisture carry-over. This project will fund the removal and replacement of the heating coils, a full AHU maintenance rehabilitation, new blow-down controls on the evaporative sump, water treatment (Nu-Calgon slow dissolving scale and corrosion inhibitor) and air balance. With proper maintenance, this project should restore the AHU to its expected useful life.

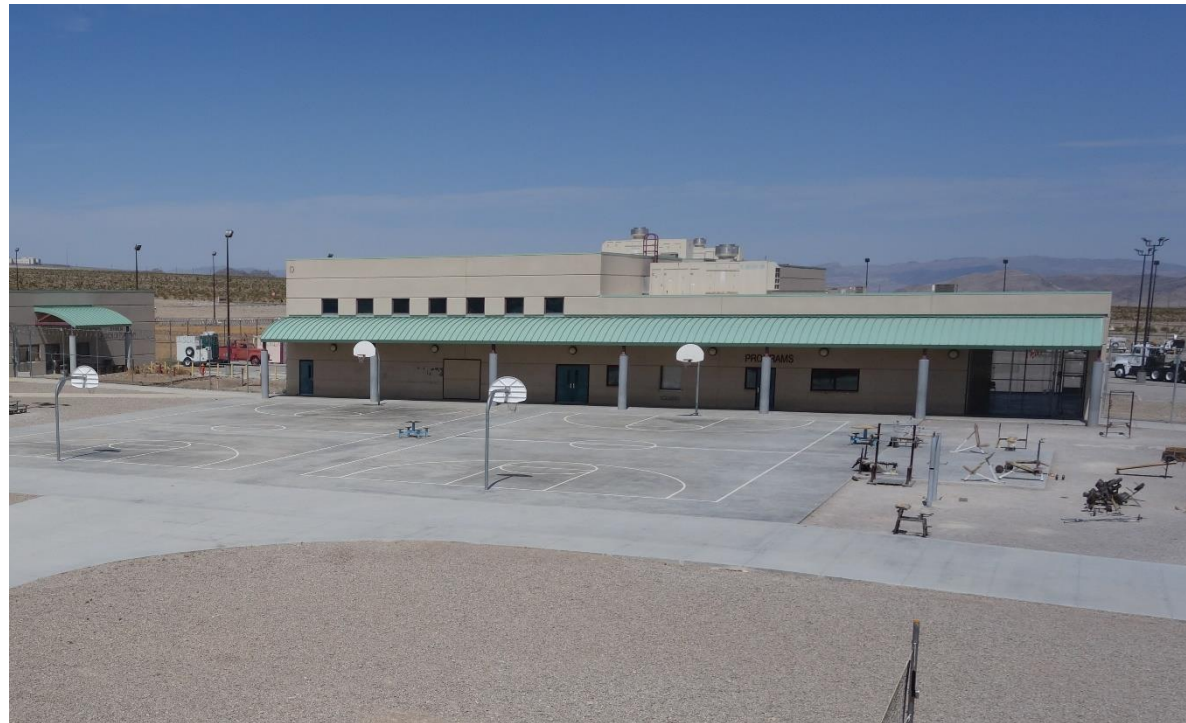
**3092 INMATE PROGRAMS D**

A visual survey of the evaporatively cooled air handling unit (AHU's) is failing prematurely and reducing its expected life. Lack of maintenance has caused the heating coil to plug with mineral scale due to moisture carry-over from the evaporative cooling section. Moisture carry-over is indicative of air velocities well above the unit specifications caused by a lack of air balance.

The severe degree of scaling renders coil cleaning ineffective and a complete replacement of the heating coil is recommended. Additionally, the AHU's exterior surfaces are showing signs of corrosion likely caused by the same moisture carry-over. This project will fund the removal and replacement of the heating coil, a full AHU maintenance rehabilitation, new blow-down controls on the evaporative sump, water treatment (Nu-Calgon slow dissolving scale and corrosion inhibitor) and air balance. With proper maintenance, this project should restore the AHU to its expected useful life.

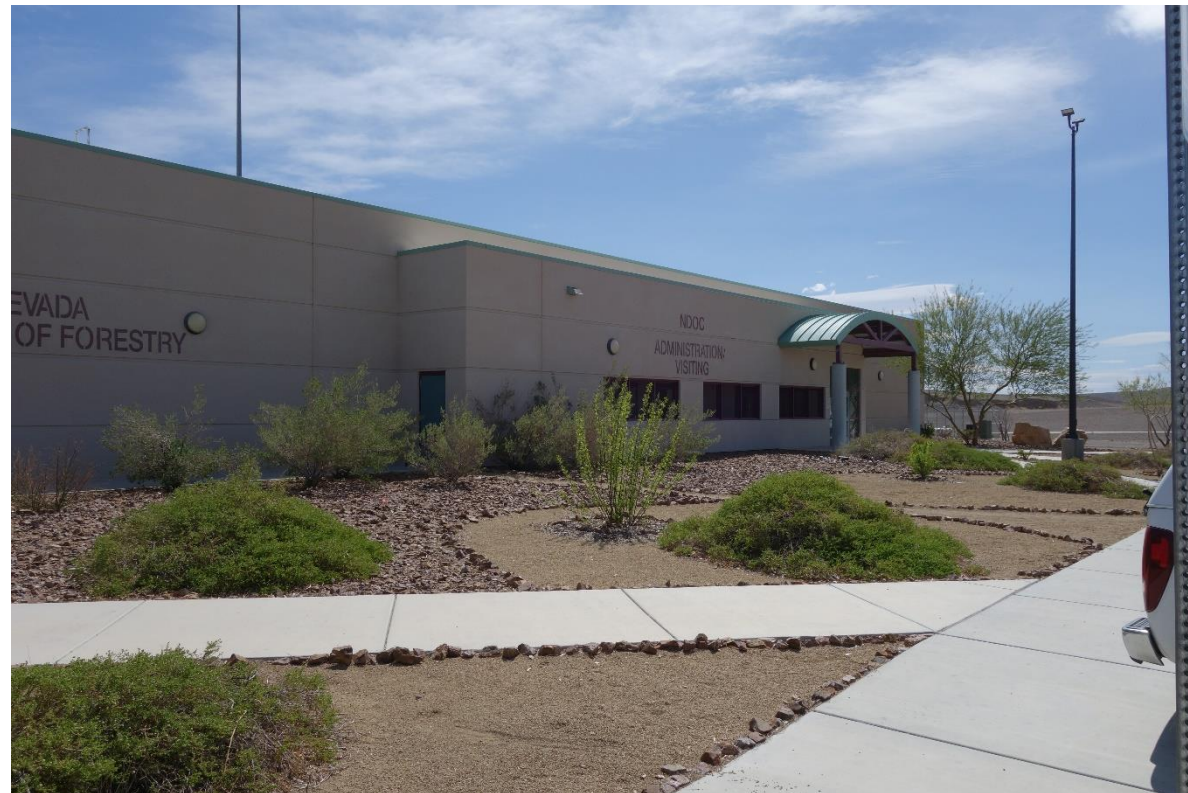
**3091 NDOC/NDF ADMINISTRATION C**

The existing water softening treatment system in the building was not operational at the time of the survey. Failure of the water softening/ treatment system causes additional wear and tear on the domestic water supply lines, water heaters and plumbing fixtures. This project would replace the existing water softener / treatment system with new equipment.

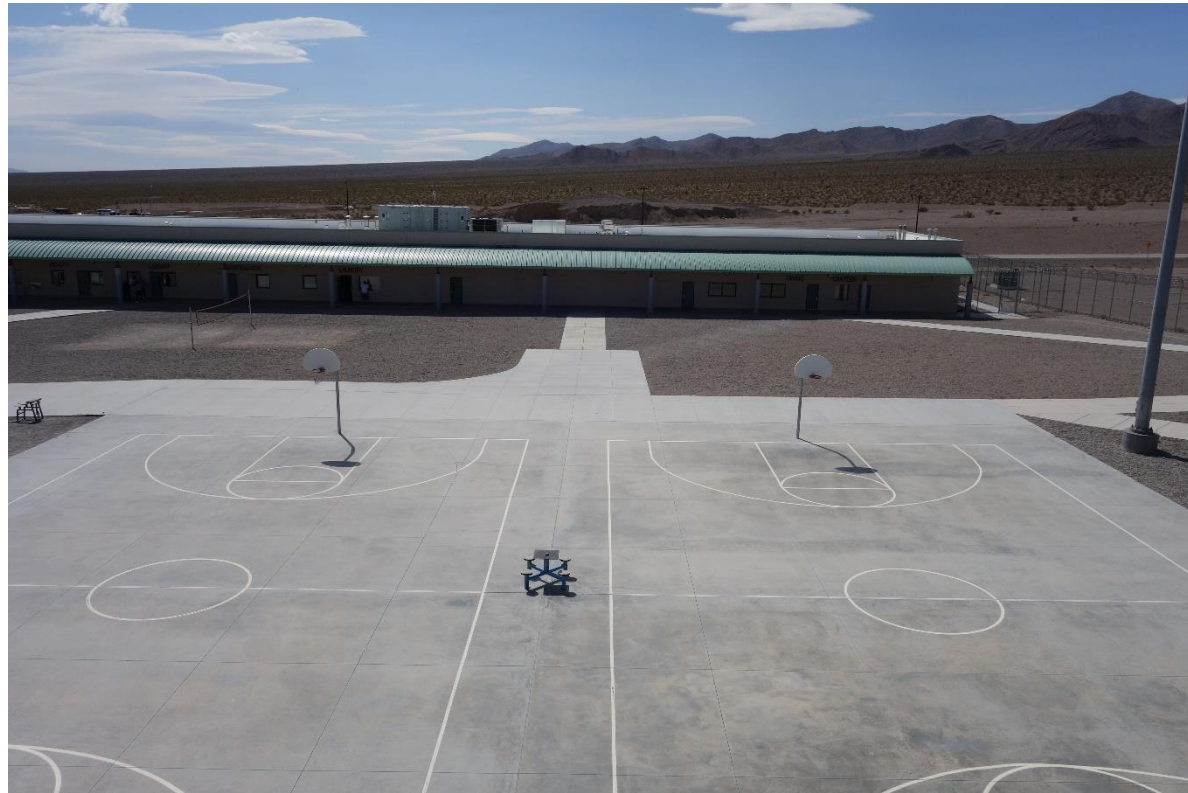
**3090 INMATE SERVICES B**

The existing water softening treatment system in the building was not operational at the time of the survey. Failure of the water softening/ treatment system causes additional wear and tear on the domestic water supply lines, water heaters and plumbing fixtures. This project would replace the existing water softener / treatment system with new equipment.

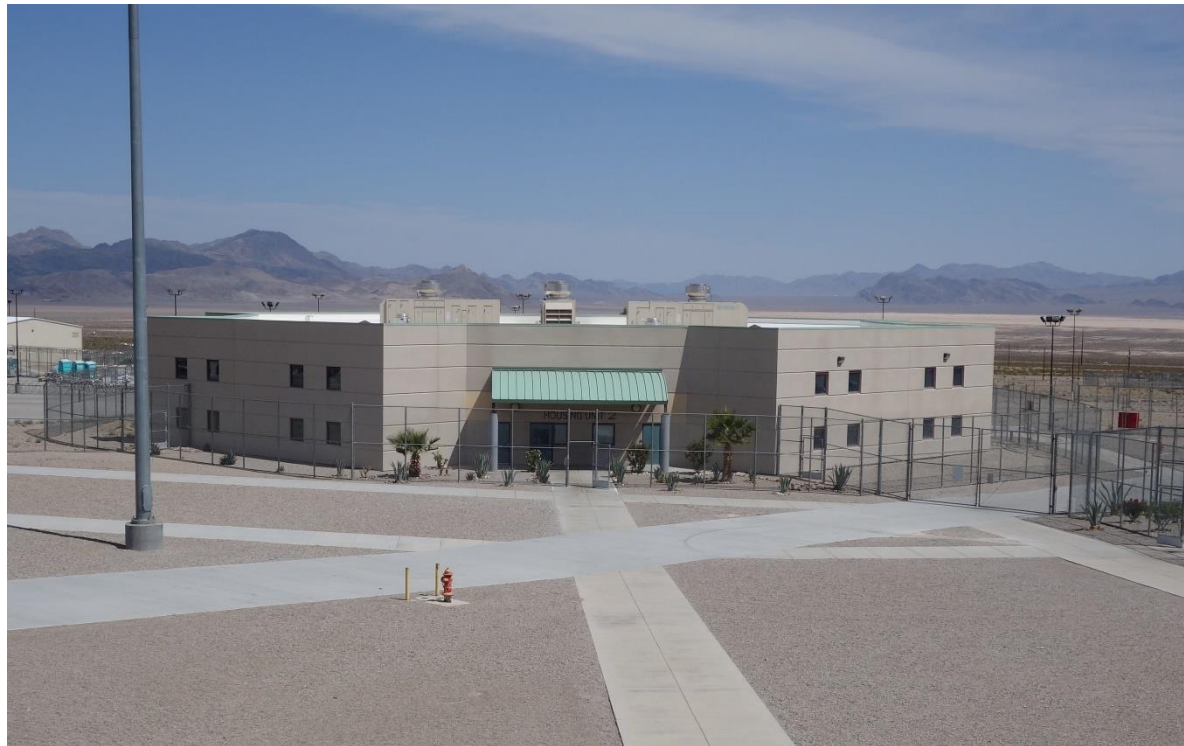
**3088 HOUSING UNIT A1**

Arc flash and electrical breaker coordination studies have not been performed or it has been more than 5 years since the last coordination study. Safety requirements for maintenance personnel and the latest electrical code require coordination studies to be verified and performed every 5 years, along with arc flash labeling on all electrical panels. This project will perform the required coordination study, evaluation, adjustments and labeling for the building's electrical distribution system.
