STATE OF NEVADA
STATE PUBLIC WORKS DIVISION

FACILITY CONDITION ASSESSMENT REPORT FOR:

DEPT OF CONSERVATION & NATURAL RESOURCES
DIVISION OF FORESTRY

SITE #: 9969 THREE LAKES VALLEY UTILITIES SITE
21055 COLD CREEK RD
INDIAN SPRINGS, NV 89070-0001

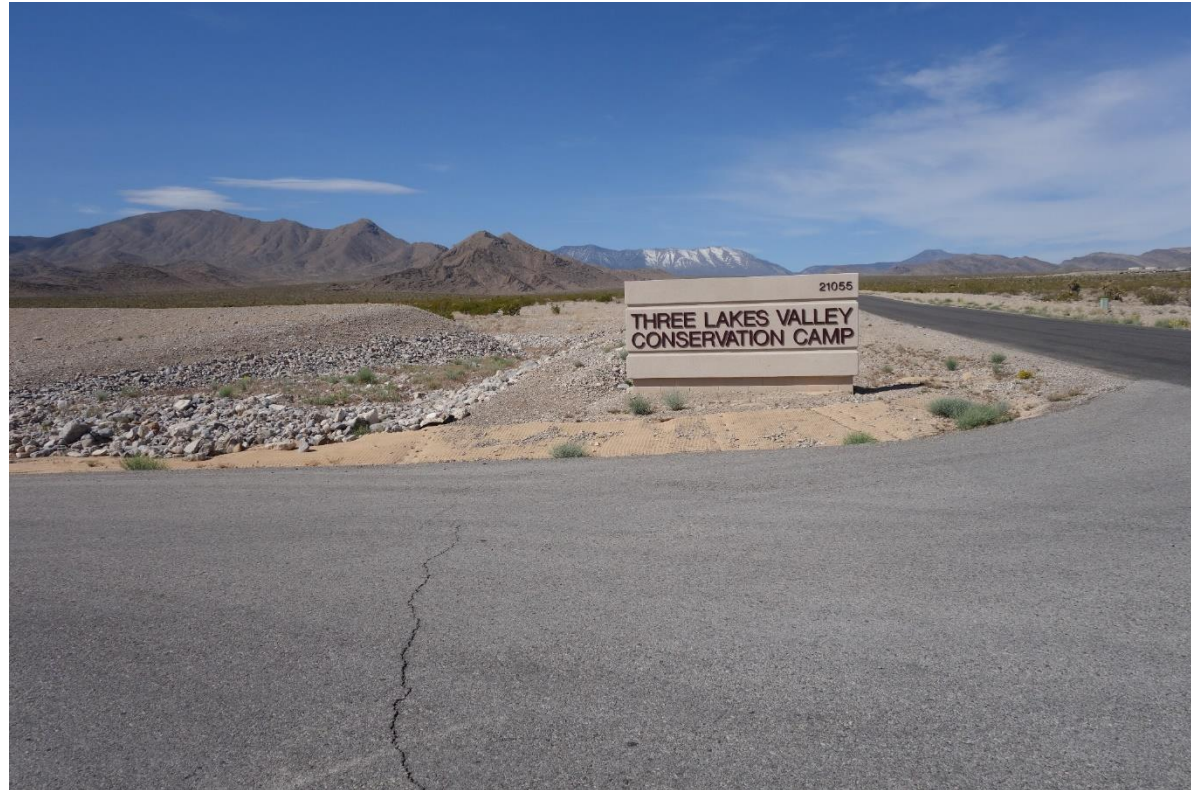
9969 THREE LAKES VALLEY UTILITIES SITE

The existing paving is in fair condition. Climate and constant use will accelerate deterioration. For proper maintenance it is recommended the entire parking area and driveway be resealed and re-striped. This type of maintenance will extend the life of the asphalt.

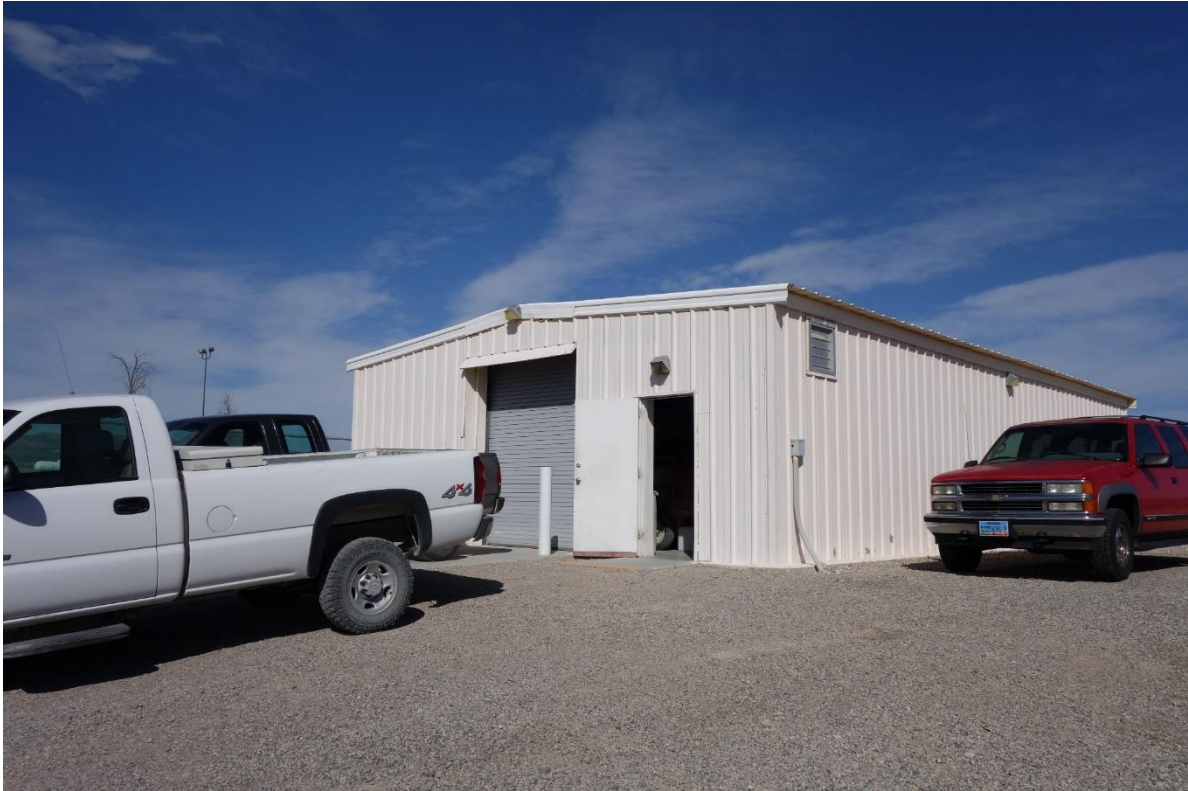
4282 WATER SERVICES BUILDING

The pre-finished metal exterior finishes were in fair condition. It is important to maintain the finish, weather resistance and appearance of the building. This project would provide funding to protect the exterior of the building excluding the roof. Included in the cost is caulking and sealing windows, flashing, fixtures and all other penetrations. It is recommended that the building be caulked and sealed in the next 6 - 8 years and that this project be scheduled on a cyclical basis to maintain the integrity of the structure.

The interior finishes were in good condition. It is recommended the interior walls and ceilings be painted in the next 7 - 9 years. All surfaces should be repaired and prepared prior to painting. For durability in wet areas, an epoxy-based paint should be used. Building maintenance should be scheduled on a cyclical basis to maintain the integrity of the structure.

provided on or within walls, shall be installed and sealed to protect structural elements from moisture. This project recommends the installation of Fiberglass Reinforced Panel (FRP) or an equal material to comply with this code Section in the restroom.

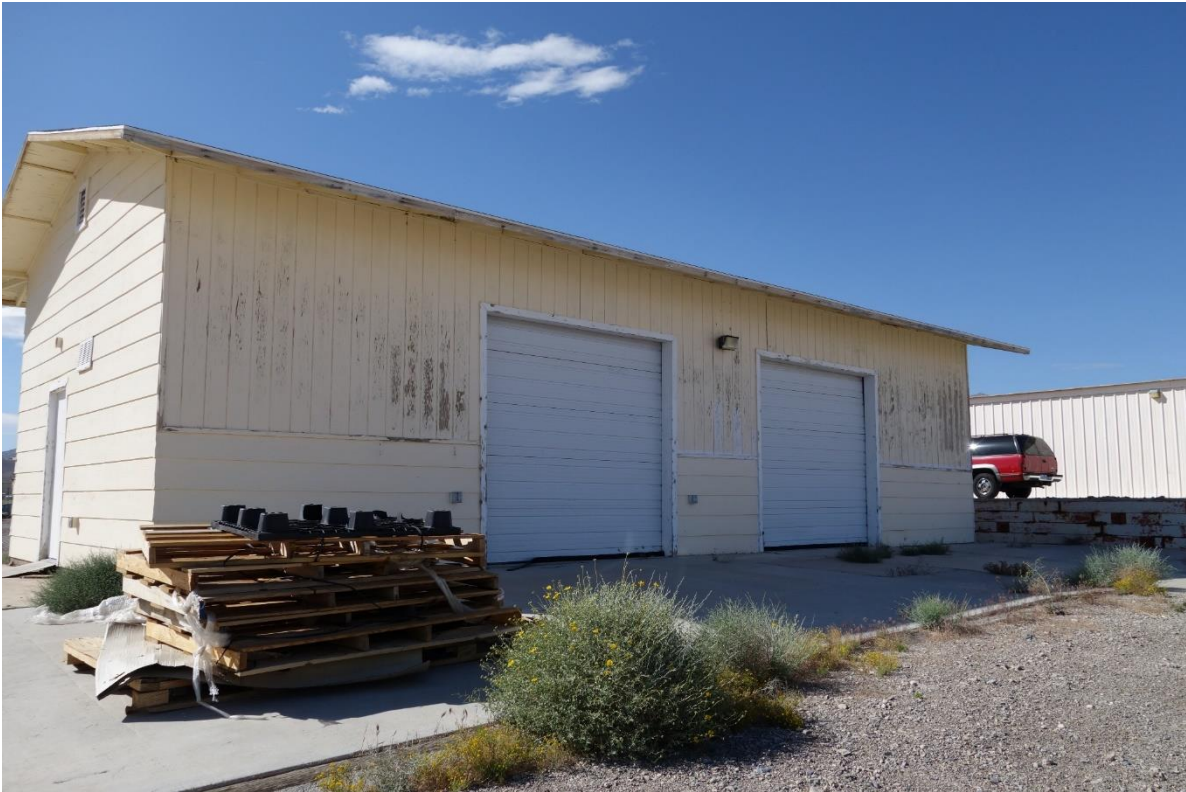
2190 STORAGE

The Storage building is a wood framed structure on a concrete slab on grade foundation with an asphalt composition roof. It has painted T1-11 and lap siding in poor condition. The interior consists of storage areas with no restrooms. The building is in poor condition. The building, previously used as a chain saw shop, is now exclusively used for storage.

The exterior finishes were in poor condition. It is important to maintain the finish, weather resistance and appearance of the building. This project would provide funding to protect the exterior of the building excluding the roof. Included in the cost is sanding, priming, painting and caulking the windows, flashing, fixtures and all other penetrations. It is recommended that the building be painted in the next 2 - 4 years and that this project be scheduled on a cyclical basis to maintain the integrity of the structure.

The asphalt composition shingle roof on this building was in poor condition at the time of the survey. It is recommended that this building be re-roofed in the next 2 - 3 years with a new 50-year asphalt composition roofing shingle and new underlayment. This estimate includes removal and disposal of the old roofing system.

The existing lighting fixtures are the older fluorescent type and are not energy efficient. This project will replace the existing fixtures with higher efficiency LED fixtures. Electrical wiring upgrades are not included in this estimate.

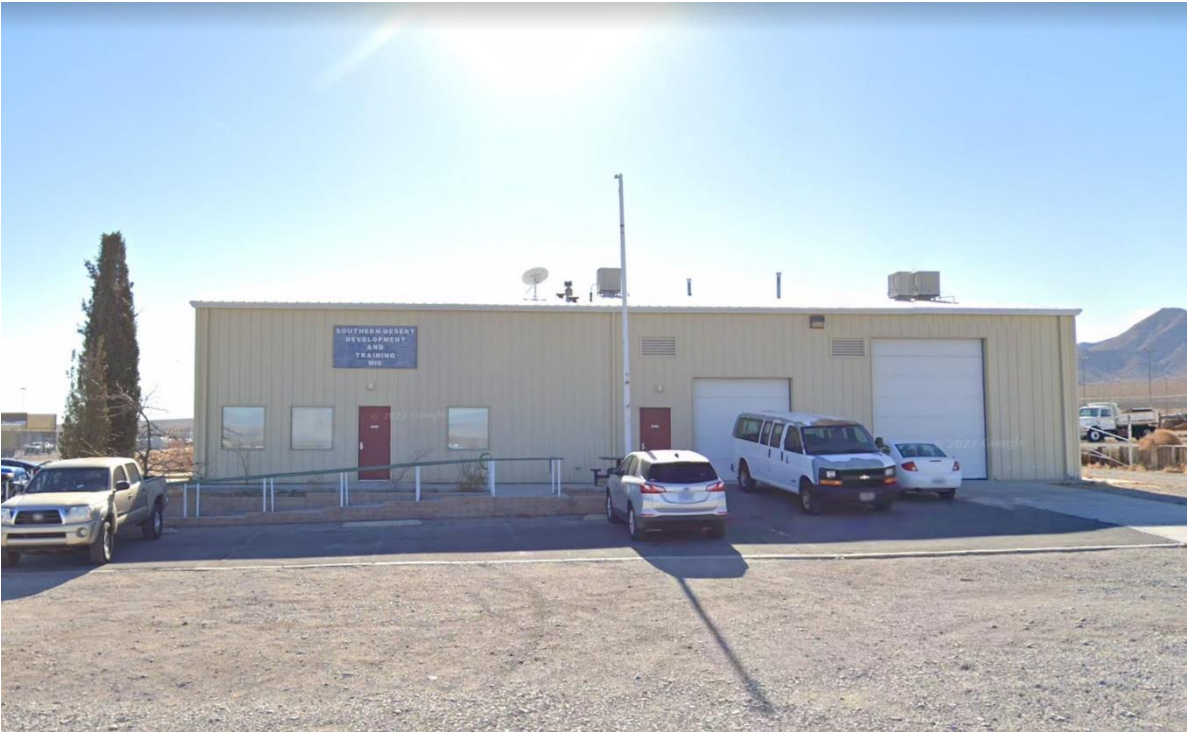
0864 INFORMATION TECHNOLOGY / STORAGE

The existing heating system in the storage areas consists of 3 ceiling suspended propane heaters. Two of three heaters are inoperable and all three should be replaced. This project would provide for disposal of the existing units and replacement with new propane fired units including connections to utilities.

The interior finishes are in good condition. It is recommended that the interior walls be painted at least once in the next 7 - 9 years. Prior to painting, all surfaces should be repaired and prepped. An epoxy-based paint should be utilized in wet areas for durability.

2018 IBC Section 1210 requires the installation of smooth, hard, nonabsorbent surfaces in the following restroom areas: on floors in toilet, bathing and shower rooms that extend upward onto the walls at least 4 inches, within 2 feet of the sides of urinals and water closets to a height of not less than 4 feet above the floor and in shower compartments to a height not less than 70 inches above the drain inlet. Accessories such as grab bars, towel bars, paper dispensers and soap dishes, provided on or within walls, shall be installed and sealed to protect structural elements from moisture. This project recommends the installation of Fiberglass Reinforced Panel (FRP) or an equal material to comply with this code Section in the restroom located in the storage area.
