DEPARTMENT OF ADMINISTRATION  
STATE PUBLIC WORKS DIVISION  
FACILITY CONDITION ASSESSMENT

### PROPERTY PORTFOLIO REVIEW PROJECT ADDENDUM

NORTHWEST REGION  
NORTHERN NEVADA CORRECTIONAL CENTER COMPLEX  
9990 - NORTHERN NEVADA CORRECTIONAL CENTER SITE  
1721 E SNYDER AVE  
CARSON CITY, NV 89701-7812  
CARSON CITY COUNTY

SURVEY DATE: 06/12/2024

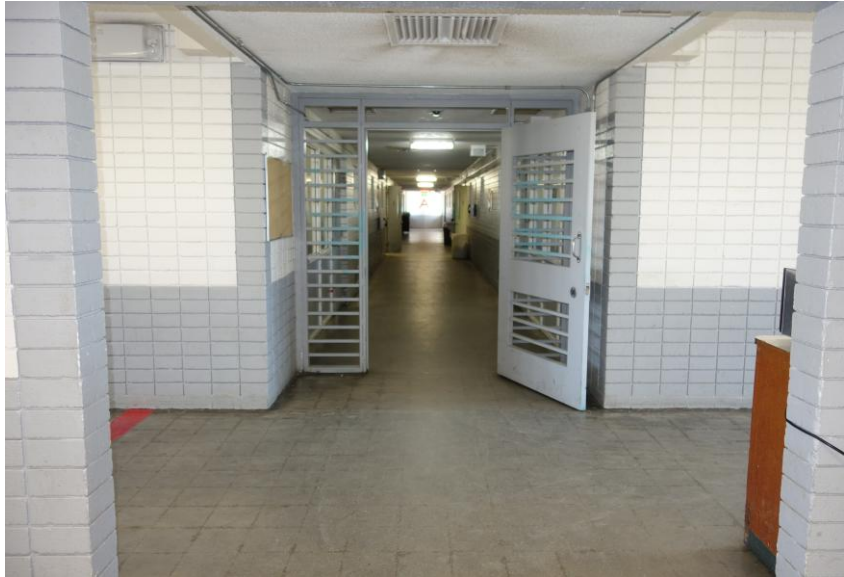
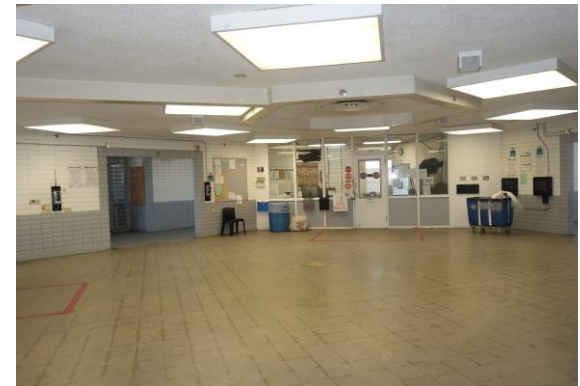
Image Applicable to Housing Units 1-3

#### 0140-SEC-1: CELL DOOR LOCK REPLACEMENT

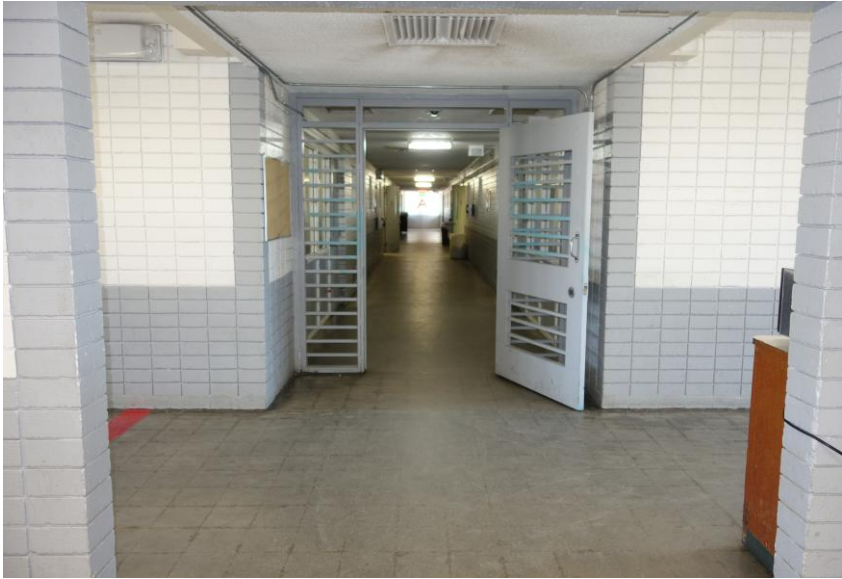
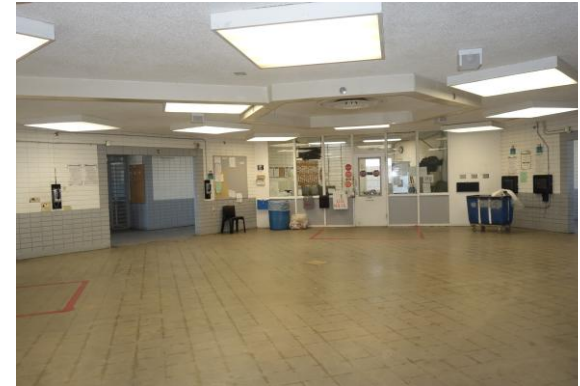
Image Applicable to Housing Units 1-3

#### 0139-SEC-1: CELL DOOR LOCK REPLACEMENT

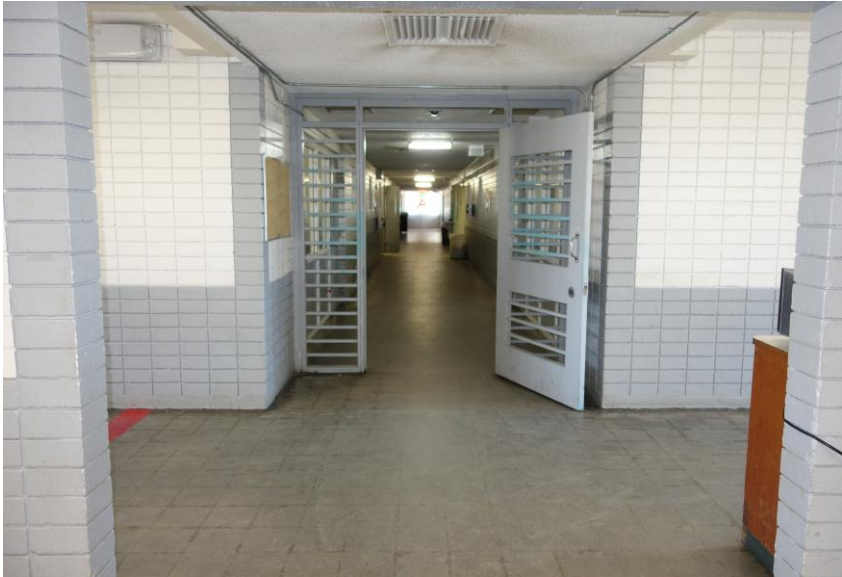
Image Applicable to Housing Units 1-3

#### 0138-SEC-1: CELL DOOR LOCK REPLACEMENT

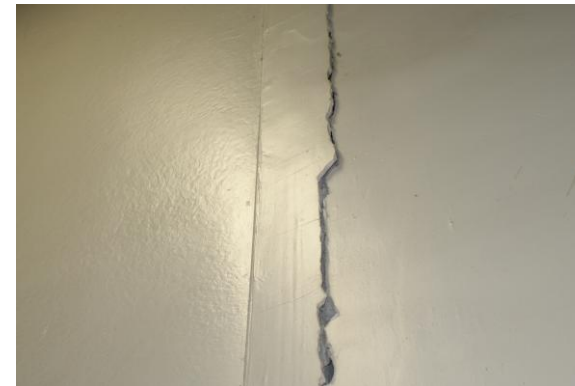
### NEW STRUCTURAL - 11/7/2025 1648-STR-2: STRUCTURAL SURVEY

A significant crack has developed in the exterior wall panel, with visible lateral displacement on one side, indicating potential compromise of the wall's structural integrity. This project recommends a full structural analysis to assess the extent of the damage and determine whether repairs are necessary. The cost of any required repair work is not included in this recommendation.

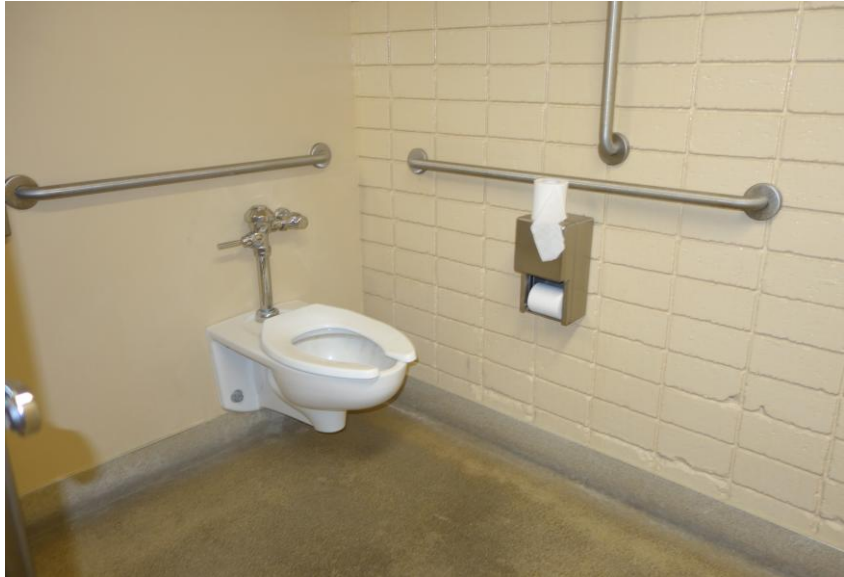
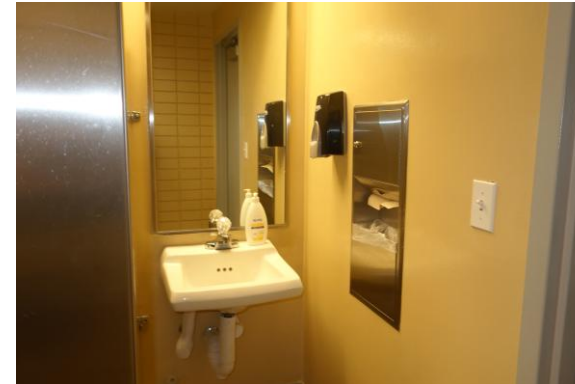
### 0136-PLM-1: BUILDING SEWER SURVEY

The building was constructed during a period when a variety of materials were commonly used for sewer, waste, and vent piping. Typical materials from this era include cast iron with lead and oakum joints, galvanized steel for vent lines, vitrified clay pipe for underground systems, and a low-cost, lightweight pipe made from compressed tar paper (commonly known as Orangeburg). Given the potential variability in materials and age-related deterioration, it is important to assess both the type and condition of the piping located within and beneath the building. This project recommends a

comprehensive inspection of the sewer and vent system to evaluate its overall integrity. The costs associated with this inspection are exclusive of any potential repair or replacement work.

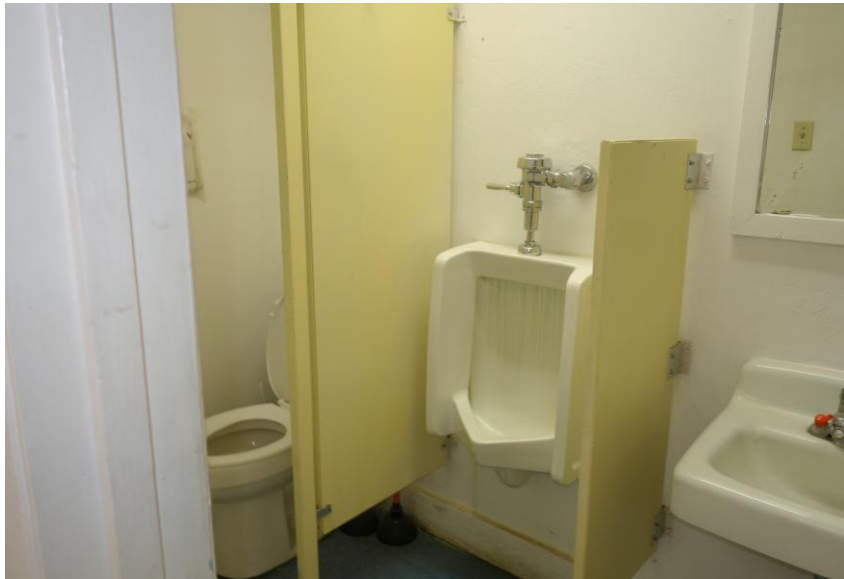
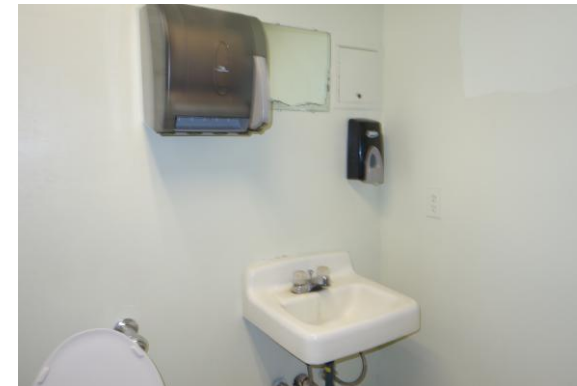
#### 0126-PLM-4: BUILDING SEWER SURVEY

The building was constructed during a period when a variety of materials were commonly used for sewer, waste, and vent piping. Typical materials from this era include cast iron with lead and oakum joints, galvanized steel for vent lines, vitrified clay pipe for underground systems, and a low-cost, lightweight pipe made from compressed tar paper (commonly known as Orangeburg). Given the potential variability in materials and age-related deterioration, it is important to assess both the type and condition of the piping located within and beneath the building. This project recommends a

comprehensive inspection of the sewer and vent system to evaluate its overall integrity. The costs associated with this inspection are exclusive of any potential repair or replacement work.

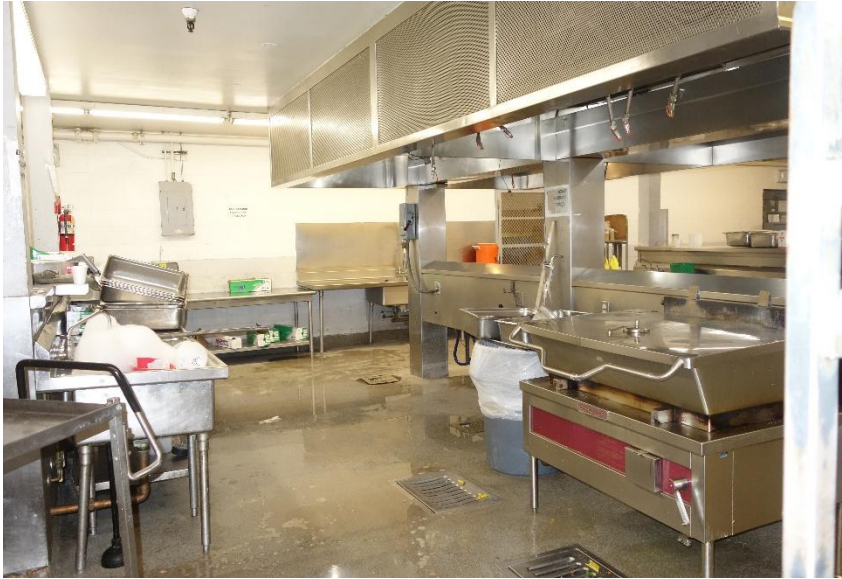
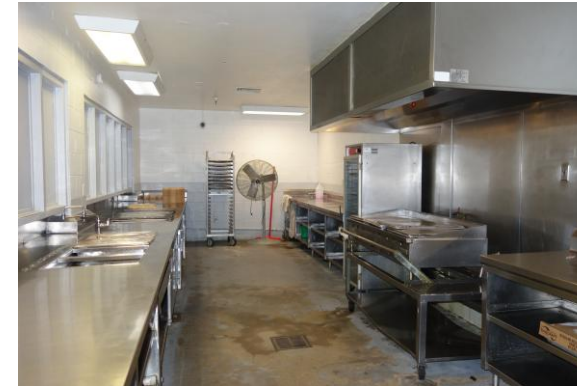
### **0129-HVA-3: CULINARY HVAC SYSTEMS REPLACEMENT**

The culinary building provides food services the entire prison population, making reliable HVAC operation critical to food service continuity. The existing culinary HVAC systems, including direct-fired make-up air units (MAUs) with evaporative cooling, have been in service for nearly 20 years. Portions of the equipment are now inoperable, and maintenance demands and costs have steadily increased. This project recommends a complete replacement of all culinary HVAC equipment to restore full operational capacity, improve energy efficiency, and ensure long-term system reliability.

To optimize construction efficiency and reduce disruptions, this work should be implemented in coordination with the Roof Replacement project.

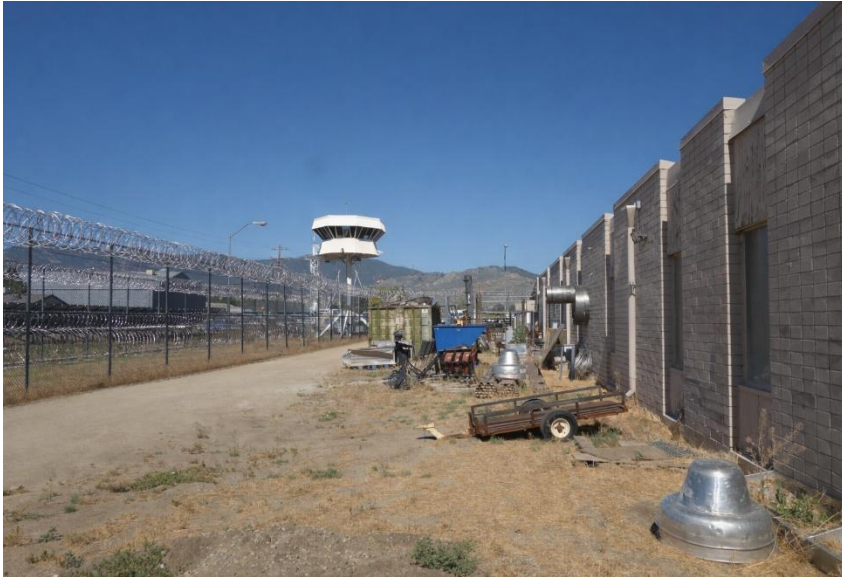
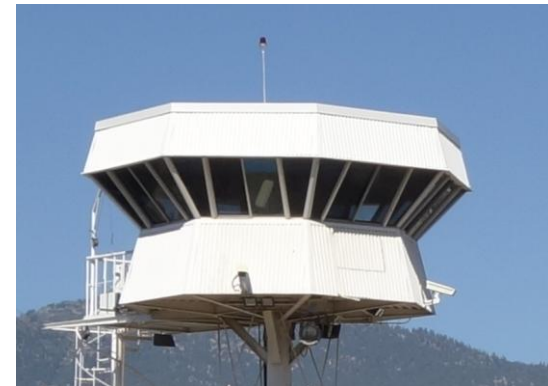
### **9990-SEC-1: SITEWIDE VIDEO SURVEILLANCE REPLACEMENT**

The existing video surveillance system, approximately 15 years old, suffers from inadequate and failing storage systems, and equipment obsolescence has made maintenance and repairs increasingly difficult. With manufacturers no longer supporting key components, the system poses growing safety risks. This project recommends a complete replacement and enhancement of the surveillance system, including expanded data storage capacity to improve reliability and security.

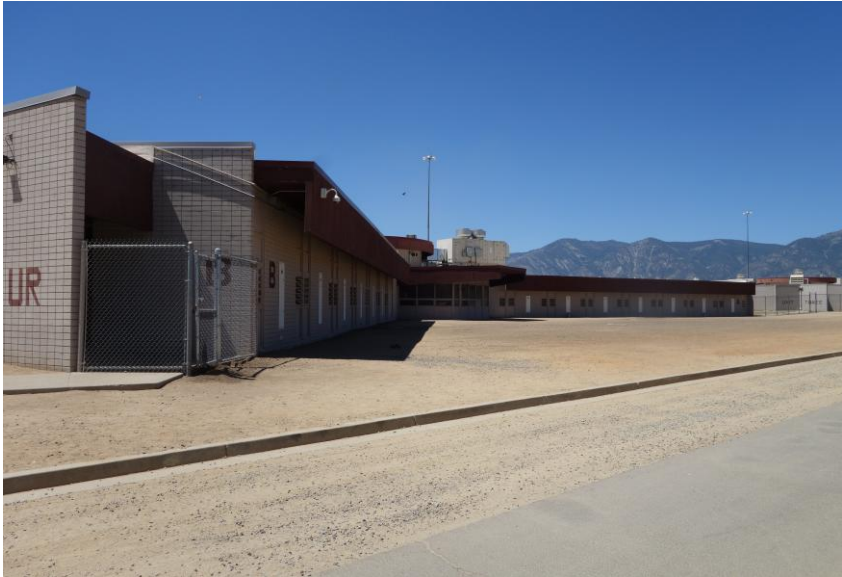
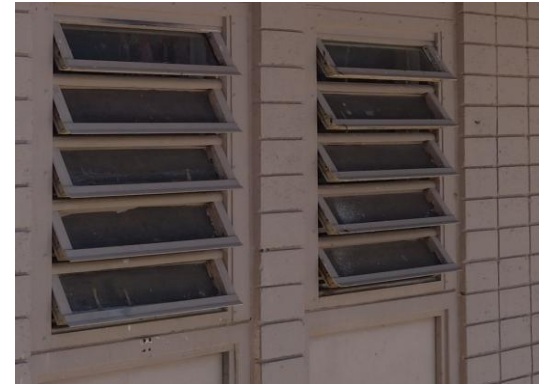
#### 0141-EXT-2: WINDOW REPLACEMENT

The existing exterior window units are original to the building and are damaged or broken and are not energy efficient. They present a safety and security issue due to their condition. This project would provide for the removal and replacement of the existing exterior window units with new institutional grade high security glazed window units.

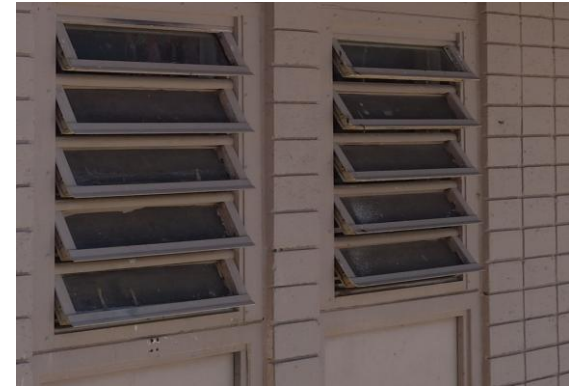
#### 0142-EXT-2: WINDOW REPLACEMENT

The existing exterior window units are original to the building and are damaged or broken and are not energy efficient. They present a safety and security issue due to their condition. This project would provide for the removal and replacement of the existing exterior window units with new institutional grade high security glazed window units.

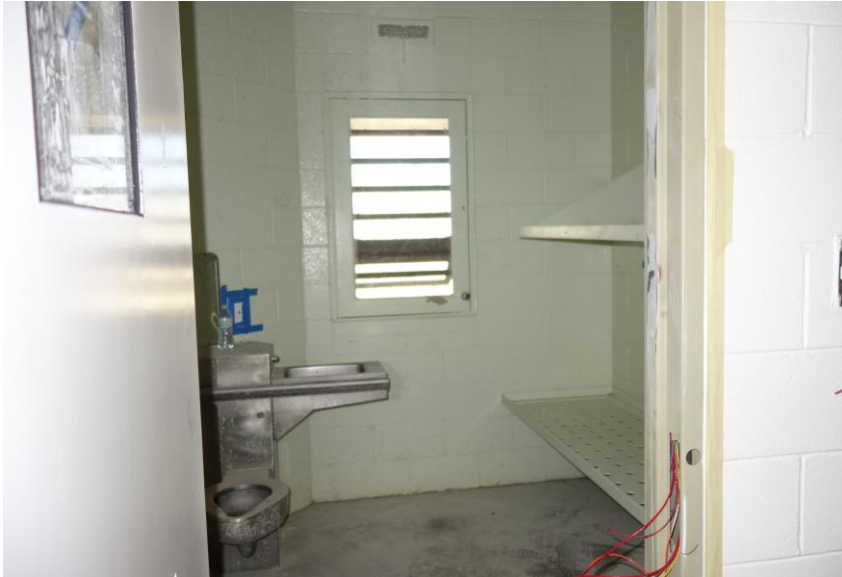
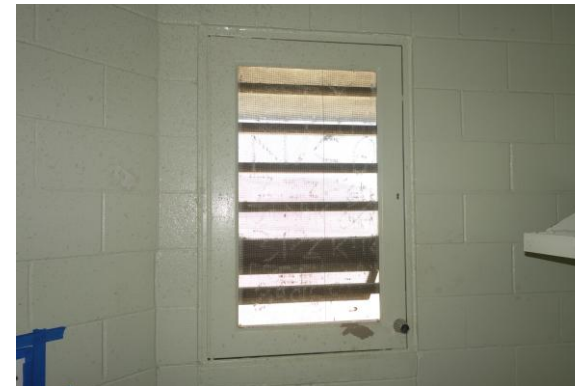
### NEW BUILDING EXTERIOR - 10/1/2025 0149-EXT-7: WINDOW REPLACEMENT

The existing exterior window units are original to the building and are damaged or broken and are not energy efficient. They present a safety and security issue due to their condition. This project would provide for the removal and replacement of the existing exterior window units with new institutional grade high security glazed window units.

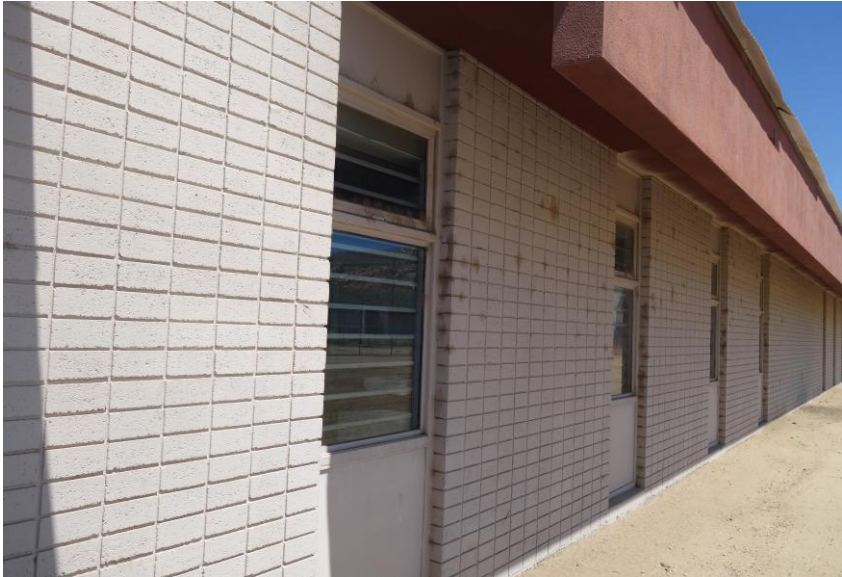
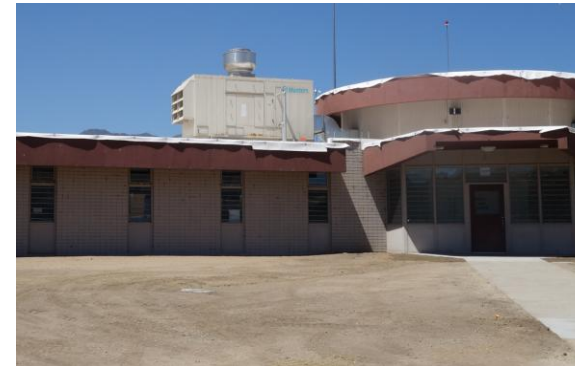
The Housing Unit is currently an uninsulated concrete structure, resulting in poor energy efficiency. In such facilities, evaporative cooling is typically used for climate control. Most corrections sites are located in areas with heavily mineral laden evaporative cooler supply water. The lack of insulation significantly increases the cooling load, which in turn drives excessive water usage and contributes to ongoing maintenance challenges. To address these inefficiencies, this project recommends the installation of an

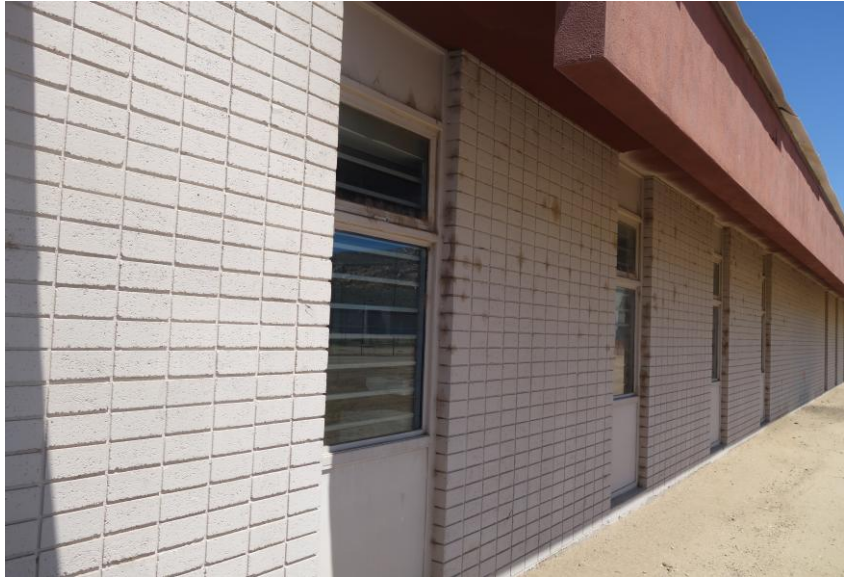
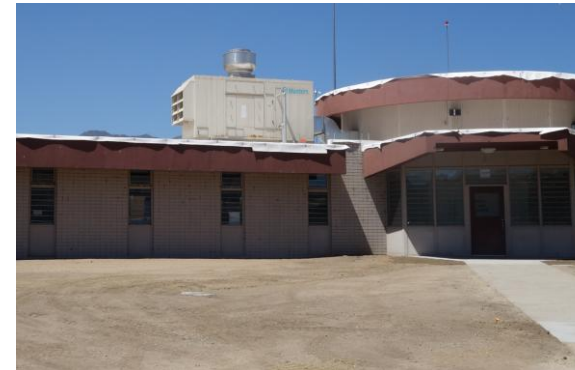
The Housing Unit is currently an uninsulated concrete structure, resulting in poor energy efficiency. In such facilities, evaporative cooling is typically used for climate control. Most corrections sites are located in areas with heavily mineral laden evaporative cooler supply water. The lack of insulation significantly increases the cooling load, which in turn drives excessive water usage and contributes to ongoing maintenance challenges. To address these inefficiencies, this project recommends the installation of an

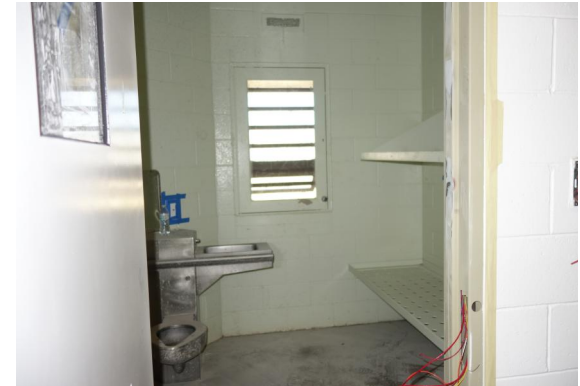
### **0149-PLM-1: BUILDING SEWER & DOMESTIC WATER REPLACEMENT**

The building's domestic water piping, waste & vent systems are over 60 years old and have exceeded their useful life. This project will involve the complete removal and replacement of all piping with durable, code-compliant materials suited to the building's conditions. All work will meet current plumbing codes and safety standards.

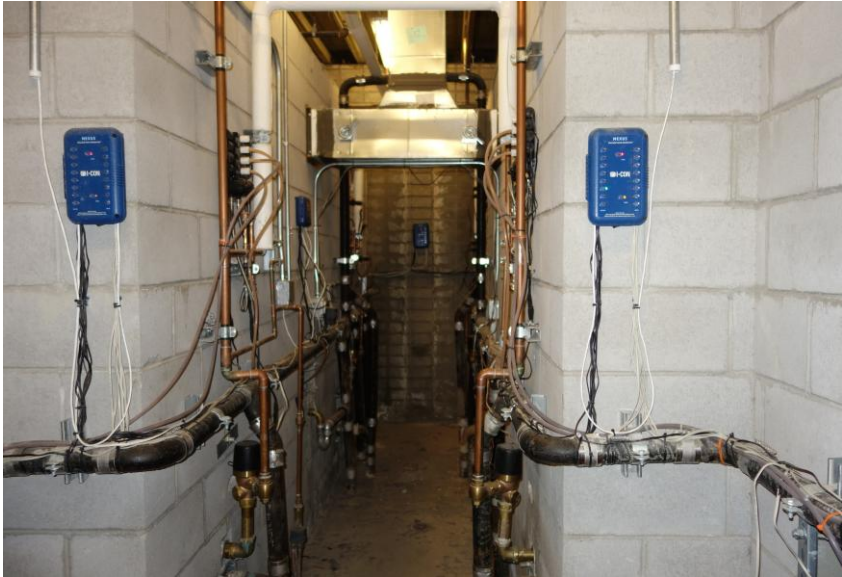
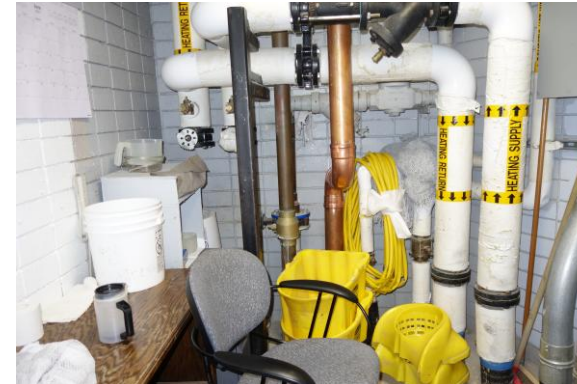
#### 0140-PLM-1: BUILDING SEWER & DOMESTIC WATER REPLACEMENT

The building's domestic water piping, waste & vent systems are over 60 years old and have exceeded their useful life. This project will involve the complete removal and replacement of all piping with durable, code-compliant materials suited to the building's conditions. All work will meet current plumbing codes and safety standards.

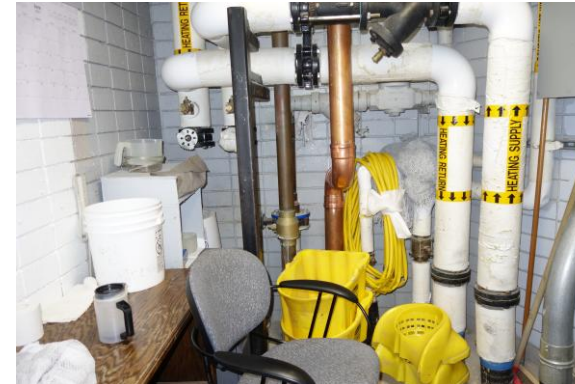
#### 0139-PLM-1: BUILDING SEWER & DOMESTIC WATER REPLACEMENT

The building's domestic water piping, waste & vent systems are over 60 years old and have exceeded their useful life. This project will involve the complete removal and replacement of all piping with durable, code-compliant materials suited to the building's conditions. All work will meet current plumbing codes and safety standards.

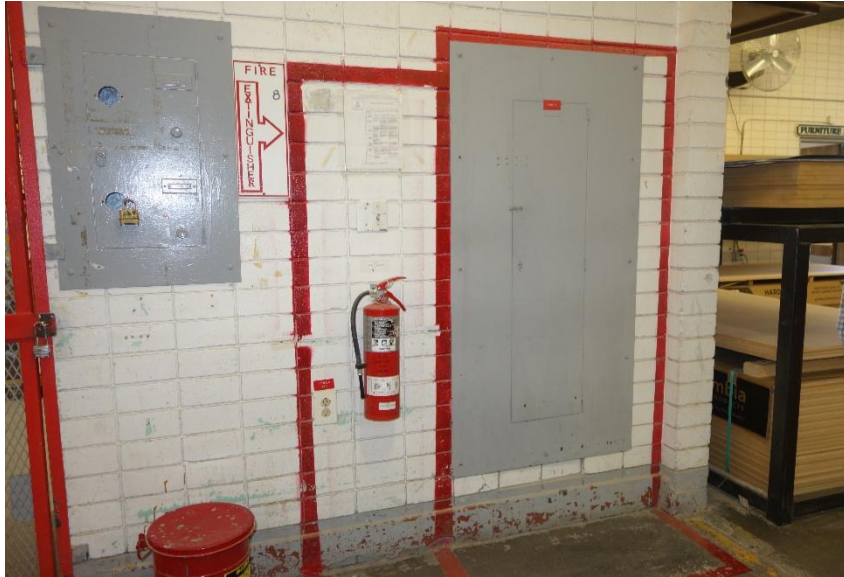
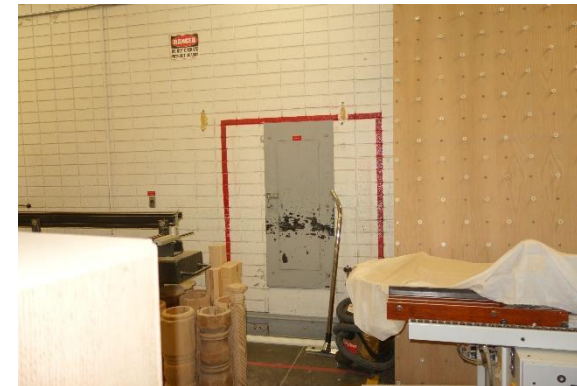
The building's 50+ year-old electrical system is nearing the end of its service life. Aging circuit breakers pose a safety risk due to potential failure or delayed operation, and replacement breakers are increasingly difficult to source due to obsolescence, limiting system maintainability or expansion. To ensure safety compliance and support required electrical studies, full replacement of the existing electrical equipment is recommended. As part of this project, a breaker coordination study and arc flash risk assessment will be performed in accordance with NFPA 70E standards. The project also

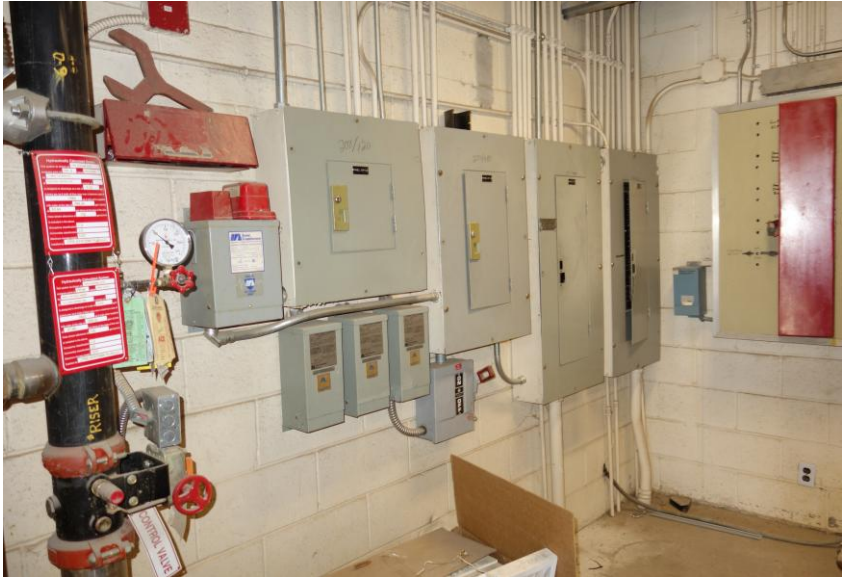
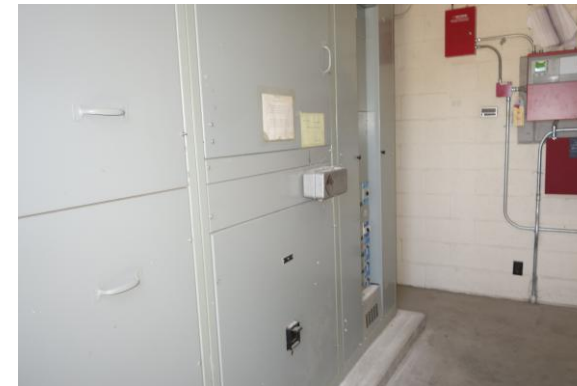
The building's 50+ year-old electrical system is nearing the end of its service life. Aging circuit breakers pose a safety risk due to potential failure or delayed operation, and replacement breakers are increasingly difficult to source due to obsolescence, limiting system maintainability or expansion. To ensure safety compliance and support required electrical studies, full replacement of the existing electrical equipment is recommended. As part of this project, a breaker coordination study and arc flash risk assessment will be performed in accordance with NFPA 70E standards. The project also

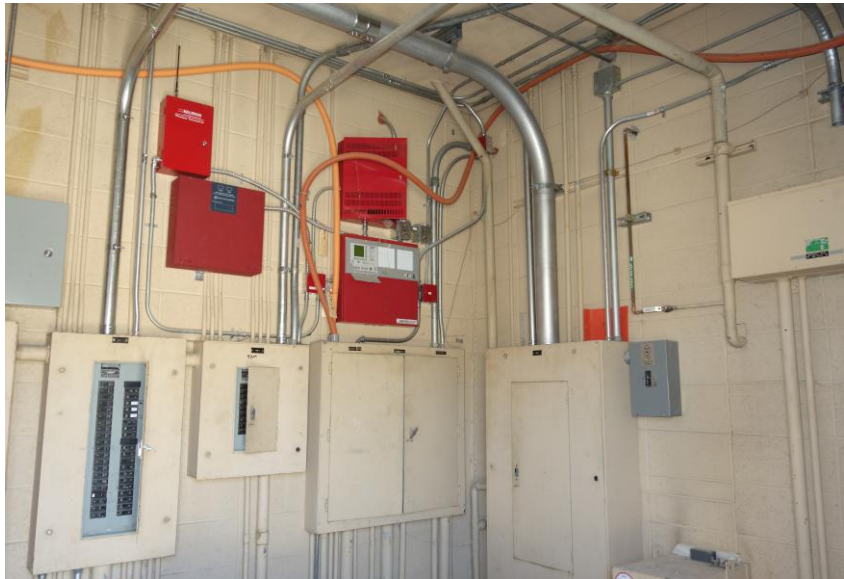
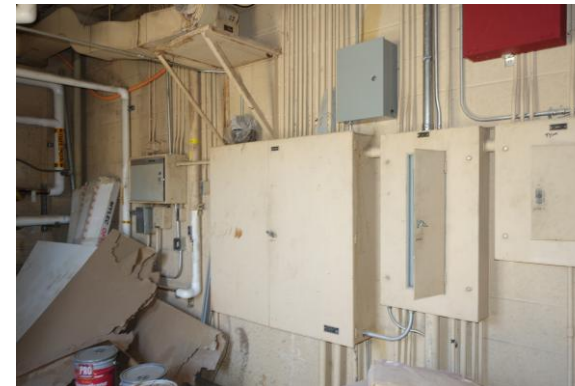
The building's 50+ year-old electrical system is nearing the end of its service life. Aging circuit breakers pose a safety risk due to potential failure or delayed operation, and replacement breakers are increasingly difficult to source due to obsolescence, limiting system maintainability or expansion. To ensure safety compliance and support required electrical studies, full replacement of the existing electrical equipment is recommended. As part of this project, a breaker coordination study and arc flash risk assessment will be performed in accordance with NFPA 70E standards. The project also

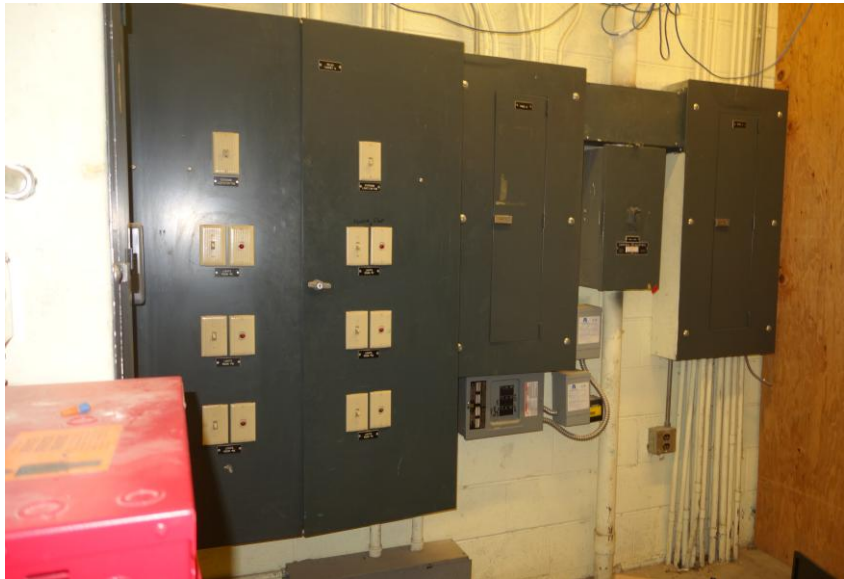
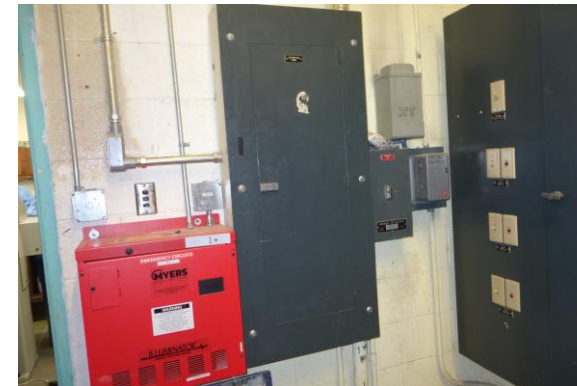
The building's 50+ year-old electrical system is nearing the end of its service life. Aging circuit breakers pose a safety risk due to potential failure or delayed operation, and replacement breakers are increasingly difficult to source due to obsolescence, limiting system maintainability or expansion. To ensure safety compliance and support required electrical studies, full replacement of the existing electrical equipment is recommended. As part of this project, a breaker coordination study and arc flash risk assessment will be performed in accordance with NFPA 70E standards. The project also

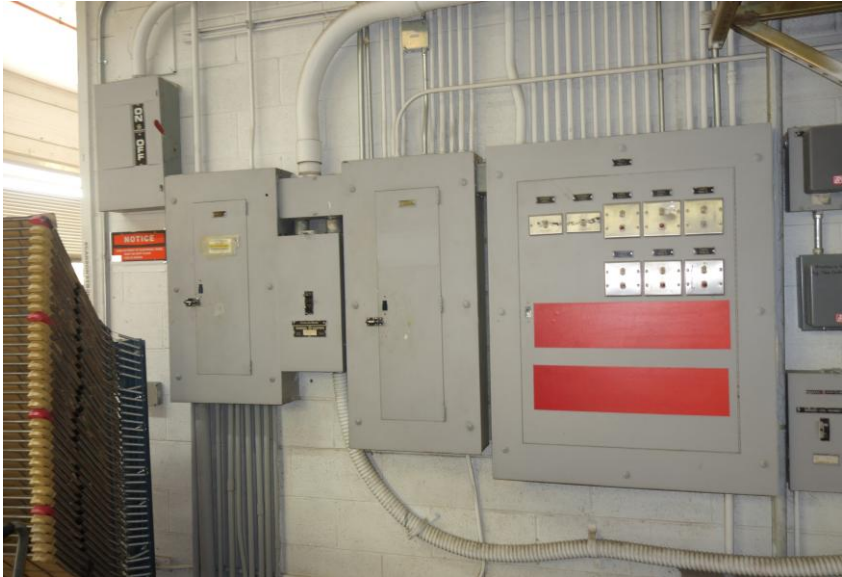
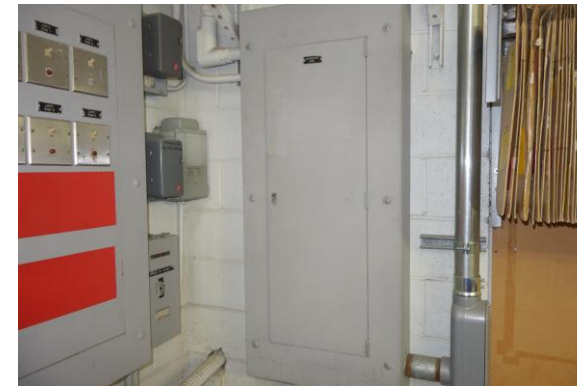
The building's 50+ year-old electrical system is nearing the end of its service life. Aging circuit breakers pose a safety risk due to potential failure or delayed operation, and replacement breakers are increasingly difficult to source due to obsolescence, limiting system maintainability or expansion. To ensure safety compliance and support required electrical studies, full replacement of the existing electrical equipment is recommended. As part of this project, a breaker coordination study and arc flash risk assessment will be performed in accordance with NFPA 70E standards. The project also

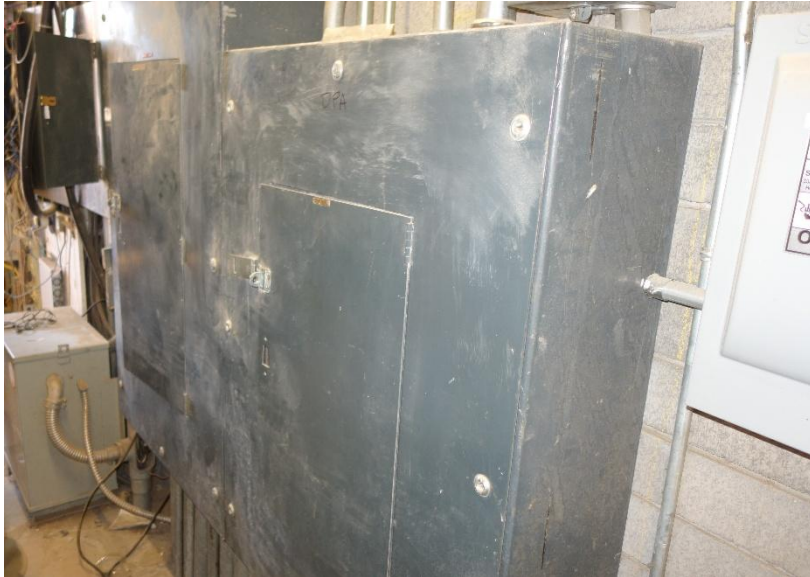
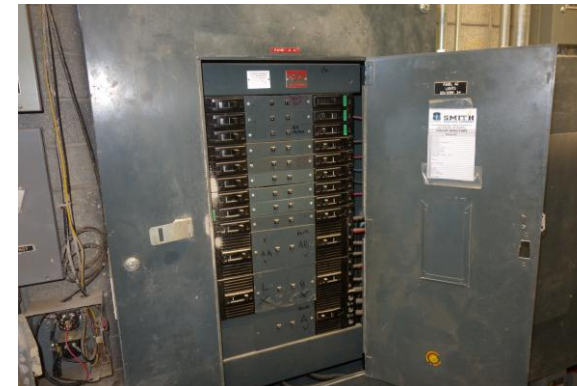
The building's 50+ year-old electrical system is nearing the end of its service life. Aging circuit breakers pose a safety risk due to potential failure or delayed operation, and replacement breakers are increasingly difficult to source due to obsolescence, limiting system maintainability or expansion. To ensure safety compliance and support required electrical studies, full replacement of the existing electrical equipment is recommended. As part of this project, a breaker coordination study and arc flash risk assessment will be performed in accordance with NFPA 70E standards. The project also

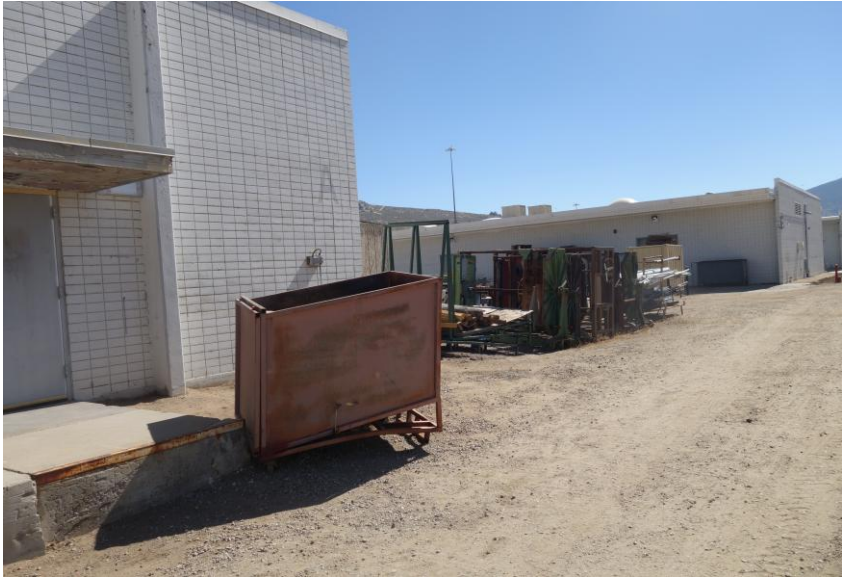
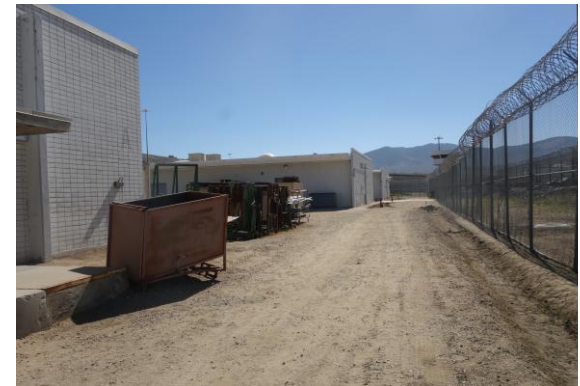
The Housing Unit is currently an uninsulated concrete structure, resulting in poor energy efficiency. In such facilities, evaporative cooling is typically used for climate control. Most corrections sites are located in areas with heavily mineral laden evaporative cooler supply water. The lack of insulation significantly increases the cooling load, which in turn drives excessive water usage and contributes to ongoing maintenance challenges. To address these inefficiencies, this project recommends the installation of an

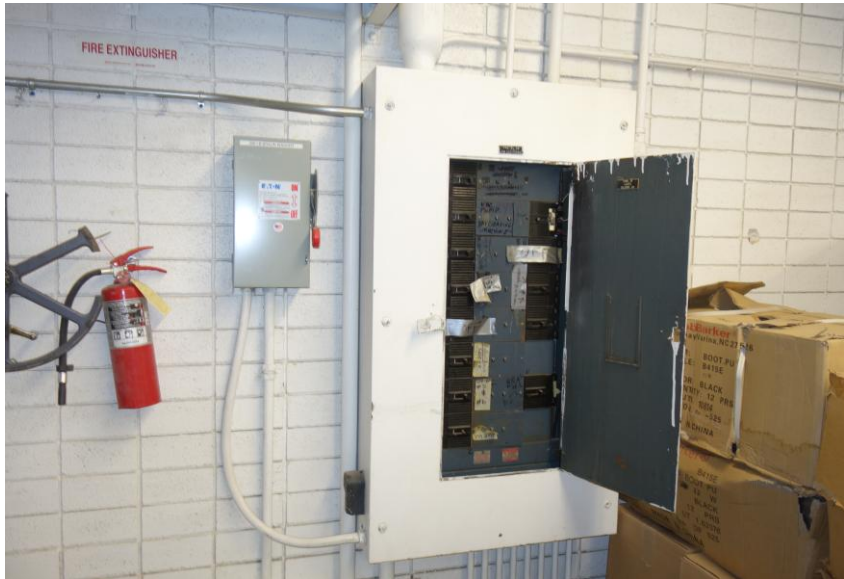
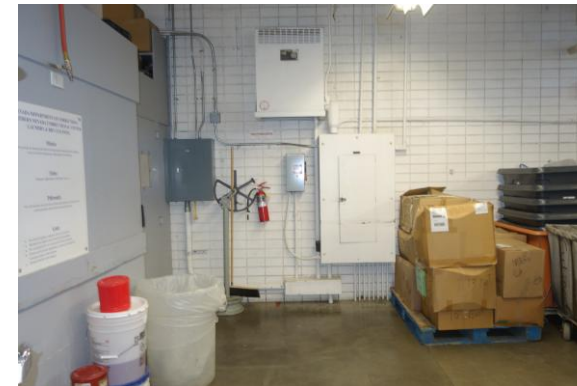
The building's 50+ year-old electrical system is nearing the end of its service life. Aging circuit breakers pose a safety risk due to potential failure or delayed operation, and replacement breakers are increasingly difficult to source due to obsolescence, limiting system maintainability or expansion. To ensure safety compliance and support required electrical studies, full replacement of the existing electrical equipment is recommended. As part of this project, a breaker coordination study and arc flash risk assessment will be

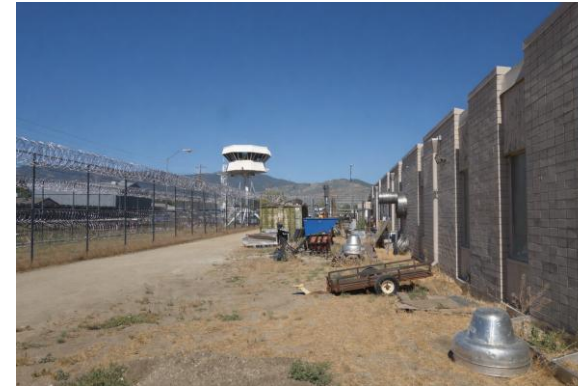
The central plant mechanical and electrical systems have been replaced. However, a portion of the building electrical systems appear to be original construction and approaching 60 years in service. The Aging circuit breakers pose a safety risk due to potential failure or delayed operation, and replacement breakers are increasingly difficult to source due to obsolescence, limiting system maintainability or expansion. To ensure safety compliance and support required electrical studies, full replacement of the existing electrical equipment is recommended. As part of this project, a

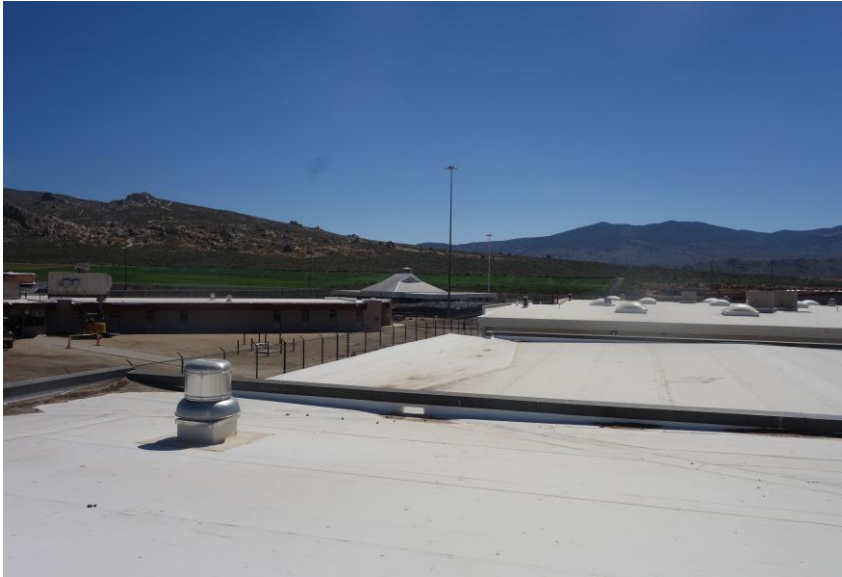
At the time of the survey, the building's roof was found to be in fair condition. Installed in 1994, the current roofing system has exceeded its typical 20–25-year useful life, and the original warranty has expired. Harsh environmental conditions—such as temperature fluctuations, windborne sand and debris, and prolonged sun exposure—have accelerated deterioration. Re-roofing is recommended within the next 2–3 years to align with the statewide roofing program and address the aging system.

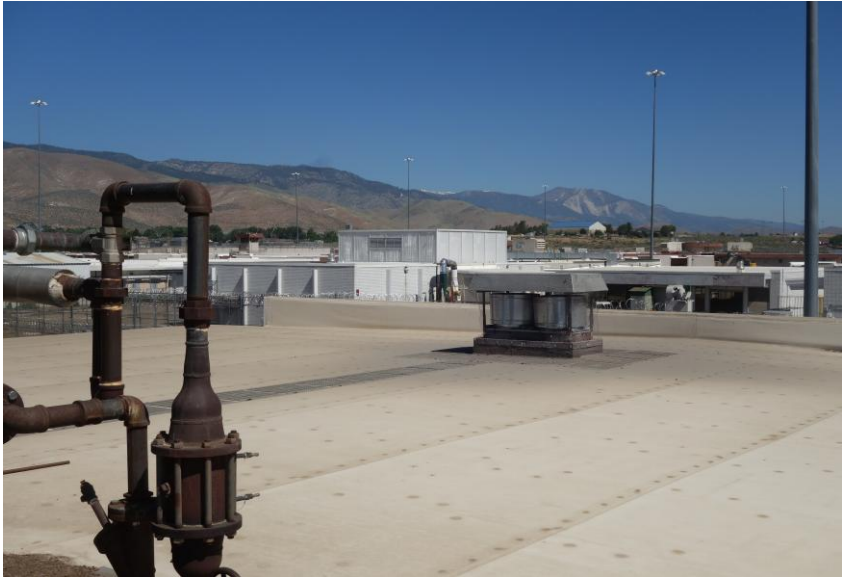
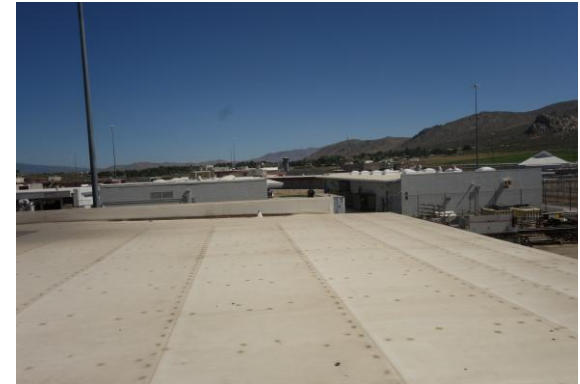
At the time of the survey, the building's roof was found to be in fair condition. Installed in 2000, the current roofing system has exceeded its typical 20–25-year useful life, and the original warranty has expired. Harsh environmental conditions—such as temperature fluctuations, windborne sand and debris, and prolonged sun exposure—have accelerated deterioration. Re-roofing is recommended within the next 3 - 4 years to align with the statewide roofing program and address the aging system.

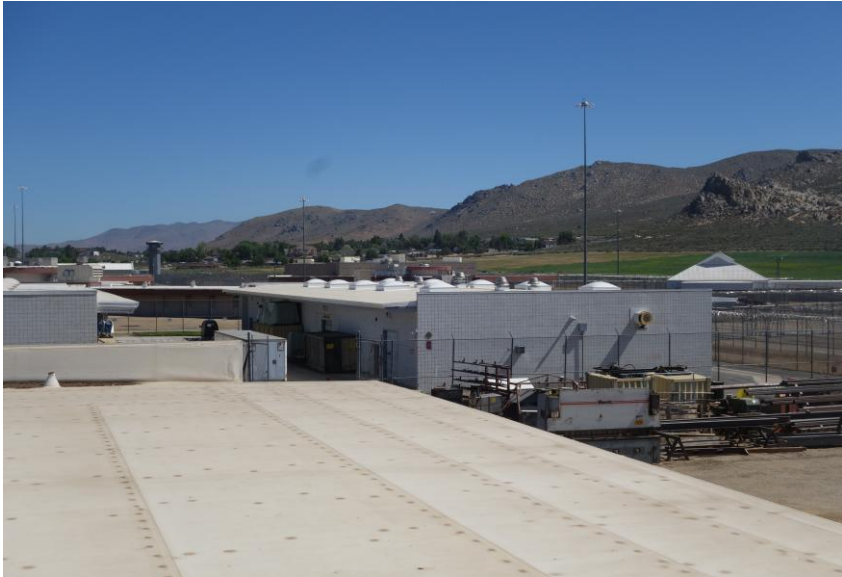
At the time of the survey, the building's roof was found to be in fair condition. Installed in 1994, the current roofing system has exceeded its typical 20–25-year useful life, and the original warranty has expired. Harsh environmental conditions—such as temperature fluctuations, windborne sand and debris, and prolonged sun exposure—have accelerated deterioration. Re-roofing is recommended within the next 2 – 3 years to align with the statewide roofing program and address the aging system.

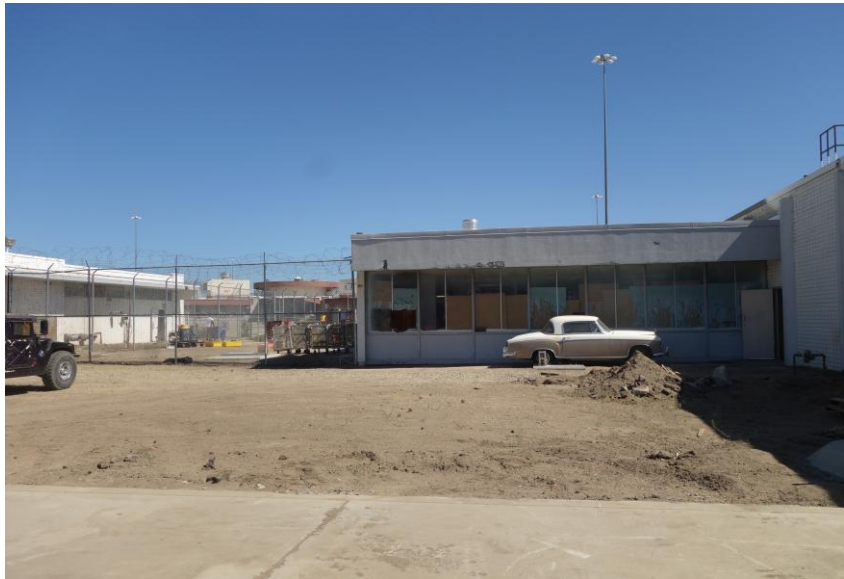
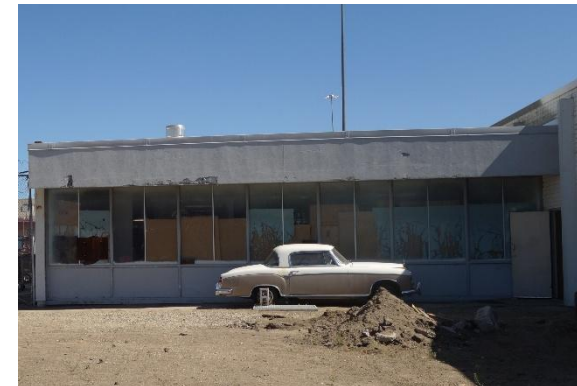
The existing windows in this building are single-pane wire mesh construction, with some units broken and all lacking energy efficiency. This project will fund the removal and replacement of these windows with new dual-pane, security-rated window systems that comply with all applicable NDOC standards, improving both safety and energy performance.

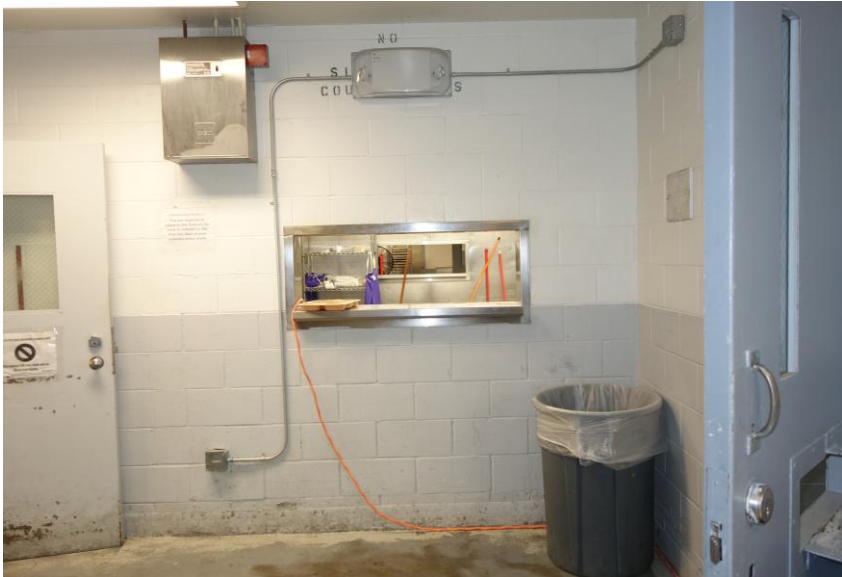
The interior doors are original to the building. Many are damaged, difficult to lock and operate and do not have lever action handles. This project would provide for the removal of the existing doors and the purchase and installation of new metal security grade doors and frames. All hardware and painting is included in this estimate. Hardware to include security keys and fusible locks. This estimate is for 28 doors.

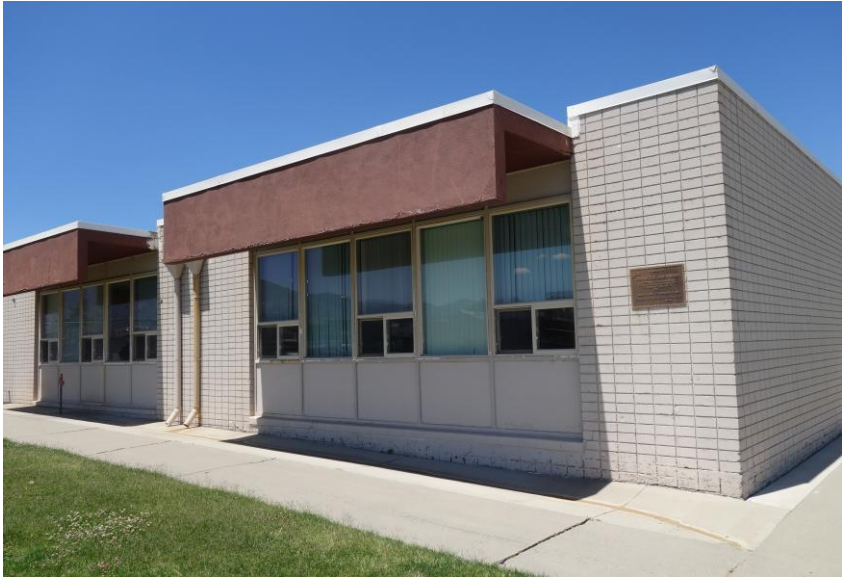
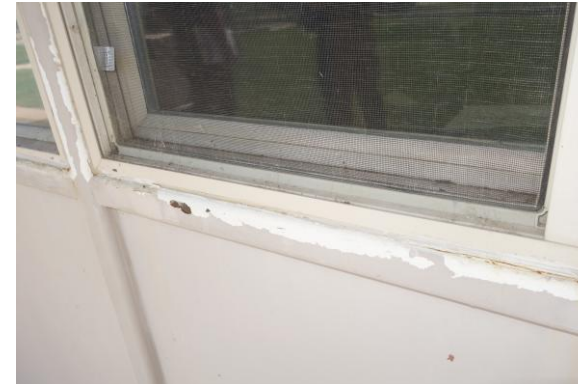
The existing windows in this building are single-pane construction, with some units broken and all lacking energy efficiency. This project will fund the removal and replacement of these windows with new dual-pane, security-rated window systems that comply with all applicable NDOC standards, improving both safety and energy performance.
