DEPARTMENT OF ADMINISTRATION  
STATE PUBLIC WORKS DIVISION  
FACILITY CONDITION ASSESSMENT

### PROPERTY PORTFOLIO REVIEW PROJECT ADDENDUM

NORTHWEST REGION  
NORTHERN NEVADA CORRECTIONAL CENTER COMPLEX  
9990 - NORTHERN NEVADA CORRECTIONAL CENTER SITE  
1721 E SNYDER AVE  
CARSON CITY, NV 89701-7812  
CARSON CITY COUNTY

SURVEY DATE: 06/12/2024

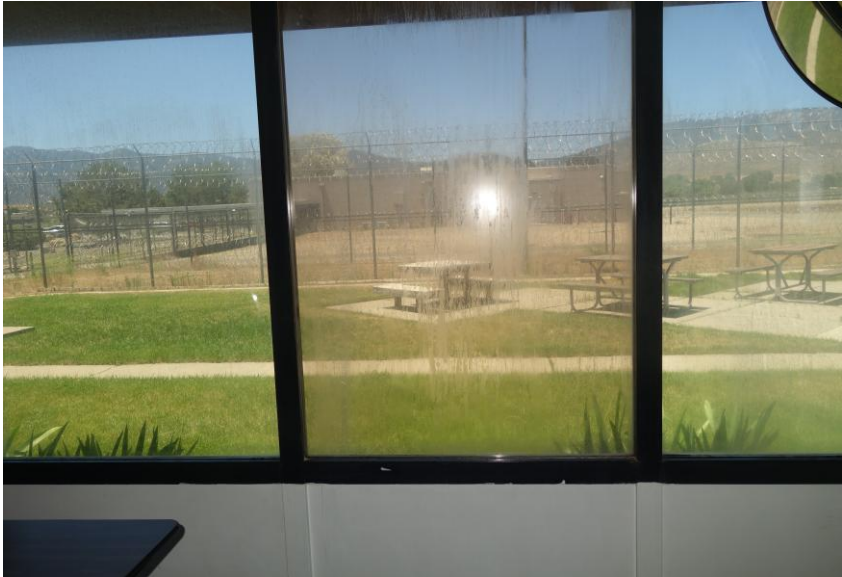
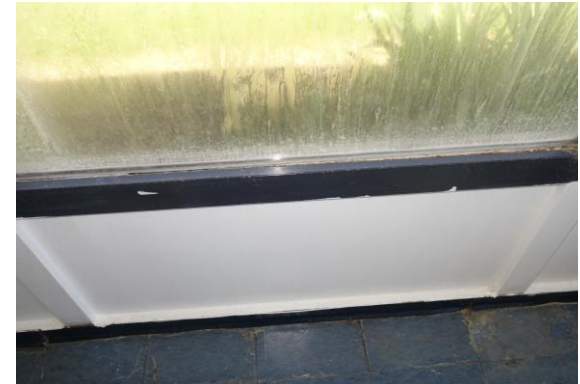
The existing windows in this building are single-pane construction, with some units broken and all lacking energy efficiency. This project will fund the removal and replacement of these windows with new dual-pane, security-rated window systems that comply with all applicable NDOC standards, improving both safety and energy performance.

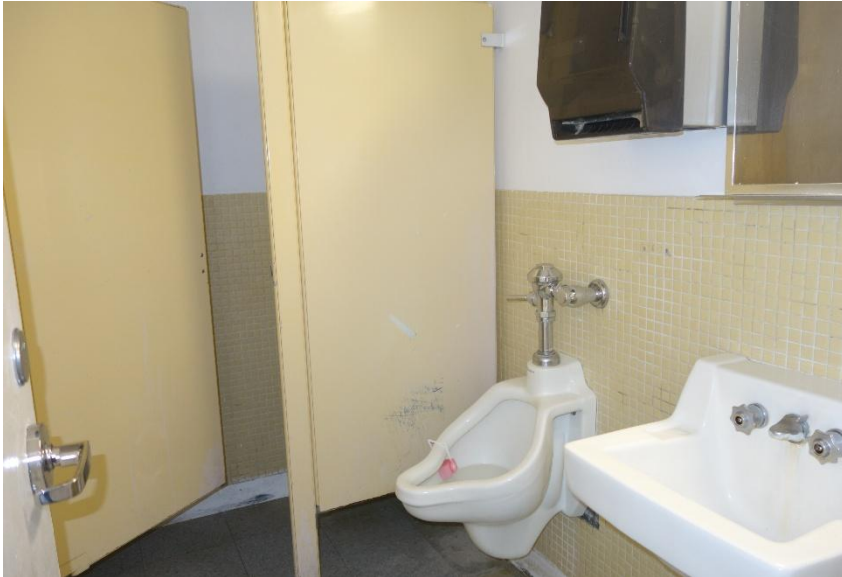
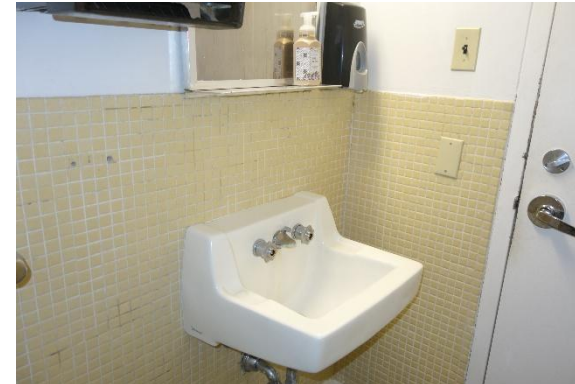
The building's non-accessible restrooms are original and in poor condition. This project will fund the complete refurbishment of each non-accessible restroom throughout the facility. The scope of work may include tile replacement, installation of new sinks, toilets, hardware, mirrors, fixtures, flooring, and finishes to improve functionality, appearance, and overall condition.

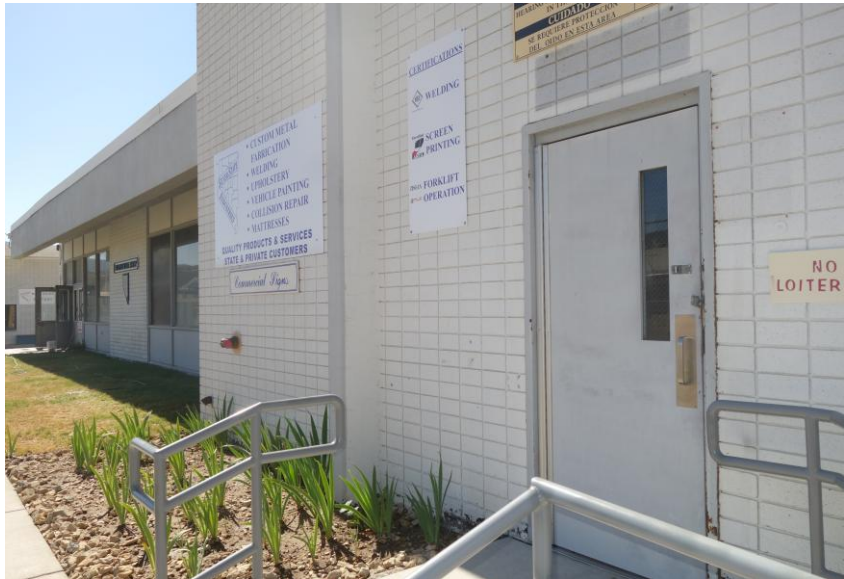
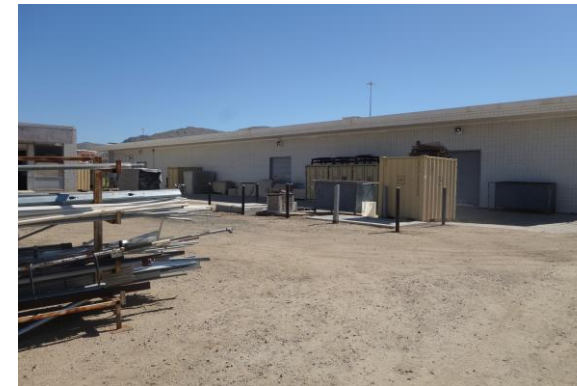
The exterior finishes of the building are in poor condition, and maintaining the building's finish, weather resistance, and appearance is essential. This project will fund improvements to protect the exterior envelope of the building, excluding the roof. The scope includes painting, staining, or sealing the exterior walls, along with caulking around windows, flashing, fixtures, and all other exterior penetrations. It is recommended that this work be completed within the next 3 to 4 years and scheduled on a recurring

maintenance cycle to preserve the structural integrity and visual condition of the facility.

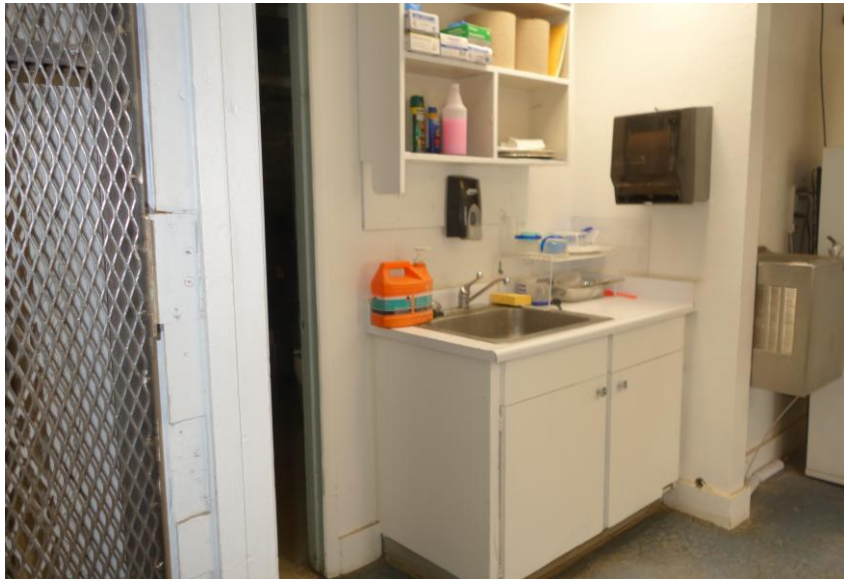
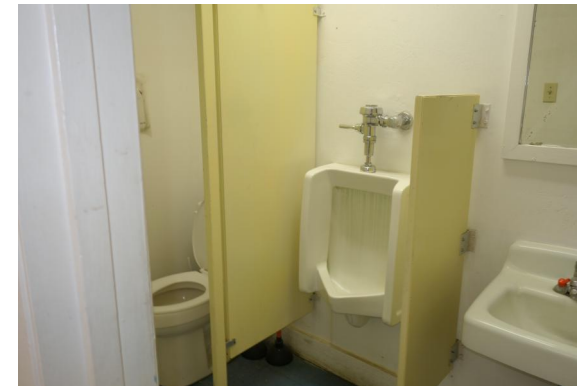
Constructed in 1969, the building has undergone minimal improvements over the years, resulting in an interior that is currently in poor condition. A minor renovation is recommended to address existing deficiencies and bring the facility up to modern standards. The proposed scope includes refurbishing restrooms by installing non-absorbent finishes behind toilets, sinks, and urinals, as well as replacing outdated fixtures to comply with current accessibility requirements. Additionally, many interior doors are not equipped with accessible hardware and will require retrofitting or

replacement to meet code compliance. Given the building's age and the potential for unforeseen needs during renovation, a budget estimate of \$50 per square foot has been used to account for additional improvements that may be necessary.

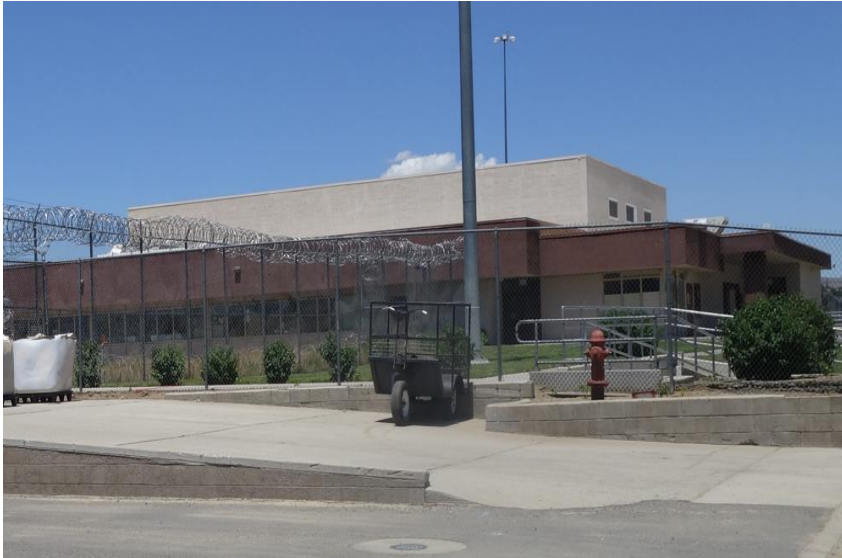
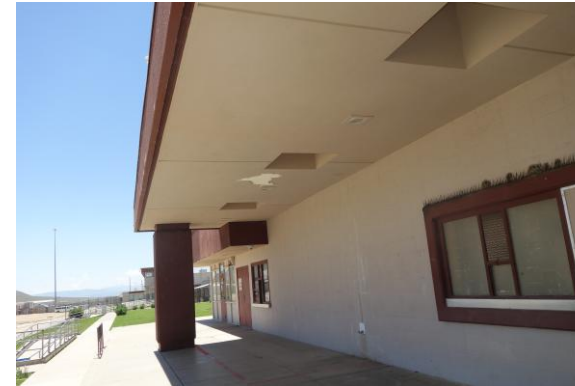
The exterior finishes of the building are in poor condition, and maintaining the building's finish, weather resistance, and appearance is essential. This project will fund improvements to protect the exterior envelope of the building, excluding the roof. The scope includes painting, staining, or sealing the exterior walls, along with caulking around windows, flashing, fixtures, and all other exterior penetrations. It is recommended that this work be completed within the next 3 to 4 years and scheduled on a recurring maintenance cycle to preserve the structural integrity and visual condition of the facility.

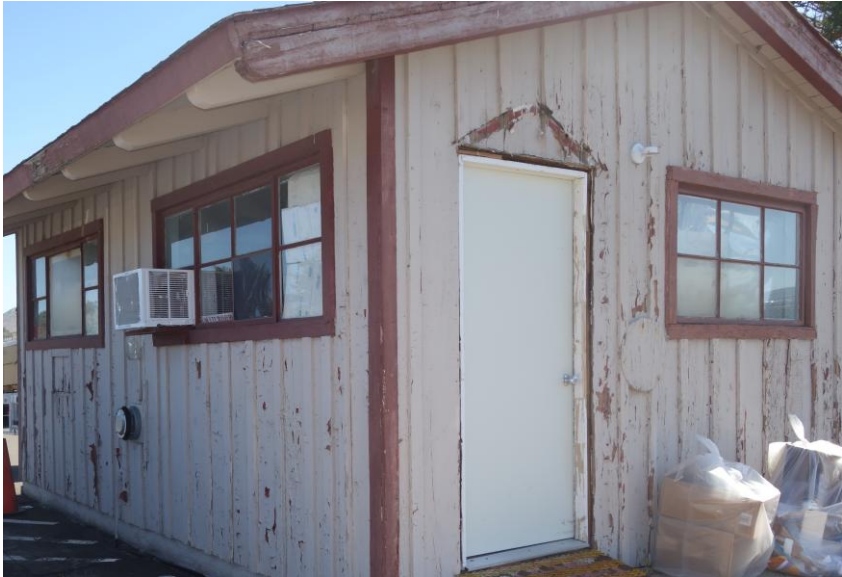
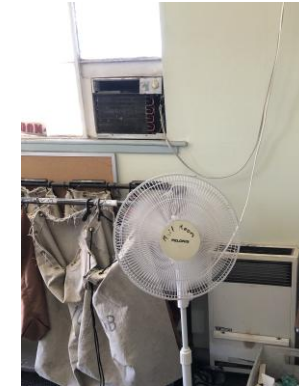
Constructed in the 1970's, the building has undergone minimal improvements over the years, resulting in an interior and exterior that is currently in poor condition. A full renovation is recommended to address existing deficiencies and bring the facility up to modern standards. The proposed scope includes a complete refurbishment of the interior, exterior, roofing and HVAC systems.

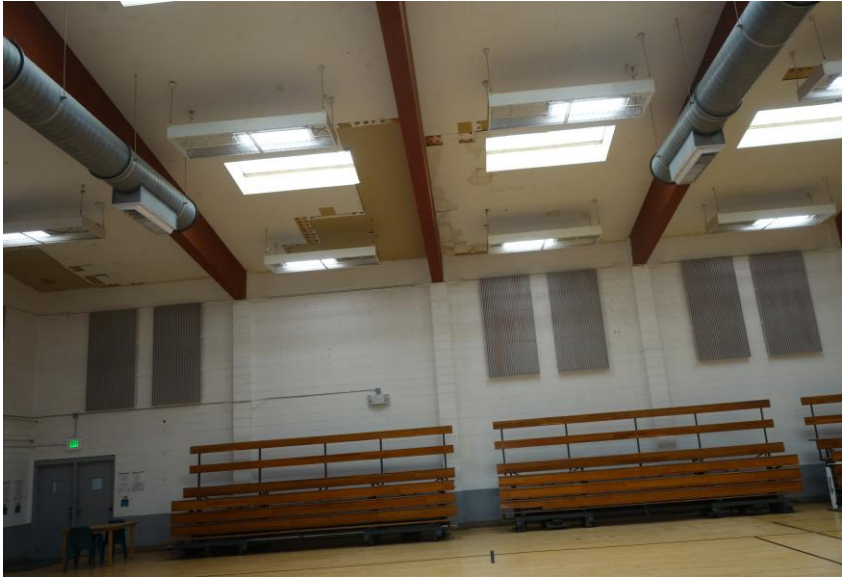
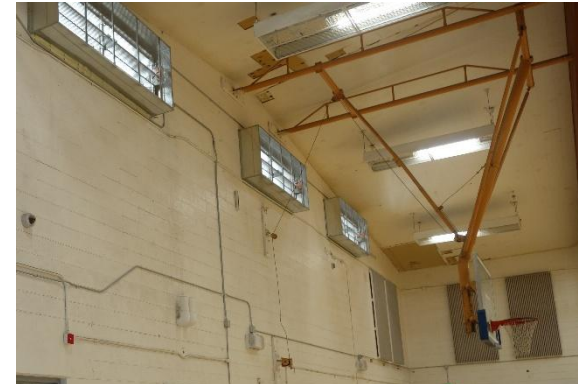
The ceiling in the Gym portion of this building is covered with acoustical ceiling tiles. The ceiling tiles are damaged and stained and many have fallen off of the substrate. This project would provide for the replacement of the ceiling tiles. Removal and disposal of the existing tiles is included in this estimate. Additional costs would be required if there is asbestos in the tiles or adhesive.

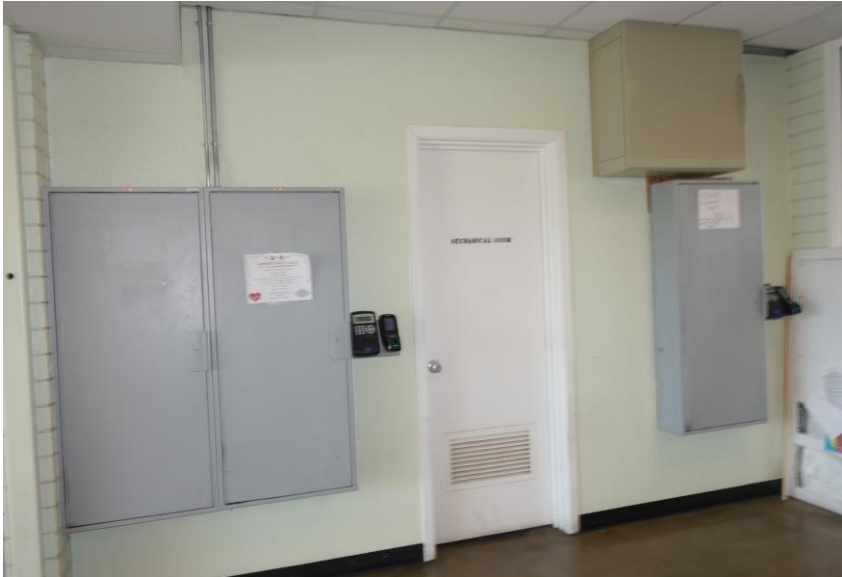
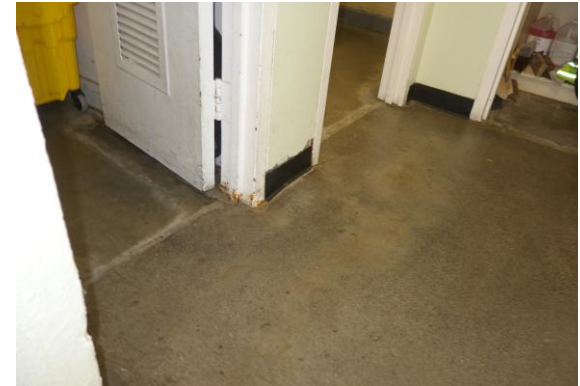
The interior doors are original to the building. Many are damaged, difficult to lock and operate and do not have lever action handles. This project would provide for the removal of the existing doors and the purchase and installation of new metal security grade doors and frames. All hardware and painting is included in this estimate. Hardware to match security lock format at the site.

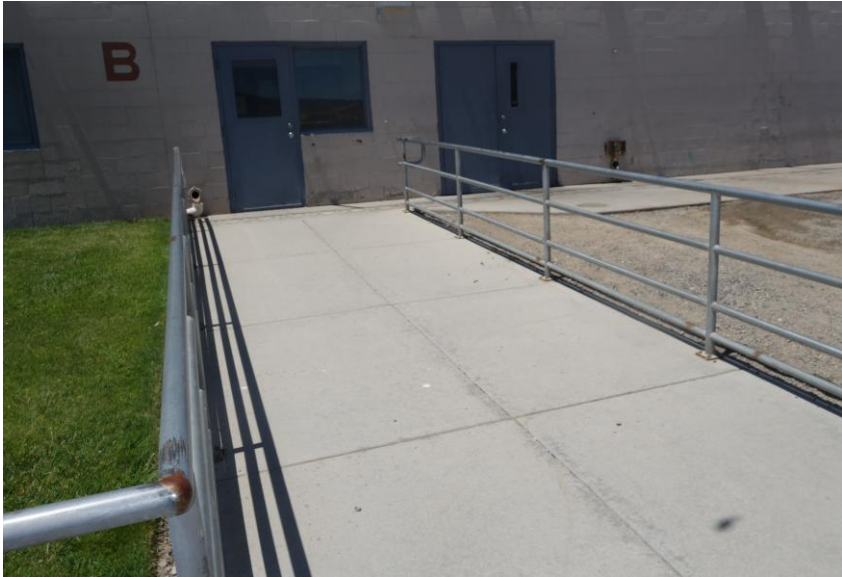
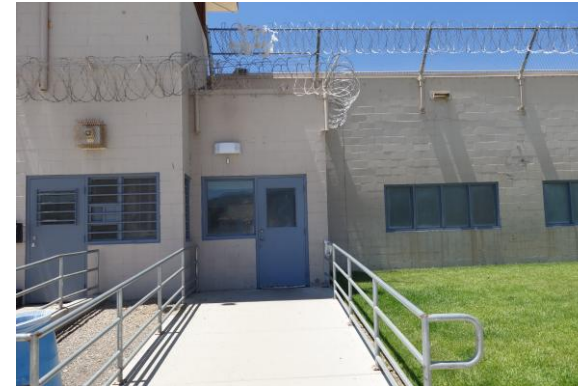
The existing exterior metal doors and frames appear to be original to the building. They are damaged from age and general wear and tear. This project would provide for the replacement and installation of 10 new security grade metal doors, frames and hardware. Removal and disposal of the existing doors and painting of the new doors is included in this estimate.

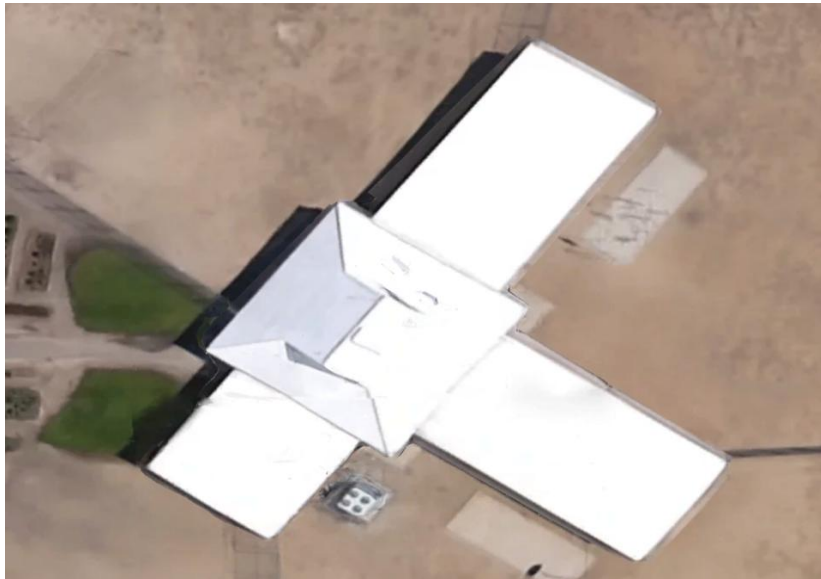
At the time of the survey, the portion of the building's membrane roof was found to be in fair condition. Installed in 1993, the current roofing system has exceeded its typical 20–25-year useful life, and the original warranty has expired. Harsh environmental conditions—such as temperature fluctuations, windborne sand and debris, and prolonged sun exposure—have accelerated deterioration. Re-roofing is recommended within the next 2 – 3 years to align with the statewide roofing program and address the aging system.

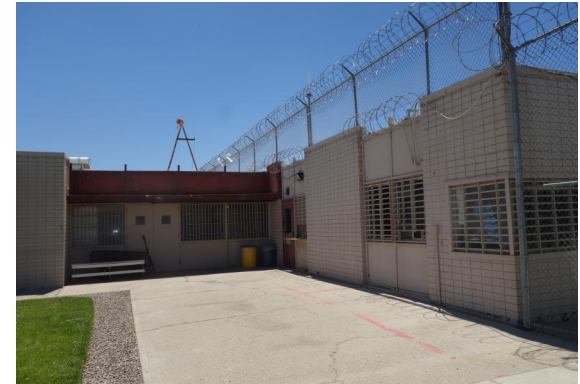
The exterior finishes of the building are in poor condition, and maintaining the building's finish, weather resistance, and appearance is essential. This project will provide funding to protect the exterior envelope of the building, excluding the roof. The scope includes painting, staining or sealing the exterior walls and caulking around windows, flashing, fixtures, and all other exterior penetrations. It is recommended that the building be painted and recaulked within the next 3 to 4 years and that this work be

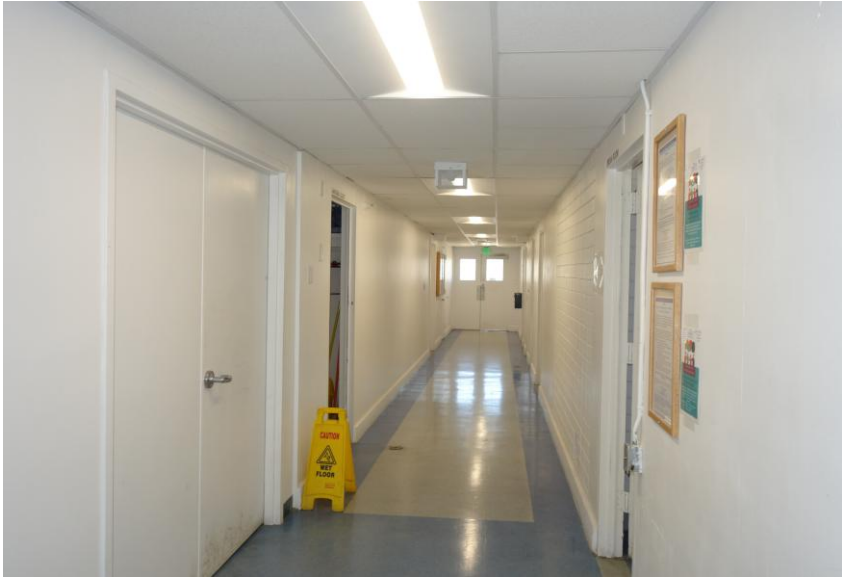
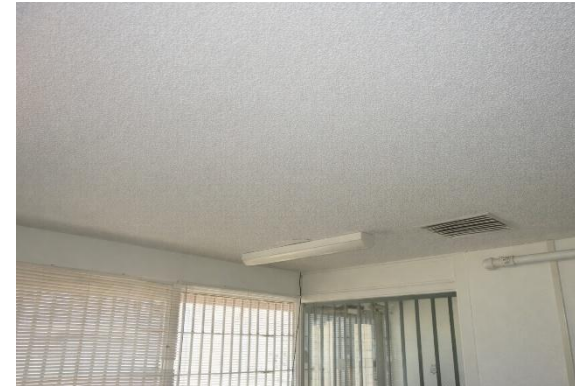
The interior finishes are in poor condition and require attention to maintain the building's overall appearance and integrity. It is recommended that the interior walls and ceilings be repainted within the next two to four years. Prior to painting, all surfaces should be properly repaired and prepared to ensure a durable and uniform finish. In wet or high-humidity areas, the use of an epoxy-based paint is recommended to enhance moisture resistance and durability. To preserve the quality of interior finishes and support

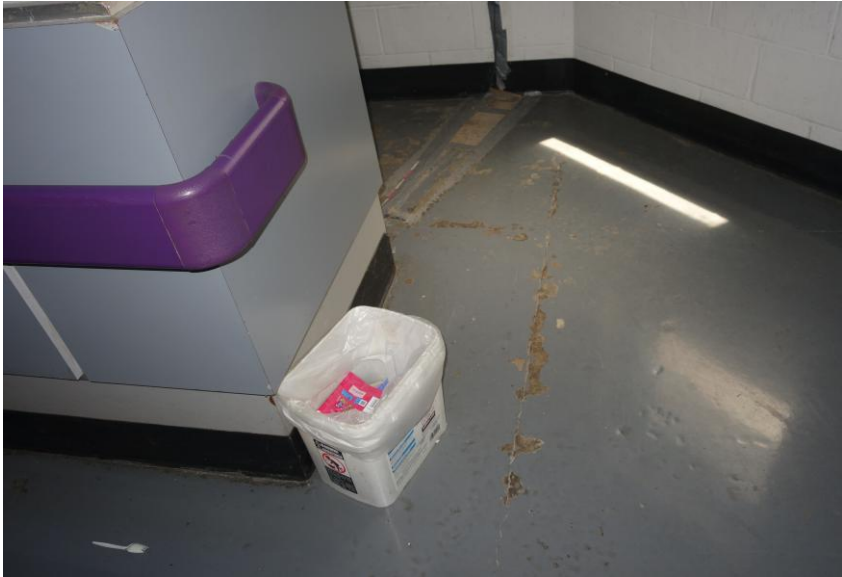
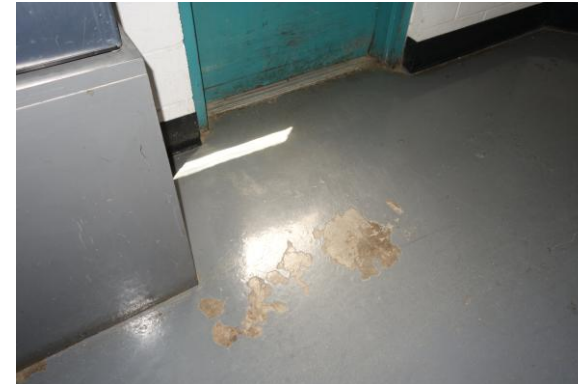
The epoxy flooring systems in the building are failing. The flooring is chipping and flaking in multiple rooms. This project recommends the replacement of the epoxy flooring. An estimate of 5,000 square feet of flooring area was used for this project.

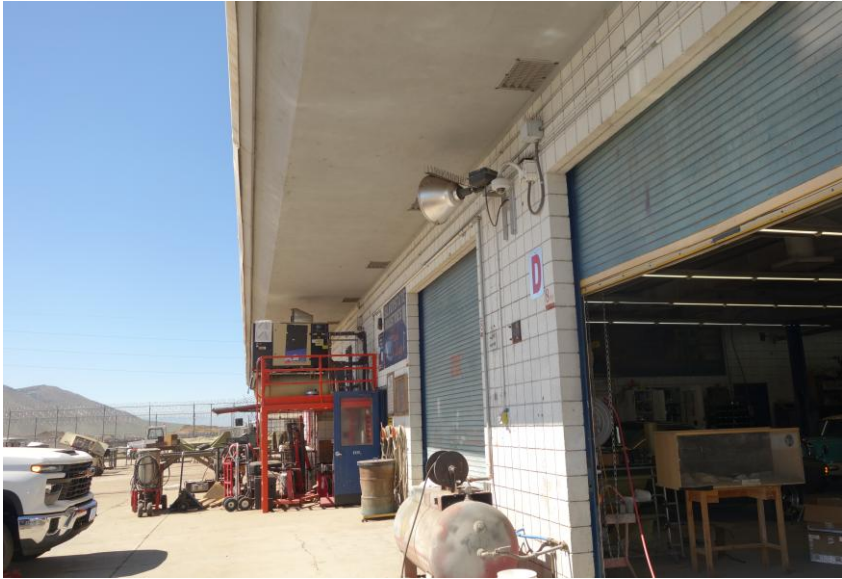
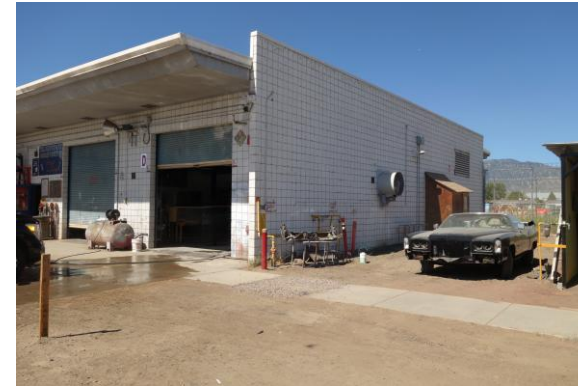
#### 0130-EXT-2: EXTERIOR FINISHES

The exterior finishes of the building are in poor condition, and maintaining the building's finish, weather resistance, and appearance is essential. This project will fund improvements to protect the exterior envelope of the building, excluding the roof. The scope includes painting, staining, or sealing the exterior walls, along with caulking around windows, flashing, fixtures, and all other exterior penetrations. It is recommended that this work be completed within the next 3 to 4 years and scheduled on a recurring

maintenance cycle to preserve the structural integrity and visual condition of the facility.

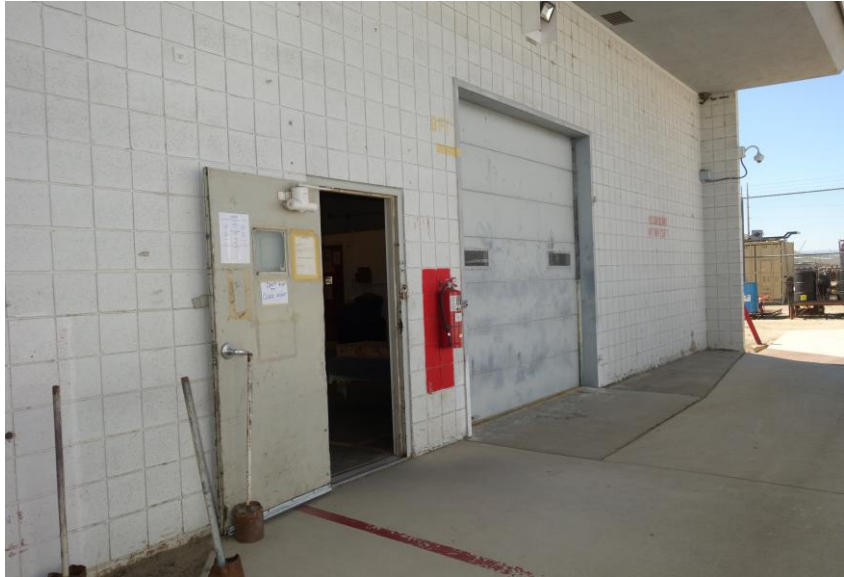
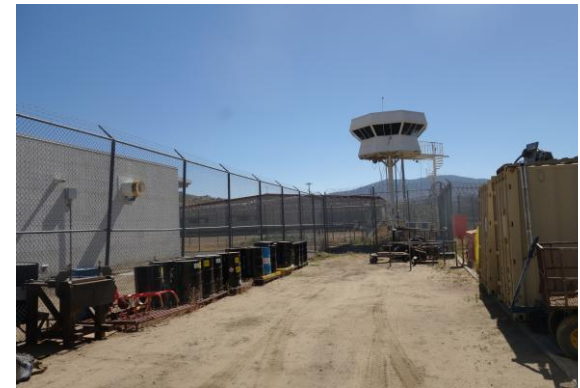
### DEFERRED BUILDING EXTERIOR - 8/19/2025 0131-EXT-2: EXTERIOR FINISHES

The exterior finishes of the building are in poor condition, and maintaining the building's finish, weather resistance, and appearance is essential. This project will fund improvements to protect the exterior envelope of the building, excluding the roof. The scope includes painting, staining, or sealing the exterior walls, along with caulking around windows, flashing, fixtures, and all other exterior penetrations. It is recommended that this work be completed within the next 3 to 4 years and scheduled on a recurring

maintenance cycle to preserve the structural integrity and visual condition of the facility.

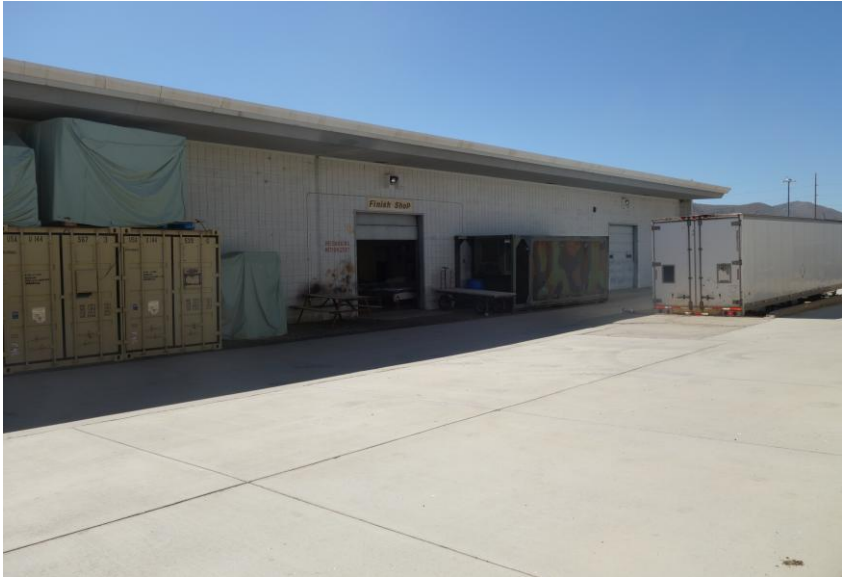
### 0127-EXT-2: EXTERIOR FINISHES

The exterior finishes of the building are in poor condition, and maintaining the building's finish, weather resistance, and appearance is essential. This project will fund improvements to protect the exterior envelope of the building, excluding the roof. The scope includes painting, staining, or sealing the exterior walls, along with caulking around windows, flashing, fixtures, and all other exterior penetrations. It is recommended that this work be completed within the next 3 to 4 years and scheduled on a recurring

maintenance cycle to preserve the structural integrity and visual condition of the facility.

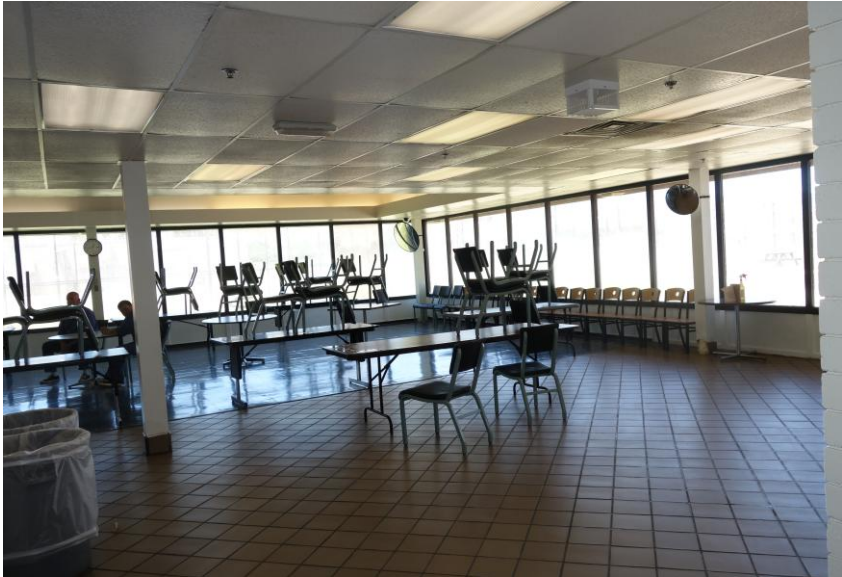
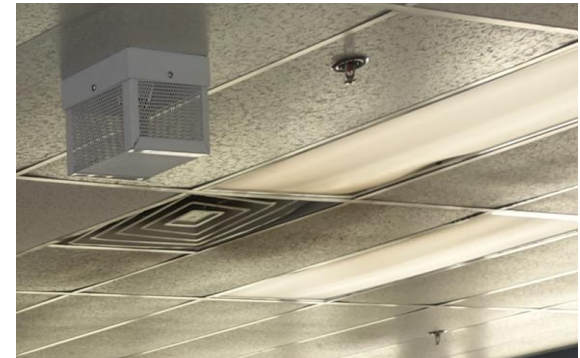
### **0135-INT-5: CEILING GRID REPLACEMENT**

The suspended acoustic tile ceiling system in the building is deteriorating, with bent and rusted T-bar framing and multiple damaged or stained tiles. This project includes the removal and disposal of the existing system and the installation of a new suspended acoustic ceiling, including new T-bar grid and tiles, to restore functionality and appearance.

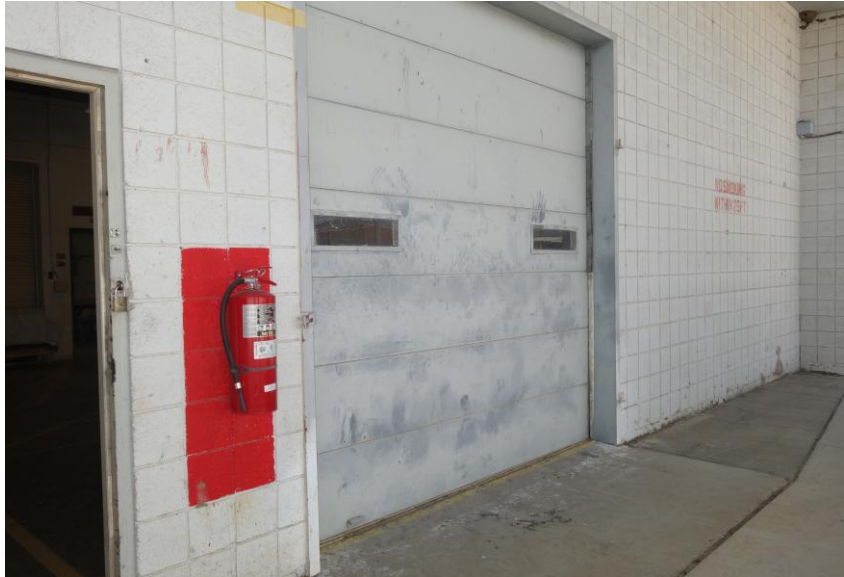
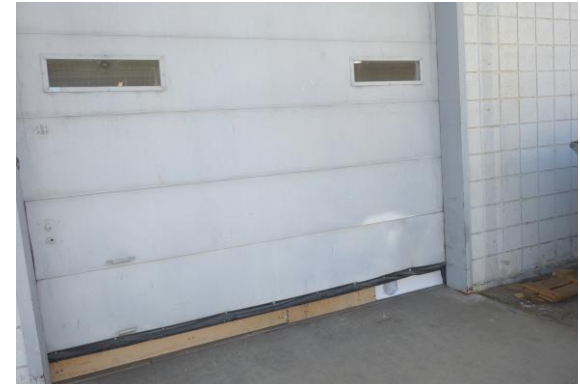
### **0131-EXT-9: OVERHEAD DOOR REPLACEMENT**

The existing overhead doors on the exterior of the building appear to be original to the structure. They show visible signs of physical damage and have increasingly become a source of maintenance issues. In addition to their deteriorating condition, the current doors lack modern energy efficiency features. This project recommends the complete replacement of the overhead doors, including all associated tracks and seals. Modern replacement doors offer significantly improved insulation and sealing, which will

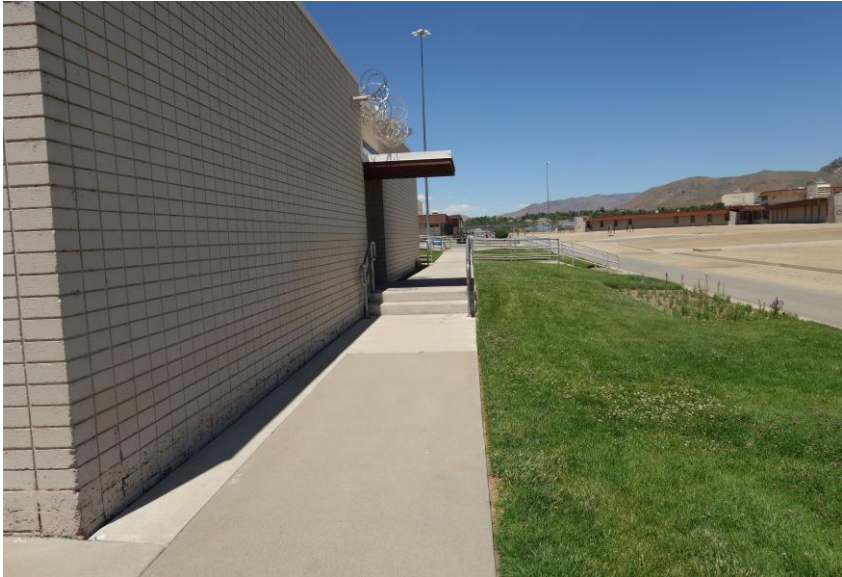
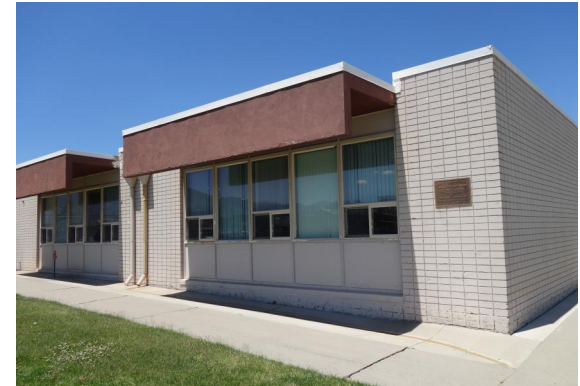
#### 1436-EXT-2: EXTERIOR FINISHES

The exterior finishes of the building are in poor condition, and maintaining the building's finish, weather resistance, and appearance is essential. This project will fund improvements to protect the exterior envelope of the building, excluding the roof. The scope includes painting, staining, or sealing the exterior walls, along with caulking around windows, flashing, fixtures, and all other exterior penetrations. It is recommended that this work be completed within the next 3 to 4 years and scheduled on a recurring

maintenance cycle to preserve the structural integrity and visual condition of the facility.

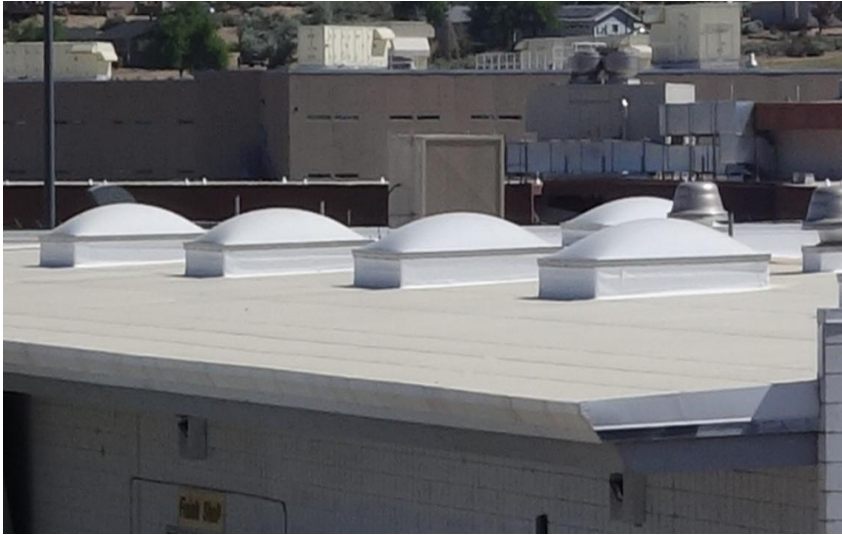
### NEW BUILDING EXTERIOR - 8/19/2025 0131-EXT-7: SKYLIGHT REPLACEMENT

A watertight roof—including properly functioning skylights—is essential to preserving the valuable assets within a building. The existing skylights appear to have been installed during the re-roof of 1994. They are now beyond their useful life. This project recommends the complete replacement of the existing skylights, along with a thorough inspection of the skylight curbs and any necessary repairs. Replacement skylights must meet OSHA 29 CFR 1910.28(b)(3) fall protection guards. This work should be coordinated with the replacement of the single-ply roofing membrane to ensure a comprehensive and integrated roofing solution.

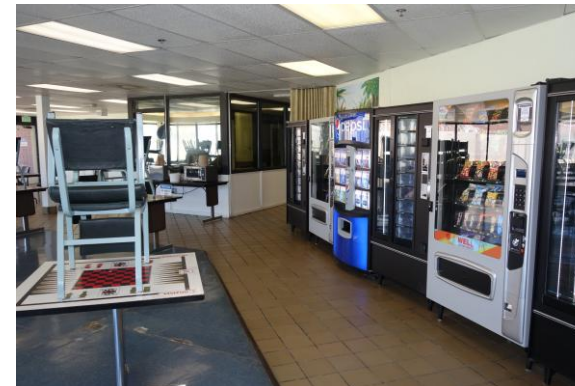
### 0135-INT-3: INTERIOR FINISHES

The interior finishes are in poor condition and require attention to maintain the building's overall appearance and integrity. It is recommended that the interior walls and ceilings be repainted within the next two to four years. Prior to painting, all surfaces should be properly repaired and prepared to ensure a durable and uniform finish. In wet or high-humidity areas, the use of an epoxy-based paint is recommended to enhance moisture resistance and durability. To preserve the quality of interior finishes and support

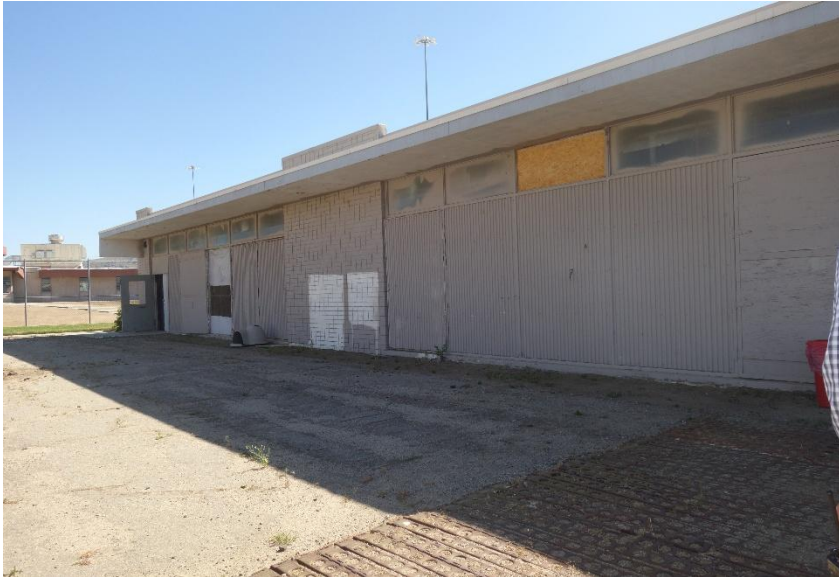
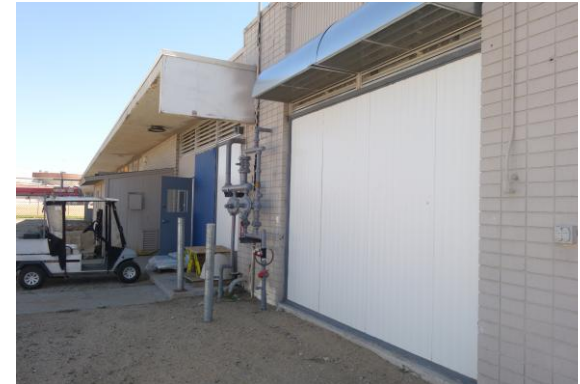
#### 0128-EXT-3: EXTERIOR FINISHES

The exterior finishes of the building are in poor condition, and maintaining the building's finish, weather resistance, and appearance is essential. This project will fund improvements to protect the exterior envelope of the building, excluding the roof. The scope includes painting, staining, or sealing the exterior walls, along with caulking around windows, flashing, fixtures, and all other exterior penetrations. It is recommended that this work be completed within the next 3 to 4 years and scheduled on a recurring

maintenance cycle to preserve the structural integrity and visual condition of the facility.

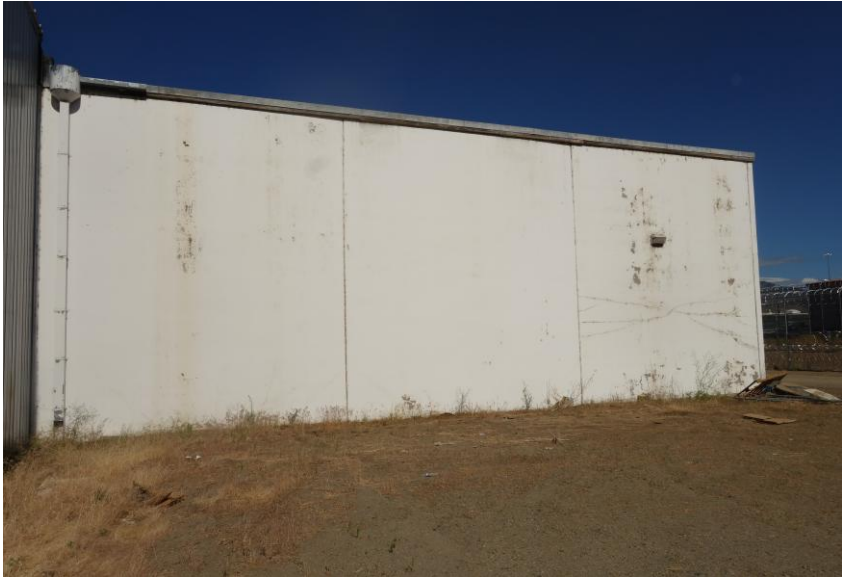
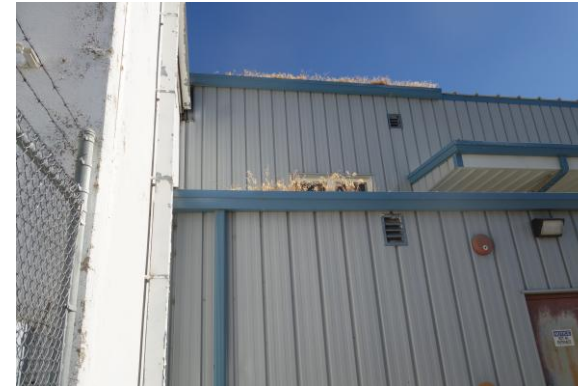
### 2004-EXT-2: EXTERIOR FINISHES

The exterior finishes of the building are in poor condition, and maintaining the building's finish, weather resistance, and appearance is essential. This project will fund improvements to protect the exterior envelope of the building, excluding the roof. The scope includes painting, staining, or sealing the exterior walls, along with caulking around windows, flashing, fixtures, and all other exterior penetrations. It is recommended that this work be completed within the next 3 to 4 years and scheduled on a recurring

maintenance cycle to preserve the structural integrity and visual condition of the facility.

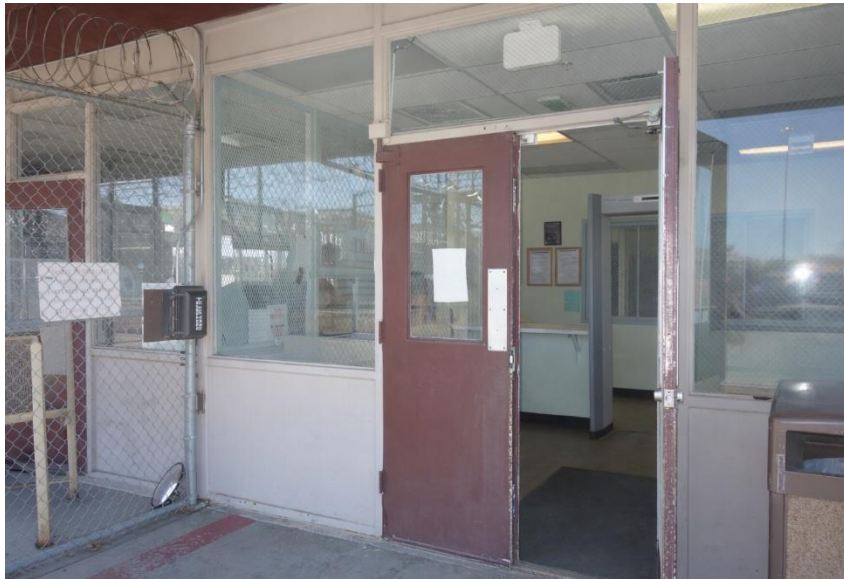
### **0124-EXT-4: EXTERIOR DOOR REPLACEMENT**

The existing exterior metal doors and frames appear to be original to the building and show signs of damage due to age and general wear. This project will fund the removal and disposal of the existing units and the replacement with security-grade metal doors, complete with frames and hardware. The scope also includes painting the new doors to ensure durability and a consistent exterior finish. Hardware to match security lock format at the site.

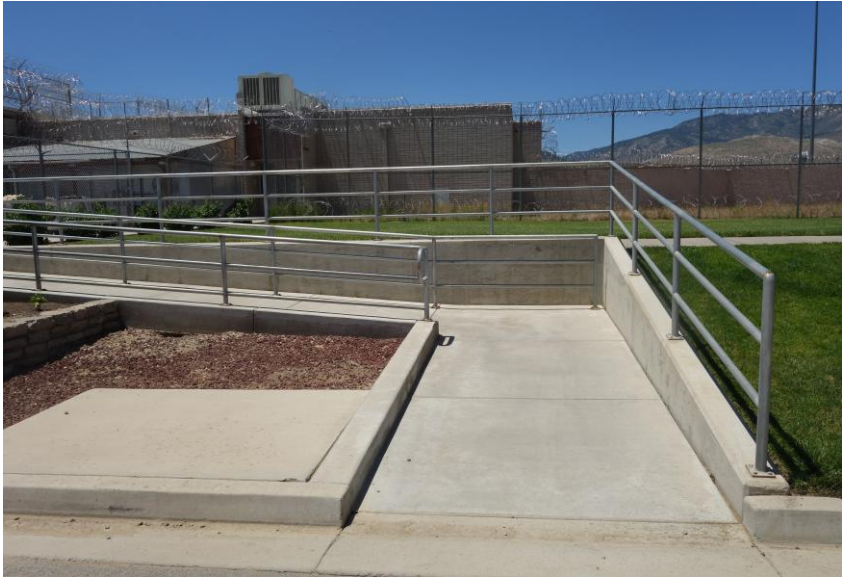
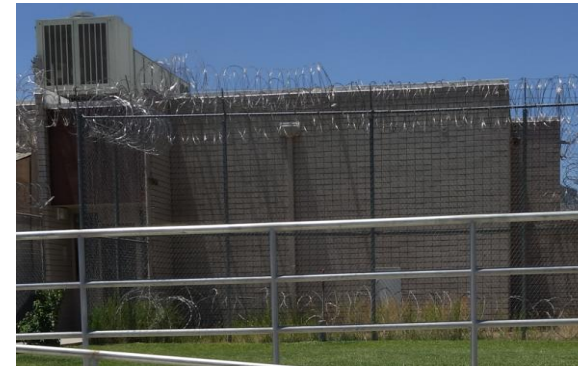
#### 0135-EXT-3: EXTERIOR FINISHES

The exterior finishes of the building are in poor condition, and maintaining the building's finish, weather resistance, and appearance is essential. This project will fund improvements to protect the exterior envelope of the building, excluding the roof. The scope includes painting, staining, or sealing the exterior walls, along with caulking around windows, flashing, fixtures, and all other exterior penetrations. It is recommended that this work be completed within the next 3 to 4 years and scheduled on a recurring

maintenance cycle to preserve the structural integrity and visual condition of the facility.

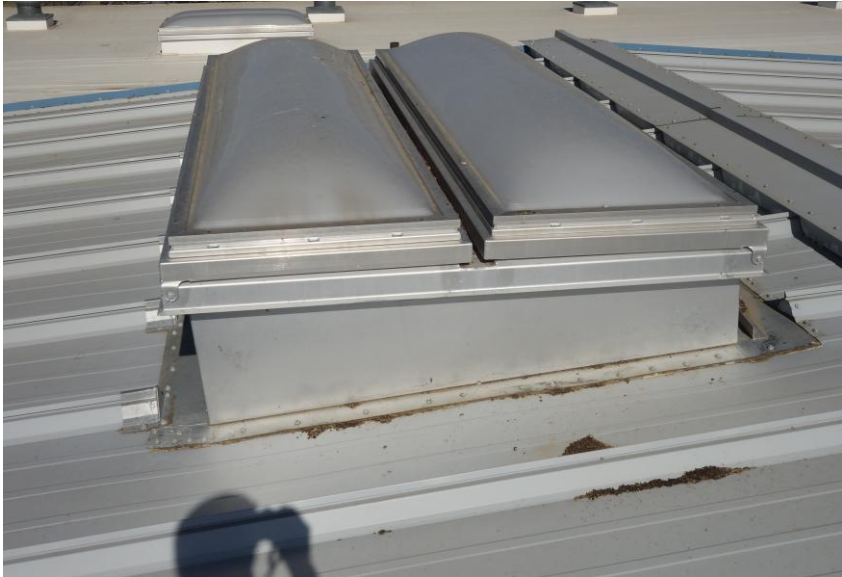
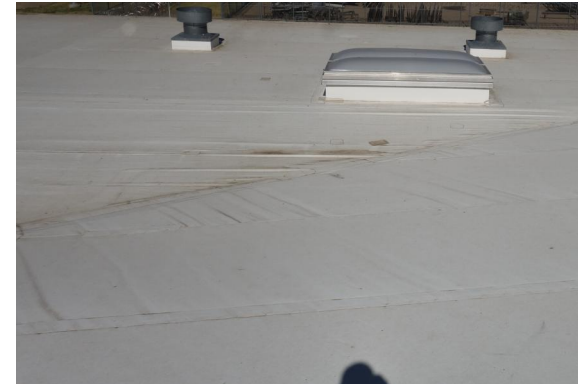
### NEW BUILDING EXTERIOR - 9/29/2025 2004-EXT-5: SKYLIGHT REPLACEMENT

A watertight roof—including properly functioning skylights—is essential to preserving the valuable assets within a building. The existing skylights have experienced multiple leaks and undergone a series of repairs over time. They are now beyond their useful life. This project recommends the complete replacement of the existing skylights, along with a thorough inspection of the skylight curbs and any necessary repairs. Replacement skylights must meet OSHA 29 CFR 1910.28(b)(3) fall protection guards. This work should be coordinated with the replacement of the single-ply roofing

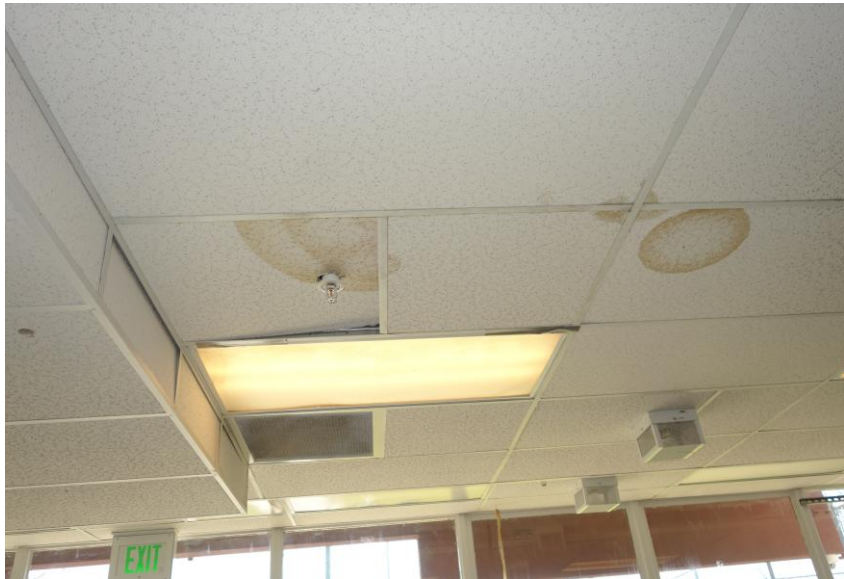
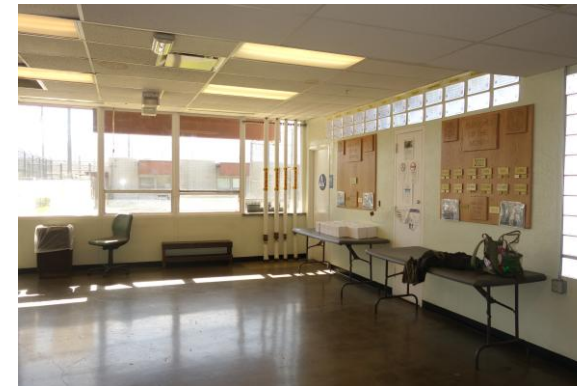
### **0124-INT-1: CEILING TILE REPLACEMENT**

The ceiling in this building is finished with acoustical ceiling tiles, many of which are damaged, stained, or coming loose from the substrate. This project will fund the removal and disposal of the existing tiles and the installation of new ceiling tiles to restore functionality and appearance. Additional costs may be incurred if asbestos is found in the existing tiles or adhesive.

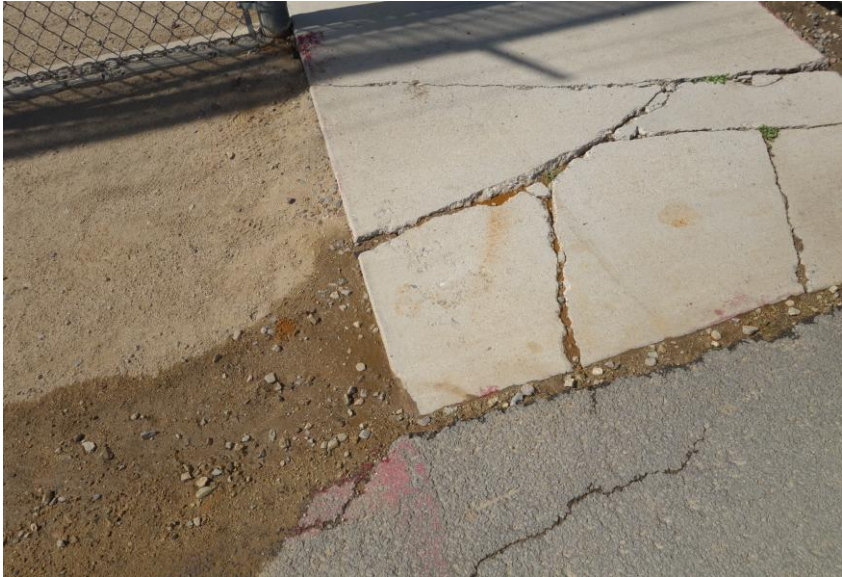
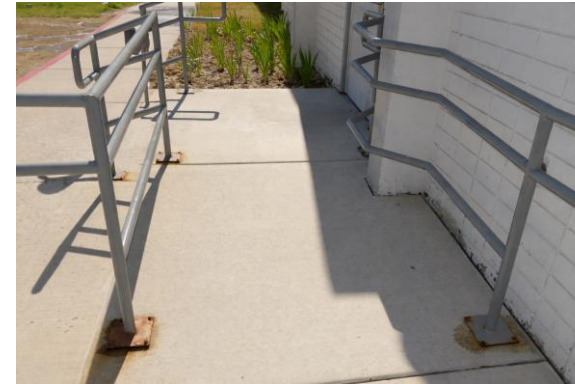
#### 0133-SIT-1: CONCRETE FLATWORK REPLACEMENT

The building perimeter has concrete curbs, ramps and / or flatwork surrounding the building. Some sections have deteriorated or settled over time, resulting in noncompliant slopes and trip hazards. This project proposes the replacement of damaged flatwork, incorporating any necessary accessibility upgrades.

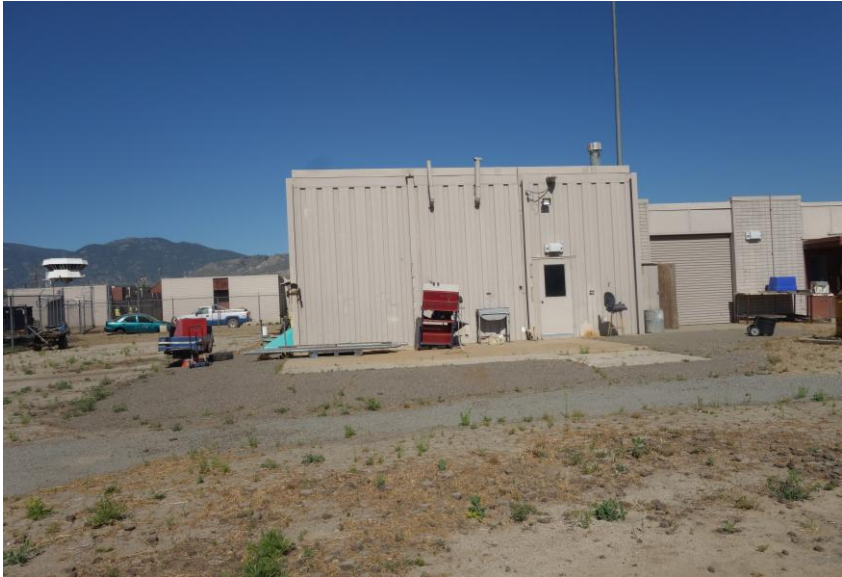
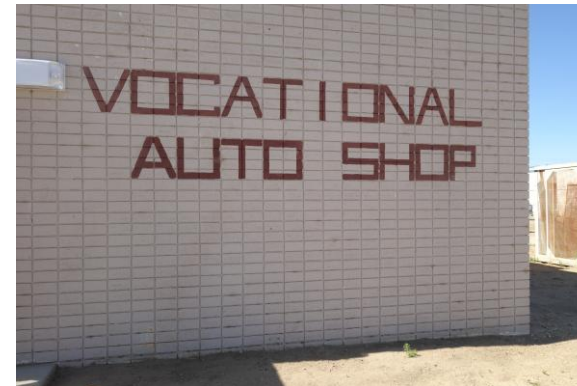
#### 0150-EXT-2: EXTERIOR FINISHES

The exterior finishes of the building are in poor condition, and maintaining the building's finish, weather resistance, and appearance is essential. This project will fund improvements to protect the exterior envelope of the building, excluding the roof. The scope includes painting, staining, or sealing the exterior walls, along with caulking around windows, flashing, fixtures, and all other exterior penetrations. It is recommended that this work be completed within the next 3 to 4 years and scheduled on a recurring

maintenance cycle to preserve the structural integrity and visual condition of the facility.
