DEPARTMENT OF ADMINISTRATION  
STATE PUBLIC WORKS DIVISION  
FACILITY CONDITION ASSESSMENT

### PROPERTY PORTFOLIO REVIEW PROJECT ADDENDUM

NORTHWEST REGION  
NORTHERN NEVADA CORRECTIONAL CENTER COMPLEX  
9990 - NORTHERN NEVADA CORRECTIONAL CENTER SITE  
1721 E SNYDER AVE  
CARSON CITY, NV 89701-7812  
CARSON CITY COUNTY

SURVEY DATE: 06/12/2024

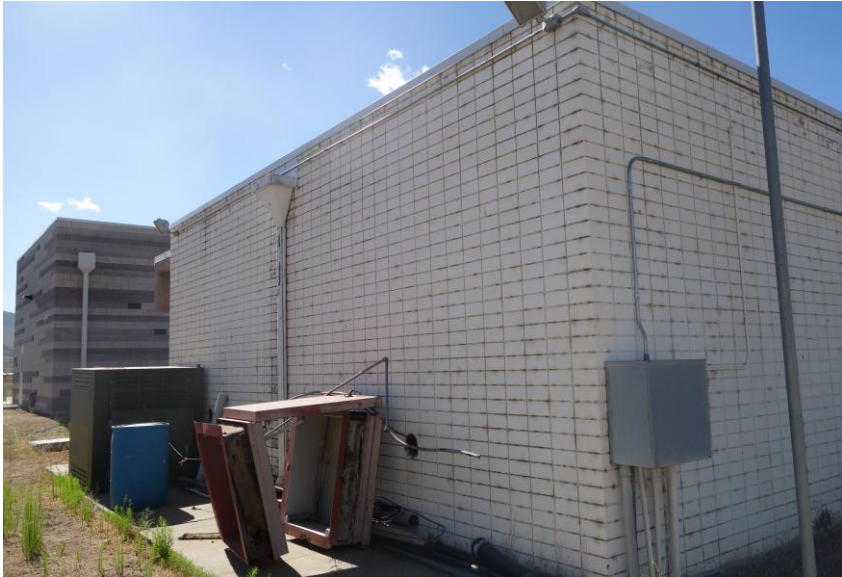
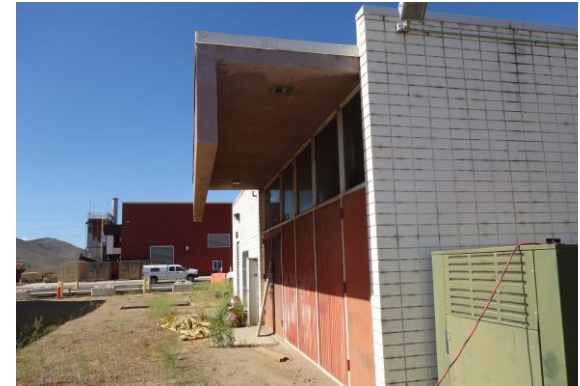
### 0143-EXT-2: EXTERIOR FINISHES

It is important to maintain the finish, weather resistance and appearance of the building. This project would provide funding to protect the exterior of the building excluding the roof. Included in the cost is painting the stucco and concrete masonry unit walls and caulking of the windows, flashing, fixtures and all other penetrations. It is recommended that the building be painted and caulked in the next 2 - 3 years and that this project is scheduled on a cyclical basis to maintain the integrity of the structure.

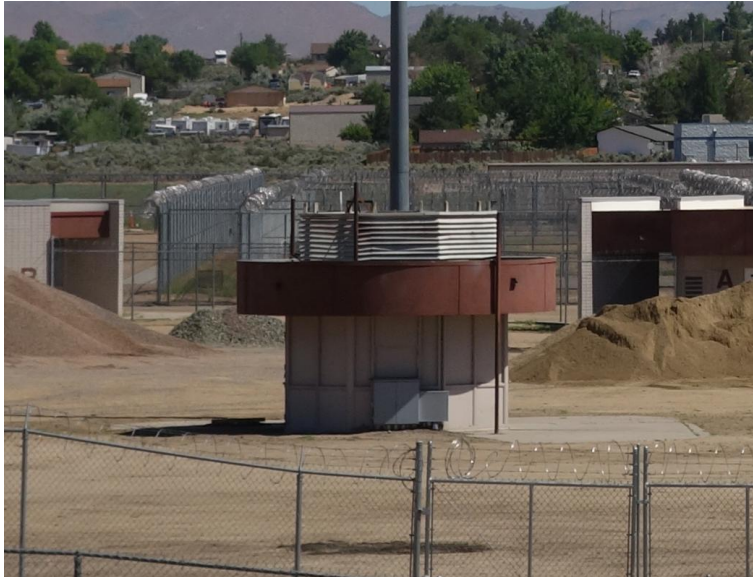
### 0132-EXT-2: EXTERIOR FINISHES

The exterior finishes of the building are in poor condition, and maintaining the building's finish, weather resistance, and appearance is essential. This project will fund improvements to protect the exterior envelope of the building, excluding the roof. The scope includes painting, staining, or sealing the exterior walls, along with caulking around windows, flashing, fixtures, and all other exterior penetrations. It is recommended that this work be completed within the next 3 to 4 years and scheduled on a recurring

maintenance cycle to preserve the structural integrity and visual condition of the facility.

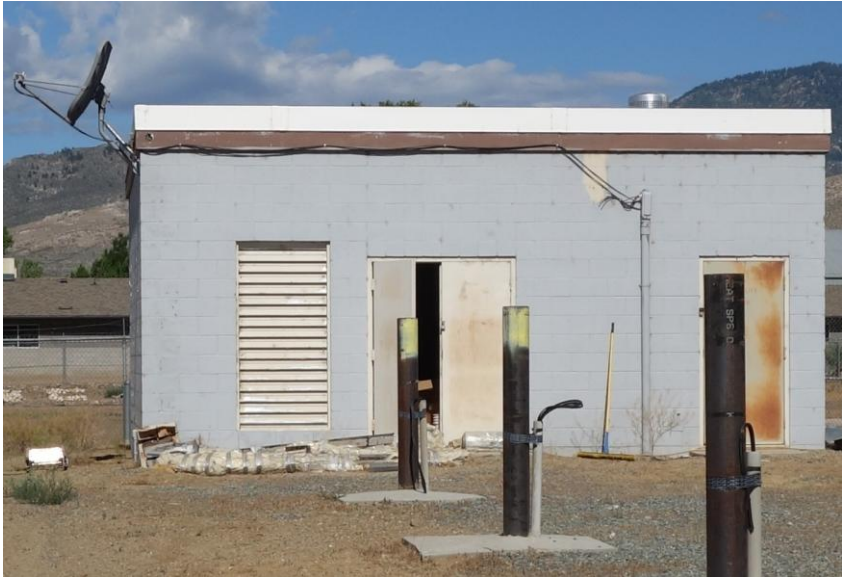
### 2006-EXT-1: EXTERIOR FINISHES

It is important to maintain the finish, weather resistance and appearance of the building. This project would provide funding to protect the exterior of the building excluding the roof. Included in the cost is painting the concrete masonry unit walls and caulking of the flashing, fixtures and all other penetrations. It is recommended that the building be painted and caulked in the next 2 - 3 years and that this project is scheduled on a cyclical basis to maintain the integrity of the structure.

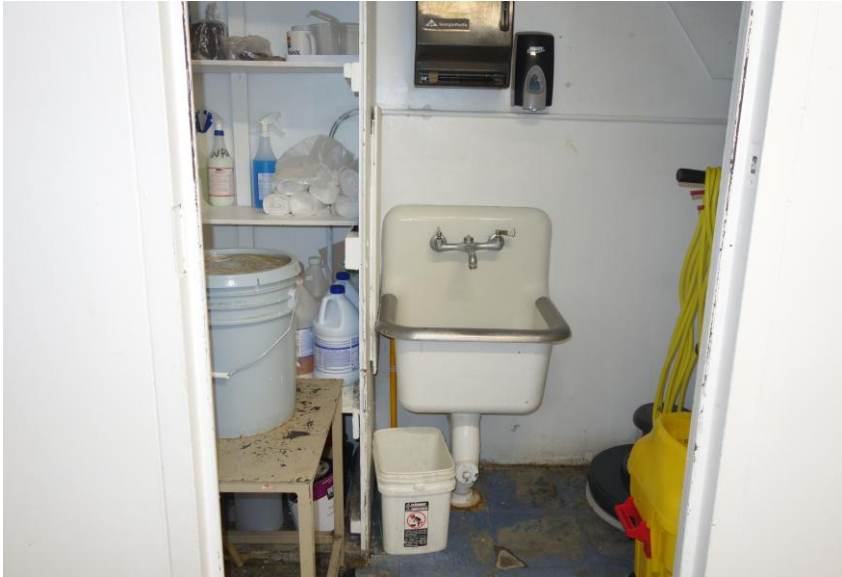
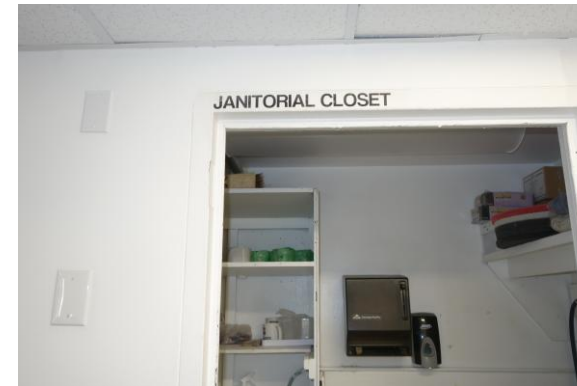
### DEFERRED BUILDING INTERIOR - 8/1/2025 0125-INT-5: JANITORS CLOSET REPAIRS

The mop sink in the Janitors Closets is mounted adjacent to gypsum board and is showing signs of water damage. This project would provide fiberglass reinforced panels (FRP) to be installed on the walls adjacent to the mop sink. The FRP shall extend two feet beyond the edge of the sink and a minimum of 54" above the floor finish.

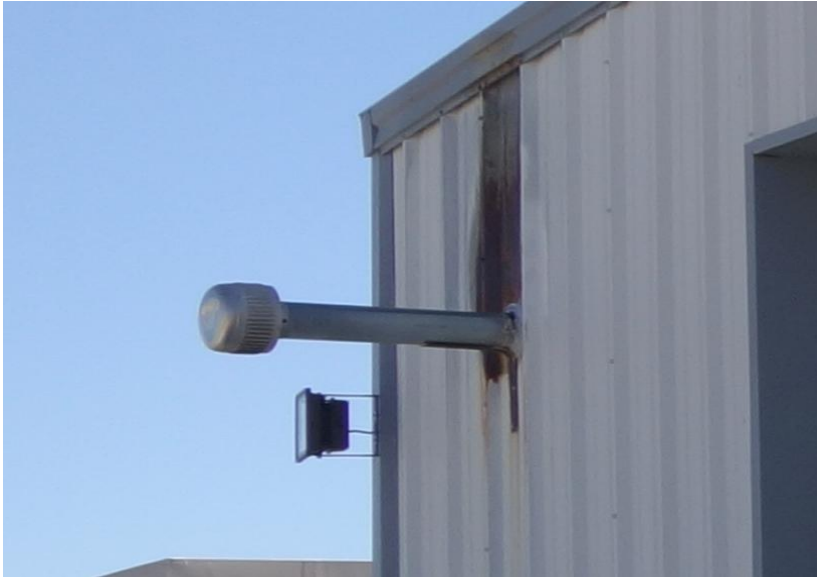
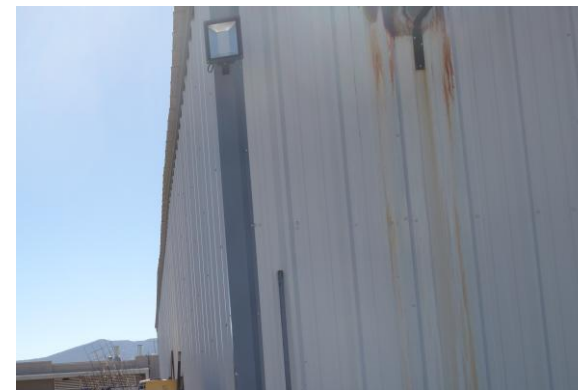
### 2557-HVA-1: FLUE REPLACEMENT

A flue from a gas fired unit heater exits on the side of the building through the pre-finished metal siding. The siding is getting severely stained and possibly damaged by what appears to be escaping flue gases from the flue penetration through the wall. This project recommends a complete replacement of the flue and wall thimble, and repair of the metal siding.

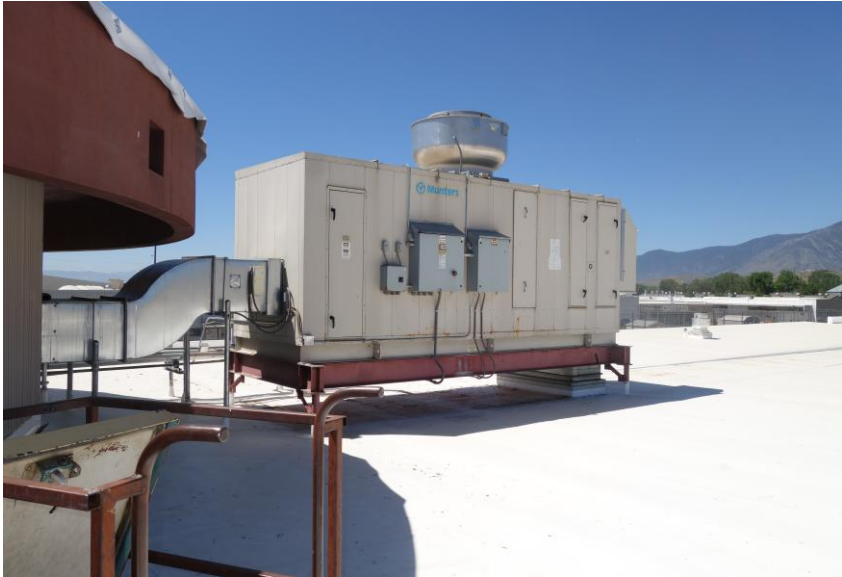
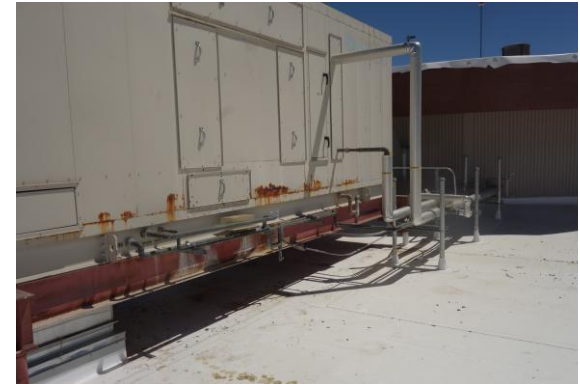
### **0140-HVA-2: HVAC REPLACEMENT**

The existing HVAC system has been in continuous operation since 2007 and is nearing the end of its serviceable life. As the equipment ages, maintenance costs and the risk of failure continue to rise. HVAC equipment failure causes a major disruption for the occupants that may cause temporary relocation until equipment repairs are completed. Budget planning should begin to support system replacement within the next 6–8 years.

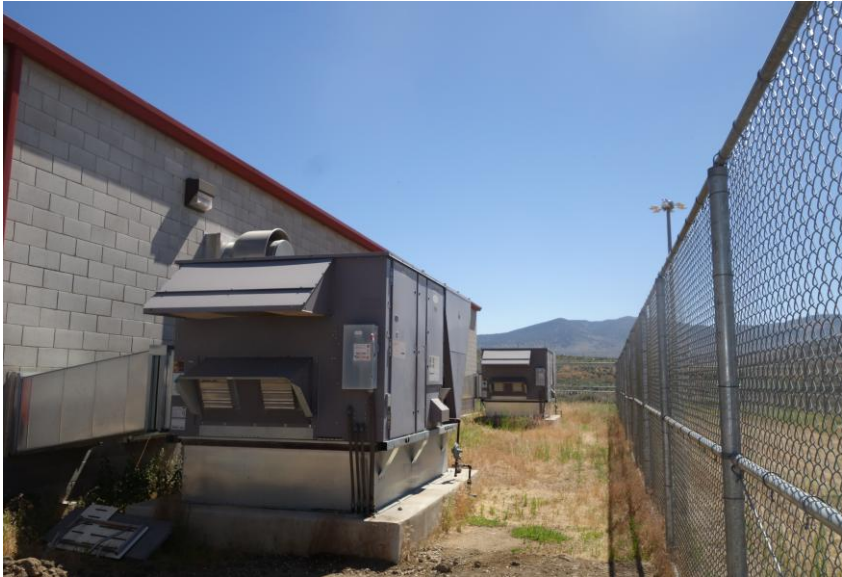
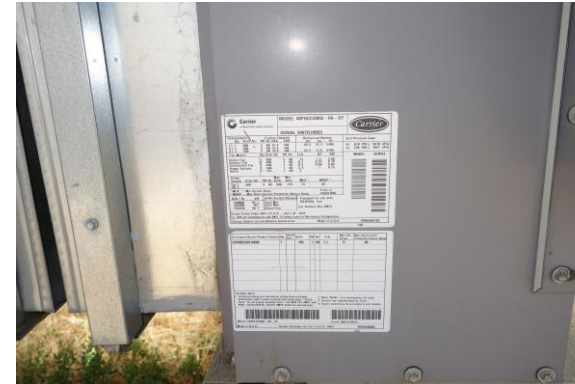
### **2785-HVA-1: HVAC EQUIPMENT REPLACEMENT**

The existing HVAC system serving the building is approaching 20 years of service, which is the typical expected lifespan for most HVAC equipment. Given its age and the likelihood of decreased efficiency and reliability, it is recommended that planning begin for the replacement of the equipment within the next 7 to 9 years. This project also recommends the replacement of the Direct Digital Control (DDC) system that manages them. The proposed project scope will involve the demolition and proper disposal of all existing HVAC equipment, followed by the installation of new, energy-

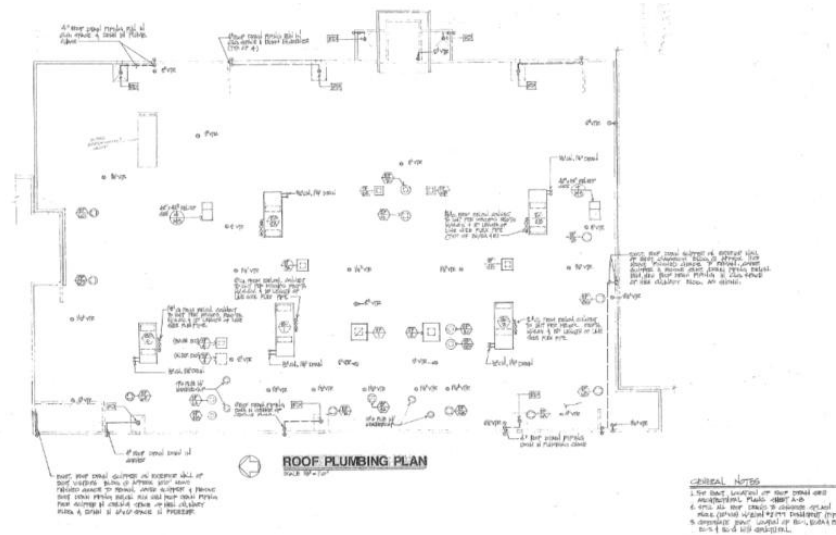
#### 0129-HVA-1: HVAC EQUIPMENT REPLACEMENT

The existing HVAC system serving the building is approaching 20 years of service, which is the typical expected lifespan for most HVAC equipment. Given its age and the likelihood of decreased efficiency and reliability, it is recommended that planning begin for the full replacement of the system within the next 7 to 9 years. This includes not only the HVAC units themselves but also the Direct Digital Control (DDC) system that manages them. The proposed project scope will involve the demolition and proper disposal of all existing HVAC equipment, followed by the installation of new, energy-efficient systems that meet current performance and code requirements.

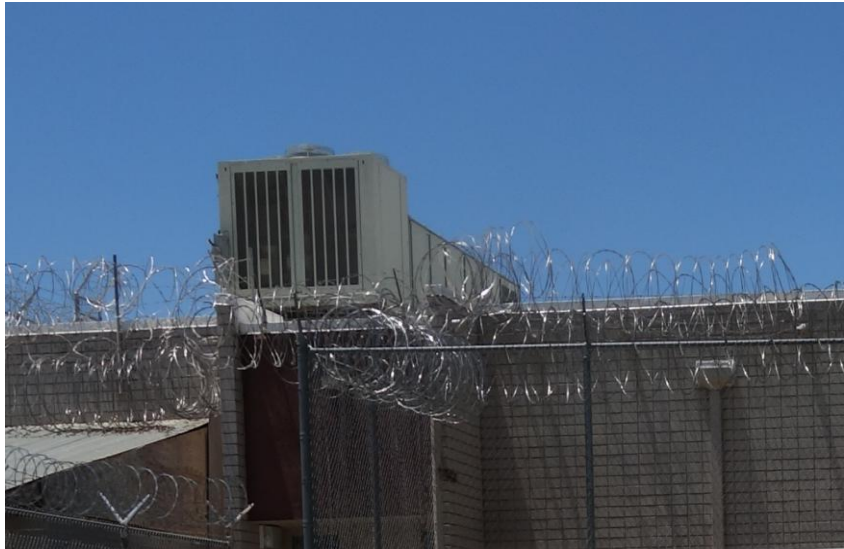
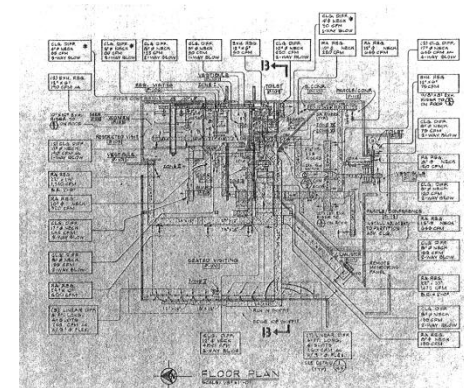
#### 0135-HVA-2: HVAC EQUIPMENT REPLACEMENT

The existing HVAC system serving the building is approaching 20 years of service, which is the typical expected lifespan for most HVAC equipment. Given its age and the likelihood of decreased efficiency and reliability, it is recommended that planning begin for the replacement of the equipment within the next 5 to 7 years. This project also recommends the replacement of the Direct Digital Control (DDC) system that manages them. The proposed project scope will involve the demolition and proper disposal of all existing HVAC equipment, followed by the installation of new, energy-

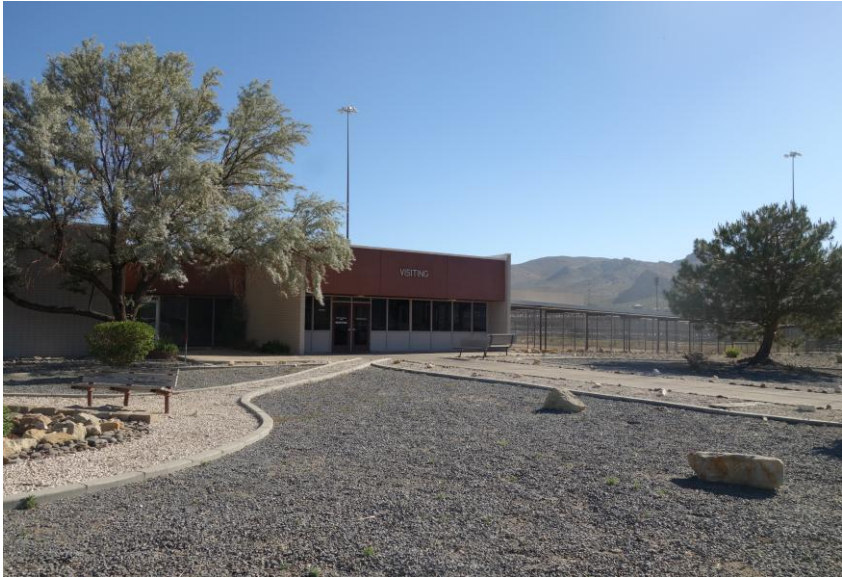
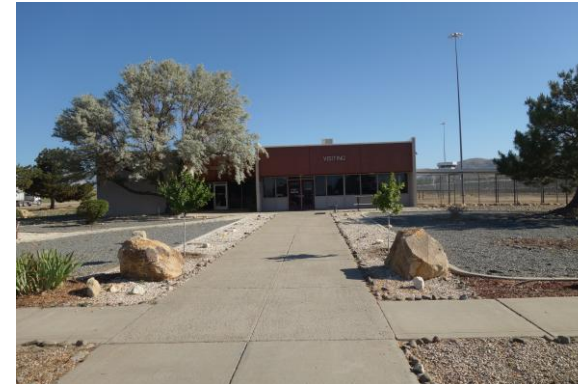
#### 0136-EXT-2: EXTERIOR FINISHES

maintenance cycle to preserve the structural integrity and visual condition of the facility.

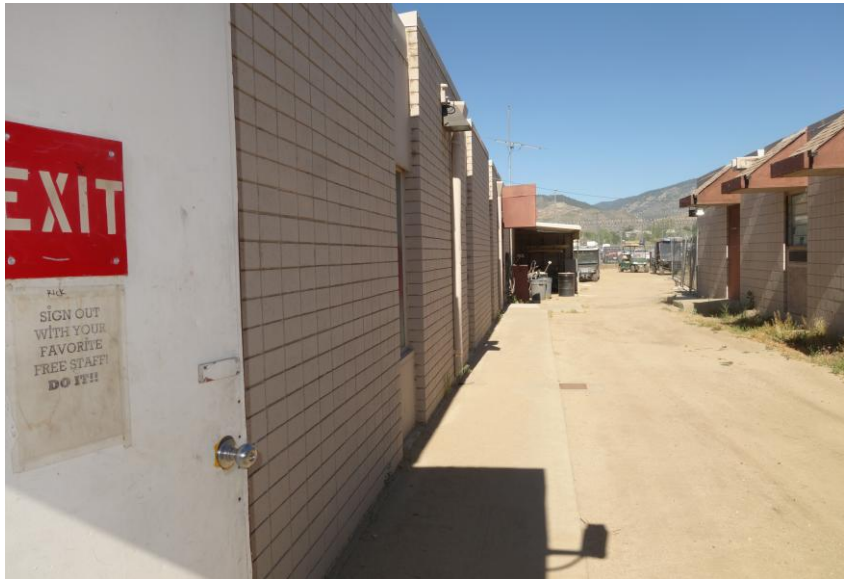
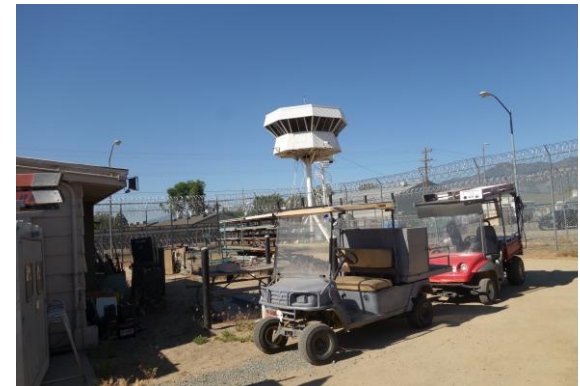
### REINSTATED BUILDING EXTERIOR - 11/4/2025 0126-EXT-2: EXTERIOR FINISHES

The exterior finishes are in fair condition. It is important to maintain the finish, weather resistance and appearance of the building. This project would provide funding to protect the exterior of the building excluding the roof. Included in the cost is painting the concrete masonry unit walls and caulking of the windows, flashing, fixtures and all other penetrations. It is recommended that the building be painted and caulked in the next 5 - 7 years and that this project is scheduled on a cyclical basis to maintain the integrity of the structure.

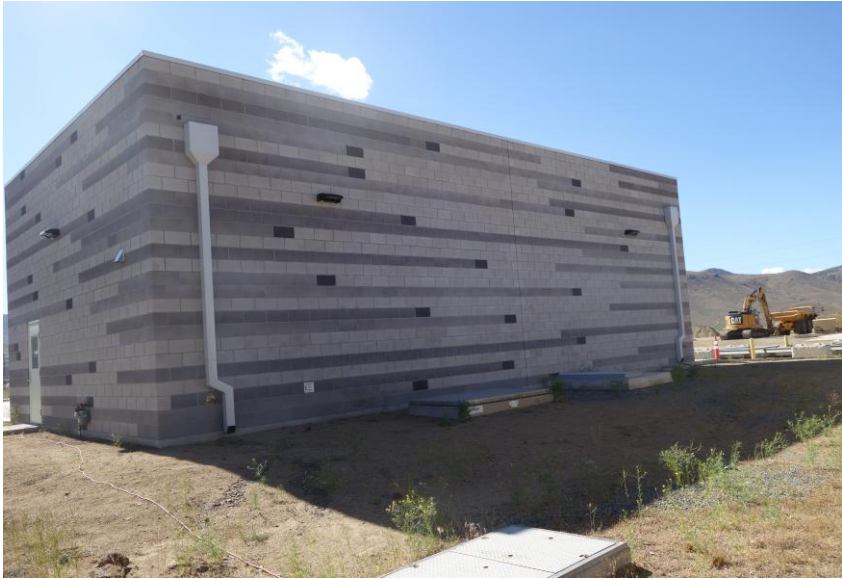
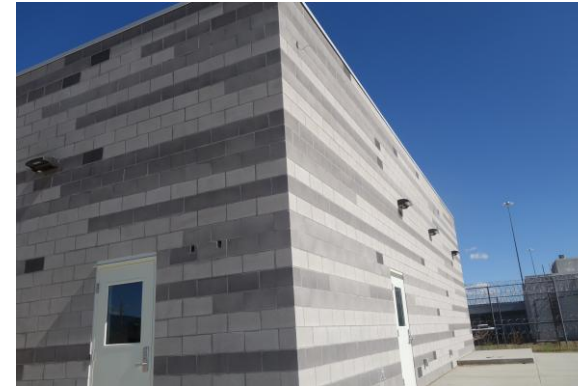
#### 4510-EXT-1: EXTERIOR FINISHES

maintenance cycle to preserve the structural integrity and visual condition of the facility.
