State of Nevada  
Department of Health & Human Services  
Aging and Disability Services Division

# DESERT REGIONAL CENTER SITE

1391 South Jones Blvd.  
Las Vegas, Nevada 89146

**Site Number: 9993**  
**STATE OF NEVADA PUBLIC WORKS DIVISION**  
**FACILITY CONDITION ANALYSIS**

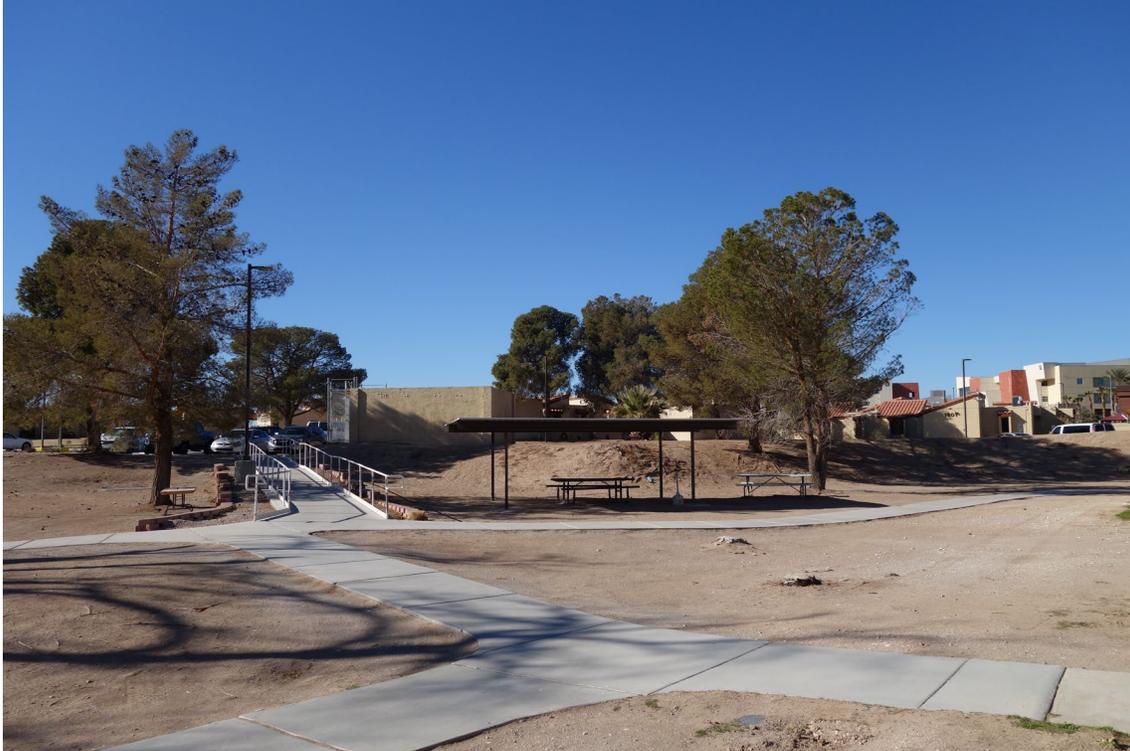
Desert Regional Center Site – FCA Site #9993 (Building # 2755 thru 2772)  
Description: Site Wide Storage Shed Roof Replacement Needed.
