HISTORICAL OVERVIEW OF THE NEVADA STATE CAPITOL AND CAPITOL ANNEX

EXISTING CONDITIONS AND OBSERVATIONS

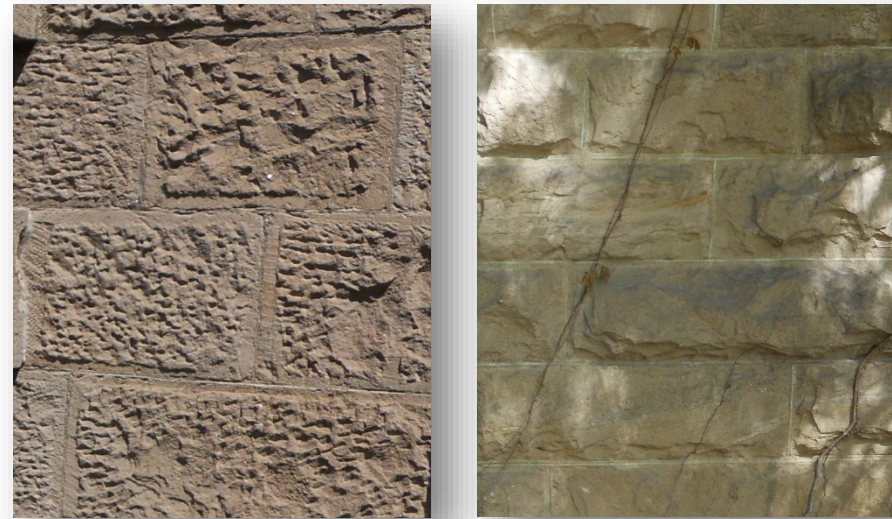
Capitol Building masonry versus Annex Building masonry

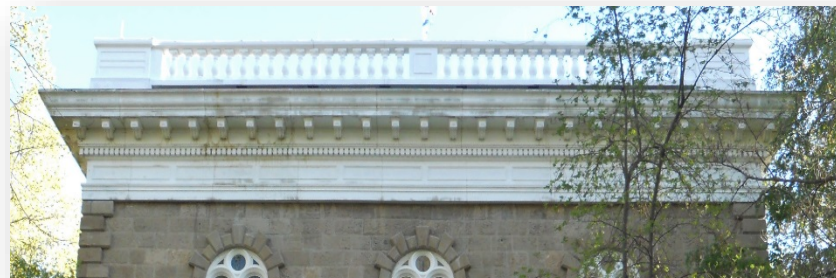
The use of fiberglass from the entablature to the roof balustrades.

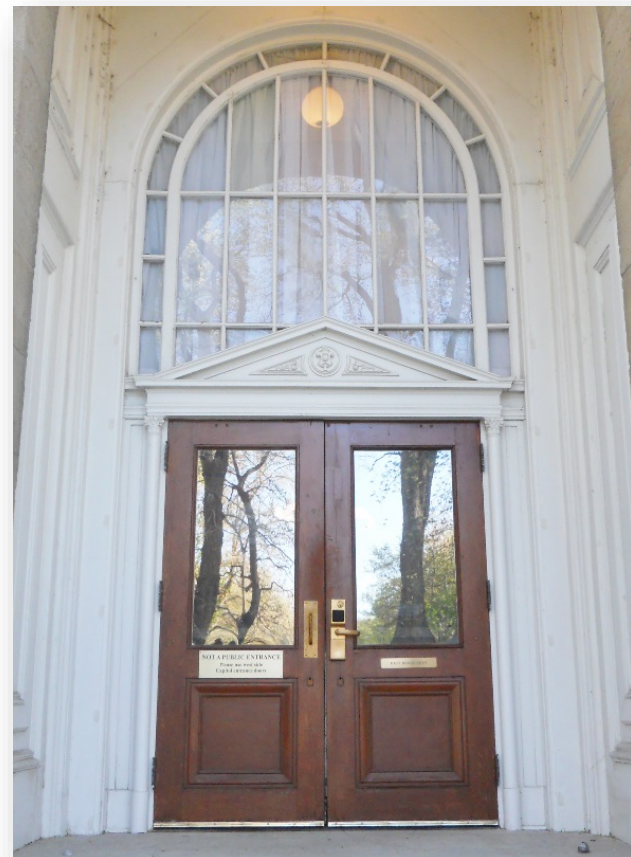
Most doors are inset from the exterior face of the building and somewhat protected from the rain and snow. The wood doors all appear to be in good condition with the exception of the door noted previously.

Typical wood stained doors contrast with the white ornamentation surrounding doors.

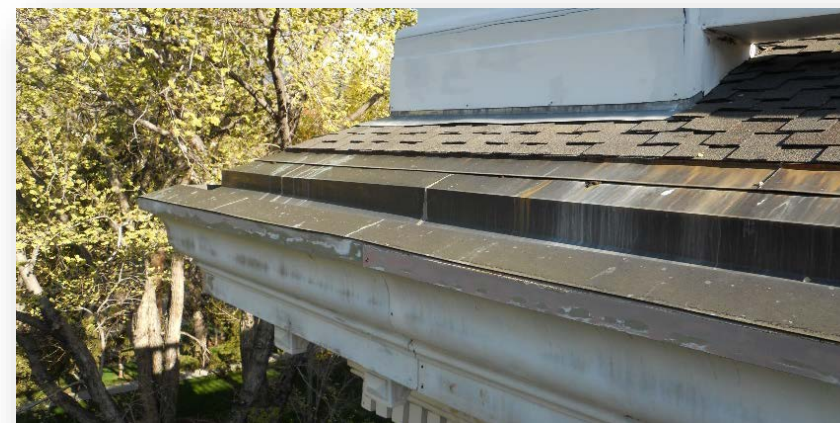
It was observed that the copper gutters have a typical brown patina for the dry desert climate of Nevada and Carson City. Some seams and fasteners have separated and come apart allowing water to infiltrate the eaves, soffits, and building. Sealants used at the joints in the copper gutter have also failed. It was also observed that some of the gutters were filled with debris (leaves, dirt, and other organic materials). Provisions for expansion and contraction of the copper gutters was not found in the field or on the construction drawings. Without provisions for expansion and contraction it makes sense that the gutter seams and fasteners have pulled apart and separated. Furthermore, conversation with maintenance personnel brought to our attention that the process of cleaning the gutters often requires foot traffic in the gutter system. It is highly unlikely that the gutter system was designed for the loading of foot traffic, thus this activity would contribute to the separation of joints and fasteners.

Typical copper gutter at the roof eave of the Capitol Building with brown patina which is most common in a dry desert environment.
