Capitol Fence

Historic Structure Report

SPWD Project #15-A025

February 2016

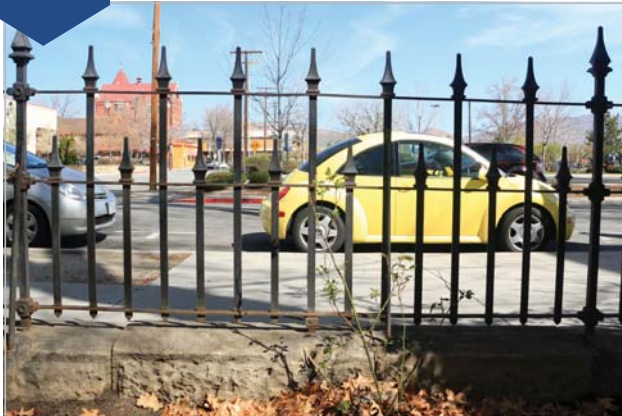
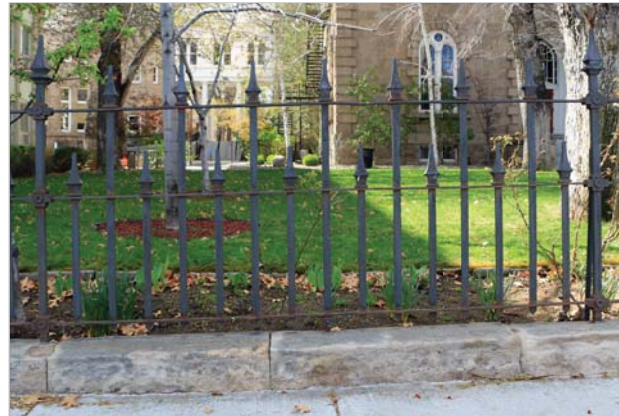
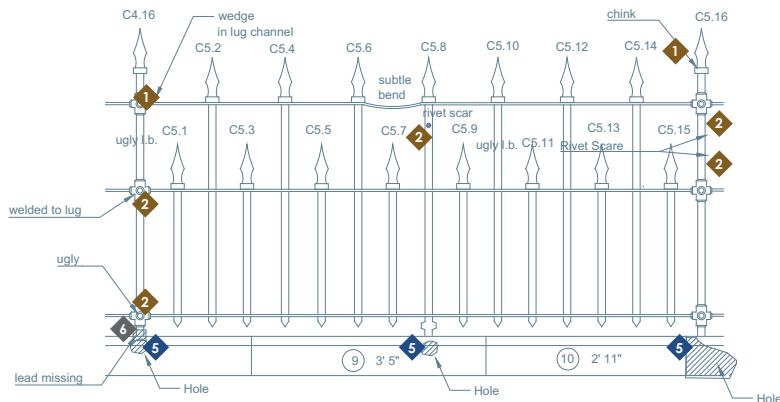
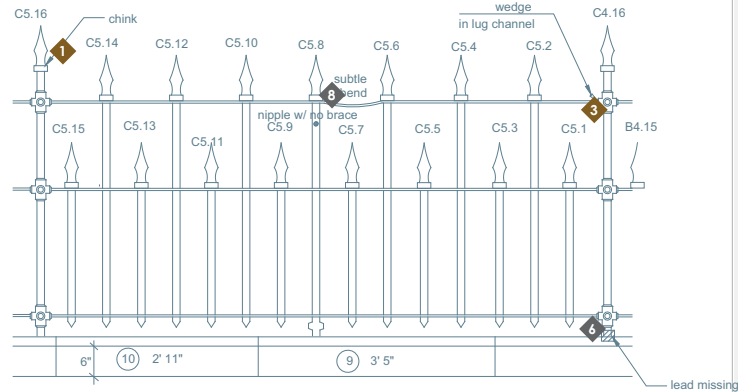
C5

Ironwork Corrosion

► Sandstone Deterioration

Structural Instability

1. Repair holes, cracks and casting defects using filler compound containing iron particles in an epoxy resin binder
2. Replace missing or severely damaged cast iron components with in-kind casting technique and material
3. Major cracks and inappropriate repairs to be repaired by brazing with special nickel alloy welding rods

4. Remove vegetation, failed patches (concrete), and embedded foreign objects
5. Eliminate water infiltration by re-setting fractured stone, filling pockets, shelves and depressions, and stabilizing post base with restoration mortar

6. Repair primary anchor points by pouring new molten lead into existing masonry socket and building up coping stone with restoration mortar
7. Replace missing or non-historic (square stock) backstays with in-kind material
8. Realign and stabilize fence to include straightening bent, bowed, or out of plumb fence sections and individual horizontal or vertical components
9. Remove non-historic end posts and restore with in-kind materials to period of significance

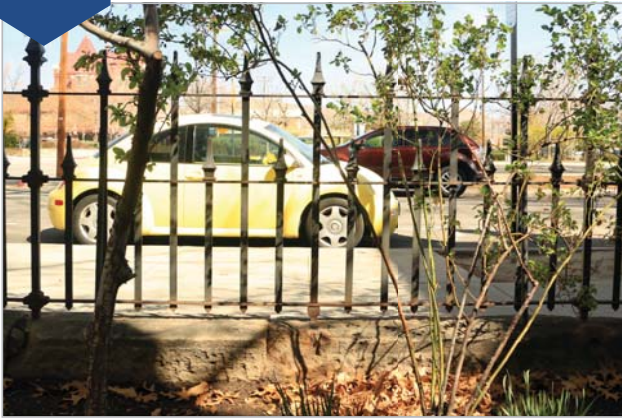
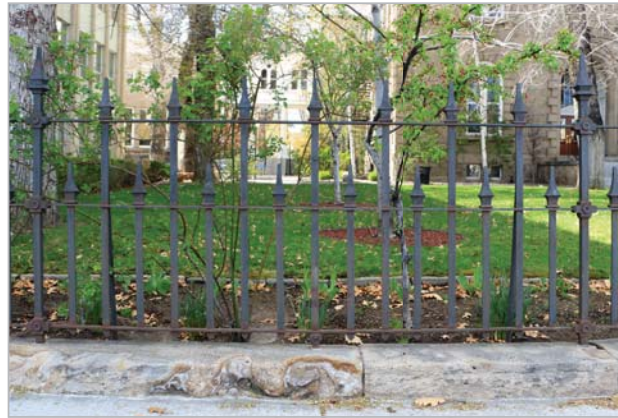
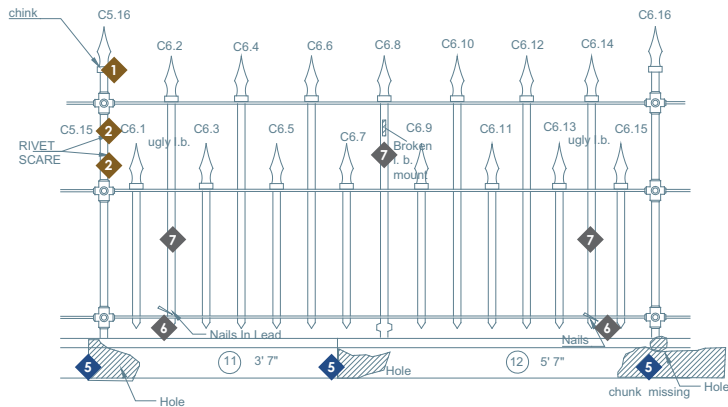
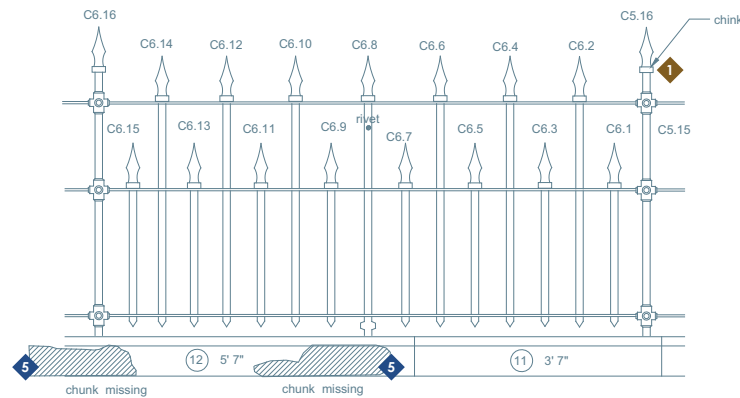
C6

Ironwork Corrosion

➤ Sandstone Deterioration

1. Repair holes, cracks and casting defects using filler compound containing iron particles in an epoxy resin binder
2. Replace missing or severely damaged cast iron components with in-kind casting technique and material
3. Major cracks and inappropriate repairs to be repaired by brazing with special nickel alloy welding rods

4. Remove vegetation, failed patches (concrete), and embedded foreign objects
5. Eliminate water infiltration by re-setting fractured stone, filling pockets, shelves and depressions, and stabilizing post base with restoration mortar

6. Repair primary anchor points by pouring new molten lead into existing masonry socket and building up coping stone with restoration mortar
7. Replace missing or non-historic (square stock) backstays with in-kind material
8. Realign and stabilize fence to include straightening bent, bowed, or out of plumb fence sections and individual horizontal or vertical components
9. Remove non-historic end posts and restore with in-kind materials to period of significance

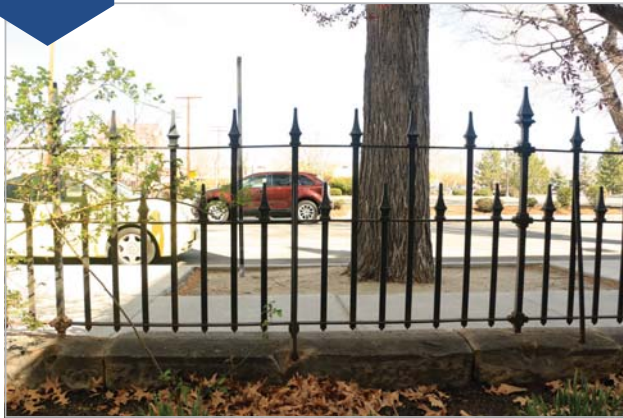
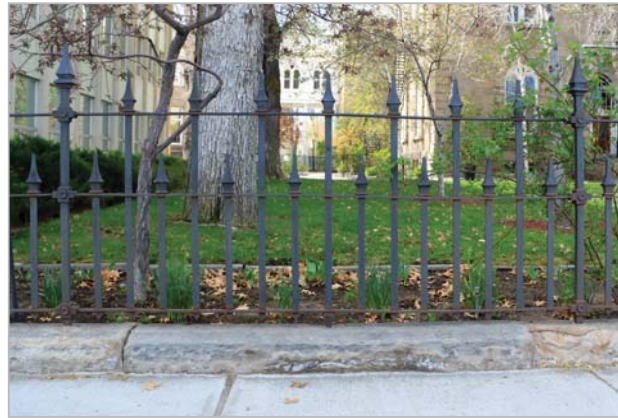
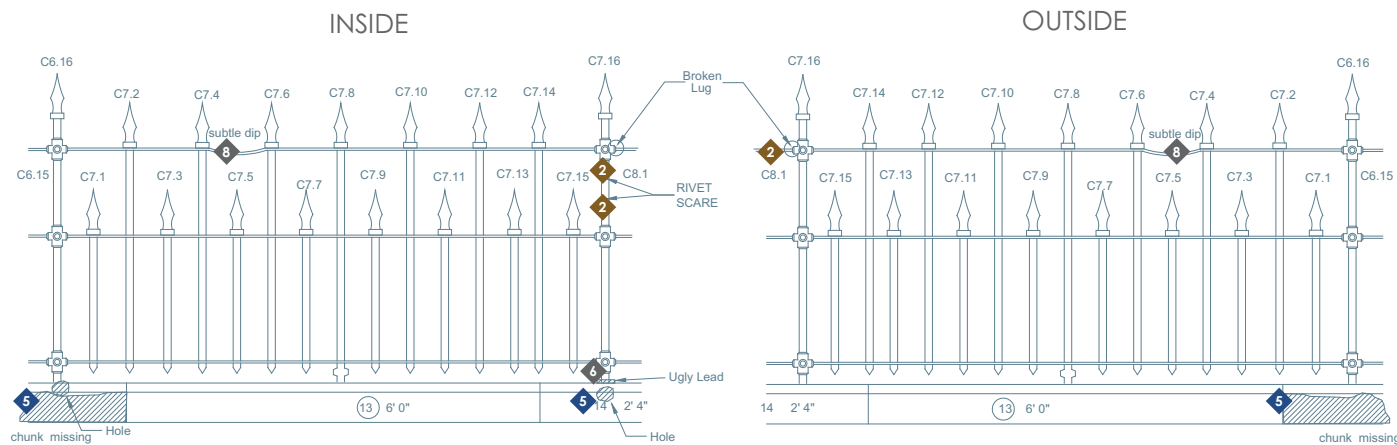
C7

Ironwork Corrosion

► Sandstone Deterioration

Structural Instability

1. Repair holes, cracks and casting defects using filler compound containing iron particles in an epoxy resin binder
2. Replace missing or severely damaged cast iron components with in-kind casting technique and material
3. Major cracks and inappropriate repairs to be repaired by brazing with special nickel alloy welding rods

4. Remove vegetation, failed patches (concrete), and embedded foreign objects
5. Eliminate water infiltration by re-setting fractured stone, filling pockets, shelves and depressions, and stabilizing post base with restoration mortar

6. Repair primary anchor points by pouring new molten lead into existing masonry socket and building up coping stone with restoration mortar
7. Replace missing or non-historic (square stock) backstays with in-kind material
8. Realign and stabilize fence to include straightening bent, bowed, or out of plumb fence sections and individual horizontal or vertical components
9. Remove non-historic end posts and restore with in-kind materials to period of significance

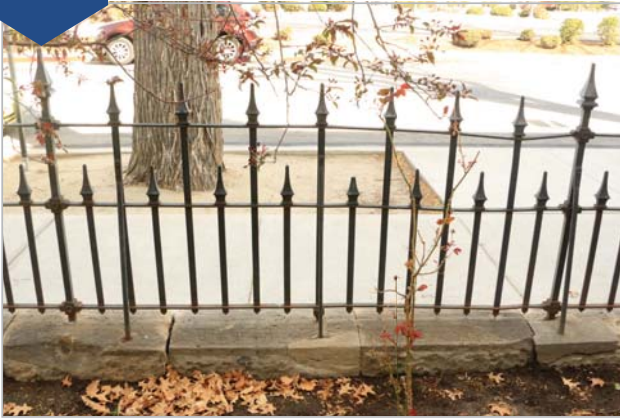
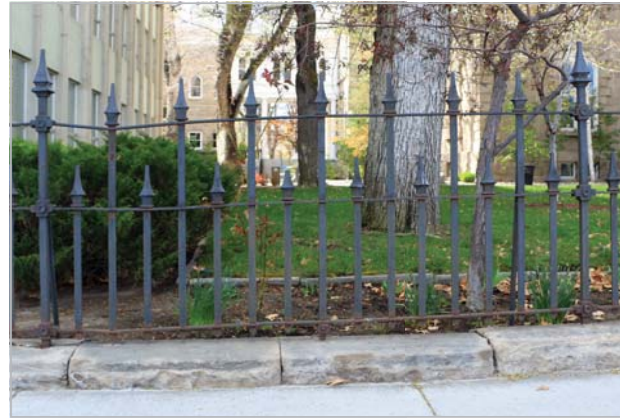
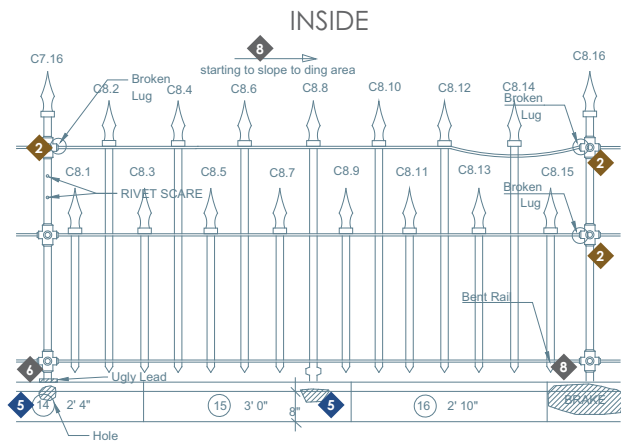
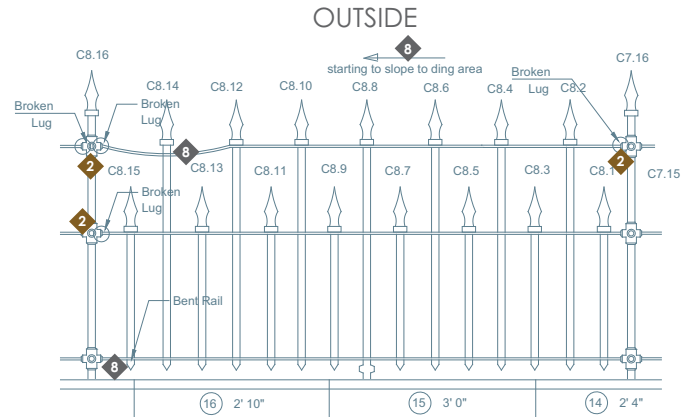
C8

Ironwork Corrosion

Sandstone Deterioration

Structural Instability

1. Repair holes, cracks and casting defects using filler compound containing iron particles in an epoxy resin binder
2. Replace missing or severely damaged cast iron components with in-kind casting technique and material
3. Major cracks and inappropriate repairs to be repaired by brazing with special nickel alloy welding rods

4. Remove vegetation, failed patches (concrete), and embedded foreign objects
5. Eliminate water infiltration by re-setting fractured stone, filling pockets, shelves and depressions, and stabilizing post base with restoration mortar

6. Repair primary anchor points by pouring new molten lead into existing masonry socket and building up coping stone with restoration mortar
7. Replace missing or non-historic (square stock) backstays with in-kind material
8. Realign and stabilize fence to include straightening bent, bowed, or out of plumb fence sections and individual horizontal or vertical components
9. Remove non-historic end posts and restore with in-kind materials to period of significance

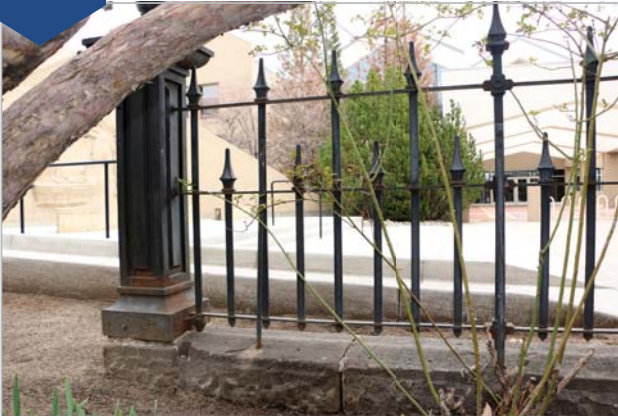
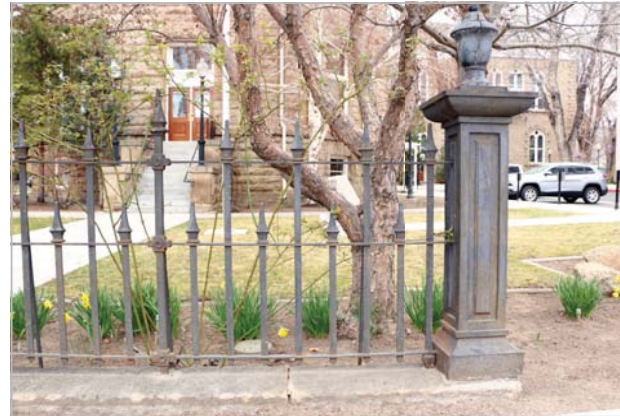
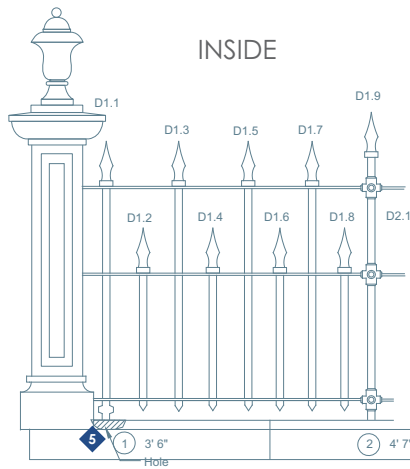
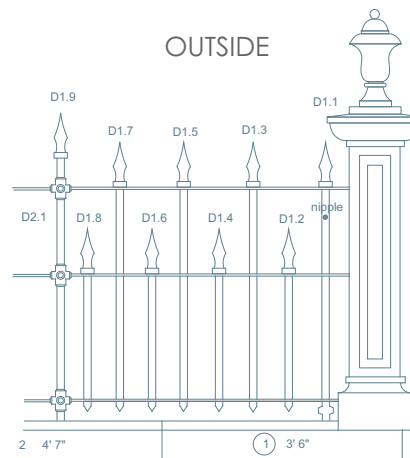
D1

Ironwork Corrosion

Sandstone Deterioration

Structural Instability

1. Repair holes, cracks and casting defects using filler compound containing iron particles in an epoxy resin binder
2. Replace missing or severely damaged cast iron components with in-kind casting technique and material
3. Major cracks and inappropriate repairs to be repaired by brazing with special nickel alloy welding rods

4. Remove vegetation, failed patches (concrete), and embedded foreign objects
5. Eliminate water infiltration by re-setting fractured stone, filling pockets, shelves and depressions, and stabilizing post base with restoration mortar

6. Repair primary anchor points by pouring new molten lead into existing masonry socket and building up coping stone with restoration mortar
7. Replace missing or non-historic (square stock) backstays with in-kind material
8. Realign and stabilize fence to include straightening bent, bowed, or out of plumb fence sections and individual horizontal or vertical components
9. Remove non-historic end posts and restore with in-kind materials to period of significance

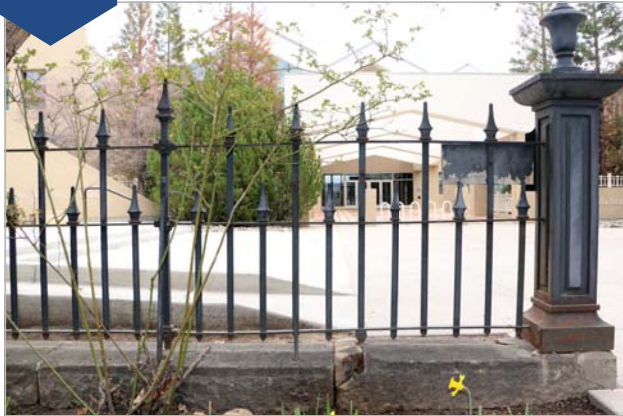
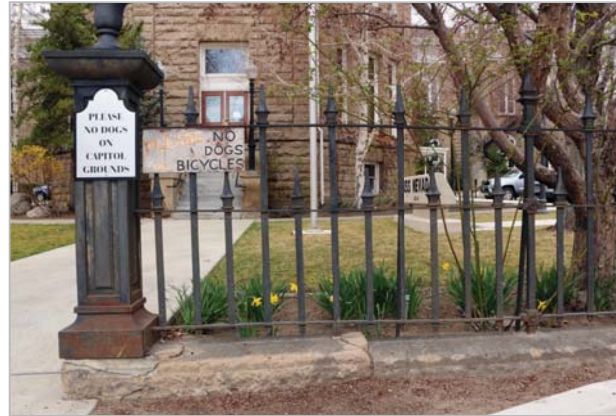
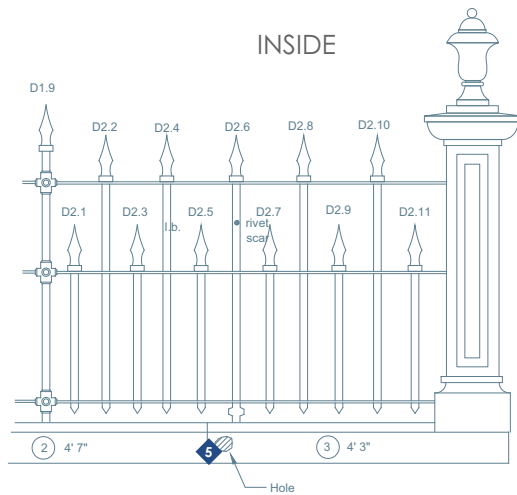
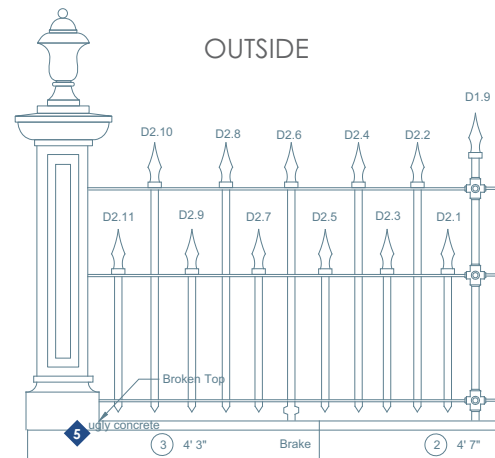
D2

Ironwork Corrosion

Sandstone Deterioration

Structural Instability

1. Repair holes, cracks and casting defects using filler compound containing iron particles in an epoxy resin binder
2. Replace missing or severely damaged cast iron components with in-kind casting technique and material
3. Major cracks and inappropriate repairs to be repaired by brazing with special nickel alloy welding rods

4. Remove vegetation, failed patches (concrete), and embedded foreign objects
5. Eliminate water infiltration by re-setting fractured stone, filling pockets, shelves and depressions, and stabilizing post base with restoration mortar

6. Repair primary anchor points by pouring new molten lead into existing masonry socket and building up coping stone with restoration mortar
7. Replace missing or non-historic (square stock) backstays with in-kind material
8. Realign and stabilize fence to include straightening bent, bowed, or out of plumb fence sections and individual horizontal or vertical components
9. Remove non-historic end posts and restore with in-kind materials to period of significance

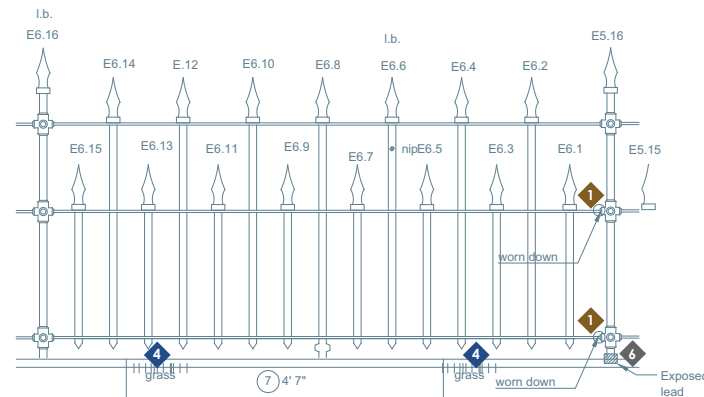
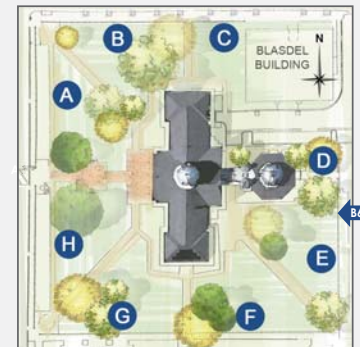
E6

- 1: Grind lips on the top rail.
- 2: Broken lug on the top rail.
- 5: Exposed lead on the bottom rail.
- 7: Broken hole in the bottom rail.

1. Repair holes, cracks and casting defects using filler compound containing iron particles in an epoxy resin binder
2. Replace missing or severely damaged cast iron components with in-kind casting technique and material
3. Major cracks and inappropriate repairs to be repaired by brazing with special nickel alloy welding rods

4. Remove vegetation, failed patches (concrete), and embedded foreign objects
5. Eliminate water infiltration by re-setting fractured stone, filling pockets, shelves and depressions, and stabilizing post base with restoration mortar

6. Repair primary anchor points by pouring new molten lead into existing masonry socket and building up coping stone with restoration mortar
7. Replace missing or non-historic (square stock) backstays with in-kind material
8. Realign and stabilize fence to include straightening bent, bowed, or out of plumb fence sections and individual horizontal or vertical components
9. Remove non-historic end posts and restore with in-kind materials to period of significance

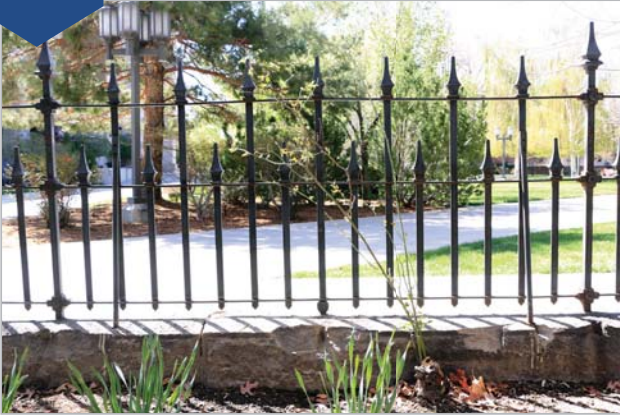
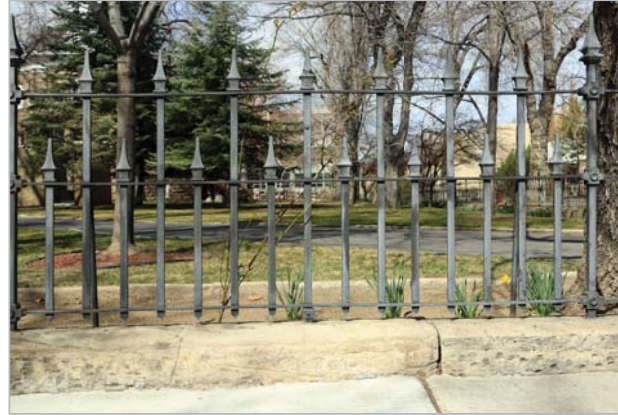
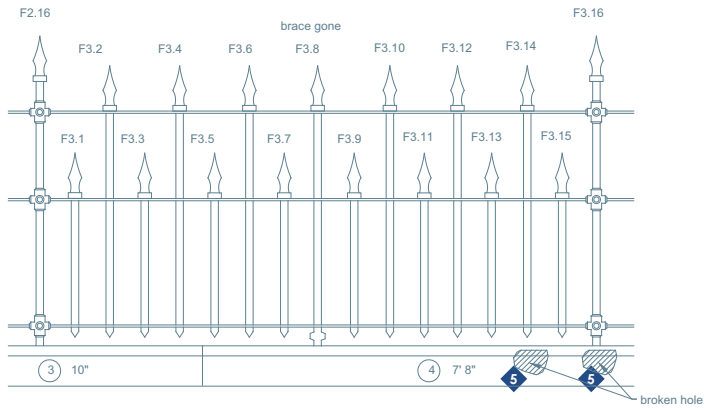
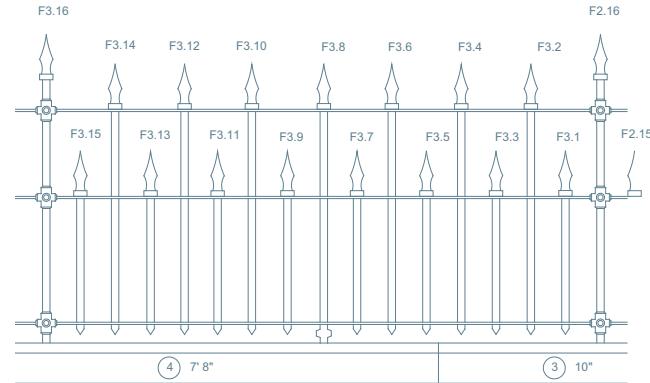
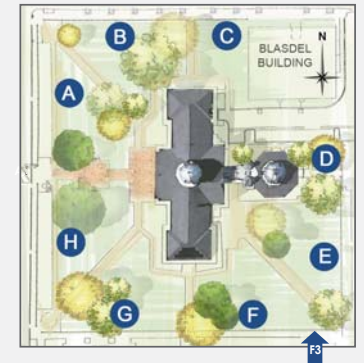
F3

Ironwork Corrosion

Sandstone Deterioration

Structural Instability

1. Repair holes, cracks and casting defects using filler compound containing iron particles in an epoxy resin binder
2. Replace missing or severely damaged cast iron components with in-kind casting technique and material
3. Major cracks and inappropriate repairs to be repaired by brazing with special nickel alloy welding rods

4. Remove vegetation, failed patches (concrete), and embedded foreign objects
5. Eliminate water infiltration by re-setting fractured stone, filling pockets, shelves and depressions, and stabilizing post base with restoration mortar

6. Repair primary anchor points by pouring new molten lead into existing masonry socket and building up coping stone with restoration mortar
7. Replace missing or non-historic (square stock) backstays with in-kind material
8. Realign and stabilize fence to include straightening bent, bowed, or out of plumb fence sections and individual horizontal or vertical components
9. Remove non-historic end posts and restore with in-kind materials to period of significance

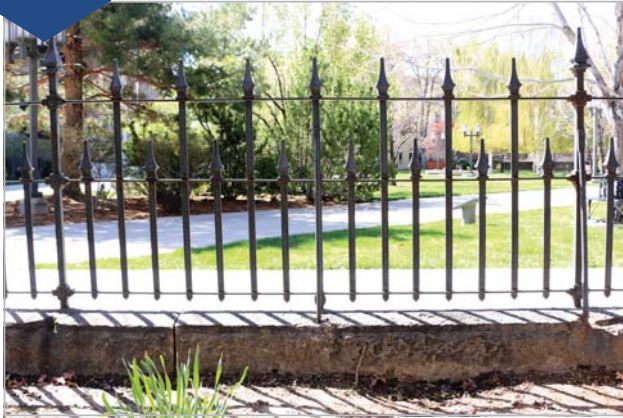
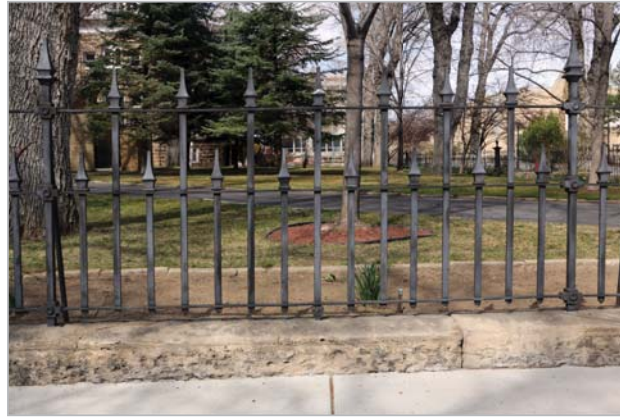
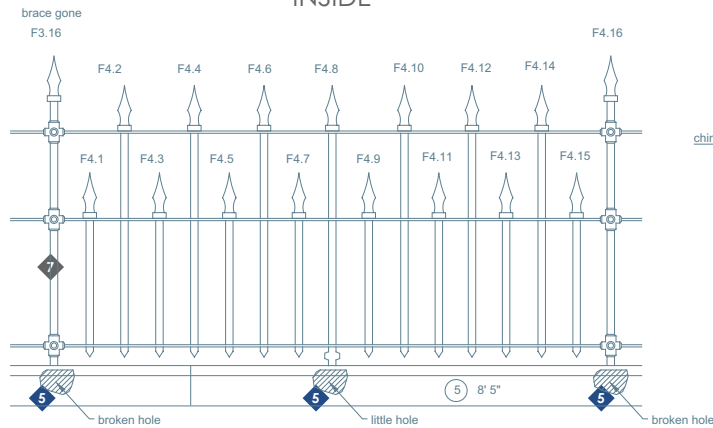
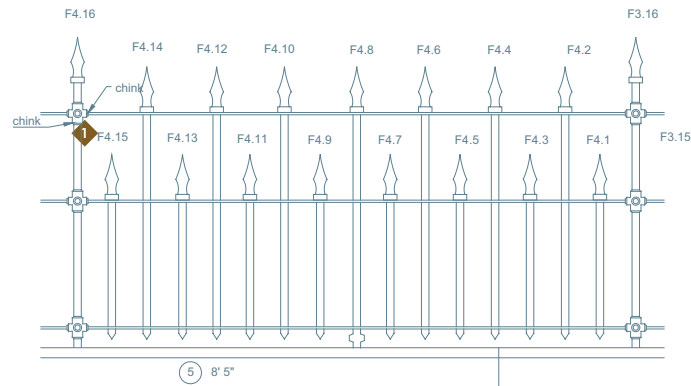
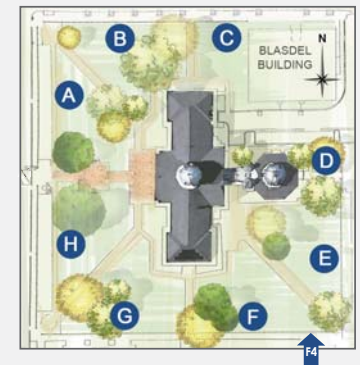
F4

Ironwork Corrosion

Sandstone Deterioration

Structural Instability

1. Repair holes, cracks and casting defects using filler compound containing iron particles in an epoxy resin binder
2. Replace missing or severely damaged cast iron components with in-kind casting technique and material
3. Major cracks and inappropriate repairs to be repaired by brazing with special nickel alloy welding rods

4. Remove vegetation, failed patches (concrete), and embedded foreign objects
5. Eliminate water infiltration by re-setting fractured stone, filling pockets, shelves and depressions, and stabilizing post base with restoration mortar

6. Repair primary anchor points by pouring new molten lead into existing masonry socket and building up coping stone with restoration mortar
7. Replace missing or non-historic (square stock) backstays with in-kind material
8. Realign and stabilize fence to include straightening bent, bowed, or out of plumb fence sections and individual horizontal or vertical components
9. Remove non-historic end posts and restore with in-kind materials to period of significance

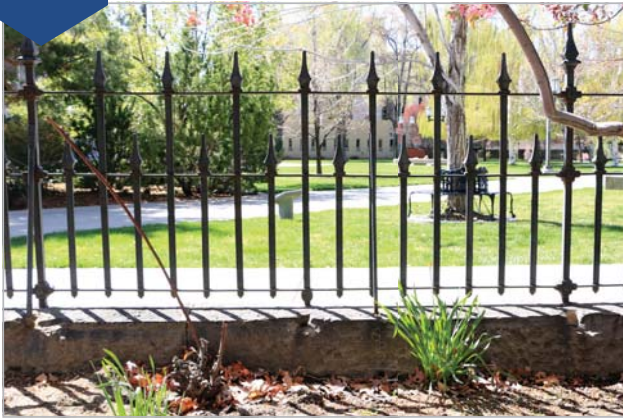
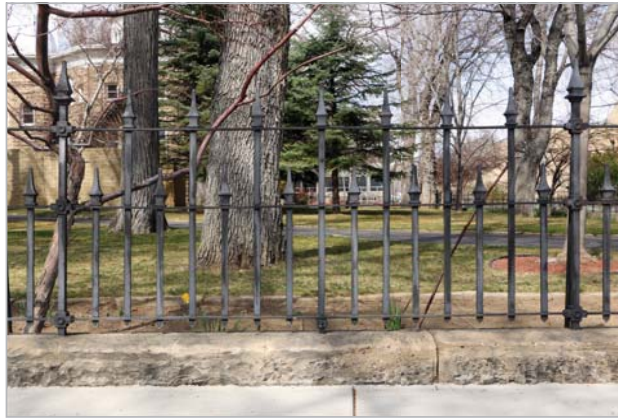
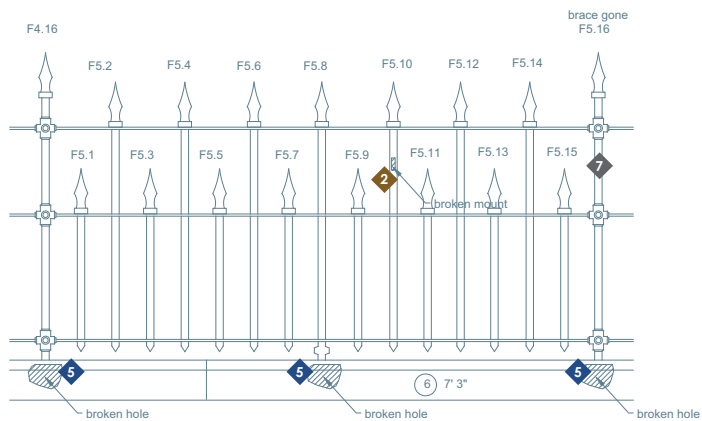
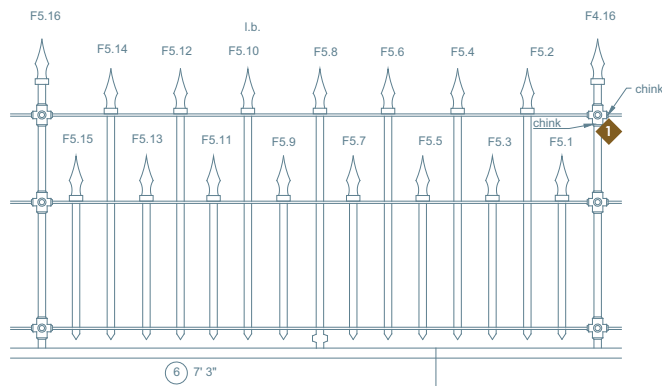
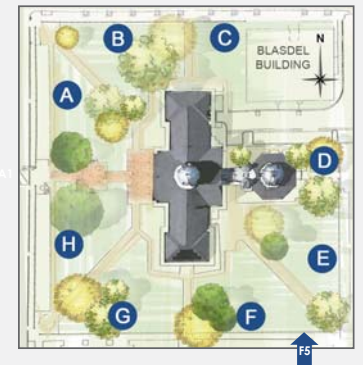
F5

Ironwork Corrosion

Sandstone Deterioration

Structural Instability

1. Repair holes, cracks and casting defects using filler compound containing iron particles in an epoxy resin binder
2. Replace missing or severely damaged cast iron components with in-kind casting technique and material
3. Major cracks and inappropriate repairs to be repaired by brazing with special nickel alloy welding rods

4. Remove vegetation, failed patches (concrete), and embedded foreign objects
5. Eliminate water infiltration by re-setting fractured stone, filling pockets, shelves and depressions, and stabilizing post base with restoration mortar

6. Repair primary anchor points by pouring new molten lead into existing masonry socket and building up coping stone with restoration mortar
7. Replace missing or non-historic (square stock) backstays with in-kind material
8. Realign and stabilize fence to include straightening bent, bowed, or out of plumb fence sections and individual horizontal or vertical components
9. Remove non-historic end posts and restore with in-kind materials to period of significance

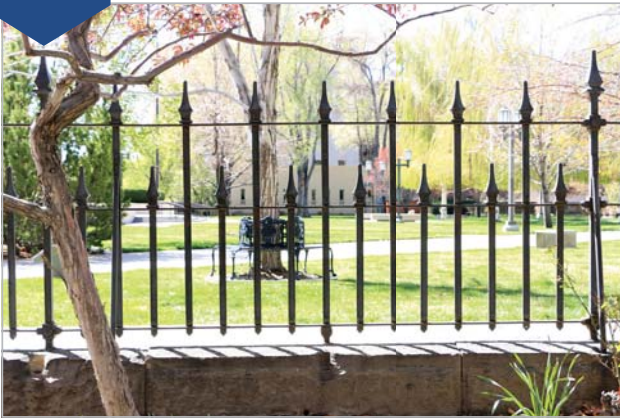
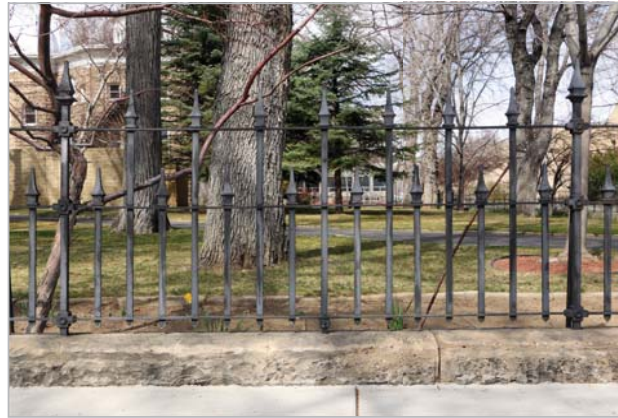
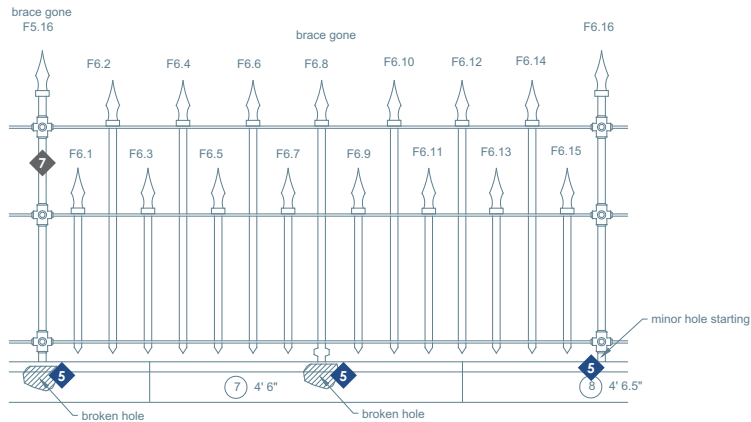
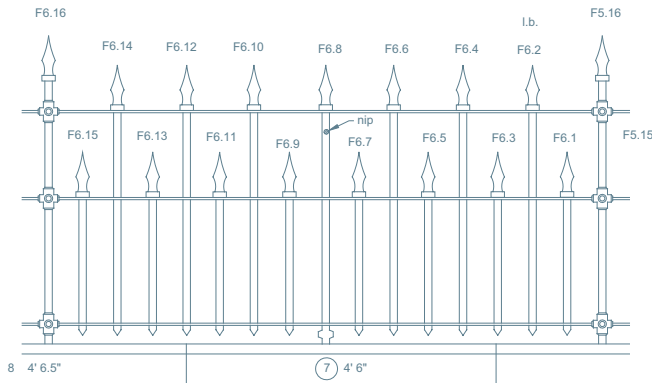
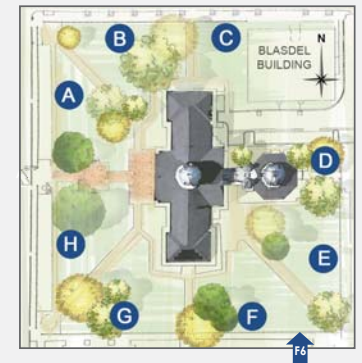
F6

Ironwork Corrosion

Sandstone Deterioration

Structural Instability

1. Repair holes, cracks and casting defects using filler compound containing iron particles in an epoxy resin binder
2. Replace missing or severely damaged cast iron components with in-kind casting technique and material
3. Major cracks and inappropriate repairs to be repaired by brazing with special nickel alloy welding rods

4. Remove vegetation, failed patches (concrete), and embedded foreign objects
5. Eliminate water infiltration by re-setting fractured stone, filling pockets, shelves and depressions, and stabilizing post base with restoration mortar

6. Repair primary anchor points by pouring new molten lead into existing masonry socket and building up coping stone with restoration mortar
7. Replace missing or non-historic (square stock) backstays with in-kind material
8. Realign and stabilize fence to include straightening bent, bowed, or out of plumb fence sections and individual horizontal or vertical components
9. Remove non-historic end posts and restore with in-kind materials to period of significance

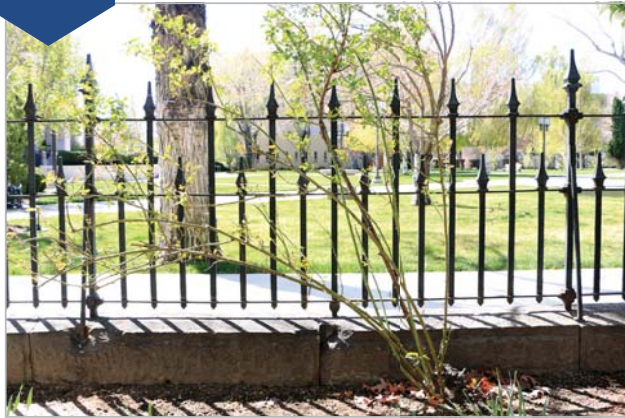
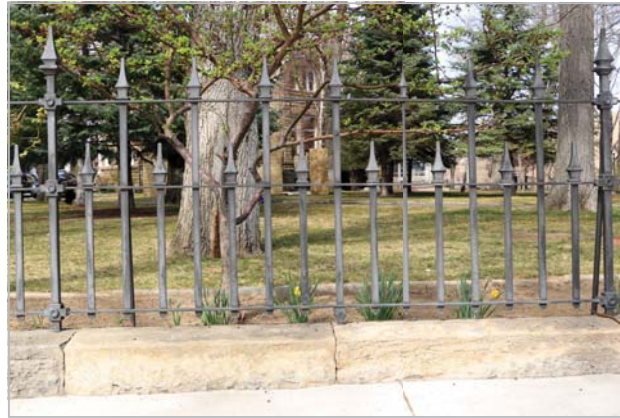
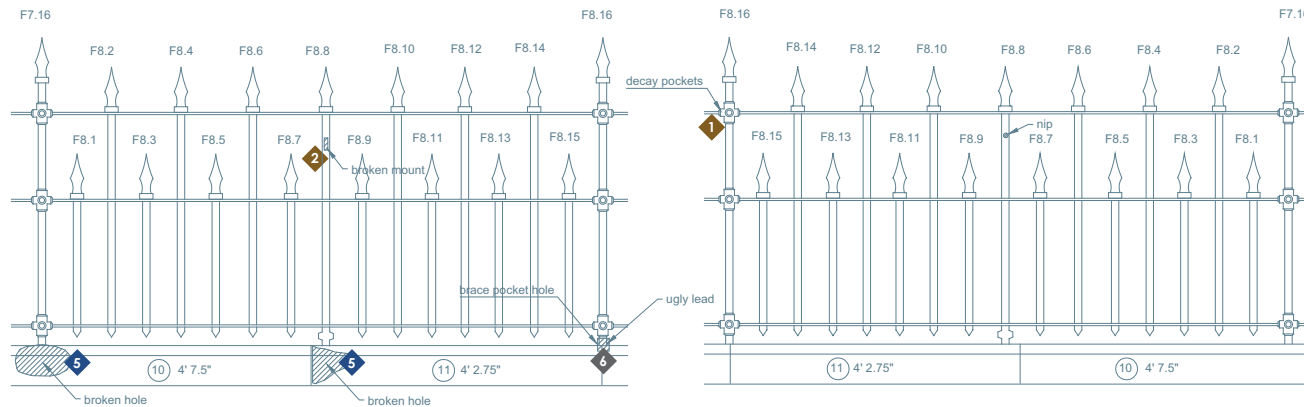
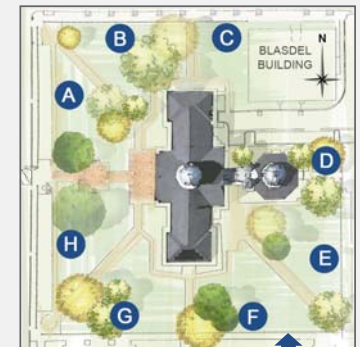
F8

**Ironwork Corrosion**

Sandstone Deterioration

Structural Instability

1. Repair holes, cracks and casting defects using filler compound containing iron particles in an epoxy resin binder
2. Replace missing or severely damaged cast iron components with in-kind casting technique and material
3. Major cracks and inappropriate repairs to be repaired by brazing with special nickel alloy welding rods

4. Remove vegetation, failed patches (concrete), and embedded foreign objects
5. Eliminate water infiltration by re-setting fractured stone, filling pockets, shelves and depressions, and stabilizing post base with restoration mortar

6. Repair primary anchor points by pouring new molten lead into existing masonry socket and building up coping stone with restoration mortar
7. Replace missing or non-historic (square stock) backstays with in-kind material
8. Realign and stabilize fence to include straightening bent, bowed, or out of plumb fence sections and individual horizontal or vertical components
9. Remove non-historic end posts and restore with in-kind materials to period of significance

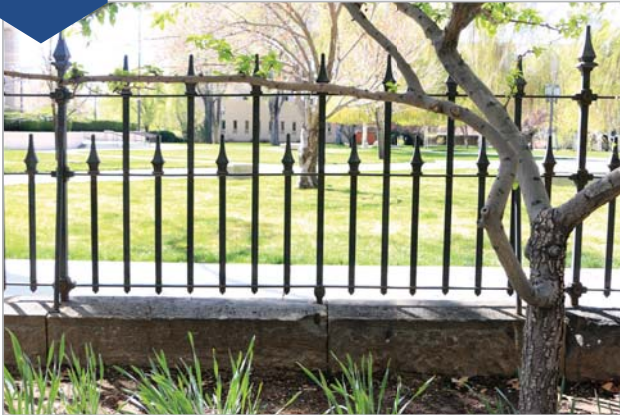
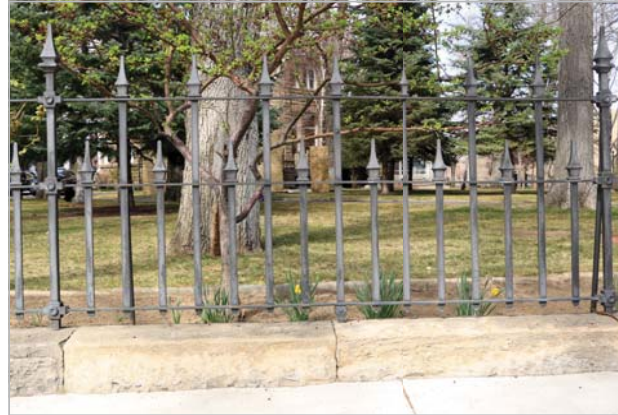
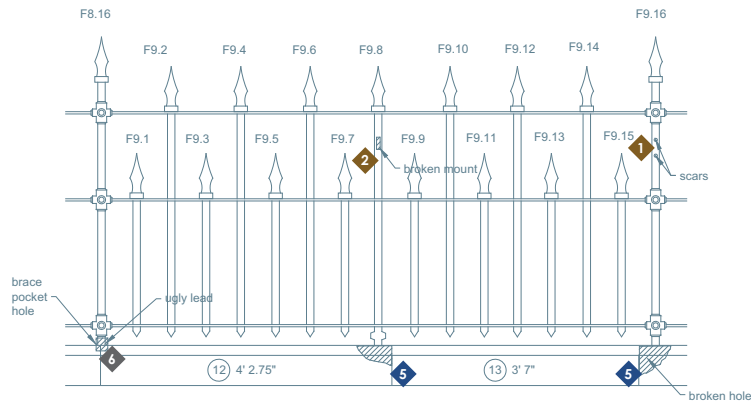
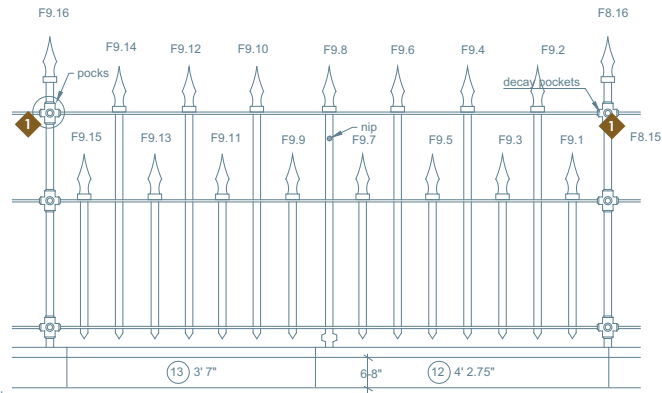
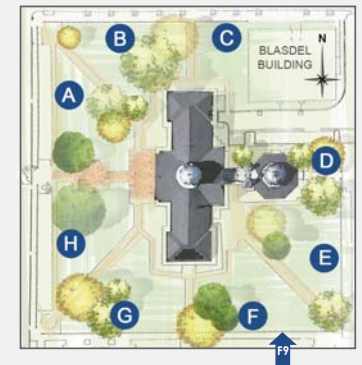
F9

Ironwork Corrosion

Sandstone Deterioration

Structural Instability

1. Repair holes, cracks and casting defects using filler compound containing iron particles in an epoxy resin binder
2. Replace missing or severely damaged cast iron components with in-kind casting technique and material
3. Major cracks and inappropriate repairs to be repaired by brazing with special nickel alloy welding rods

4. Remove vegetation, failed patches (concrete), and embedded foreign objects
5. Eliminate water infiltration by re-setting fractured stone, filling pockets, shelves and depressions, and stabilizing post base with restoration mortar

6. Repair primary anchor points by pouring new molten lead into existing masonry socket and building up coping stone with restoration mortar
7. Replace missing or non-historic (square stock) backstays with in-kind material
8. Realign and stabilize fence to include straightening bent, bowed, or out of plumb fence sections and individual horizontal or vertical components
9. Remove non-historic end posts and restore with in-kind materials to period of significance

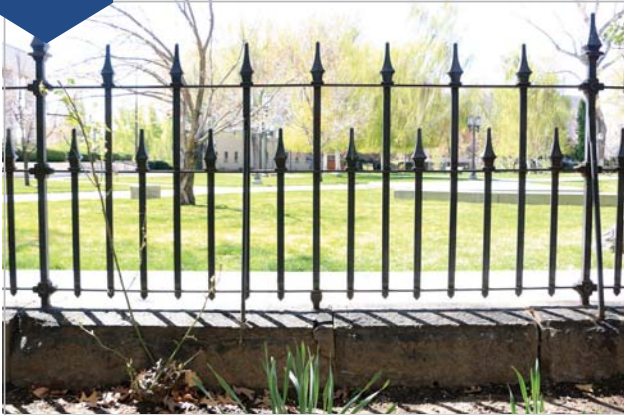
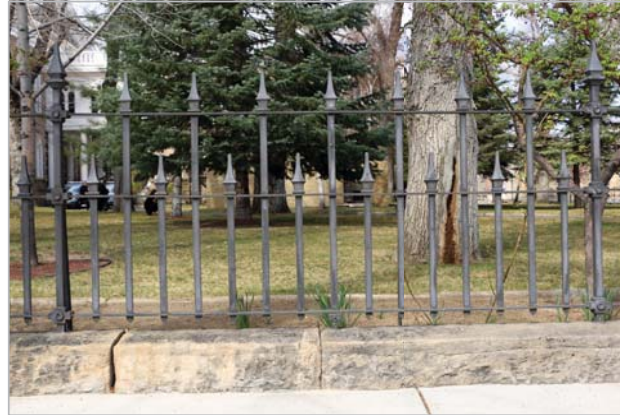
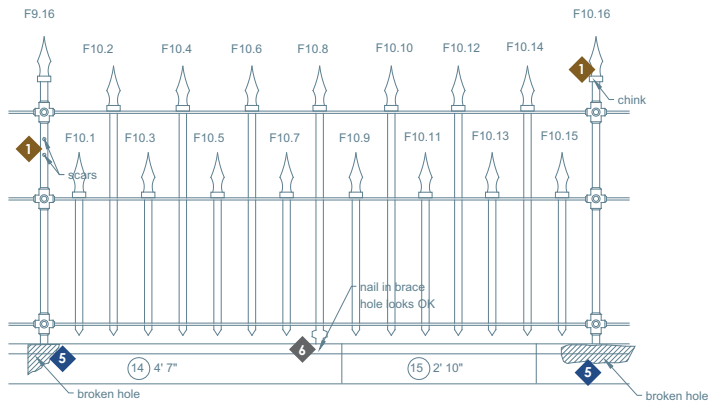
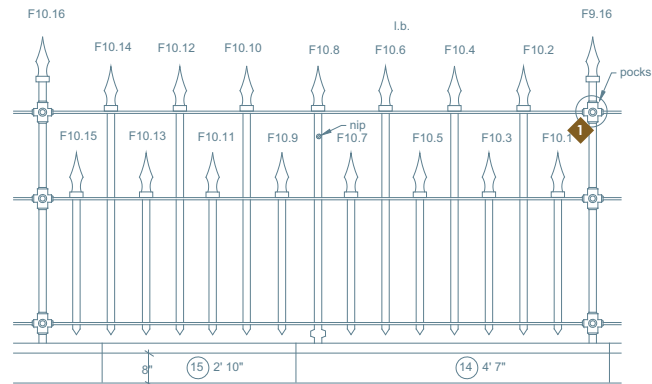
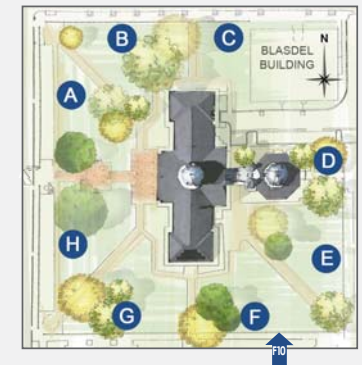
F10

Ironwork Corrosion

Sandstone Deterioration

Structural Instability

1. Repair holes, cracks and casting defects using filler compound containing iron particles in an epoxy resin binder
2. Replace missing or severely damaged cast iron components with in-kind casting technique and material
3. Major cracks and inappropriate repairs to be repaired by brazing with special nickel alloy welding rods

4. Remove vegetation, failed patches (concrete), and embedded foreign objects
5. Eliminate water infiltration by re-setting fractured stone, filling pockets, shelves and depressions, and stabilizing post base with restoration mortar

6. Repair primary anchor points by pouring new molten lead into existing masonry socket and building up coping stone with restoration mortar
7. Replace missing or non-historic (square stock) backstays with in-kind material
8. Realign and stabilize fence to include straightening bent, bowed, or out of plumb fence sections and individual horizontal or vertical components
9. Remove non-historic end posts and restore with in-kind materials to period of significance

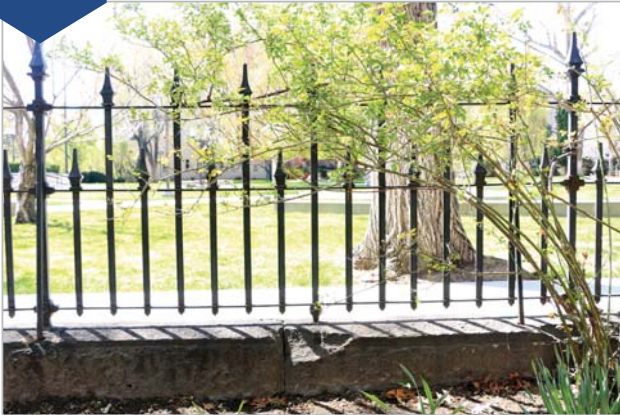
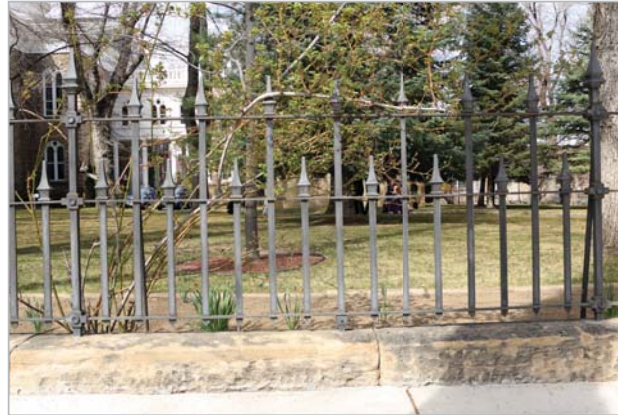
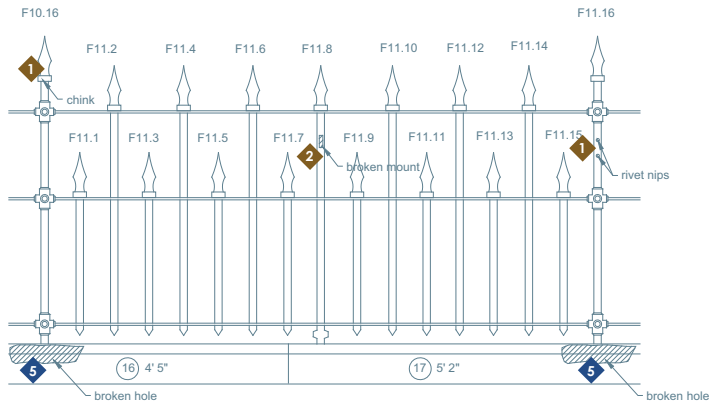
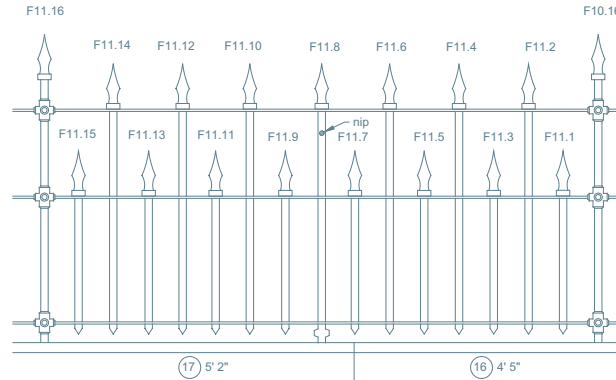
F11

Ironwork Corrosion

Sandstone Deterioration

1. Repair holes, cracks and casting defects using filler compound containing iron particles in an epoxy resin binder
2. Replace missing or severely damaged cast iron components with in-kind casting technique and material
3. Major cracks and inappropriate repairs to be repaired by brazing with special nickel alloy welding rods

4. Remove vegetation, failed patches (concrete), and embedded foreign objects
5. Eliminate water infiltration by re-setting fractured stone, filling pockets, shelves and depressions, and stabilizing post base with restoration mortar

6. Repair primary anchor points by pouring new molten lead into existing masonry socket and building up coping stone with restoration mortar
7. Replace missing or non-historic (square stock) backstays with in-kind material
8. Realign and stabilize fence to include straightening bent, bowed, or out of plumb fence sections and individual horizontal or vertical components
9. Remove non-historic end posts and restore with in-kind materials to period of significance

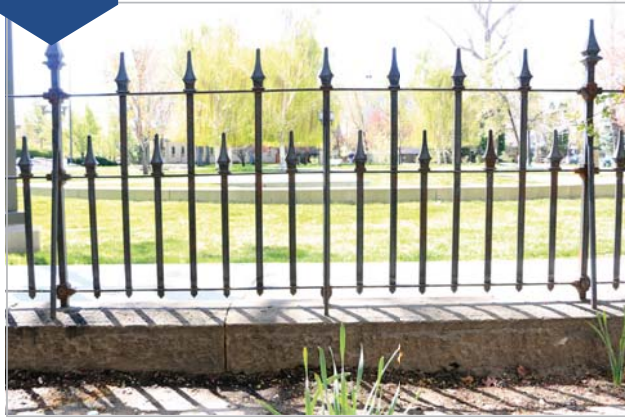
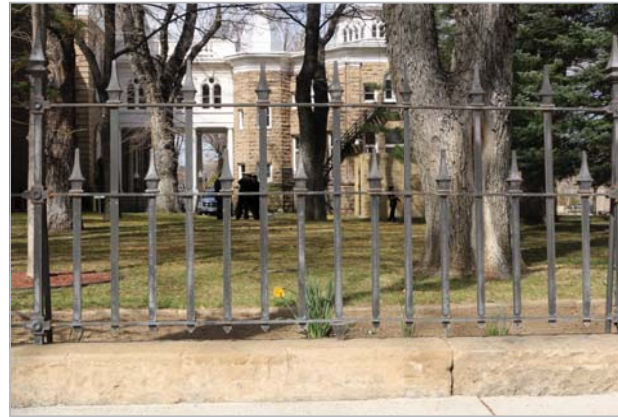
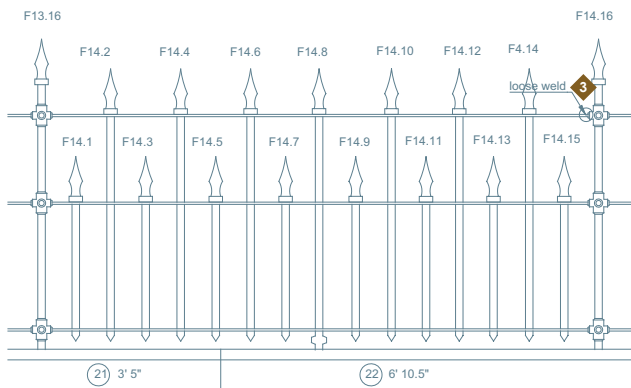
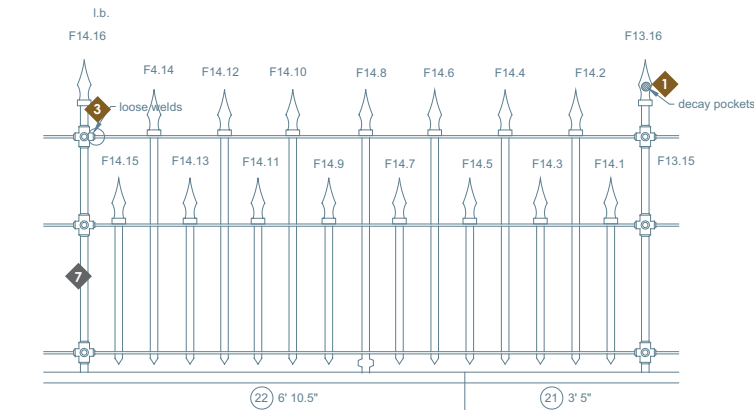
F14

Broken Corner

1. Repair holes, cracks and casting defects using filler compound containing iron particles in an epoxy resin binder
2. Replace missing or severely damaged cast iron components with in-kind casting technique and material
3. Major cracks and inappropriate repairs to be repaired by brazing with special nickel alloy welding rods

4. Remove vegetation, failed patches (concrete), and embedded foreign objects
5. Eliminate water infiltration by re-setting fractured stone, filling pockets, shelves and depressions, and stabilizing post base with restoration mortar

6. Repair primary anchor points by pouring new molten lead into existing masonry socket and building up coping stone with restoration mortar
7. Replace missing or non-historic (square stock) backstays with in-kind material
8. Realign and stabilize fence to include straightening bent, bowed, or out of plumb fence sections and individual horizontal or vertical components
9. Remove non-historic end posts and restore with in-kind materials to period of significance
