Capitol Fence

Historic Structure Report

SPWD Project #15-A025

February 2016

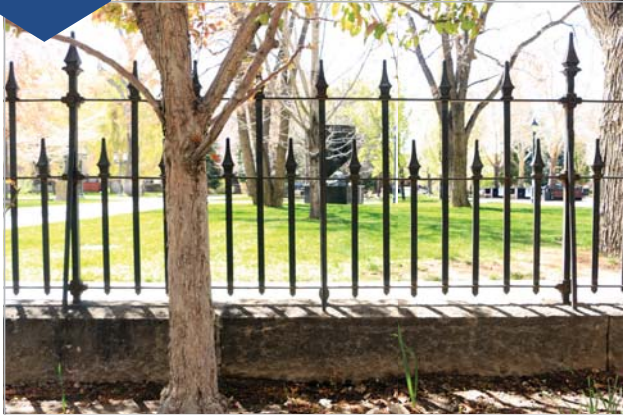
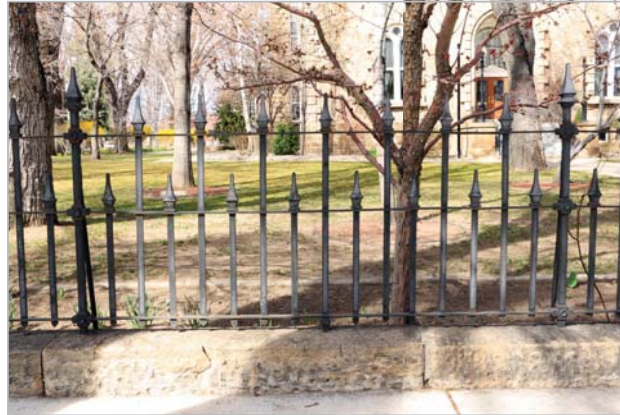
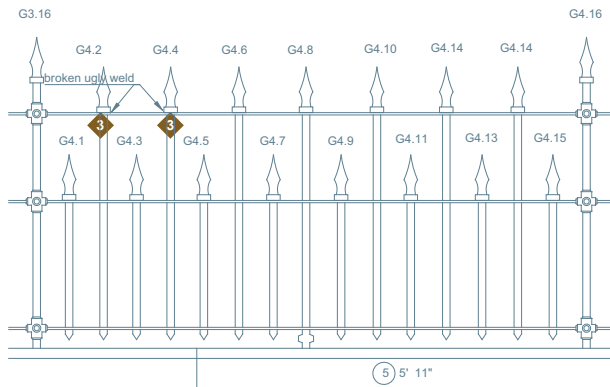
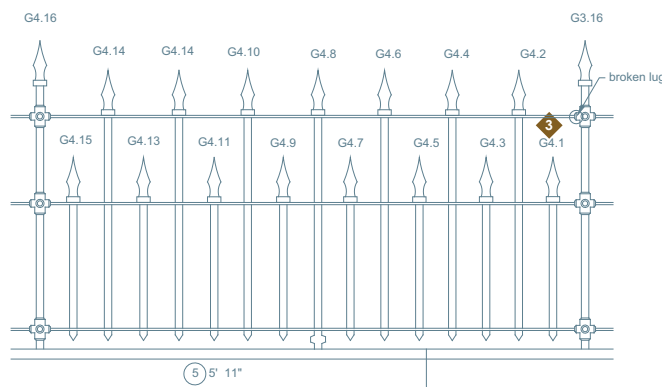
G4

Ironwork Corrosion

Sandstone Deterioration

Structural Instability

1. Repair holes, cracks and casting defects using filler compound containing iron particles in an epoxy resin binder
2. Replace missing or severely damaged cast iron components with in-kind casting technique and material
3. Major cracks and inappropriate repairs to be repaired by brazing with special nickel alloy welding rods

4. Remove vegetation, failed patches (concrete), and embedded foreign objects
5. Eliminate water infiltration by re-setting fractured stone, filling pockets, shelves and depressions, and stabilizing post base with restoration mortar

6. Repair primary anchor points by pouring new molten lead into existing masonry socket and building up coping stone with restoration mortar
7. Replace missing or non-historic (square stock) backstays with in-kind material
8. Realign and stabilize fence to include straightening bent, bowed, or out of plumb fence sections and individual horizontal or vertical components
9. Remove non-historic end posts and restore with in-kind materials to period of significance

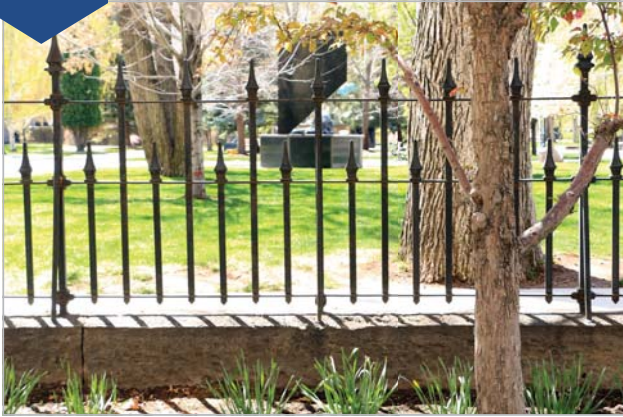
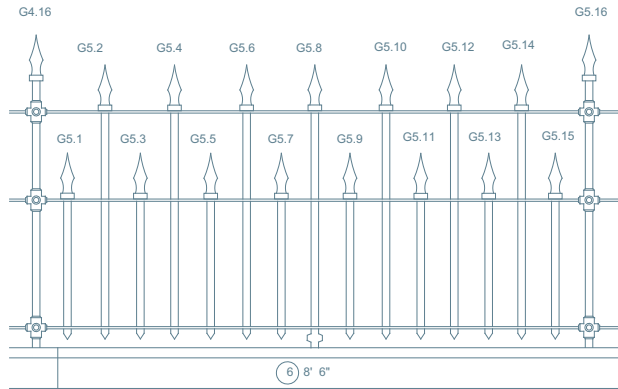
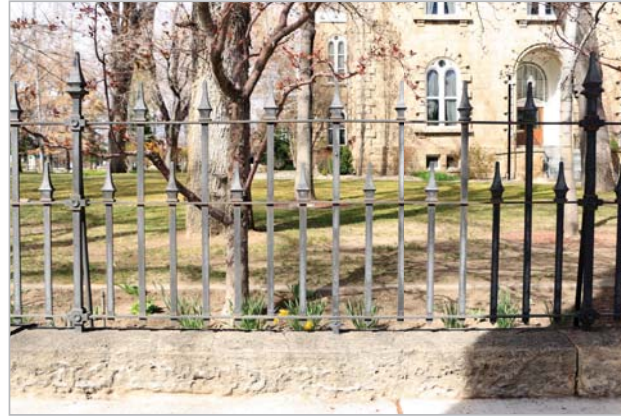
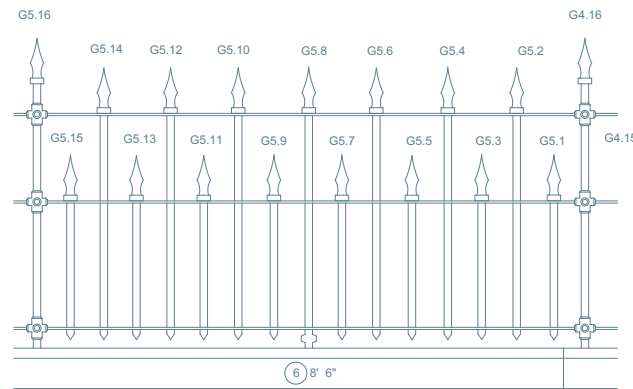
G5

Ironwork Corrosion

Sandstone Deterioration

Structural Instability

1. Repair holes, cracks and casting defects using filler compound containing iron particles in an epoxy resin binder
2. Replace missing or severely damaged cast iron components with in-kind casting technique and material
3. Major cracks and inappropriate repairs to be repaired by brazing with special nickel alloy welding rods

4. Remove vegetation, failed patches (concrete), and embedded foreign objects
5. Eliminate water infiltration by re-setting fractured stone, filling pockets, shelves and depressions, and stabilizing post base with restoration mortar

6. Repair primary anchor points by pouring new molten lead into existing masonry socket and building up coping stone with restoration mortar
7. Replace missing or non-historic (square stock) backstays with in-kind material
8. Realign and stabilize fence to include straightening bent, bowed, or out of plumb fence sections and individual horizontal or vertical components
9. Remove non-historic end posts and restore with in-kind materials to period of significance

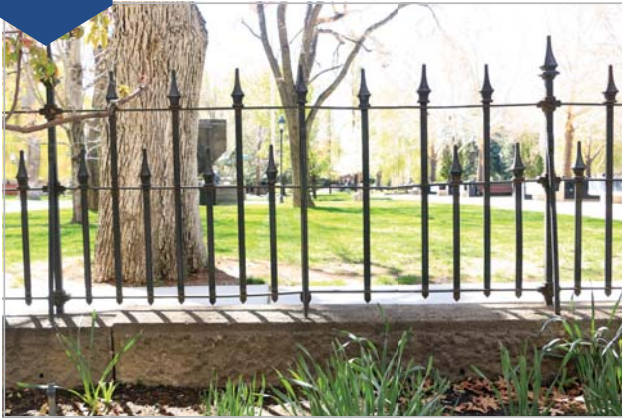
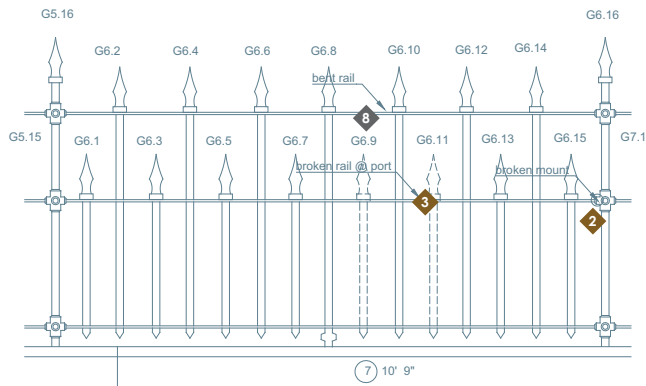
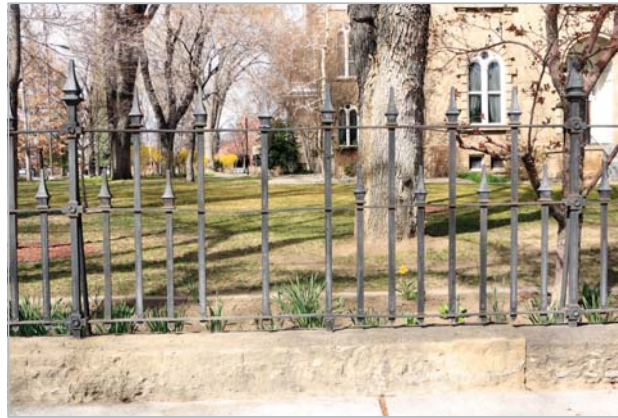
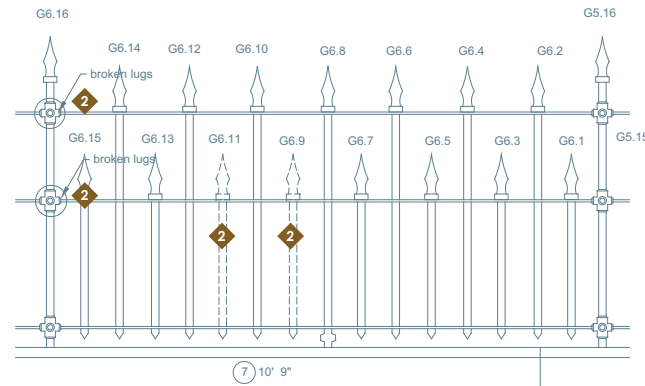
G6

Ironwork Corrosion

Sandstone Deterioration

Structural Instability

1. Repair holes, cracks and casting defects using filler compound containing iron particles in an epoxy resin binder
2. Replace missing or severely damaged cast iron components with in-kind casting technique and material
3. Major cracks and inappropriate repairs to be repaired by brazing with special nickel alloy welding rods

4. Remove vegetation, failed patches (concrete), and embedded foreign objects
5. Eliminate water infiltration by re-setting fractured stone, filling pockets, shelves and depressions, and stabilizing post base with restoration mortar

6. Repair primary anchor points by pouring new molten lead into existing masonry socket and building up coping stone with restoration mortar
7. Replace missing or non-historic (square stock) backstays with in-kind material
8. Realign and stabilize fence to include straightening bent, bowed, or out of plumb fence sections and individual horizontal or vertical components
9. Remove non-historic end posts and restore with in-kind materials to period of significance

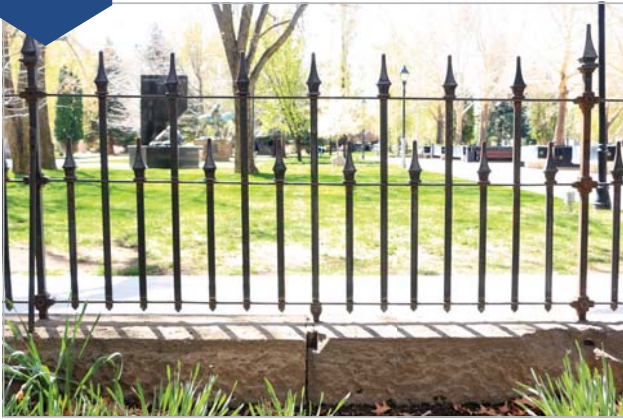
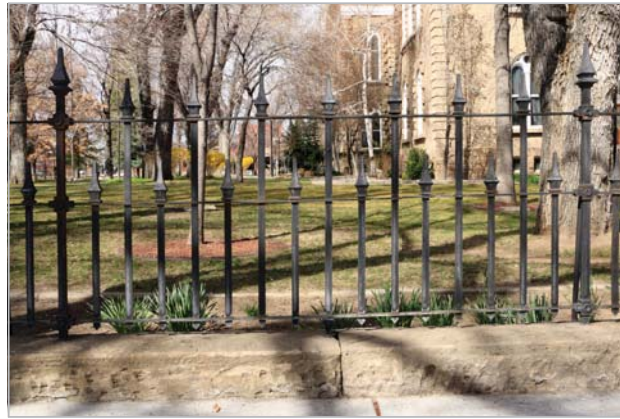
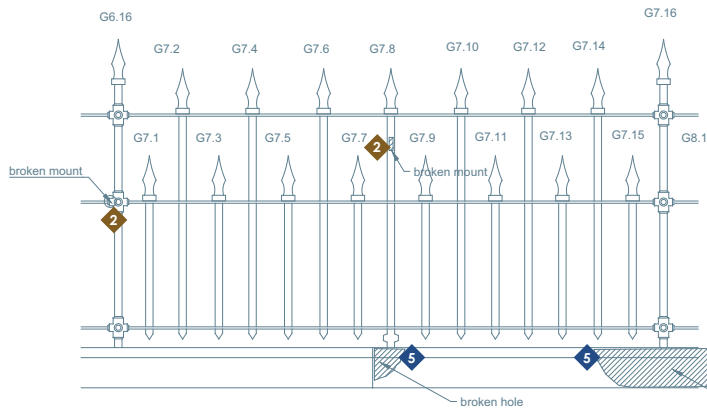
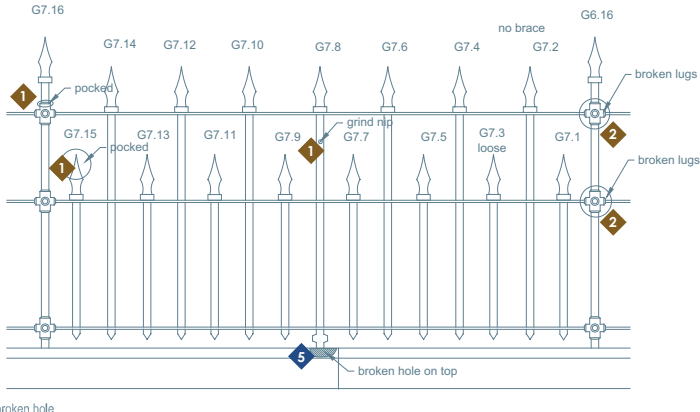
Ironwork Corrosion

Sandstone Deterioration

1. Repair holes, cracks and casting defects using filler compound containing iron particles in an epoxy resin binder
2. Replace missing or severely damaged cast iron components with in-kind casting technique and material
3. Major cracks and inappropriate repairs to be repaired by brazing with special nickel alloy welding rods

4. Remove vegetation, failed patches (concrete), and embedded foreign objects
5. Eliminate water infiltration by re-setting fractured stone, filling pockets, shelves and depressions, and stabilizing post base with restoration mortar

6. Repair primary anchor points by pouring new molten lead into existing masonry socket and building up coping stone with restoration mortar
7. Replace missing or non-historic (square stock) backstays with in-kind material
8. Realign and stabilize fence to include straightening bent, bowed, or out of plumb fence sections and individual horizontal or vertical components
9. Remove non-historic end posts and restore with in-kind materials to period of significance

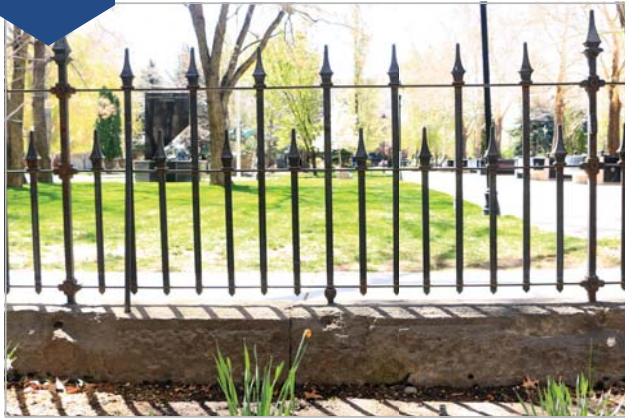
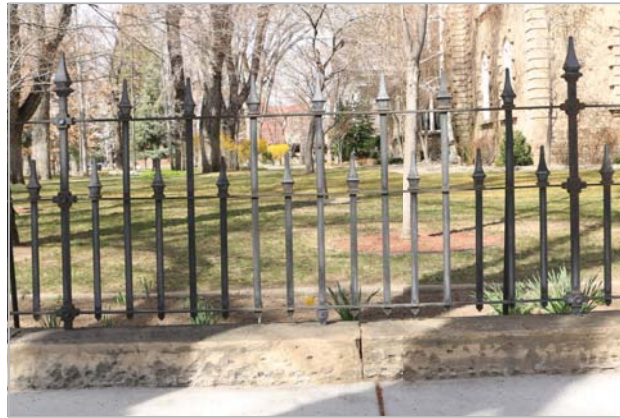
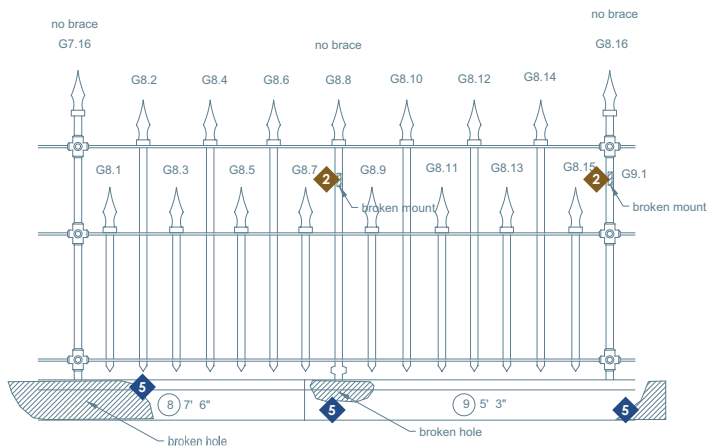
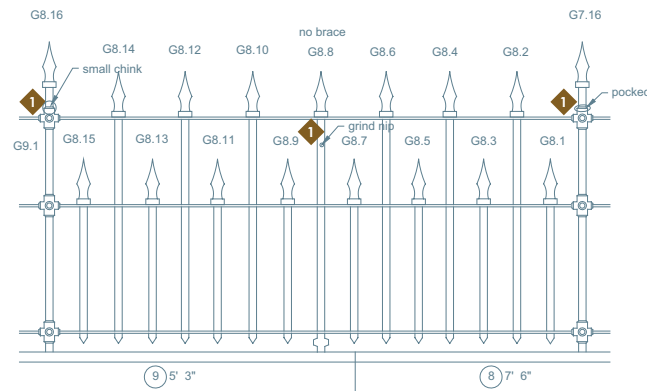
G8

Ironwork Corrosion

Sandstone Deterioration

Structural Instability

1. Repair holes, cracks and casting defects using filler compound containing iron particles in an epoxy resin binder
2. Replace missing or severely damaged cast iron components with in-kind casting technique and material
3. Major cracks and inappropriate repairs to be repaired by brazing with special nickel alloy welding rods

4. Remove vegetation, failed patches (concrete), and embedded foreign objects
5. Eliminate water infiltration by re-setting fractured stone, filling pockets, shelves and depressions, and stabilizing post base with restoration mortar

6. Repair primary anchor points by pouring new molten lead into existing masonry socket and building up coping stone with restoration mortar
7. Replace missing or non-historic (square stock) backstays with in-kind material
8. Realign and stabilize fence to include straightening bent, bowed, or out of plumb fence sections and individual horizontal or vertical components
9. Remove non-historic end posts and restore with in-kind materials to period of significance

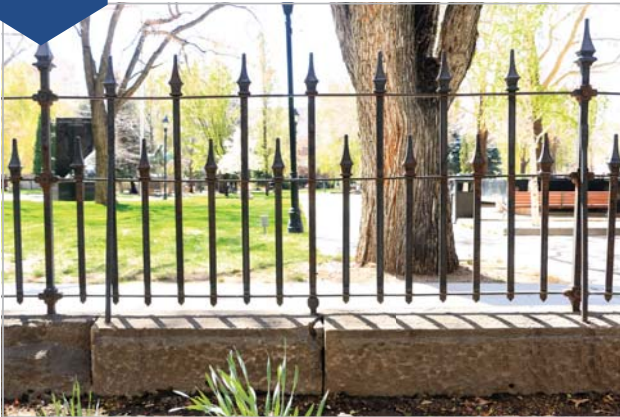
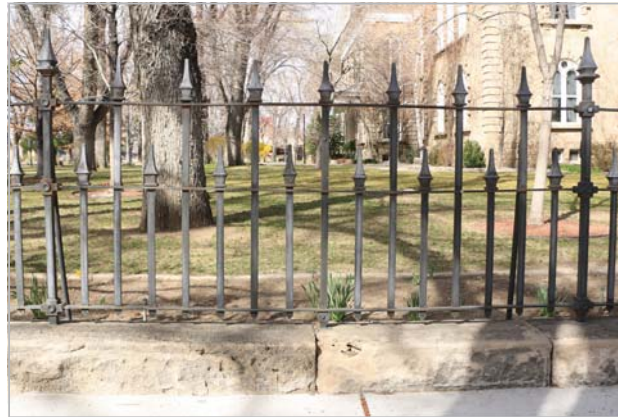
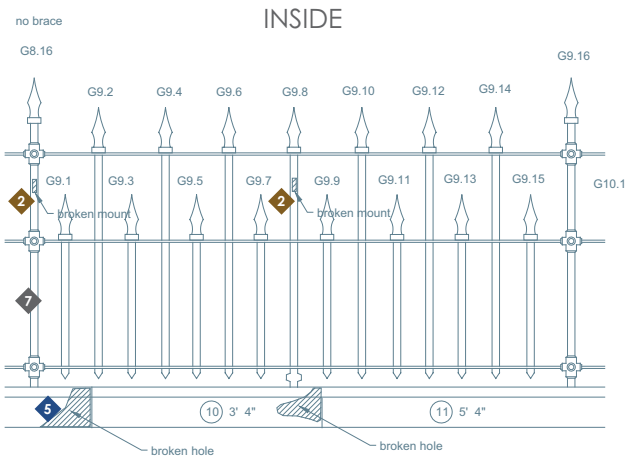
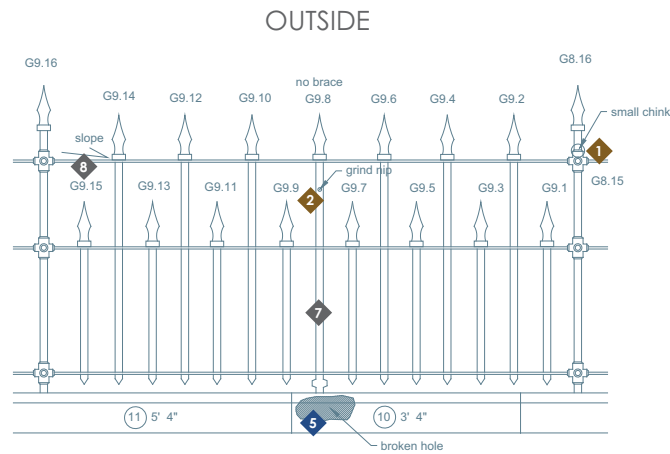
G9

Ironwork Corrosion

Sandstone Deterioration

Structural Instability

1. Repair holes, cracks and casting defects using filler compound containing iron particles in an epoxy resin binder
2. Replace missing or severely damaged cast iron components with in-kind casting technique and material
3. Major cracks and inappropriate repairs to be repaired by brazing with special nickel alloy welding rods

4. Remove vegetation, failed patches (concrete), and embedded foreign objects
5. Eliminate water infiltration by re-setting fractured stone, filling pockets, shelves and depressions, and stabilizing post base with restoration mortar

6. Repair primary anchor points by pouring new molten lead into existing masonry socket and building up coping stone with restoration mortar
7. Replace missing or non-historic (square stock) backstays with in-kind material
8. Realign and stabilize fence to include straightening bent, bowed, or out of plumb fence sections and individual horizontal or vertical components
9. Remove non-historic end posts and restore with in-kind materials to period of significance

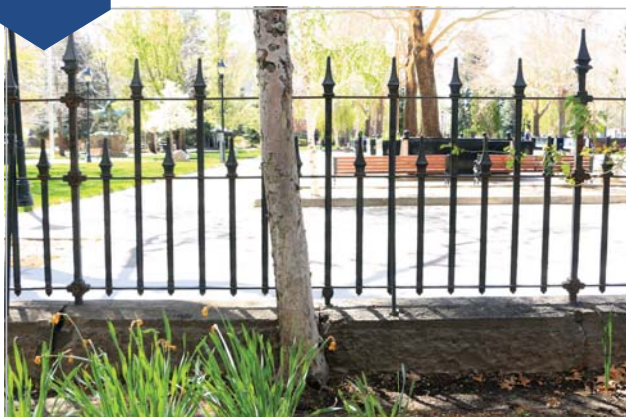
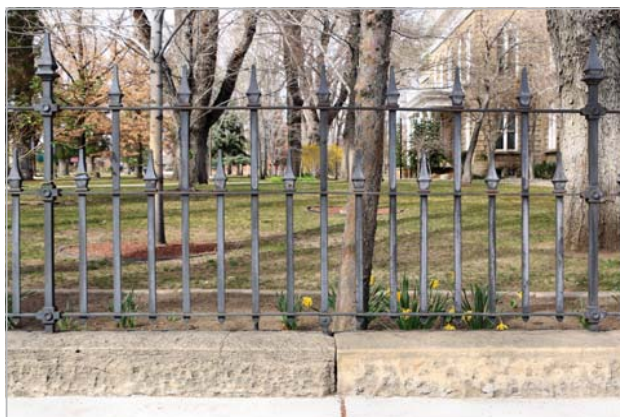
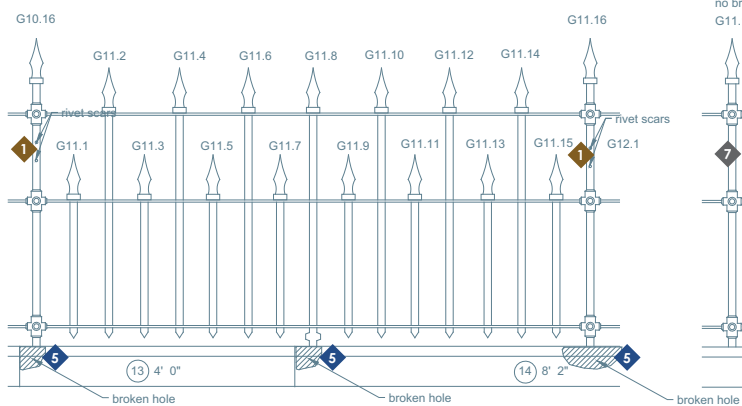
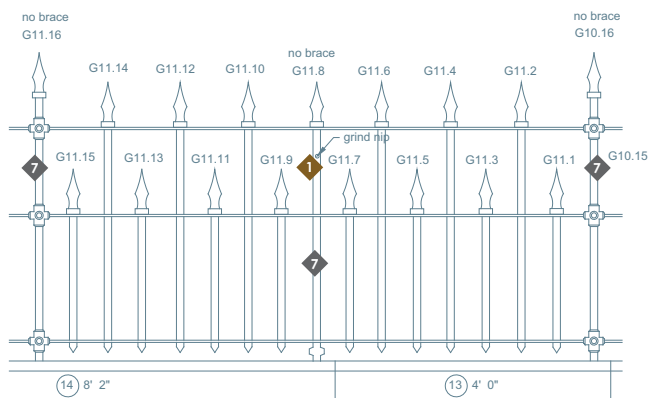
Ironwork Corrosion

► Sandstone Deterioration

Structural Instability

1. Repair holes, cracks and casting defects using filler compound containing iron particles in an epoxy resin binder
2. Replace missing or severely damaged cast iron components with in-kind casting technique and material
3. Major cracks and inappropriate repairs to be repaired by brazing with special nickel alloy welding rods

4. Remove vegetation, failed patches (concrete), and embedded foreign objects
5. Eliminate water infiltration by re-setting fractured stone, filling pockets, shelves and depressions, and stabilizing post base with restoration mortar

6. Repair primary anchor points by pouring new molten lead into existing masonry socket and building up coping stone with restoration mortar
7. Replace missing or non-historic (square stock) backstays with in-kind material
8. Realign and stabilize fence to include straightening bent, bowed, or out of plumb fence sections and individual horizontal or vertical components
9. Remove non-historic end posts and restore with in-kind materials to period of significance

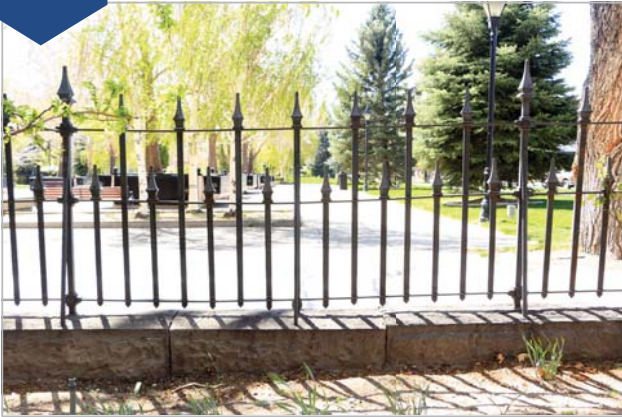
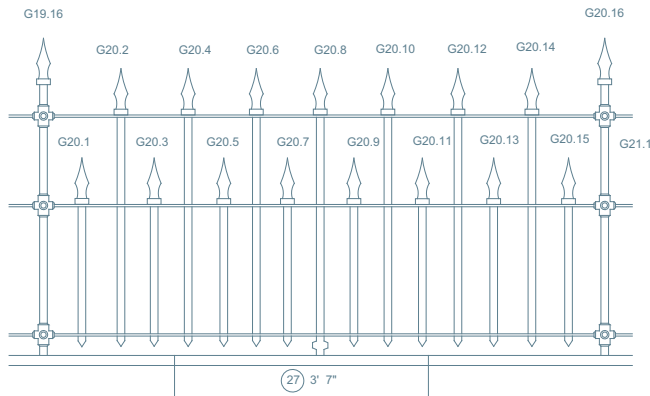
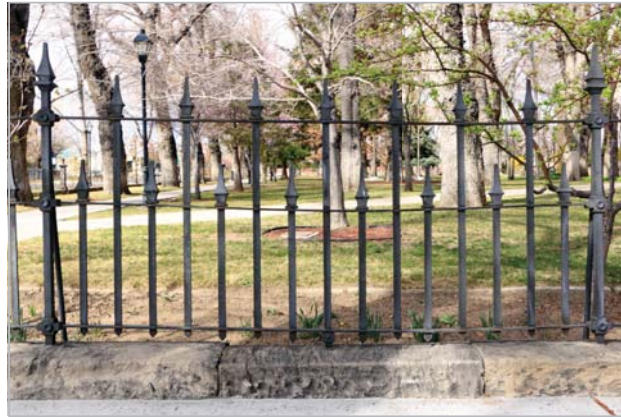
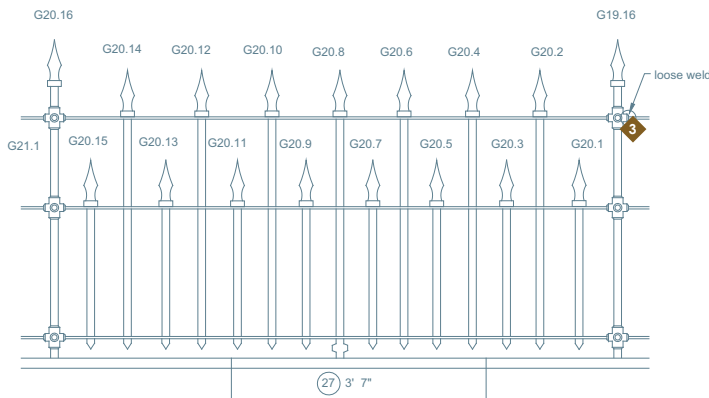
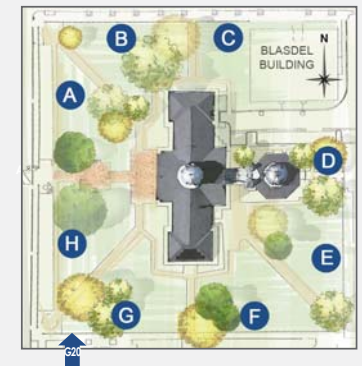
SECTION
G20

Ironwork Corrosion

Sandstone Deterioration

Structural Instability

1. Repair holes, cracks and casting defects using filler compound containing iron particles in an epoxy resin binder
2. Replace missing or severely damaged cast iron components with in-kind casting technique and material
3. Major cracks and inappropriate repairs to be repaired by brazing with special nickel alloy welding rods

4. Remove vegetation, failed patches (concrete), and embedded foreign objects
5. Eliminate water infiltration by re-setting fractured stone, filling pockets, shelves and depressions, and stabilizing post base with restoration mortar

6. Repair primary anchor points by pouring new molten lead into existing masonry socket and building up coping stone with restoration mortar
7. Replace missing or non-historic (square stock) backstays with in-kind material
8. Realign and stabilize fence to include straightening bent, bowed, or out of plumb fence sections and individual horizontal or vertical components
9. Remove non-historic end posts and restore with in-kind materials to period of significance

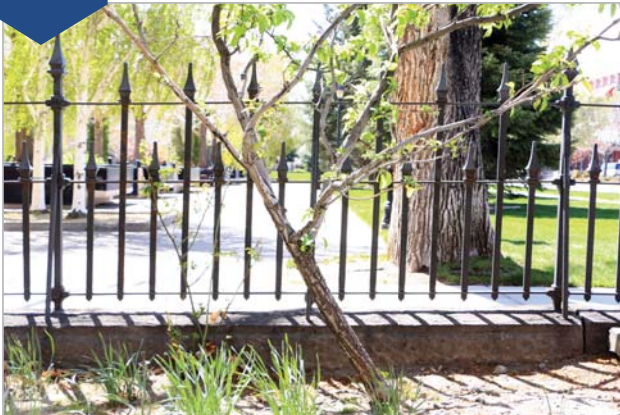
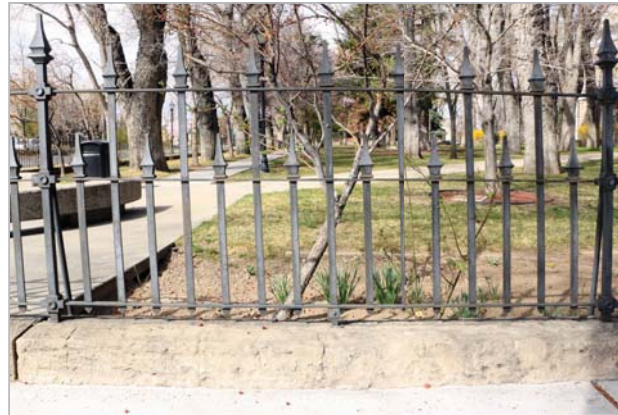
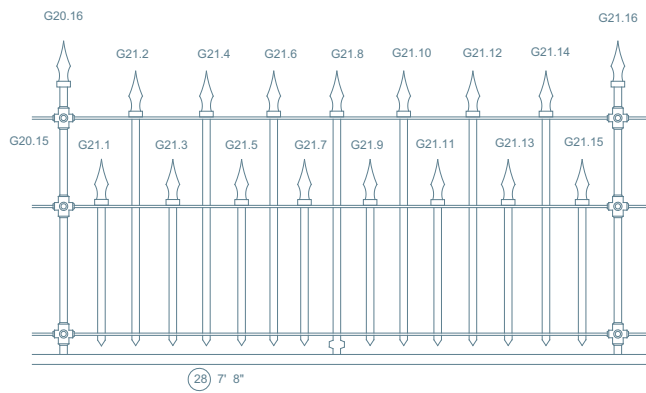
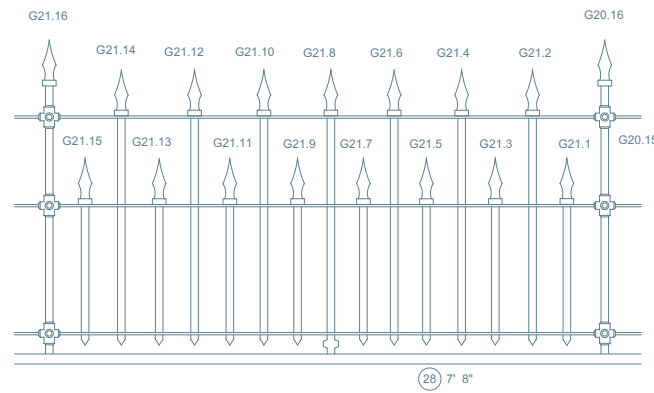
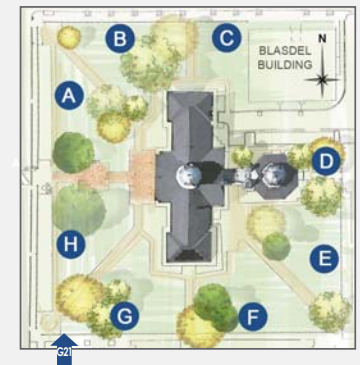
SECTION G21

Ironwork Corrosion

Sandstone Deterioration

Structural Instability

1. Repair holes, cracks and casting defects using filler compound containing iron particles in an epoxy resin binder
2. Replace missing or severely damaged cast iron components with in-kind casting technique and material
3. Major cracks and inappropriate repairs to be repaired by brazing with special nickel alloy welding rods

4. Remove vegetation, failed patches (concrete), and embedded foreign objects
5. Eliminate water infiltration by re-setting fractured stone, filling pockets, shelves and depressions, and stabilizing post base with restoration mortar

6. Repair primary anchor points by pouring new molten lead into existing masonry socket and building up coping stone with restoration mortar
7. Replace missing or non-historic (square stock) backstays with in-kind material
8. Realign and stabilize fence to include straightening bent, bowed, or out of plumb fence sections and individual horizontal or vertical components
9. Remove non-historic end posts and restore with in-kind materials to period of significance

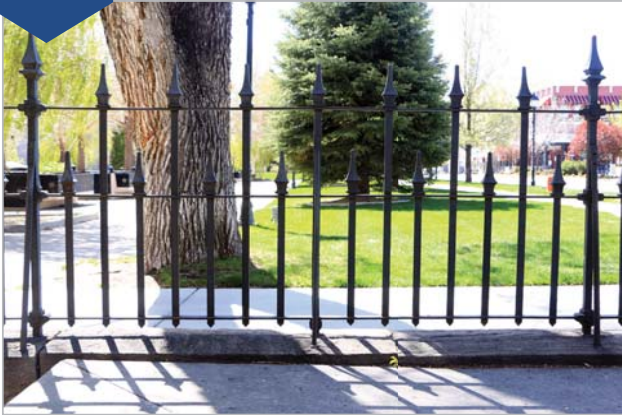
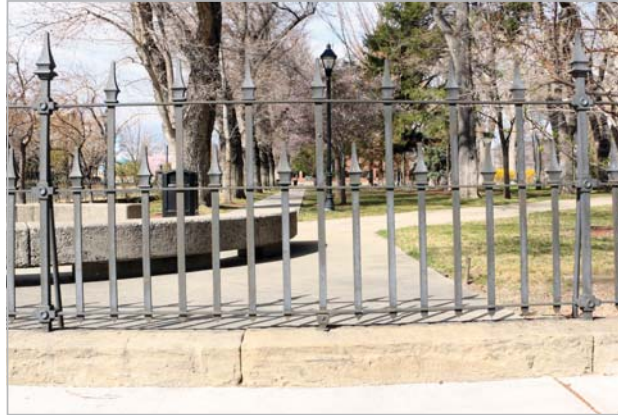
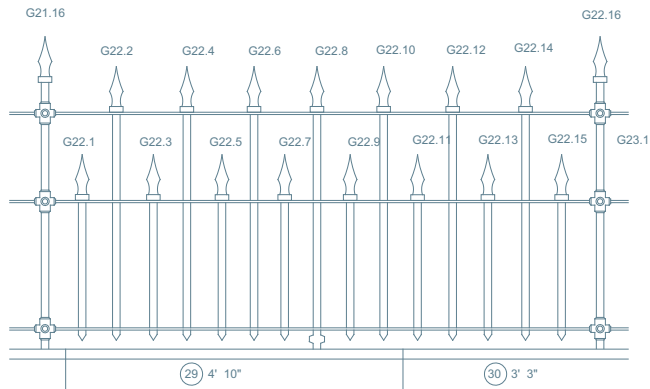
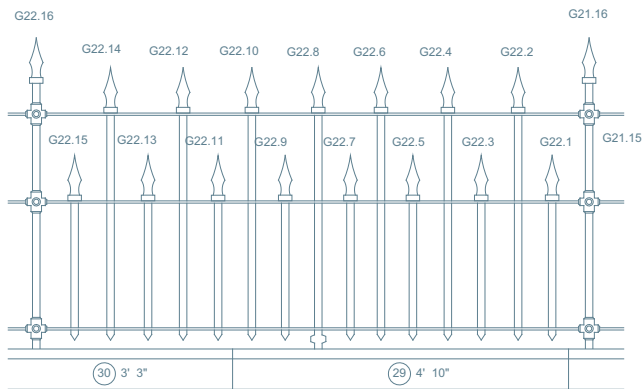
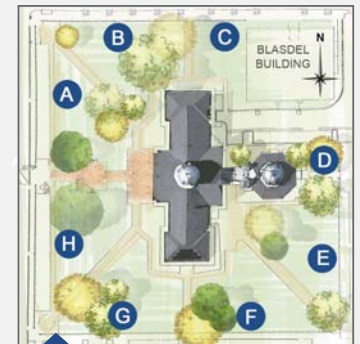
G22

Ironwork Corrosion

Sandstone Deterioration

Structural Instability

1. Repair holes, cracks and casting defects using filler compound containing iron particles in an epoxy resin binder
2. Replace missing or severely damaged cast iron components with in-kind casting technique and material
3. Major cracks and inappropriate repairs to be repaired by brazing with special nickel alloy welding rods

4. Remove vegetation, failed patches (concrete), and embedded foreign objects
5. Eliminate water infiltration by re-setting fractured stone, filling pockets, shelves and depressions, and stabilizing post base with restoration mortar

6. Repair primary anchor points by pouring new molten lead into existing masonry socket and building up coping stone with restoration mortar
7. Replace missing or non-historic (square stock) backstays with in-kind material
8. Realign and stabilize fence to include straightening bent, bowed, or out of plumb fence sections and individual horizontal or vertical components
9. Remove non-historic end posts and restore with in-kind materials to period of significance

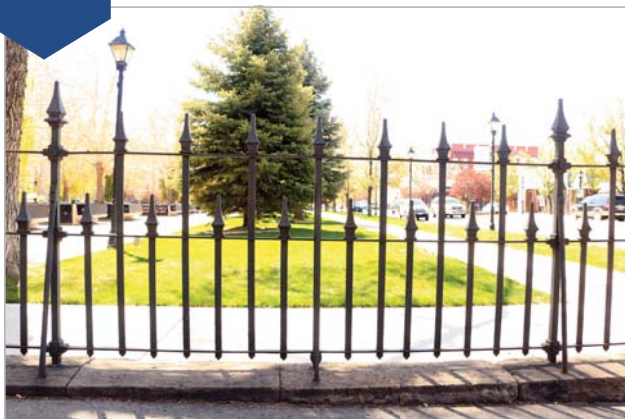
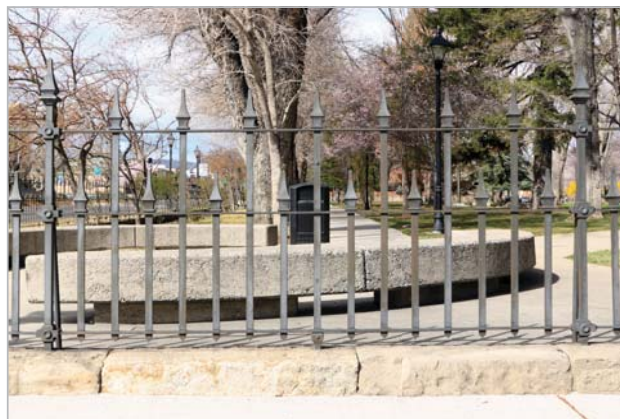
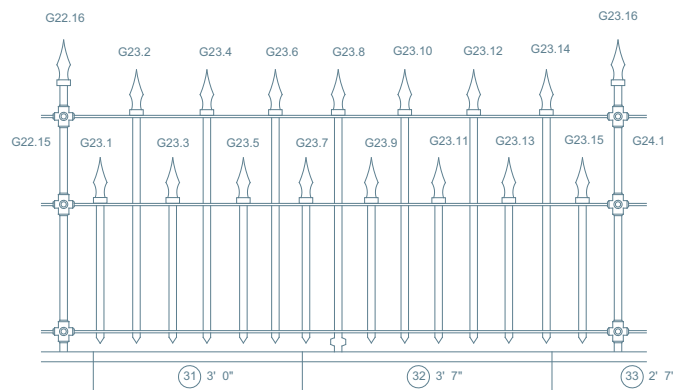
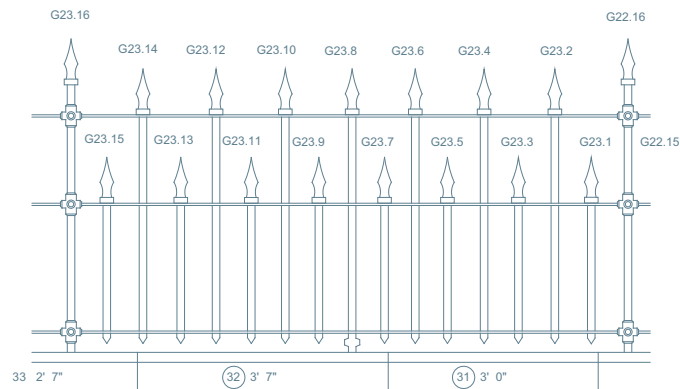
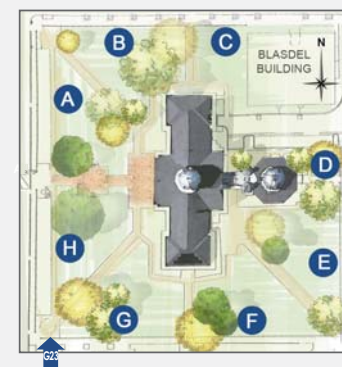
SECTION G23

Ironwork Corrosion

Sandstone Deterioration

Structural Instability

1. Repair holes, cracks and casting defects using filler compound containing iron particles in an epoxy resin binder
2. Replace missing or severely damaged cast iron components with in-kind casting technique and material
3. Major cracks and inappropriate repairs to be repaired by brazing with special nickel alloy welding rods

4. Remove vegetation, failed patches (concrete), and embedded foreign objects
5. Eliminate water infiltration by re-setting fractured stone, filling pockets, shelves and depressions, and stabilizing post base with restoration mortar

6. Repair primary anchor points by pouring new molten lead into existing masonry socket and building up coping stone with restoration mortar
7. Replace missing or non-historic (square stock) backstays with in-kind material
8. Realign and stabilize fence to include straightening bent, bowed, or out of plumb fence sections and individual horizontal or vertical components
9. Remove non-historic end posts and restore with in-kind materials to period of significance

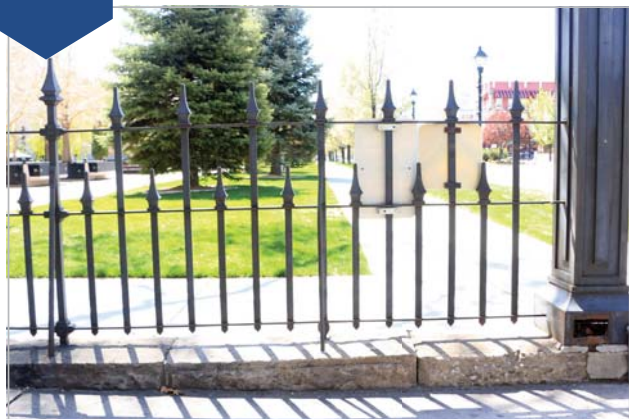
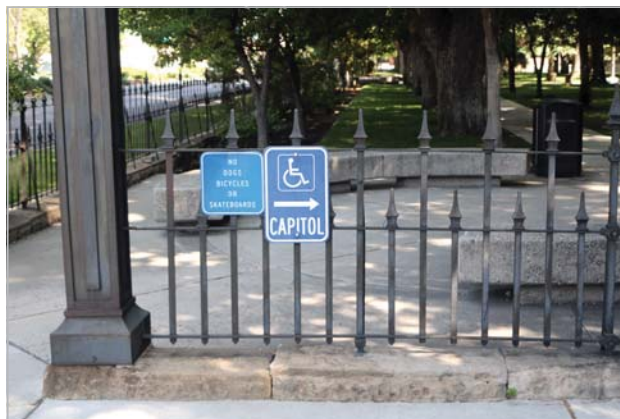
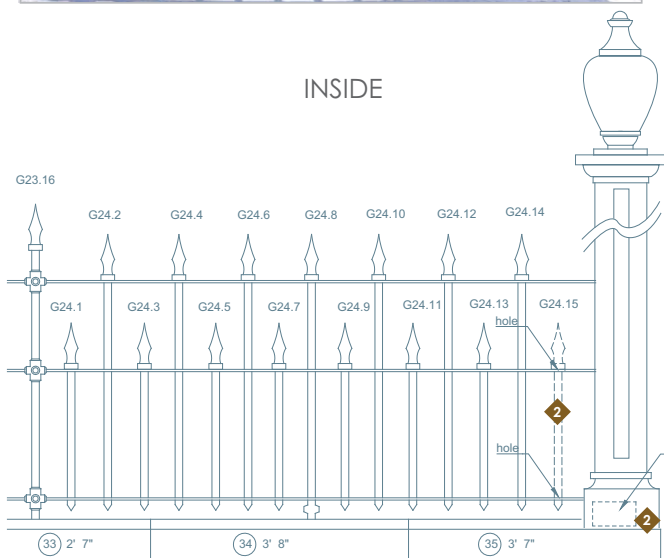
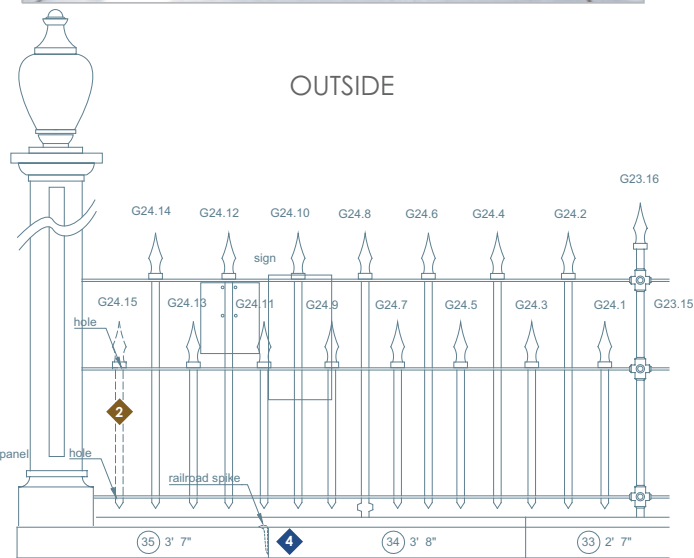
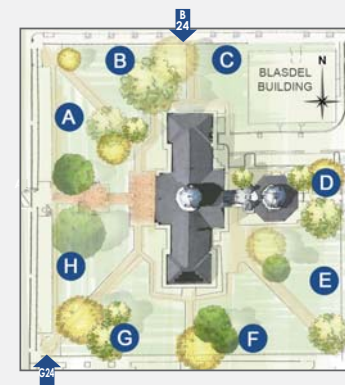
SECTION G24

Ironwork Corrosion

Sandstone Deterioration

Structural Instability

1. Repair holes, cracks and casting defects using filler compound containing iron particles in an epoxy resin binder
2. Replace missing or severely damaged cast iron components with in-kind casting technique and material
3. Major cracks and inappropriate repairs to be repaired by brazing with special nickel alloy welding rods

4. Remove vegetation, failed patches (concrete), and embedded foreign objects
5. Eliminate water infiltration by re-setting fractured stone, filling pockets, shelves and depressions, and stabilizing post base with restoration mortar

6. Repair primary anchor points by pouring new molten lead into existing masonry socket and building up coping stone with restoration mortar
7. Replace missing or non-historic (square stock) backstays with in-kind material
8. Realign and stabilize fence to include straightening bent, bowed, or out of plumb fence sections and individual horizontal or vertical components
9. Remove non-historic end posts and restore with in-kind materials to period of significance

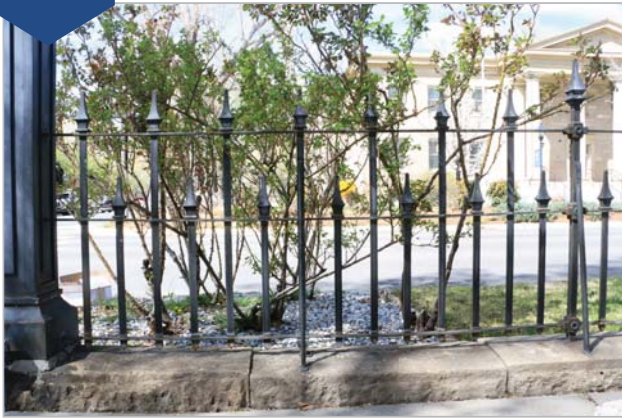
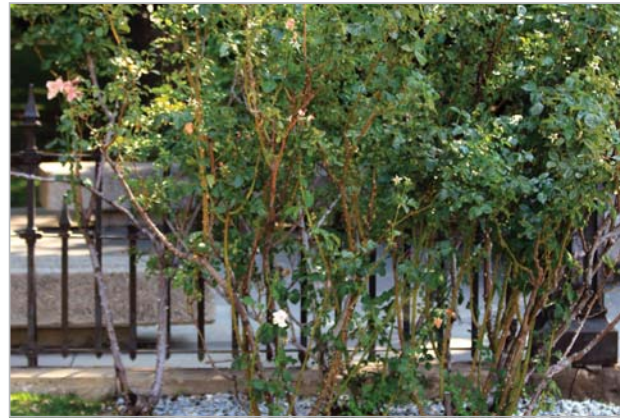
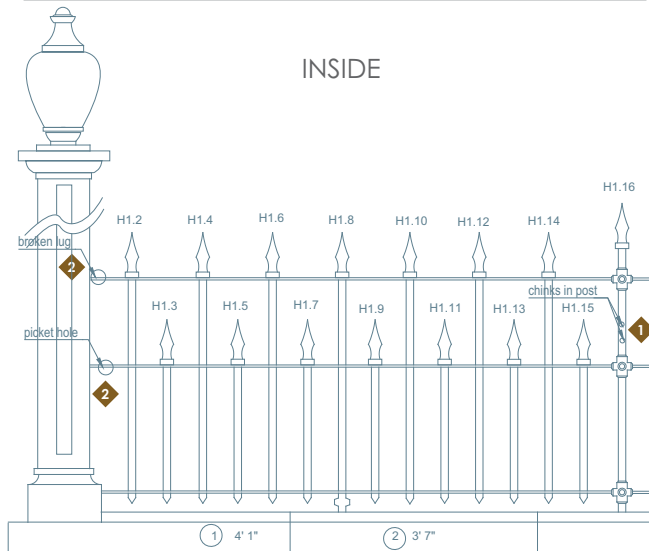
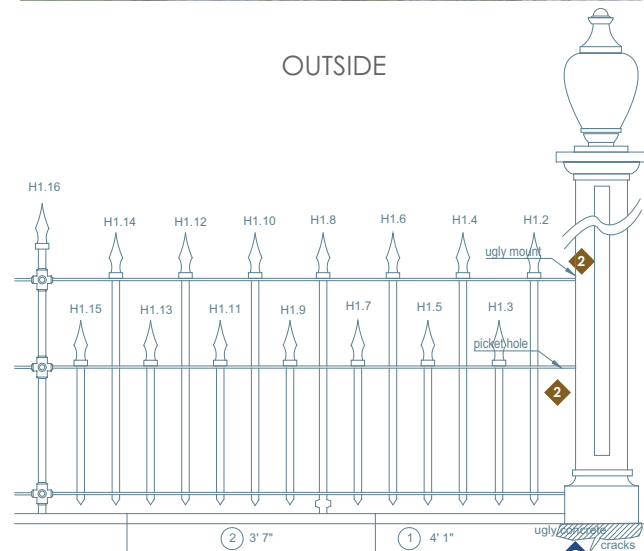
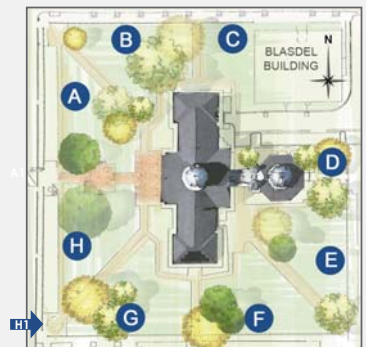
H1

Ironwork Corrosion

Sandstone Deterioration

Structural Instability

1. Repair holes, cracks and casting defects using filler compound containing iron particles in an epoxy resin binder
2. Replace missing or severely damaged cast iron components with in-kind casting technique and material
3. Major cracks and inappropriate repairs to be repaired by brazing with special nickel alloy welding rods

4. Remove vegetation, failed patches (concrete), and embedded foreign objects
5. Eliminate water infiltration by re-setting fractured stone, filling pockets, shelves and depressions, and stabilizing post base with restoration mortar

6. Repair primary anchor points by pouring new molten lead into existing masonry socket and building up coping stone with restoration mortar
7. Replace missing or non-historic (square stock) backstays with in-kind material
8. Realign and stabilize fence to include straightening bent, bowed, or out of plumb fence sections and individual horizontal or vertical components
9. Remove non-historic end posts and restore with in-kind materials to period of significance

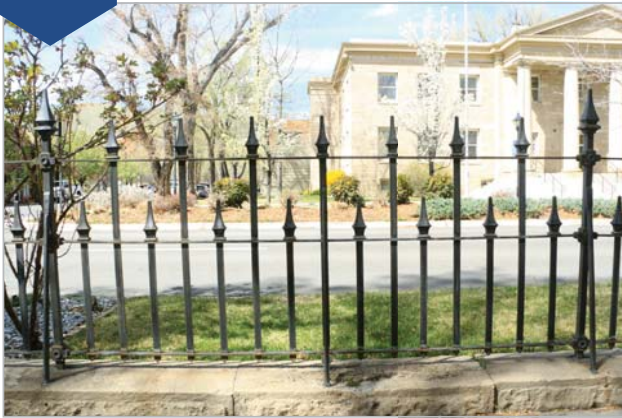
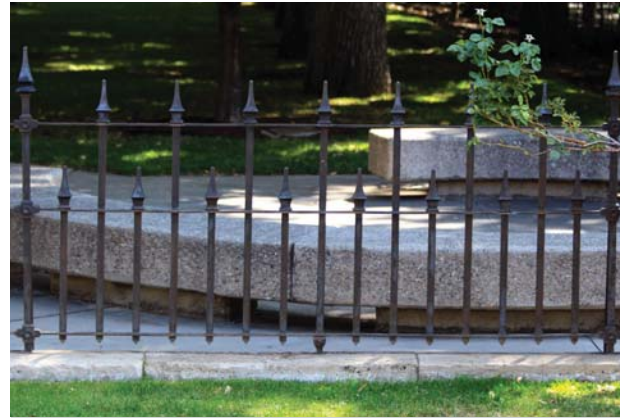
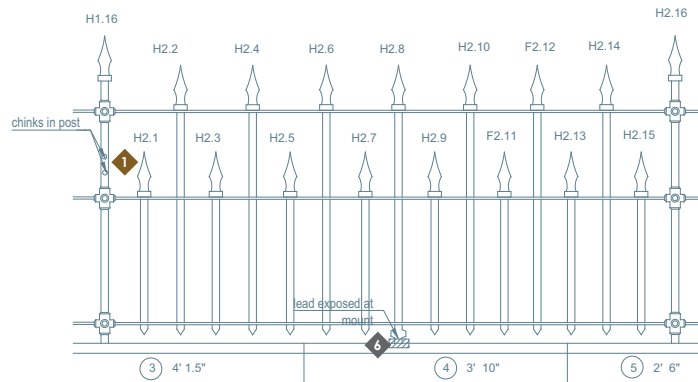
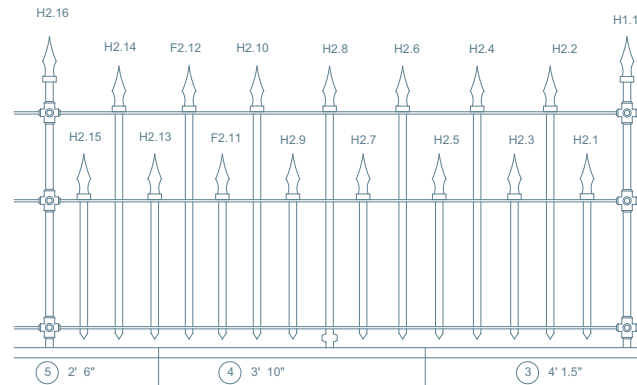
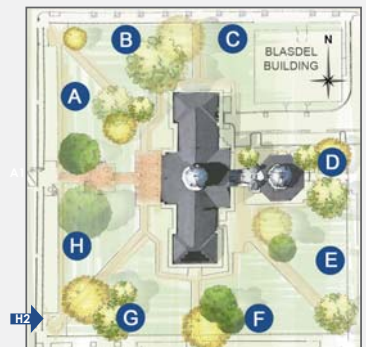
H2

**Ironwork Corrosion**

Sandstone Deterioration

Structural Instability

1. Repair holes, cracks and casting defects using filler compound containing iron particles in an epoxy resin binder
2. Replace missing or severely damaged cast iron components with in-kind casting technique and material
3. Major cracks and inappropriate repairs to be repaired by brazing with special nickel alloy welding rods

4. Remove vegetation, failed patches (concrete), and embedded foreign objects
5. Eliminate water infiltration by re-setting fractured stone, filling pockets, shelves and depressions, and stabilizing post base with restoration mortar

6. Repair primary anchor points by pouring new molten lead into existing masonry socket and building up coping stone with restoration mortar
7. Replace missing or non-historic (square stock) backstays with in-kind material
8. Realign and stabilize fence to include straightening bent, bowed, or out of plumb fence sections and individual horizontal or vertical components
9. Remove non-historic end posts and restore with in-kind materials to period of significance

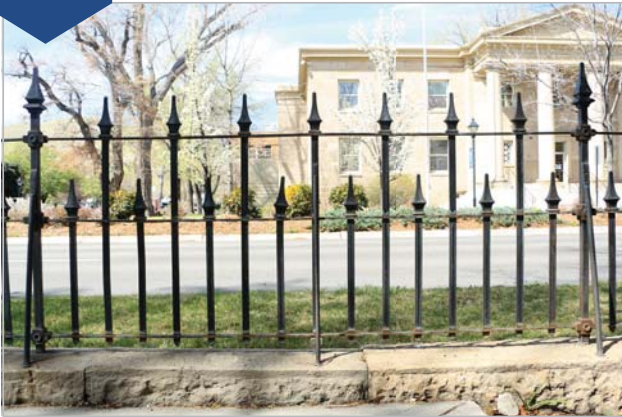
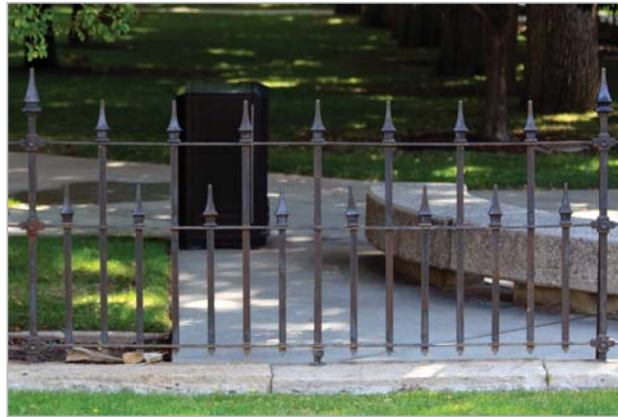
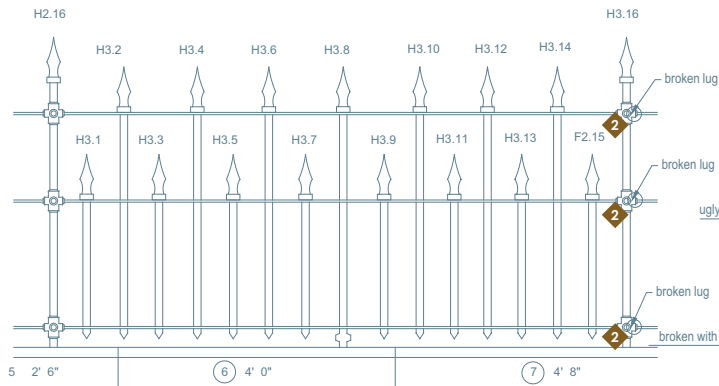
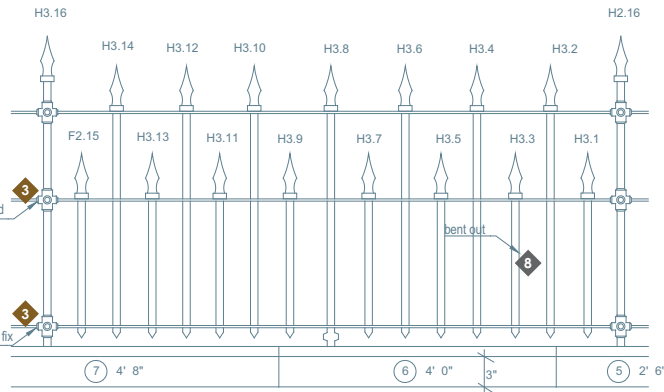
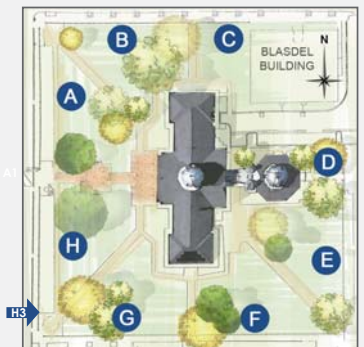
H3

Ironwork Corrosion

Sandstone Deterioration

Structural Instability

1. Repair holes, cracks and casting defects using filler compound containing iron particles in an epoxy resin binder
2. Replace missing or severely damaged cast iron components with in-kind casting technique and material
3. Major cracks and inappropriate repairs to be repaired by brazing with special nickel alloy welding rods

4. Remove vegetation, failed patches (concrete), and embedded foreign objects
5. Eliminate water infiltration by re-setting fractured stone, filling pockets, shelves and depressions, and stabilizing post base with restoration mortar

6. Repair primary anchor points by pouring new molten lead into existing masonry socket and building up coping stone with restoration mortar
7. Replace missing or non-historic (square stock) backstays with in-kind material
8. Realign and stabilize fence to include straightening bent, bowed, or out of plumb fence sections and individual horizontal or vertical components
9. Remove non-historic end posts and restore with in-kind materials to period of significance
