Capitol Fence

Historic Structure Report

SPWD Project #15-A025

February 2016

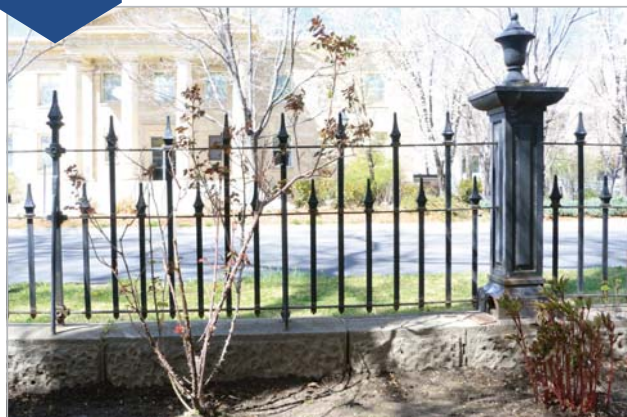
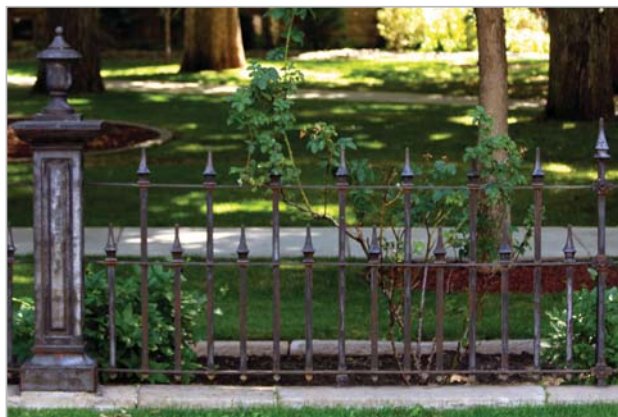
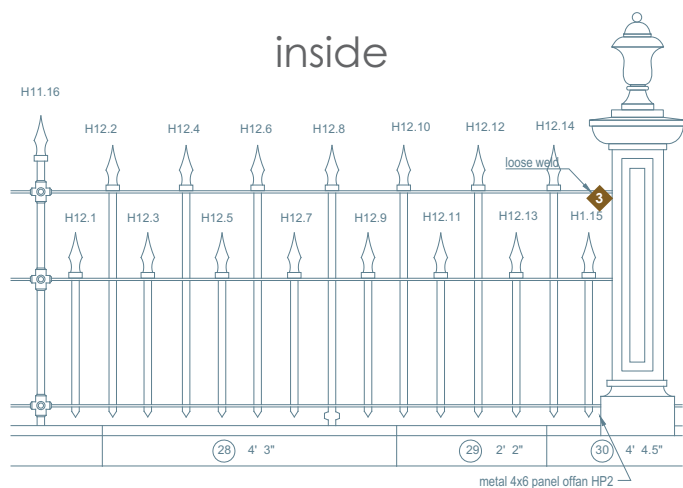
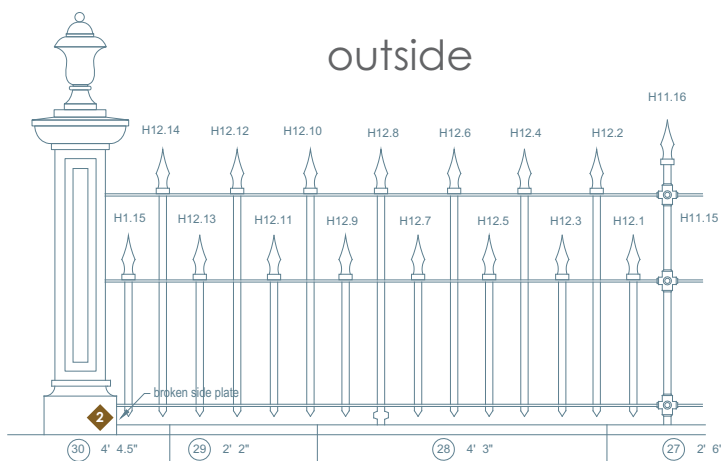
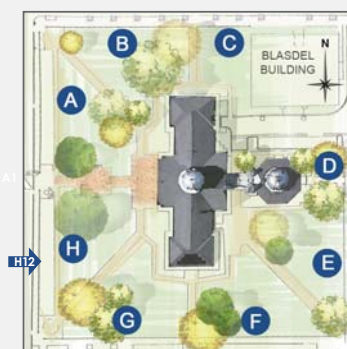
H12

Ironwork Corrosion

Sandstone Deterioration

Structural Instability

1. Repair holes, cracks and casting defects using filler compound containing iron particles in an epoxy resin binder
2. Replace missing or severely damaged cast iron components with in-kind casting technique and material
3. Major cracks and inappropriate repairs to be repaired by brazing with special nickel alloy welding rods

4. Remove vegetation, failed patches (concrete), and embedded foreign objects
5. Eliminate water infiltration by re-setting fractured stone, filling pockets, shelves and depressions, and stabilizing post base with restoration mortar

6. Repair primary anchor points by pouring new molten lead into existing masonry socket and building up coping stone with restoration mortar
7. Replace missing or non-historic (square stock) backstays with in-kind material
8. Realign and stabilize fence to include straightening bent, bowed, or out of plumb fence sections and individual horizontal or vertical components
9. Remove non-historic end posts and restore with in-kind materials to period of significance

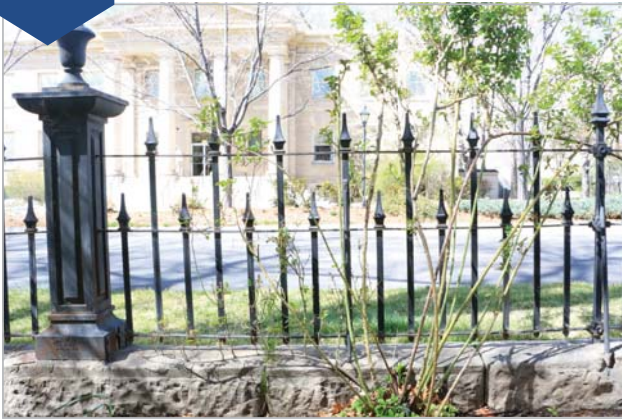
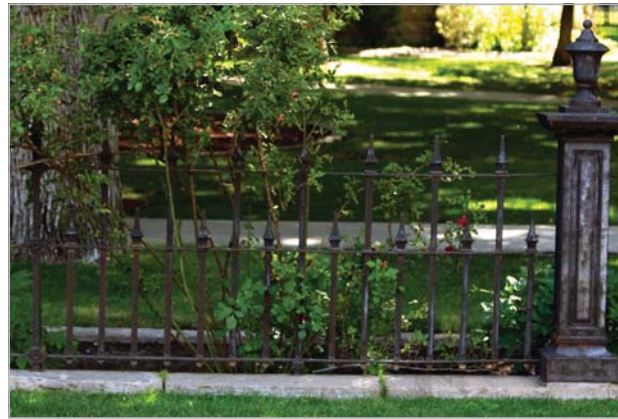
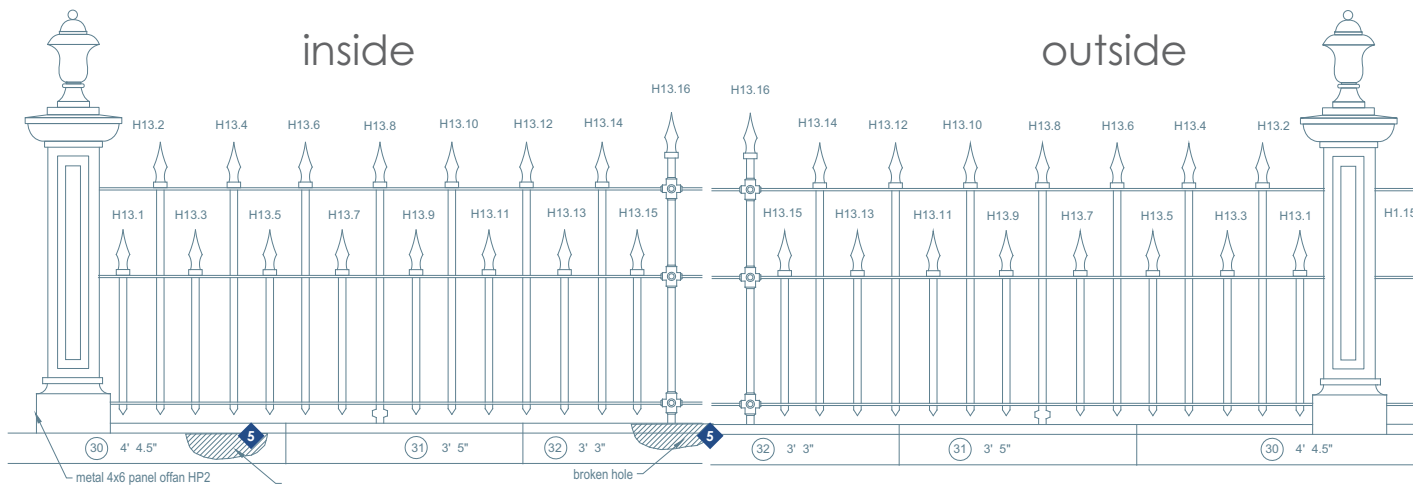
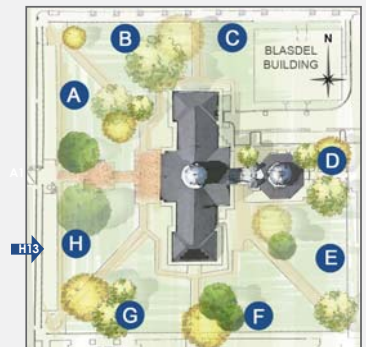
H13 Condition Assessment

Ironwork Corrosion

Sandstone Deterioration

Structural Instability

1. Repair holes, cracks and casting defects using filler compound containing iron particles in an epoxy resin binder
2. Replace missing or severely damaged cast iron components with in-kind casting technique and material
3. Major cracks and inappropriate repairs to be repaired by brazing with special nickel alloy welding rods

4. Remove vegetation, failed patches (concrete), and embedded foreign objects
5. Eliminate water infiltration by re-setting fractured stone, filling pockets, shelves and depressions, and stabilizing post base with restoration mortar

6. Repair primary anchor points by pouring new molten lead into existing masonry socket and building up coping stone with restoration mortar
7. Replace missing or non-historic (square stock) backstays with in-kind material
8. Realign and stabilize fence to include straightening bent, bowed, or out of plumb fence sections and individual horizontal or vertical components
9. Remove non-historic end posts and restore with in-kind materials to period of significance

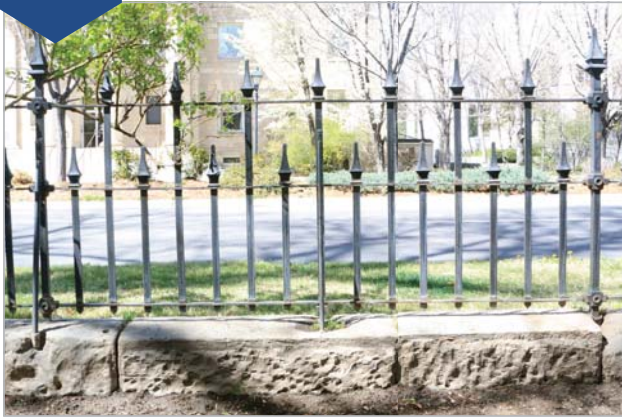
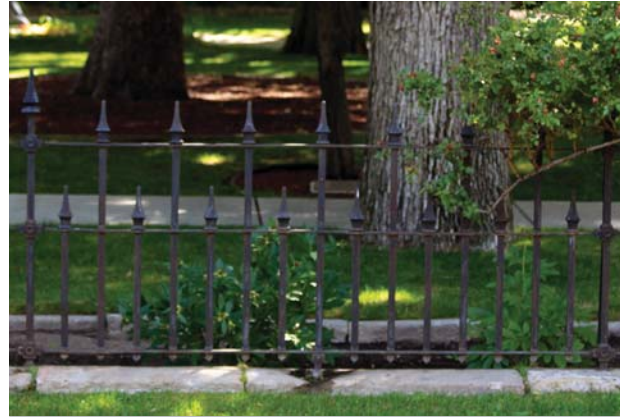
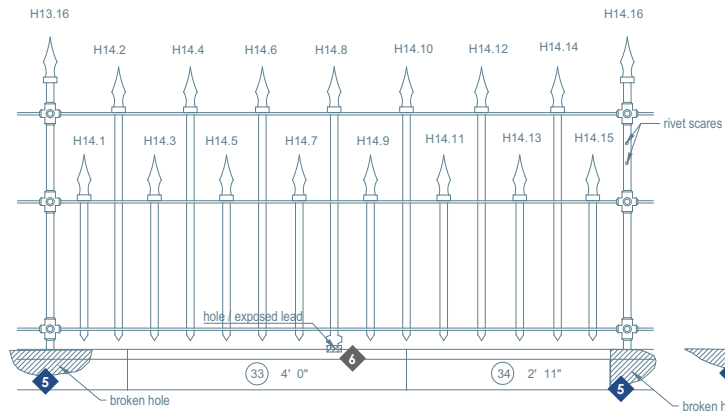
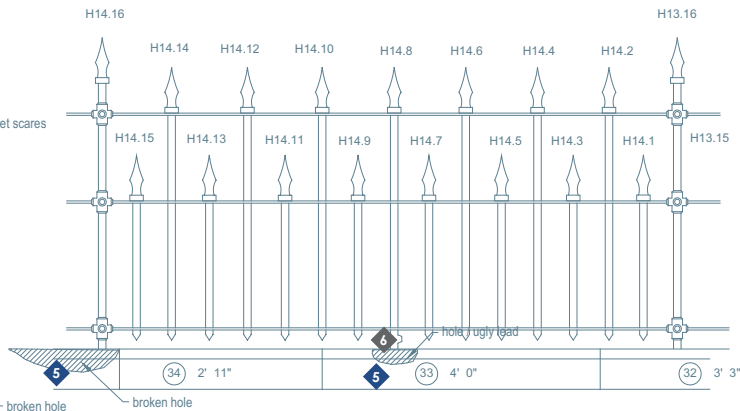
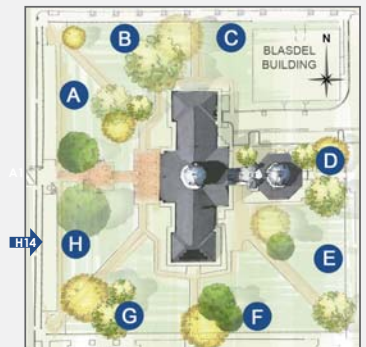
H14

Ironwork Corrosion

Sandstone Deterioration

Structural Instability

1. Repair holes, cracks and casting defects using filler compound containing iron particles in an epoxy resin binder
2. Replace missing or severely damaged cast iron components with in-kind casting technique and material
3. Major cracks and inappropriate repairs to be repaired by brazing with special nickel alloy welding rods

4. Remove vegetation, failed patches (concrete), and embedded foreign objects
5. Eliminate water infiltration by re-setting fractured stone, filling pockets, shelves and depressions, and stabilizing post base with restoration mortar

6. Repair primary anchor points by pouring new molten lead into existing masonry socket and building up coping stone with restoration mortar
7. Replace missing or non-historic (square stock) backstays with in-kind material
8. Realign and stabilize fence to include straightening bent, bowed, or out of plumb fence sections and individual horizontal or vertical components
9. Remove non-historic end posts and restore with in-kind materials to period of significance

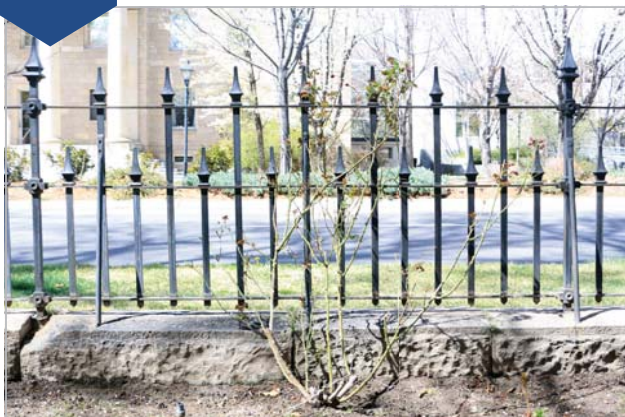
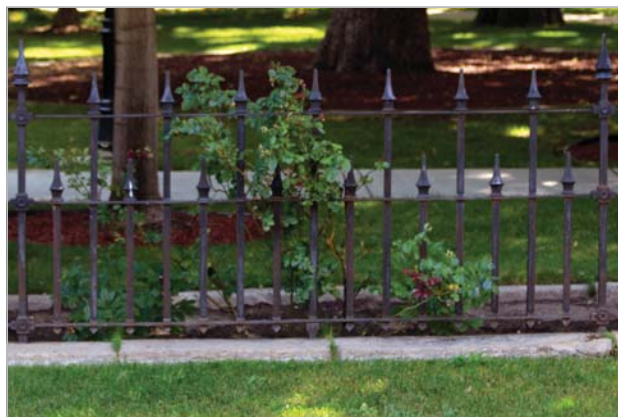
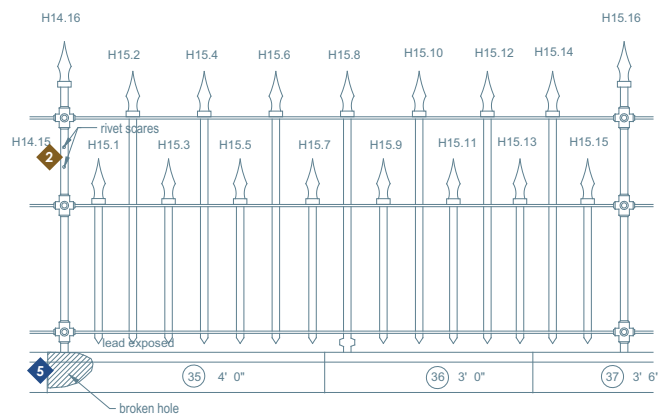
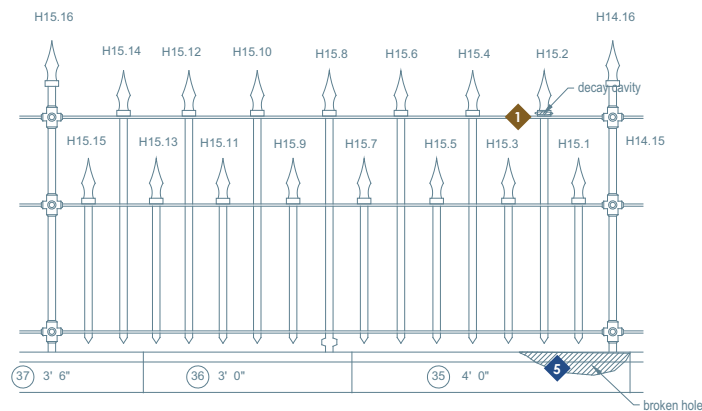
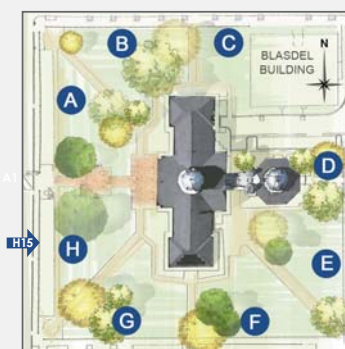
H15

Ironwork Corrosion

Sandstone Deterioration

Structural Instability

1. Repair holes, cracks and casting defects using filler compound containing iron particles in an epoxy resin binder
2. Replace missing or severely damaged cast iron components with in-kind casting technique and material
3. Major cracks and inappropriate repairs to be repaired by brazing with special nickel alloy welding rods

4. Remove vegetation, failed patches (concrete), and embedded foreign objects
5. Eliminate water infiltration by re-setting fractured stone, filling pockets, shelves and depressions, and stabilizing post base with restoration mortar

6. Repair primary anchor points by pouring new molten lead into existing masonry socket and building up coping stone with restoration mortar
7. Replace missing or non-historic (square stock) backstays with in-kind material
8. Realign and stabilize fence to include straightening bent, bowed, or out of plumb fence sections and individual horizontal or vertical components
9. Remove non-historic end posts and restore with in-kind materials to period of significance

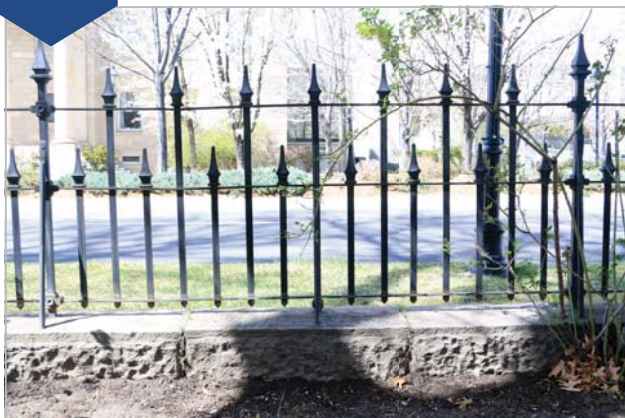
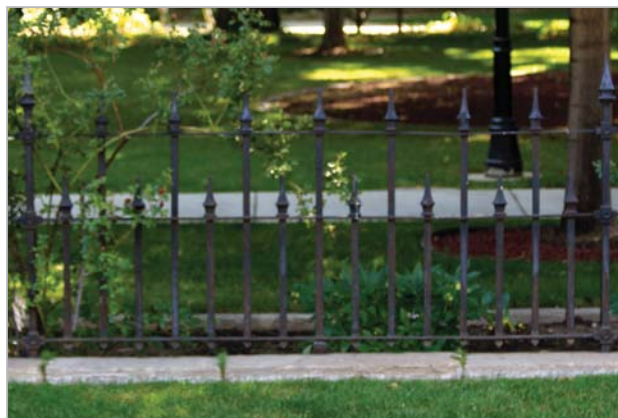
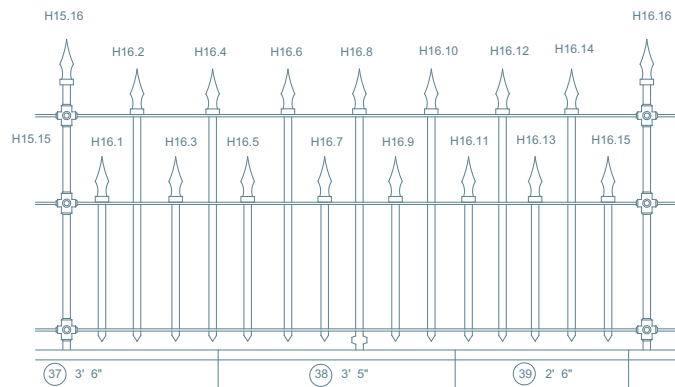
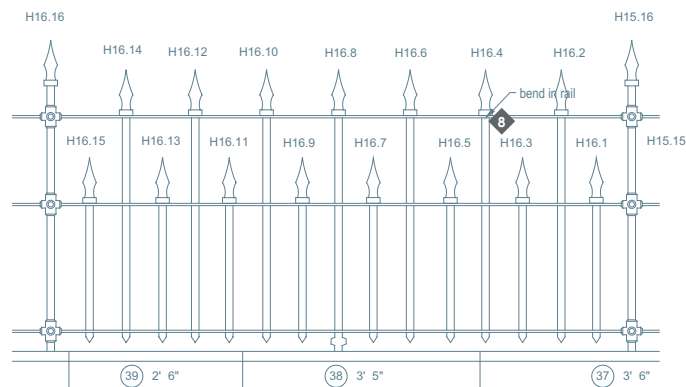
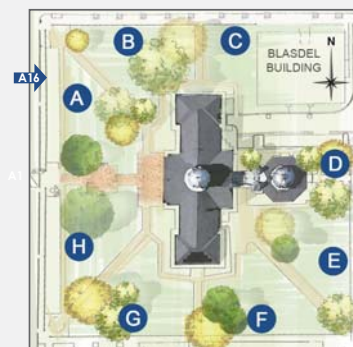
H16

Ironwork Corrosion

Sandstone Deterioration

Structural Instability

1. Repair holes, cracks and casting defects using filler compound containing iron particles in an epoxy resin binder
2. Replace missing or severely damaged cast iron components with in-kind casting technique and material
3. Major cracks and inappropriate repairs to be repaired by brazing with special nickel alloy welding rods

4. Remove vegetation, failed patches (concrete), and embedded foreign objects
5. Eliminate water infiltration by re-setting fractured stone, filling pockets, shelves and depressions, and stabilizing post base with restoration mortar

6. Repair primary anchor points by pouring new molten lead into existing masonry socket and building up coping stone with restoration mortar
7. Replace missing or non-historic (square stock) backstays with in-kind material
8. Realign and stabilize fence to include straightening bent, bowed, or out of plumb fence sections and individual horizontal or vertical components
9. Remove non-historic end posts and restore with in-kind materials to period of significance

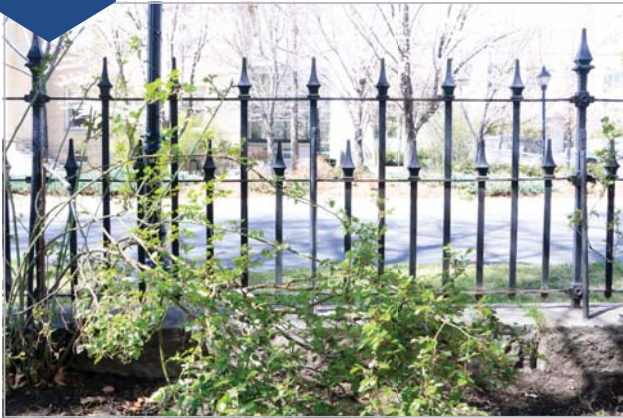
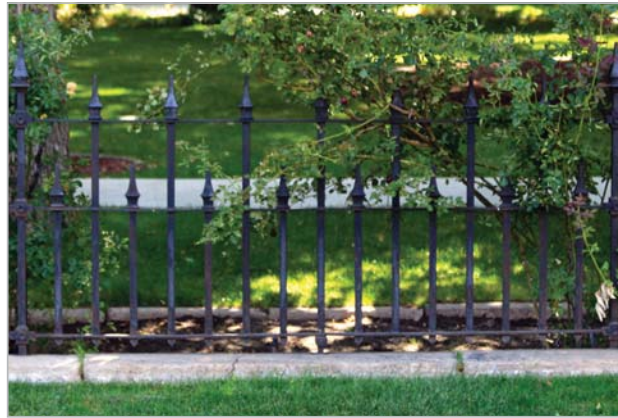
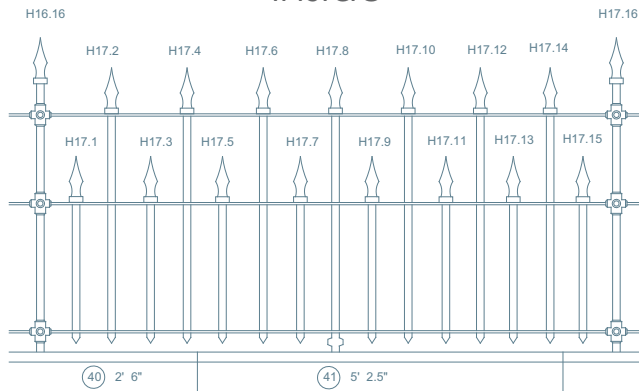
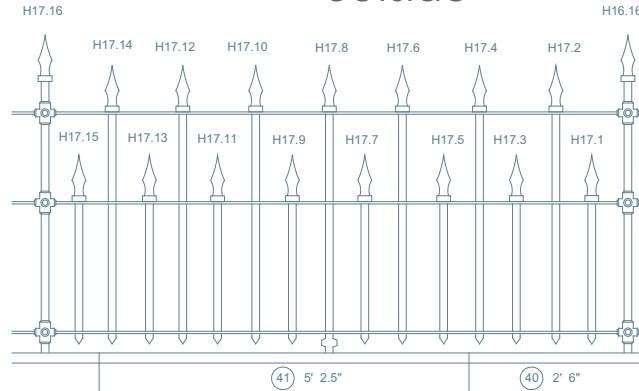
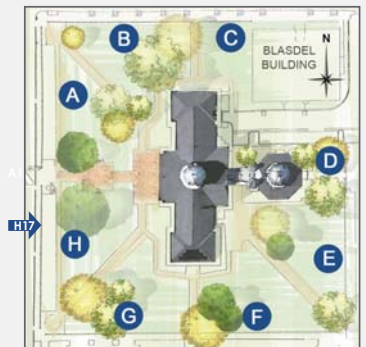
H17

Ironwork Corrosion

Sandstone Deterioration

Structural Instability

1. Repair holes, cracks and casting defects using filler compound containing iron particles in an epoxy resin binder
2. Replace missing or severely damaged cast iron components with in-kind casting technique and material
3. Major cracks and inappropriate repairs to be repaired by brazing with special nickel alloy welding rods

4. Remove vegetation, failed patches (concrete), and embedded foreign objects
5. Eliminate water infiltration by re-setting fractured stone, filling pockets, shelves and depressions, and stabilizing post base with restoration mortar

6. Repair primary anchor points by pouring new molten lead into existing masonry socket and building up coping stone with restoration mortar
7. Replace missing or non-historic (square stock) backstays with in-kind material
8. Realign and stabilize fence to include straightening bent, bowed, or out of plumb fence sections and individual horizontal or vertical components
9. Remove non-historic end posts and restore with in-kind materials to period of significance

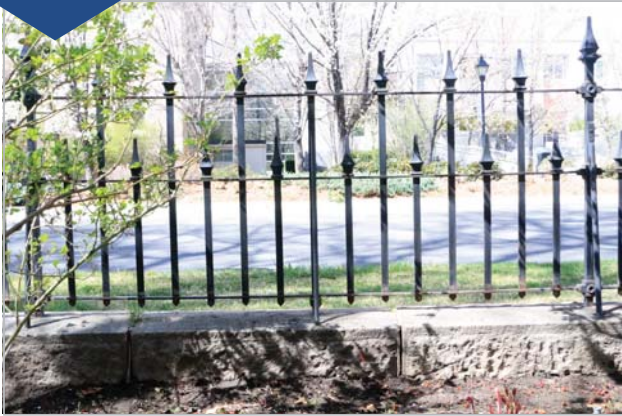
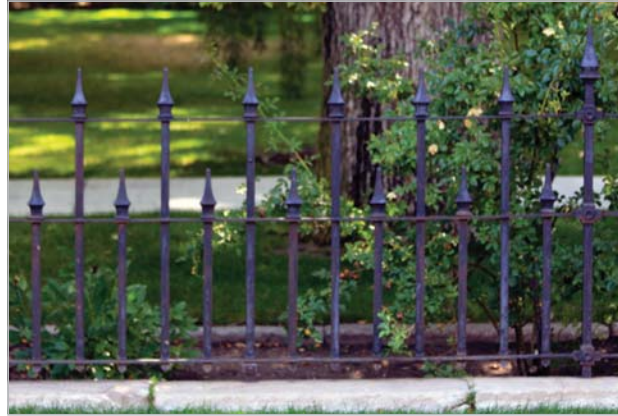
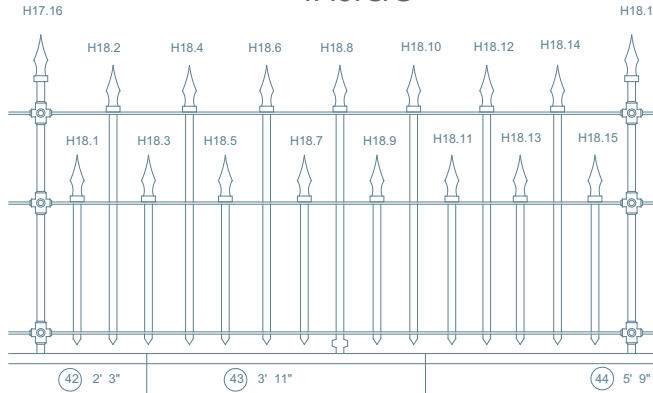
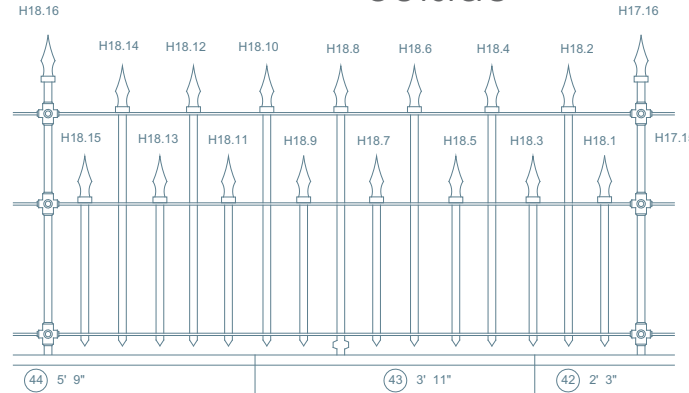
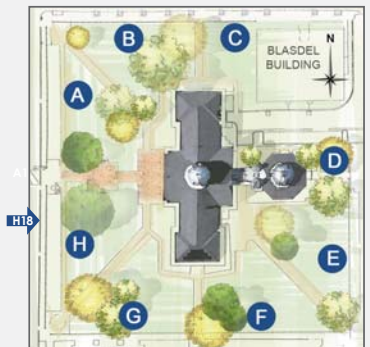
H18

Ironwork Corrosion

Sandstone Deterioration

Structural Instability

1. Repair holes, cracks and casting defects using filler compound containing iron particles in an epoxy resin binder
2. Replace missing or severely damaged cast iron components with in-kind casting technique and material
3. Major cracks and inappropriate repairs to be repaired by brazing with special nickel alloy welding rods

4. Remove vegetation, failed patches (concrete), and embedded foreign objects
5. Eliminate water infiltration by re-setting fractured stone, filling pockets, shelves and depressions, and stabilizing post base with restoration mortar

6. Repair primary anchor points by pouring new molten lead into existing masonry socket and building up coping stone with restoration mortar
7. Replace missing or non-historic (square stock) backstays with in-kind material
8. Realign and stabilize fence to include straightening bent, bowed, or out of plumb fence sections and individual horizontal or vertical components
9. Remove non-historic end posts and restore with in-kind materials to period of significance

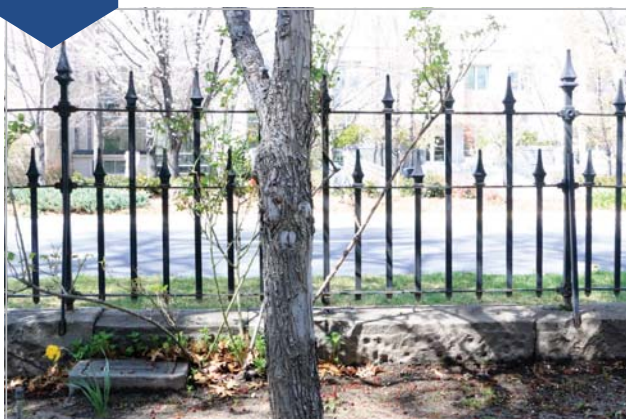
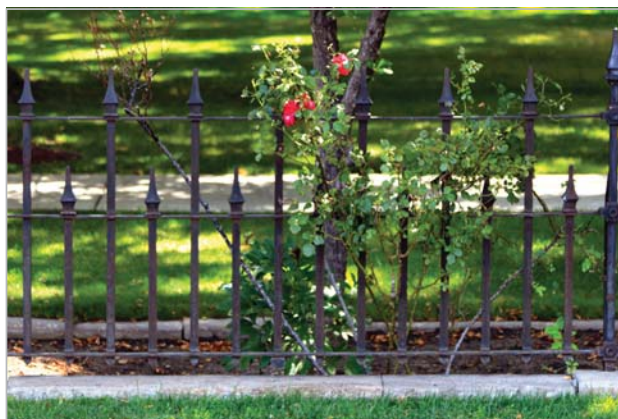
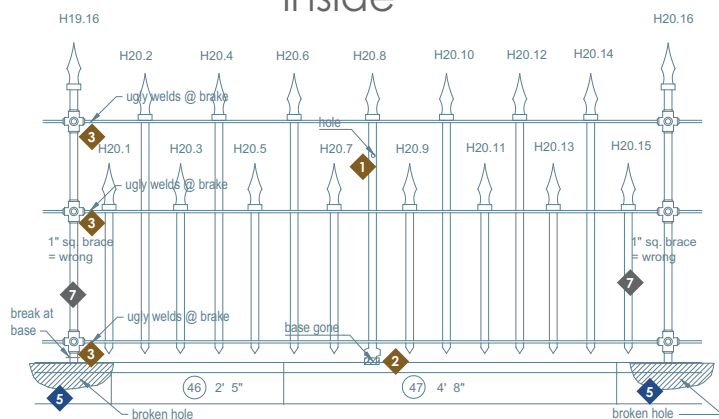
SECTION H20

Ironwork Corrosion

Sandstone Deterioration

1. Repair holes, cracks and casting defects using filler compound containing iron particles in an epoxy resin binder
2. Replace missing or severely damaged cast iron components with in-kind casting technique and material
3. Major cracks and inappropriate repairs to be repaired by brazing with special nickel alloy welding rods

4. Remove vegetation, failed patches (concrete), and embedded foreign objects
5. Eliminate water infiltration by re-setting fractured stone, filling pockets, shelves and depressions, and stabilizing post base with restoration mortar

6. Repair primary anchor points by pouring new molten lead into existing masonry socket and building up coping stone with restoration mortar
7. Replace missing or non-historic (square stock) backstays with in-kind material
8. Realign and stabilize fence to include straightening bent, bowed, or out of plumb fence sections and individual horizontal or vertical components
9. Remove non-historic end posts and restore with in-kind materials to period of significance

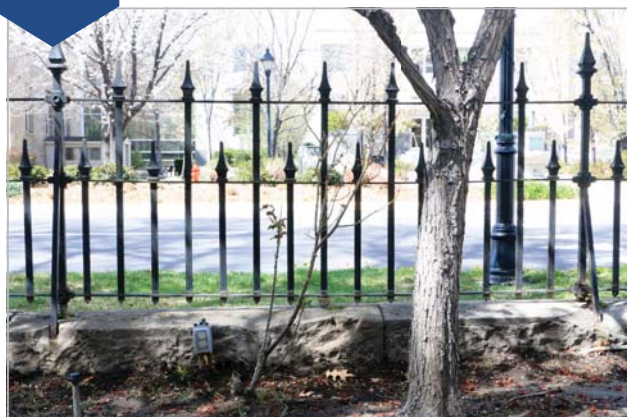
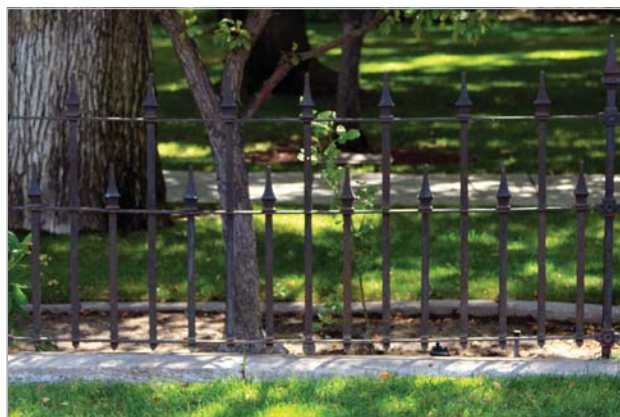
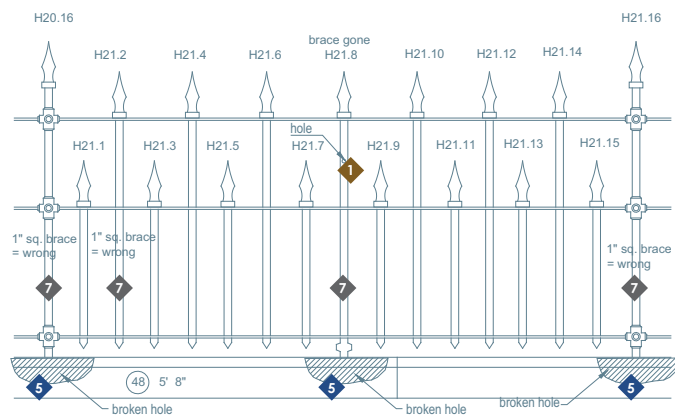
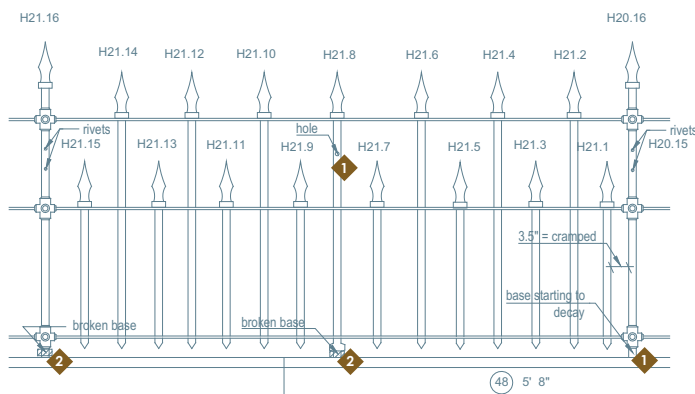
H21

Ironwork Corrosion

Sandstone Deterioration

Structural Instability

1. Repair holes, cracks and casting defects using filler compound containing iron particles in an epoxy resin binder
2. Replace missing or severely damaged cast iron components with in-kind casting technique and material
3. Major cracks and inappropriate repairs to be repaired by brazing with special nickel alloy welding rods

4. Remove vegetation, failed patches (concrete), and embedded foreign objects
5. Eliminate water infiltration by re-setting fractured stone, filling pockets, shelves and depressions, and stabilizing post base with restoration mortar

6. Repair primary anchor points by pouring new molten lead into existing masonry socket and building up coping stone with restoration mortar
7. Replace missing or non-historic (square stock) backstays with in-kind material
8. Realign and stabilize fence to include straightening bent, bowed, or out of plumb fence sections and individual horizontal or vertical components
9. Remove non-historic end posts and restore with in-kind materials to period of significance

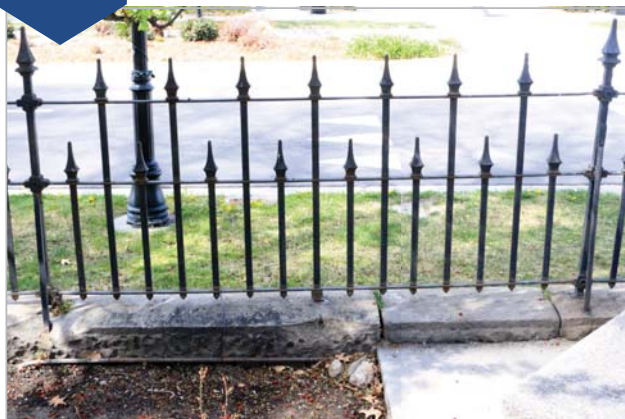
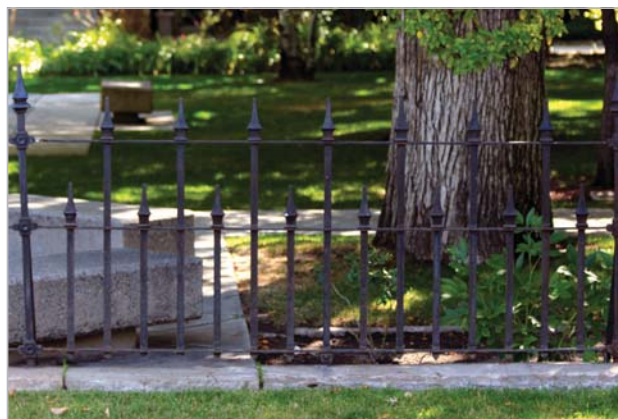
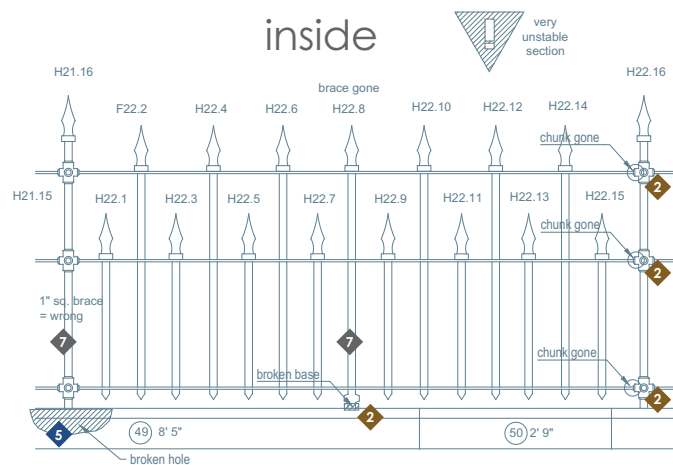
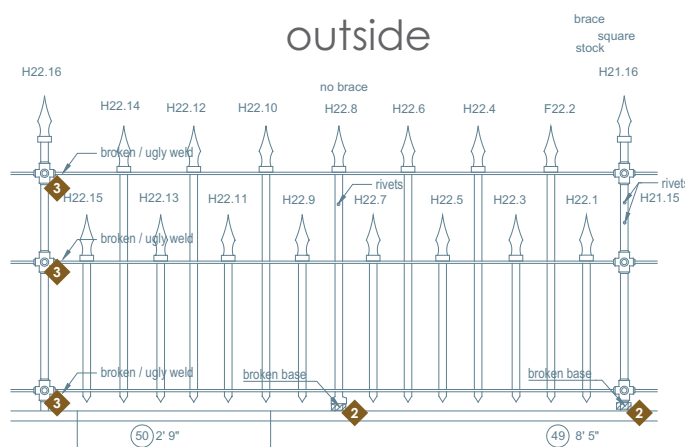
SECTION H22

Ironwork Corrosion

Sandstone Deterioration

Structural Instability

1. Repair holes, cracks and casting defects using filler compound containing iron particles in an epoxy resin binder
2. Replace missing or severely damaged cast iron components with in-kind casting technique and material
3. Major cracks and inappropriate repairs to be repaired by brazing with special nickel alloy welding rods

4. Remove vegetation, failed patches (concrete), and embedded foreign objects
5. Eliminate water infiltration by re-setting fractured stone, filling pockets, shelves and depressions, and stabilizing post base with restoration mortar

6. Repair primary anchor points by pouring new molten lead into existing masonry socket and building up coping stone with restoration mortar
7. Replace missing or non-historic (square stock) backstays with in-kind material
8. Realign and stabilize fence to include straightening bent, bowed, or out of plumb fence sections and individual horizontal or vertical components
9. Remove non-historic end posts and restore with in-kind materials to period of significance

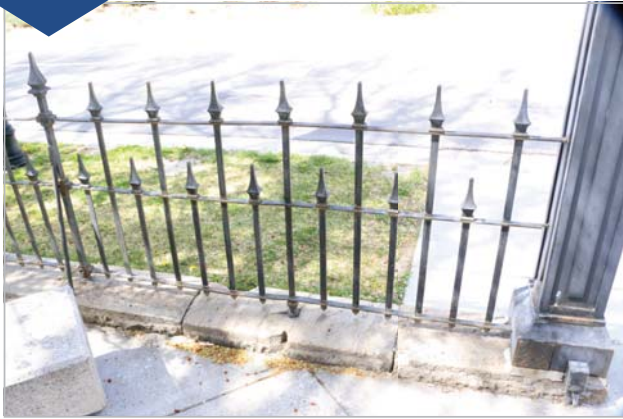
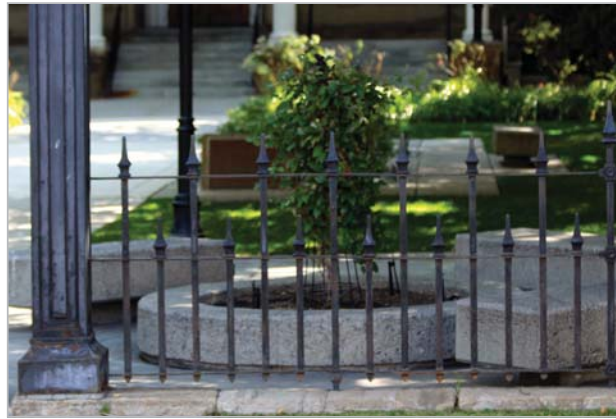
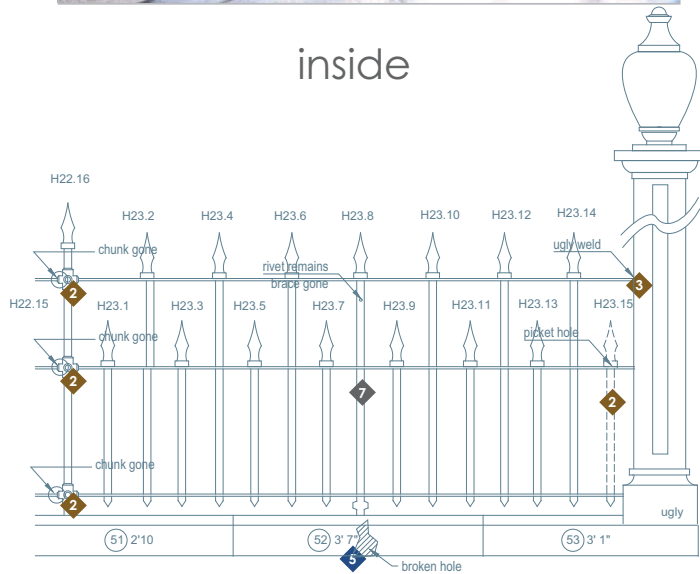
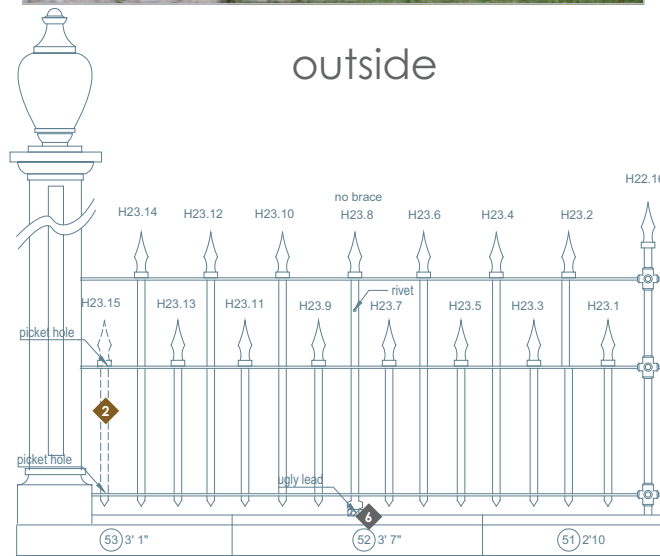
SECTION H23

Ironwork Corrosion

Sandstone Deterioration

Structural Instability

1. Repair holes, cracks and casting defects using filler compound containing iron particles in an epoxy resin binder
2. Replace missing or severely damaged cast iron components with in-kind casting technique and material
3. Major cracks and inappropriate repairs to be repaired by brazing with special nickel alloy welding rods

4. Remove vegetation, failed patches (concrete), and embedded foreign objects
5. Eliminate water infiltration by re-setting fractured stone, filling pockets, shelves and depressions, and stabilizing post base with restoration mortar

6. Repair primary anchor points by pouring new molten lead into existing masonry socket and building up coping stone with restoration mortar
7. Replace missing or non-historic (square stock) backstays with in-kind material
8. Realign and stabilize fence to include straightening bent, bowed, or out of plumb fence sections and individual horizontal or vertical components
9. Remove non-historic end posts and restore with in-kind materials to period of significance

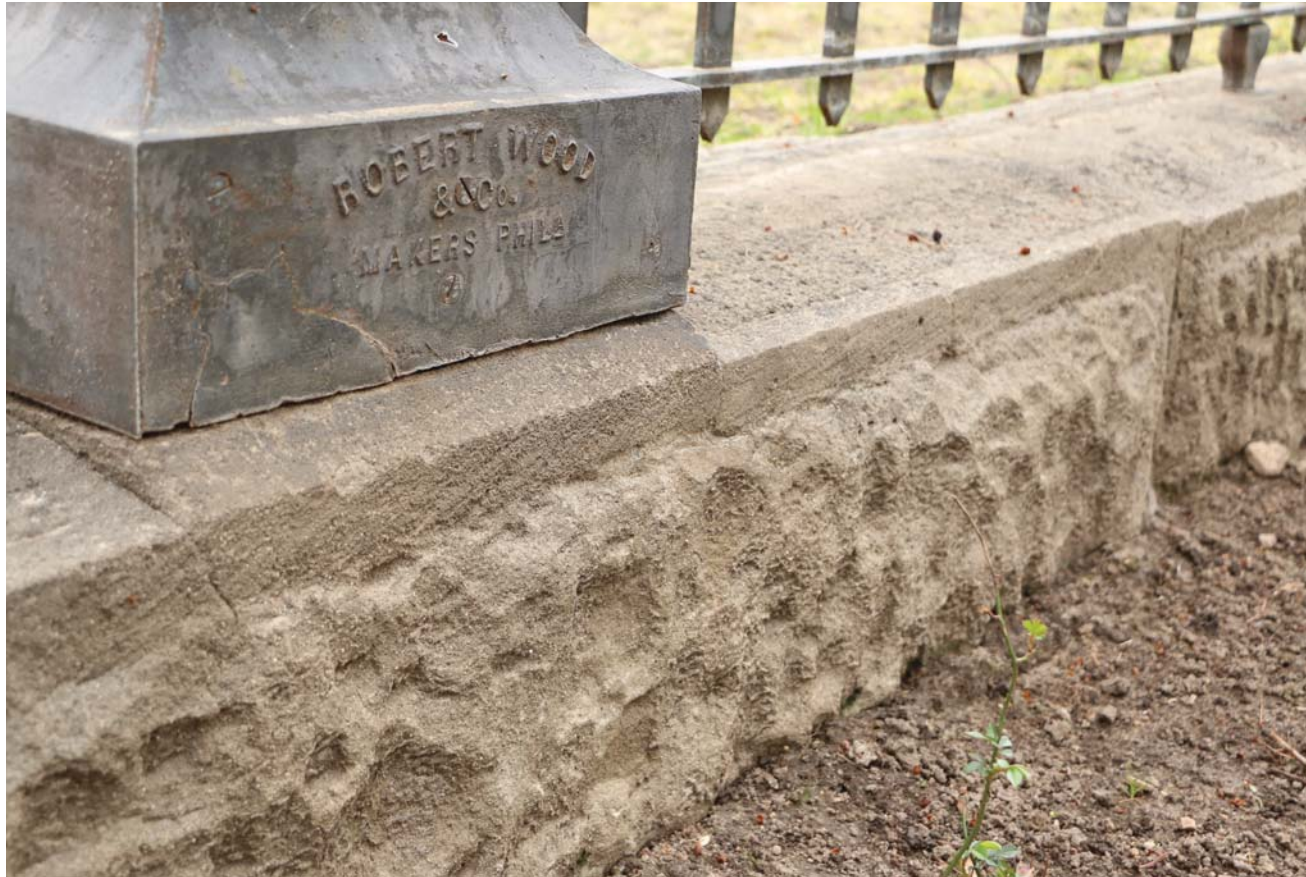
Sandstone is very porous by nature; cracks and flaking develop, important to identify cracks that will become a problem later. Between the sandstone blocks is a lime mortar. Quarried formed border visible on the blocks. A single jack was used on the sides for texturing. This technique requires two workers, a driller, referred to as a "cousin jack" wielded a 4lb hammer and drove a chisel pointed steel into the rock. The other worker would strike the chisel with the hammer, and rotate the chisel 90 degrees before striking it again.

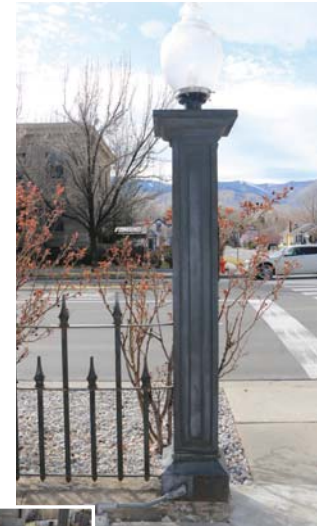
The fence rehabilitation design plan in 1980 called for replacing the 1911 light fixtures with new material. The new design undermined the overall structural integrity of the fence. The height of the replacement light fixtures was not scaled appropriately in relation to the historic fence making the base unstable. The fence railing connection at the new post did not offer the same structural strength as the original. The instability of the new light fixtures pose a safety hazard, as they could be potentially pushed over. Buildings and Grounds staff have attempted to stabilize the lights at the sandstone base using concrete. They have also made upgrades to the electrical feed. They shared their concerns on the stability and overall safety of the light posts with the project team.

Note footing and electrical repairs on 1980 light fixture addition.

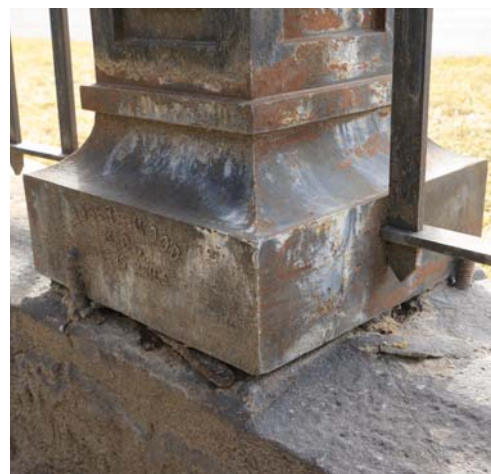
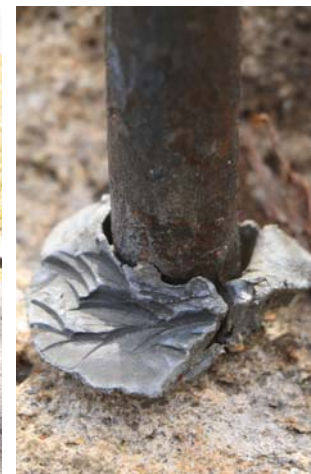
Photo Documentation - Structural Instability

Fence instability caused by 1980 light fixture rehab; attachment points compromised, footing unstable, electrical feed to be upgraded. Repair lead sleeve; railings secured into masonry sockets using hot poured lead; melt lead to close the gaps. Realign and stabilize fence to include straightening bent, bowed, or out of plumb fence section(s) and / or individual horizontal or vertical component(s), repair post base. Bent or damaged parts can be straightened with a crowbar. A straight panel is only important if fence components are not fitting together correctly.
