Marlette Lake Dam Resilient Infrastructure Project

BCA 3 – Project Useful Life Justification

Life-span of storage dams

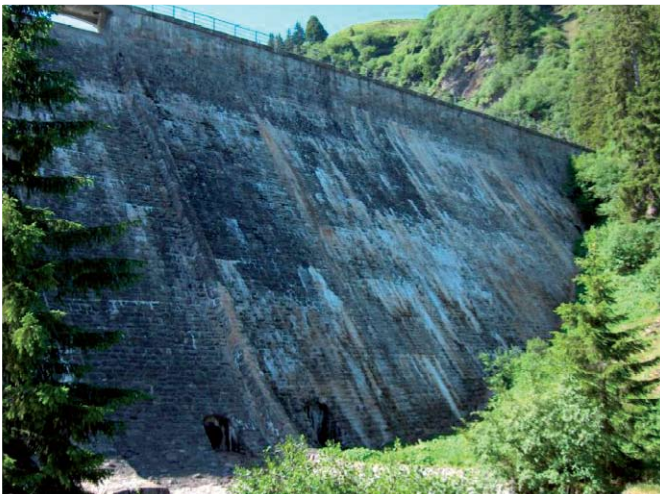
Above left: Figure 1 – Leaching traces at downstream face of Garichte gravity dam completed in 1931 in Switzerland due to high water-cement ratio and high permeability of mass concrete; Above right: Figure 2 – Enguri arch dam in Georgia: 272 m high dam with peripheral joint (top); leakage of bottom outlets (bottom)

- (i) Chemical processes (swelling due to alkali aggregate reactivity (AAR), sulphate attack, leaching (Figure 1), etc).
- (ii) Physical and mechanical processes (thawing-freezing and drying-wetting cycles, cracking due to seismic actions or non-uniform foundation movements etc).
- (iii) Biological processes (growth of plants in cracks, mussels etc).
- (iii) Seepage in the foundation and the dam body (dissolution of material, weakening of conglomerate, change in uplift of the

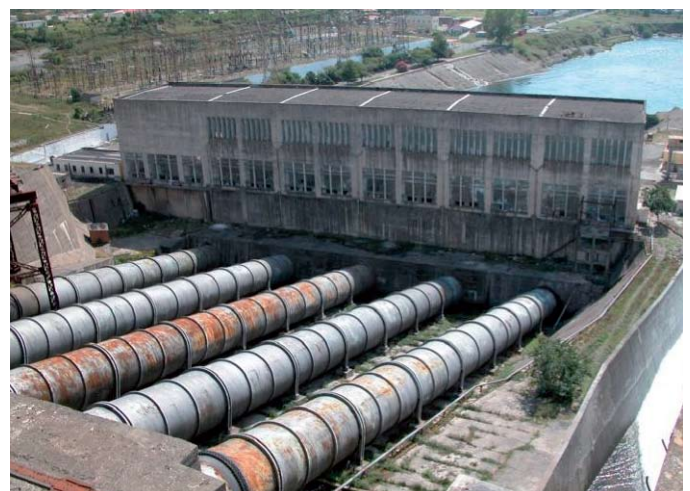
Below: Figure 3 – Deficiencies in hydromechanical equipment: Leakage of spillway gates (left) and corrosion of penstocks (right)

The service life of a well-designed, well-constructed and well-maintained and monitored embankment and concrete dams can easily reach 100 years. Hydromechanical elements such as gates and their motors have to be replaced after 30 to 50 years. The life-span of penstocks is 40 to 60 years (Figure 3).

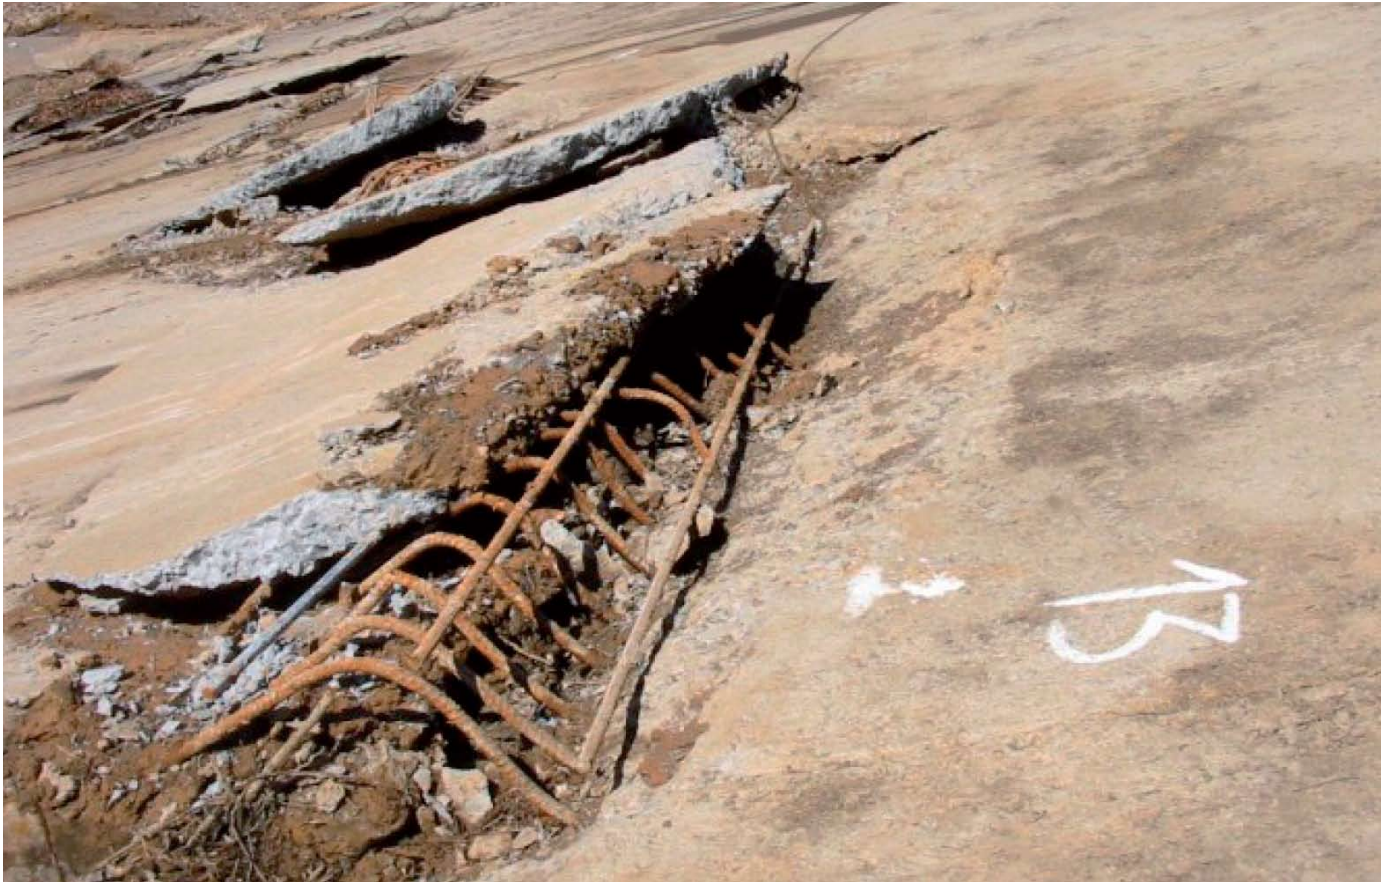
Above, top: Figure 4 – Damaged concrete slab of concrete face rockfill dam detected after the first filling of the reservoir; Figure 5 – Erosion damage at dam toe (left) and concrete protection in plunge pool after operation of the tunnel spillways (right)

Embankment dams are engineered structures using mostly natural materials, part of which may be processed (e.g. filters). In dams with upstream impervious facings, concrete or asphaltic concrete is used. In concrete face rockfill dams (CFRDs) cracking of the face slab is a problem as this leads to undesired seepage losses and accelerated corrosion of the steel reinforcement (Figure 4).
