DEPARTMENT OF ADMINISTRATION  
STATE PUBLIC WORKS DIVISION  
FACILITY CONDITION ASSESSMENT

## PROPERTY PORTFOLIO REVIEW FACILITY INSIGHTS

NORTHWEST REGION  
NORTHERN NEVADA CORRECTIONAL CENTER COMPLEX  
9601 - DMV - LICENSE PLATE FACTORY SITE  
1721 E SNYDER AVE  
CARSON CITY, NV 89701-7812  
CARSON CITY COUNTY

SURVEY DATE: 08/19/2025

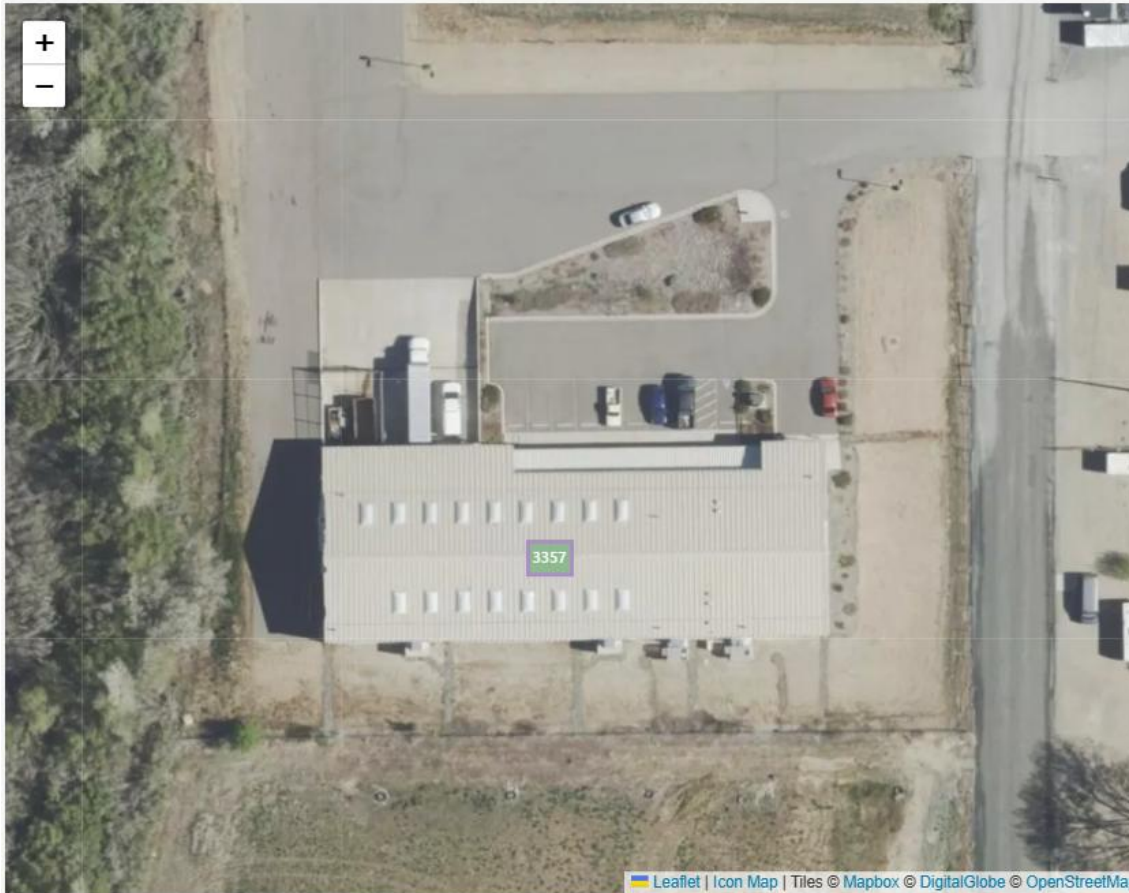
## PROPERTY MAP, 1721 E SNYDER AVE, CARSON CITY

| B# | NAME | STATUS | RIGHTS |
| 3357 | DMV - LICENSE PLATE FACTORY | OCCUPIED | OWNED |
