DEPARTMENT OF ADMINISTRATION
STATE PUBLIC WORKS DIVISION
FACILITY CONDITION ASSESSMENT

PROPERTY PORTFOLIO REVIEW FACILITY INSIGHTS

9772 - NDF INDUSTRIAL SHOP SITE
1213 N INDUSTRIAL WAY
ELY, NV 89301-6682
WHITE PINE COUNTY

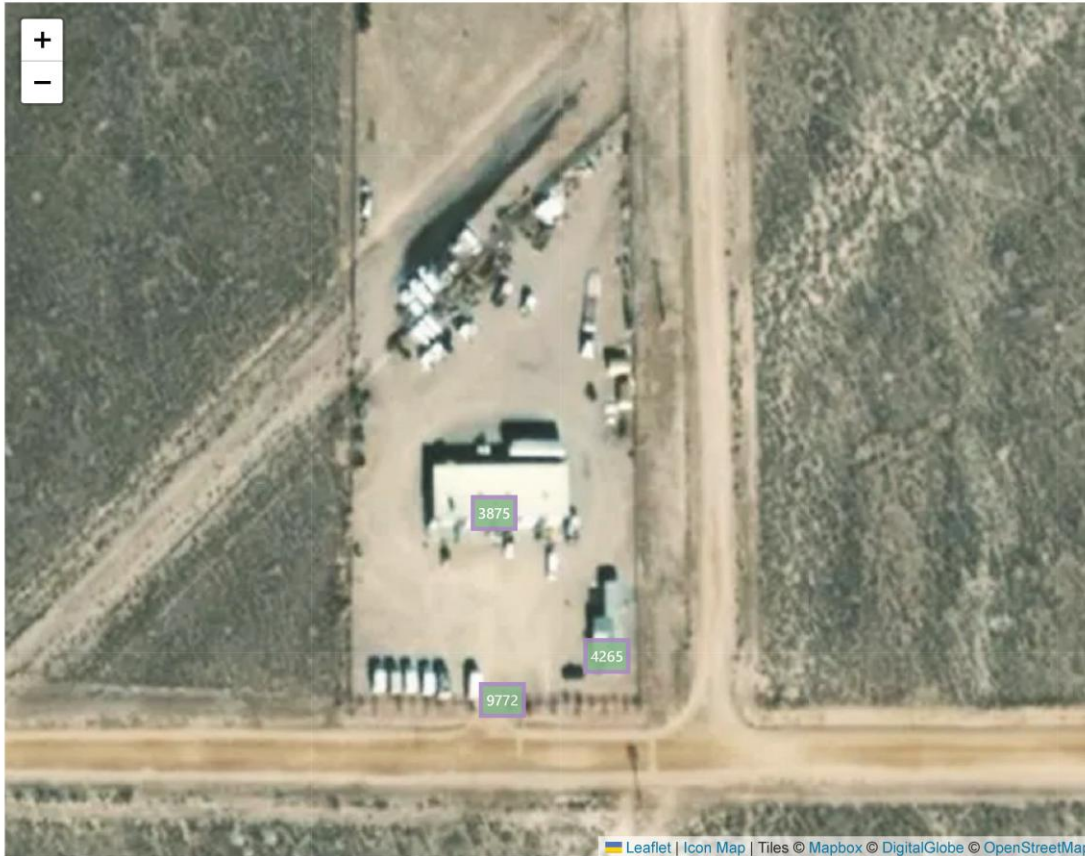
PROPERTY MAP, 1213 N INDUSTRIAL WAY, ELY

B#	NAME	STATUS	RIGHTS
3875	ELY INDUSTRIAL SHOP	OCCUPIED	OWNED
4265	NDF SHOP OFFICE	OCCUPIED	OWNED
9772	NDF INDUSTRIAL SHOP SITE	OCCUPIED	OWNED
