FACILITY CONDITION ASSESSMENT

PROPERTY PORTFOLIO REVIEW

9790 - FLEET SERVICES - LAS VEGAS SITE

7060 LA CIENEGA ST

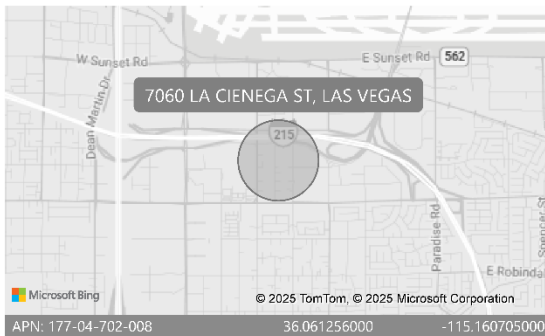
The Fleet Services facility in Las Vegas sits on a 1-acre paved site with a single building. It includes vehicle parking, storage, and an above-ground fuel tank. ADA parking is provided, but the access route to the building is not fully ADA compliant, with a small curb ramp, a protrusion in the path, and potential clearance issues at the entrance. The site has city water, sewer, and electrical service.

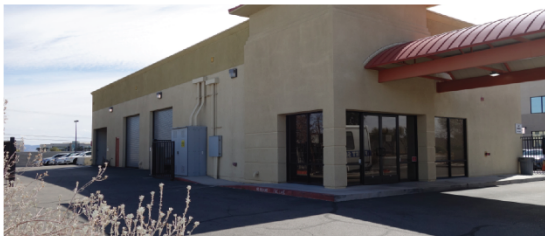
The FLEET SERVICES OFFICE - LAS VEGAS includes a lobby, service desk, conference room, break room, small office, parts storage, ADA restrooms (Men's, Women's, and unisex in the service bay), a service bay, and an automatic car wash bay.
