DEPARTMENT OF ADMINISTRATION
STATE PUBLIC WORKS DIVISION
FACILITY CONDITION ASSESSMENT

PROPERTY PORTFOLIO REVIEW FACILITY INSIGHTS

9823 - ELKO DETR OFFICE SITE
172 6TH ST
ELKO, NV 89801-3708
ELKO COUNTY

SURVEY DATE: 04/25/2024

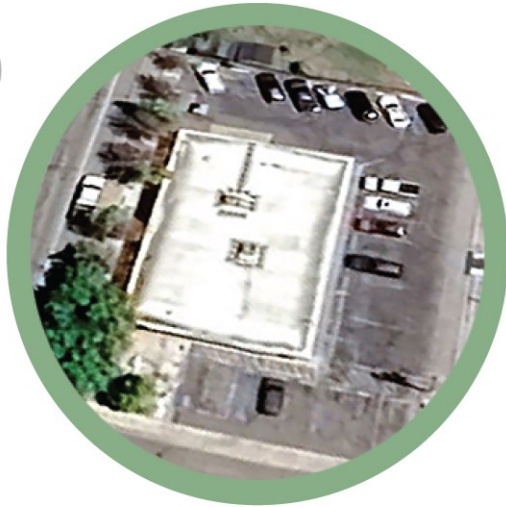
9823 ELKO DETR OFFICE SITE

STATUS:	OCCUPIED
PARCEL SIZE:	0.370 ACRE(S)
HARDSCAPE:	8,418.000 SF PAVING 1,136.000 SF CFW
LOCATION:	APN: 001-354-001 LAT/LONG: 40.832219, -115.759518
USAGE:	SITE-GENERAL
# OF BLDGS:	1
ADDR:	NORTHEAST REGION 172 6TH ST ELKO, NV 89801-3708 ELKO COUNTY
OCC / MAINT:	DEPARTMENT - DETR DEPT OF EMPLOYMENT, TRAINING AND REHABILITATION

The ELKO DETR OFFICE SITE is located in Elko County under APN 001-354-001. This 0.37-acre parcel includes 8,418 sf of paved parking and 1,136 sf of a concrete walkway surrounding the structure on three sides. Additionally, the north side features a small, landscaped area with a retaining wall adjacent to the public sidewalk.

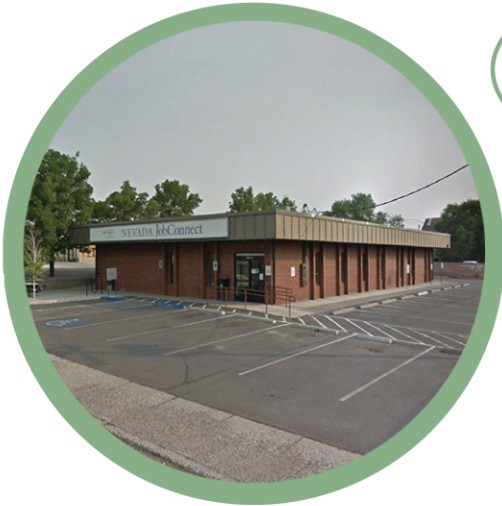
1476 EMPLOY_NV - ELKO OFFICE

BUILDING COMPONENTS	
CHIMNEY:	NO
ROOF:	100% MEMBRANE - SINGLE-PLY - EPDM
FRAME:	UNKNOWN
CLADDING:	80% MASONRY - CLAY - BRICK 20% GLASS - WALL SYSTEM - STOREFRONT
FOUNDATION:	100% - SLAB-ON-GRADE CONCRETE - IN-SITU - SEISMIC: UNKNOWN
ENGINEERING:	ENCLOSED ASCE 7-16, if it doesn't meet the requirements for being open or partially enclosed.
FABRICATION:	SITE-BUILT
