DEPARTMENT OF ADMINISTRATION  
STATE PUBLIC WORKS DIVISION  
FACILITY CONDITION ASSESSMENT

## PROPERTY PORTFOLIO REVIEW FACILITY INSIGHTS

9859 - NEVADA EARLY INTERVENTION SERVICES SITE  
2667 ENTERPRISE RD  
RENO, NV 89512-1666  
WASHOE COUNTY

SURVEY DATE: 03/18/2025

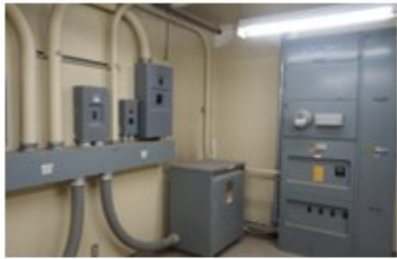
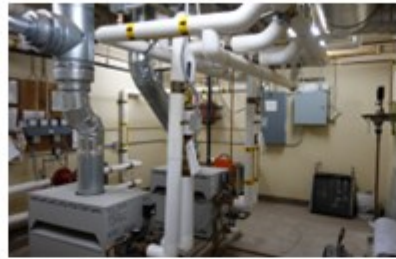
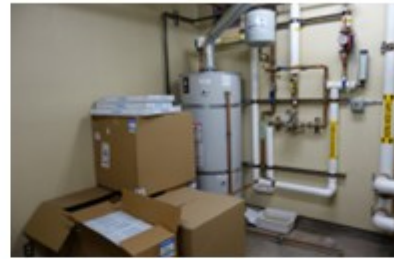
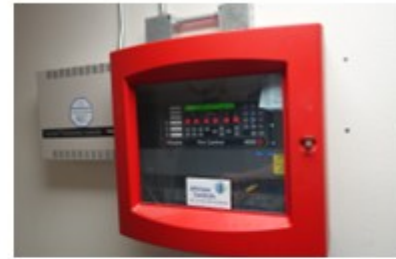
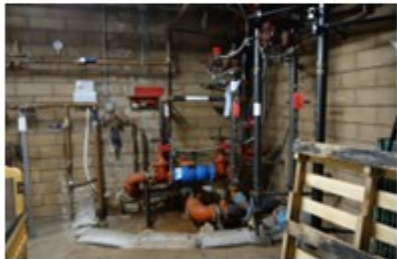
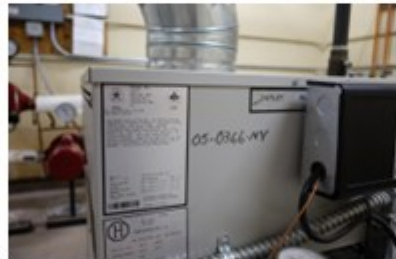
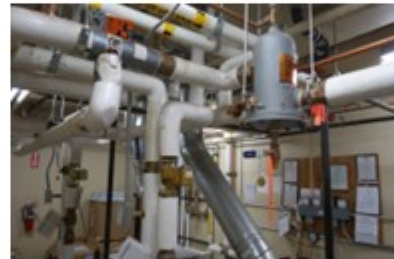
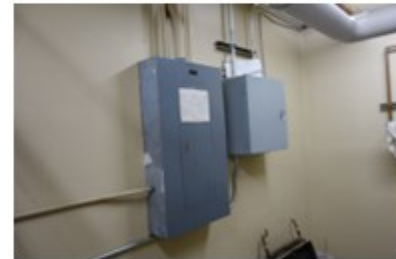
## BUILDING SYSTEMS

The facility serves infants and toddlers with developmental disabilities. The HVAC system includes two hot water boilers in the basement, AC condensers on the roof, and fan coil units distributed throughout the building for efficient climate control.

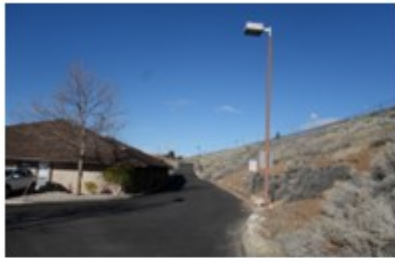
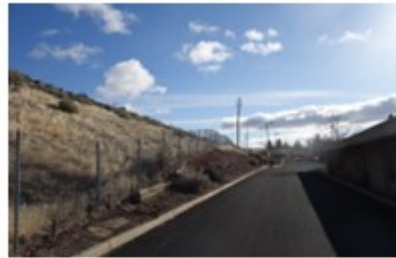
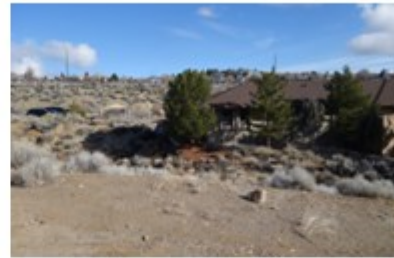
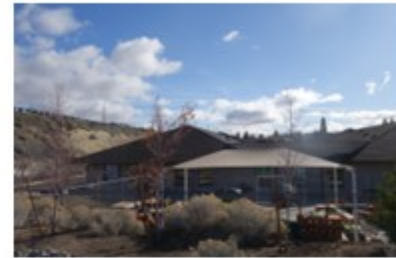
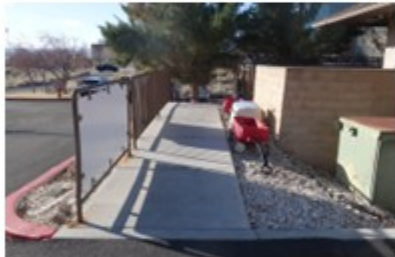
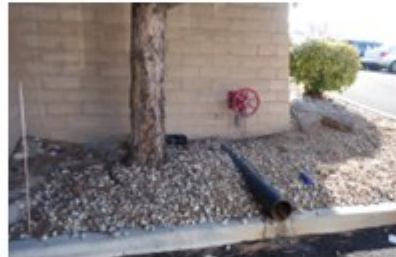
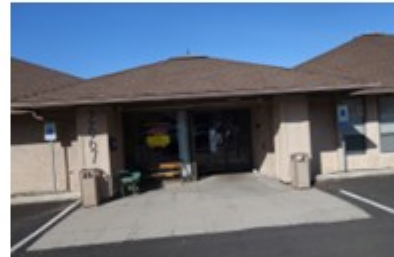
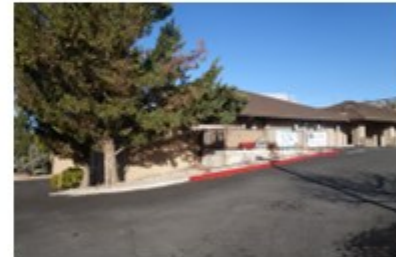
## EXTERIOR

- **Infrastructure:** Well-maintained, with limited drainage and accessibility. Paved areas, including parking lots and walkways, are in good condition.
- **Findings:** Issues were identified that will require corrective action related to building systems and exterior conditions:
  - HVAC is original and has exceeded its expected service life.
  - Lighting is limited in certain areas, peeling and deteriorated paint was observed around exterior window assemblies.
