DEPARTMENT OF ADMINISTRATION  
STATE PUBLIC WORKS DIVISION  
FACILITY CONDITION ASSESSMENT

## PROPERTY PORTFOLIO REVIEW FACILITY INSIGHTS

9885 - FALLON ARMORY SITE  
895 E RICHARDS ST  
FALLON, NV 89406-3436  
CHURCHILL COUNTY

**SURVEY DATE: 01/11/2023**

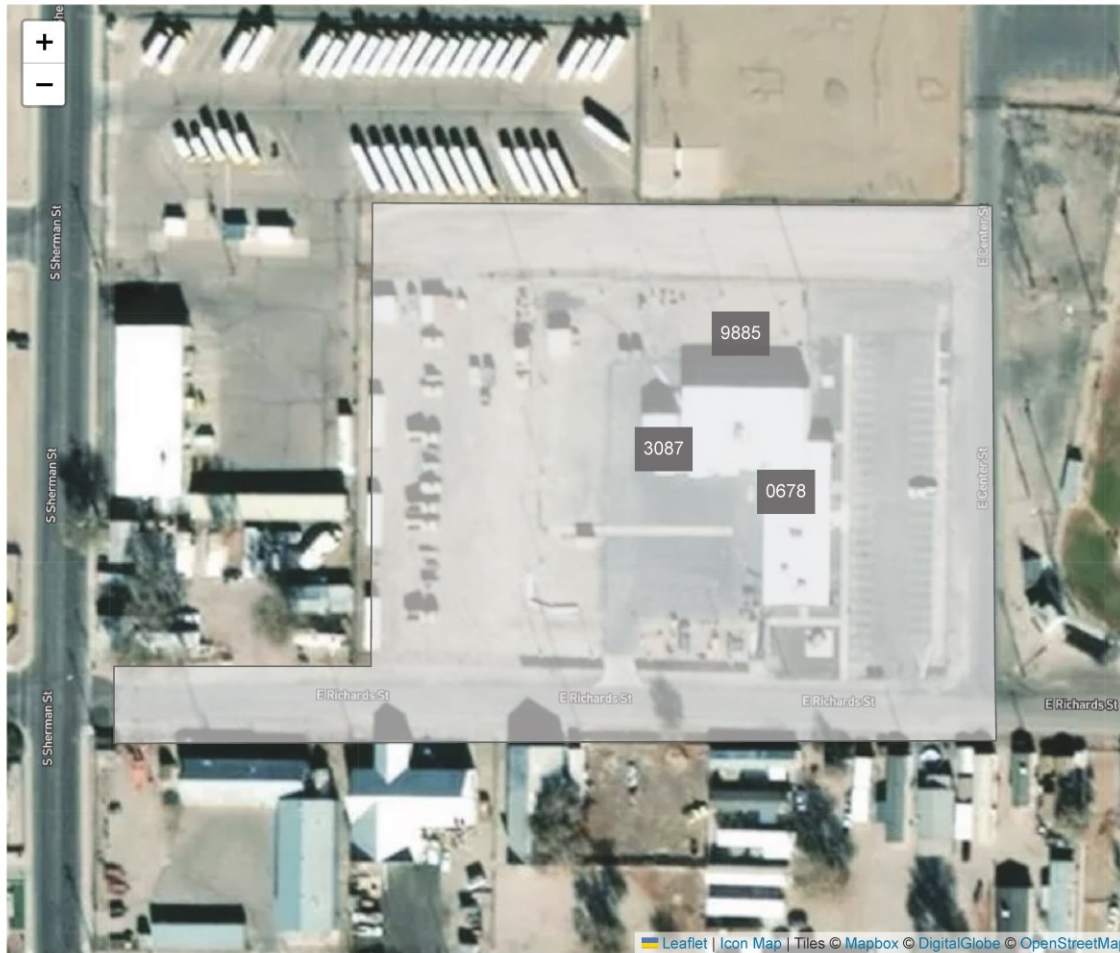
# PROPERTY MAP, 895 E RICHARDS ST, FALLON

TOTAL # OF BLDGS 2  
NORTHWEST REGION  
895 E RICHARDS ST  
FALLON, NV 89406-3436 CHURCHILL  
COUNTY

SITE	BLDG	NAME	STATUS
9885	0678	FALLON ARMORY	OCCUPIED
9885	3087	STORAGE BUILDING	OCCUPIED
9885	9885	FALLON ARMORY SITE	OCCUPIED

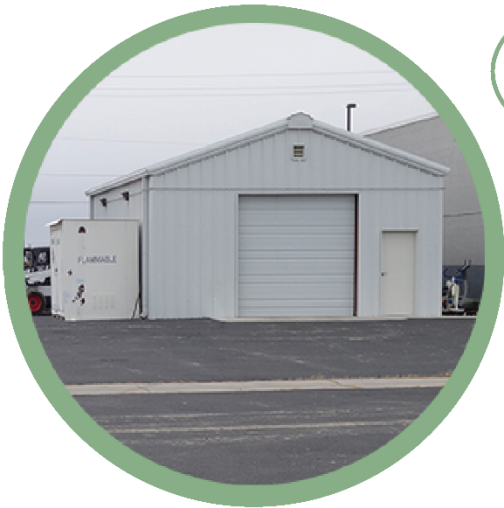
3087 STORAGE BUILDING

The STORAGE BUILDING is a pre-engineered steel structure set on a concrete foundation, wrapped in corrugated metal siding and a corrugated metal roof. Access is provided through an overhead rolling door and a man door. The building is designed for the storage of a wide range of materials and equipment.

BUILDING COMPONENTS	
CHIMNEY:	NO
ROOF:	100% METAL - ALUMINUM - SIDING
FRAME:	100% STEEL - STRUCTURAL STEEL - POST & BEAM
CLADDING:	100% METAL - ALUMINUM - SIDING
FOUNDATION:	100% - SLAB-ON-GRADE CONCRETE - IN-SITU - SEISMIC: UNKNOWN
ENGINEERING:	ENCLOSED ASCE 7-16, if it doesn't meet the requirements for being open or partially enclosed.
FABRICATION:	PRE-ENGINEERED
