DEPARTMENT OF ADMINISTRATION STATE PUBLIC WORKS DIVISION FACILITY CONDITION ASSESSMENT

PROPERTY PORTFOLIO REVIEW FACILITY INSIGHTS

9902 - NDOW WESTERN REGION FALLON OFFICE SITE 380 W B ST FALLON, NV 89406-2916 CHURCHILL COUNTY

SURVEY DATE: 01/11/2023

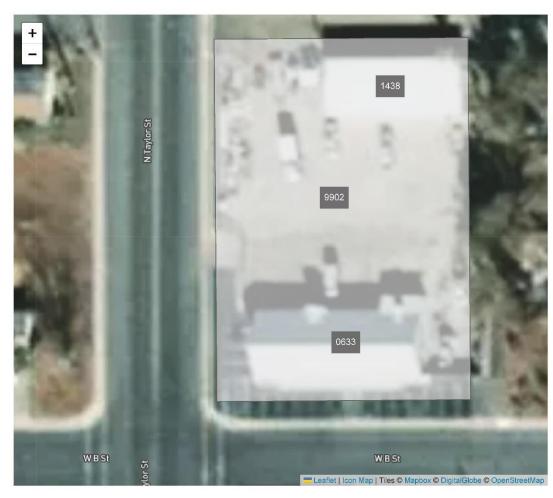
PROPERTY MAP, 380 W B ST, FALLON

TOTAL # OF BLDGS NORTHWEST REGION
380 W B ST
2 FALLON, NV 89406-2916
CHURCHILL COUNTY

SITE	BLDG	NAME	STATUS	
9902	0633	WESTERN REGION FALLON FIELD OFFICE	OCCUPIED	ı
9902	1438	DEPT. OF WILDLIFE BOAT STORAGE FACILITY	OCCUPIED	
9902	9902	NDOW WESTERN REGION FALLON OFFICE SITE	OCCUPIED

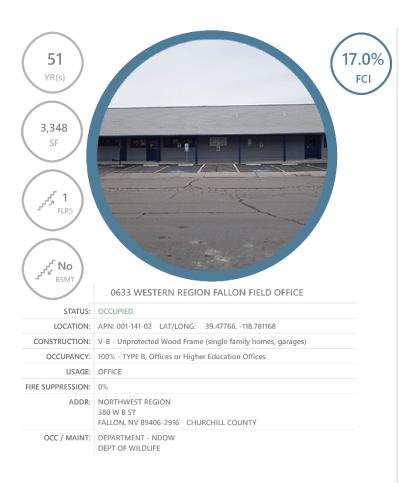
FACILITY DETAILS, WESTERN REGION FALLON FIELD OFFICE

for men and women, a conference room, and office

space.
