DEPARTMENT OF ADMINISTRATION
STATE PUBLIC WORKS DIVISION
FACILITY CONDITION ASSESSMENT

PROPERTY PORTFOLIO REVIEW FACILITY INSIGHTS

SOUTH REGION
INDIAN SPRINGS CORRECTIONAL CENTER COMPLEX
9952 - HIGH DESERT STATE PRISON SITE
22010 COLD CREEK RD
INDIAN SPRINGS, NV 89018-
CLARK COUNTY

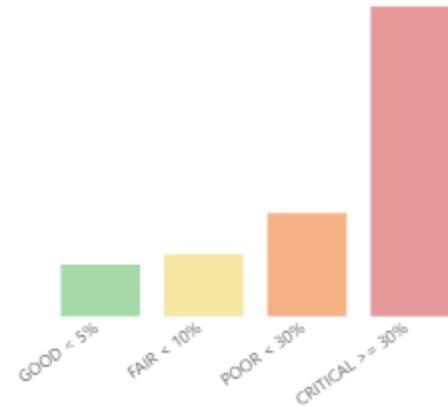
- Provides a quick snapshot of a facility's health, expressed as a percentage
 - **Lower FCI Values:**
 - 0.05: Indicates a facility is good condition
 - 0.06 – 0.10: Indicates a facility is in fair condition

- **Higher FCI Values:**
 - 0.11 – 0.30: Indicates a facility is in poor condition
 - 0.30: Indicates a facility is in critical condition
- **Use Cases:**

- Helps prioritize repairs
 - Guides funding allocation by comparing conditions across multiple facilities in a portfolio
- **Calculation:**
$$FCI = \frac{\text{Cost of necessary repairs or Deferred Maintenance}}{\text{Current Replacement Value}}$$

- **Example:** The facility's replacement cost is \$11,540,000, and the required repairs total \$2,236,200, resulting in an FCI of **19%** (0.19)
