DEPARTMENT OF ADMINISTRATION  
STATE PUBLIC WORKS DIVISION  
FACILITY CONDITION ASSESSMENT

## PROPERTY PORTFOLIO REVIEW FACILITY INSIGHTS

9972 - HUMBOLDT CONSERVATION CAMP SITE  
8105 CONSERVATION RD  
WINNEMUCCA, NV 89445-8990  
HUMBOLDT COUNTY

**SURVEY DATE: 04/18/2023**

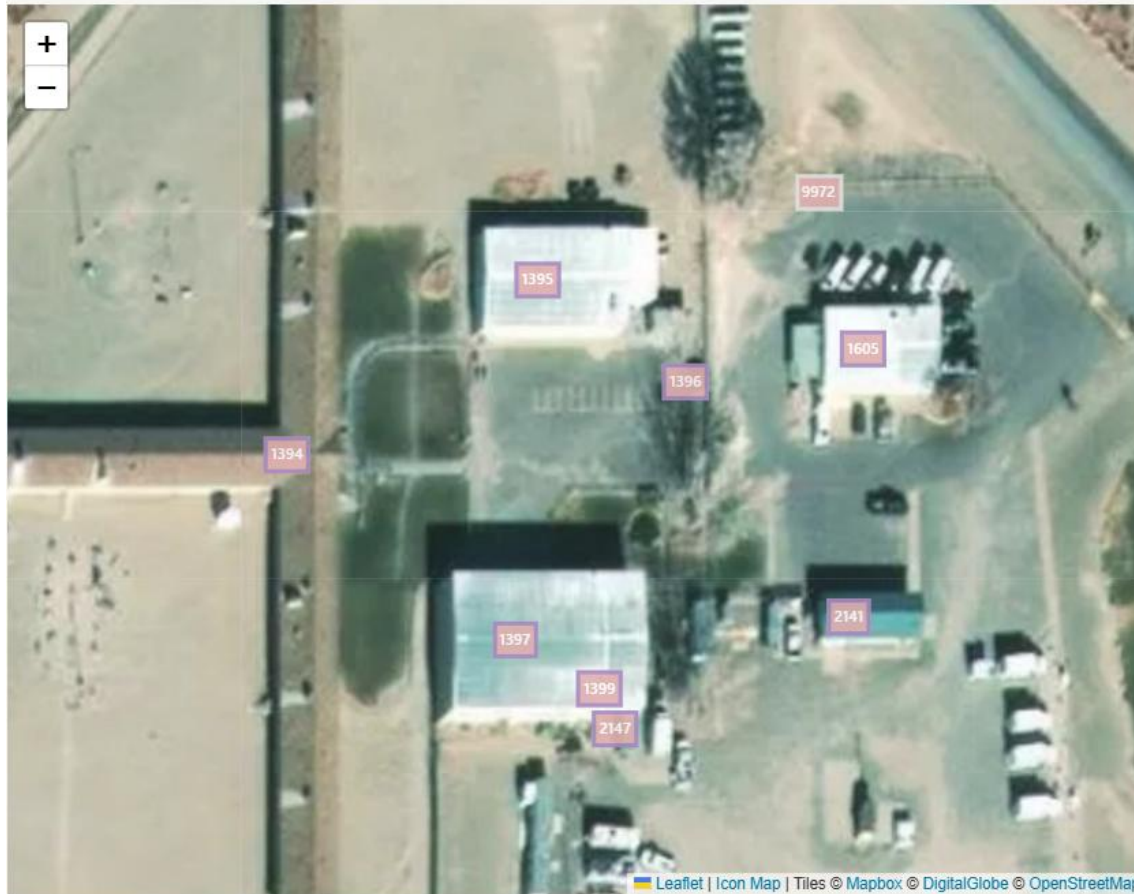
# PROPERTY MAP, 8105 CONSERVATION RD, WINNEMUCCA

B#	NAME	STATUS	RIGHTS
1394	ADMINISTRATION/ HOUSING UNIT	UNOCCUPIED	OWNED
1395	CAFETERIA/ CULINARY BUILDING	UNOCCUPIED	OWNED
1396	GATEHOUSE/ GUARD SHACK	UNOCCUPIED	OWNED
1397	MULTI-PURPOSE BUILDING	UNOCCUPIED	OWNED
1399	NDF MAINTENANCE SHOP	UNOCCUPIED	OWNED
1605	NDF ADMINISTRATION OFFICE	UNOCCUPIED	OWNED
2141	MECHANICAL SHOP	UNOCCUPIED	OWNED
2147	NDF COMPRESSOR BUILDING	UNOCCUPIED	OWNED
9972	HUMBOLDT CONSERVATION CAMP SITE	UNOCCUPIED	EASEMENT

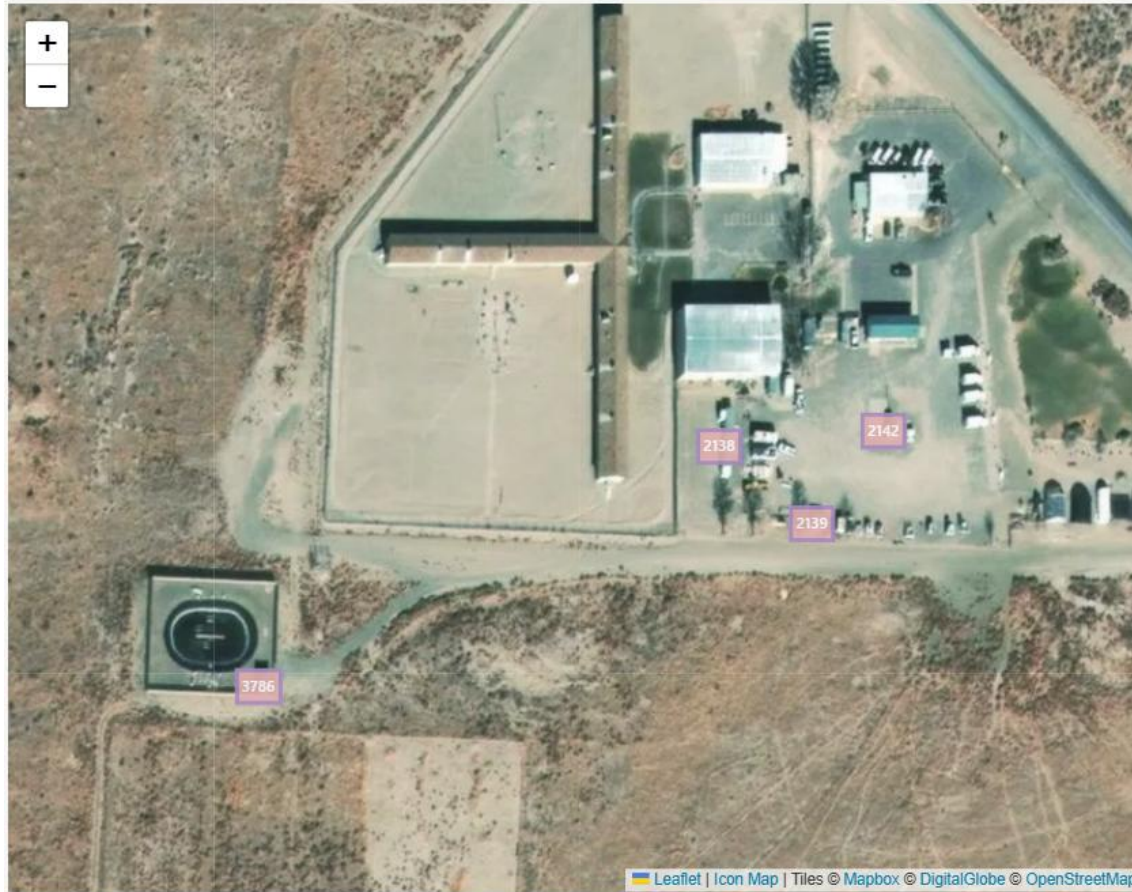
# PROPERTY MAP, 8105 CONSERVATION RD, WINNEMUCCA

B#	NAME	STATUS	RIGHTS
2138	SAW SHOP	UNOCCUPIED	OWNED
2139	METAL STORAGE SHED	UNOCCUPIED	OWNED
2142	FUEL ISLAND BUILDING	UNOCCUPIED	OWNED
3786	WASTEWATER TREATMENT BUILDING	UNOCCUPIED	OWNED

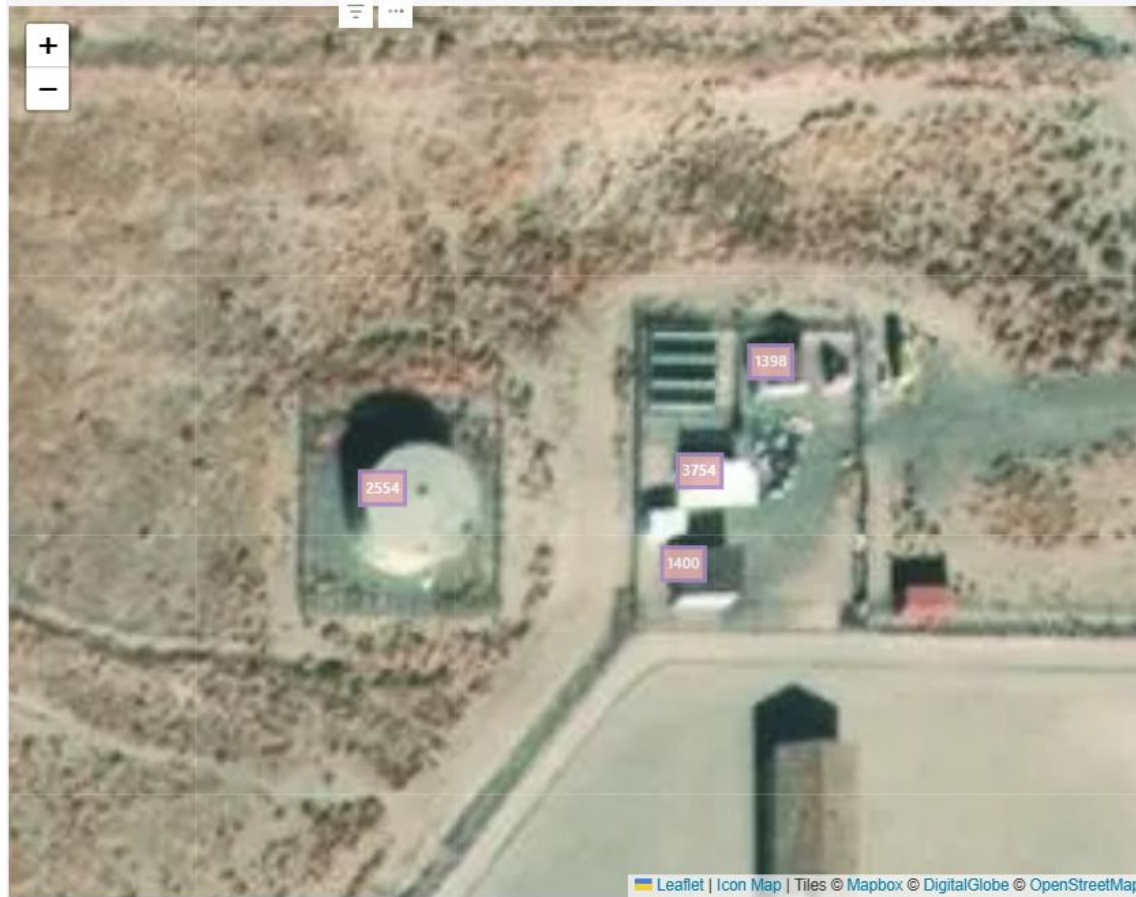
B#	NAME	STATUS	RIGHTS
1398	STORAGE SHED	UNOCCUPIED	OWNED
1400	PUMP HOUSE	UNOCCUPIED	OWNED
2554	WATER TANK	UNOCCUPIED	OWNED
3754	ARSENIC TREATMENT BUILDING	UNOCCUPIED	OWNED
