DEPARTMENT OF ADMINISTRATION
STATE PUBLIC WORKS DIVISION
FACILITY CONDITION ASSESSMENT

PROPERTY PORTFOLIO REVIEW FACILITY INSIGHTS

9973 - CARLIN CONSERVATION CAMP SITE
124 SUSIE CREEK WAY
CARLIN, NV 89822-
ELKO COUNTY

SURVEY DATE: 06/05/2023

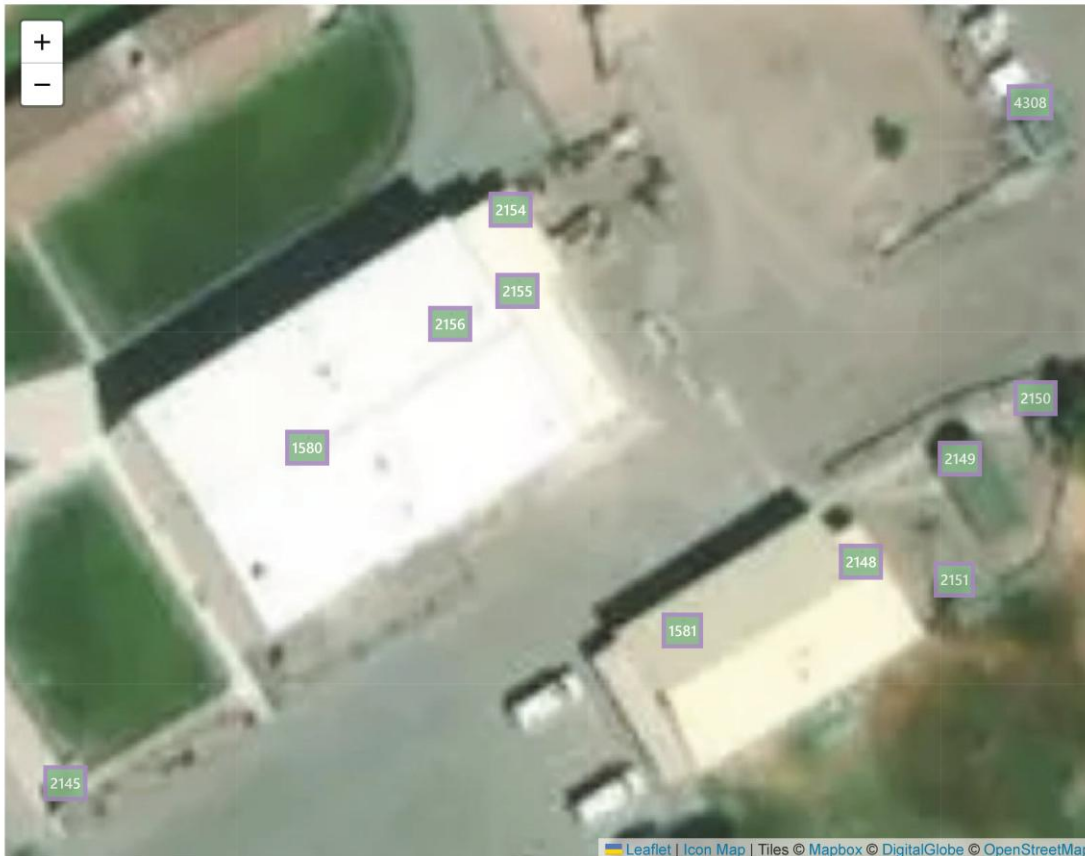
PROPERTY MAP, 124 SUSIE CREEK WAY, CARLIN

B#	NAME	STATUS	RIGHTS
1580	CCC MULTI-PURPOSE BUILDING	OCCUPIED	OWNED
1581	NDF ADMINISTRATION OFFICE	OCCUPIED	OWNED
2145	CCC GATEHOUSE	OCCUPIED	OWNED
2148	NDF CHAIN LINK STORAGE SHED	OCCUPIED	OWNED
2149	CUBIE/EUREKA COUNTY STORAGE SHED	OCCUPIED	OWNED
2150	NDF PAINT STORAGE SHED	OCCUPIED	OWNED
2151	NDF LANDSCAPING SHED	OCCUPIED	OWNED
2154	NDF TOOL SHED	OCCUPIED	OWNED
2155	TRAINING ROOM	OCCUPIED	OWNED
2156	NDF SHOP	OCCUPIED	OWNED
4308	USED OIL CONTAINMENT STORAGE	OCCUPIED	OWNED
