DEPARTMENT OF ADMINISTRATION
STATE PUBLIC WORKS DIVISION
FACILITY CONDITION ASSESSMENT

PROPERTY PORTFOLIO REVIEW FACILITY INSIGHTS

NORTHWEST REGION
NORTHERN NEVADA CORRECTIONAL CENTER COMPLEX
9982 - NORTHERN NEVADA DAIRY FARM SITE
1721 SNYDER AVE
CARSON CITY, NV 89701-7812
CARSON CITY COUNTY

SURVEY DATE: 06/26/2024

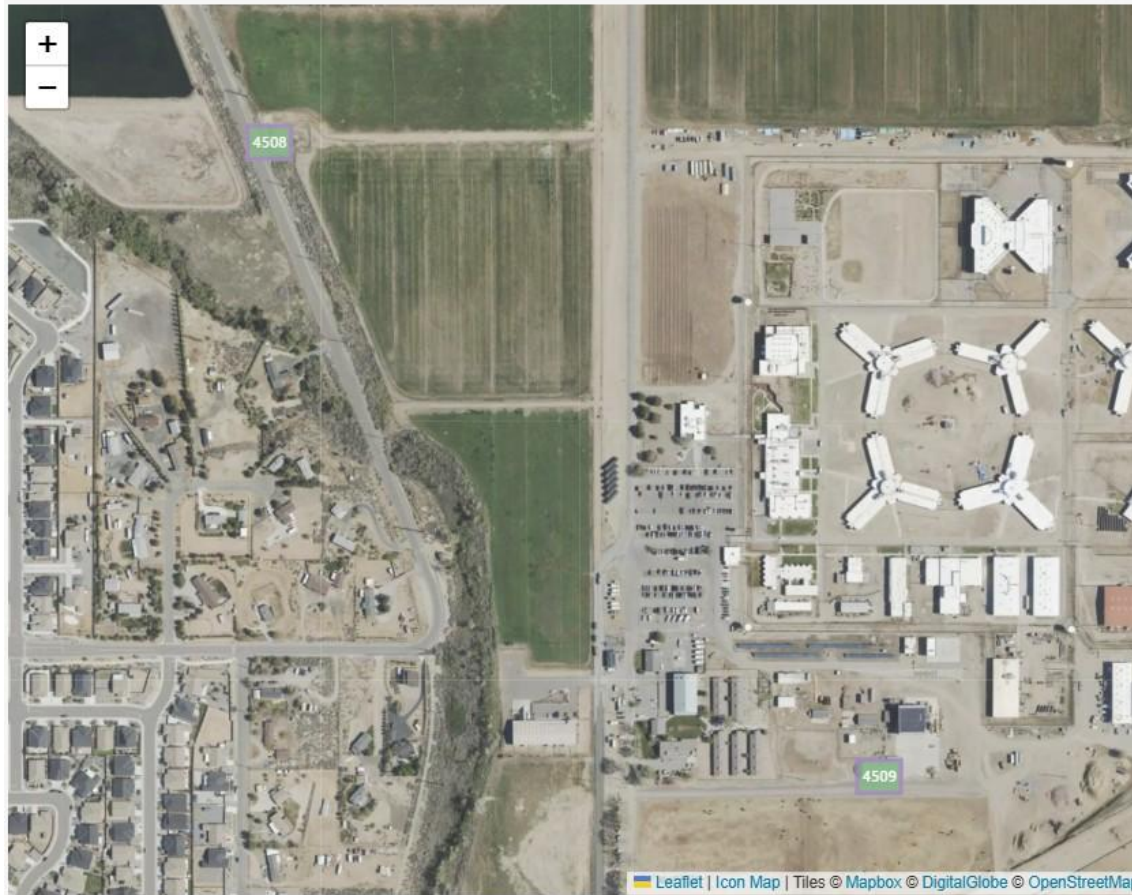
B#	NAME	STATUS	RIGHTS
4508	DAIRY IRRIGATION PUMPHOUSE	OCCUPIED	OWNED
4509	DAIRY FARM QUONSET HUT	OCCUPIED	OWNED

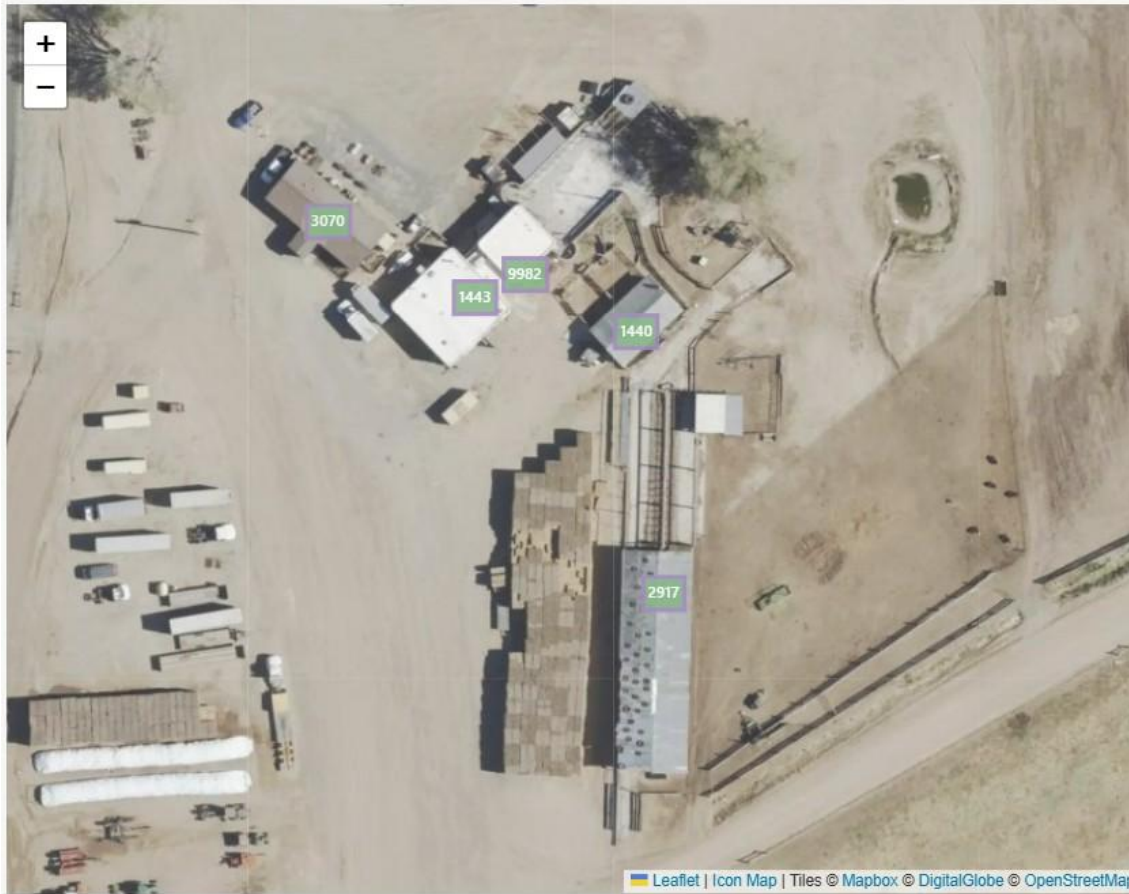
B#	NAME	STATUS	RIGHTS
1440	BULL BARN	OCCUPIED	OWNED
1443	DAIRY BARN	OCCUPIED	OWNED
2917	FREE STALL BARN	OCCUPIED	OWNED
3070	MOBILE HOME OFFICE	OCCUPIED	OWNED
9982	NORTHERN NEVADA DAIRY FARM SITE	OCCUPIED	OWNED

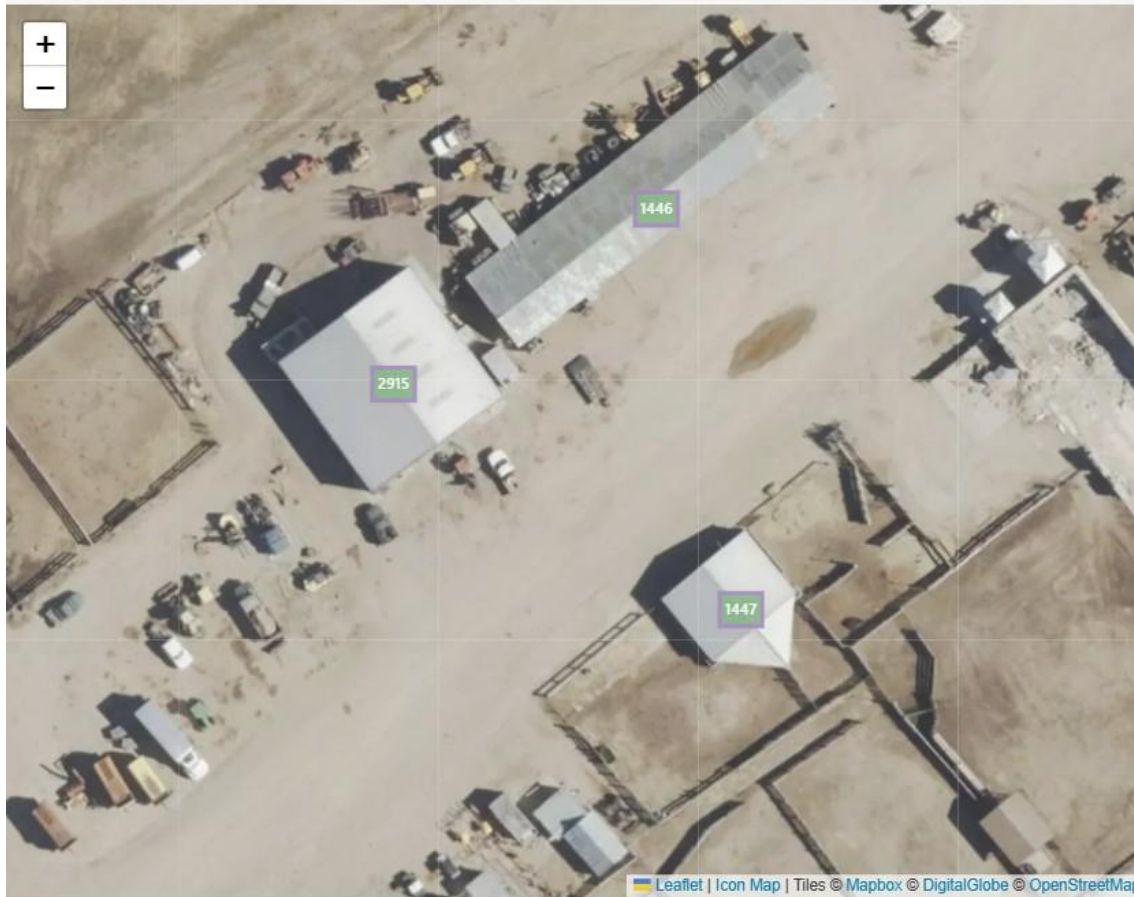
B#	NAME	STATUS	RIGHTS
1446	EQUIPMENT SHED	OCCUPIED	OWNED
1447	CALVING BARN	OCCUPIED	OWNED
2915	MAINTENANCE SHOP	OCCUPIED	OWNED

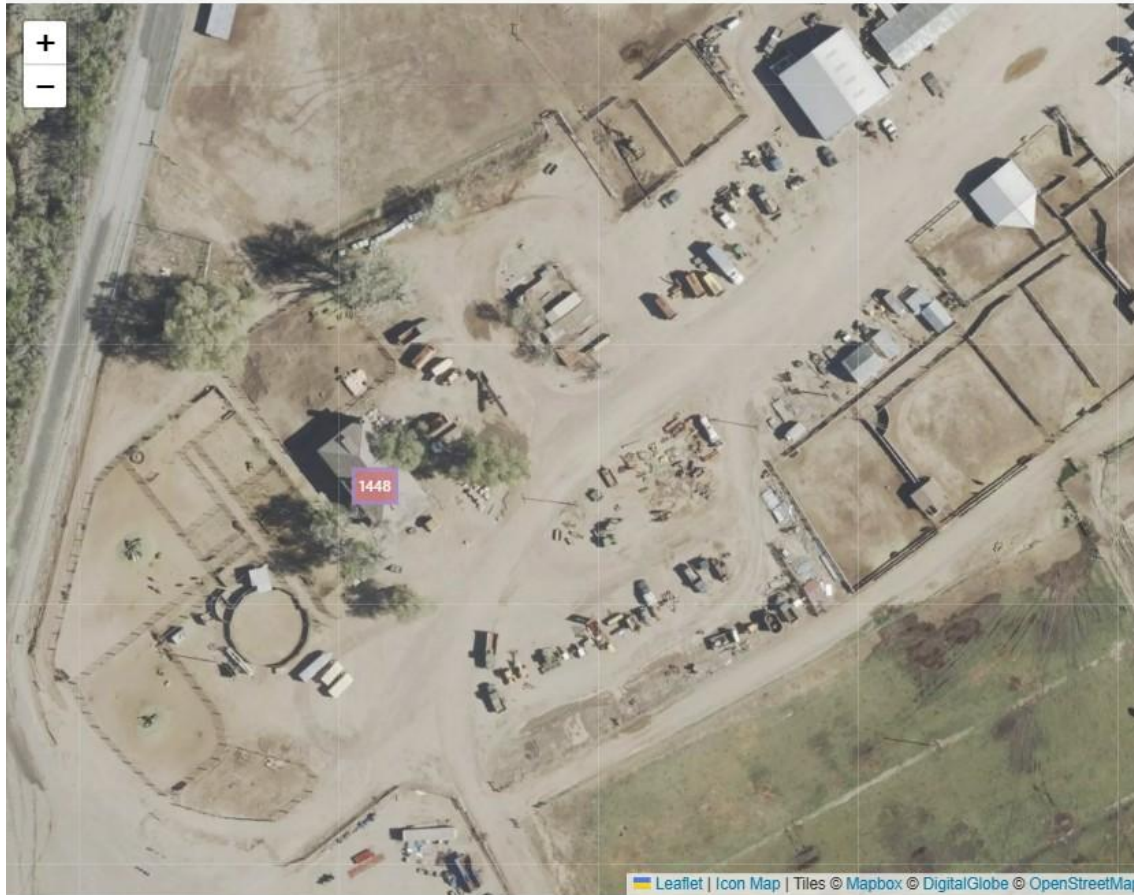
B#	NAME	STATUS	RIGHTS
1448	RANCH HOUSE	ARRESTED DECAY	OWNED

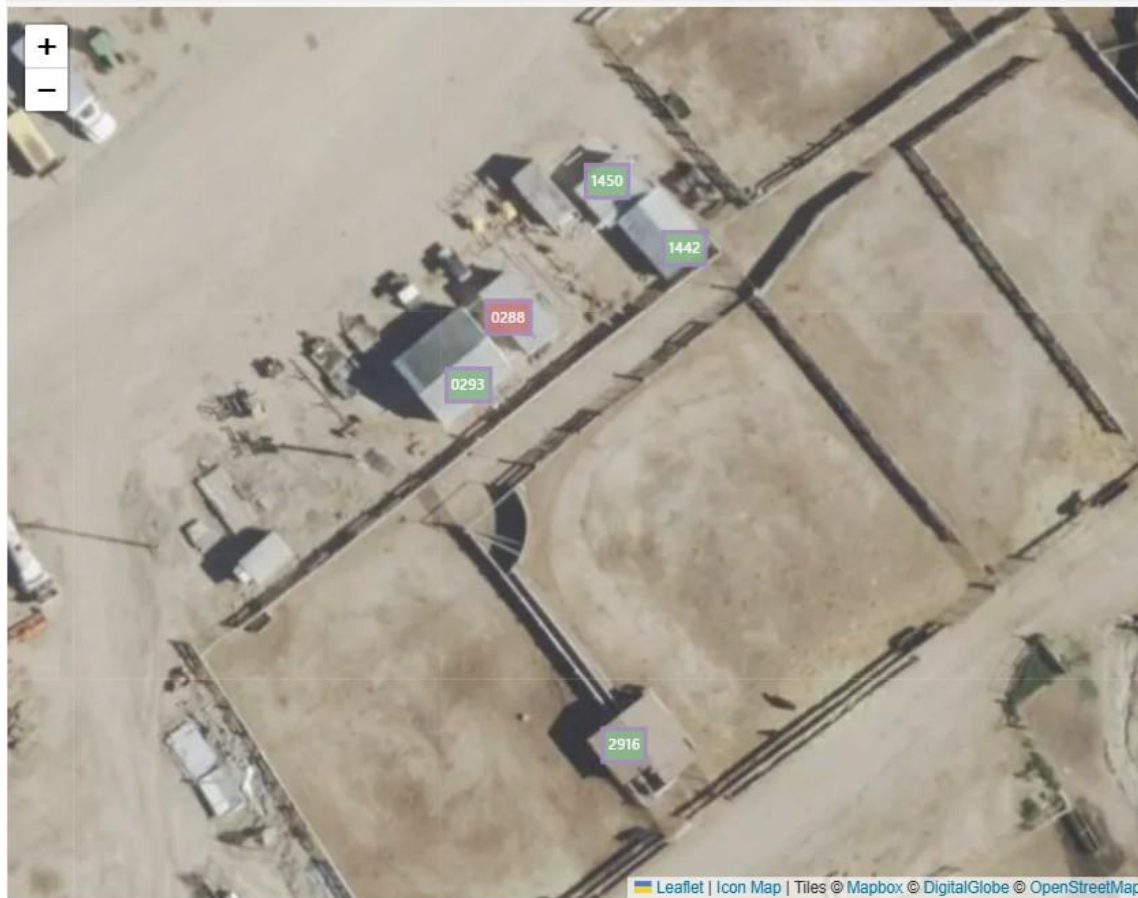
B#	NAME	STATUS	RIGHTS
0288	PUMP HOUSE	ARRESTED DECAY	OWNED
0293	BREAK ROOM	OCCUPIED	OWNED
1442	CHICKEN HOUSE	OCCUPIED	OWNED
1450	YARD OFFICE	OCCUPIED	OWNED
2916	A. I. BUILDING	OCCUPIED	OWNED

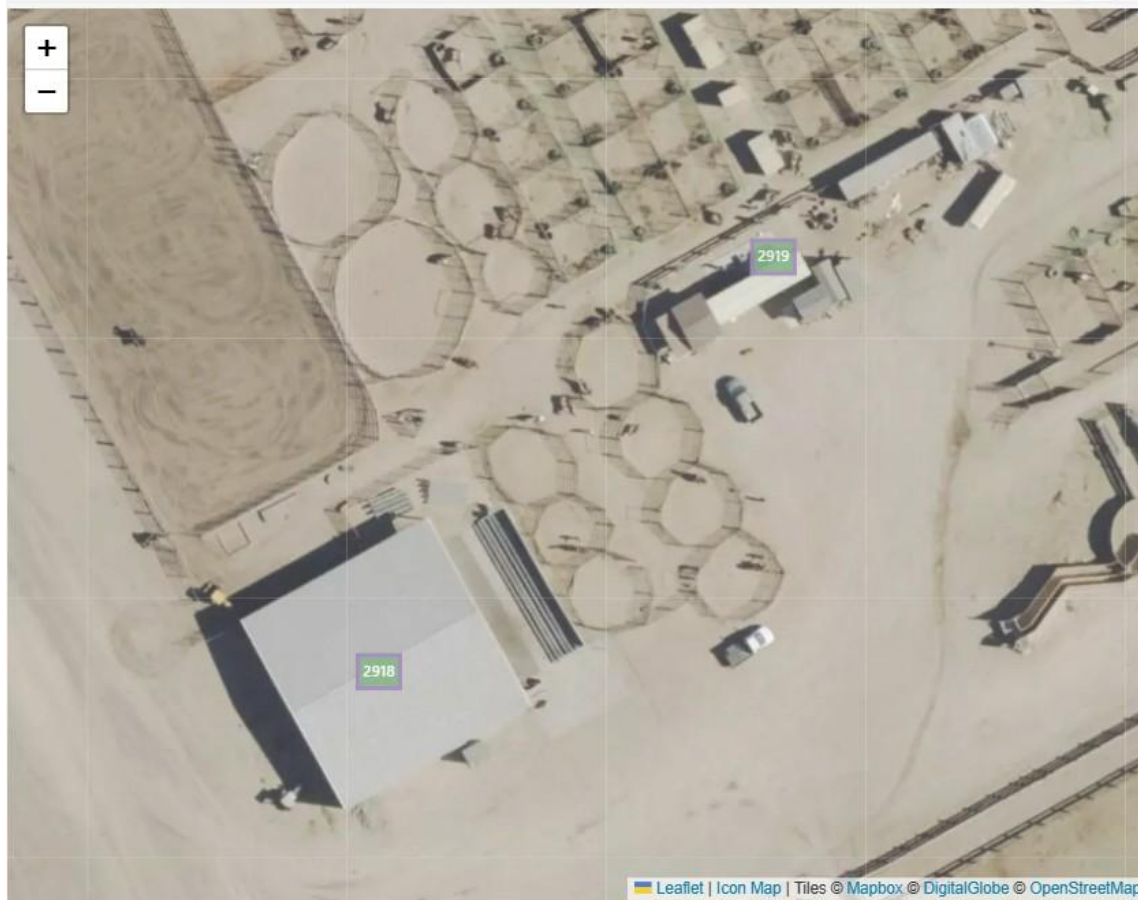
B#	NAME	STATUS	RIGHTS
2918	WILD HORSE ARENA	OCCUPIED	OWNED
2919	WILD HORSE OFFICE	OCCUPIED	OWNED
