State of Nevada Employment, Training and Rehabilitation Facility Condition Analysis

WASHOE CASUAL LABOR OFFICE

420 Galletti Way Reno, Nevada 89431

Site Number: 9847 STATE OF NEVADA PUBLIC WORKS DIVISION FACILITY CONDITION ANALYSIS

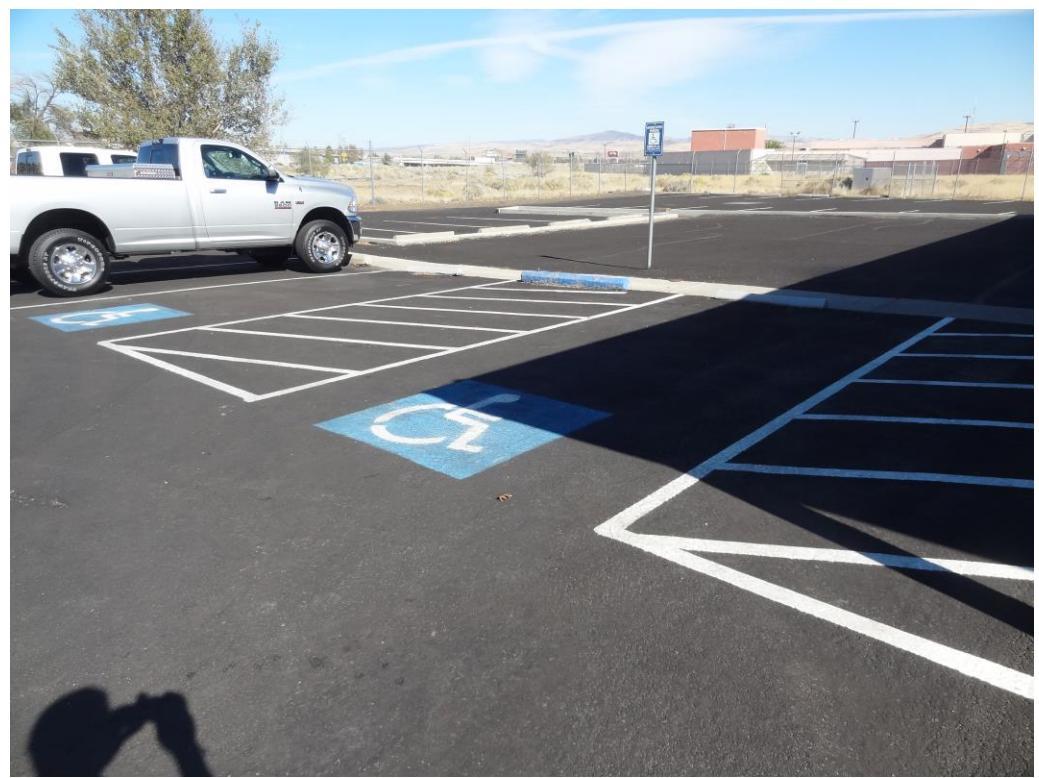
The ADA provides for accessibility to sites and services for people with physical limitations. A concrete parking area, passenger loading area and path of travel to the office are necessary to comply with ADA accessibility requirements. This project would provide for a concrete van accessible ADA parking and loading space and concrete walkway to the existing sidewalk. This will require regrading, placement of P.C. concrete, signage, striping and any other necessary upgrades. The 2012 IBC, ICC/ANSI A117.1 - 2009, NRS 338.180 and the most current version of the ADA Standards for Accessible Design were used as references for this project. 750 square feet of concrete was used for this estimate. It is recommended that this project coincide with the paving project.

Washoe Casual Labor Office – Site #9847 Description: ADA accessible path of travel needed.

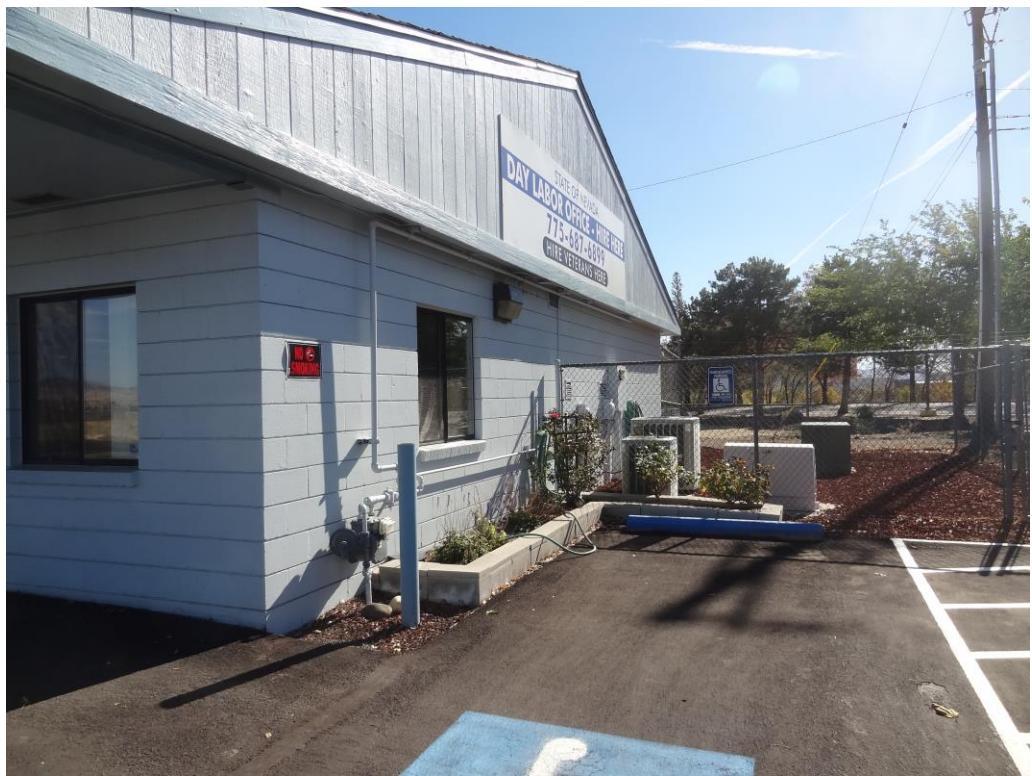
to entering the building. This estimate is based on the manufacturer Pacific Seismic Products or approved equal, and/or with an audible alarm). The gas piping immediately adjacent to the seismic gas valve shall be secured to the building utilizing unistrut channel bracing.

This project would provide for the installation of a seismic gas shut-off valve on the main gas service piping just prior equipped with the optional Model MS remote monitoring switch (to be interfaced with the direct digital control system

Washoe Casual Labor Office – Building #1473 Description: Seismic gas shut-off valve installation needed.

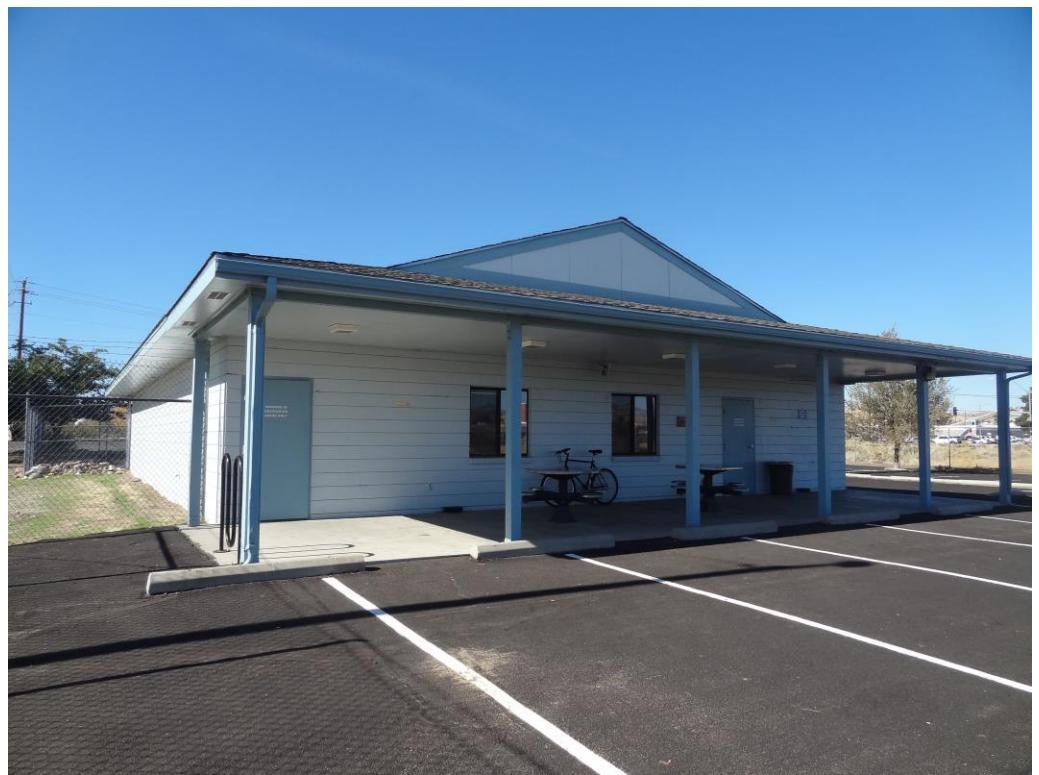
It is important to maintain the finish, weather resistance and appearance of the building. This project would provide funding to protect the exterior of the building excluding the roof. Included in the cost is painting the concrete masonry unit walls and caulking of the windows, flashing, fixtures and all other penetrations. It is recommended that the building be painted and caulked in the next 4-5 years and that this project be scheduled on a cyclical basis to maintain the integrity of the structure.

Washoe Casual Labor Office - Building #1473 Description: Exterior finishes.

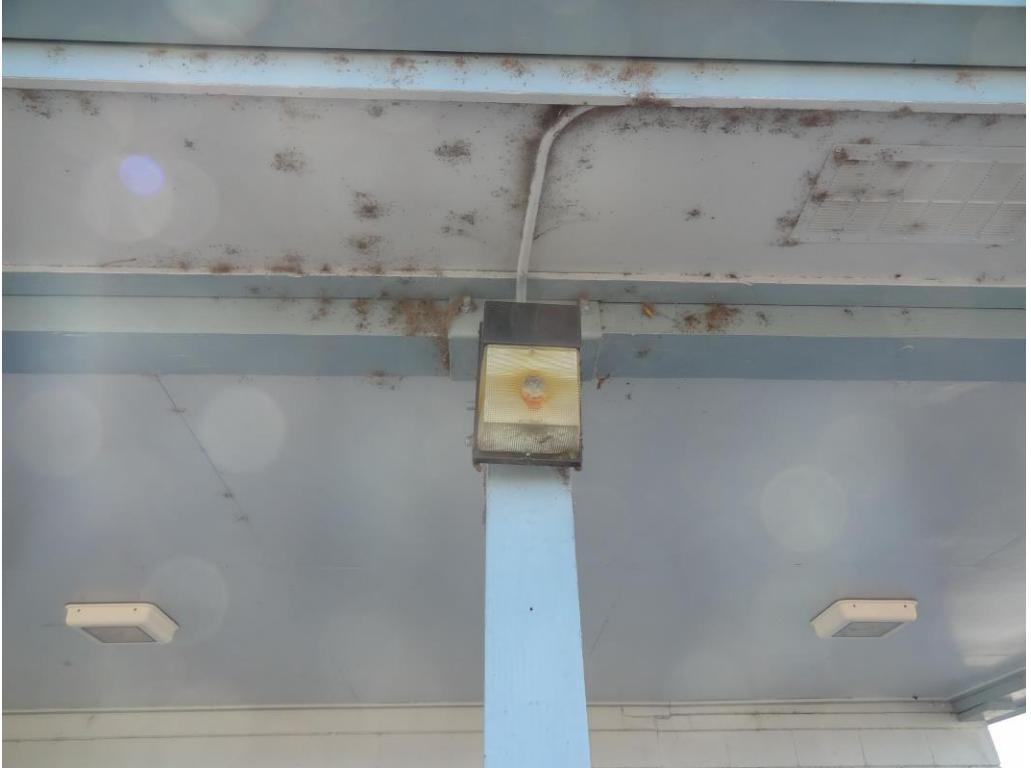
The building has perimeter lighting on the exterior of the building, but the light fixtures are old and not energy efficient. This project would provide for the replacement of the exterior lighting fixtures with new LED light fixtures, using existing wiring.

Washoe Casual Labor Office - Building #1473 Description: Exterior lighting replacement needed.

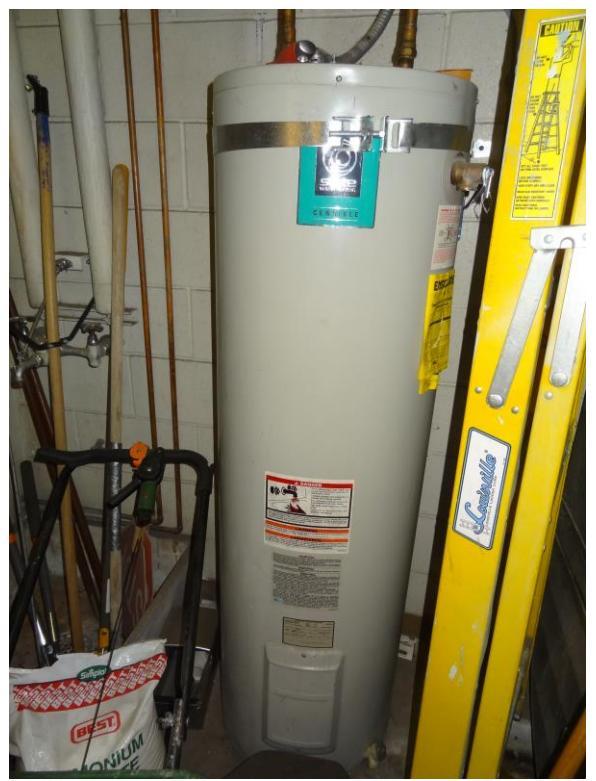
There are two natural gas fired water heaters in the building. One is a 50 gallon and the other is a 40 gallon water heater. The average life span of a water heater is eight to ten years. With the passage of time and constant use, these units are showing signs of wear and should be scheduled for replacement in the next 2-3 years. It is recommended that the new natural gas fired water heaters be installed. Removal and disposal of the existing equipment is included in this estimate.

Washoe Casual Labor Office - Building #1473 Description: Water heater replacement needed.

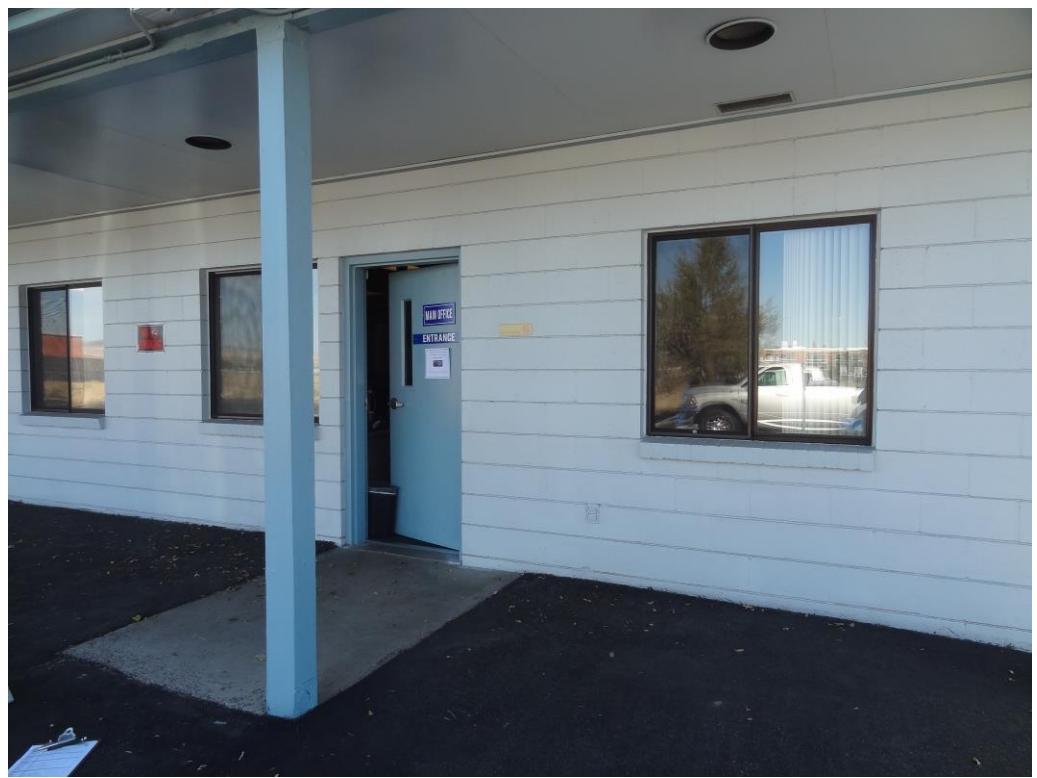
The windows are original, double pane construction in metal frames. These older windows are drafty and not energy efficient. This project recommends replacing the windows with dual pane, higher efficiency units. This estimate is for the replacement of 7 units. Removal and disposal of the existing windows is included in this estimate.

Washoe Casual Labor Office - Building #1473 Description: Window replacement needed.
